APPENDIX H

PIPELINE REMOVAL DOCUMENTS

Building Feature Documentation Log
Feature Number: B1-2-001
Santa Susana Field Laboratory, Ventura County, California

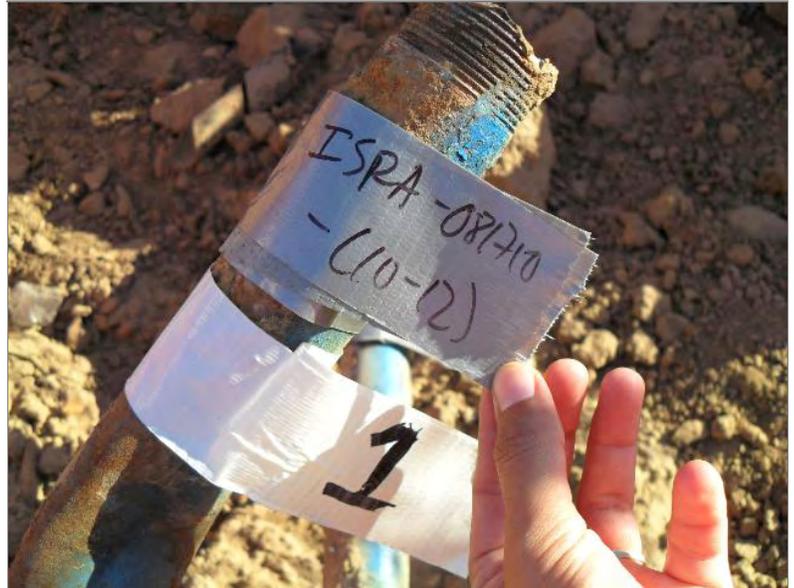
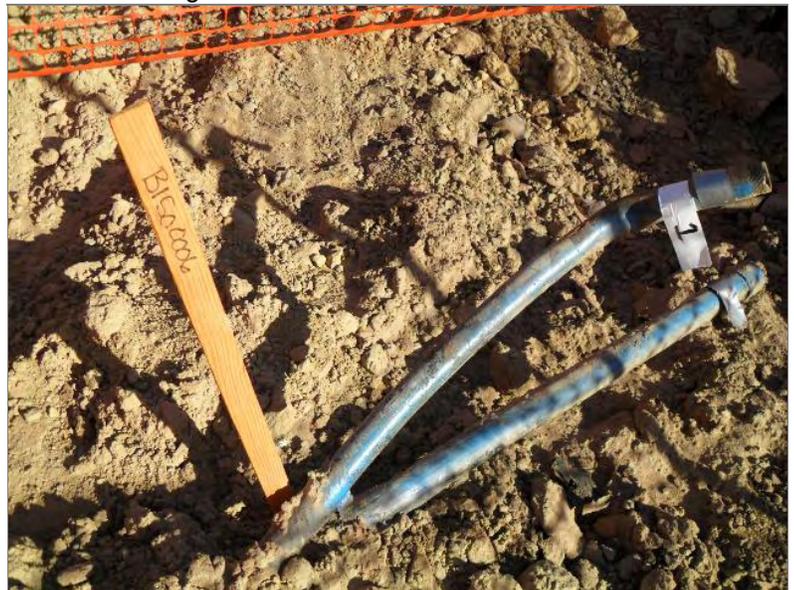
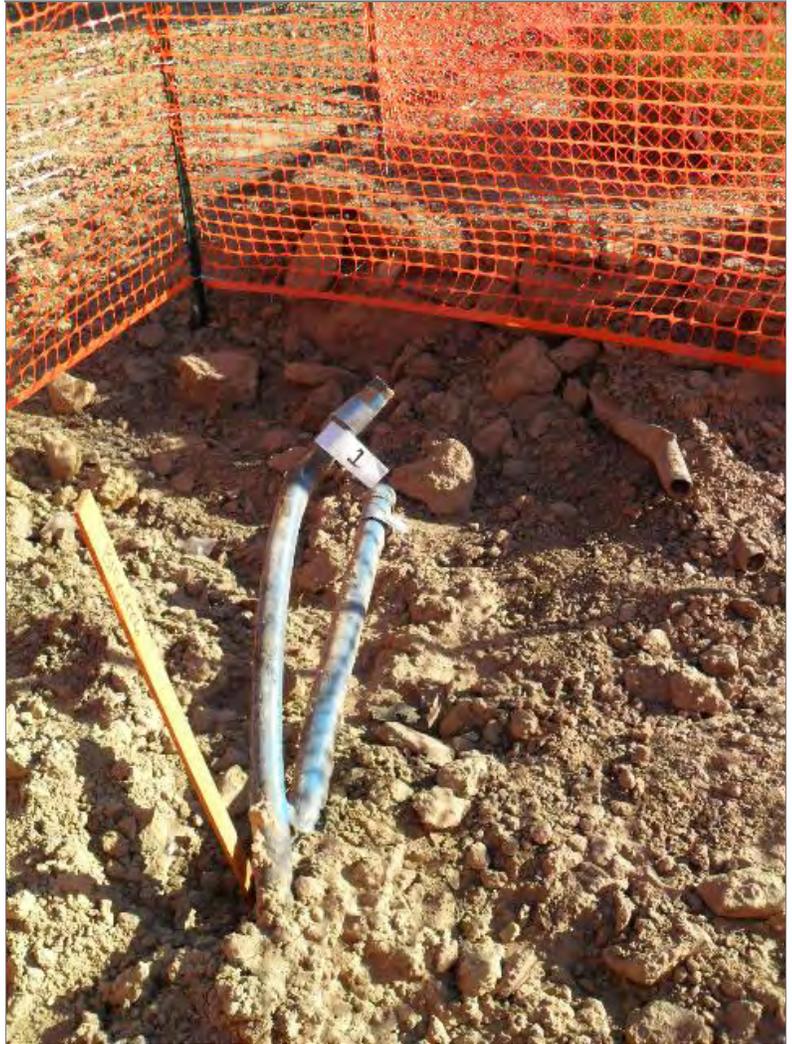
Feature Type: **Pipelines (2): Electric**
Operational Use / Process: **Conduits**
Associated Chemicals: **None**
Discharge: **No**
Size: **2-inch and 1-1/2-inch**
Construction Material: **Metal with black pipe wrapping. Pipe is painted blue beneath wrapping.**
Status: **Partially removed**

General Condition: **Intact**
Debris: **No**
Staining: **No**
Odor: **No**
PID Reading: **N/A**
Likelihood of Impact from Feature: **Potential from pipe wrapping.**

Sampling Warranted?: **Yes**
Sampling Description/Notes: **Collected sample of pipe wrapping.**
Sampling Type: **Solid**
Sample ID Number(s): **B1SO0006 and ISRA-081710-(10-12)**
Analyses: **PCBs and asbestos. PCB-1254 - 0.200 mg/kg (1.4 x HH RBSL, 2.6 x Eco RBSL); PCB-1260 - 0.090 mg/kg (1.2 x Eco RBSL); Asbestos detected.**

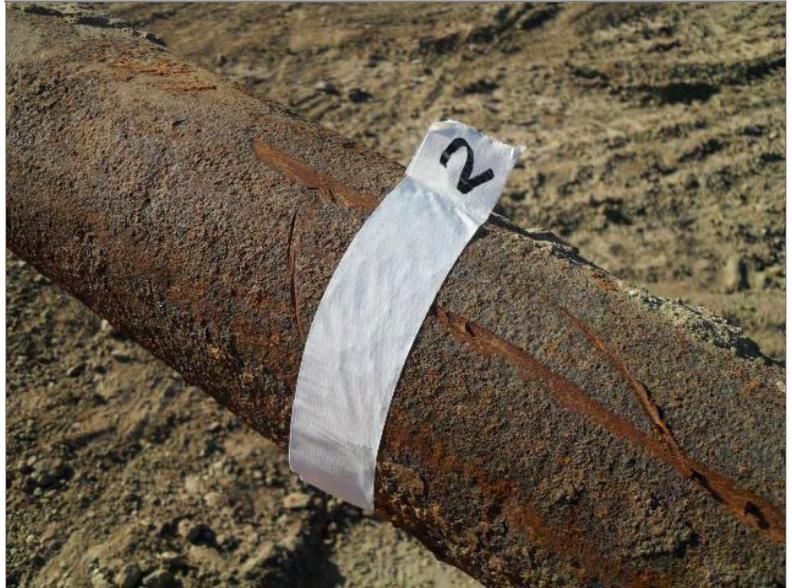
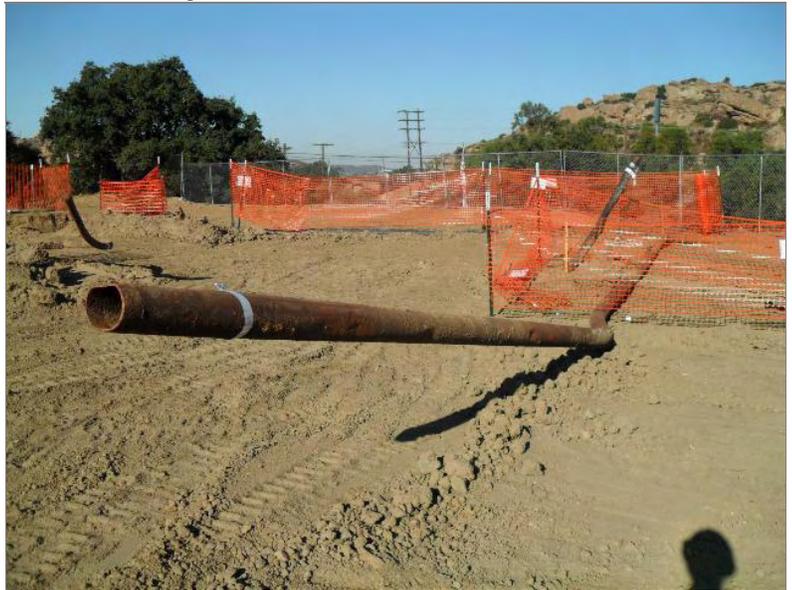
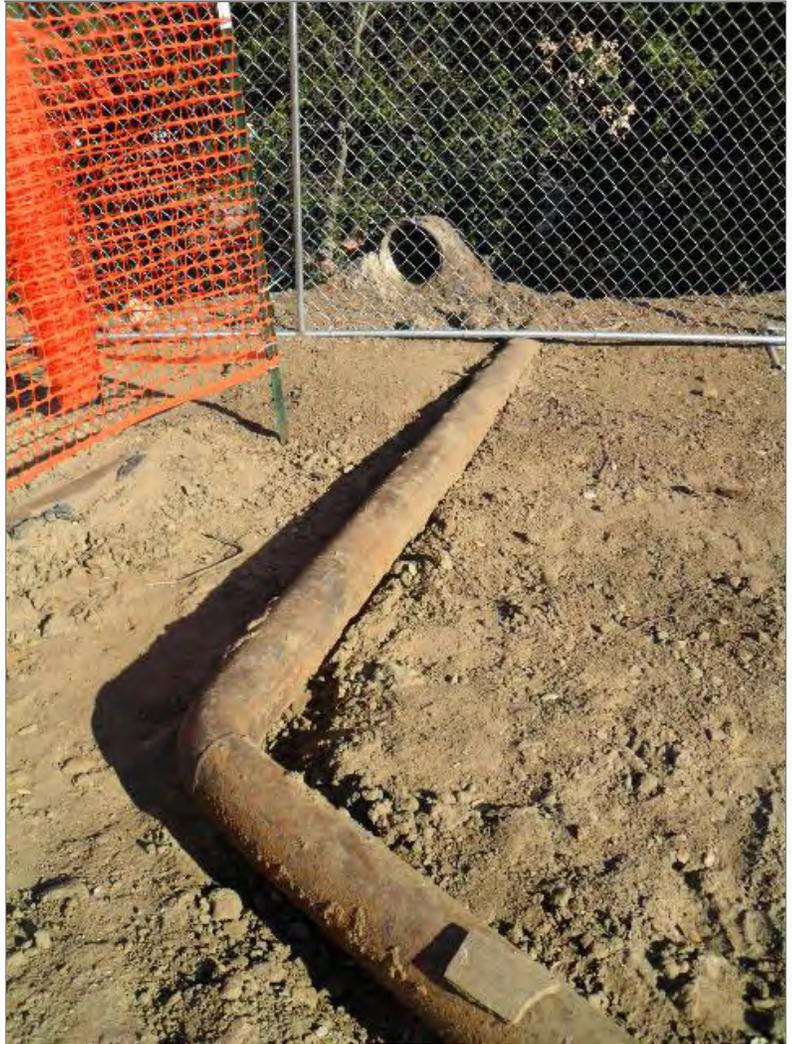
Feature Type: **Pipeline: Water**
Operational Use / Process: **Water conveyance to test stand**
Associated Chemicals: **None**
Discharge: **Unknown**
Size: **6-inch**
Construction Material: **Metal**
Status: **Partially removed**

General Condition: **Intact**
Debris: **No**
Staining: **No**
Odor: **No**
PID Reading: **N/A**
Likelihood of Impact from Feature: **Unlikely**

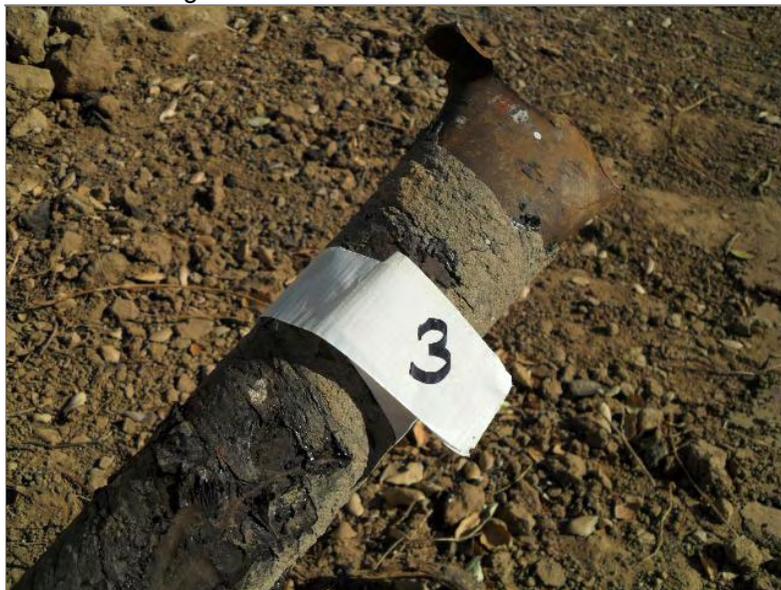
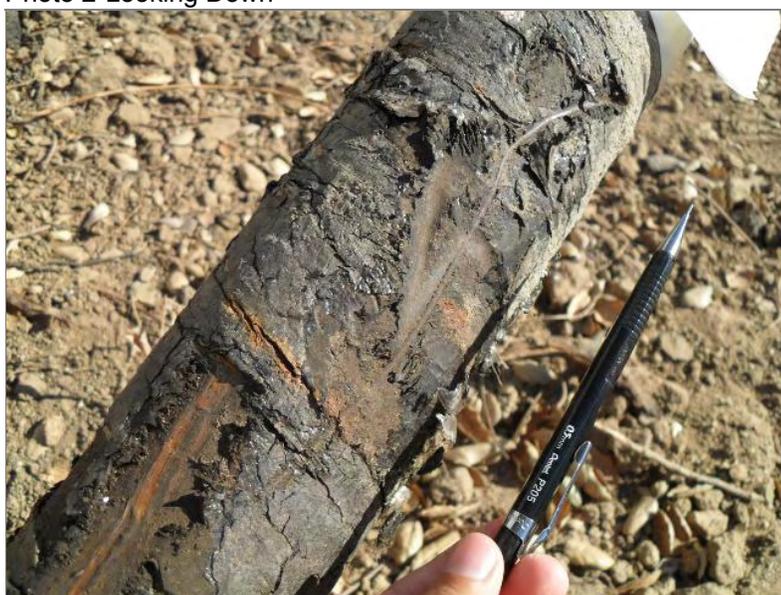
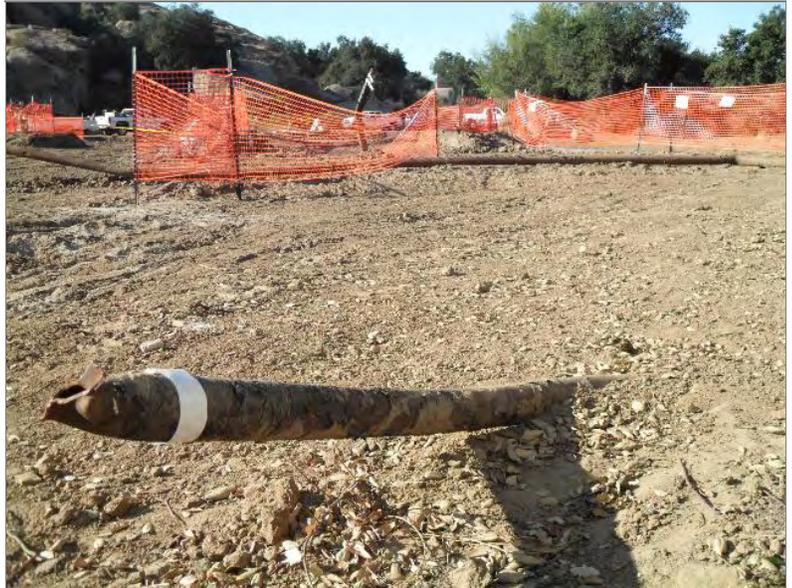
Feature Type: **Pipeline: Test Wires**
Operational Use / Process: **Conduits**
Associated Chemicals: **None**
Discharge: **No**
Size: **4-inch**
Construction Material: **Metal with black material coating.**
Status: **Partially removed**

General Condition: **Intact**
Debris: **No**
Staining: **No**
Odor: **No**
PID Reading: **N/A**
Likelihood of Impact from Feature: **Unlikely**

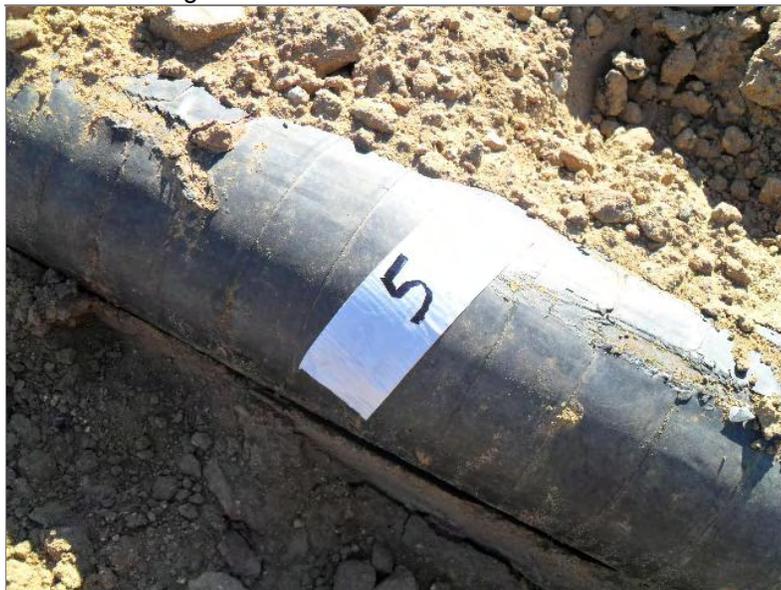
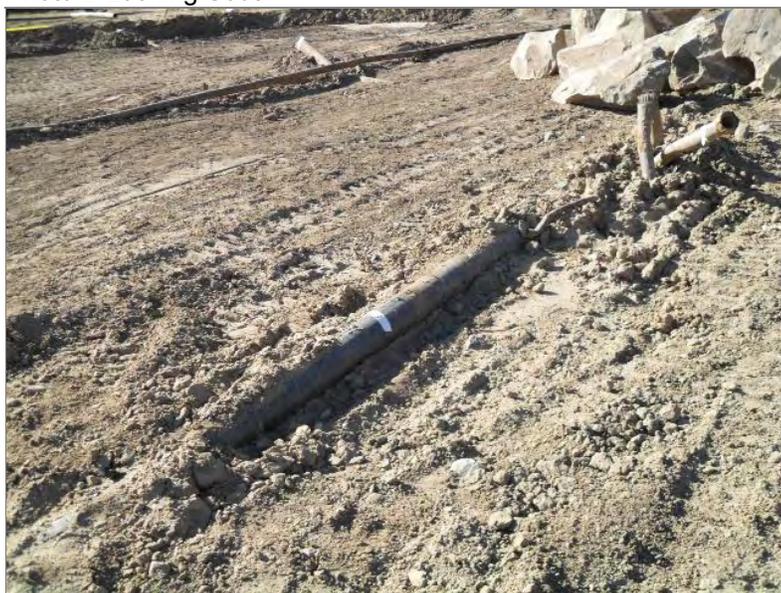
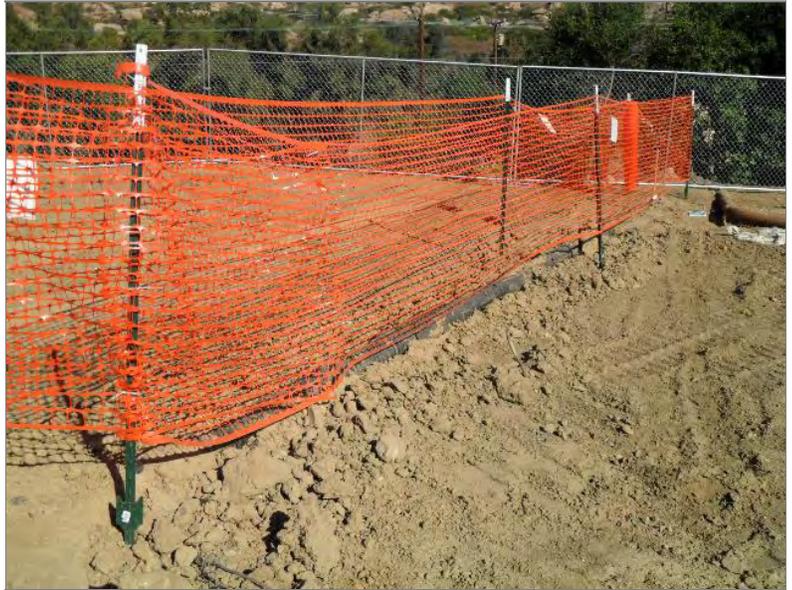
Feature Type: **Pipeline: Water**
Operational Use / Process: **Water conveyance**
Associated Chemicals: **None**
Discharge: **No**
Size: **6-inch to 8-inch**
Construction Material: **Metal with black plastic-like wrapping.**
Status: **Partially removed**

General Condition: **Intact**
Debris: **No**
Staining: **No**
Odor: **No**
PID Reading: **N/A**
Likelihood of Impact from Feature: **Potential from pipe wrapping.**

Sampling Warranted?: **Yes**
Sampling Description/Notes: **Collected sample of pipe wrapping.**
Sampling Type: **Solid**
Sample ID Number(s): **B1S00003**
Analyses: **PCBs, PCB-1254 - 22 mg/kg (282 x Eco RBSL, 157 x HH RBSL).**

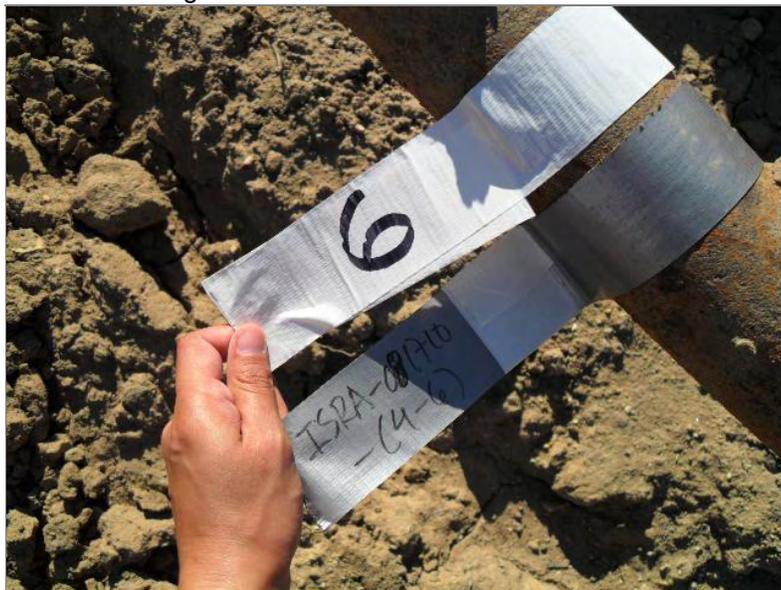
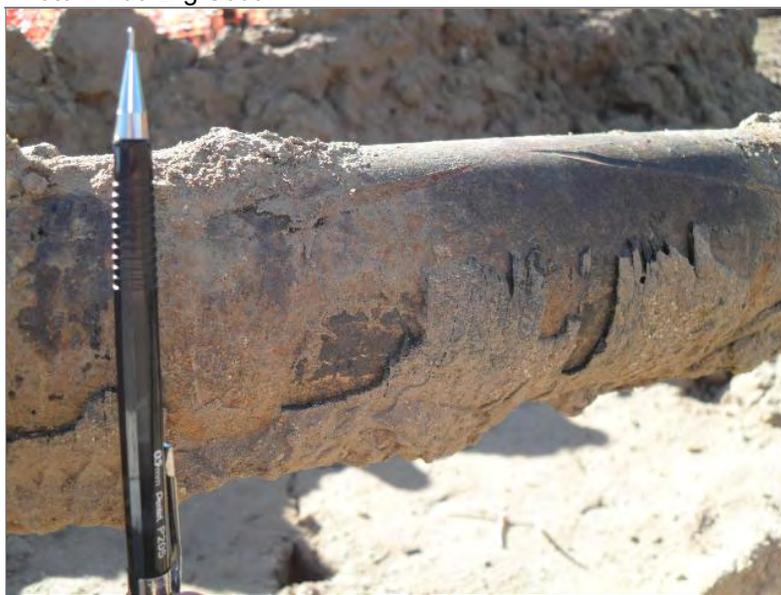
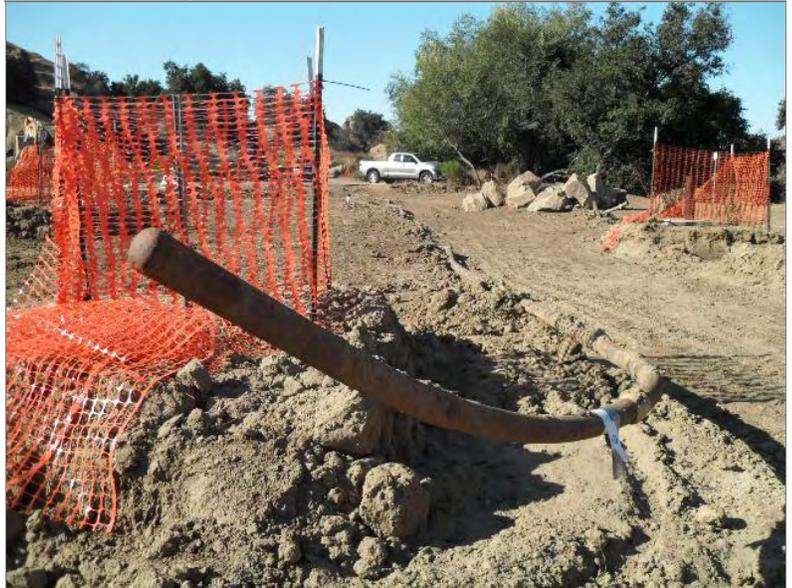
Feature Type: **Pipeline: Water**
Operational Use / Process: **Water conveyance**
Associated Chemicals: **None**
Discharge: **Unknown**
Size: **3-inch**
Construction Material: **Metal with black pipe wrapping**
Status: **Partially removed**

General Condition: **Intact**
Debris: **No**
Staining: **No**
Odor: **No**
PID Reading: **N/A**
Likelihood of Impact from Feature: **Potential from pipe wrapping**

Sampling Warranted?: **Yes**
Sampling Description/Notes: **Collected sample of pipe wrapping**
Sampling Type: **Solid**
Sample ID Number(s): **B1S00004 and ISRA-081710-(4-6)**
Analyses: **PCBs and asbestos: PCB-1254 - 0.16 mg/kg (1.1 x HH RBSL, 2.1 x Eco**

RBSL); PCB-1260 - 0.110 mg/kg (1.4 x Eco
RBSL); Asbestos not detected.

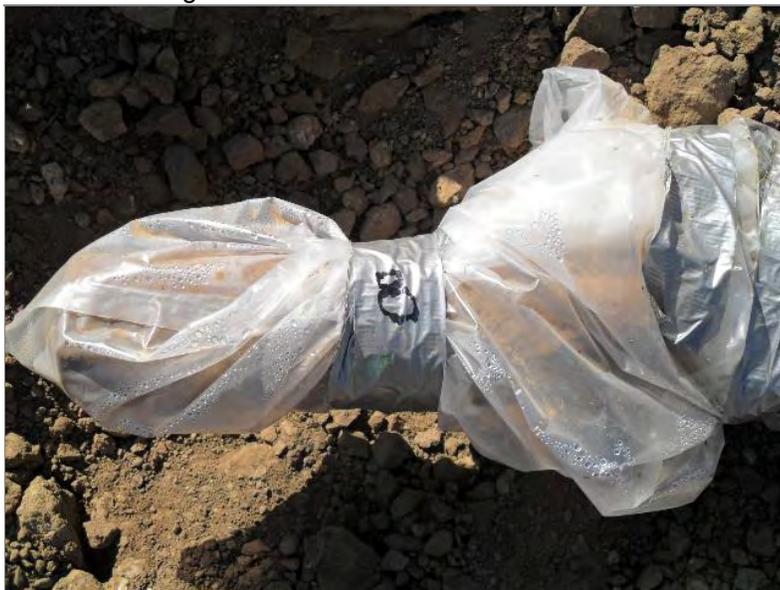
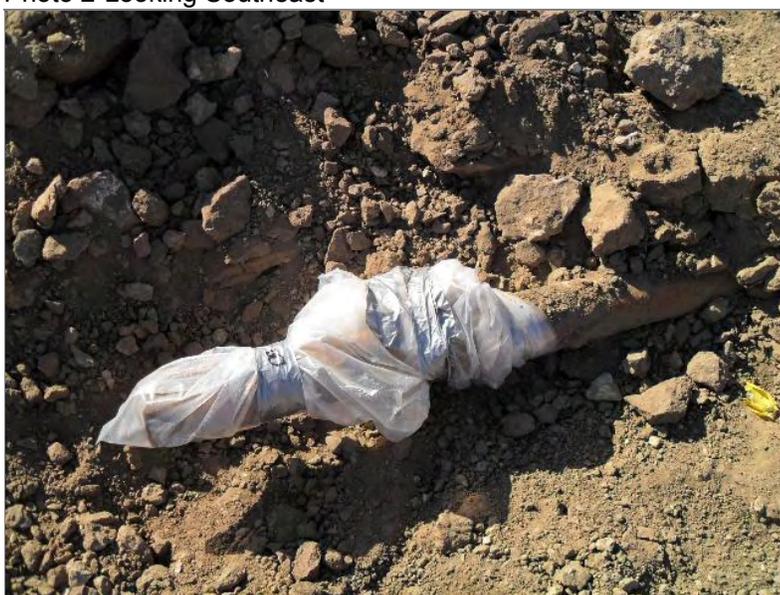
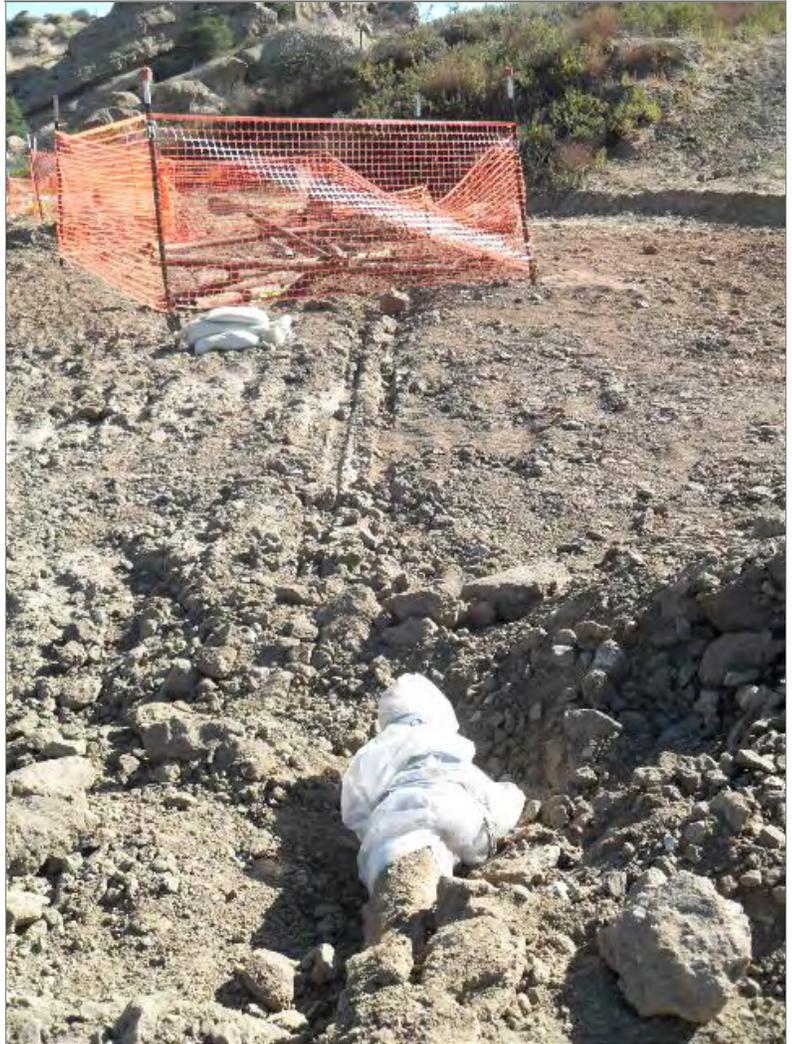
Feature Type: **Pipelines (2): Fuel**
Operational Use / Process: **Hazardous material conveyance**
Associated Chemicals: **Petroleum Fuel**
Discharge: **Unknown**
Size: **3 1/2-inch**
Construction Material: **Metal**
Status: **Partially removed**

General Condition: **Intact, some liquid was present within the pipe.**
Debris: **No**
Staining: **Yes**
Odor: **Yes**
PID Reading: **Up to 1076 ppm within the pipe**
Likelihood of Impact from Feature: **Potential**

Sample ID Number(s): N/A
Analyses: Alpha, beta, gamma. All not detected.

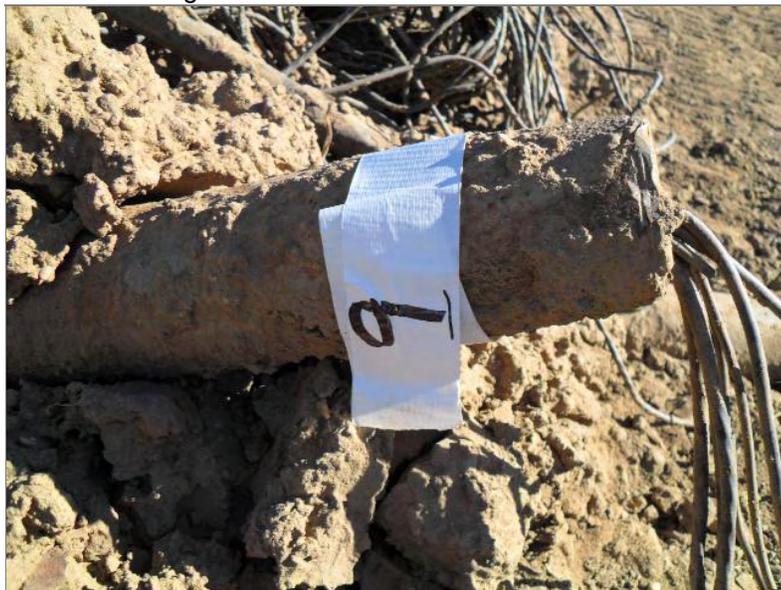
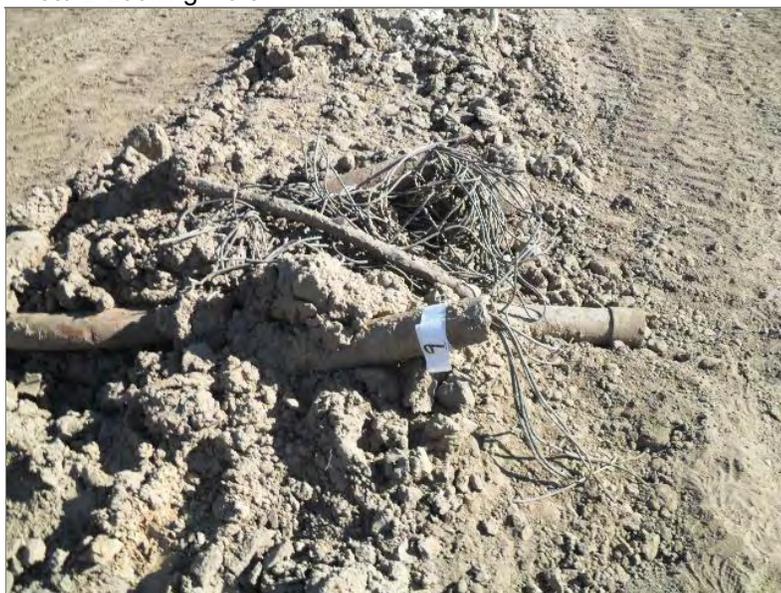
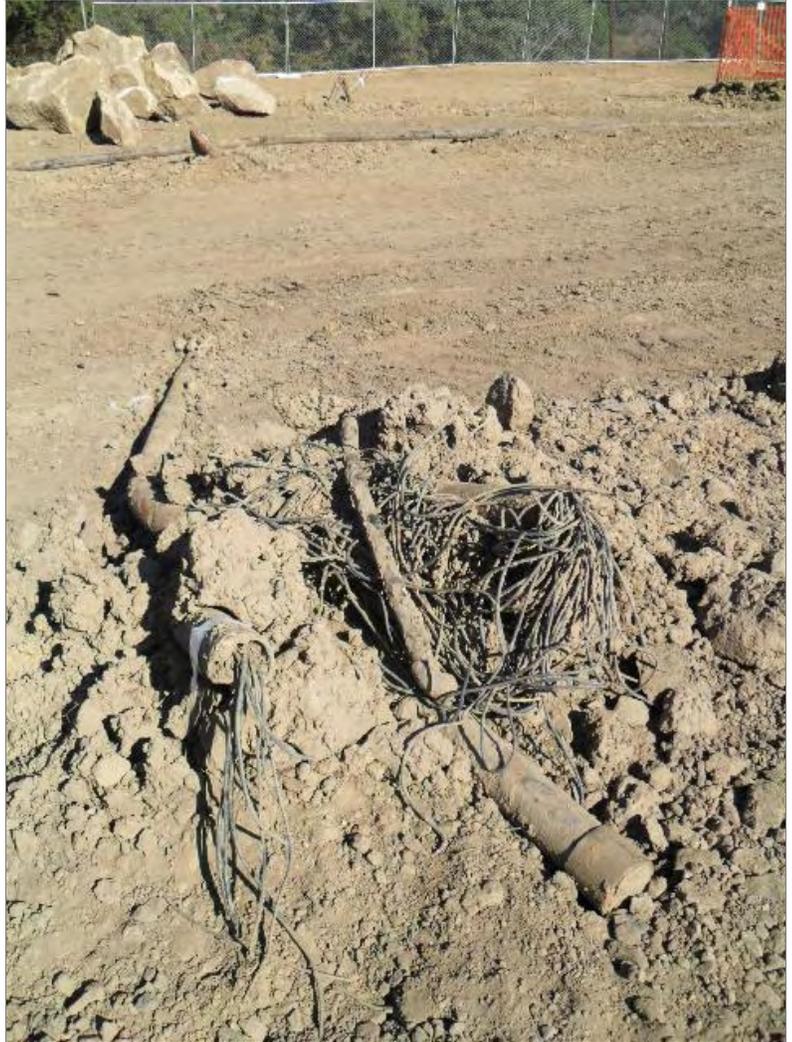
Feature Type: **Pipelines (3): Electrical**
Operational Use / Process: **Conduits**
Associated Chemicals: **None**
Discharge: **No**
Size: **3 1/2-inch (one in the middle cement plugged and other two open-ended with wires inside)**
Construction Material: **Metal**
Status: **Partially removed**

General Condition: **Intact**
Debris: **No**
Staining: **No**
Odor: **No**
PID Reading: **N/A**
Likelihood of Impact from Feature: **Unlikely**

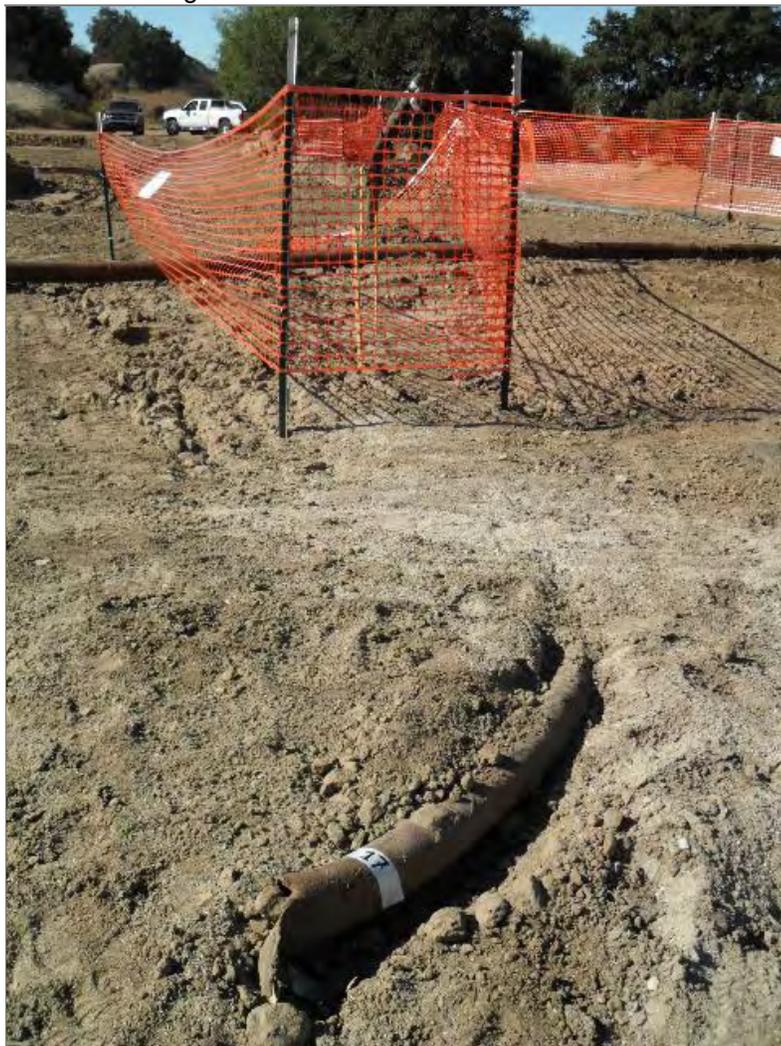
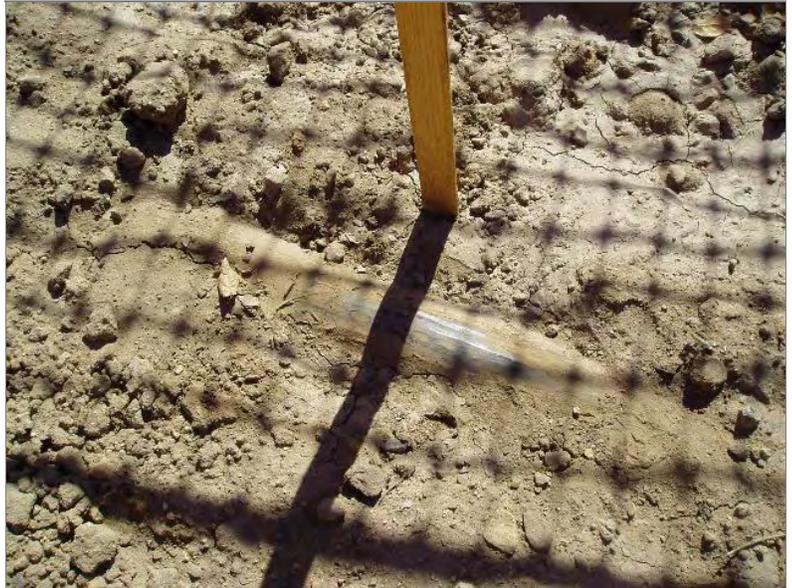
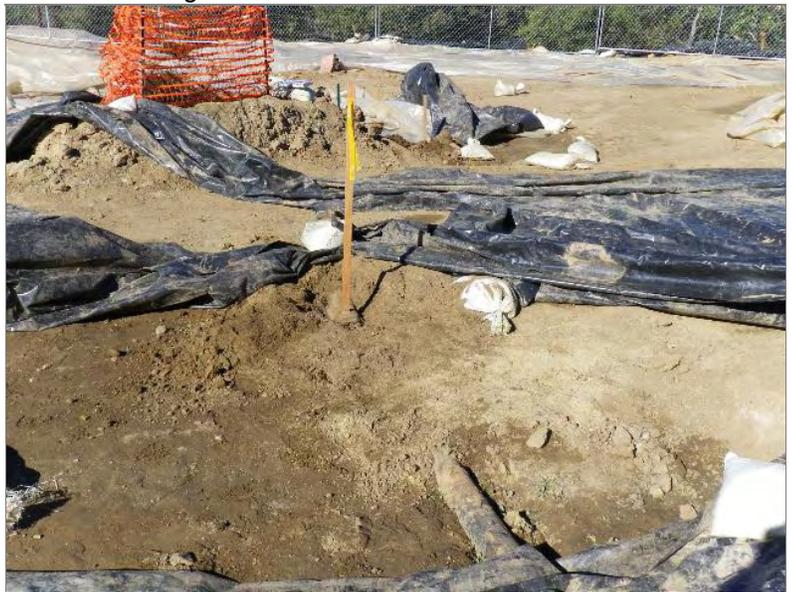
General Condition: **Intact**
Debris: **No**
Staining: **No**
Odor: **No**
PID Reading: **N/A**
Likelihood of Impact from Feature: **Potential from pipe wrapping.**

Sampling Warranted?: **Yes**
Sampling Description/Notes: **Collected sample of pipe wrapping.**
Sampling Type: **Solid**
Sample ID Number(s): **B1SO0005 and ISRA-081710-(7-9)**
Analyses: **PCBs and asbestos. Both not detected.**

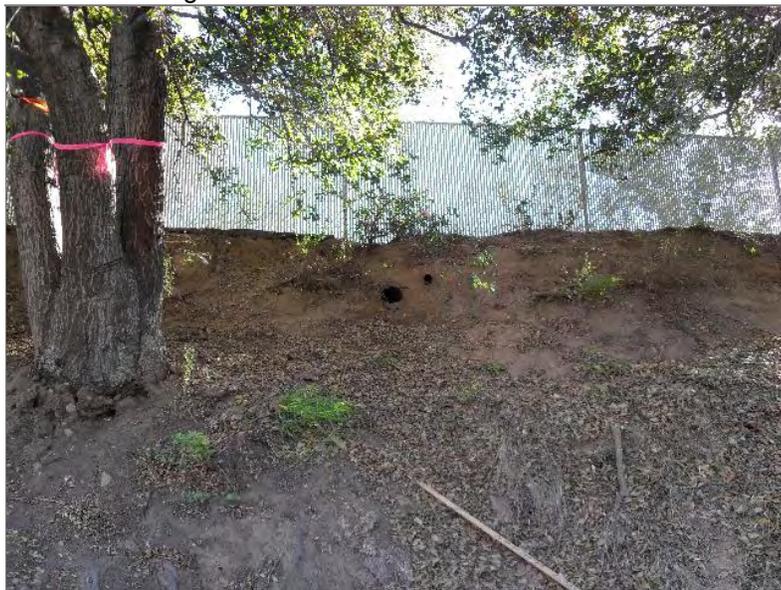
General Condition: **Unknown, majority of pipe buried.**
Debris: **No**
Staining: **No**
Odor: **No**
PID Reading: **N/A**
Likelihood of Impact from Feature: **Unlikely**

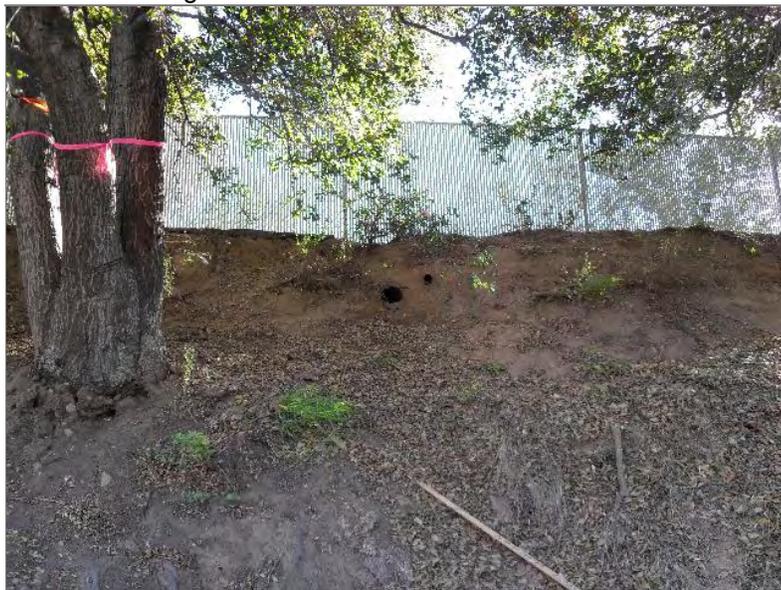
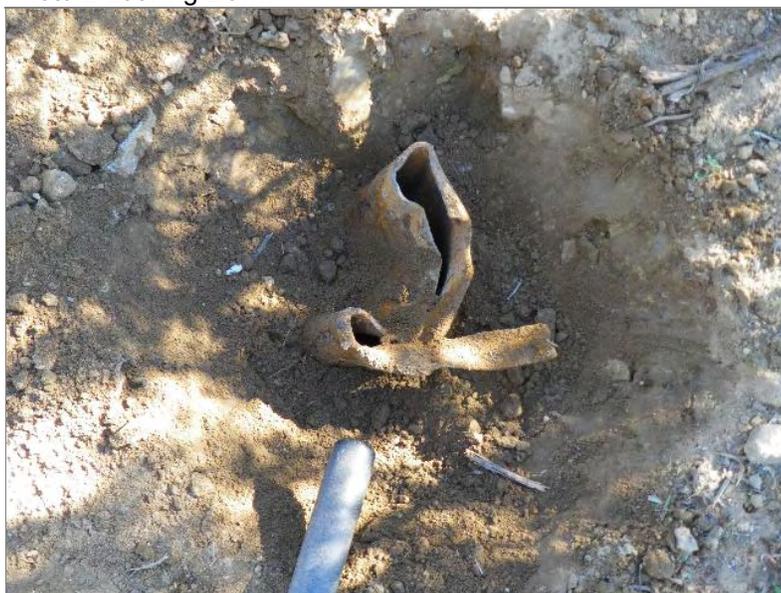
General Condition: **Unknown, majority of pipe buried.**
Debris: **No**
Staining: **No**
Odor: **No**
PID Reading: **N/A**
Likelihood of Impact from Feature: **Unlikely**

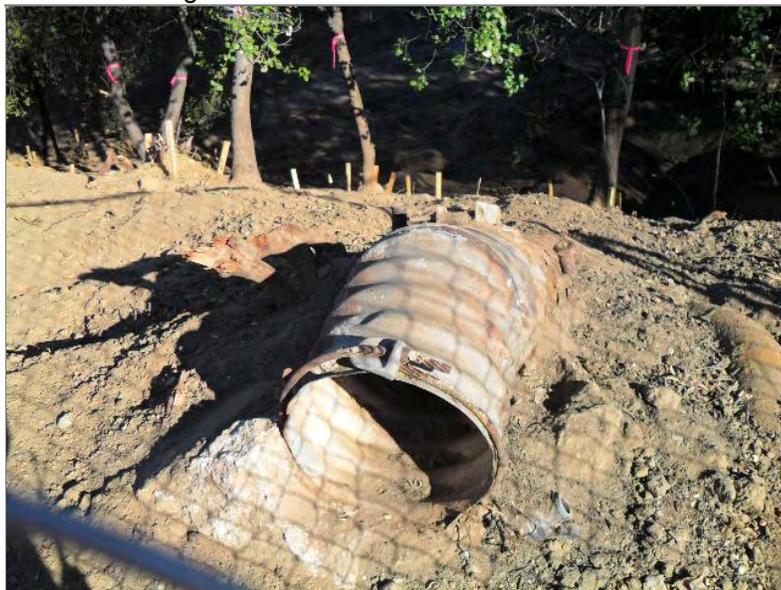
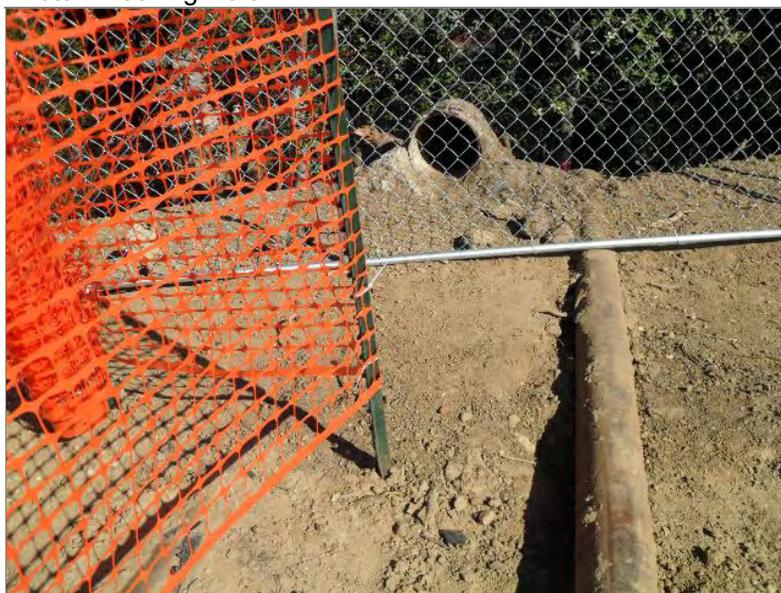
General Condition: **Intact**
Debris: **No**
Staining: **No**
Odor: **No**
PID Reading: **N/A**
Likelihood of Impact from Feature: **Unlikely**

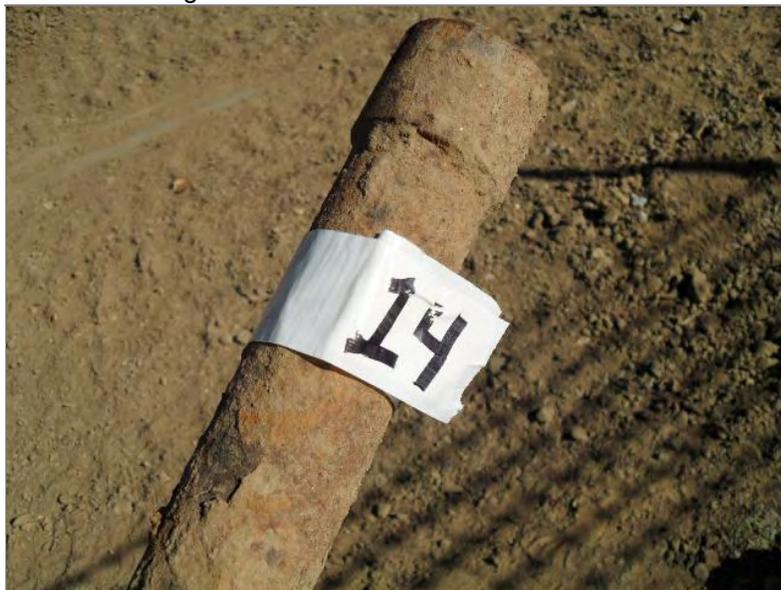
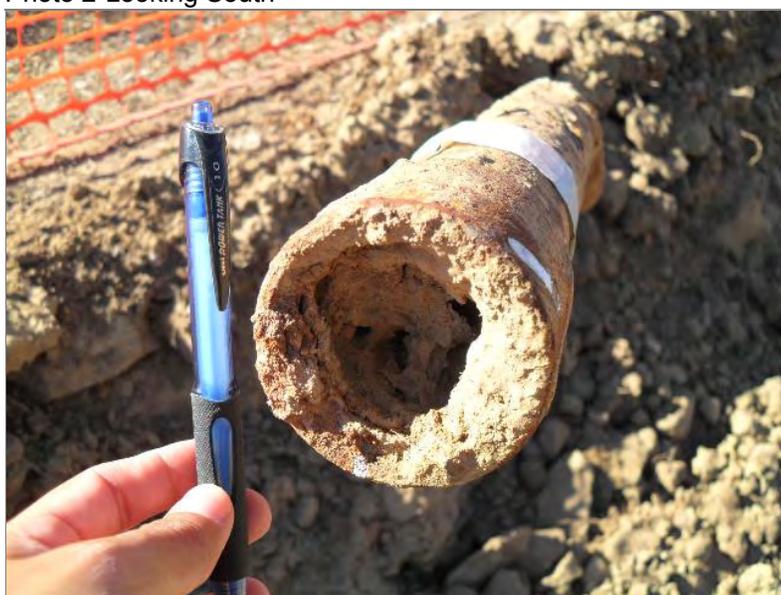
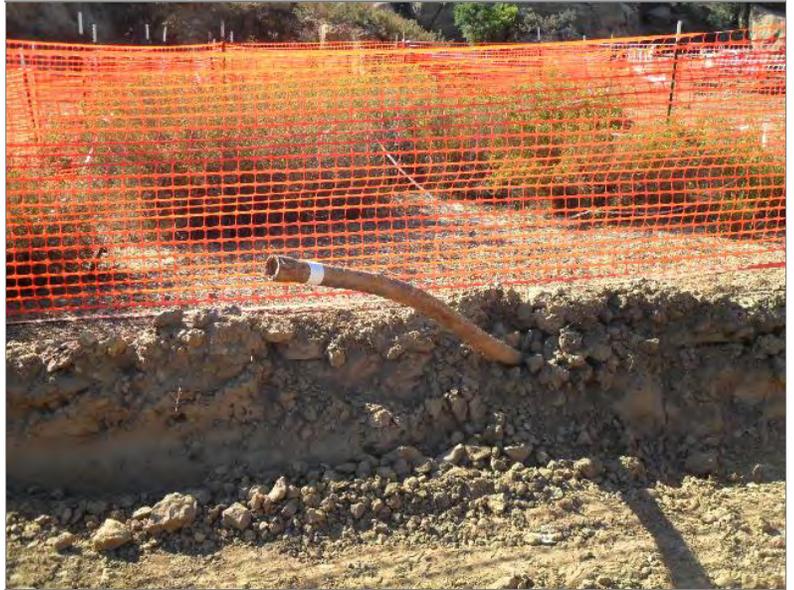
General Condition: Intact
Debris: No
Staining: No
Odor: No
PID Reading: N/A
Likelihood of Impact from Feature: Unlikely

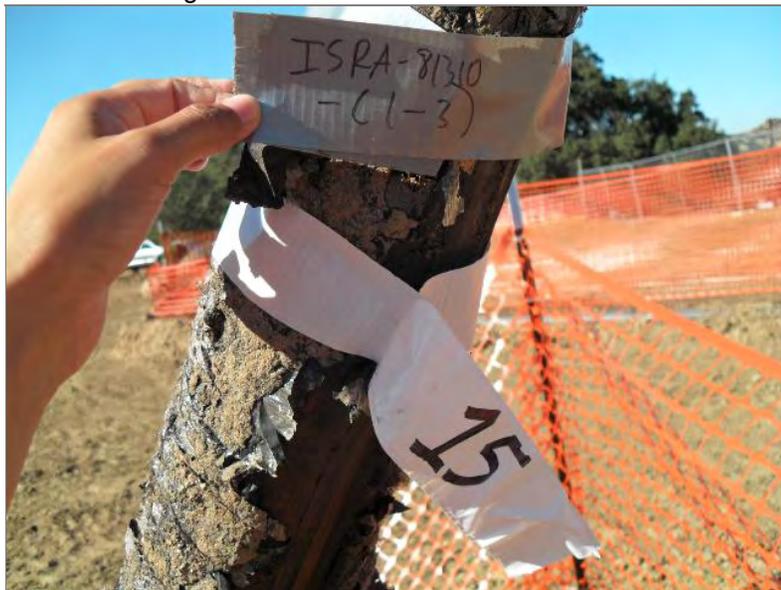
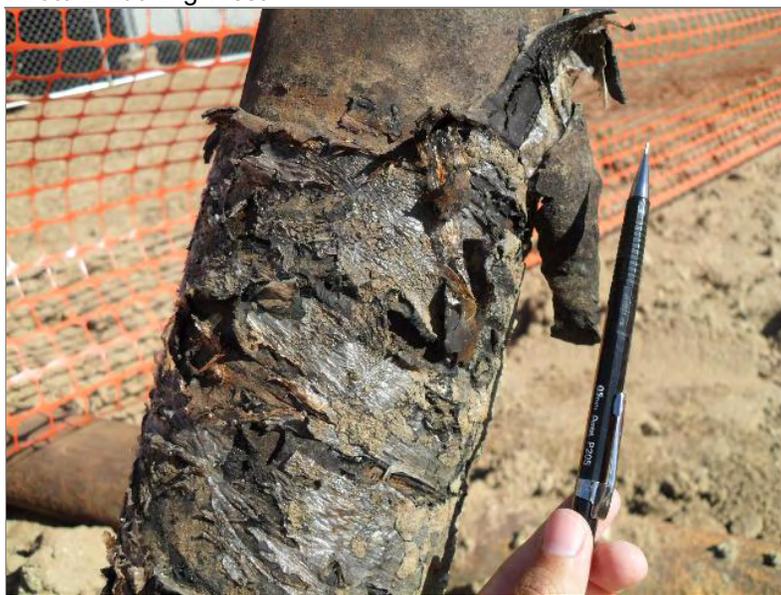
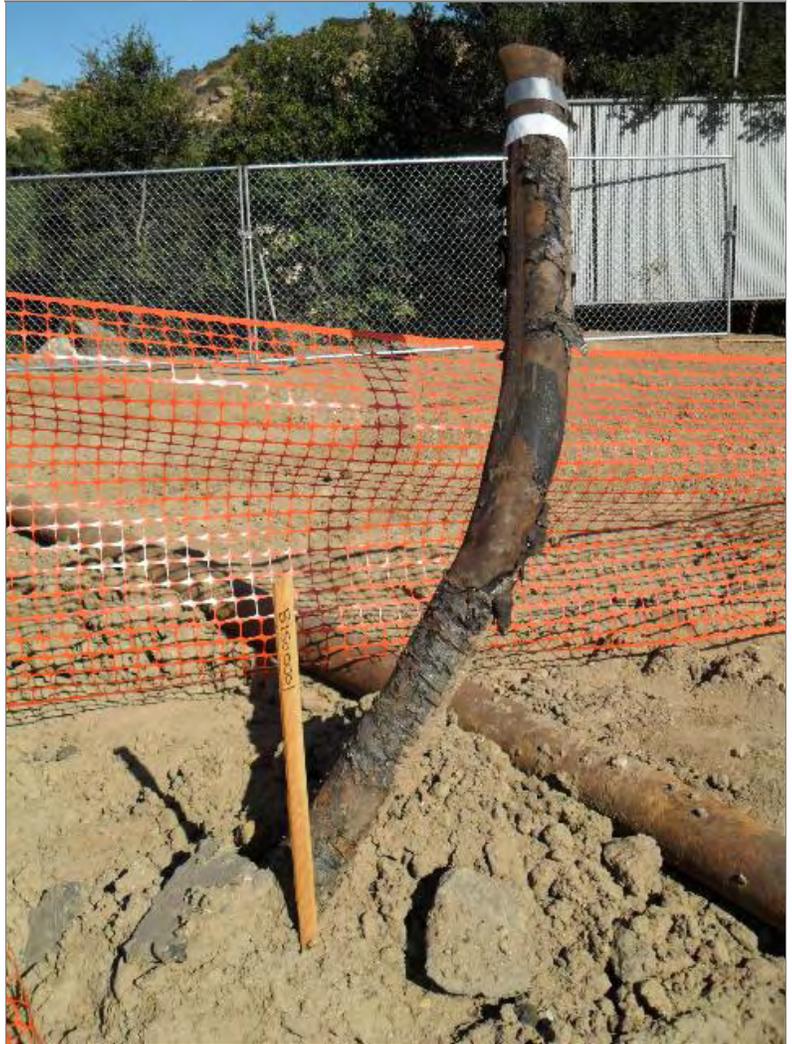
General Condition: **Intact**
Debris: **No**
Staining: **No**
Odor: **No**
PID Reading: **N/A**
Likelihood of Impact from Feature: **Potential from pipe wrapping.**

Sampling Warranted?: **Yes**
Sampling Description/Notes: **Collected sample of pipe wrapping.**
Sampling Type: **Solid**
Sample ID Number(s): **B1S00001 and ISRA-081310-(1-3)**
Analyses: **PCBs and asbestos. Both not detected.**

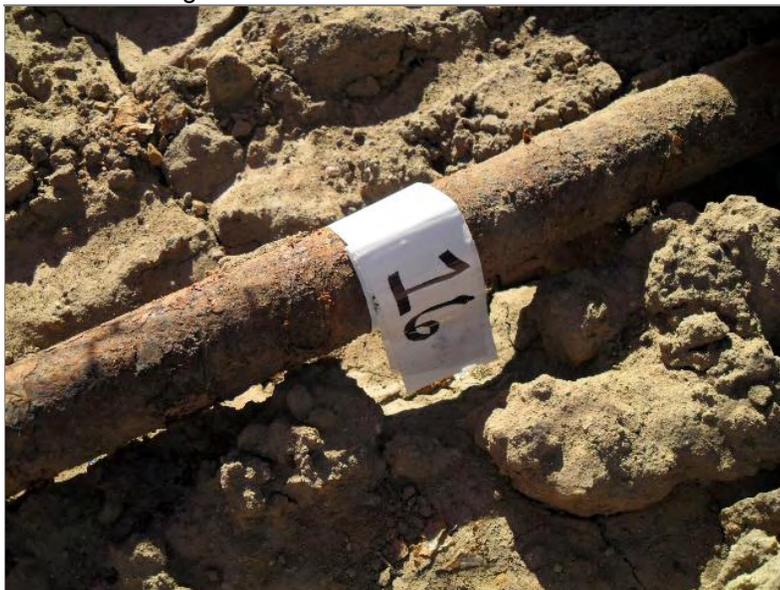
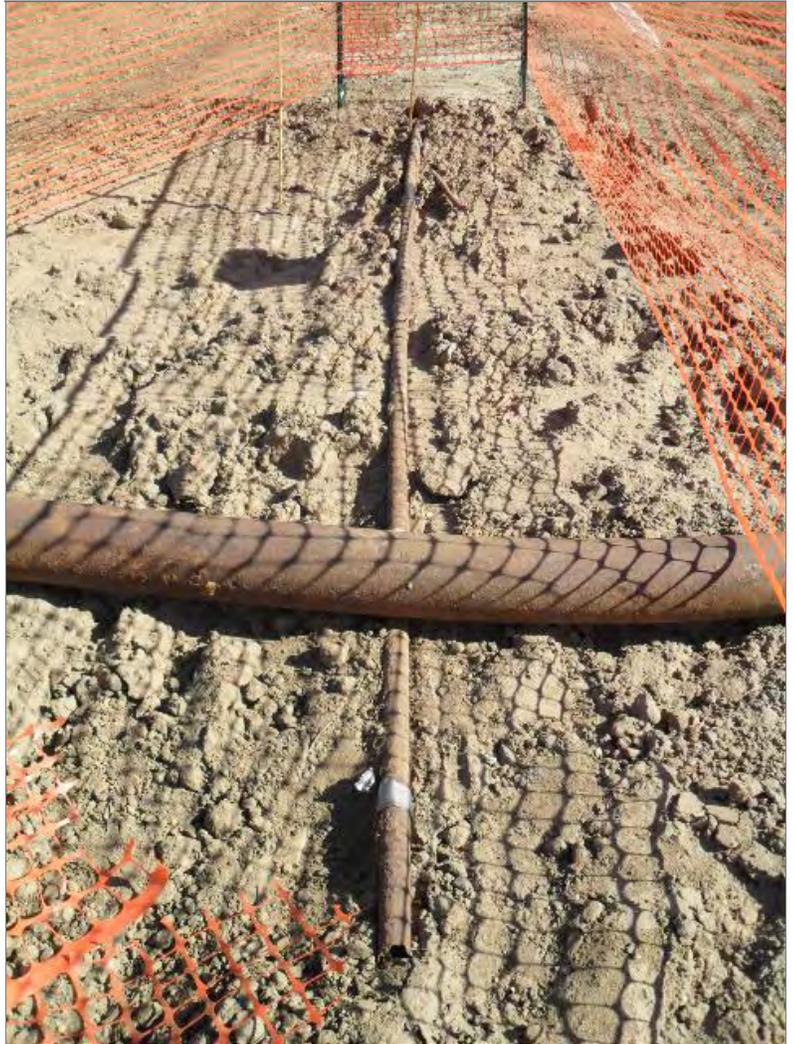
General Condition: Intact
Debris: No
Staining: No
Odor: No
PID Reading: N/A
Likelihood of Impact from Feature: Potential from pipe wrapping.

Sampling Warranted?: Yes
Sampling Description/Notes: Collected sample of pipe wrapping.
Sampling Type: Solid
Sample ID Number(s): B1S00002 and ISRA-081710-(1-3)
Analyses: PCBs and asbestos. Both not detected.

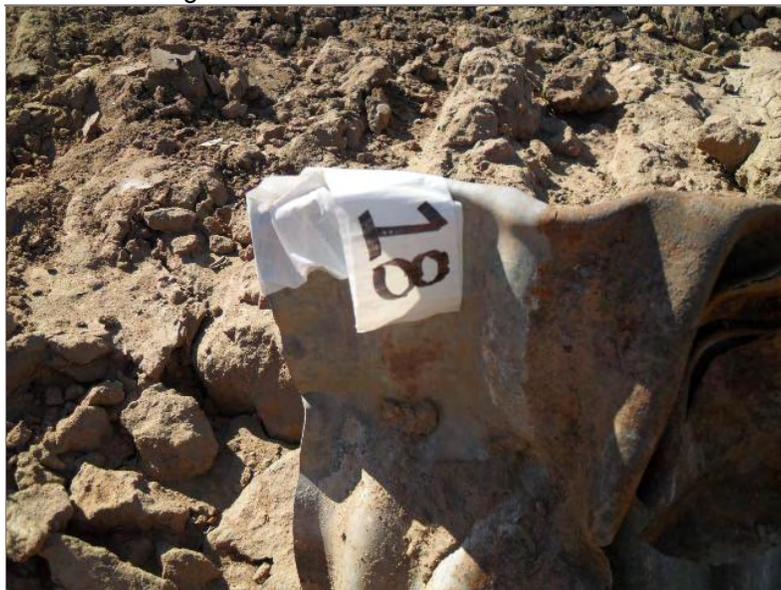
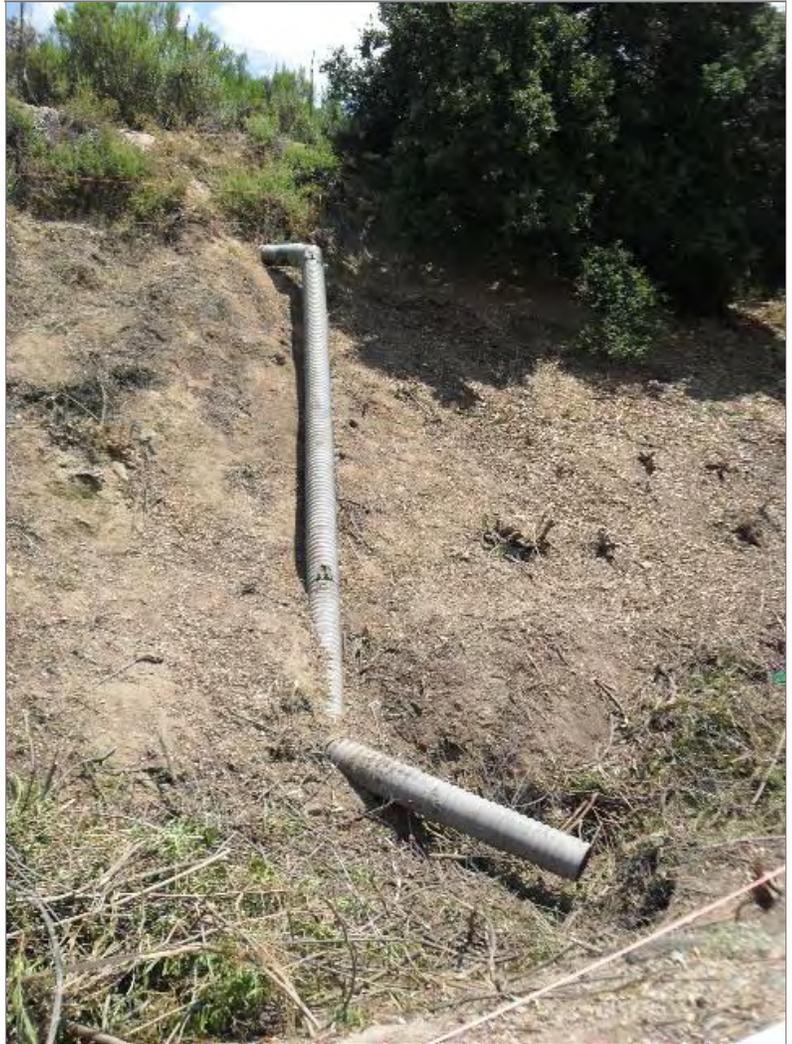
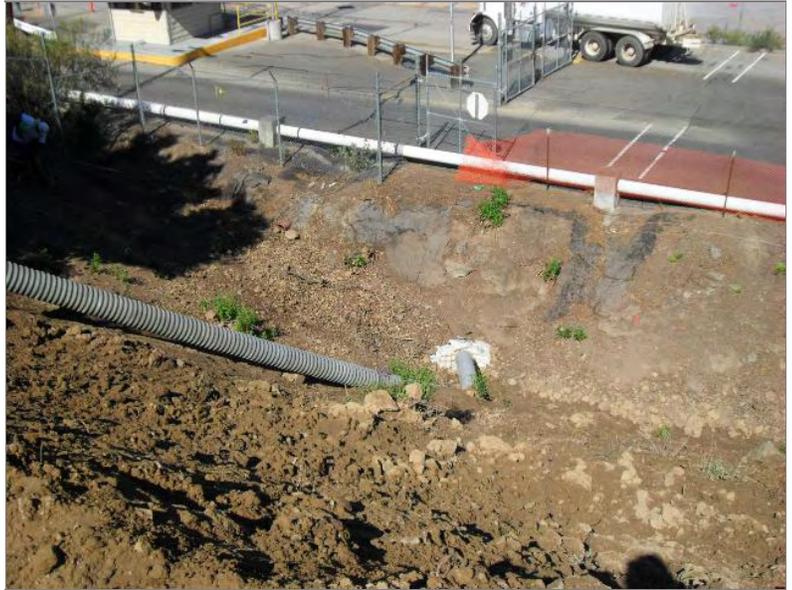
General Condition: **Intact**
Debris: **No**
Staining: **No**
Odor: **No**
PID Reading: **N/A**
Likelihood of Impact from Feature: **Unlikely**
