APPENDIX H

PIPELINE REMOVAL DOCUMENTS

Building Feature Documentation Log
Feature Number: B1-2-001
Santa Susana Field Laboratory, Ventura County, California

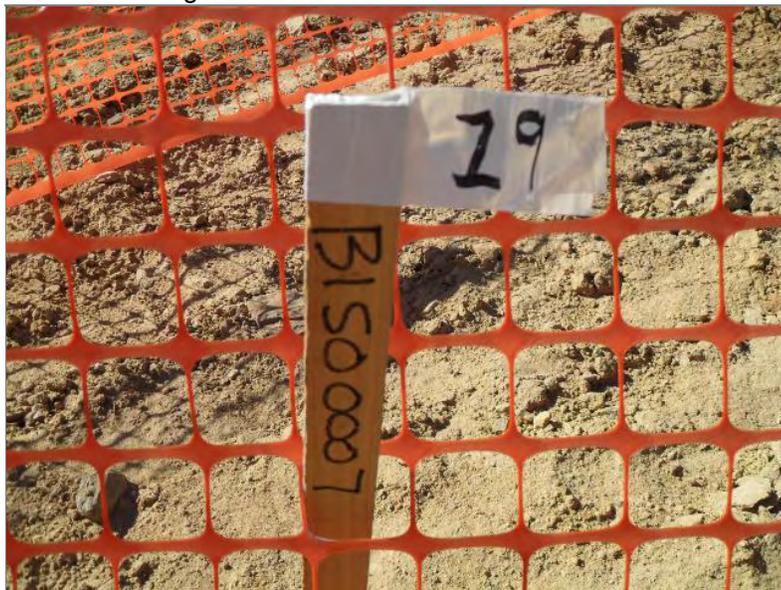
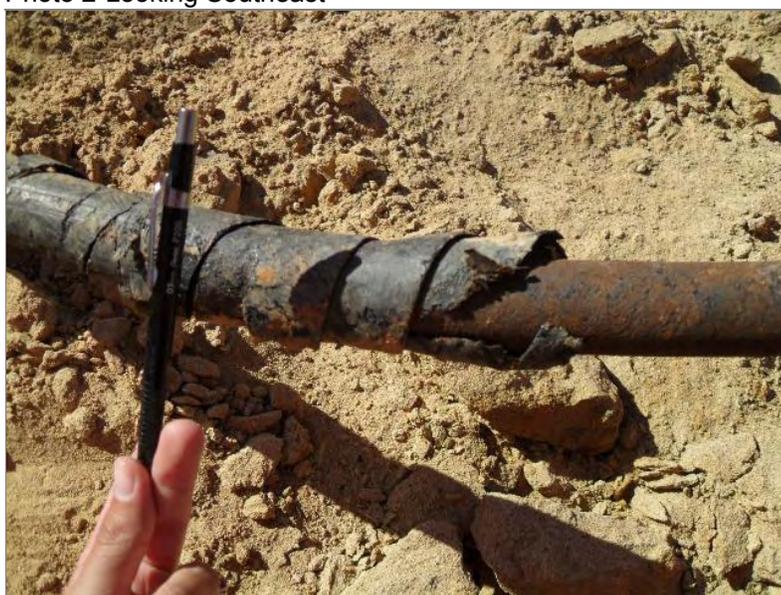
General Condition: **Intact**
Debris: **No**
Staining: **No**
Odor: **No**
PID Reading: **N/A**
Likelihood of Impact from Feature: **Potential from pipe wrapping**

Sampling Warranted?: **Yes**
Sampling Description/Notes: **Collected sample of pipe wrapping.**
Sampling Type: **Solid**
Sample ID Number(s): **B1S00007**
Analyses: **PCBs: PCB-1260 - 0.640 mg/kg (4.6 x HH RBSL, 8.2 x Eco RBSL).**
