Building Feature Documentation Log
Feature Number: B1-2-019
Santa Susana Field Laboratory, Ventura County, California

**TABLE H-2 PIPELINE CHARACTERISTICS AND SAMPLING INFORMATION AT CTLI-1A
THE BOEING COMPANY
SANTA SUSANA FIELD LABORATORY**

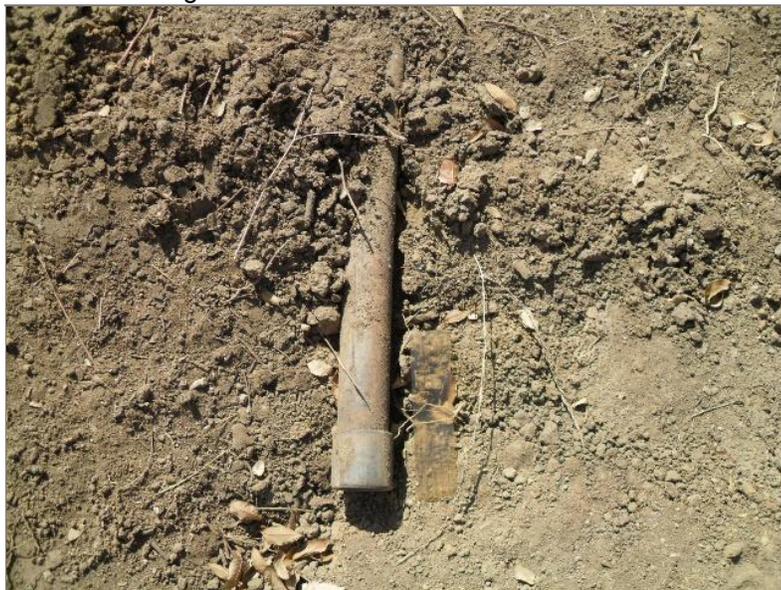
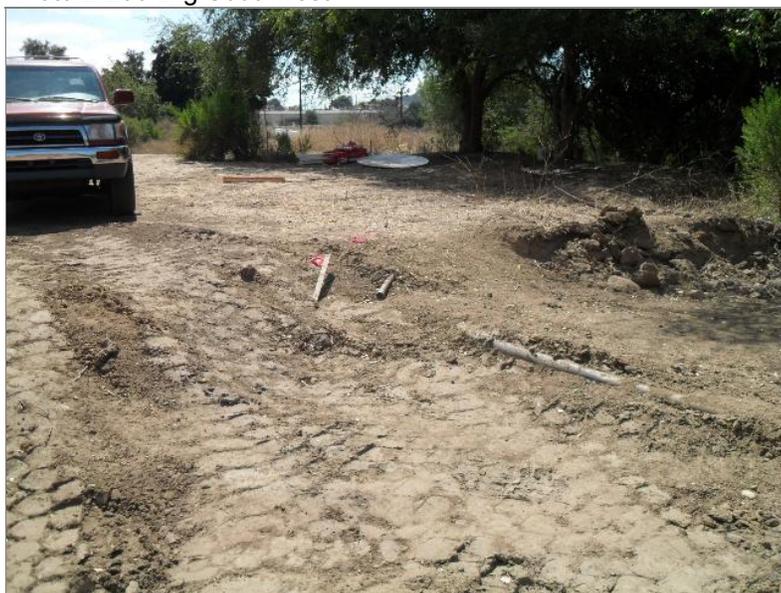
Feature Type: **Pipeline: Unknown**
Operational Use / Process: **Unknown**
Associated Chemicals: **Unknown**
Discharge: **Unknown**
Size: **2-inch**
Construction Material: **Metal**
Status: **Partially removed**

General Condition: **Intact**
Debris: **No**
Staining: **No**
Odor: **No**
PID Reading: **N/A**
Likelihood of Impact from Feature: **Unlikely**

Proximity to Nearest Chemical Use Area:
Within CUA 12 (Equipment Storage - Old Property Yard)
Likelihood of Impact from Other Source:
Unlikely
Comments: **Feature was identified during 2010 ISRA Implementation activities by geophysical surveying and/or by initial soil removal down to 2 feet bgs. Additional soil removal was conducted in selected areas to a depth of 5 feet bgs, to remove soil associated with confirmation samples exceeding soil remediation goals (SRGs).**
GPS Coordinates: **E1796817.84, N269147.69**

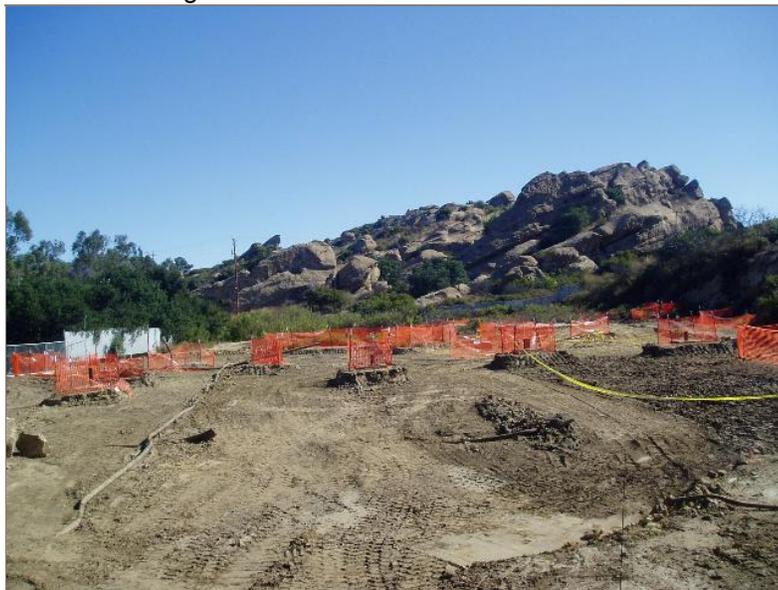
Photo 1-Looking North

Feature Type: **Pipeline: Unknown**
Operational Use / Process: **Unknown**
Associated Chemicals: **Unknown**
Discharge: **Unknown**
Size: **6-inch**
Construction Material: **Metal**
Status: **Partially removed**

General Condition: **Intact**
Debris: **No**
Staining: **No**
Odor: **No**
PID Reading: **N/A**
Likelihood of Impact from Feature: **Unlikely**

Proximity to Nearest Chemical Use Area:
Within CUA 12 (Equipment Storage - Old Property Yard) and near CUA 4c (transformer)
Likelihood of Impact from Other Source:
Unlikely
Comments: **Feature was identified during 2010 ISRA Implementation activities by geophysical surveying and/or by initial soil removal down to 2 feet bgs. Additional soil removal was conducted in selected areas to a depth of 5 feet bgs, to remove soil associated with confirmation samples exceeding soil remediation goals (SRGs).**
GPS Coordinates: **E1796834.53, N269187.42**

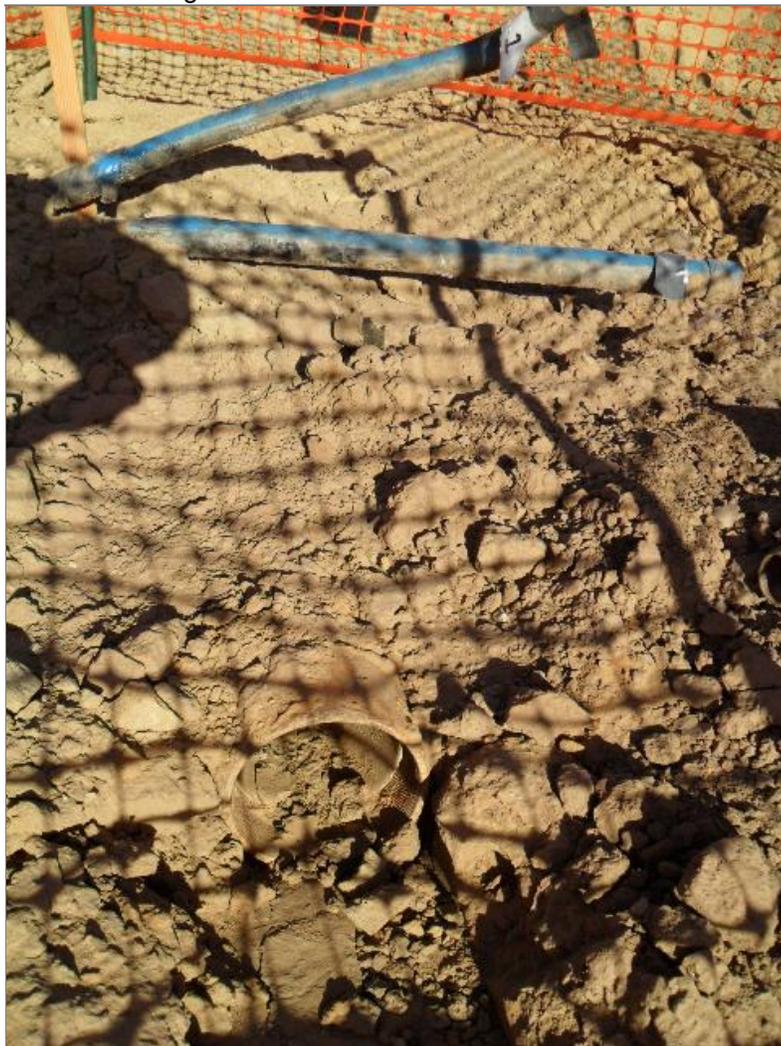
Photo 1-Looking Southwest

Feature Type: **Pipeline: Unknown**
Operational Use / Process: **Unknown**
Associated Chemicals: **Unknown**
Discharge: **Unknown**
Size: **3-1/2-inch**
Construction Material: **Metal**
Status: **Partially removed**

General Condition: **Intact**
Debris: **No**
Staining: **No**
Odor: **No**
PID Reading: **N/A**
Likelihood of Impact from Feature: **Unlikely**

Comments: **Feature was identified during 2010 ISRA Implementation activities by geophysical surveying and/or by initial soil removal down to 2 feet bgs.**

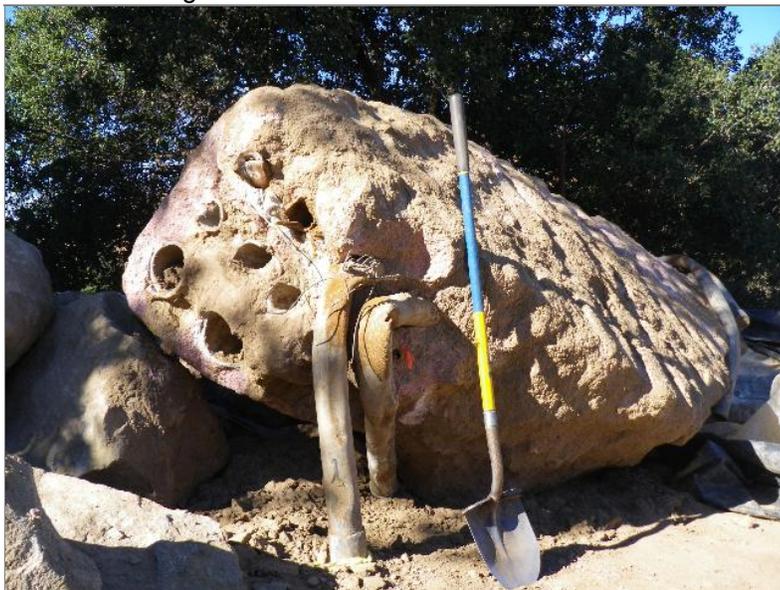
Photo 1-Looking Southwest

Feature Type: **Pipelines (11): Electrical**
Operational Use / Process: **Conduits**
Associated Chemicals: **None**
Discharge: **No**
Size: **Various sizes of pipes encased within red concrete.**
Construction Material: **Metal**
Status: **Partially removed**

General Condition: **Intact**
Debris: **No**
Staining: **No**
Odor: **No**
PID Reading: **N/A**
Likelihood of Impact from Feature: **Unlikely**

Proximity to Nearest Chemical Use Area: **Within CUA 12 (Equipment Storage - Old Property Yard) and near CUA 4b (transformer)**
Likelihood of Impact from Other Source: **Unlikely**
Comments: **Feature was identified during 2010 ISRA Implementation activities by geophysical surveying and/or by initial soil removal down to 2 feet bgs. Additional soil removal was conducted in selected areas to a depth of 5 feet bgs, to remove soil associated with confirmation samples exceeding soil remediation goals (SRGs).**
GPS Coordinates: **E1796889.66, N269291.76**

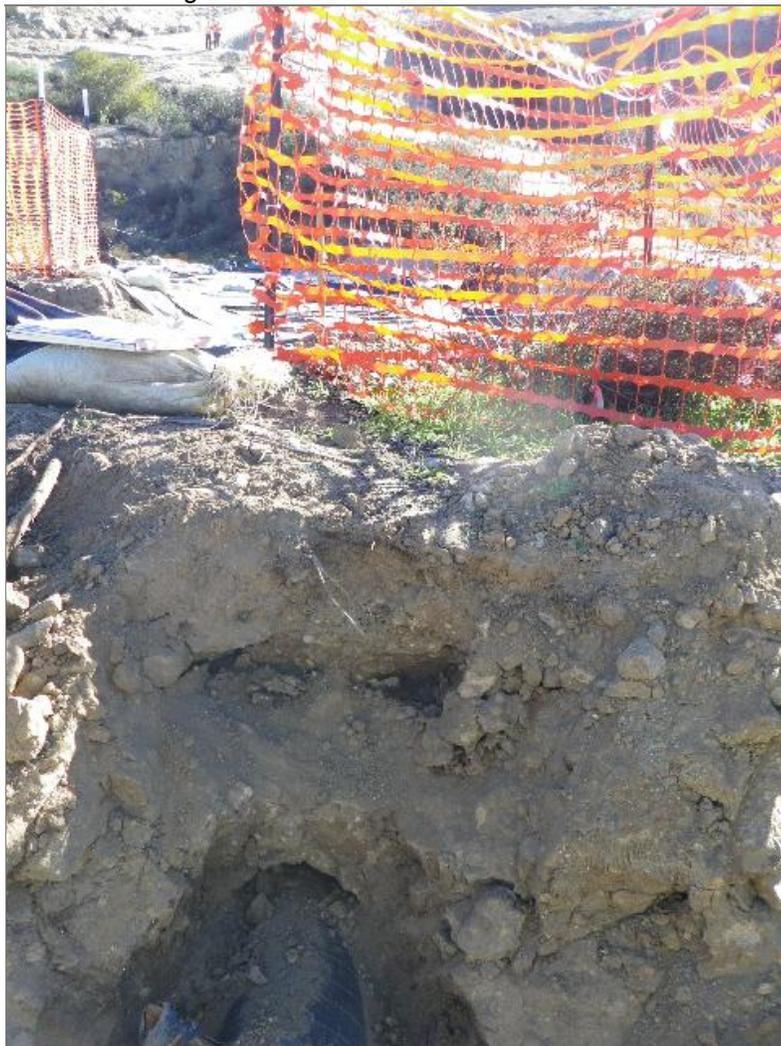
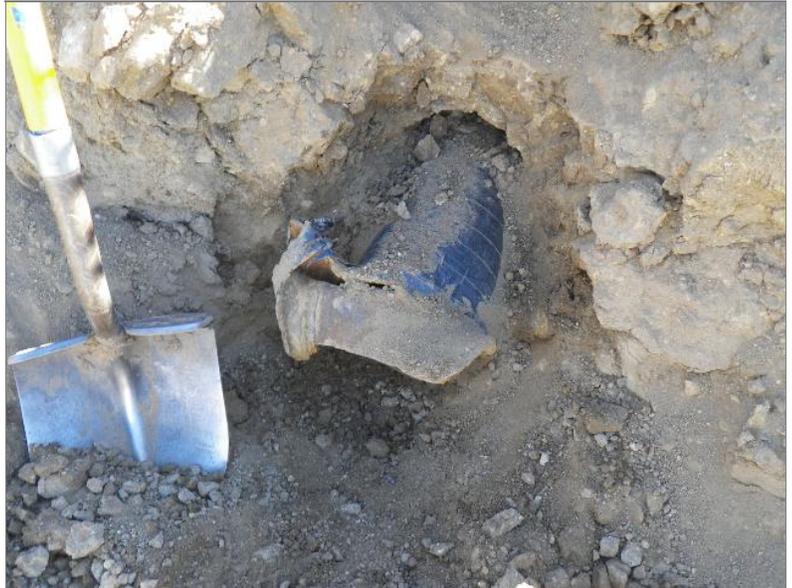
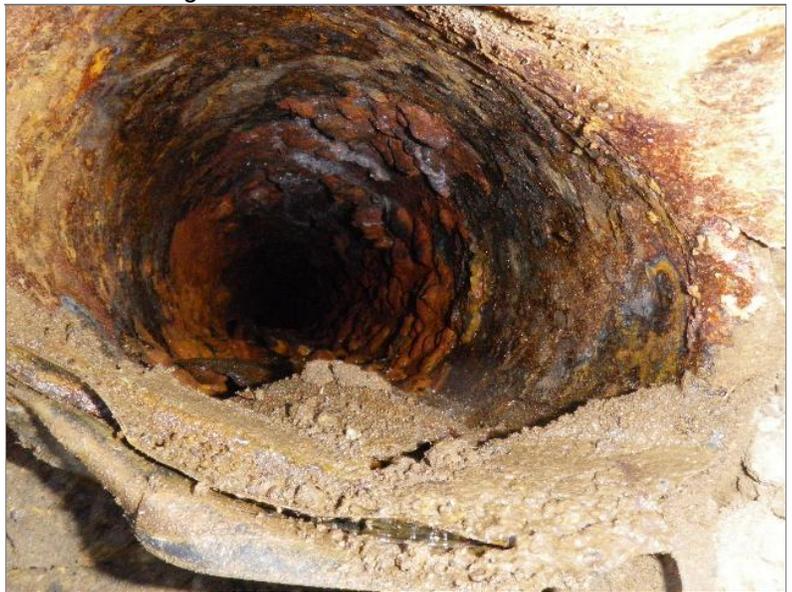
Feature Type: **Pipeline: Unknown**
Operational Use / Process: **Unknown**
Associated Chemicals: **Unknown**
Discharge: **Unknown**
Size: **8-inch**
Construction Material: **Metal with black pipe wrapping**
Status: **Partially removed**

General Condition: **Intact**
Debris: **No**
Staining: **No**
Odor: **No**
PID Reading: **N/A**
Likelihood of Impact from Feature: **Unlikely**

Proximity to Nearest Chemical Use Area:
Within CUA 12 (Equipment Storage - Old Property Yard)
Likelihood of Impact from Other Source:
Unlikely
Comments: **Feature was identified during 2010 ISRA Implementation activities by geophysical surveying and/or by initial soil removal down to 2 feet bgs. Additional soil removal was conducted in selected areas to a depth of 5 feet bgs, to remove soil associated with confirmation samples exceeding soil remediation goals (SRGs).**
GPS Coordinates: **E1796855.31, N269244.27**

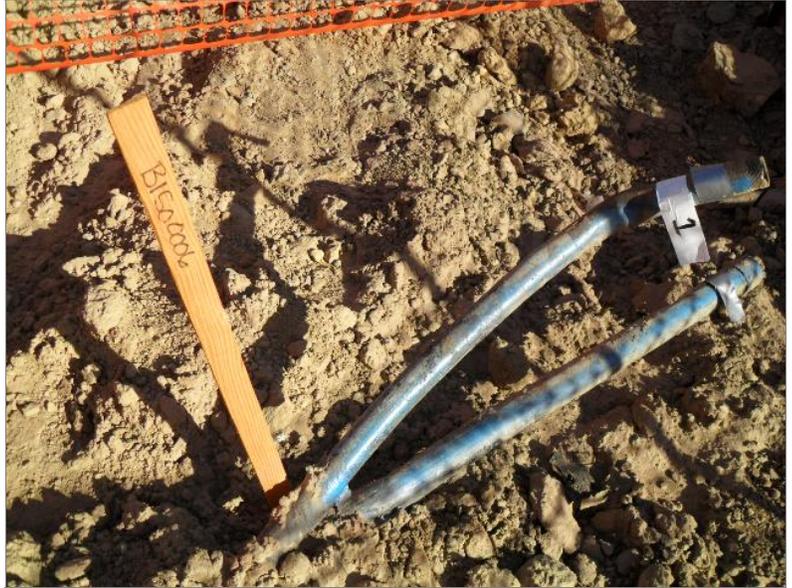
Photo 1-Looking Down

- Condition of Soil: **Not impacted**
- PID Headspace Reading: **N/A**
- Sample Collected: **No**
- Sample ID: **N/A**
- Analyses: **N/A**
- Comments: **Removal of the pipeline was limited only to those sections visible at or above the excavation surface. Approximately 14 feet of pipe was removed.**

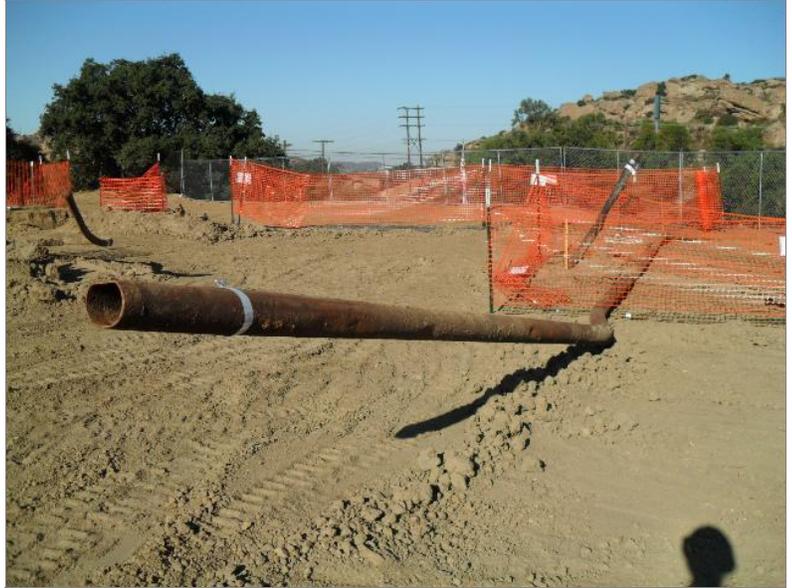
Photo 1-Looking Southwest

- Condition of Soil: **Not impacted**
- PID Headspace Reading: **N/A**
- Sample Collected: **No**
- Sample ID: **N/A**
- Analyses: **N/A**
- Comments: **Removal of the pipeline was limited only to those sections visible at or above the excavation surface. Approximately 48 feet of pipe was removed.**

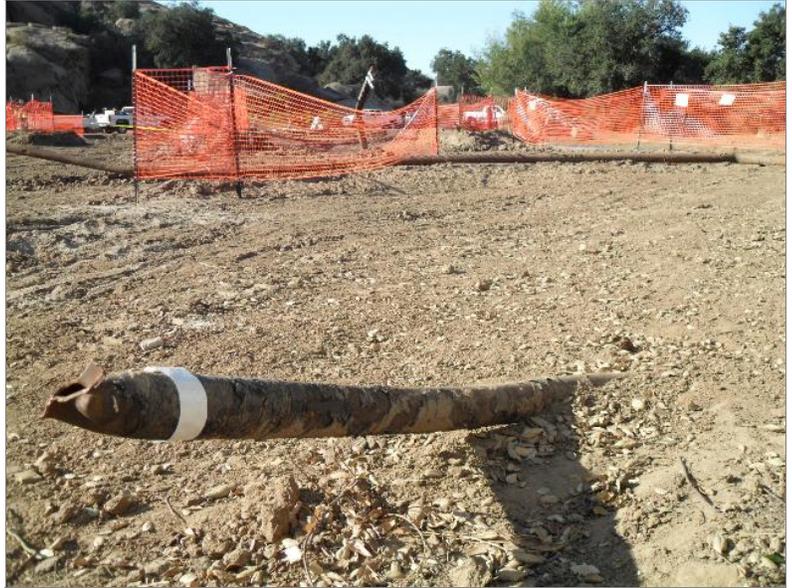
Photo 1-Looking South

- Condition of Soil: **Not impacted**
- PID Headspace Reading: **N/A**
- Sample Collected: **No**
- Sample ID: **N/A**
- Analyses: **N/A**
- Comments: **Removal of the pipeline was limited only to those sections visible at or above the excavation surface. Approximately 6 feet of pipe was removed.**

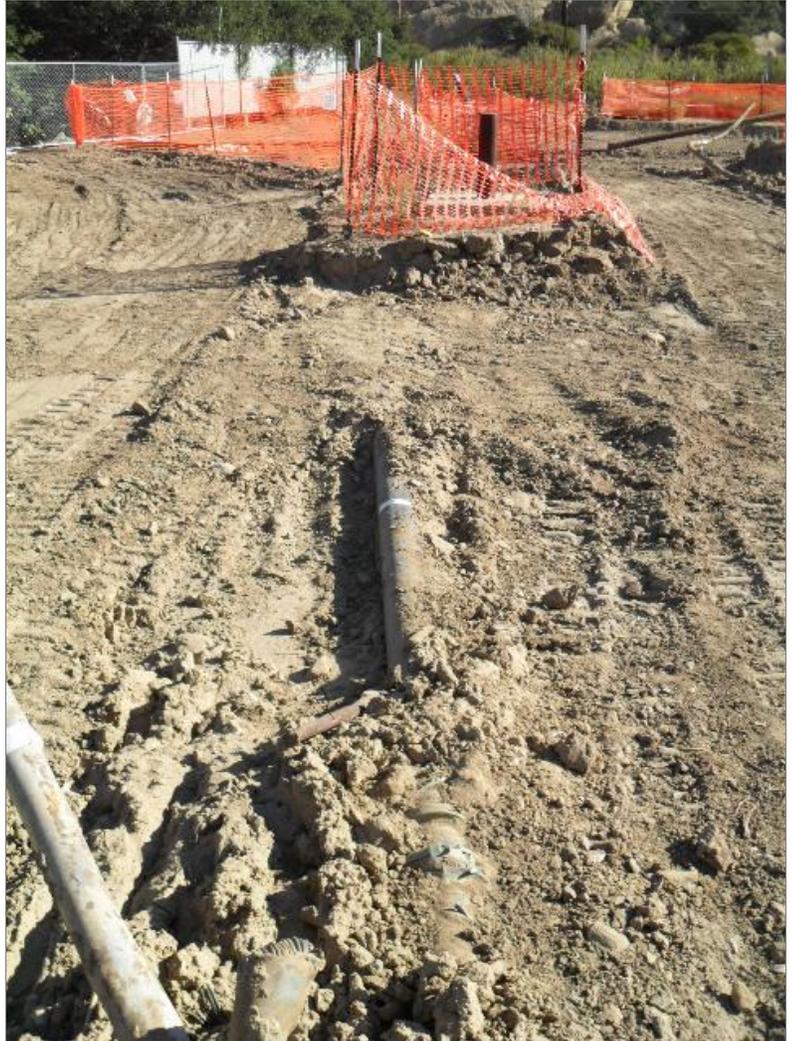
Photo 1-Looking Northeast

- Condition of Soil: **Not impacted**
- PID Headspace Reading: **N/A**
- Sample Collected: **No**
- Sample ID: **N/A**
- Analyses: **N/A**
- Comments: **Removal of the pipeline was limited only to those sections visible at or above the excavation surface. Approximately 97 feet of pipe was removed.**

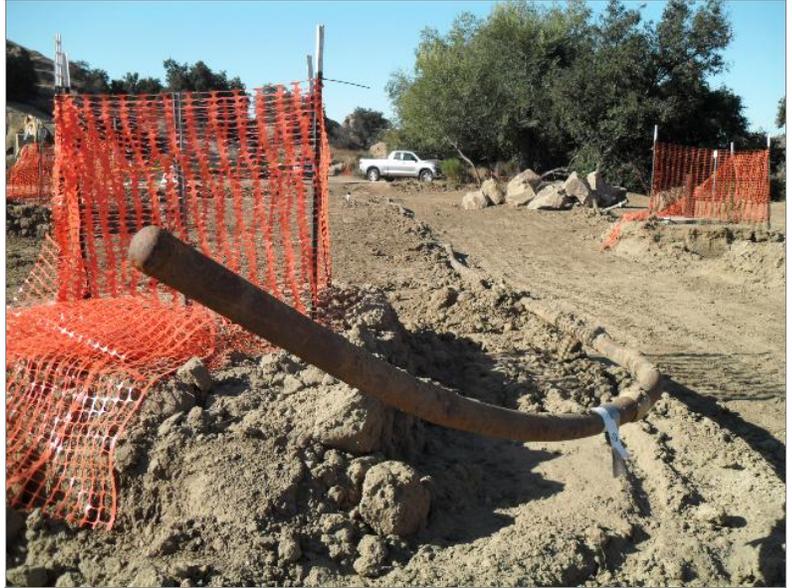
Photo 1-Looking South

- Condition of Soil: **Not impacted**
- PID Headspace Reading: **N/A**
- Sample Collected: **No**
- Sample ID: **N/A**
- Analyses: **N/A**
- Comments: **Removal of the pipeline was limited only to those sections visible at or above the excavation surface. Approximately 80 feet of pipe was removed.**

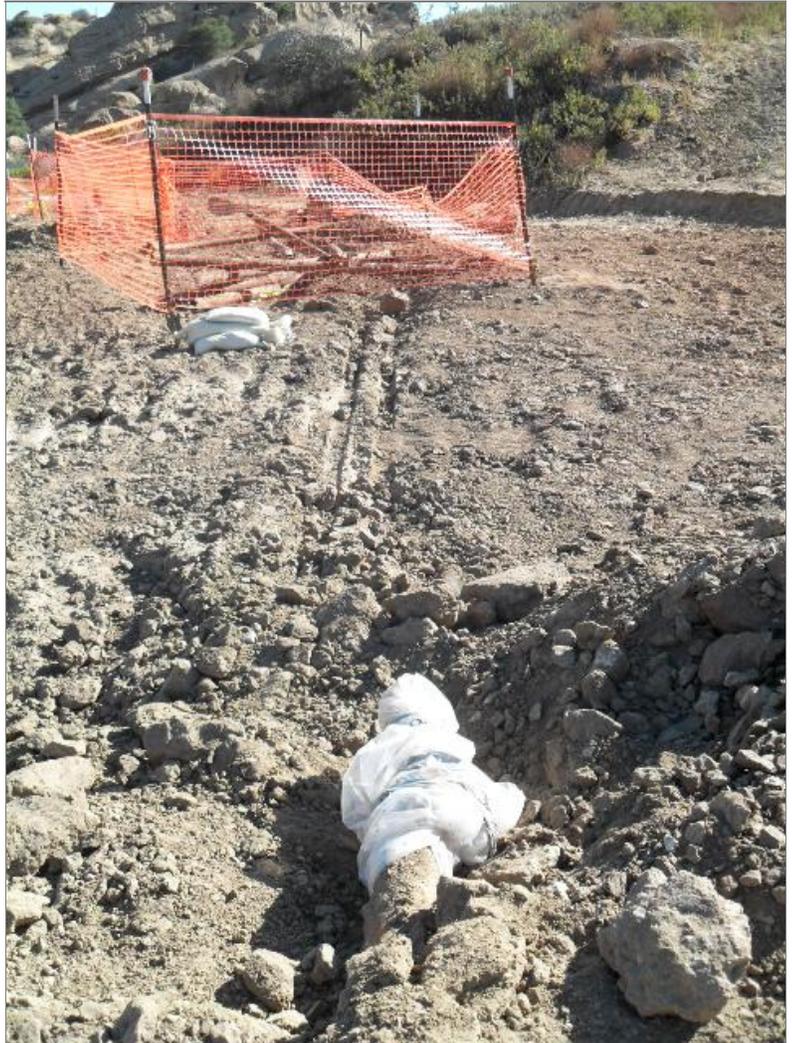
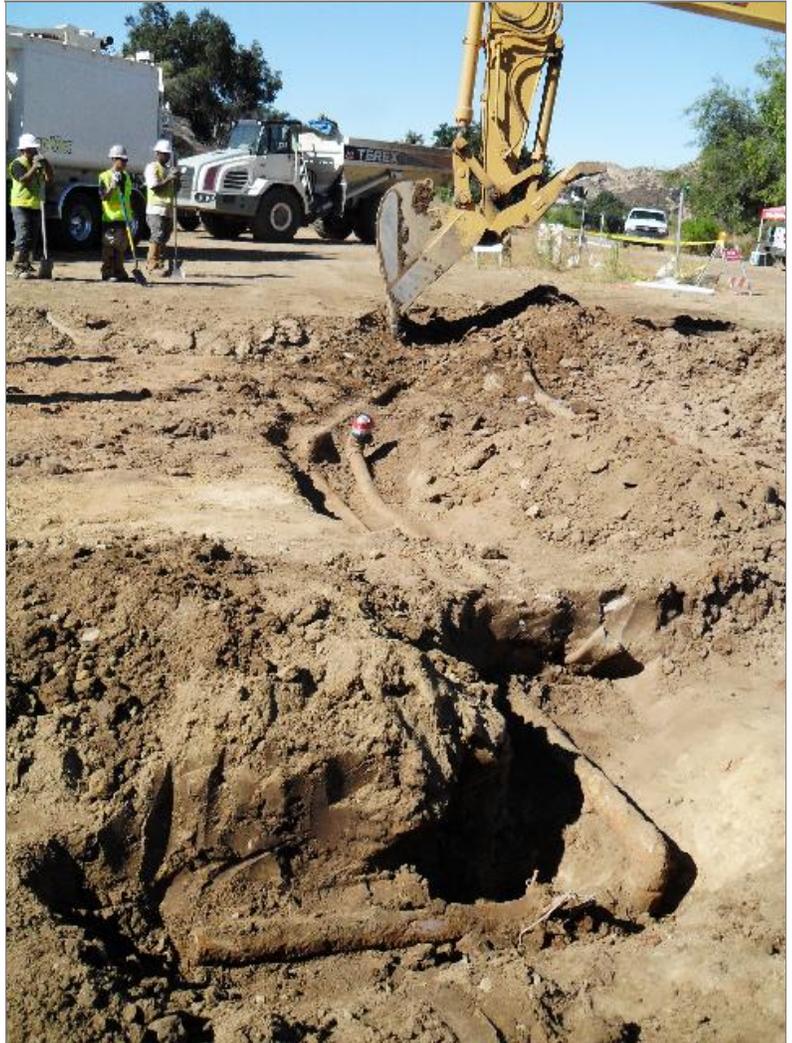
- Condition of Soil: **Not impacted**
- PID Headspace Reading: **N/A**
- Sample Collected: **No**
- Sample ID: **N/A**
- Analyses: **N/A**
- Comments: **Removal of the pipeline was limited only to those sections visible at or above the excavation surface. Approximately 23 feet of pipe was removed through the southeastern area of ISRA Area B1-2. The rest of the pipeline to the south was left in place and the end capped.**

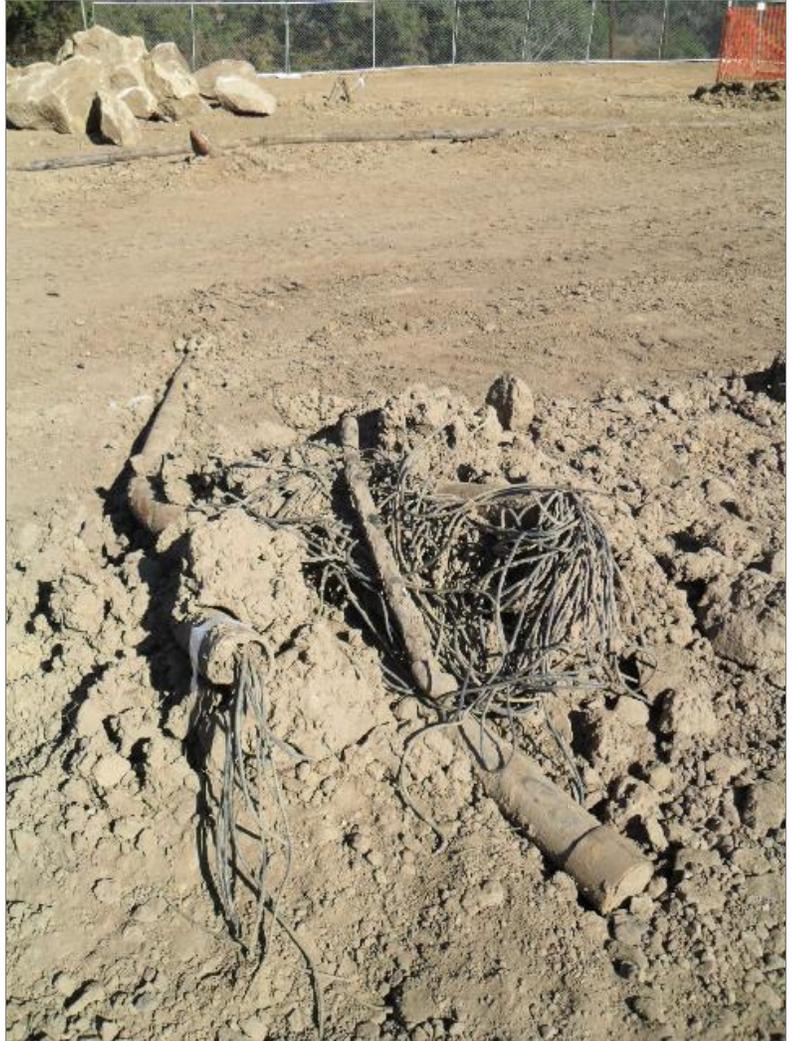
Photo 1-Looking West

- Condition of Soil: **Not impacted**
- PID Headspace Reading: **N/A**
- Sample Collected: **No**
- Sample ID: **N/A**
- Analyses: **N/A**
- Comments: **Removal of the pipeline was limited only to those sections visible at or above the excavation surface. Approximately 18 feet of pipe was removed.**

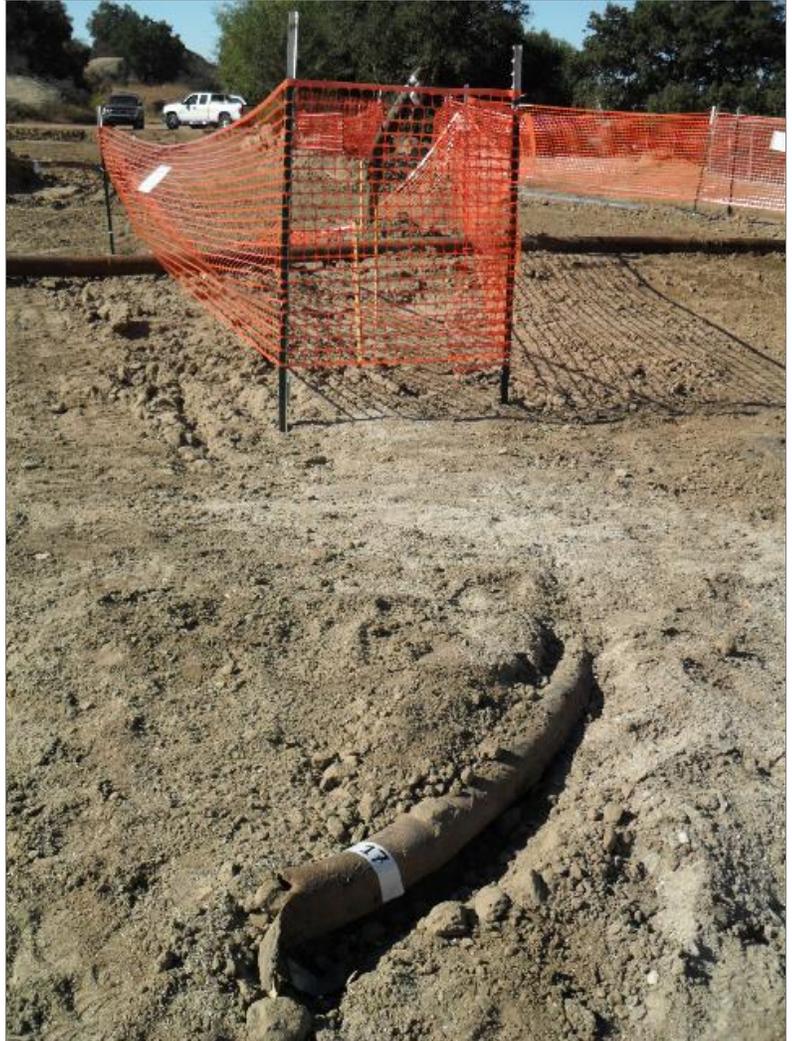
Photo 1-Looking South

- Condition of Soil: **Not impacted**
- PID Headspace Reading: **N/A**
- Sample Collected: **No**
- Sample ID: **N/A**
- Analyses: **N/A**
- Comments: **Removal of the pipeline was limited only to those sections visible at or above the excavation surface. Approximately 13 feet of pipe was removed.**

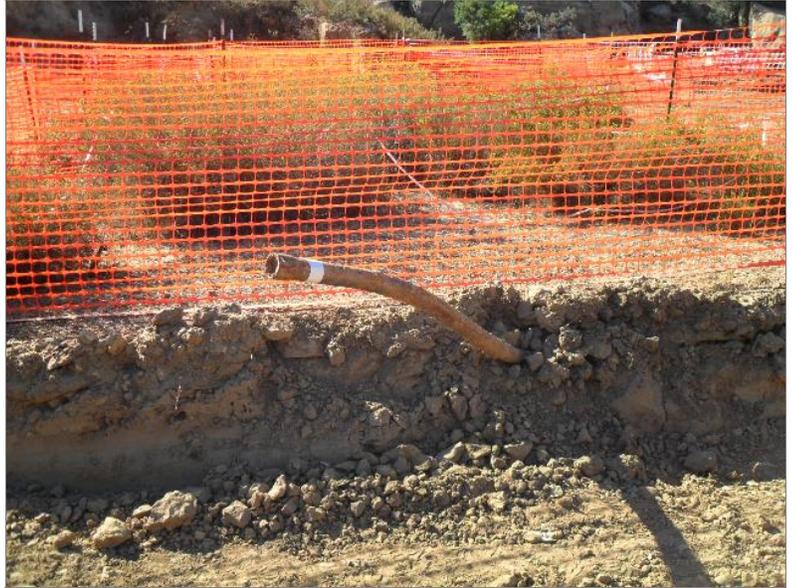
Photo 1-Looking Southwest

- Condition of Soil: **Not impacted**
- PID Headspace Reading: **N/A**
- Sample Collected: **No**
- Sample ID: **N/A**
- Analyses: **N/A**
- Comments: **Removal of the pipeline was limited only to those sections visible at or above the excavation surface. Approximately 8 feet of pipe was removed.**

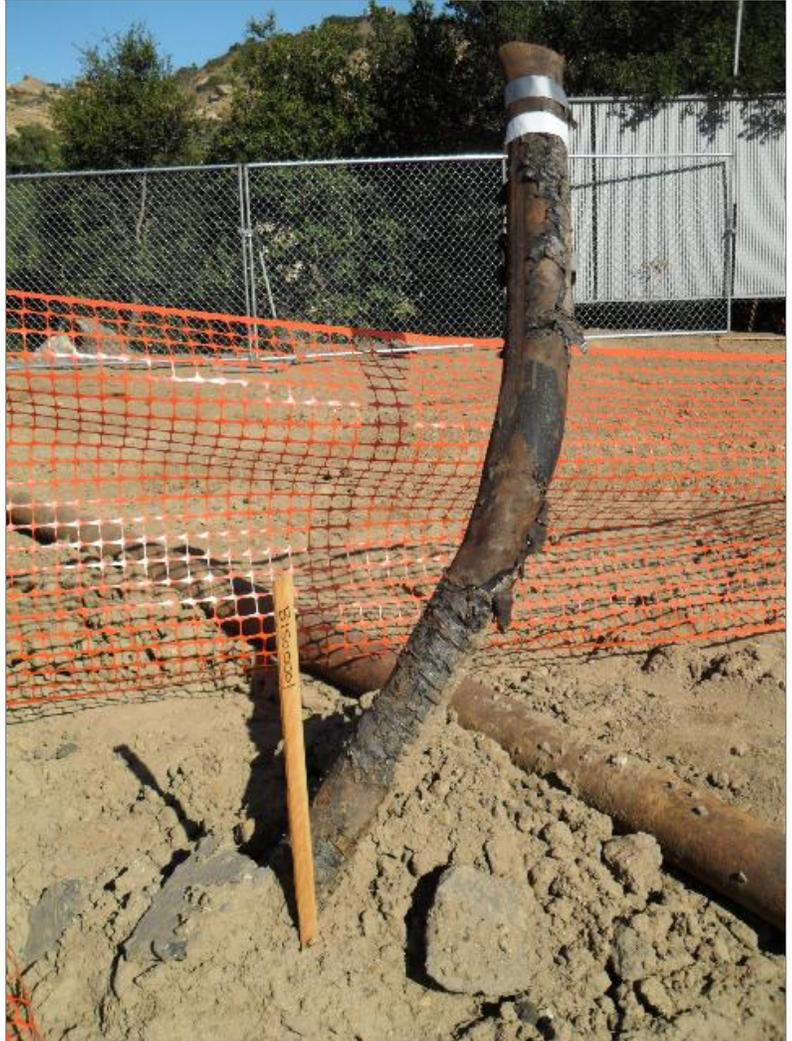
Photo 1-Looking West

- Condition of Soil: **Not impacted**
- PID Headspace Reading: **N/A**
- Sample Collected: **No**
- Sample ID: **N/A**
- Analyses: **N/A**
- Comments: **Removal of the pipeline was limited only to those sections visible at or above the excavation surface. Approximately 12 feet of pipe was removed.**

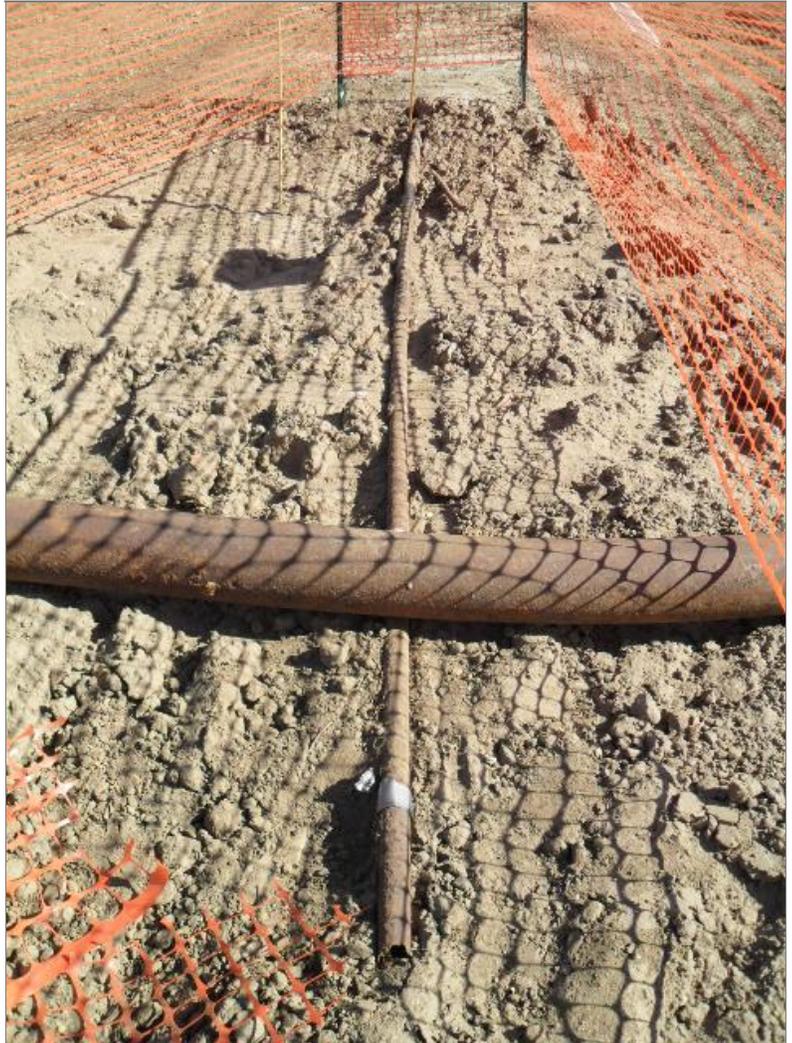
Photo 1-Looking Northeast

- Condition of Soil: **Not impacted**
- PID Headspace Reading: **N/A**
- Sample Collected: **No**
- Sample ID: **N/A**
- Analyses: **N/A**
- Comments: **Removal of the pipeline was limited only to those sections visible at or above the excavation surface. Approximately 16 feet of pipe was removed.**

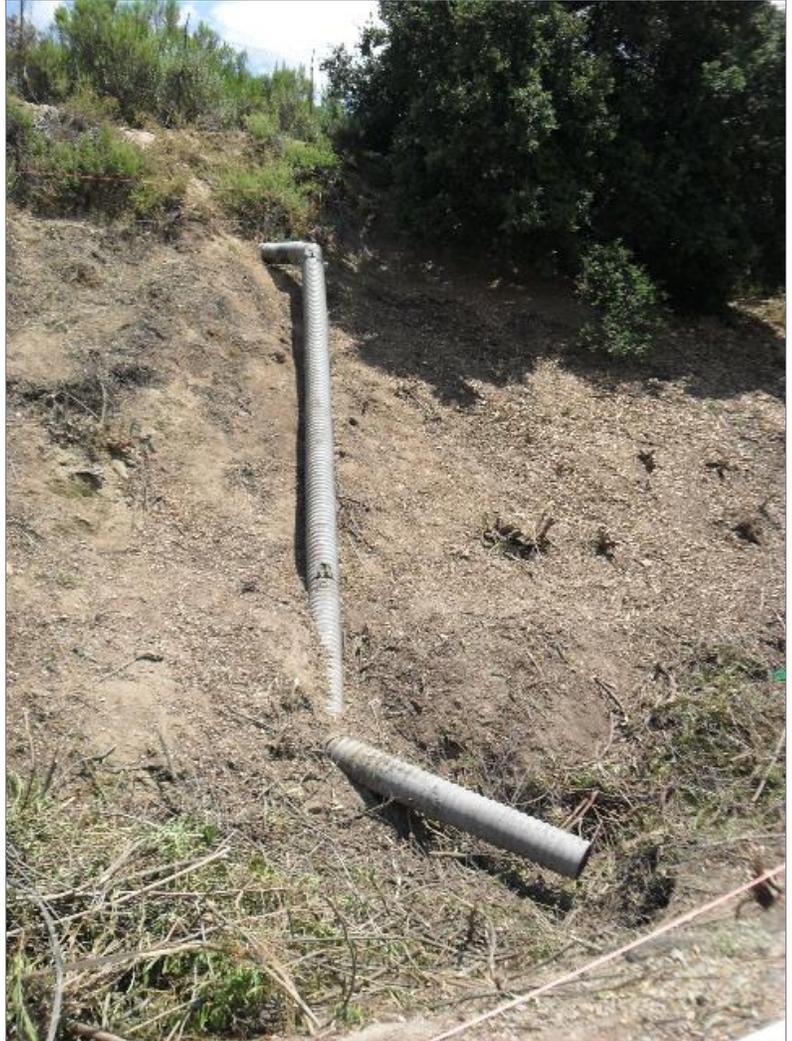
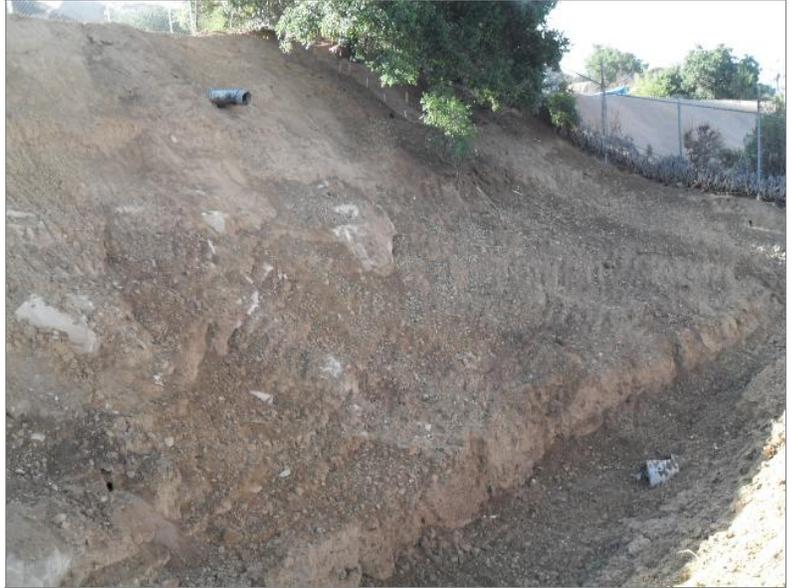
- Condition of Soil: **Not impacted**
- PID Headspace Reading: **N/A**
- Sample Collected: **No**
- Sample ID: **N/A**
- Analyses: **N/A**
- Comments: **Removal of the pipeline was limited only to those sections visible at or above the excavation surface. Approximately 40 feet of pipe was removed.**

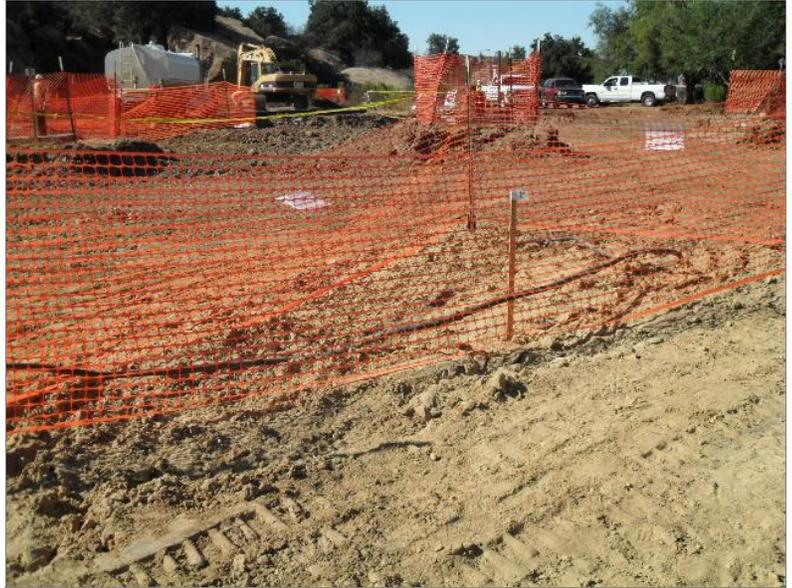
Photo 1-Looking South

- Condition of Soil: **Not impacted**
- PID Headspace Reading: **N/A**
- Sample Collected: **No**
- Sample ID: **N/A**
- Analyses: **N/A**
- Comments: **Removal of the pipeline was limited only to those sections visible at or above the excavation surface. Approximately 16 feet of pipe was removed.**

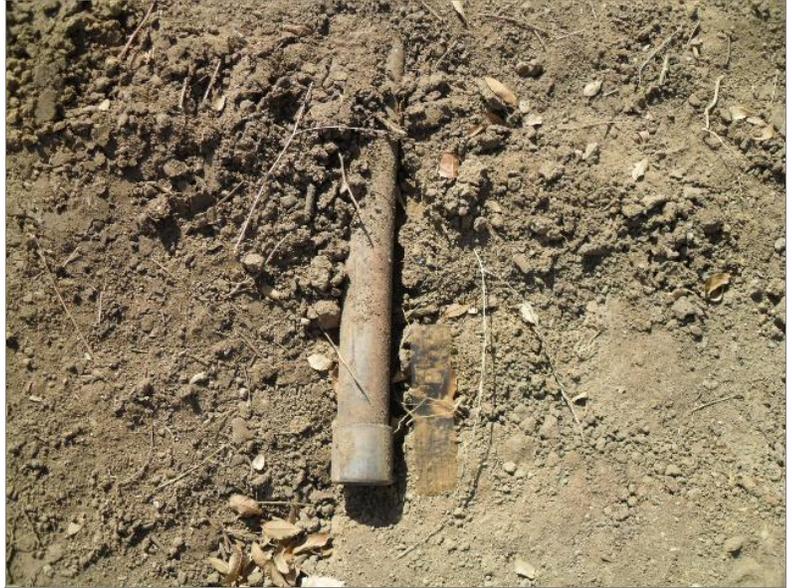
Photo 1-Looking Down

- Condition of Soil: **Not impacted**
- PID Headspace Reading: **N/A**
- Sample Collected: **No**
- Sample ID: **N/A**
- Analyses: **N/A**
- Comments: **Removal of the pipeline was limited only to those sections visible at or above the excavation surface. Approximately 8 feet of pipe was removed.**

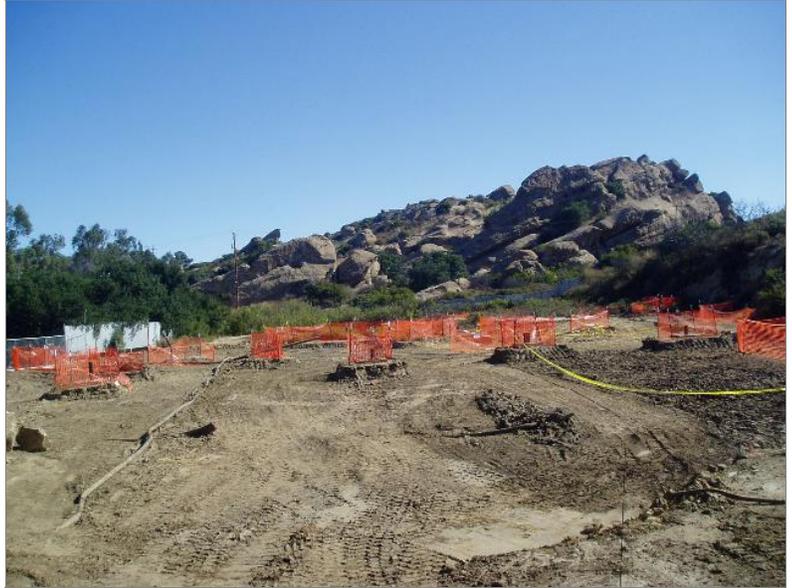
Photo 1-Looking North

- Condition of Soil: **Not impacted**
- PID Headspace Reading: **N/A**
- Sample Collected: **No**
- Sample ID: **N/A**
- Analyses: **N/A**
- Comments: **Removal of the pipeline was limited only to those sections visible at or above the excavation surface. Approximately 16 feet of pipe was removed.**

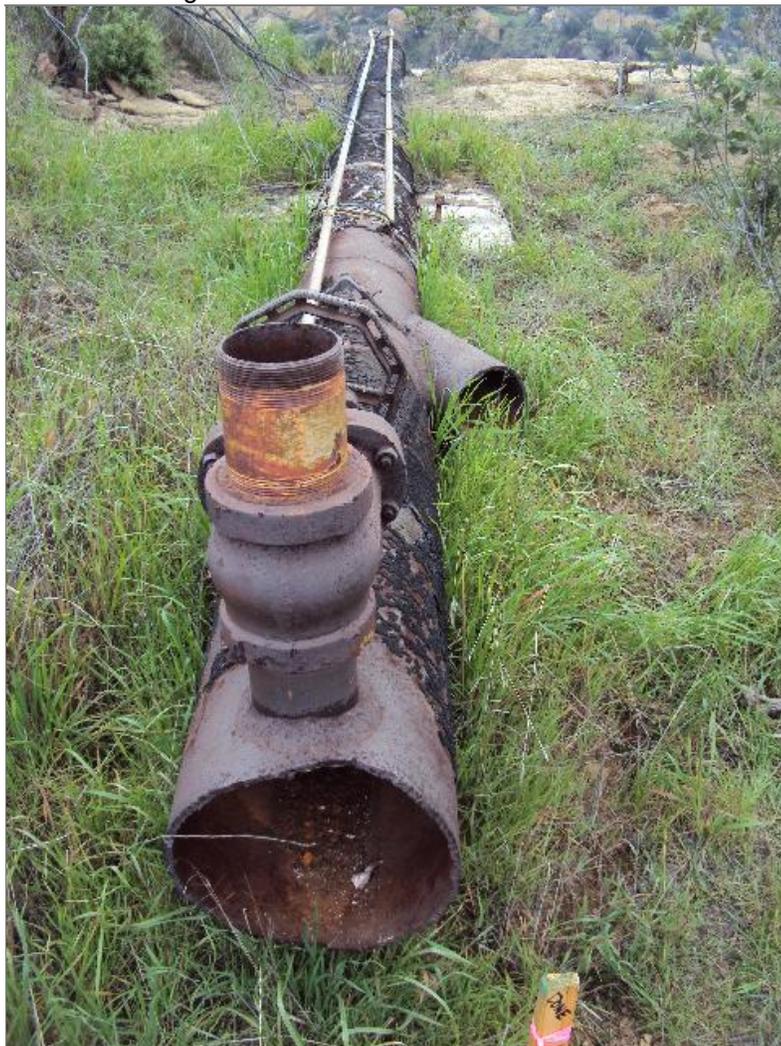
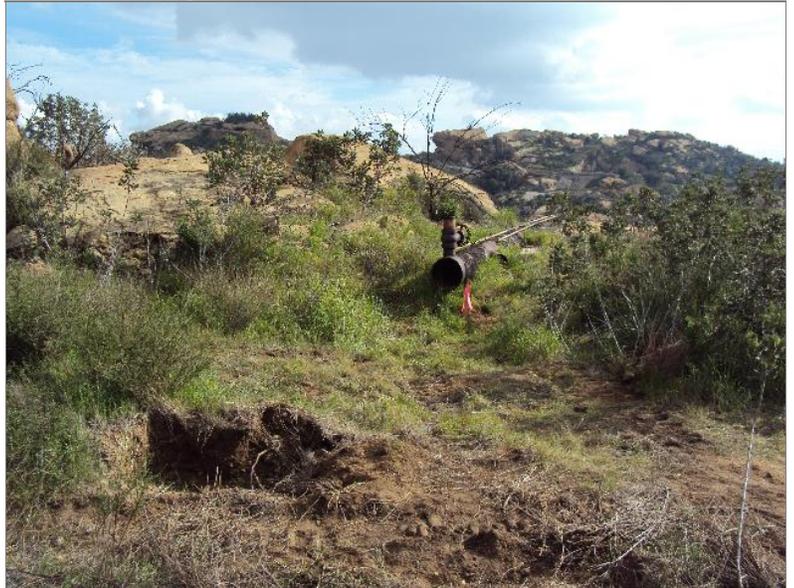
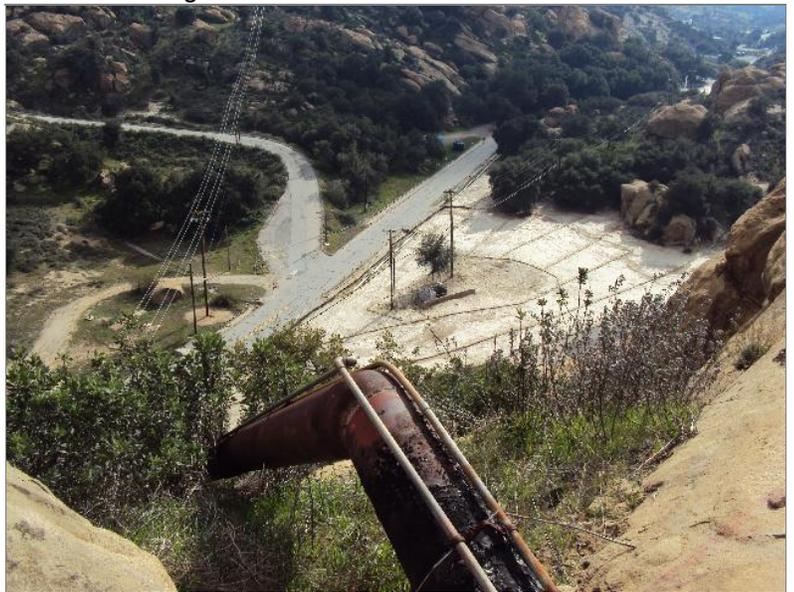
General Condition: **Intact**
Debris: **No**
Staining: **No**
Odor: **No**
PID Reading: **N/A**
Likelihood of Impact from Feature: **Potential from pipe wrapping.**

Proximity to Nearest Chemical Use Area: **N/A**
Likelihood of Impact from Other Source: **Unlikely**
Comments: **Feature was noted during 2010 ISRA data gap sampling of the CTLI-1 ISRA Area. This section of pipeline was left in place following removal of water tanks and used to convey water to the former B1309 area.**
GPS Coordinates: **E1794305.86, N267796.85**

Sampling Warranted?: **Yes**
Sampling Description/Notes: **Collected sample of pipe wrapping.**
Sampling Type: **Solid**
Sample ID Number(s): **LFSO0005S001; SSFL-052110-1; SSFL-052110-2; and SSFL-052110-3**
Analyses: **Asbestos, PCBS**

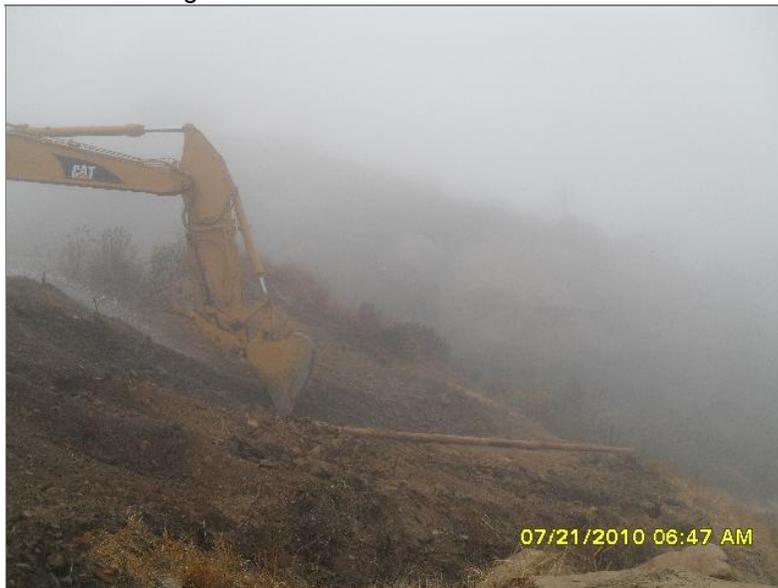
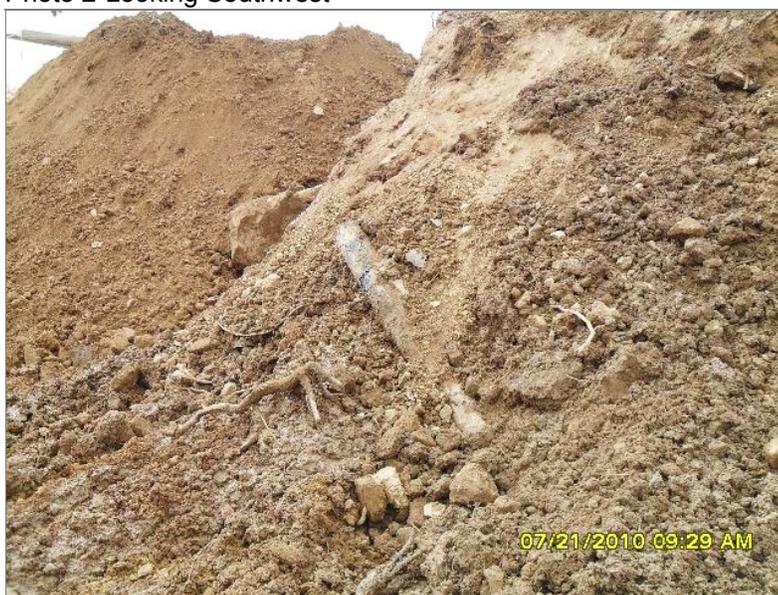
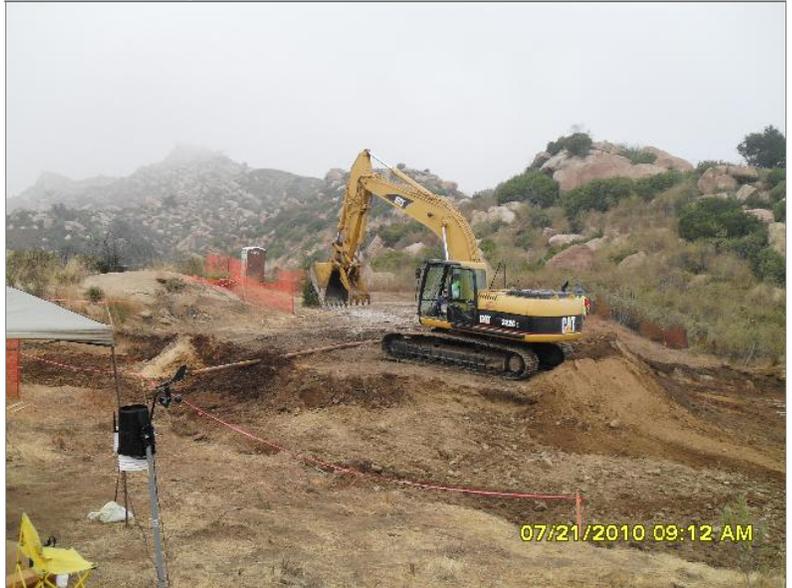
General Condition: **Intact**
Debris: **No**
Staining: **No**
Odor: **No**
PID Reading: **N/A**
Likelihood of Impact from Feature: **Unlikely**

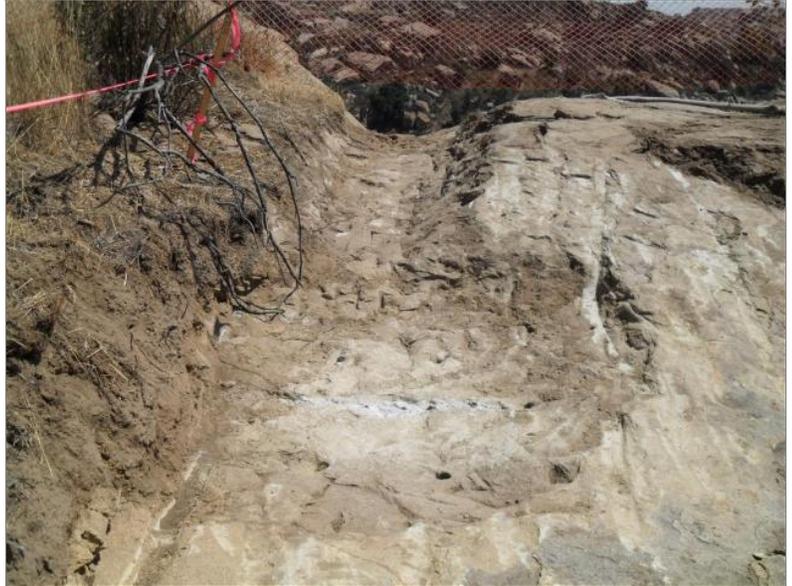
Photo 1-Looking South

- Condition of Soil: **Not impacted**
- PID Headspace Reading: **N/A**
- Sample Collected: **No**
- Sample ID: **N/A**
- Analyses: **N/A**
- Comments: **Prior to and during 2010 ISRA Implementation activities at ISRA Area CTLI-1, approximately 14 feet of pipeline was removed at the flat top area, and a portion of the pipeline was removed down the cliff face. Soil beneath the pipeline at the flat top area was excavated to bedrock.**

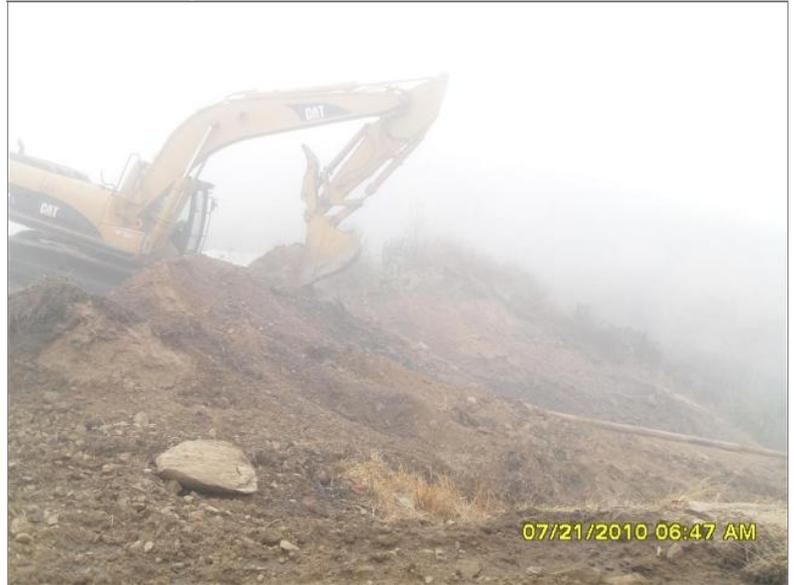
Photo 1-Looking Southwest

- Condition of Soil: **Not impacted**
- PID Headspace Reading: **N/A**
- Sample Collected: **No**
- Sample ID: **N/A**
- Analyses: **N/A**
- Comments: **During 2010 ISRA**
Implementation soil removal activities
down to 2 feet bgs, approximately 30 feet
of pipeline was removed.
