Building Feature Documentation Log
Feature Number: B1-2-019
Santa Susana Field Laboratory, Ventura County, California

**TABLE H-2 PIPELINE CHARACTERISTICS AND SAMPLING INFORMATION AT CTLI-1A
THE BOEING COMPANY
SANTA SUSANA FIELD LABORATORY**

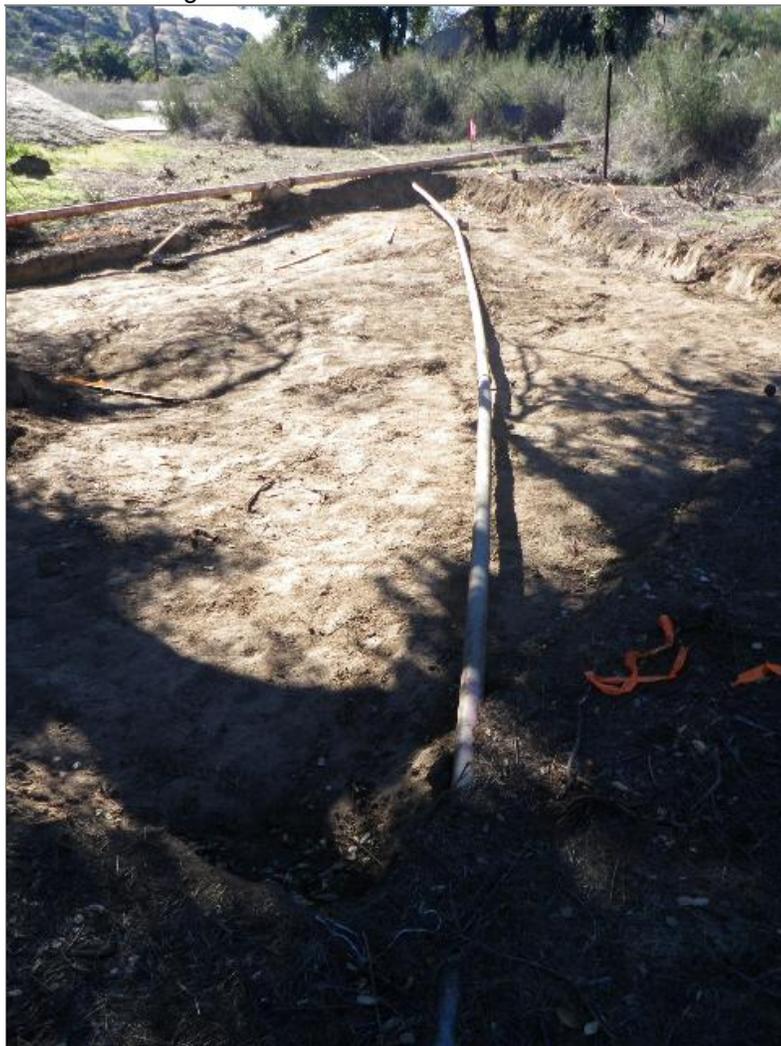
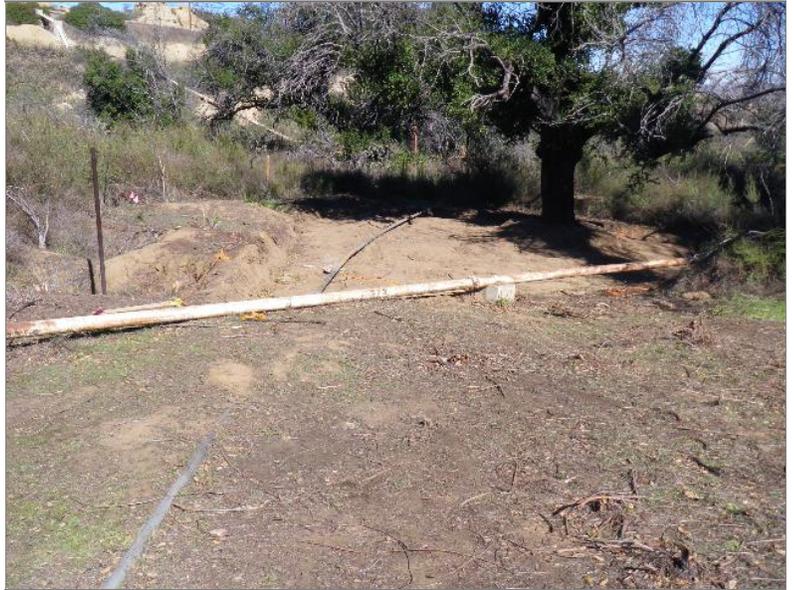
General Condition: **Intact**
Debris: **No**
Staining: **No**
Odor: **No**
PID Reading: **N/A**
Likelihood of Impact from Feature: **Unlikely**

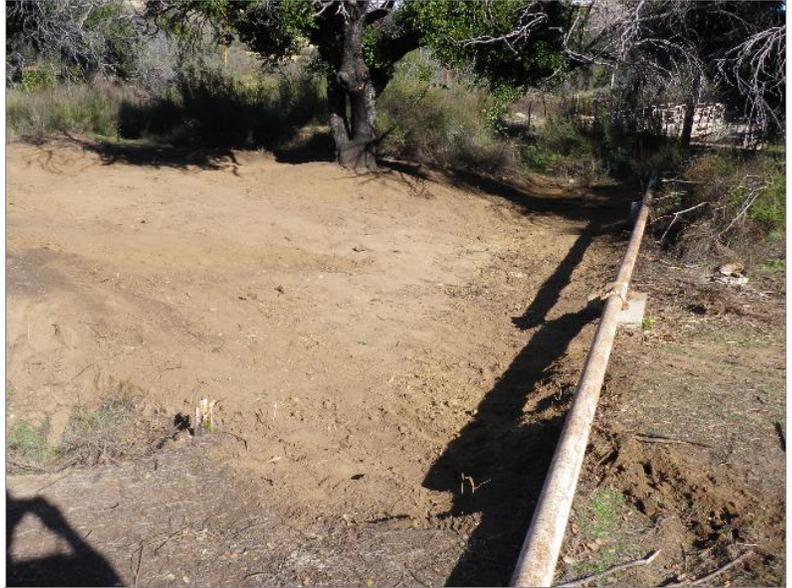
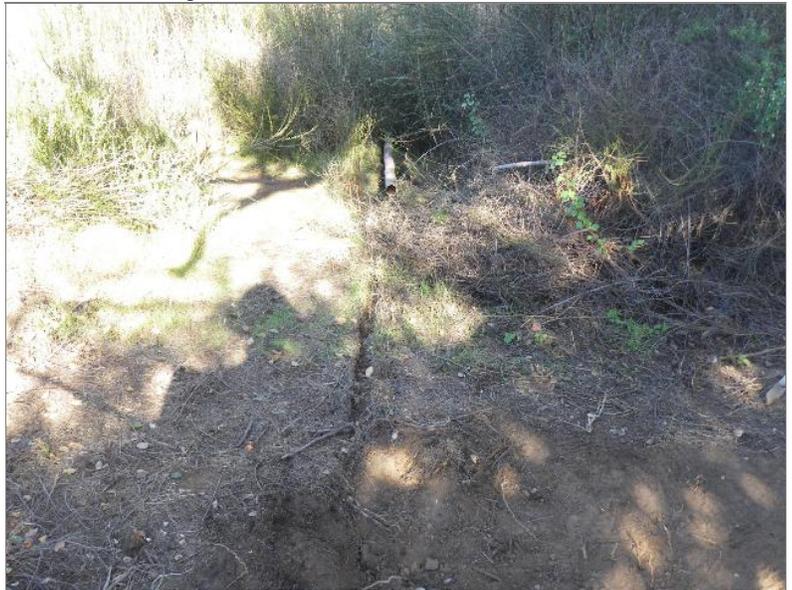
- Condition of Soil: **Not impacted**
- PID Headspace Reading: **N/A**
- Sample Collected: **No**
- Sample ID: **N/A**
- Analyses: **N/A**
- Comments: **Approximately 80 feet of pipeline was removed from within ISRA Area AP/STP-1A and to the south. The pipeline is in place north of ISRA Area AP/STP-1A.**
