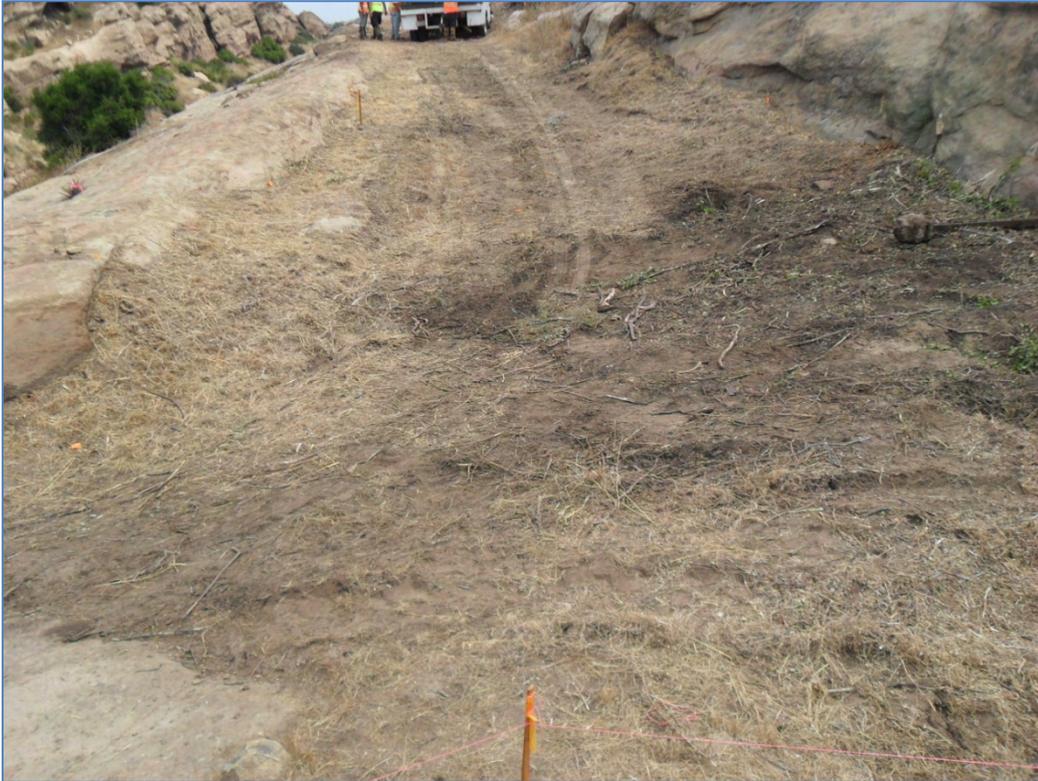
ISRA area B1-1D, west leg, after vegetation clearance, prior to excavation (7/16/2010, looking northeast).

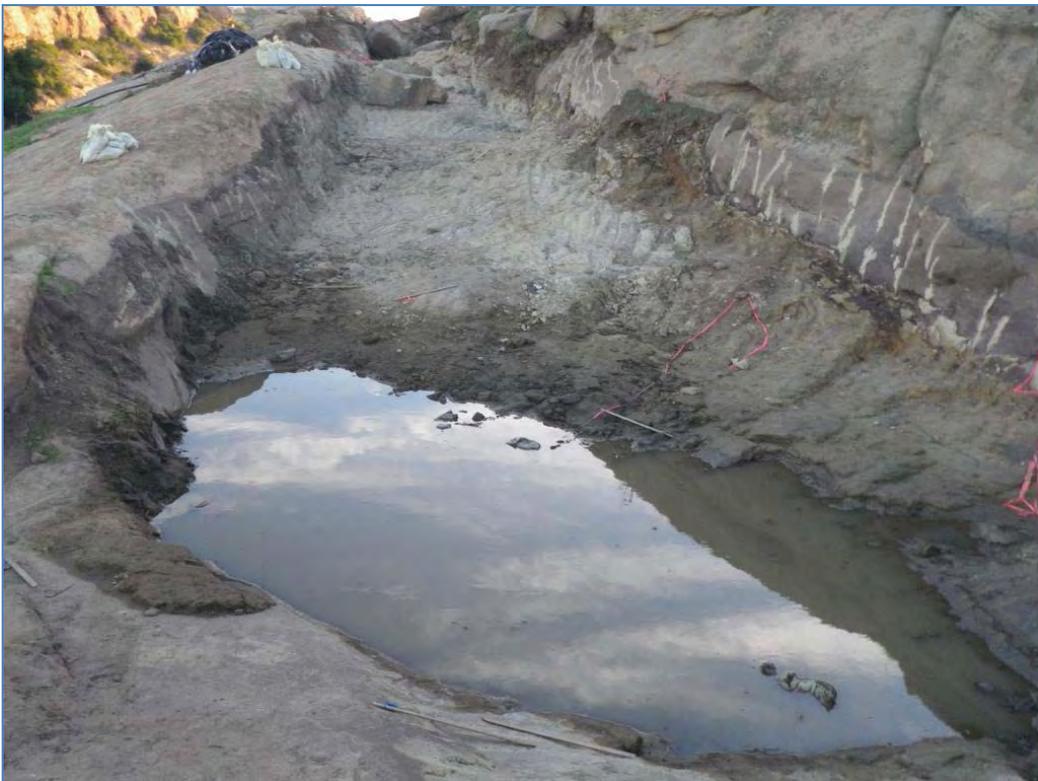
ISRA area B1-1D, west leg, after excavation (10/29/2010, looking northeast).

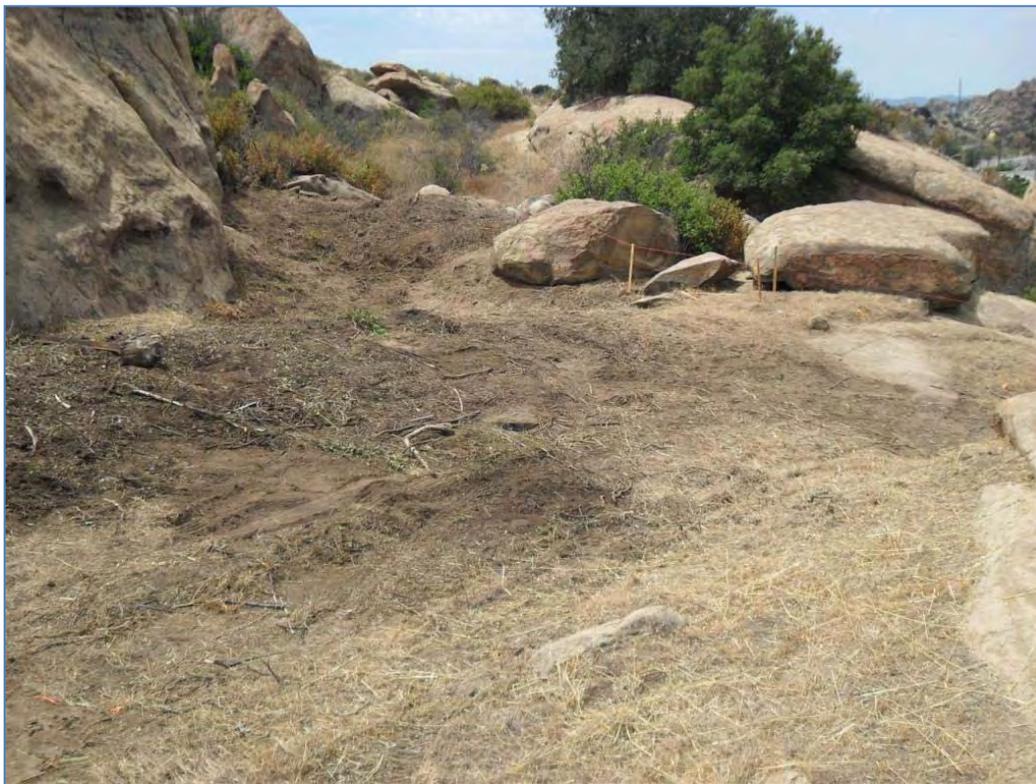
ISRA area B1-1D, west leg, after vegetation clearance, prior to excavation (7/16/2010, looking southwest).

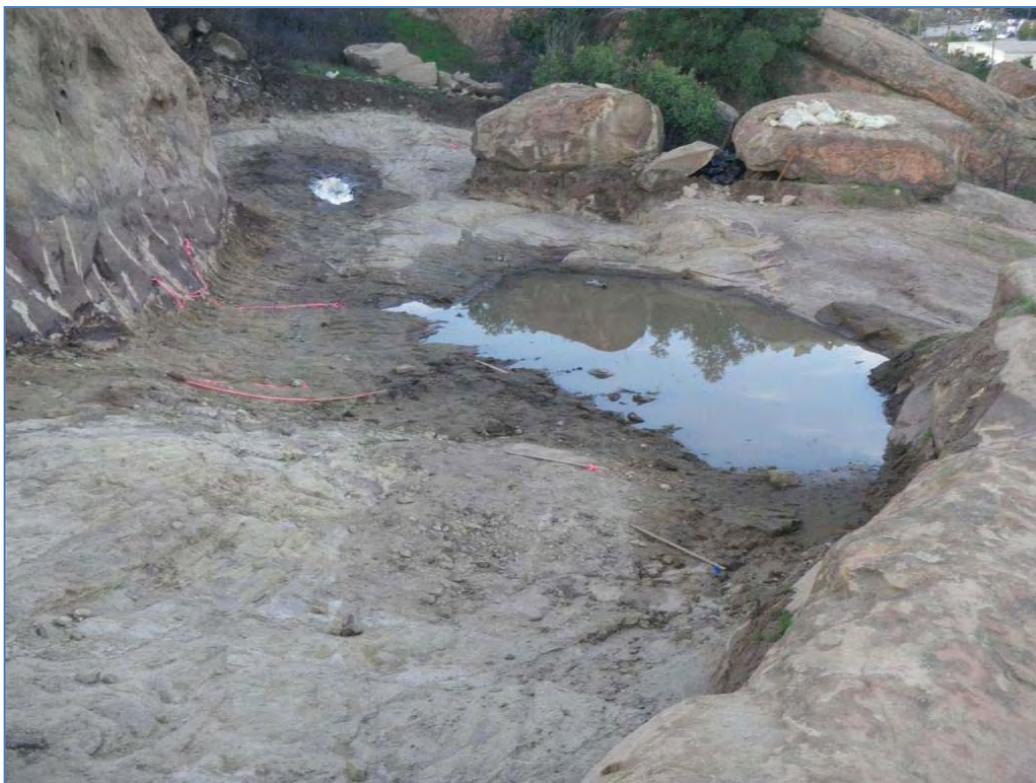
ISRA area B1-1D, west leg, after excavation (10/29/2010, looking southwest).

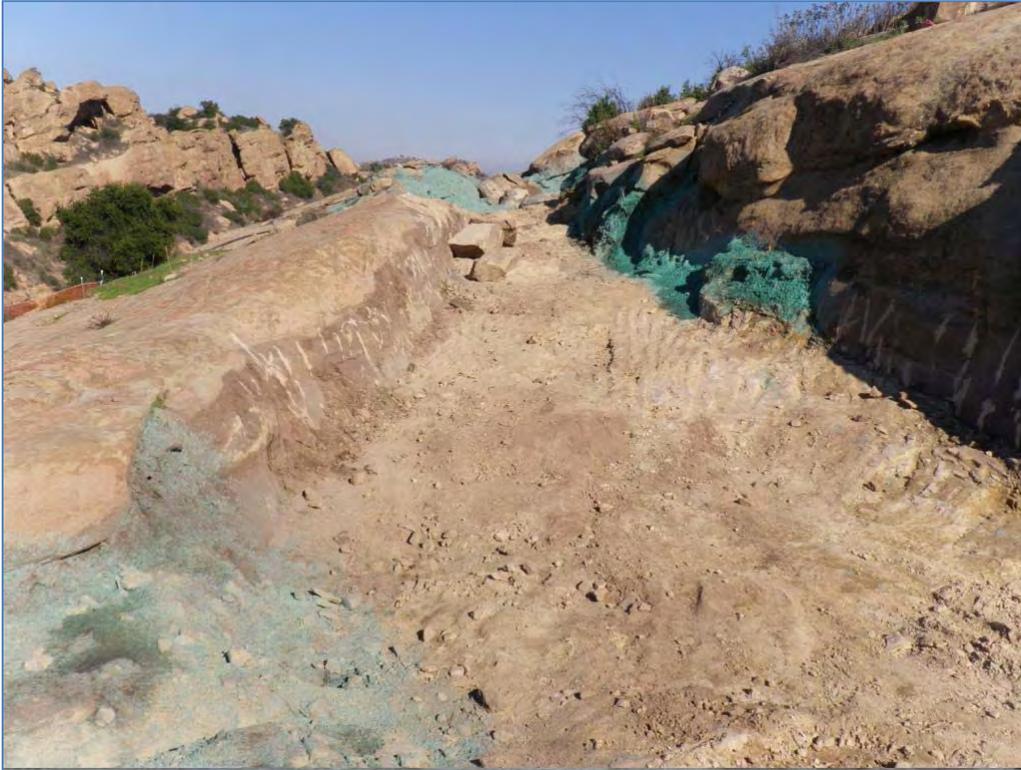
ISRA area B1-1D, west leg, after restoration (11/16/2010, looking northeast). Blue-green hydroseed mulch is visible, bedrock present where hydroseed mulch not applied.

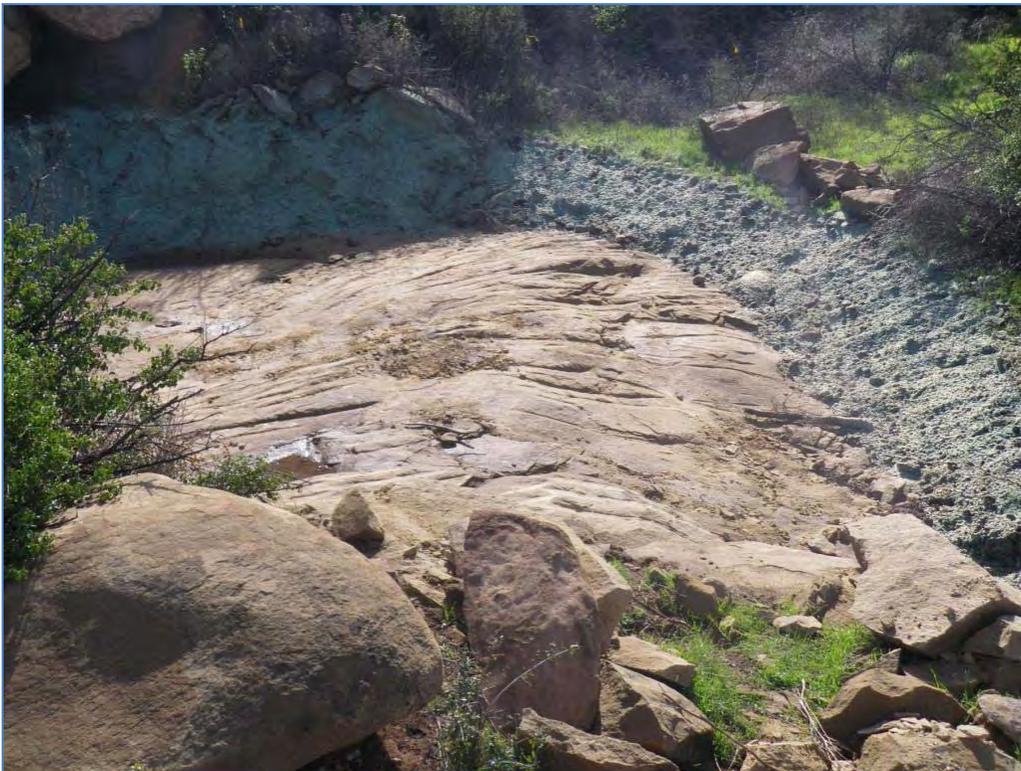
ISRA area B1-1D, west terminus, after restoration (11/23/2010, looking southwest). Blue-green hydroseed mulch is visible, bedrock present where hydroseed mulch not applied.

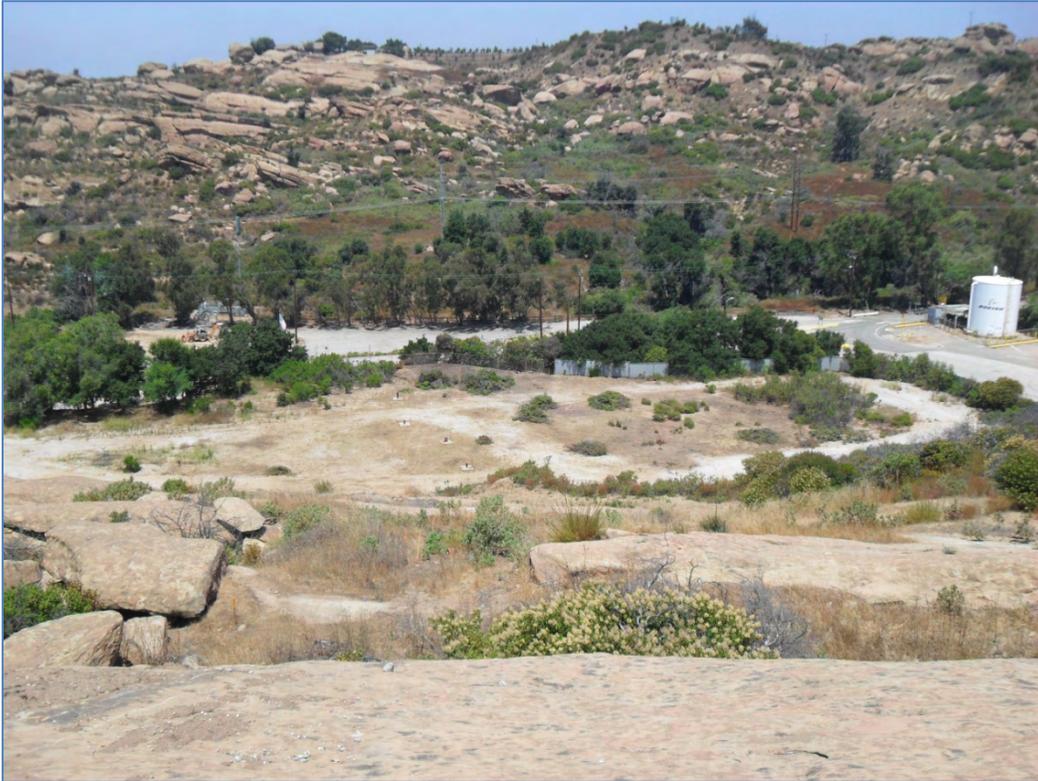
ISRA area B1-2 prior to vegetation clearance (7/7/2010, looking northwest).

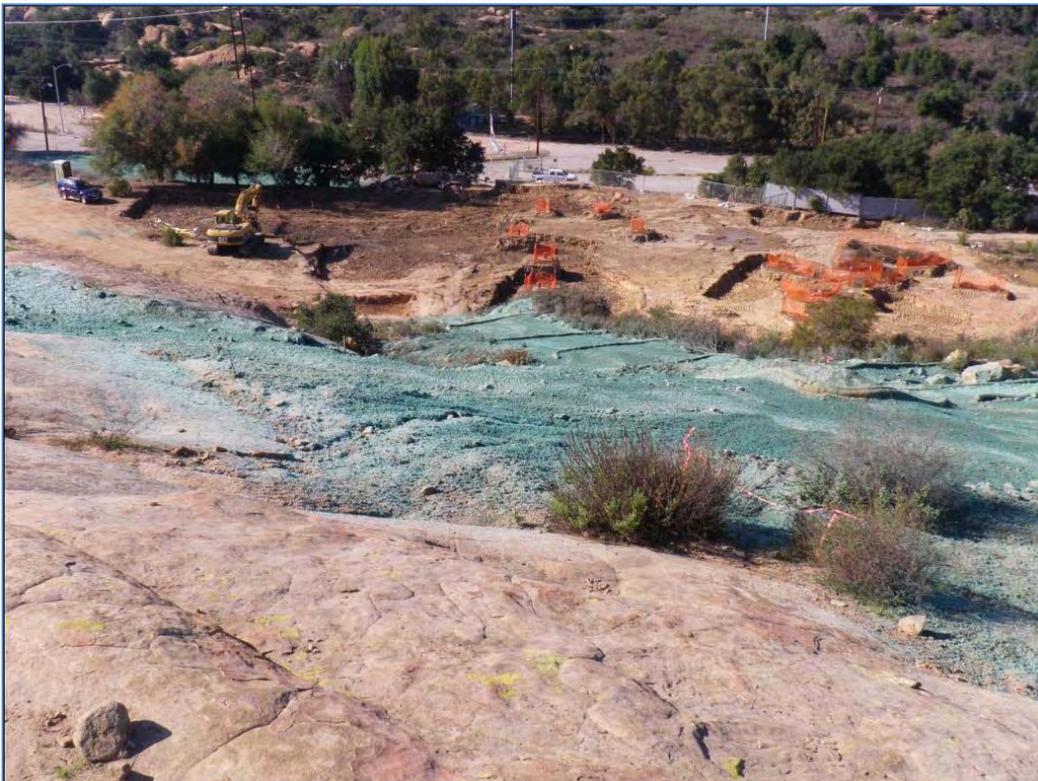
ISRA area B1-2 in background during excavation, ISRA area B1-1B in foreground after restoration with green-blue hydroseed mulch visible (11/19/2010, looking northwest). Orange fencing around Santa Susana tar plants and monitoring wells.

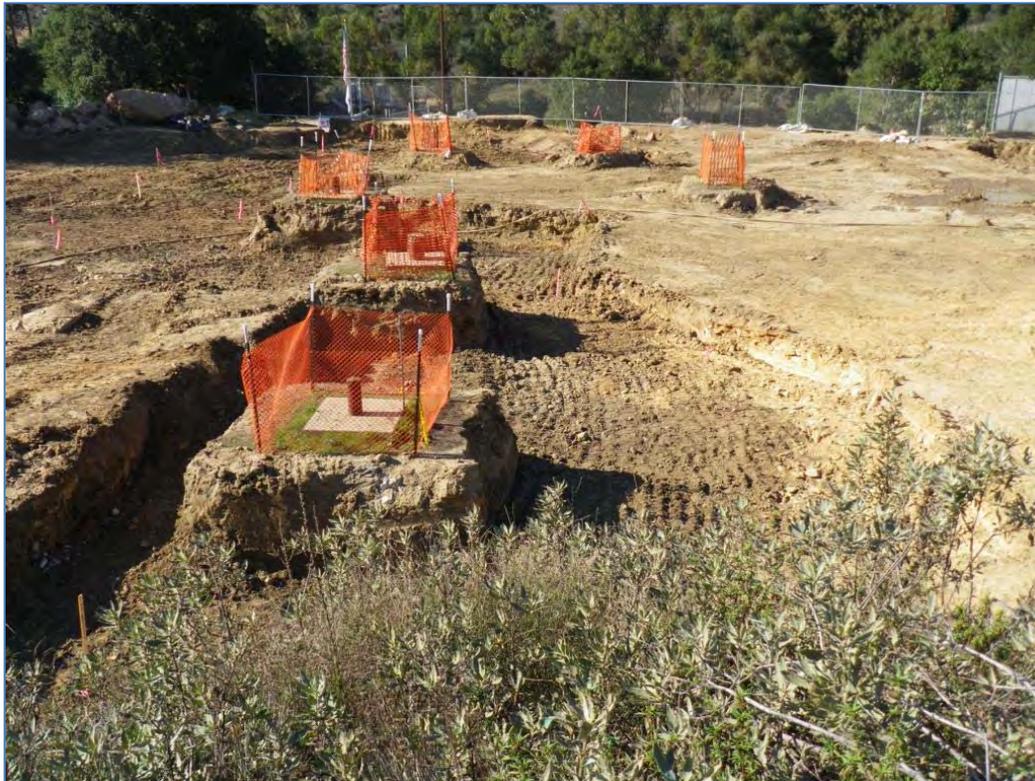
ISRA area B1-2, eastern portion during excavation (11/19/2010, looking west). Orange fencing around monitoring wells.

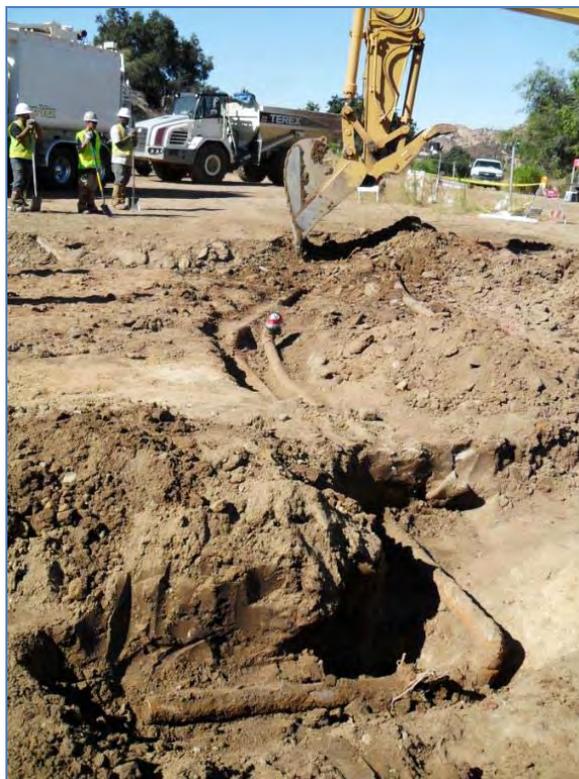
ISRA area B1-2 during excavation (9/17/2010, looking southwest). Encountered buried pipeline visible. Several buried pipelines encountered within the excavation boundary were removed (see Appendix H for details).

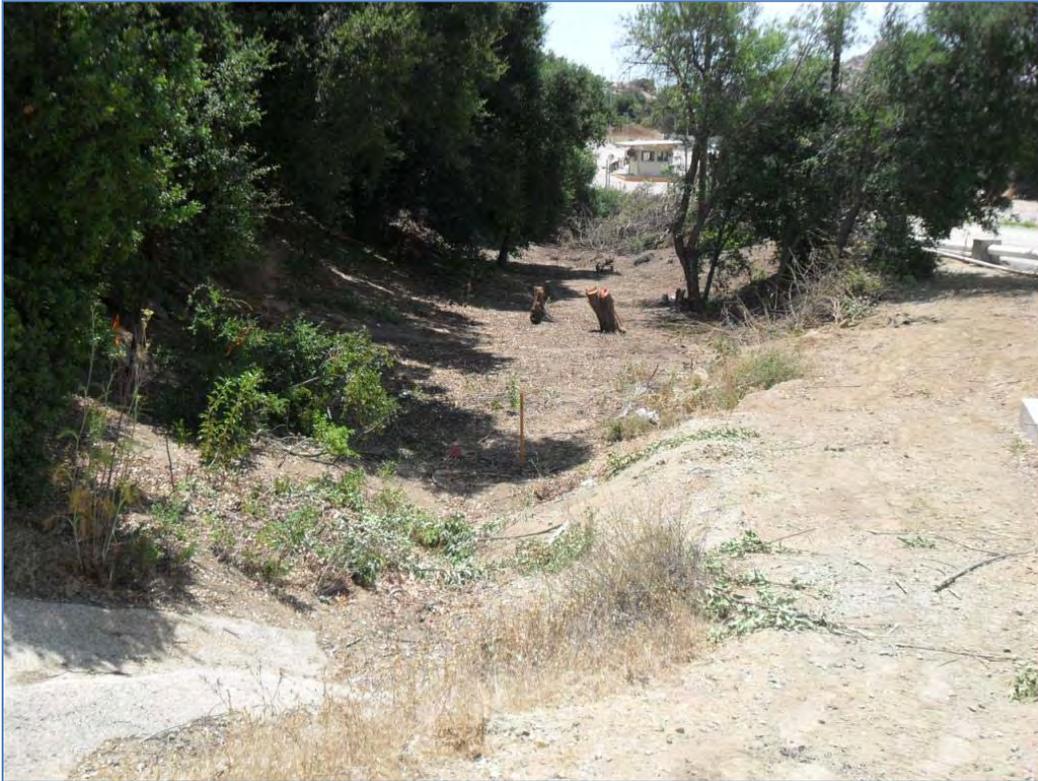
ISRA area B1-2, western portion along entrance road, after vegetation clearance, prior to excavation (7/16/2010, looking southwest).

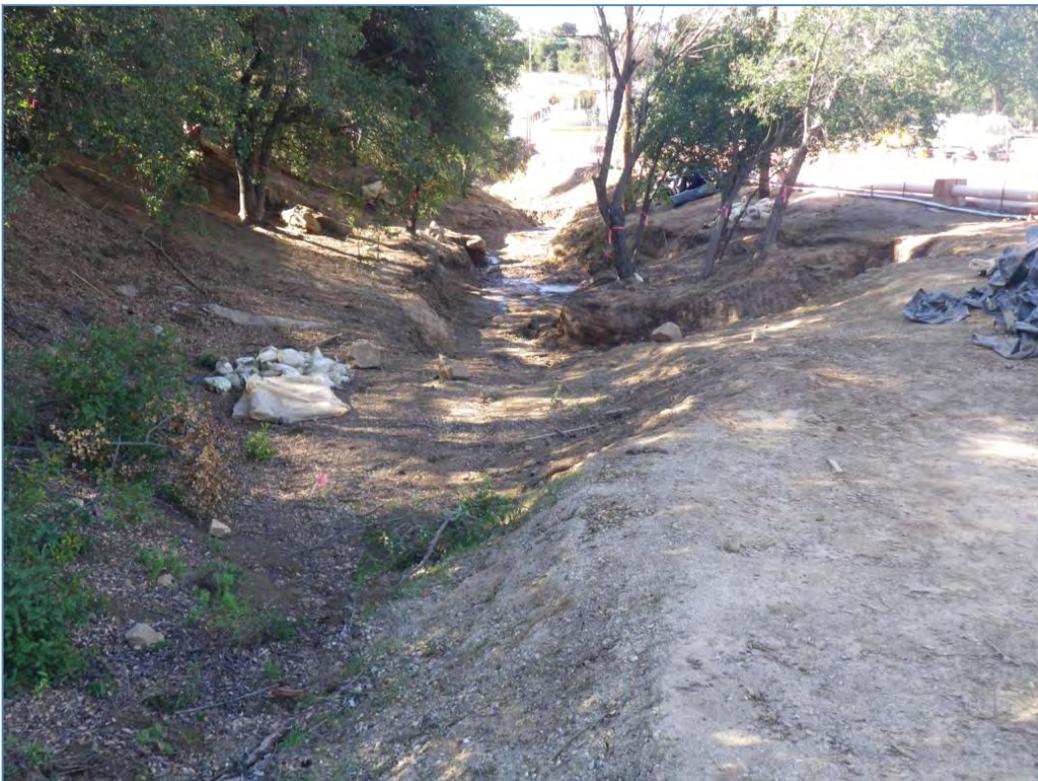
ISRA area B1-2, western portion along entrance road, after excavation (1/13/2011, looking southwest).

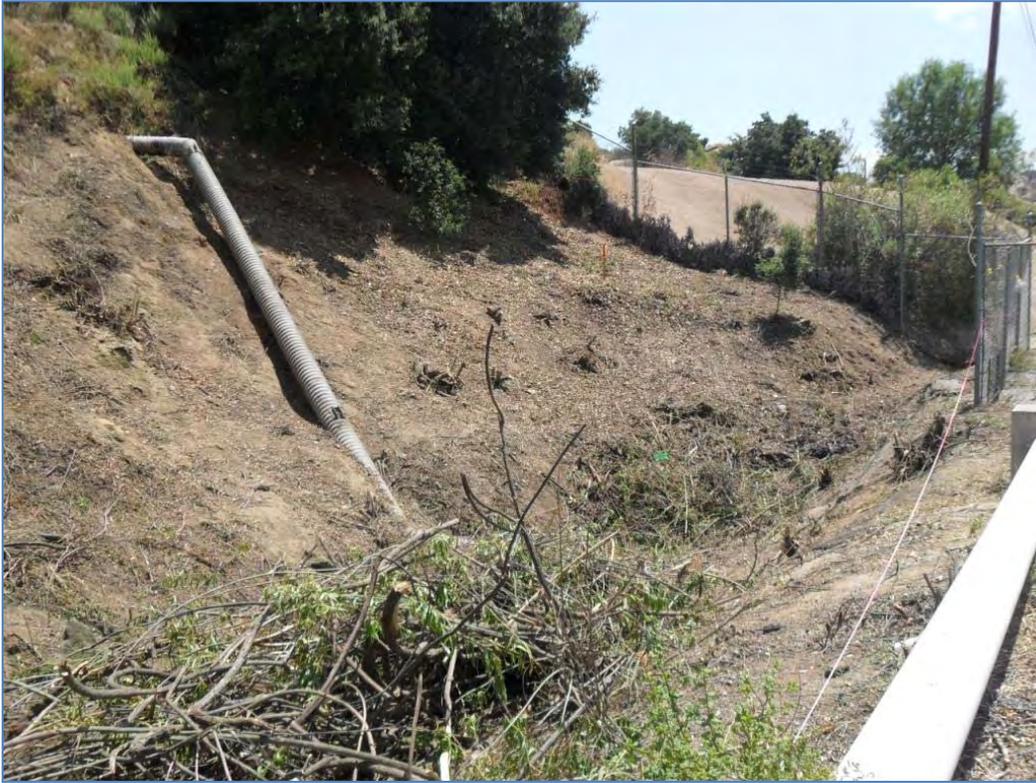
ISRA area B1-2, western portion along entrance road, after vegetation clearance, prior to excavation (7/16/2010, looking southwest).

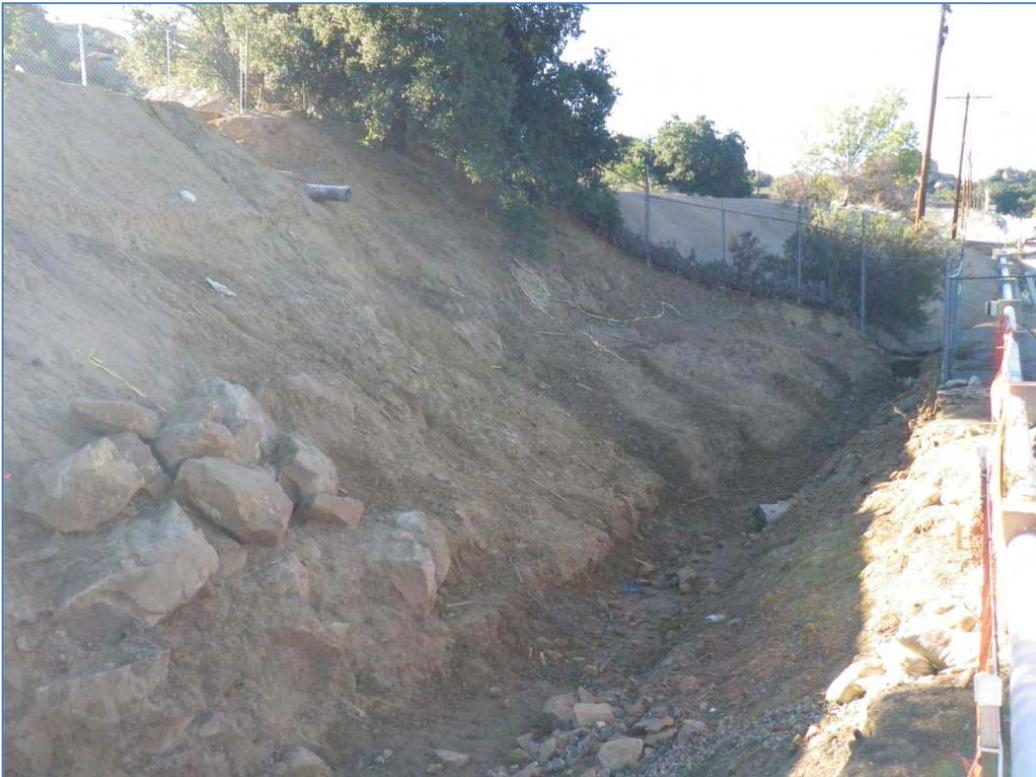
ISRA area B1-2, western portion along entrance road, after excavation (12/13/2010, looking southwest).

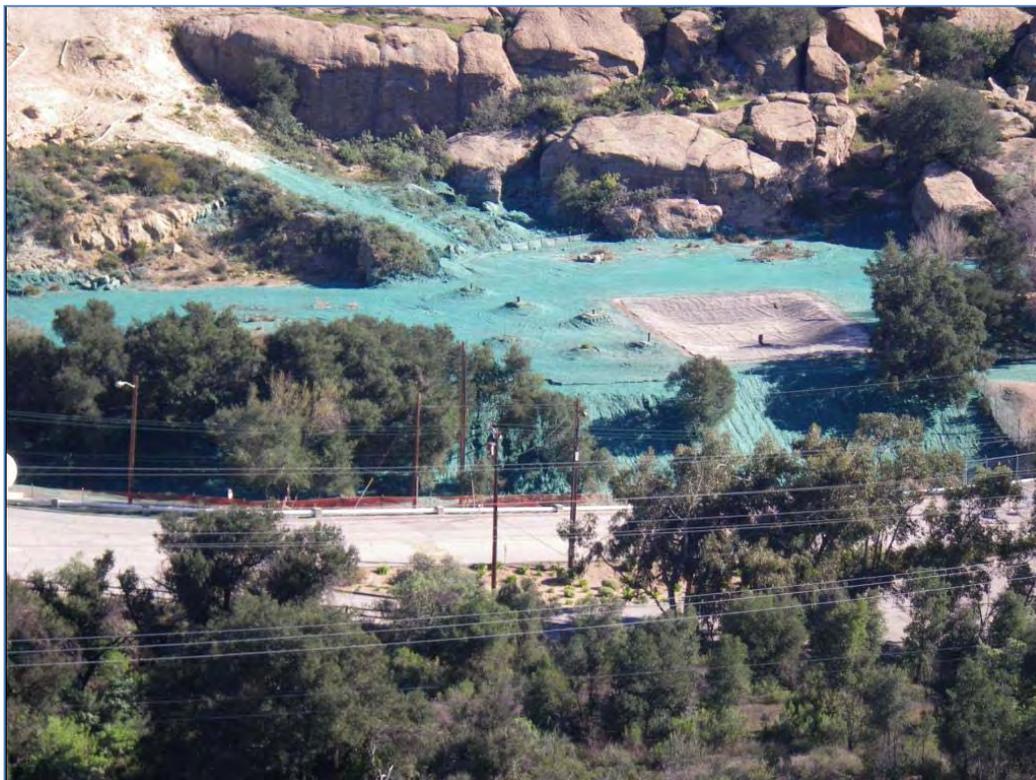
ISRA area B1-2 after restoration (2/11/2011, looking south). Blue-green hydroseed mulch and lined retention basin are visible.

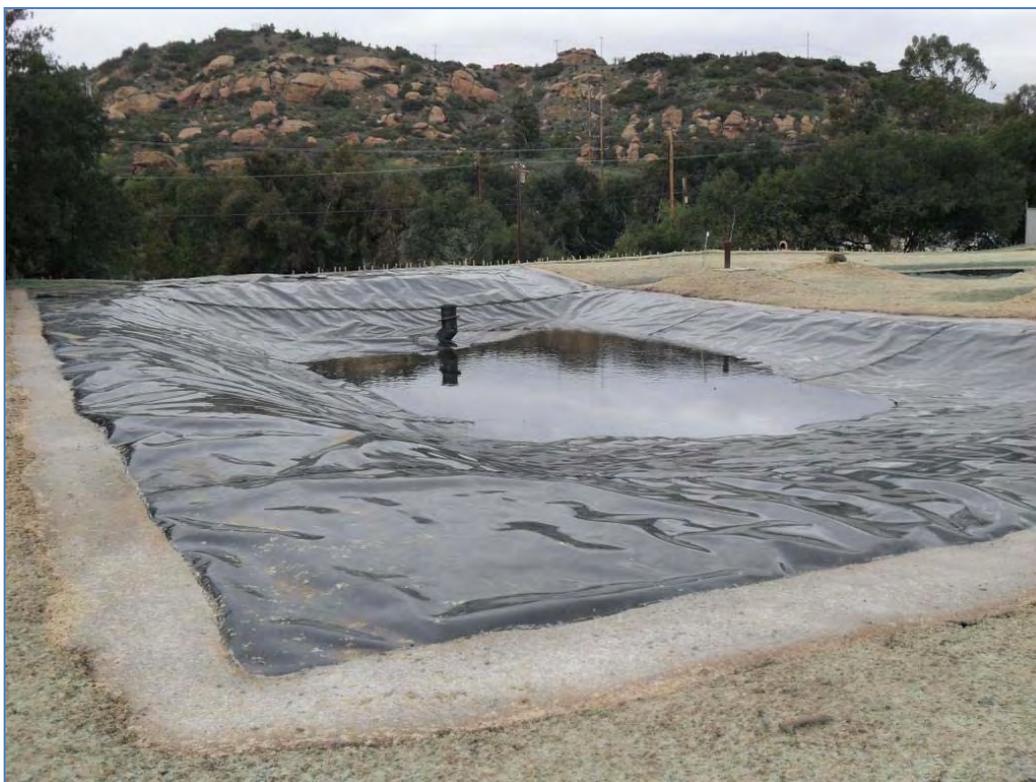
ISRA area B1-2 after restoration, lined retention basin (2/18/2011, looking northwest).

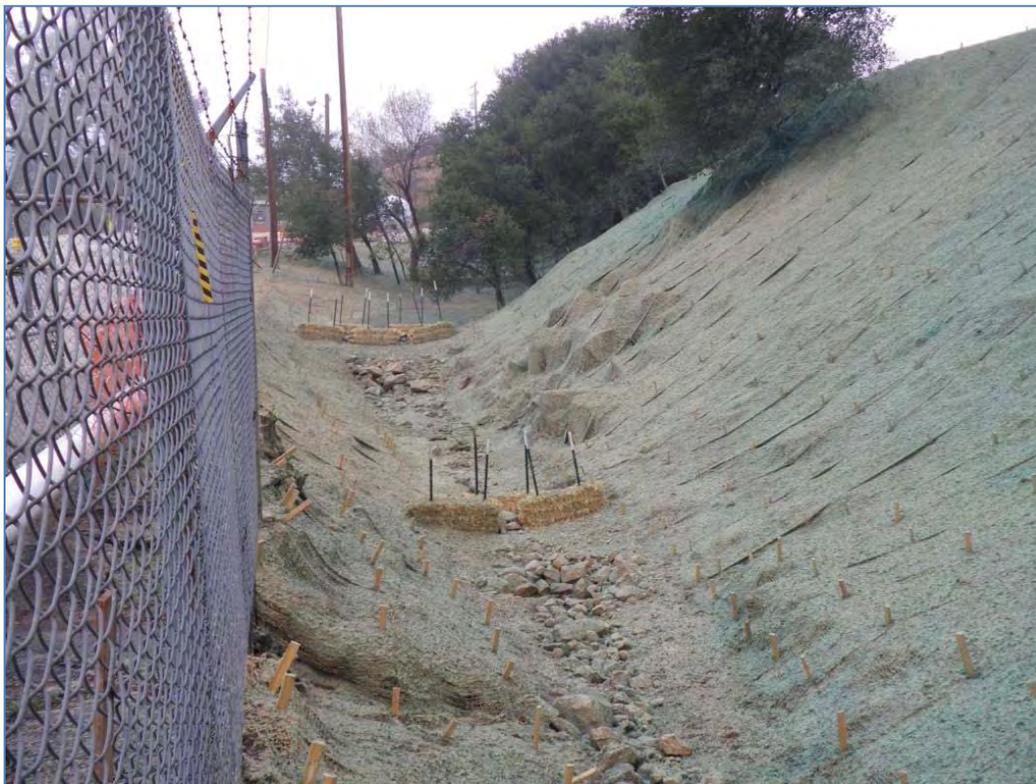
ISRA area B1-2, western portion along entrance road, after restoration (2/15/2011, looking northeast). Fiber matting covered with blue-green hydroseed mulch is visible.

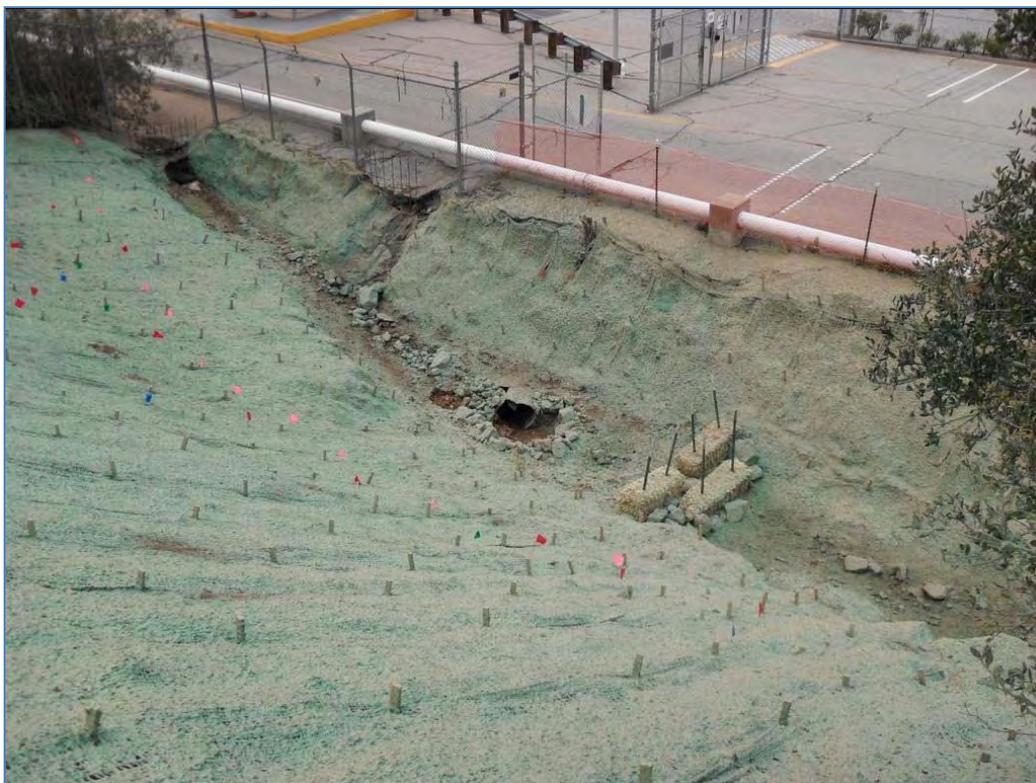
ISRA area B1-2, western portion along entrance road, after restoration (2/15/2011, looking west). Fiber matting covered with blue-green hydroseed mulch is visible

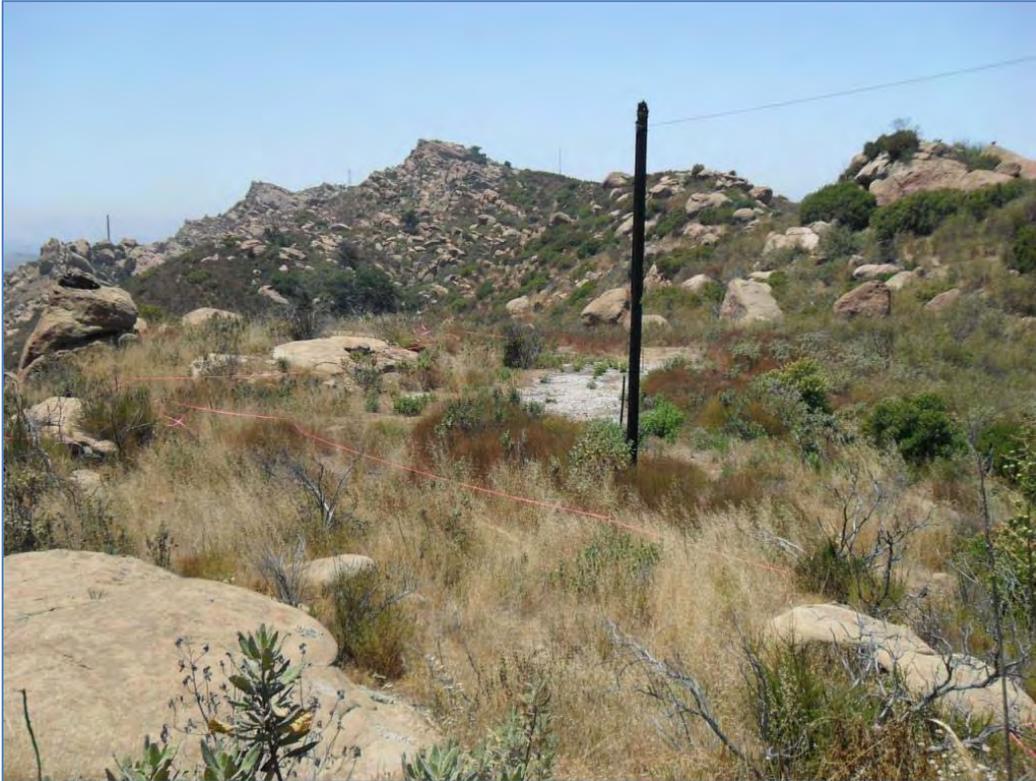
ISRA area CTLI-1A prior to vegetation clearance (7/7/2010, looking southwest).

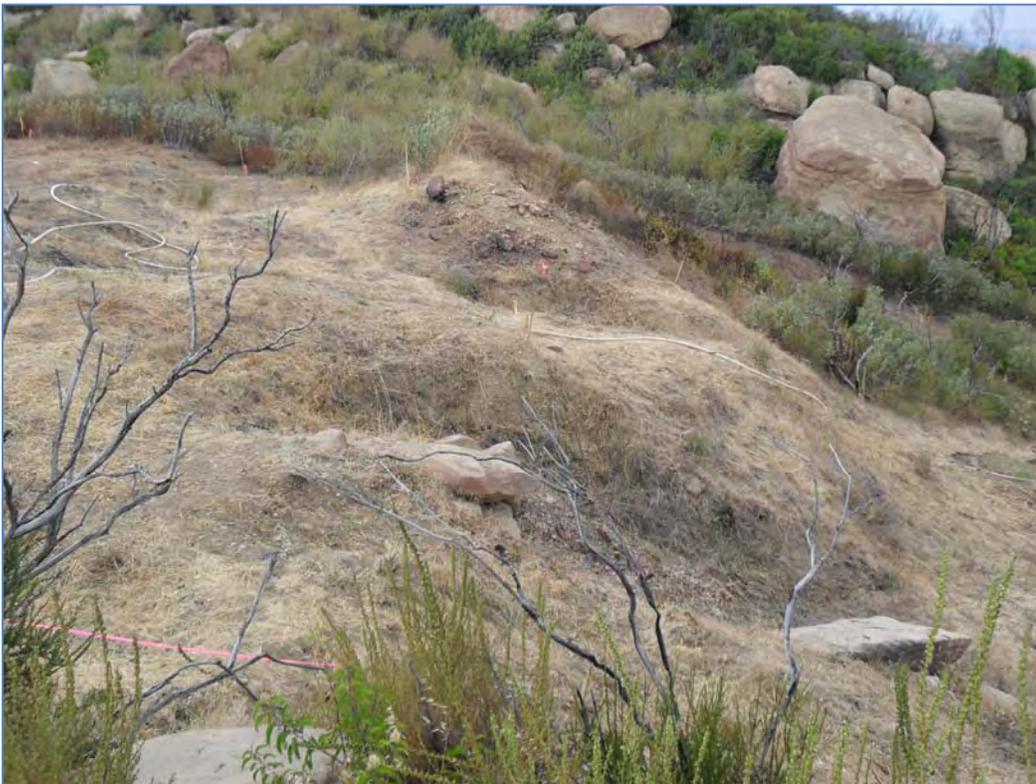
ISRA area CTLI-1A after vegetation clearance, prior to excavation (7/16/2010, looking west).

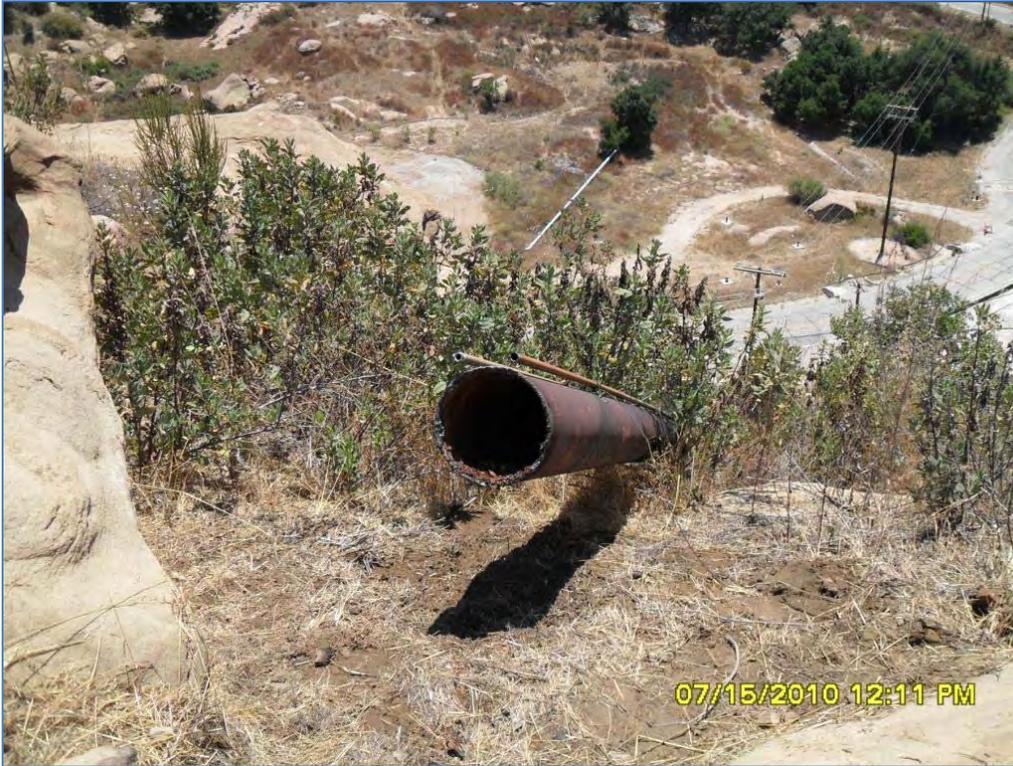
ISRA area CTLI-1A after vegetation clearance, prior to excavation activities, aboveground pipeline partially removed (7/15/2010, looking south). Remaining portion of pipeline was subsequently removed (see Appendix H for details).

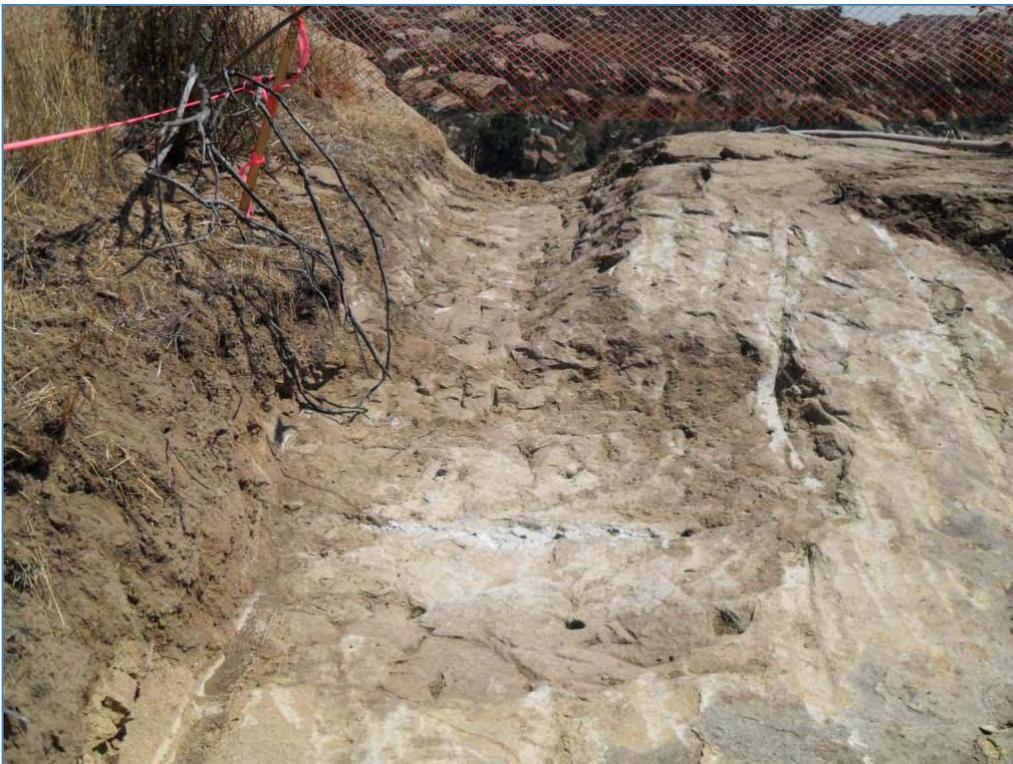
ISRA area CTLI-1A after excavation, aboveground pipeline removed (see Appendix H for details) (8/15/2010, looking south).

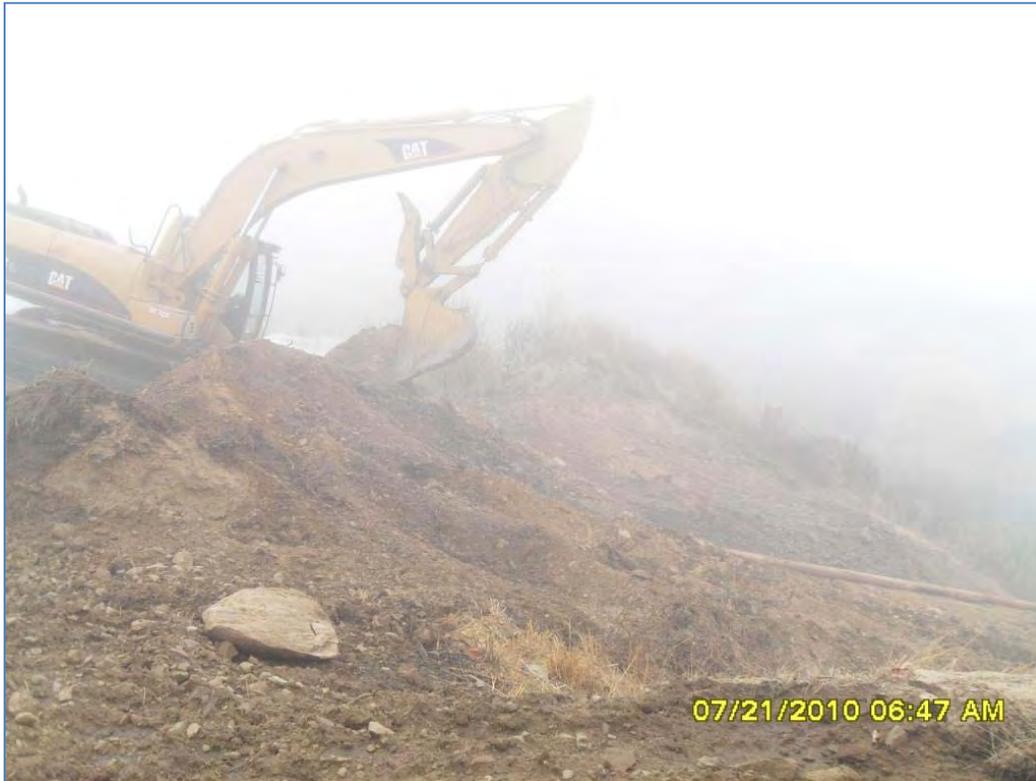
ISRA area CTLI-1A during excavation (7/21/2010, looking west). Previously buried pipeline segment is visible and was subsequently removed (see Appendix H for details).

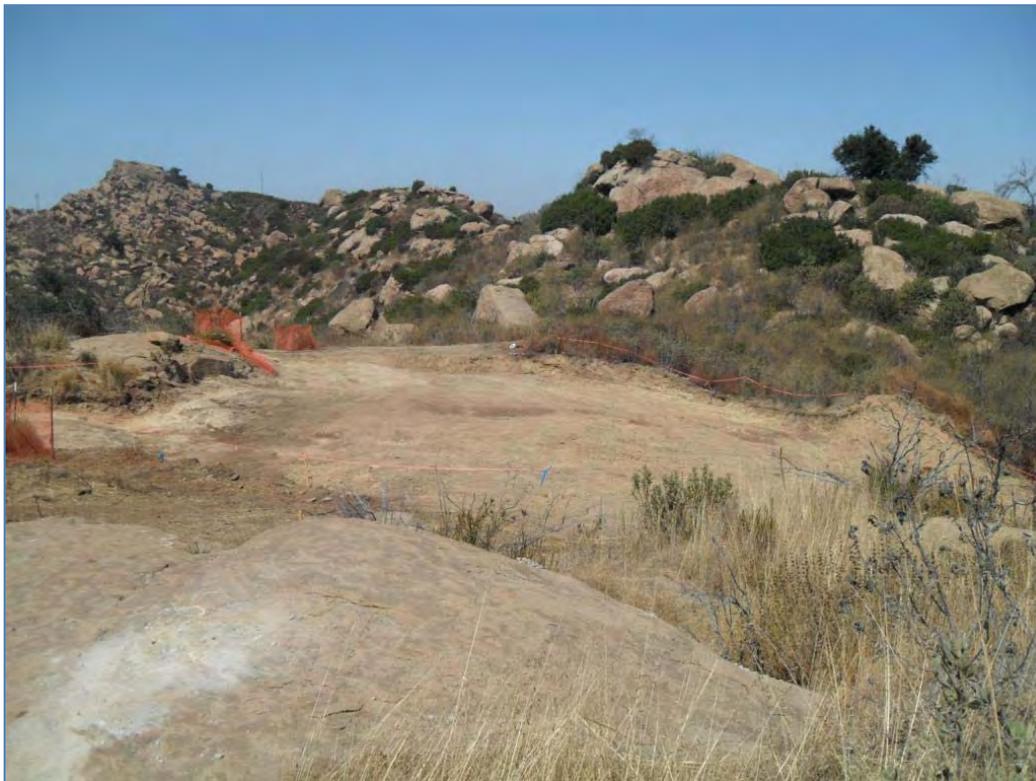
ISRA area CTLI-1A after planned excavation, (8/6/2010, looking southwest). Orange fencing around Santa Susana tar plants.

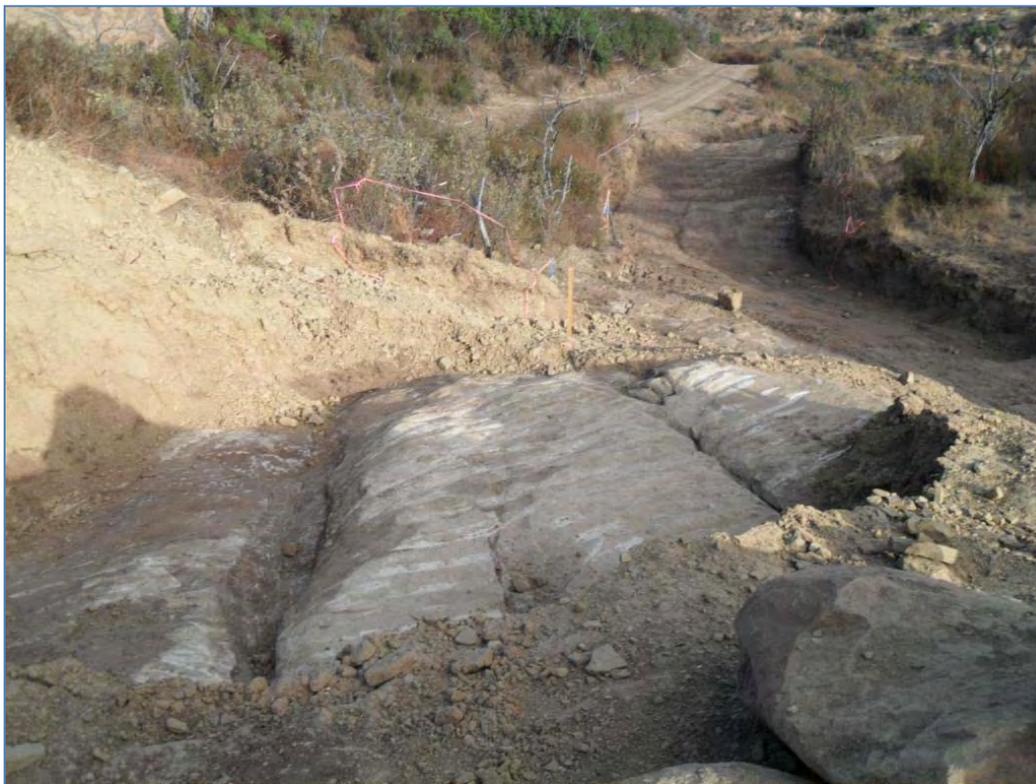
ISRA area CTLI-1A, northern portion, after additional excavation (10/1/2010, looking north).

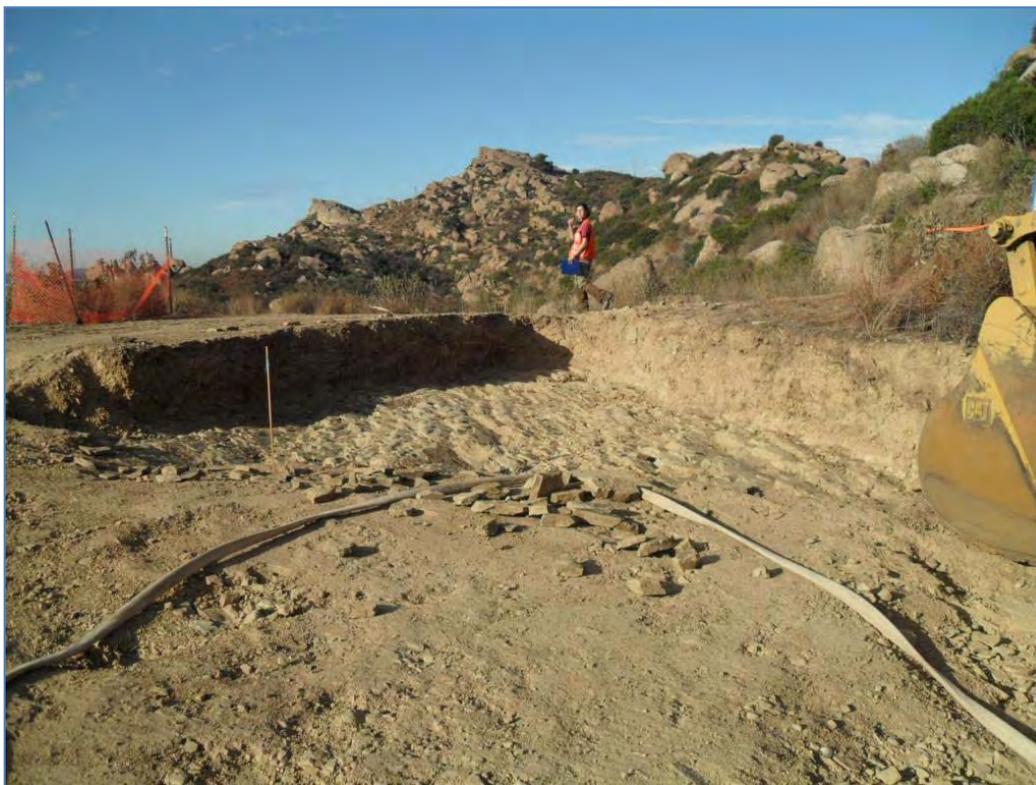
ISRA area CTLI-1A, southwestern portion, after additional excavation (10/1/2010, looking southwest).

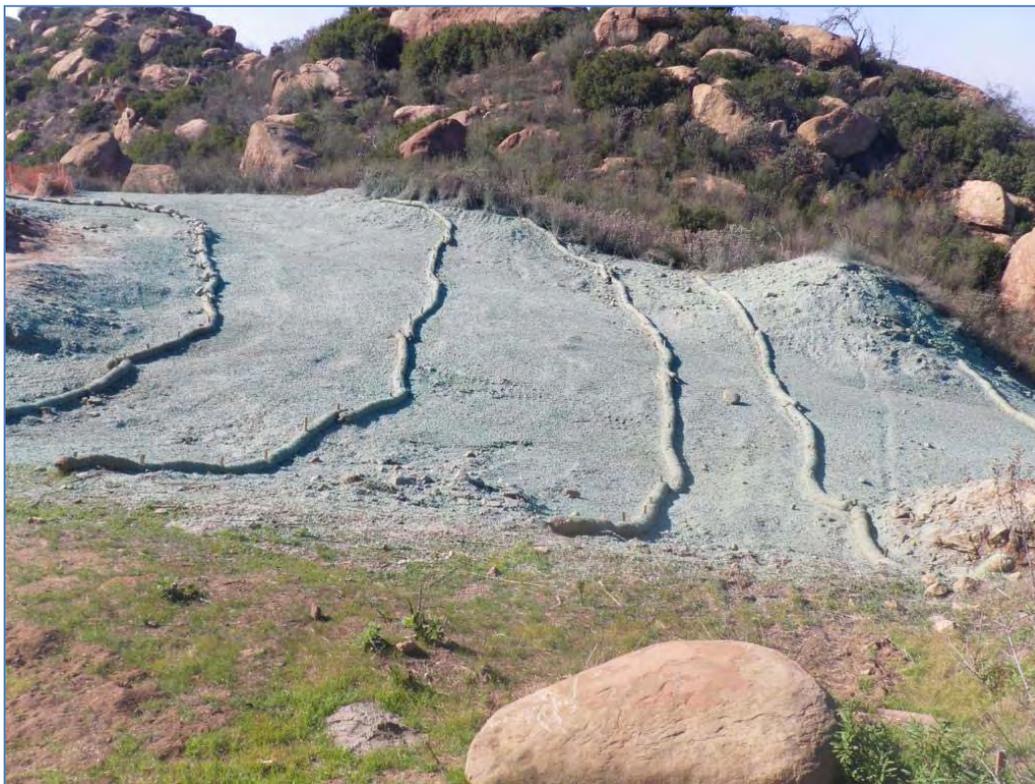
ISRA area CTLI-1A after restoration (11/16/201, looking west). Blue-green hydroseed mulch is visible.

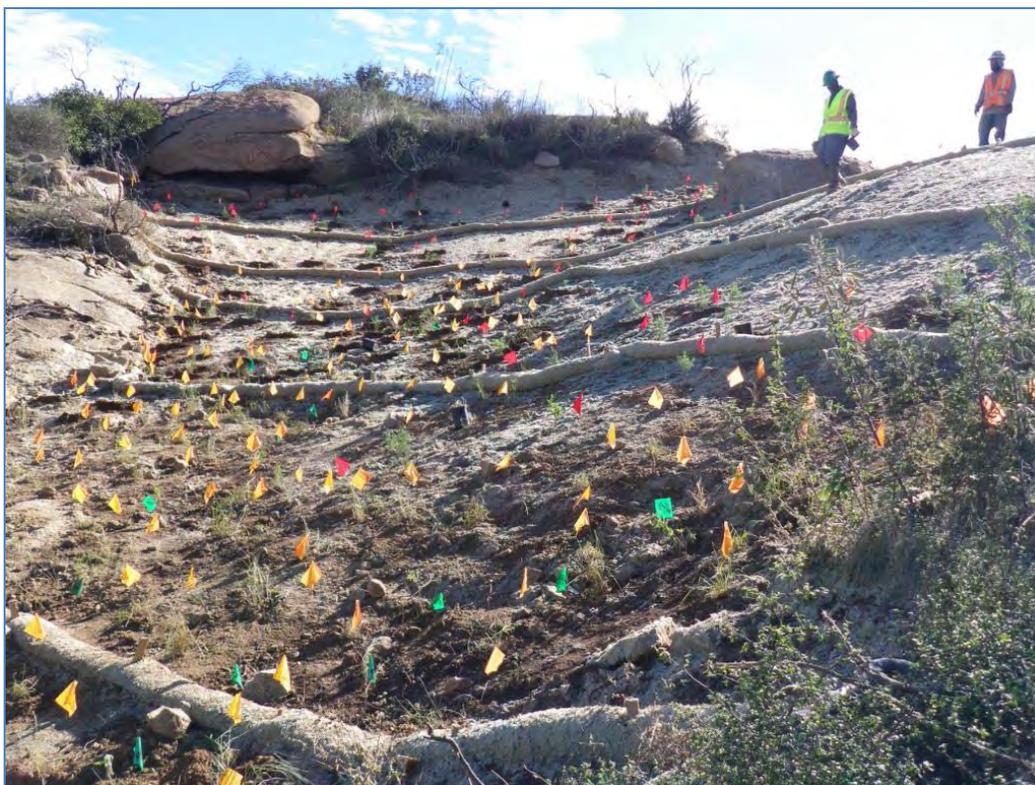
ISRA area CTLI-1A after restoration, during installation of containerized plants (12/2/2010, looking southeast). Pin flags mark the locations of installed plants.
