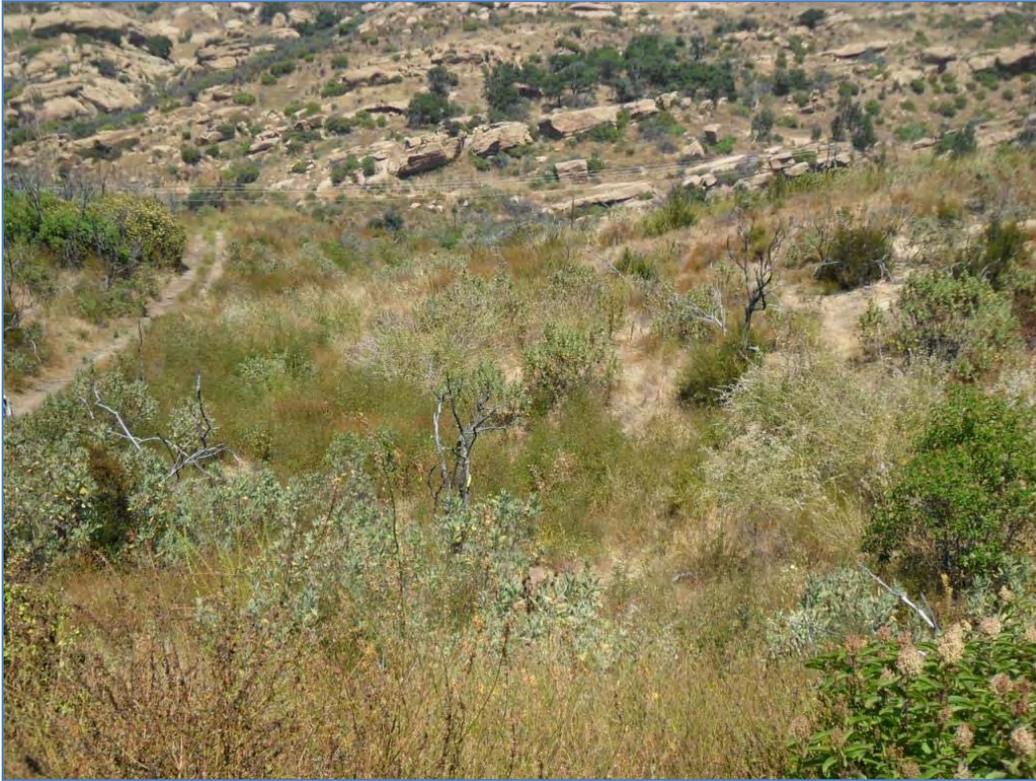
ISRA area CTLI-1B prior to vegetation clearance (7/7/2010, looking north).

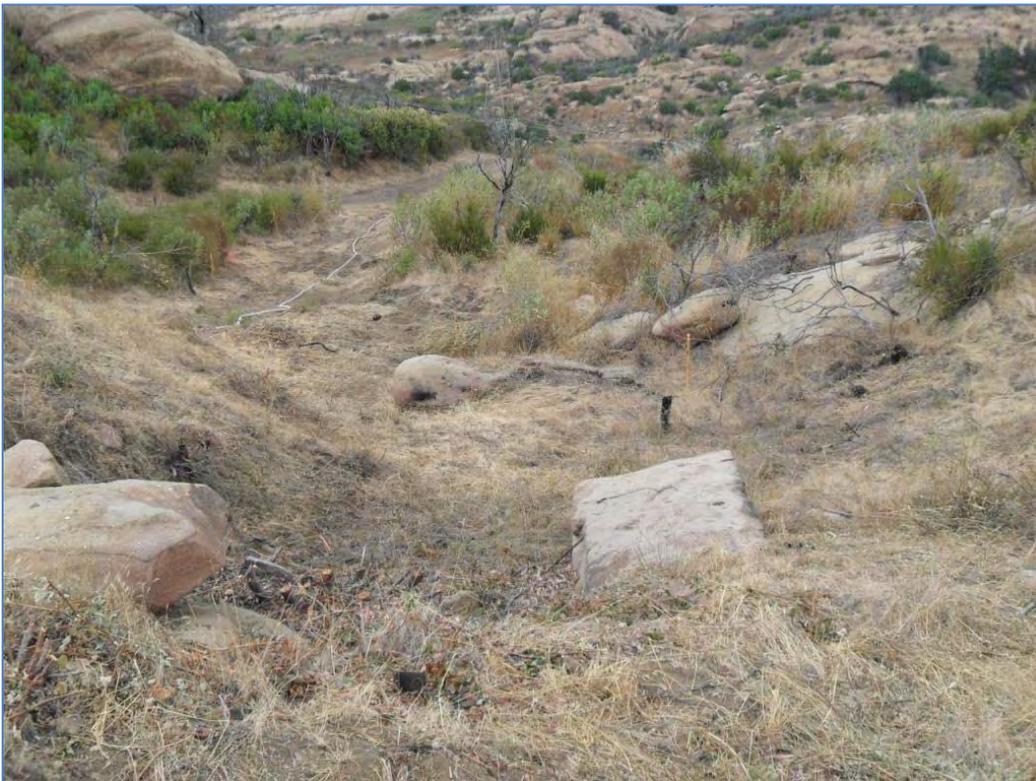
ISRA area CTLI-1B after vegetation clearance, prior to excavation (7/16/2010, looking north).

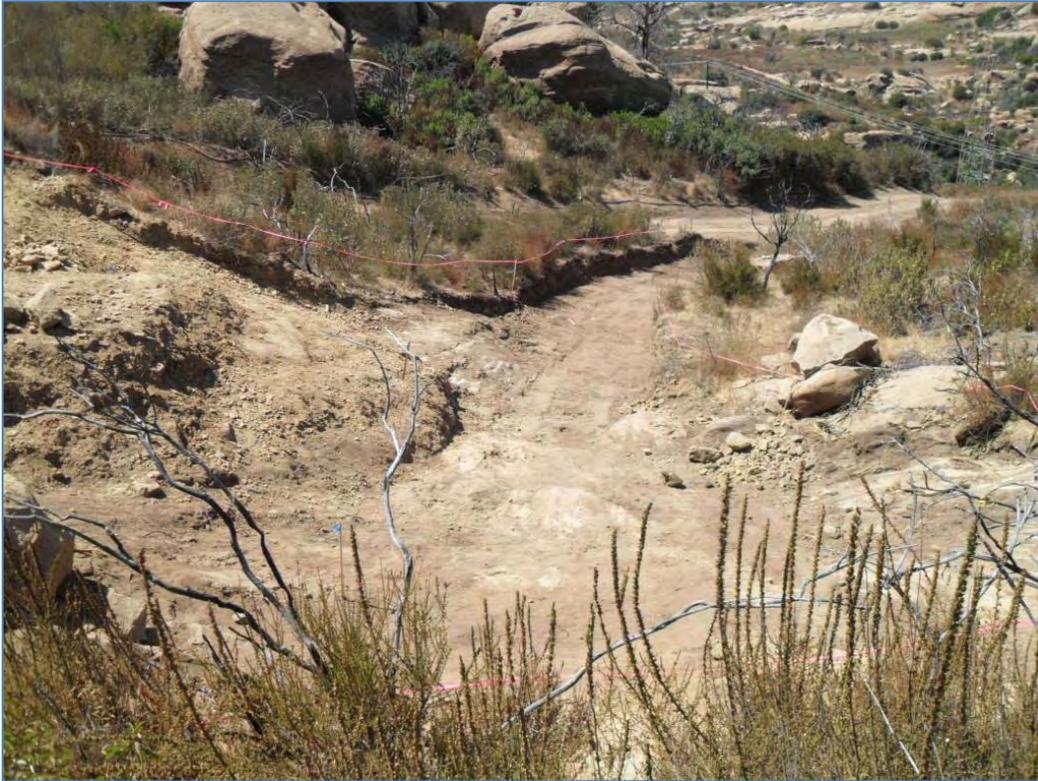
ISRA area CTLI-1B after excavation (8/12/2010, looking north).

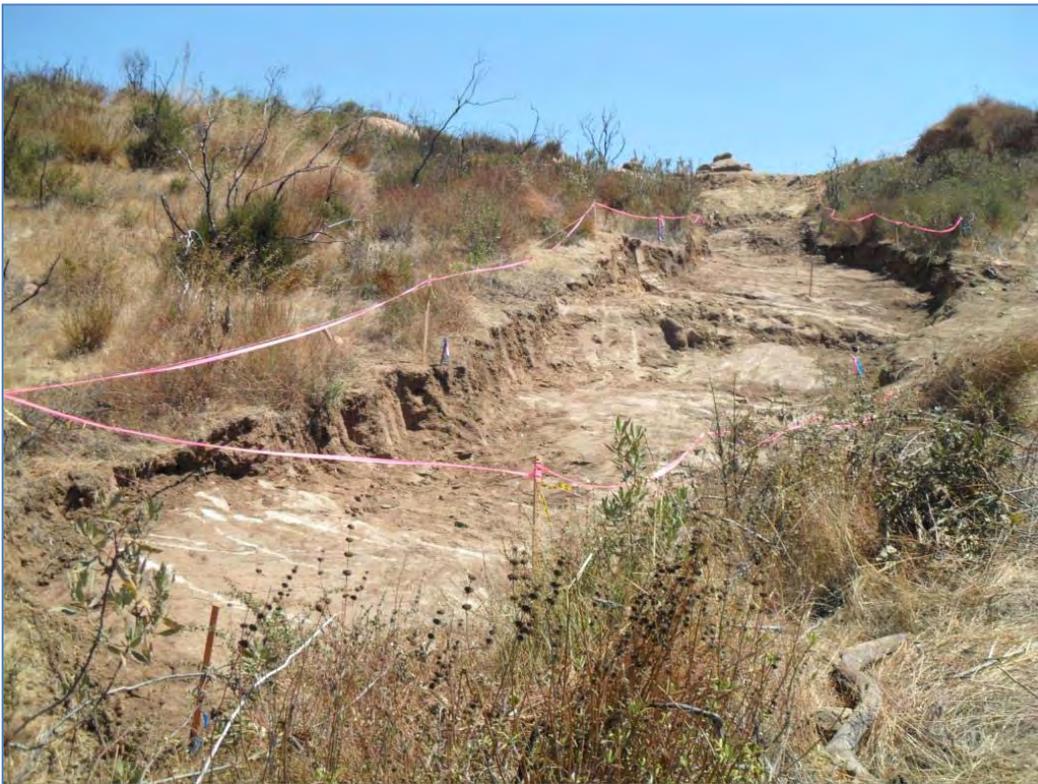
ISRA area CTLI-1B after excavation (8/12/2010, looking south).

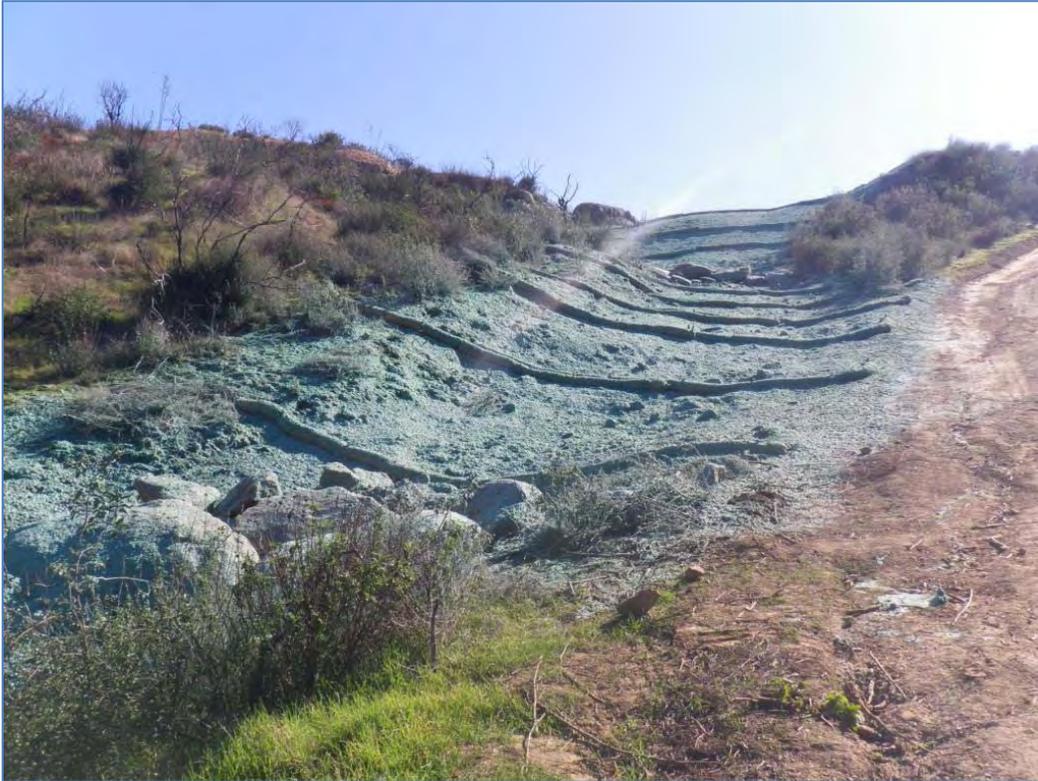
ISRA area CTLI-1B after restoration (11/16/2010, looking south). Blue-green hydroseed mulch is visible.

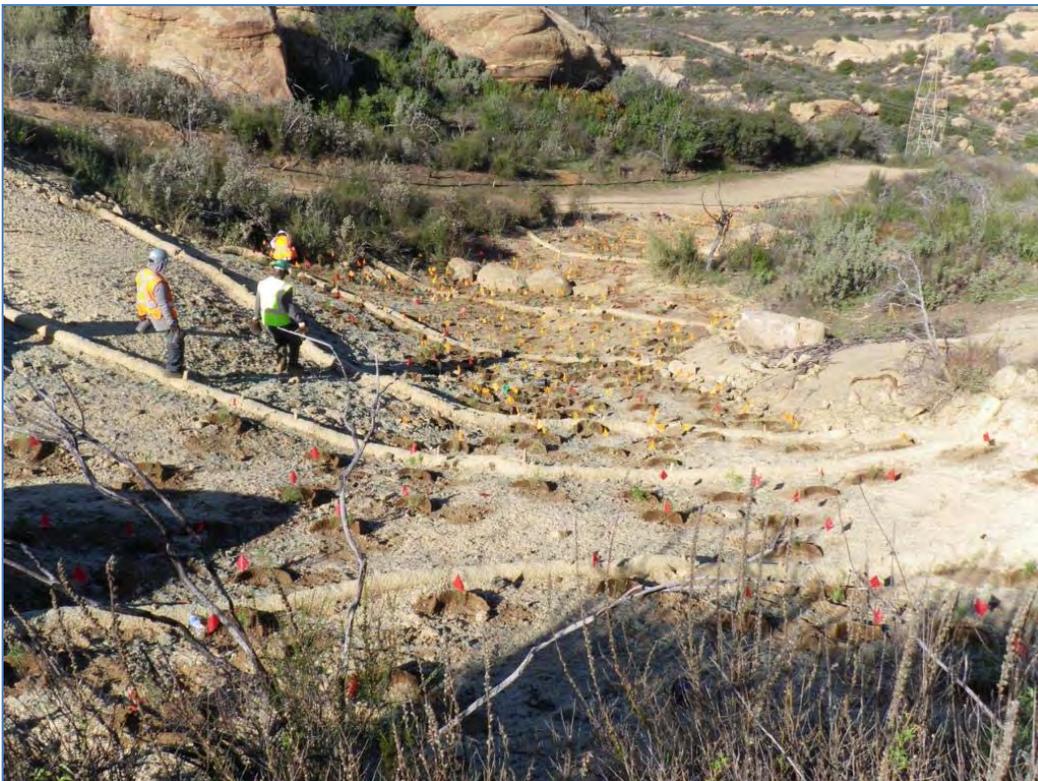
ISRA area CTLI-1B after restoration, during installation of containerized plants (12/2/2010, looking north). Pin flags mark the locations of installed plants.

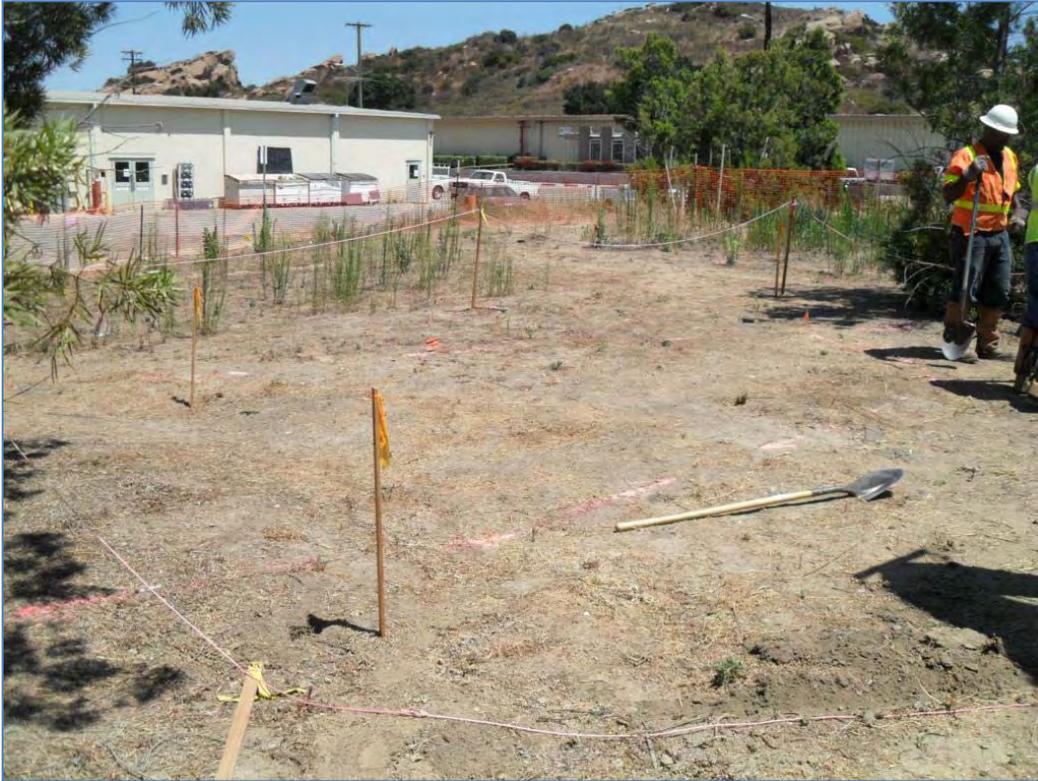
ISRA area IEL-1 after vegetation clearance, prior to excavation (8/10/2010, looking northeast).

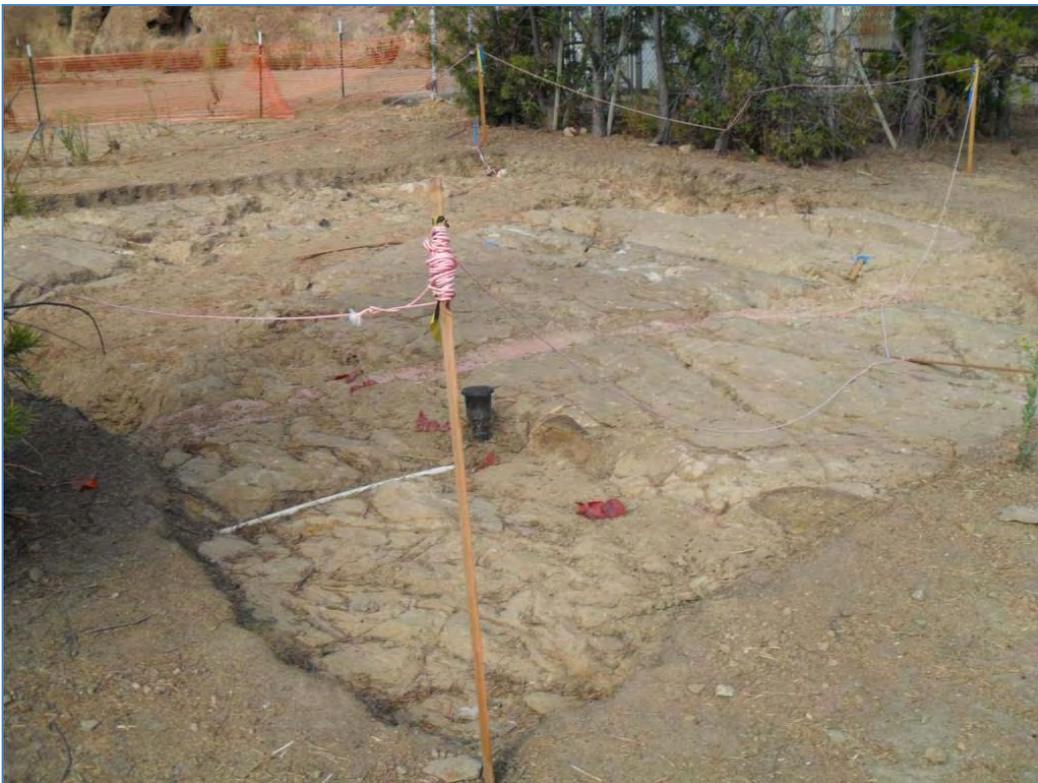
ISRA area IEL-1 after excavation (10/1/2010, looking west).

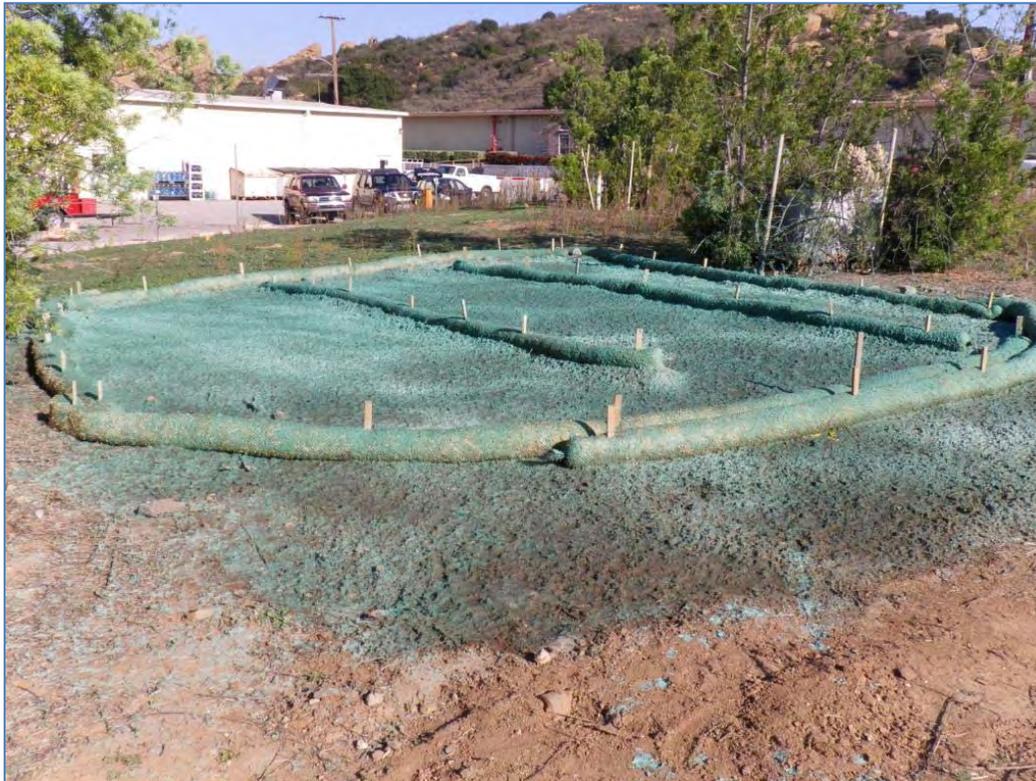
ISRA area IEL-1 after restoration (11/16/2010, looking northeast). Blue-green hydroseed mulch is visible.
