APPENDIX H

**BUILDING FEATURE DESCRIPTION LOGS AND
BUILDING FEATURE REMOVAL LOGS**

Appendix H – Building Feature Description (BFD) Logs and Building Feature Removal (Feature Removal) Logs

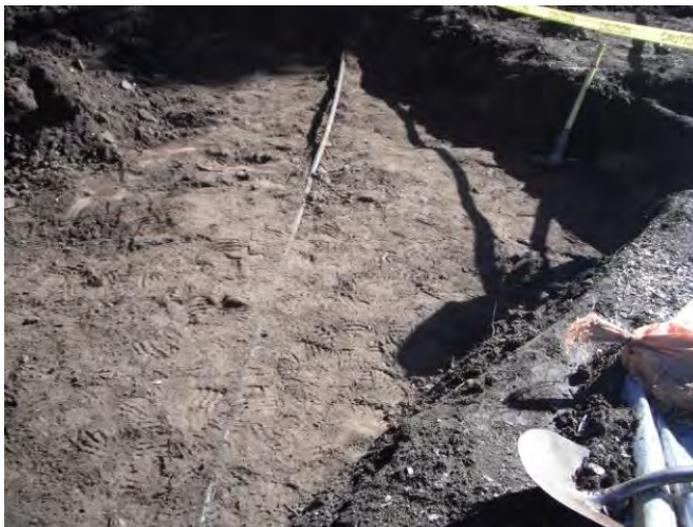
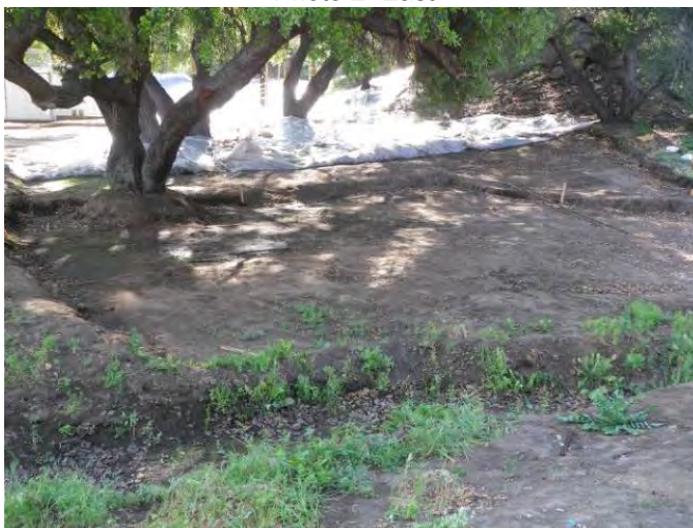
Building Feature Documentation Log
Feature Number: 2509-001
Santa Susana Field Laboratory, Ventura County, California

General Condition: **Intact**
Debris: **N/A**
Staining: **No**
Odor: **No**
PID Reading: **N/A**
Likelihood of Impact from Feature: **Unlikely**

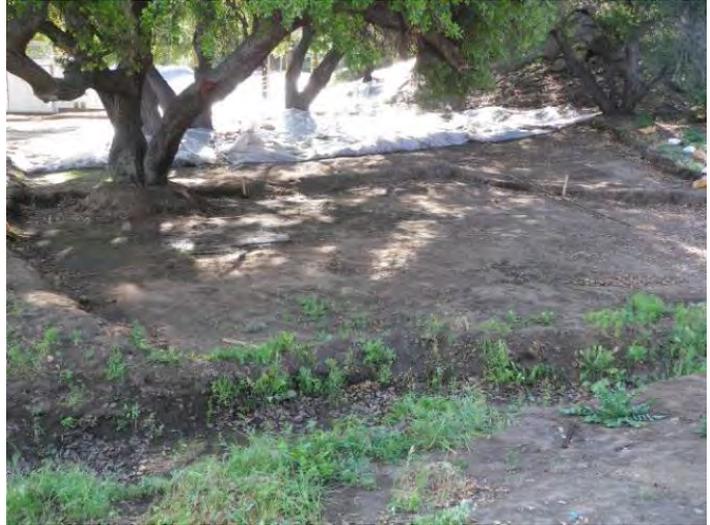
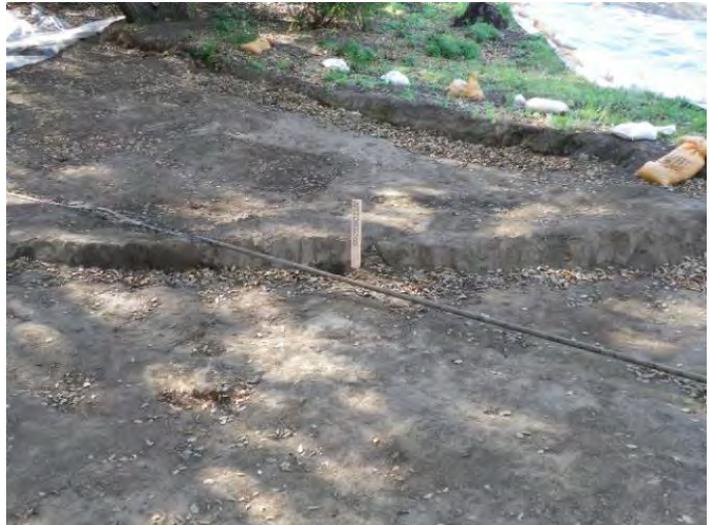
Building Feature Removal Log
Feature Number: 2509-001
Santa Susana Field Laboratory, Ventura County, California

- Condition of Soil: **Not impacted**
- PID Headspace Reading: **N/A**
- Sample Collected: **No**
- Sample ID: **N/A**
- Analyses: **N/A**
- Comments: **Feature 2509-001 was a subsurface 1.0-inch conduit pipeline, trending approximately east-west and located west of former Building 2758 (incinerator). Approximately 80 feet of pipeline was removed during ISRA implementation activities at ISRA area AP/STP-1C-2 between February and March 2013 (the feature was completely removed). No staining or odors observed in soils during removal.**

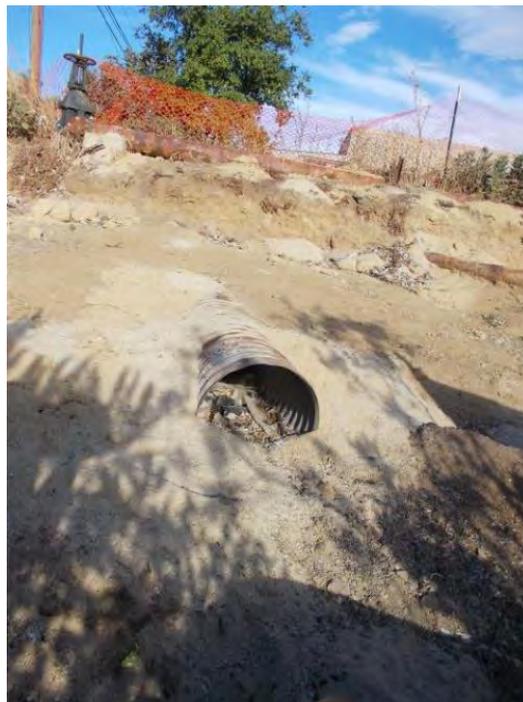
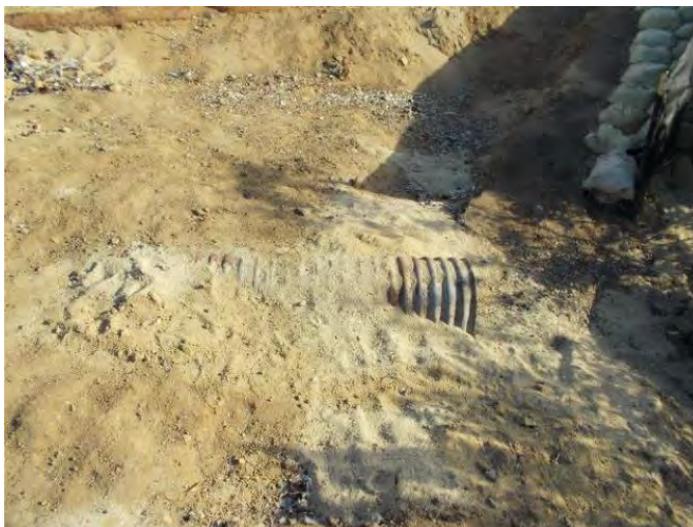
Building Feature Documentation Log
Feature Number: ELV-1C-01
Santa Susana Field Laboratory, Ventura County, California

General Condition: **Intact some corrosion**
Debris: **No**
Staining: **No**
Odor: **No**
PID Reading: **0.0 ppm**
Likelihood of Impact from Feature: **Unlikely**

Comments: **Feature ELV-1C-01 is a subsurface 12-inch corrugated metal drain pipe, trending approximately N 30 W. Feature was identified during 2012 ISRA implementation activities at ISRA area ELV-1C, in the western portion of the excavation area. The pipe was left in-place and no staining or odors were observed in adjacent soils; soil appears to be fill material.**

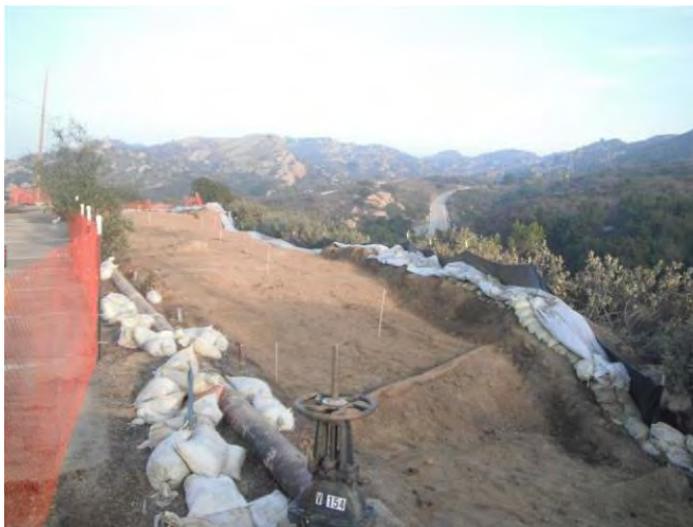
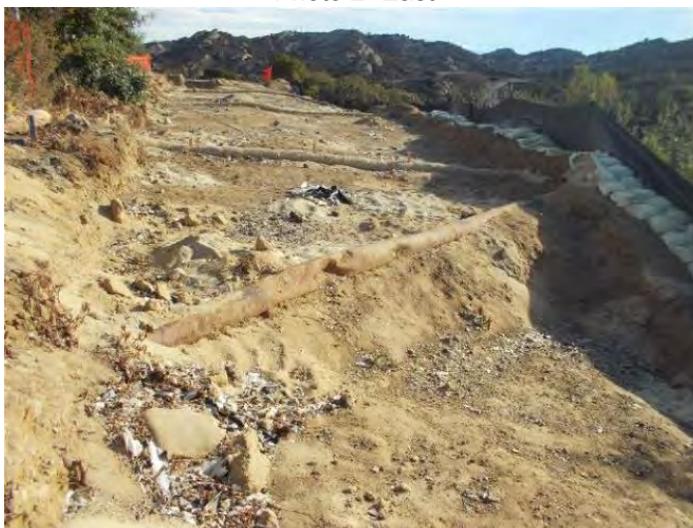
Building Feature Documentation Log
Feature Number: ELV-1C-02
Santa Susana Field Laboratory, Ventura County, California

General Condition: **Intact some corrosion**
Debris: **No**
Staining: **No**
Odor: **No**
PID Reading: **0.0 ppm**
Likelihood of Impact from Feature: **Unlikely**

Proximity to Nearest Chemical Use Area: **Approximately 50 feet south of CUA 2 (ELV RFI Site; Drum Storage Area)**
Likelihood of Impact from Other Source: **Unlikely**
Comments: **Feature ELV-1C-02 is a subsurface 4-inch sewer pipeline, trending approximately N 30 W. Feature was identified during 2012 ISRA implementation activities at ISRA area ELV-1C, in the western portion of the excavation area. The pipe was left in-place and no staining or odors were observed in adjacent soils removal; soil appears to be fill material.**
GPS Coordinates: **268775.825 Northing - 1789282.736 Easting**

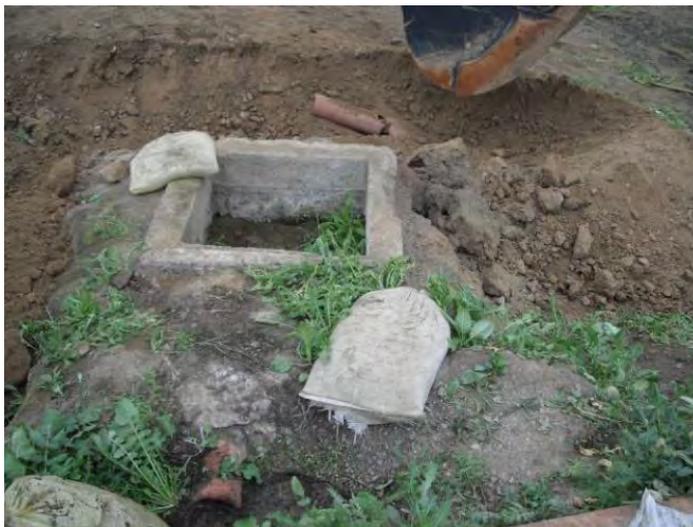
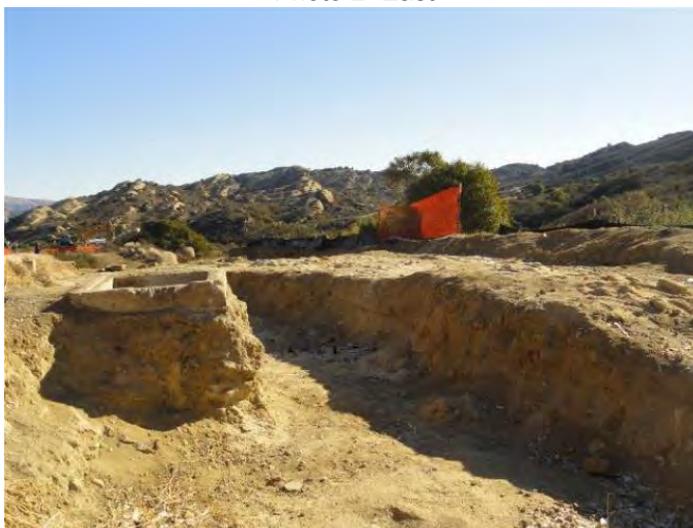
Building Feature Documentation Log
Feature Number: ELV-1C-03
Santa Susana Field Laboratory, Ventura County, California

General Condition: **Missing pieces**
Debris: **No**
Staining: **No**
Odor: **No**
PID Reading: **0.0 ppm**
Likelihood of Impact from Feature: **Unlikely**

Comments: **Feature ELV-1C-03 was a subsurface 24-inch by 24-inch square and 24-inch deep concrete stormwater drain. Feature was identified during 2012 ISRA implementation activities at ISRA area ELV-1C, within the central portion of the excavation area. The storm water drain was left in-place but associated clay piping (see Feature ELV-1C-04) was removed during ISRA Implementation activities. No staining or odors were observed in soils; soil appears to be fill material.**

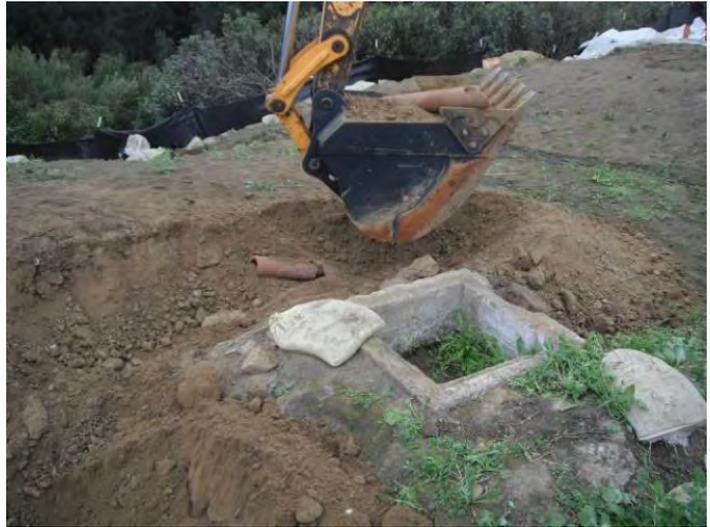
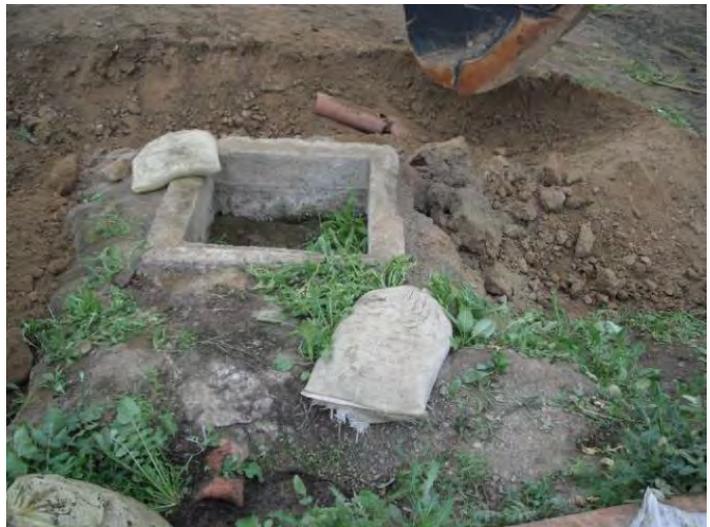
Building Feature Documentation Log
Feature Number: ELV-1C-04
Santa Susana Field Laboratory, Ventura County, California

General Condition: **Missing pieces**

Comments: **Feature ELV-1C-04 was a subsurface 3-inch clay drain pipe for a storm water drain (see Feature ELV-1C-03). Feature was identified during 2012 ISRA implementation activities at ISRA area ELV-1C, within the central portion of the excavation area. The clay drain pipe was removed during ISRA implementation activities. No staining or odors were observed in soils during removal; soil appears to be fill material.**

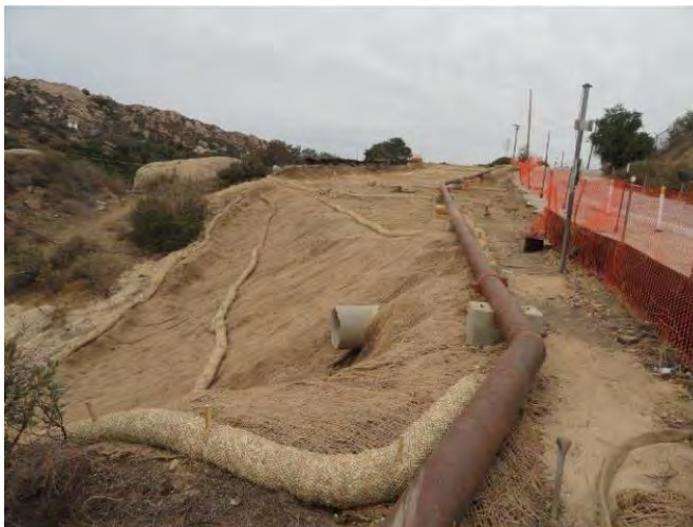
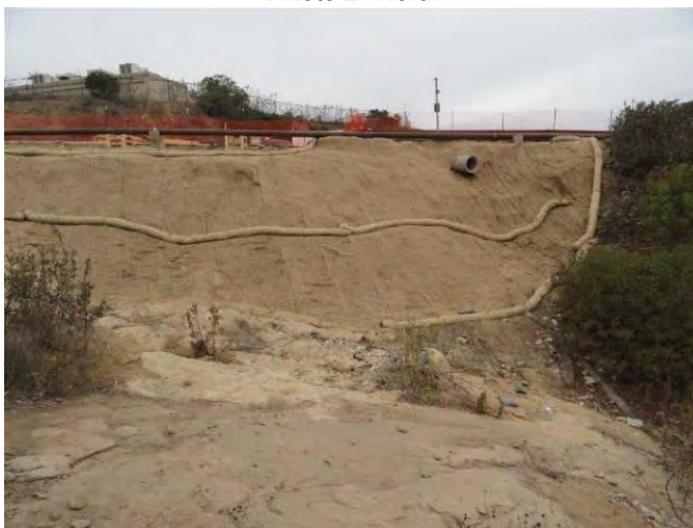
Building Feature Documentation Log
Feature Number: ELV-1C-05
Santa Susana Field Laboratory, Ventura County, California

General Condition: **Missing pieces**
Debris: **No**
Staining: **No**
Odor: **No**
PID Reading: **0.0 ppm**
Likelihood of Impact from Feature: **Potential**

Comments: **Feature ELV-1C-05 is a subsurface 18-inch concrete drain pipe. Feature was identified during February 2013 ISRA implementation activities at ISRA area ELV-1C, in the eastern portion of the excavation. The concrete drain pipe was left in-place and no staining or odors were observed in adjacent soils; soil appears to be fill material.**

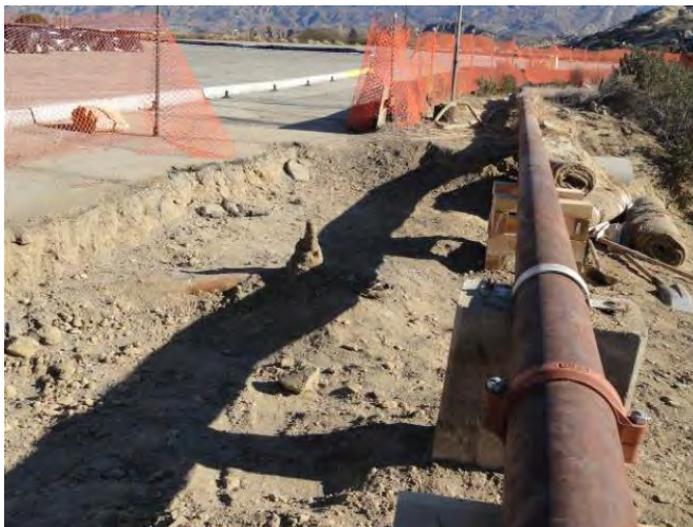
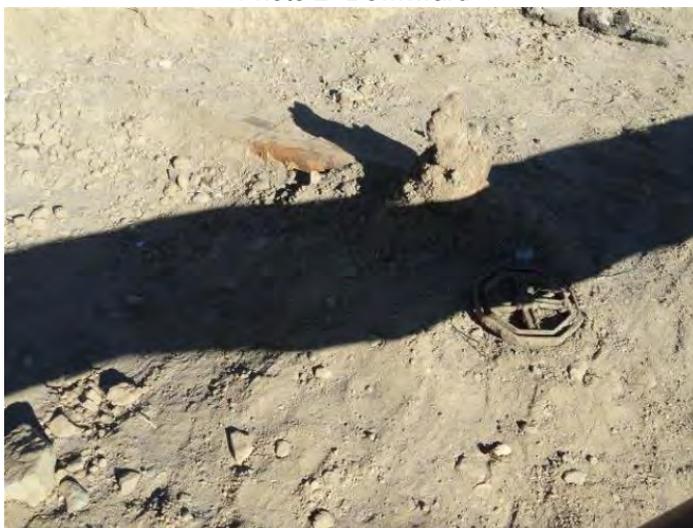
Building Feature Documentation Log
Feature Number: ELV-1C-06
Santa Susana Field Laboratory, Ventura County, California

General Condition: **Broken**
Debris: **No**
Staining: **No**
Odor: **No**
PID Reading: **0.0 ppm**
Likelihood of Impact from Feature: **Unlikely**

Comments: **Feature ELV-1C-06 is a subsurface valve and 2-inch metal pipe. Feature was identified during October 2013 ISRA implementation activities at ISRA area ELV-1C, in the eastern portion of the excavation area. The valve and pipe were left in-place and no staining or odors were observed in adjacent soils; soil appears to be fill material.**

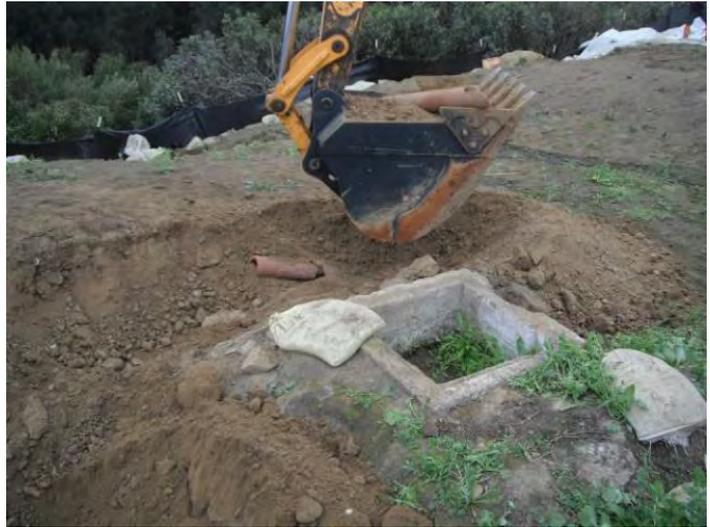
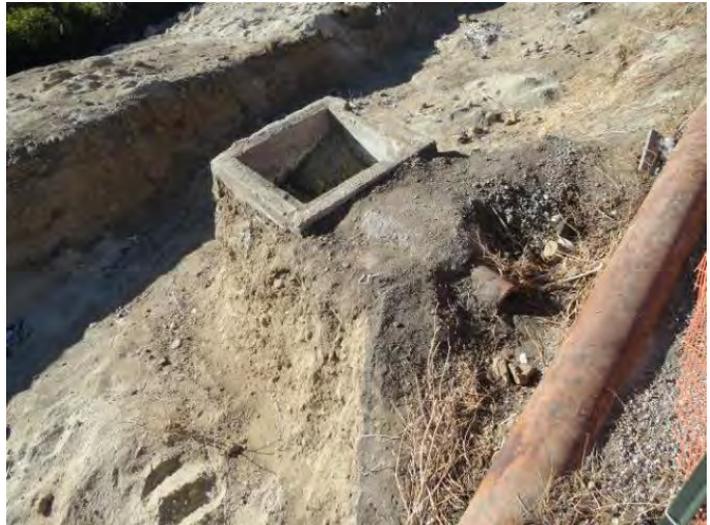
Building Feature Removal Log
Feature Number: ELV-1C-04
Santa Susana Field Laboratory, Ventura County, California

- Condition of Soil: **Not impacted.**
- PID Headspace Reading: **0.0 ppm**
- Sample Collected: **No**
- Sample ID: **N/A**
- Analyses: **N/A**
- Comments: **Feature ELV-1C-04 was a subsurface 3-inch clay drain pipe for a storm water drain (see Feature ELV-1C-03), located south of the paved area in ELV. Approximately 4 feet of pipe was removed during ISRA implementation activities at ISRA area ELV-1C in February 2013. No staining or odors observed in soils during removal; soil appears to be fill material. Coordinates 268850.220 Northing, 1789387.598 Easting.**

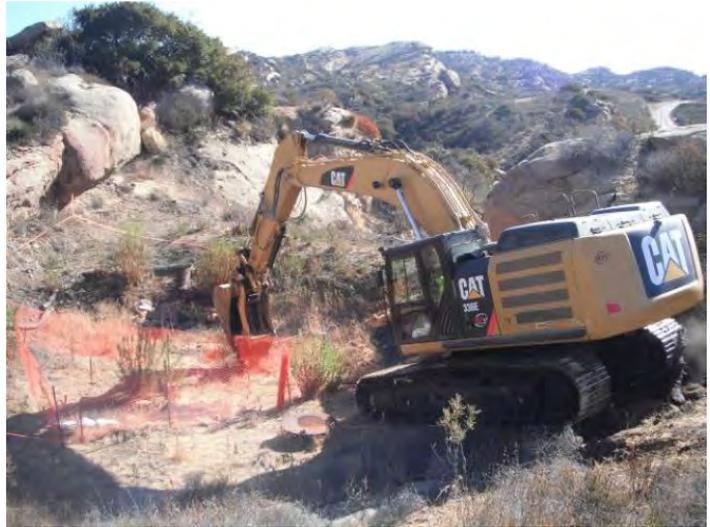
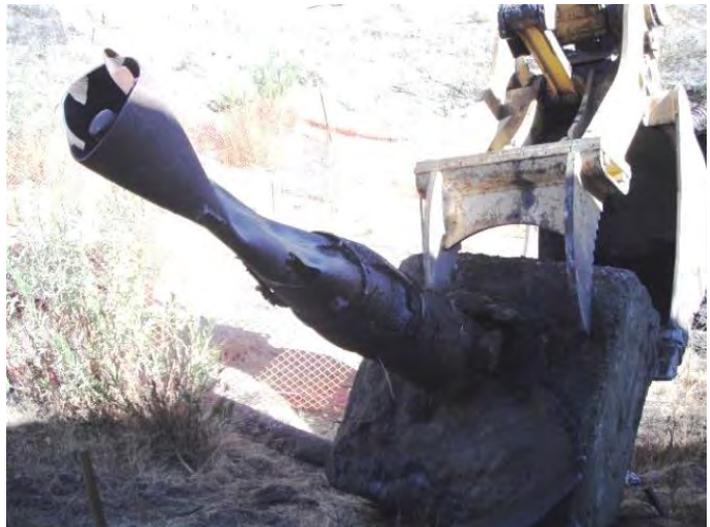
Building Feature Removal Log
Feature Number: ELV-1D-01
Santa Susana Field Laboratory, Ventura County, California

- Condition of Soil: **Not impacted**
- PID Headspace Reading: **0.0 ppm**
- Sample Collected: **No**
- Sample ID: **N/A**
- Analyses: **N/A**
- Comments: **Feature ELV-1D-01 was a subsurface 10-inch vertical drain pipe in the southeastern portion of the ELV pond. Feature was removed during ISRA implementation activities at ISRA area ELV-1D in September 2013. Soil was discolored but no odors were observed in shallow soils during removal (soils were excavated to bedrock within this ISRA area); soil appears to be fill material. GPS Coordinates 268954.548 Northing - 1789650.843 Easting.**

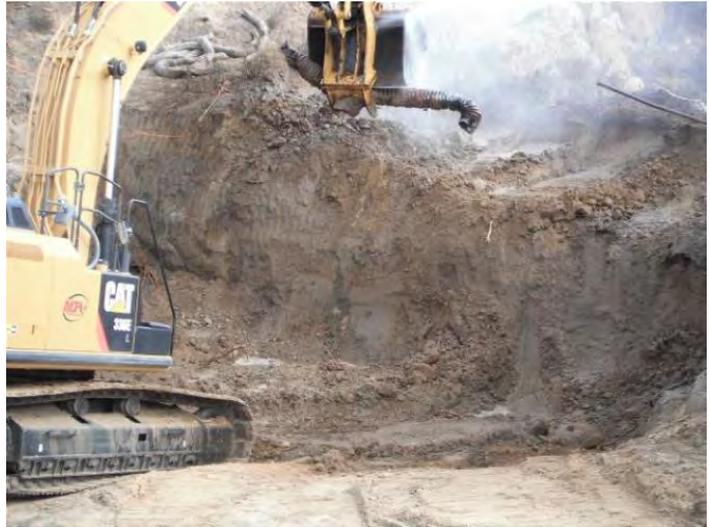
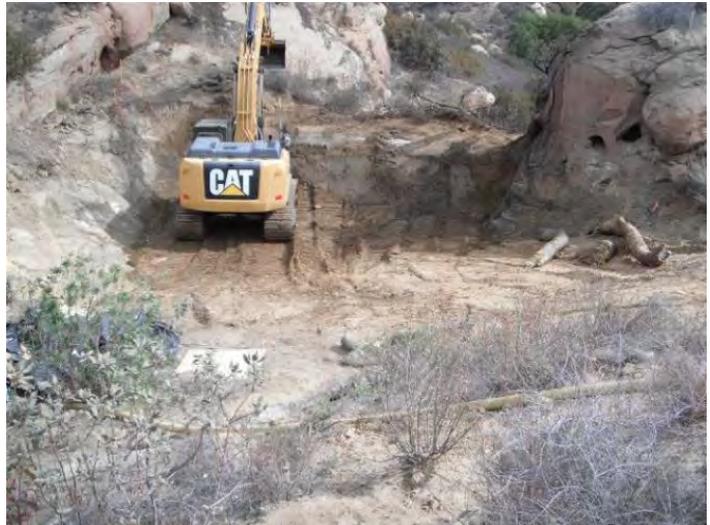
Building Feature Removal Log
Feature Number: ELV-1D-02
Santa Susana Field Laboratory, Ventura County, California

- Condition of Soil: **Not impacted**
- PID Headspace Reading: **0.0 ppm**
- Sample Collected: **No**
- Sample ID: **N/A**
- Analyses: **N/A**
- Comments: **Feature ELV-1D-02 was a partially subsurface 12-inch slope/overflow corrugated drain pipe on the berm slope in the eastern portion of the ELV pond. Feature was removed during ISRA implementation activities at ISRA area ELV-1D in September 2013. No staining or odors observed during removal (soils were excavated to bedrock within this ISRA area); soil appears to be fill material. GPS Coordinates 268955.508 Northing - 1789660.990 Easting.**

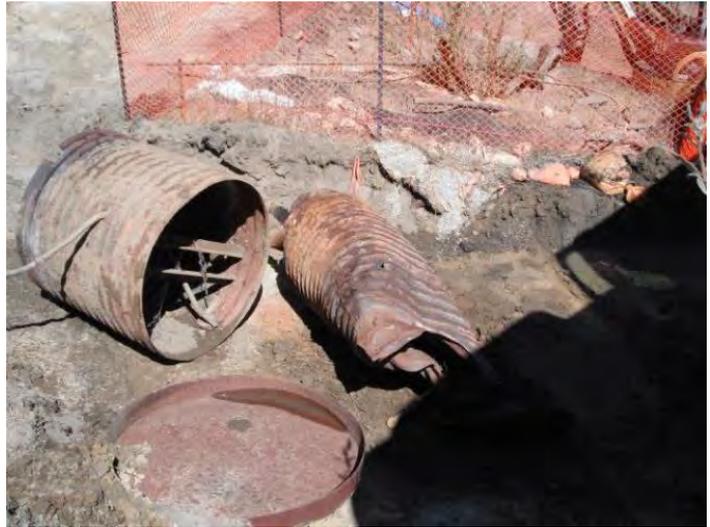
Building Feature Removal Log
Feature Number: ELV-1D-03
Santa Susana Field Laboratory, Ventura County, California

- Condition of Soil: **Not impacted**
- PID Headspace Reading: **0.0 ppm**
- Sample Collected: **No**
- Sample ID: **N/A**
- Analyses: **N/A**
- Comments: **Feature ELV-1D-03 was a subsurface 16-inch corrugated vertical pipe with metal cover in the western portion of the ELV pond. Pipe was removed during ISRA implementation activities at ISRA area ELV-1D in September 2013. No staining or odors observed in soils during removal (soils were excavated to bedrock within this ISRA area); soil appears to be fill material. GPS Coordinates 268937.202 Northing - 1789627.465 Easting.**

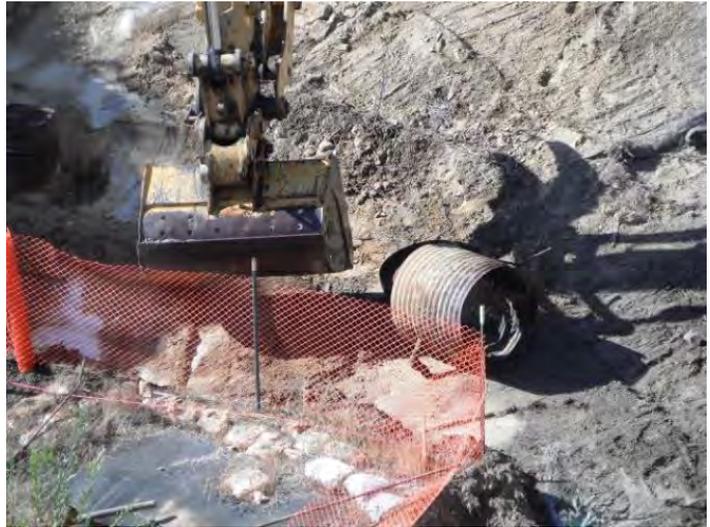
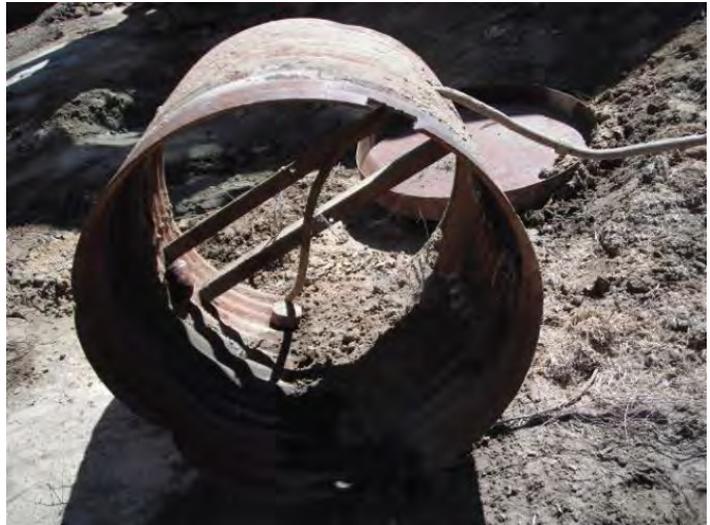
- Condition of Soil: **Not impacted**
- PID Headspace Reading: **0.0 ppm**
- Sample Collected: **No**
- Sample ID: **N/A**
- Analyses: **N/A**
- Comments: **Feature ELV-1D-04 was a subsurface 24-inch corrugated vertical pipe with lid in the western portion of the ELV pond. Pipe was removed during ISRA implementation activities at ISRA area ELV-1D in September 2013. No staining or odors observed in soils during removal (soils were excavated to bedrock within this ISRA area); soil appears to be fill material. GPS Coordinates 268945.330 Northing - 1789628.673 Easting**

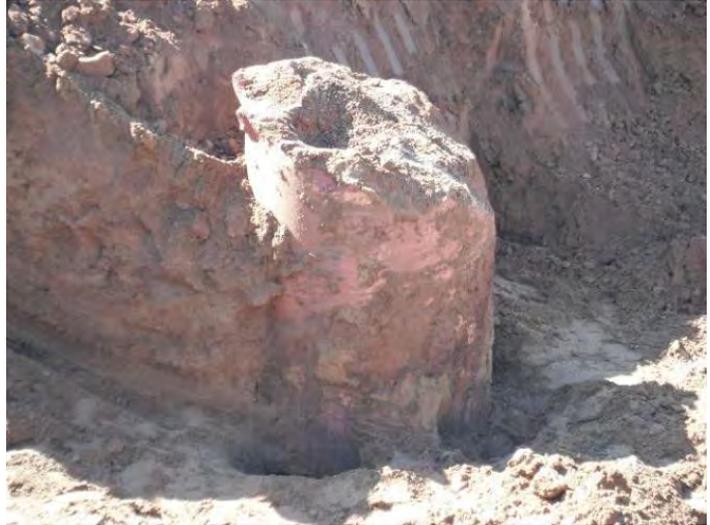
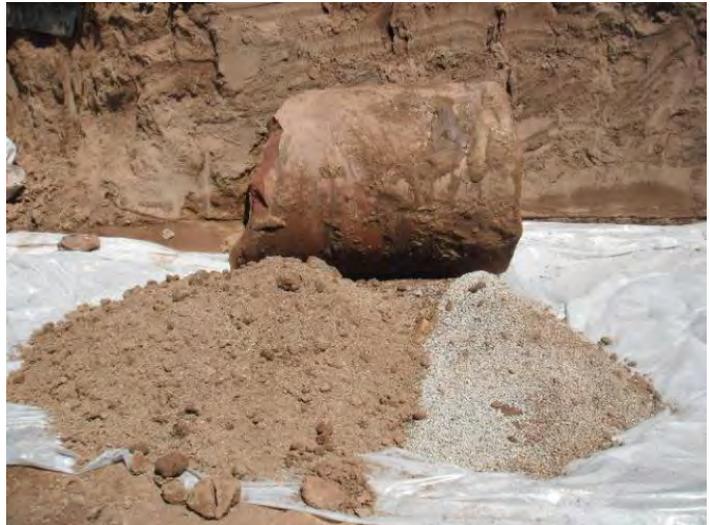
Building Feature Removal Log
Feature Number: 1301-031
Santa Susana Field Laboratory, Ventura County, California

- Condition of Soil: **Not Impacted**
- PID Headspace Reading: **0.0 ppm**
- Sample Collected: **Yes**
- Sample ID: **ILET0114**
- Analyses: **VOCs, SVOCs, PCBs, metals, TPH, perchlorate, pH**
- Comments: **Feature 1301-031 was a subsurface concrete cylindrical pipe standing upright and filled with pea gravel near the former location of Building 1301. No staining or odors were observed however a sample was collected from underneath the previous location of the pipe following its removal as part of confirmation sampling at ISRA area IEL-2.**

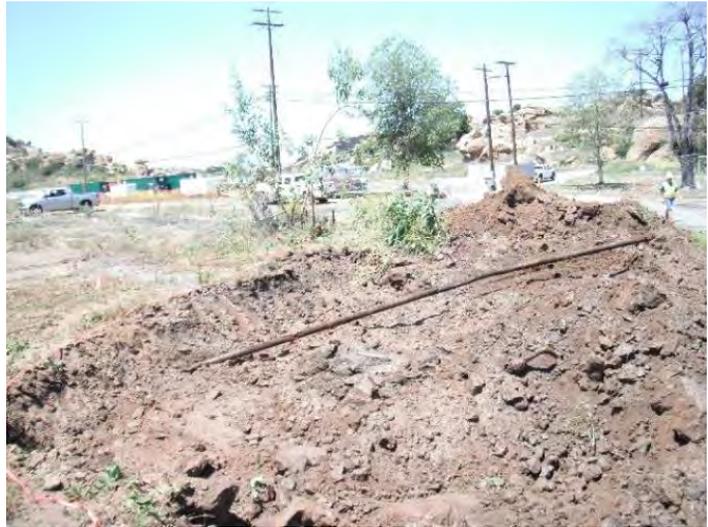
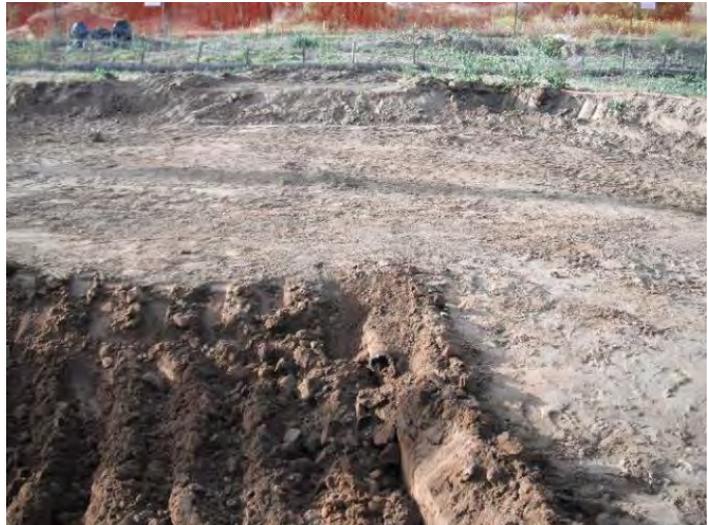
Building Feature Removal Log
Feature Number: 1301-032
Santa Susana Field Laboratory, Ventura County, California

- Condition of Soil: **Not Impacted**
- PID Headspace Reading: **0.0 ppm**
- Sample Collected: **No**
- Sample ID: **N/A**
- Analyses: **N/A**
- Comments: **Feature 1301-032 was a subsurface 2-inch metal pipe with couplers trending N 60 E and then N 15 W. Approximately 16 feet of pipeline was removed during ISRA Implementation activities. No staining or odors were observed.**

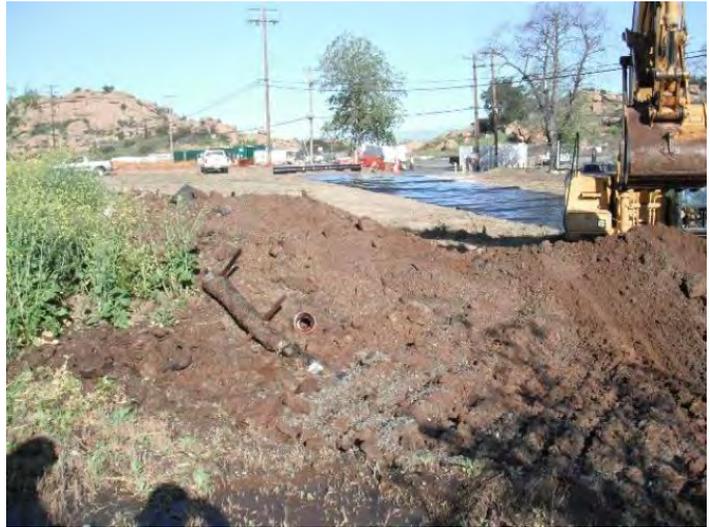
Building Feature Removal Log
Feature Number: 1301-033
Santa Susana Field Laboratory, Ventura County, California

- Condition of Soil: **Not Impacted**
- PID Headspace Reading: **N/A**
- Sample Collected: **No**
- Sample ID: **N/A**
- Analyses: **N/A**
- Comments: **Feature 1301-033 was a subsurface 3-inch clay sewer drain line. Approximately 1.5 feet was removed during ISRA implementation activities. No staining or odors were observed.**

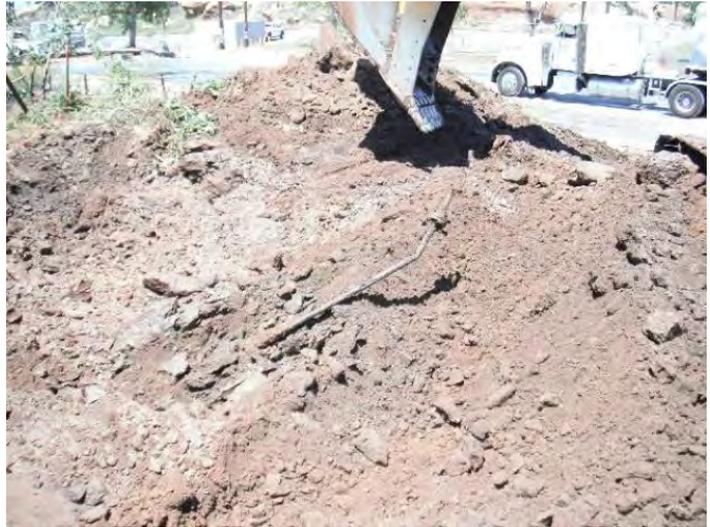
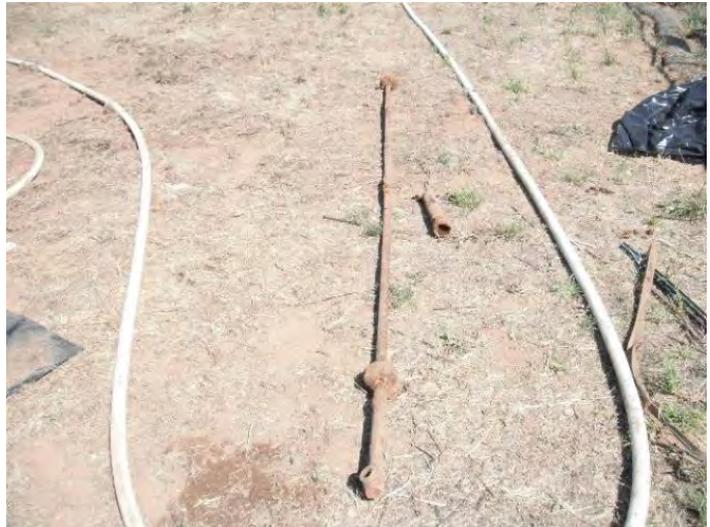
Building Feature Removal Log
Feature Number: 1301-034
Santa Susana Field Laboratory, Ventura County, California

- Condition of Soil: **Not Impacted**
- PID Headspace Reading: **0.0 ppm**
- Sample Collected: **No**
- Sample ID: **N/A**
- Analyses: **N/A**
- Comments: **Feature 1301-034 was a subsurface 1-inch metal pipe with couplers trending N 60 E then N 15 W. Approximately 26 feet of pipeline was removed during ISRA Implementation activities. No staining or odors were observed.**

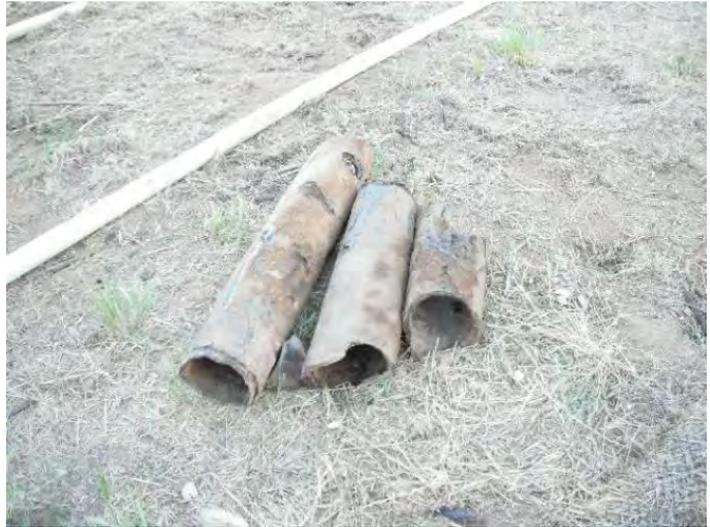
Building Feature Removal Log
Feature Number: 1301-035
Santa Susana Field Laboratory, Ventura County, California

- Condition of Soil: **Not Impacted**
- PID Headspace Reading: **0.0 ppm**
- Sample Collected: **No**
- Sample ID: **N/A**
- Analyses: **N/A**
- Comments: **Feature 1301-035 was a subsurface 3-inch section of pipe that did not appear to be in place when it was removed. Approximately 3 feet of pipe was removed during ISRA Implementation activities. No staining or odors were observed.**

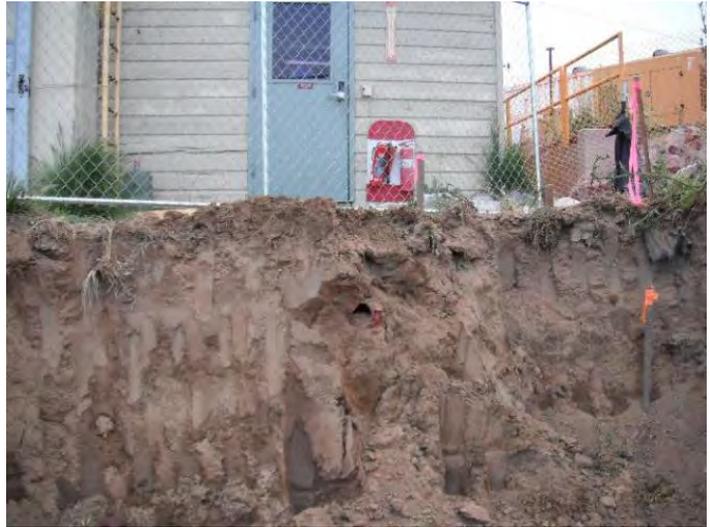
Building Feature Removal Log
Feature Number: 1301-036
Santa Susana Field Laboratory, Ventura County, California

- Condition of Soil: **Not Impacted**
- PID Headspace Reading: **0.0 ppm**
- Sample Collected: **No**
- Sample ID: **N/A**
- Analyses: **N/A**
- Comments: **Feature 1301-036 was a subsurface 3-inch clay sewer drain pipeline, which trends N 45 E and continues beneath Building 1302 (Fire Station) where it is in place. Approximately 3 feet of pipe was removed during ISRA Implementation activities. No staining or odors were observed.**

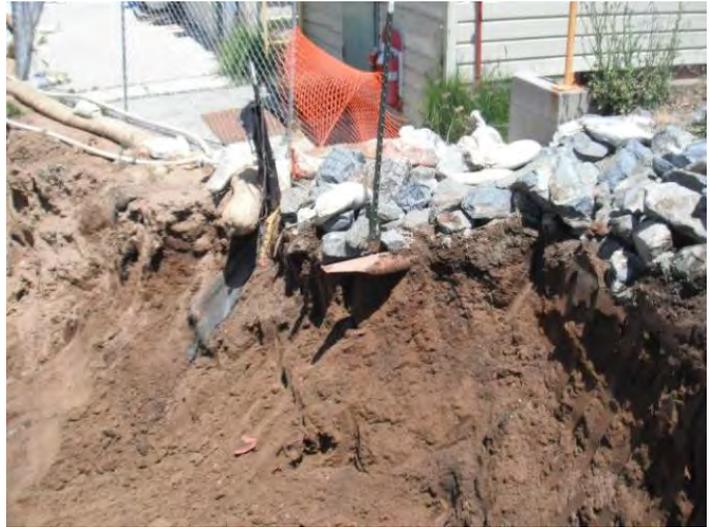
Building Feature Removal Log
Feature Number: 1301-037
Santa Susana Field Laboratory, Ventura County, California

- Condition of Soil: **Not Impacted**
- PID Headspace Reading: **0.0 ppm**
- Sample Collected: **No**
- Sample ID: **N/A**
- Analyses: **N/A**
- Comments: **Feature 1301-037 was a subsurface 3-inch clay inactive sewer drain pipeline, trending N 45 E near Building 1302 (Fire Station). Approximately 2 feet of pipe was removed during ISRA Implementation activities. No staining or odors were observed.**

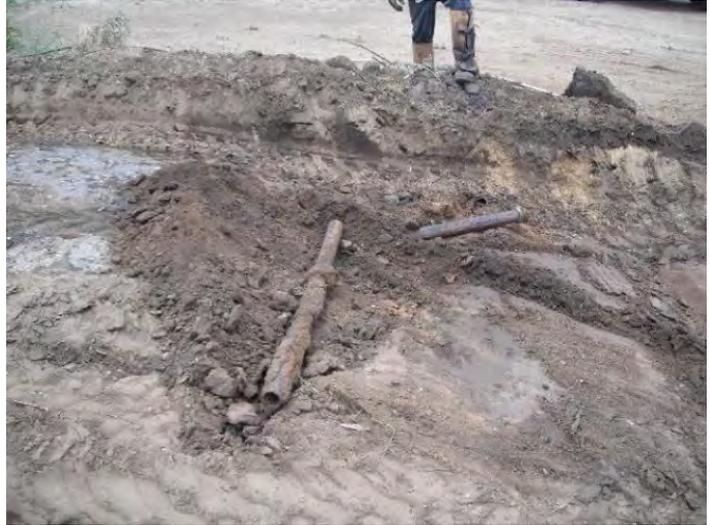
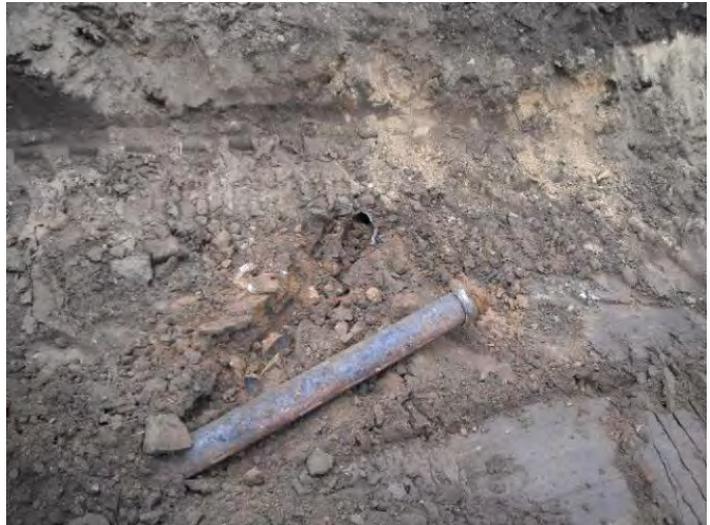
Building Feature Removal Log
Feature Number: 1301-038
Santa Susana Field Laboratory, Ventura County, California

- Condition of Soil: **Not Impacted**
- PID Headspace Reading: **0.0 ppm**
- Sample Collected: **No**
- Sample ID: **N/A**
- Analyses: **N/A**
- Comments: **Feature 1301-038 was a subsurface 2-inch metal pipe trending N 60 W. Approximately 1 foot of pipe was removed during ISRA Implementation activities. No staining or odors were observed.**

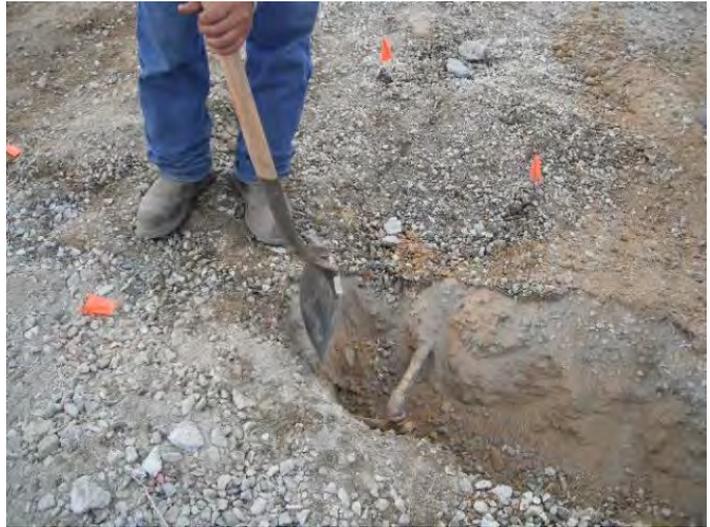
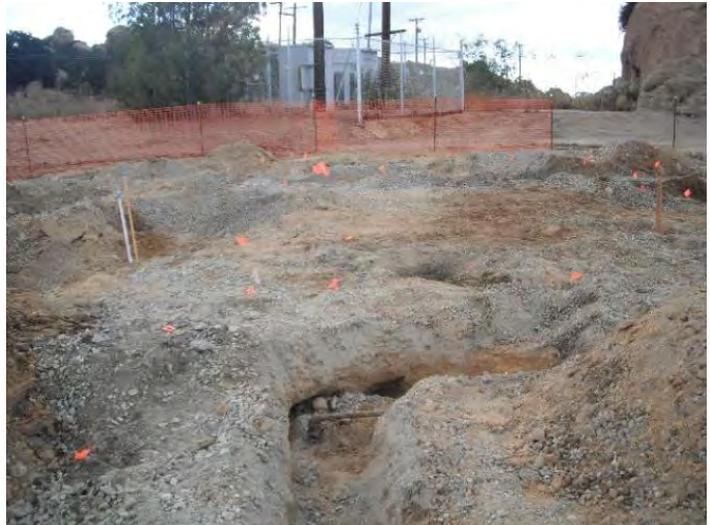
Building Feature Removal Log
Feature Number: 1300-45
Santa Susana Field Laboratory, Ventura County, California

- Condition of Soil: **Not impacted.**
- PID Headspace Reading: **0.0 ppm**
- Sample Collected: **No**
- Sample ID: **N/A**
- Analyses: **N/A**
- Comments: **Feature 1300-045 was a subsurface 1-inch piping with couplers trending in two directions approximately N 30 W and N 30 E in the western portion of former Building 1300. Approximately 15 feet of piping was removed during ISRA Implementation activities at ISRA area IEL-3 in January 2013. No staining or odors observed in soils during removal; soil appears to be fill material. GPS coordinates 268399.469 Northing 1795962.298 Easting.**

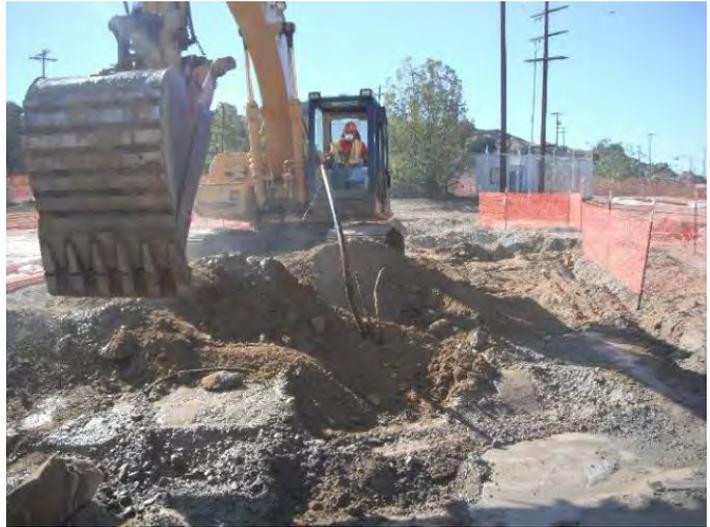
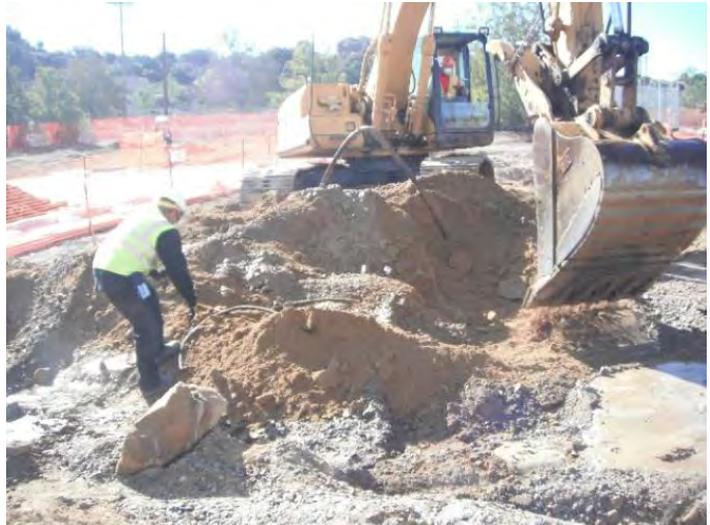
Building Feature Removal Log
Feature Number: 1300-47
Santa Susana Field Laboratory, Ventura County, California

- Condition of Soil: **Not impacted.**
- PID Headspace Reading: **0.0 ppm**
- Sample Collected: **No**
- Sample ID: **N/A**
- Analyses: **N/A**
- Comments: **Feature 1300-047 is a subsurface 2-inch piping with couplers trending approximately N 60 W in the western portion of former Building 1300. Approximately 15 feet of piping was removed during ISRA Implementation activities at ISRA area IEL-3 in January 2013. No staining or odors observed during removal; soil appears to be fill material. GPS coordinates 268420.296 Northing 1795992.09 Easting.**
