Building Feature Documentation Log
Feature Number: LOX-1B-1-01
Santa Susana Field Laboratory, Ventura County, California

Building Feature Removal Log
Feature Number: LOX-1B-1-01
Santa Susana Field Laboratory, Ventura County, California

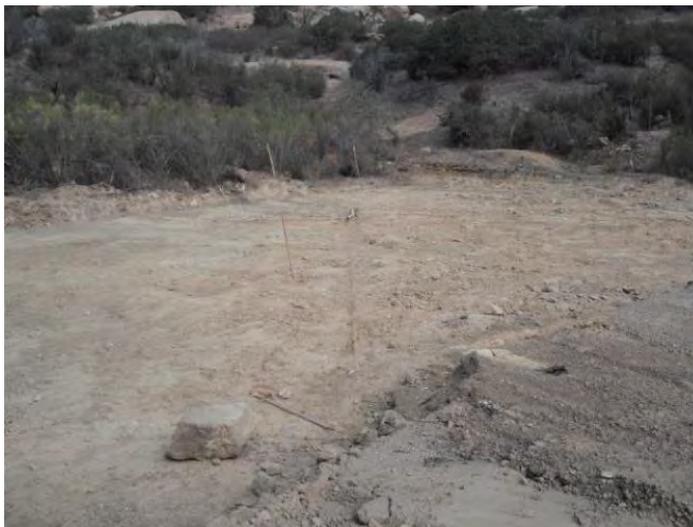
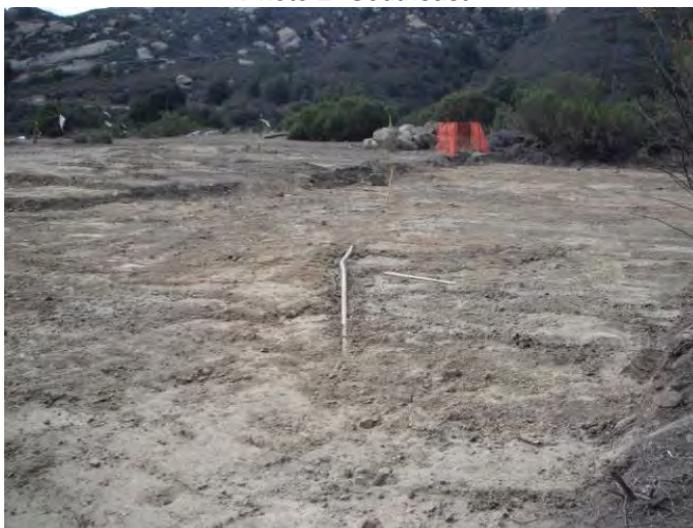
General Condition: **Intact**
Debris: **No**
Staining: **No**
Odor: **No**
PID Reading: **0.0 ppm**
Likelihood of Impact from Feature: **Potential**

Proximity to Nearest Chemical Use Area:
Within Group 2 LOX Site CUAs "LOX Western Debris Area" and "Western Hummocks"
Likelihood of Impact from Other Source:
Unlikely
Comments: **Feature LOX-1B-1-01 is a subsurface 1-inch steel line identified during 2013 ISRA implementation activities at ISRA area LOX-1B-1 during soil excavation down to 1 feet bgs.**
GPS Coordinates: **269115.063 Northing - 1792464.499 Easting**

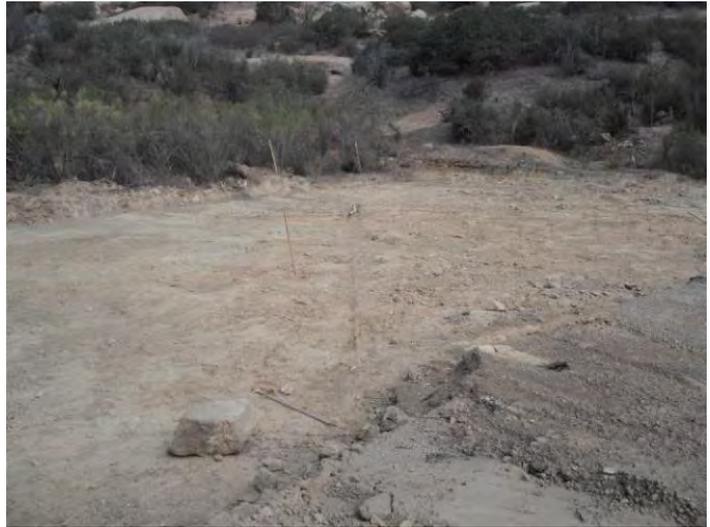
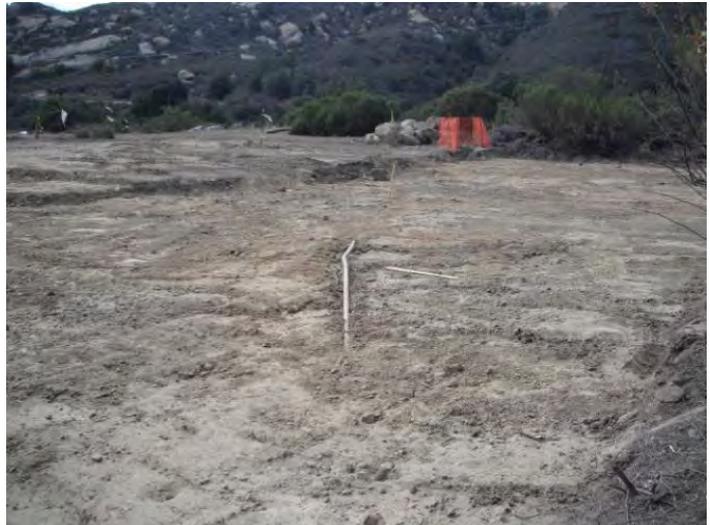
- Condition of Soil: **Not impacted**
- PID Headspace Reading: **0.0 ppm**
- Sample Collected: **No**
- Sample ID: **N/A**
- Analyses: **N/A**
- Comments: **Feature LOX-1B-1-01 was a subsurface 1-inch steel line identified within ISRA area LOX-1B-1 during 2013 ISRA implementation activities. The pipe contained a liquid with a hydrocarbon odor, which was removed prior to removal of the pipeline itself. No staining or odors were observed in soils during removal; soil appears to be fill material. GPS coordinates 269116.251 Northing 1792758.733 Easting.**

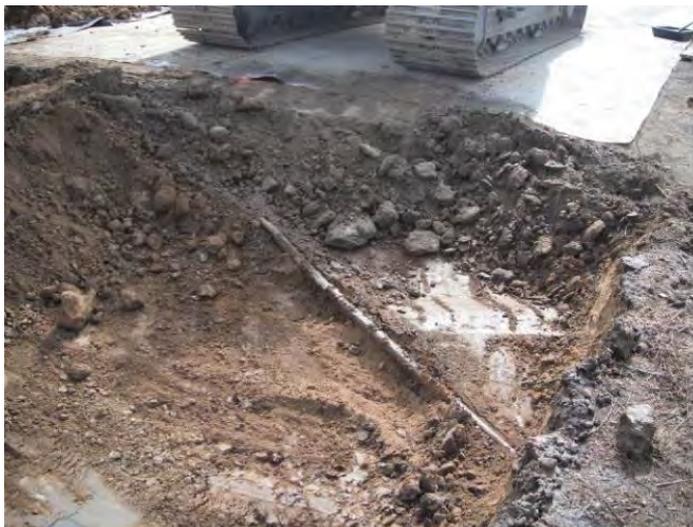
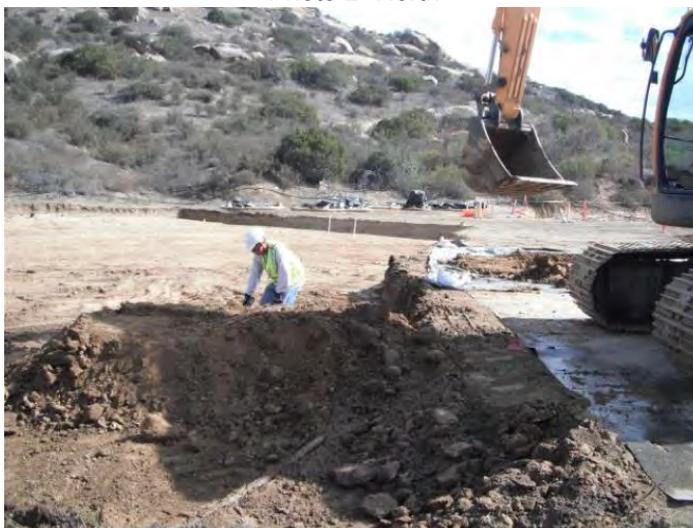
General Condition: **Intact**
Debris: **No**
Staining: **No**
Odor: **No**
PID Reading: **0.0 ppm**
Likelihood of Impact from Feature: **Potential**

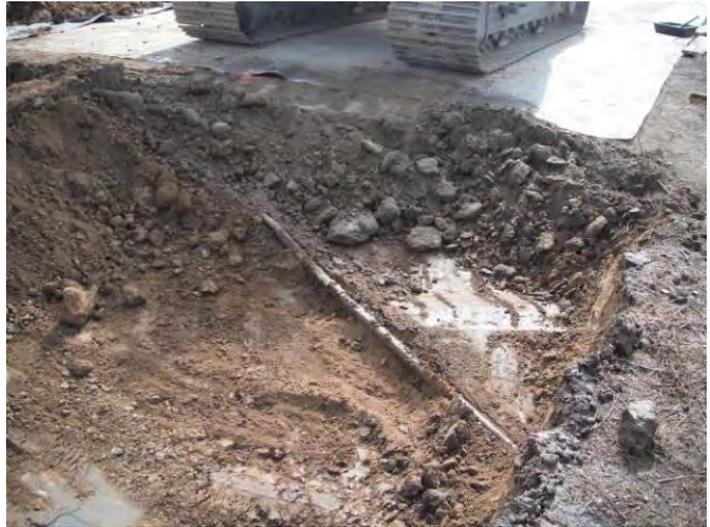
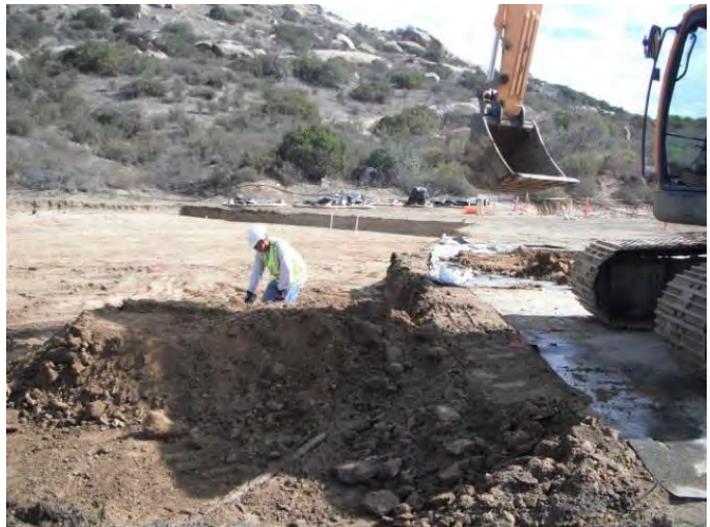
- Condition of Soil: **Not impacted**
- PID Headspace Reading: **0.0 ppm**
- Sample Collected: **No**
- Sample ID: **N/A**
- Analyses: **N/A**
- Comments: **Feature LOX-1B-2-01 was a subsurface metal pipeline found in the southern portion of ISRA area LOX-1B-2 during 2013 ISRA implementation activities. A portion of the line was left in place outside the ISRA area and approximately 15 feet of line within the ISRA area was removed. No staining or odors observed during removal. GPS Coordinates 269037.741 Northing - 1792595.024 Easting.**

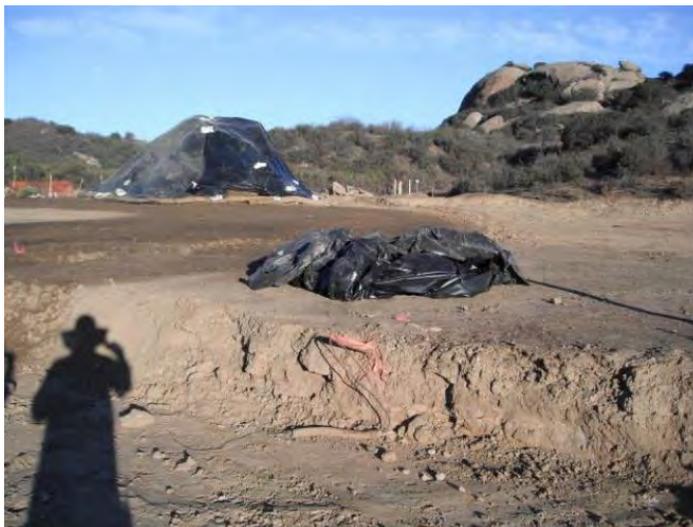
Photo 1- North

General Condition: **Broken**
Debris: **No**
Staining: **No**
Odor: **No**
PID Reading: **0.0 ppm**
Likelihood of Impact from Feature: **Unlikely**

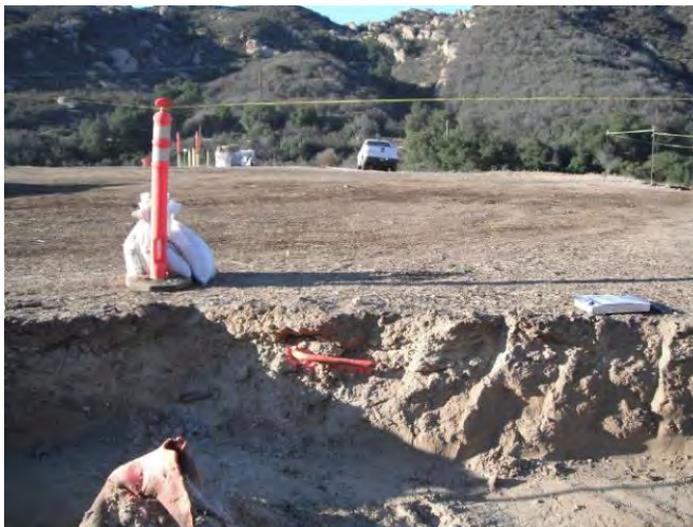
Photo 1- South

General Condition: **Broken**
Debris: **No**
Staining: **No**
Odor: **No**
PID Reading: **0.0 ppm**
Likelihood of Impact from Feature: **Unlikely**

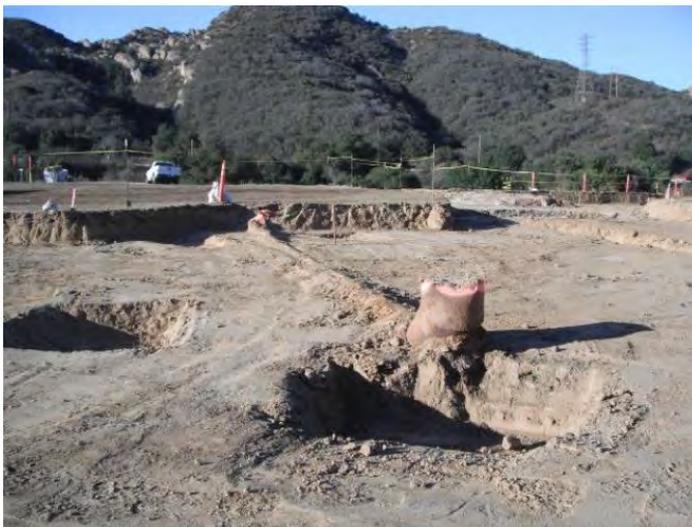
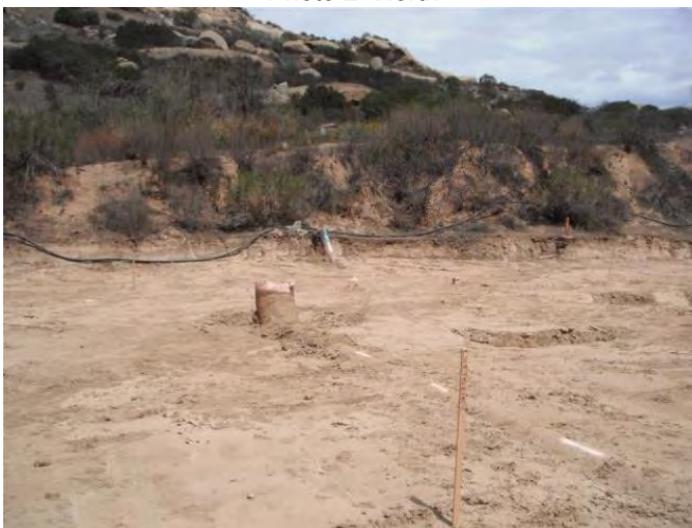
General Condition: **Broken; Corroded**
Debris: **No**
Staining: **No**
Odor: **No**
PID Reading: **0.0 ppm**
Likelihood of Impact from Feature: **Unlikely**

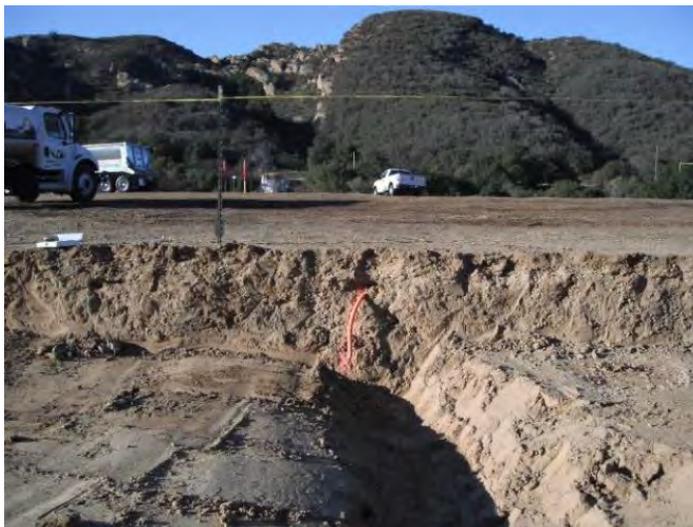
Photo 1- South

General Condition: **Broken**
Debris: **No**
Staining: **No**
Odor: **No**
PID Reading: **0.0 ppm**
Likelihood of Impact from Feature: **Potential**

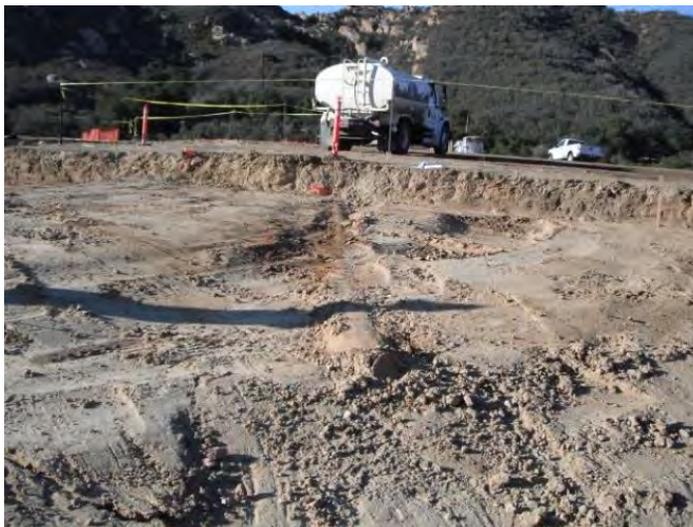
Photo 1- South

General Condition: **Corroded**
Debris: **No**
Staining: **No**
Odor: **No**
PID Reading: **0.0 ppm**
Likelihood of Impact from Feature: **Potential**

Proximity to Nearest Chemical Use Area: **Approximately 120 feet east of Group 2 LOX Site CUA "LOX Solvent Release"**
Likelihood of Impact from Other Source: **Unlikely**
Comments: **Feature LOX-1B-3-05 was a subsurface 24-inch pipeline identified during 2013 ISRA Implementation activities at ISRA area LOX-1B-3 during soil excavation down to 2 feet bgs. The pipeline was left in place and no staining or odors were observed in adjacent soils; soil appears to be fill material.**
GPS Coordinates: **269100.969 Northing - 1792817.240 Easting**

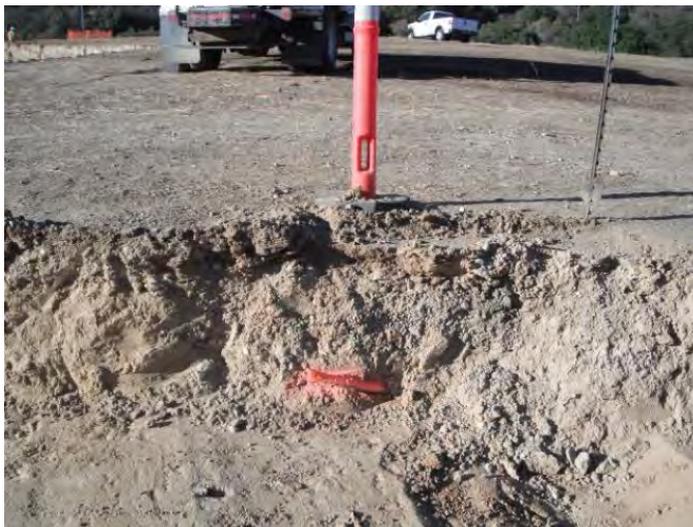
Photo 1- South

General Condition: **Missing pieces**
Debris: **No**
Staining: **No**
Odor: **No**
PID Reading: **0.0 ppm**
Likelihood of Impact from Feature: **Potential**

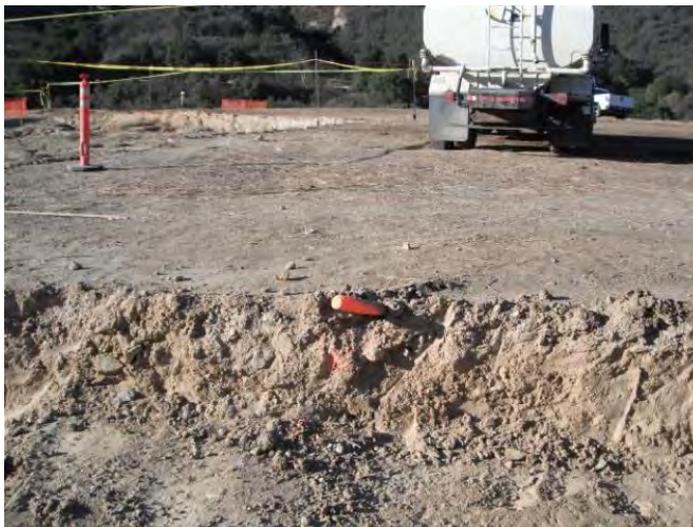
Photo 1- South

General Condition: **Broken**
Debris: **No**
Staining: **No**
Odor: **No**
PID Reading: **0.0 ppm**
Likelihood of Impact from Feature: **Potential**

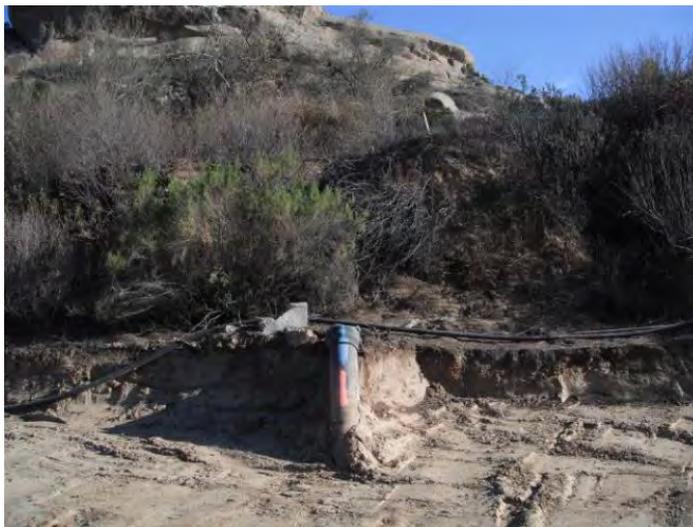
Photo 1- North

General Condition: **Intact**
Debris: **No**
Staining: **No**
Odor: **No**
PID Reading: **0.0 ppm**
Likelihood of Impact from Feature: **Unlikely**

Comments: **Feature LOX-1B-3-08 was a subsurface 12-inch water line identified during 2013 ISRA Implementation activities at ISRA area LOX-1B-3 during soil excavation down to 2 feet bgs. The pipeline was left in place and no staining or odors were observed in adjacent soils; soil appears to be fill material.**

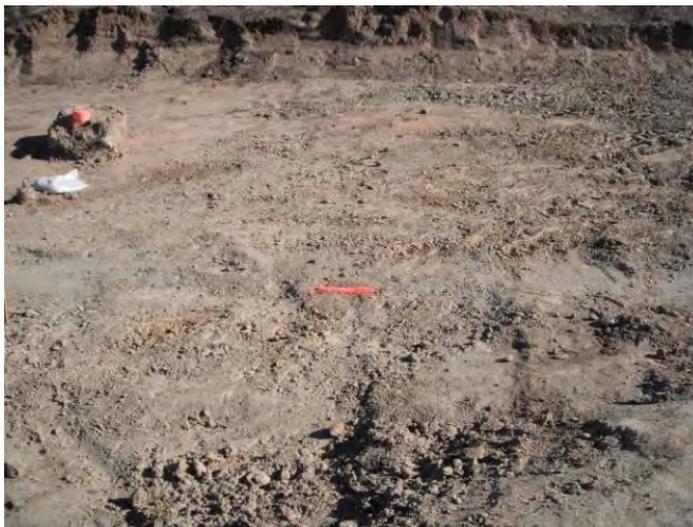
Photo 1- Northwest

General Condition: **Missing pieces**
Debris: **No**
Staining: **No**
Odor: **No**
PID Reading: **0.0 ppm**
Likelihood of Impact from Feature: **Potential**

Proximity to Nearest Chemical Use Area:
Approximately 130 feet east-northeast of
Group 2 LOX Site CUA "LOX Solvent
Release"
Likelihood of Impact from Other Source:
Unlikely
Comments: **Feature LOX-1B-3-09 was a**
subsurface 1.5-inch pipeline identified
during 2013 ISRA Implementation
activities at ISRA area LOX-1B-3 during
soil excavation down to 2 feet bgs. The
pipeline was left in place and no staining
or odors were observed in adjacent soils;
soil appears to be fill material.
GPS Coordinates: **269145.816 Northing -**
1792835.590 Easting

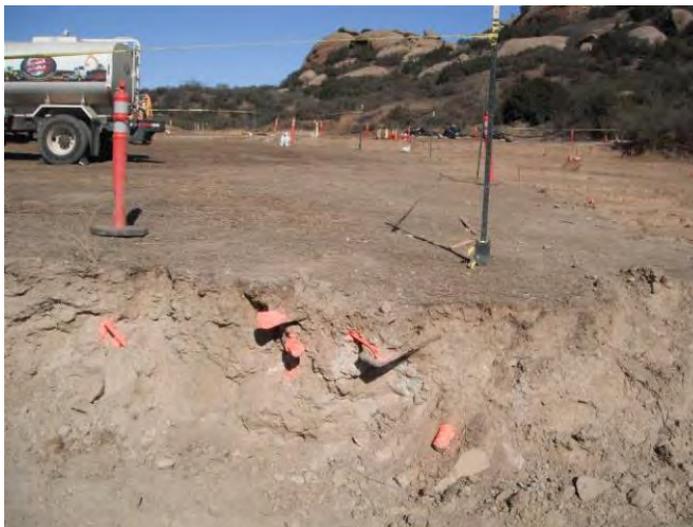
Photo 1- West

General Condition: **Broken, Corroded**
Debris: **No**
Staining: **No**
Odor: **No**
PID Reading: **0.0 ppm**
Likelihood of Impact from Feature: **Potential**

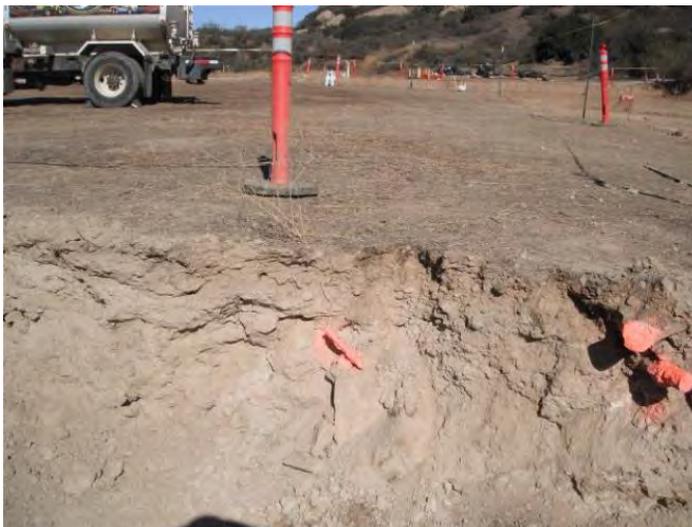
Photo 1- West

General Condition: **Broken**
Debris: **No**
Staining: **No**
Odor: **No**
PID Reading: **0.0 ppm**
Likelihood of Impact from Feature: **Unlikely**

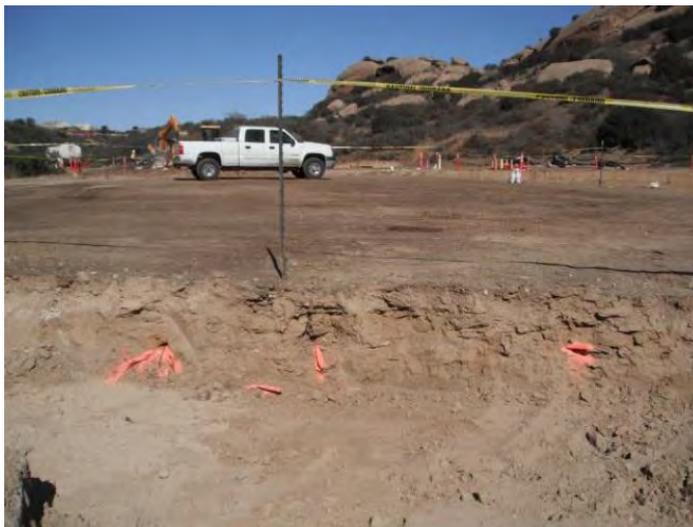
Photo 1- West

General Condition: **Broken**
Debris: **No**
Staining: **No**
Odor: **No**
PID Reading: **0.0 ppm**
Likelihood of Impact from Feature: **Unlikely**

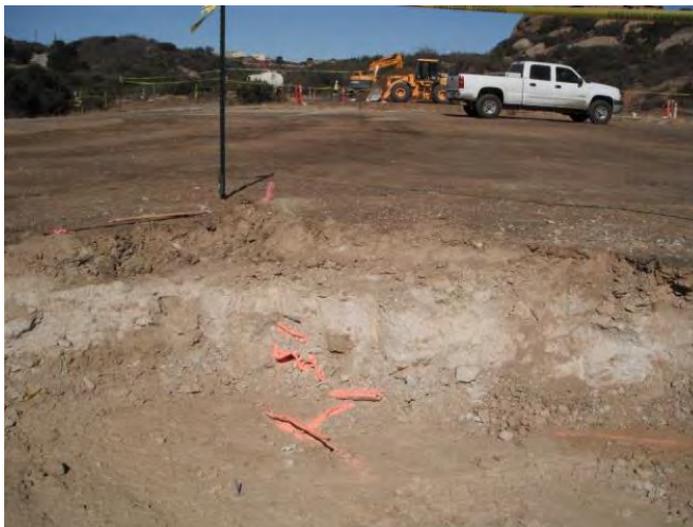
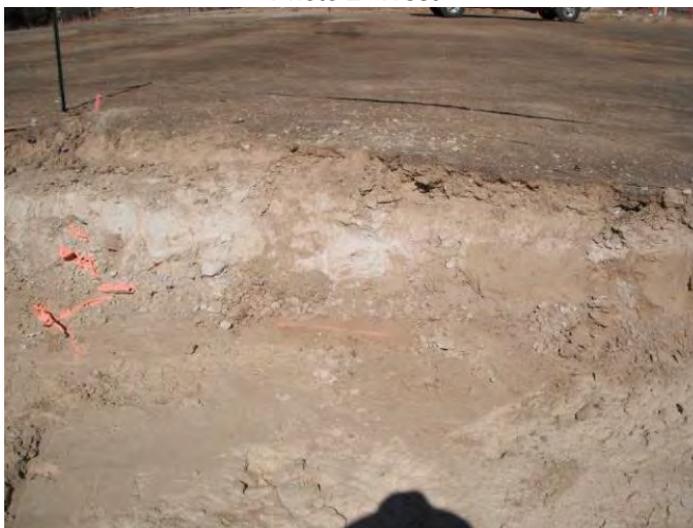
General Condition: Broken
Debris: No
Staining: No
Odor: No
PID Reading: 0.0 ppm
Likelihood of Impact from Feature: Unlikely

Proximity to Nearest Chemical Use Area:
Approximately 150 feet southeast of Group 2 LOX Site CUA "LOX Solvent Release"
Likelihood of Impact from Other Source:
Unlikely
Comments: Feature LOX-1B-3-13 was a subsurface 2-inch diameter pipeline identified during 2013 ISRA Implementation activities at ISRA area LOX-1B-3 during soil excavation down to 2 feet bgs. The conduit was left in place and no staining or odors were observed in adjacent soils; soil appears to be fill material.
GPS Coordinates: 269031.966 Northing - 1792818.084 Easting

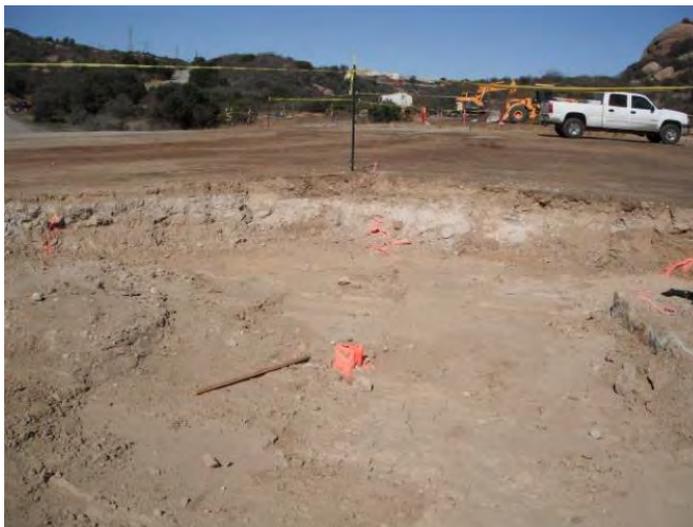
Photo 1- West

General Condition: **Corroded**
Debris: **No**
Staining: **No**
Odor: **No**
PID Reading: **0.0 ppm**
Likelihood of Impact from Feature: **Potential**

Comments: **Feature LOX-1B-3-14 was a**
4-inch metal riser identified during 2013
ISRA implementation activities at ISRA
area LOX-1B-3 during soil excavation
down to 2 feet bgs. The riser was left in
place and no staining or odors were
observed in adjacent soils; soil appears
to be fill material.

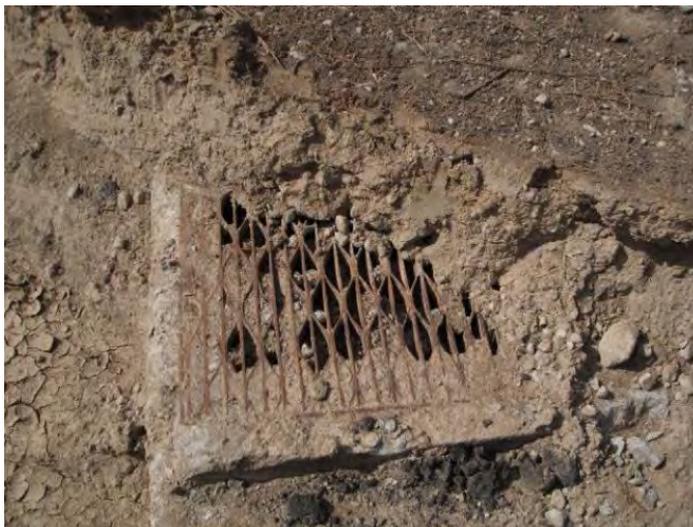
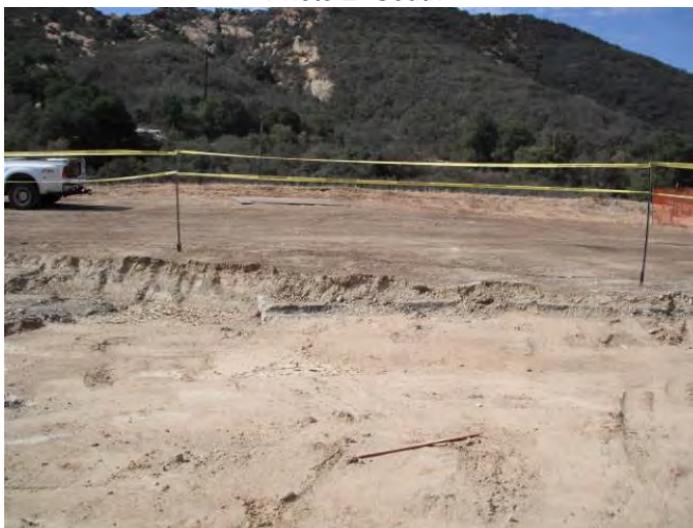
General Condition: **Intact; Corroded**
Debris: **No**
Staining: **No**
Odor: **No**
PID Reading: **0.0 ppm**
Likelihood of Impact from Feature: **Potential**

Proximity to Nearest Chemical Use Area:
Approximately 290 feet southeast of Group 2 LOX Site CUA "LOX Solvent Release"
Likelihood of Impact from Other Source:
Unlikely
Comments: **Feature LOX-1B-3-15 was a 24-inch x 24-inch storm drain grate identified during 2013 ISRA implementation activities at ISRA area LOX-1B-3 during soil excavation down to 2 feet bgs. The storm drain grate was left in place and no staining or odors were observed in adjacent soils; soil appears to be fill material.**
GPS Coordinates: **268938.092 Northing - 1792934.978 Easting**

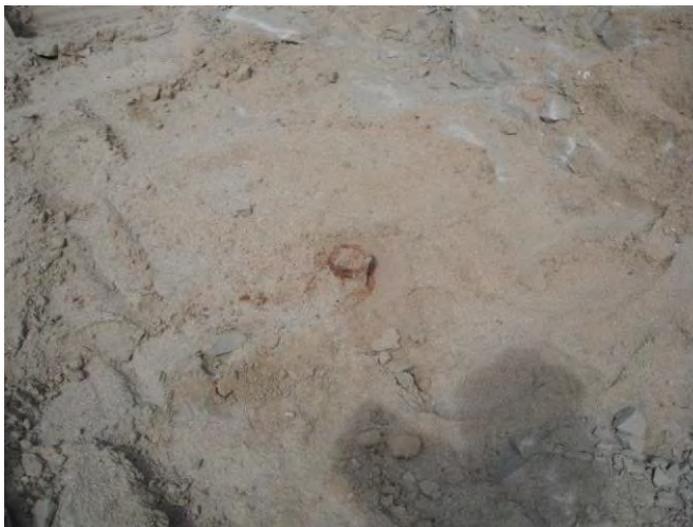
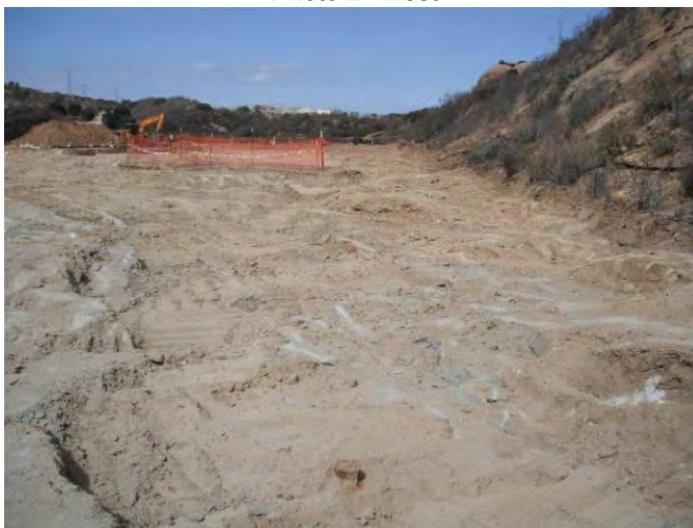
General Condition: **Corroded; missing pieces**

Comments: **Feature LOX-1B-3-16 was a stick-up valve identified during 2013 ISRA implementation activities at ISRA area LOX-1B-3 during soil excavation down to 2 feet bgs. The stick-up valve was left in place and no staining or odors were observed in adjacent soils; soil appears to be fill material.**

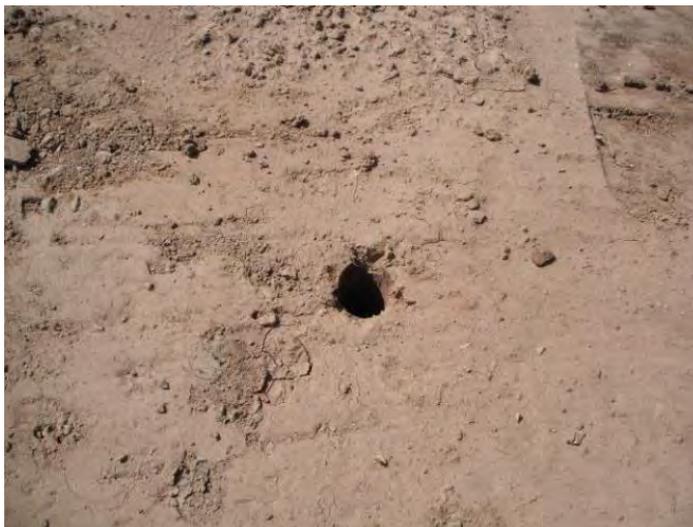
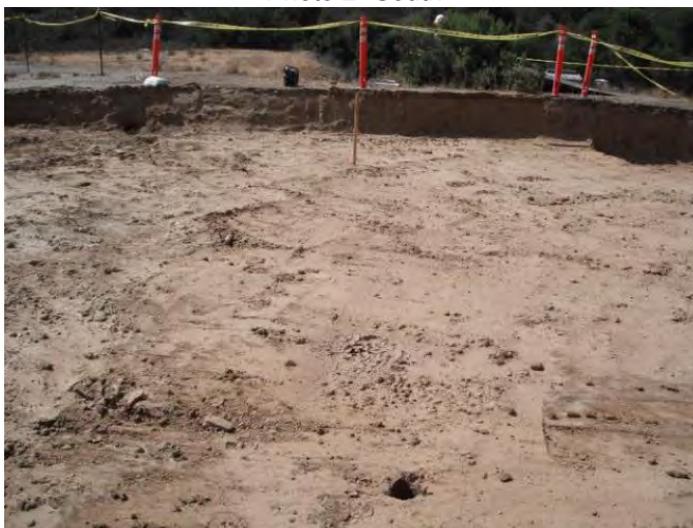
General Condition: **Intact**
Debris: **No**
Staining: **No**
Odor: **No**
PID Reading: **0.0 ppm**
Likelihood of Impact from Feature: **Potential**

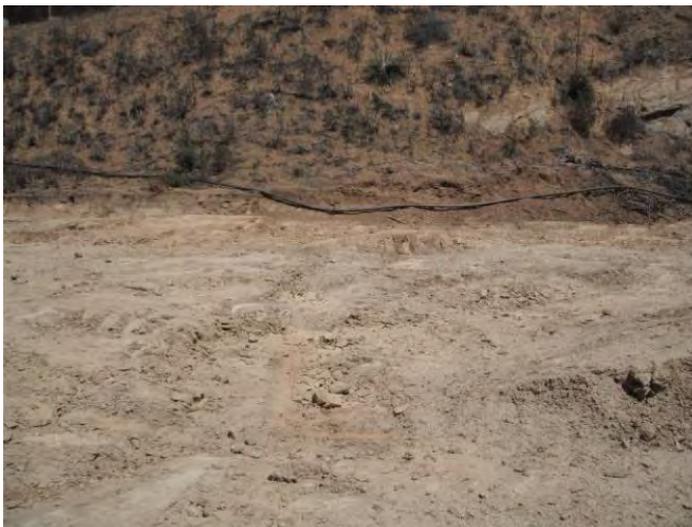
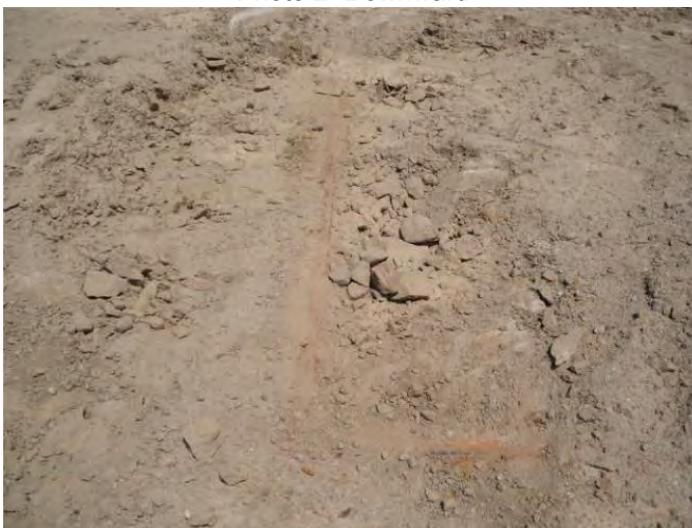
General Condition: **Corroded**
Debris: **No**
Staining: **No**
Odor: **No**
PID Reading: **0.0 ppm**
Likelihood of Impact from Feature: **Potential**

Proximity to Nearest Chemical Use Area:
**Approximately 200 feet east of Group 2
LOX Site CUA "LOX Solvent Release"**
Likelihood of Impact from Other Source:
Unlikely
Comments: **Feature LOX-1B-3-18 was a
subsurface 0.5-inch diameter pipeline
identified during 2013 ISRA
implementation activities at ISRA area
LOX-1B-3 during soil excavation down to
2 feet bgs. The pipeline was left in-place
and no staining or odors were observed
in adjacent soils; soil appears to be fill
material.**
GPS Coordinates: **269116.331 Northing -
1792907.069 Easting**

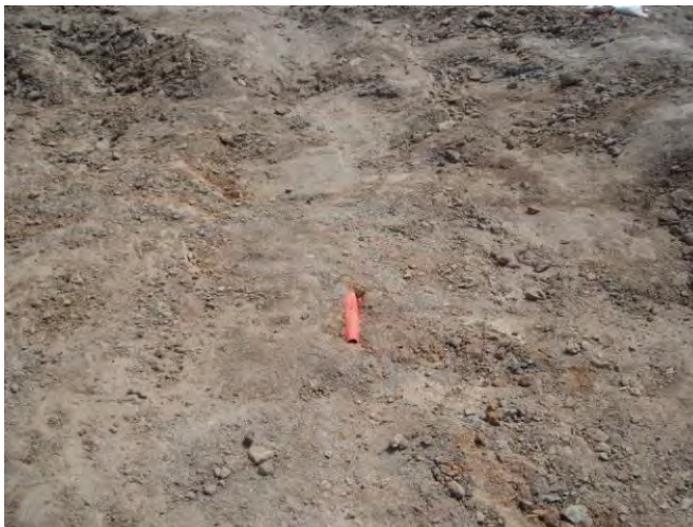
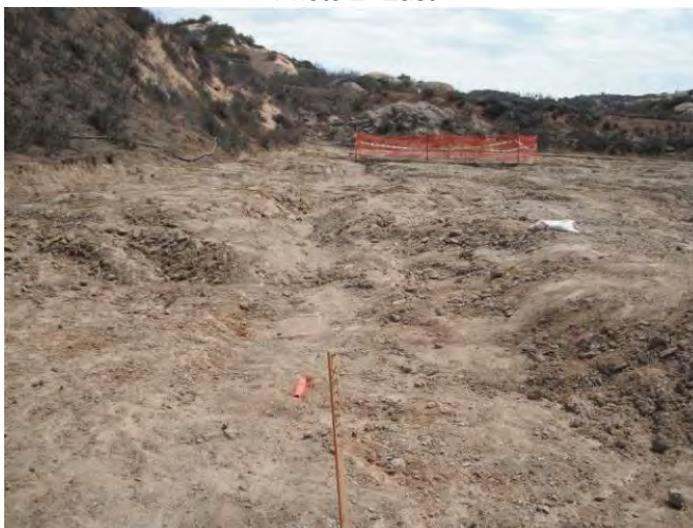
General Condition: **Broken**
Debris: **No**
Staining: **No**
Odor: **No**
PID Reading: **0.0 ppm**
Likelihood of Impact from Feature: **Potential**

Comments: **Feature LOX-1B-3-19 was a subsurface 2-inch diameter pipeline identified during 2013 ISRA implementation activities at ISRA area LOX-1B-3 during soil excavation down to 2 feet bgs. The pipeline was left in-place and no staining or odors were observed in adjacent soils; soil appears to be fill material.**

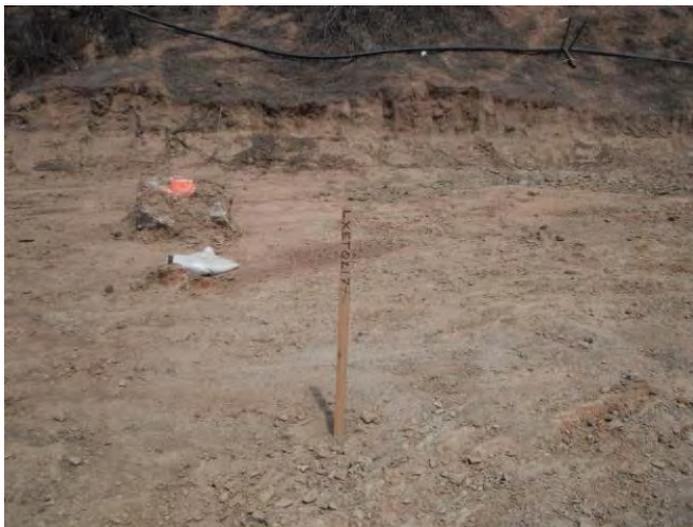
Photo 1- North

General Condition: **Broken/Cut**
Debris: **No**
Staining: **No**
Odor: **No**
PID Reading: **0.0 ppm**
Likelihood of Impact from Feature: **Potential**

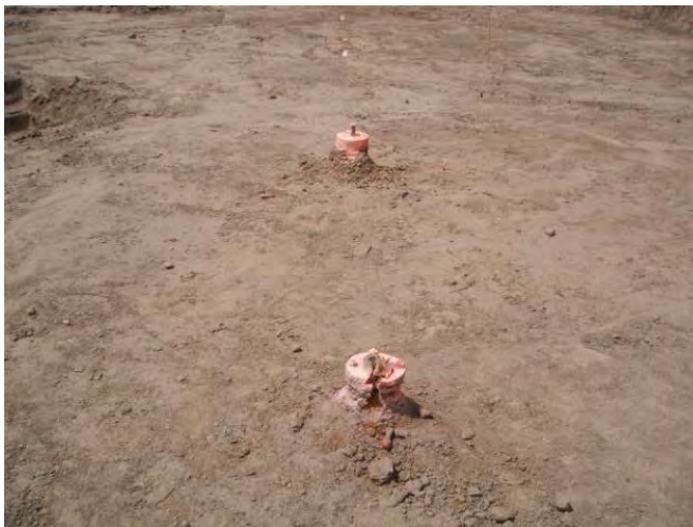
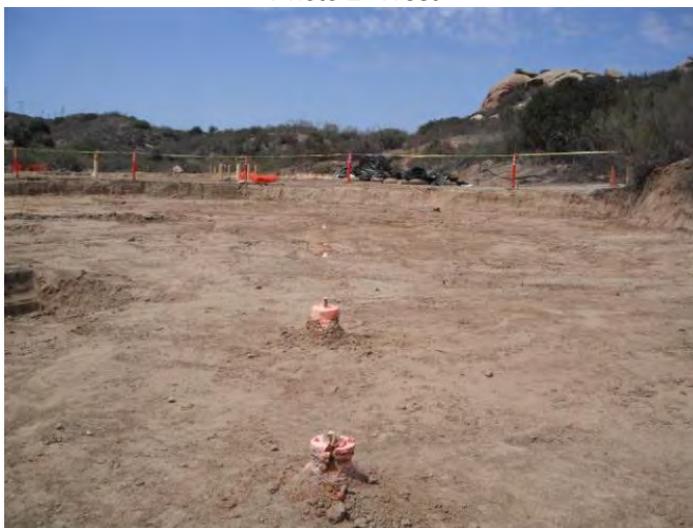
General Condition: **Corroded; Broken**
Debris: **No**
Staining: **No**
Odor: **No**
PID Reading: **0.0 ppm**
Likelihood of Impact from Feature: **Unlikely**

Proximity to Nearest Chemical Use Area:
Approximately 70 feet east-northeast of Group 2 LOX Site CUA "LOX Solvent Release"
Likelihood of Impact from Other Source:
Unlikely
Comments: **Feature LOX-1B-3-21 was a subsurface 6-inch water line stickup valve identified during 2013 ISRA implementation activities at ISRA area LOX-1B-3 during soil excavation down to 2 feet bgs. The stick-up valve was left in-place and no staining or odors were observed in adjacent soils; soil appears to be fill material.**
GPS Coordinates: **269151.164 Northing - 1792780.675 Easting**

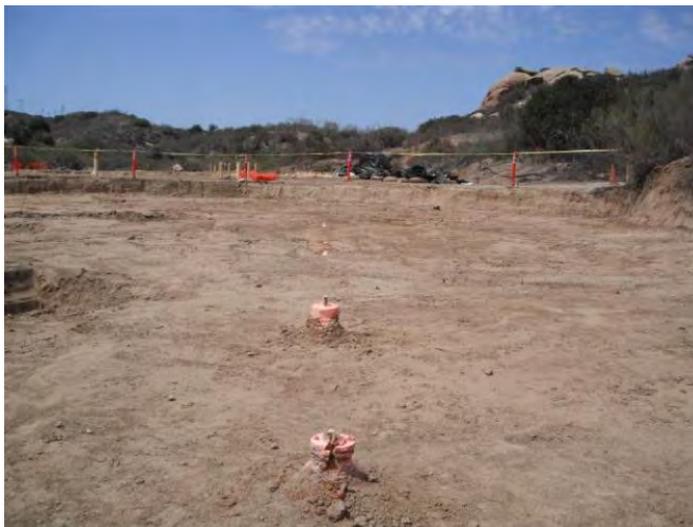
Photo 1- North

General Condition: **Corroded; Broken**
Debris: **No**
Staining: **No**
Odor: **No**
PID Reading: **0.0 ppm**
Likelihood of Impact from Feature: **Unlikely**

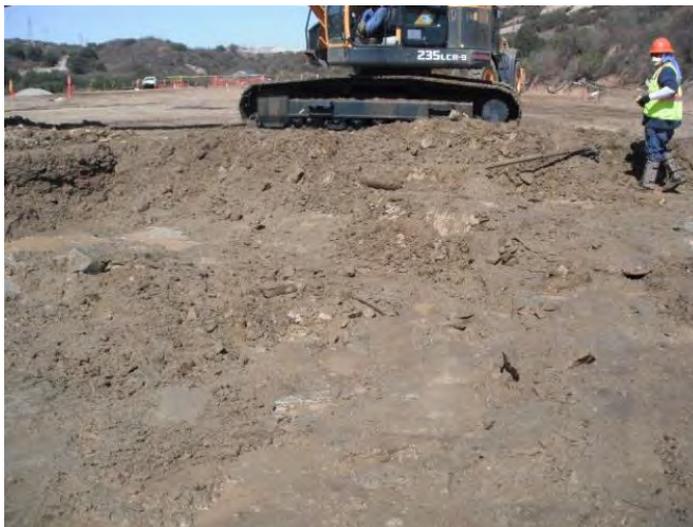
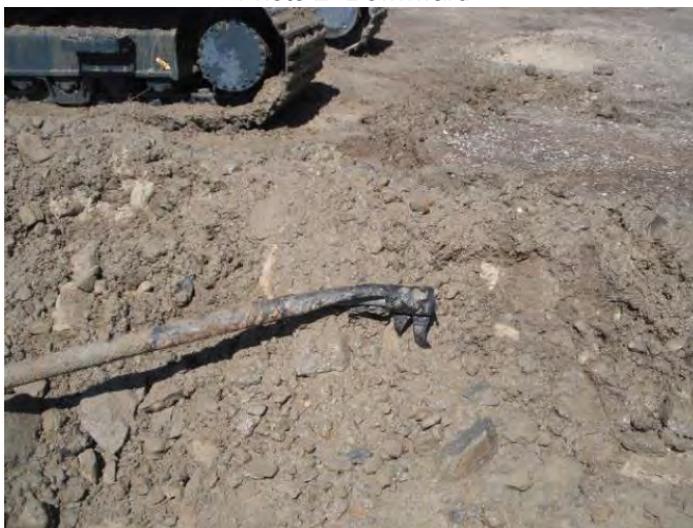
General Condition: **Broken**
Debris: **No**
Staining: **No**
Odor: **No**
PID Reading: **0.0 ppm**
Likelihood of Impact from Feature: **Potential**

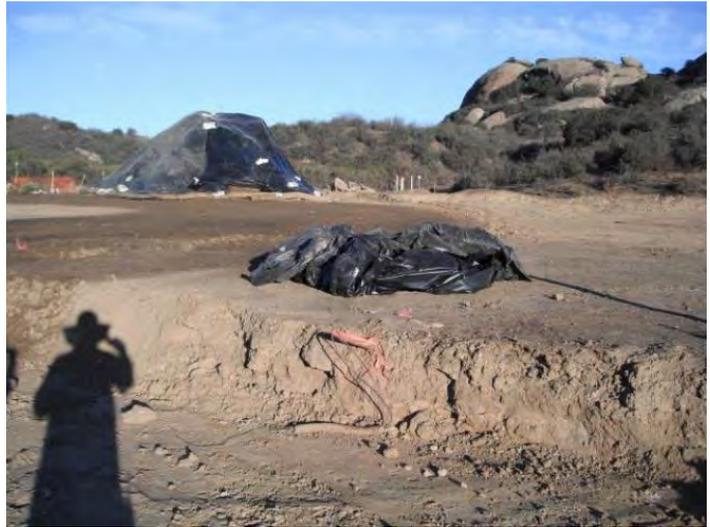
- Condition of Soil: **Not impacted**
- PID Headspace Reading: **0.0 ppm**
- Sample Collected: **No**
- Sample ID: **N/A**
- Analyses: **N/A**
- Comments: **Feature LOX-1B-3-01 was a subsurface 1.5-inch diameter electrical conduit found in the western portion of LOX-1B-3 during 2013 ISRA implementation activities. The portion of the line within the ISRA area was removed and the rest of the line outside the ISRA excavation was left in place. No staining or odors observed during removal. GPS Coordinates 269081.259 Northing - 1792660.922 Easting.**

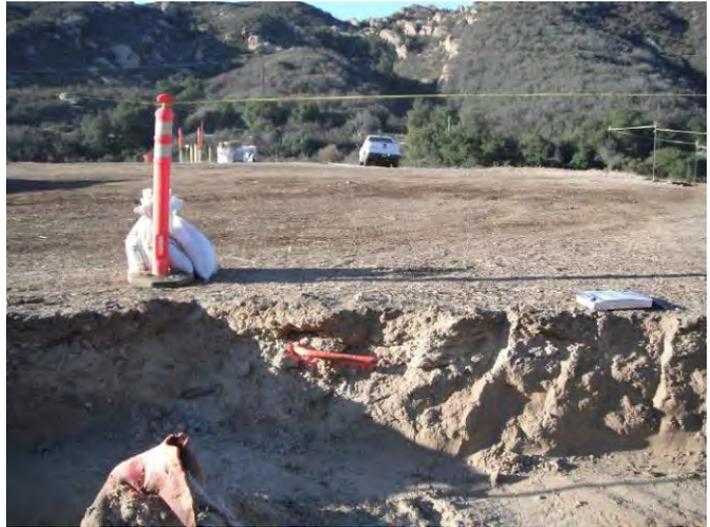
- Condition of Soil: **Not impacted**
- PID Headspace Reading: **0.0 ppm**
- Sample Collected: **No**
- Sample ID: **N/A**
- Analyses: **N/A**
- Comments: **Feature LOX-1B-3-02 was a subsurface 1-inch diameter high pressure line found in the western portion of LOX-1B-3 during 2013 ISRA implementation activities. The portion of the line within the ISRA area was removed and the rest of the line outside the ISRA excavation was left in place. No staining or odors observed during removal. GPS Coordinates 269092.445 Northing - 1792755.802 Easting.**

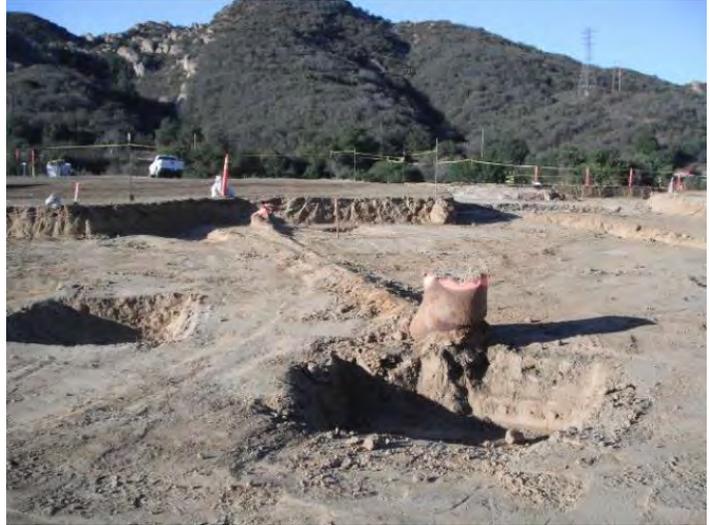
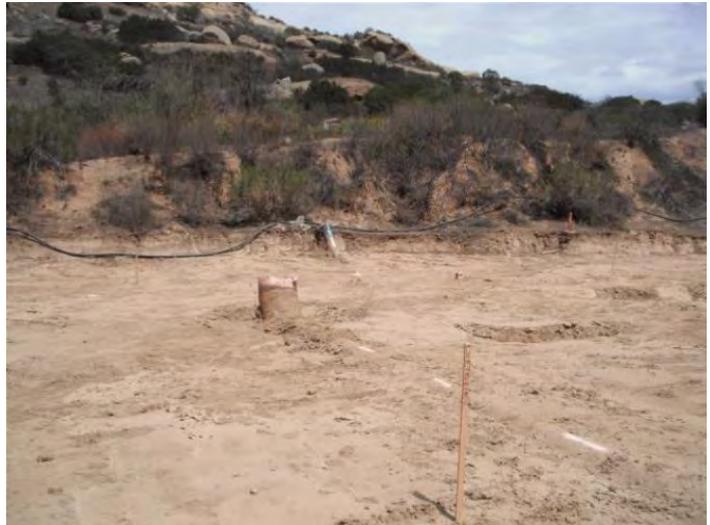
- Condition of Soil: **Not impacted**
- PID Headspace Reading: **0.0 ppm**
- Sample Collected: **No**
- Sample ID: **N/A**
- Analyses: **N/A**
- Comments: **Feature LOX-1B-3-03 was a subsurface 24-inch water line found in the western portion of LOX-1B-3 during 2013 ISRA implementation activities. No staining or odors observed during removal; soil appears to be fill material. GPS coordinates 269116.251 Northing 1792758.733 Easting.**

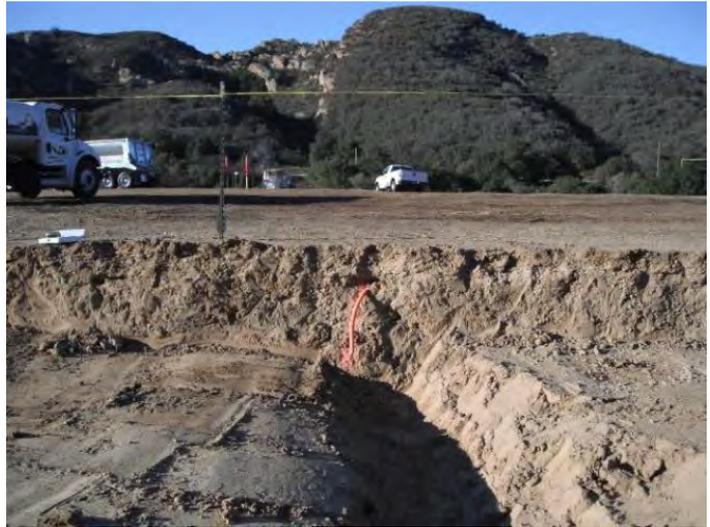
- Condition of Soil: **Not impacted**
- PID Headspace Reading: **0.0 ppm**
- Sample Collected: **No**
- Sample ID: **N/A**
- Analyses: **N/A**
- Comments: **Feature LOX-1B-3-04 was a subsurface 1-inch diameter steel pipeline found in the western portion of LOX-1B-3 during 2013 ISRA implementation activities. The portion of the line within the ISRA area was removed and the rest of the line outside the ISRA excavation was left in place. No staining or odors observed during removal. GPS Coordinates 269094.461 Northing - 1792788.904 Easting.**

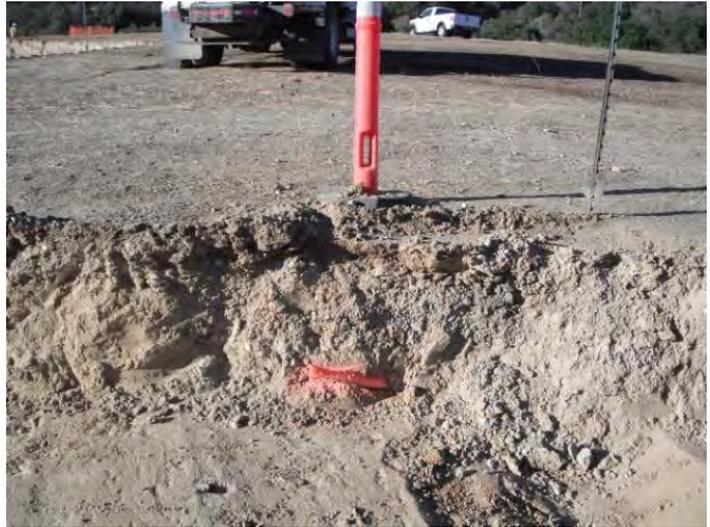
Photo 1- South

- Condition of Soil: **Not Impacted**
- PID Headspace Reading: **0.0 ppm**
- Sample Collected: **No**
- Sample ID: **N/A**
- Analyses: **N/A**
- Comments: **Feature LOX-1B-3-06 was a subsurface 1-inch diameter steel line found in the western portion of LOX-1B-3 during 2013 ISRA implementation activities. The portion of the line within the ISRA area was removed and the rest of the line outside the ISRA excavation was left in place. No staining or odors observed during removal. GPS Coordinates 269116.251 Northing - 1792758.733 Easting.**

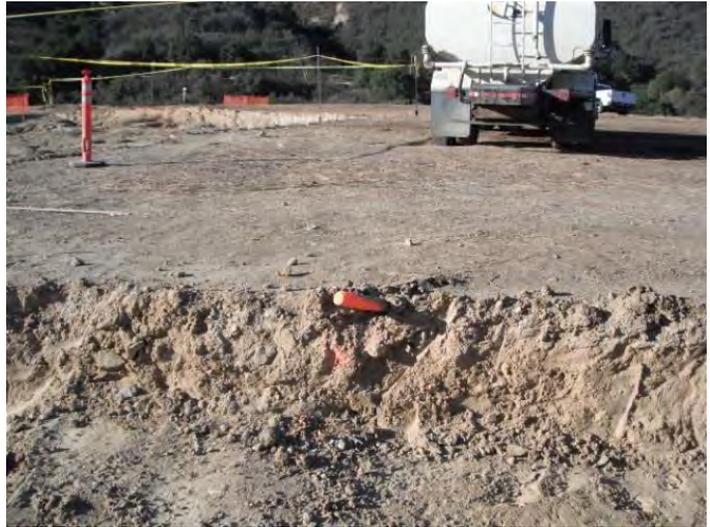
Photo 1- South

- Condition of Soil: **Not Impacted**
- PID Headspace Reading: **0.0 ppm**
- Sample Collected: **No**
- Sample ID: **N/A**
- Analyses: **N/A**
- Comments: **Feature LOX-1B-3-07 was a subsurface 2-inch diameter steel line found in the western portion of LOX-1B-3 during 2013 ISRA implementation activities. The portion of the line within the ISRA area was removed and the rest of the line outside the ISRA excavation was left in place. No staining or odors observed during removal. GPS Coordinates 269080.109 Northing - 1792826.121 Easting.**

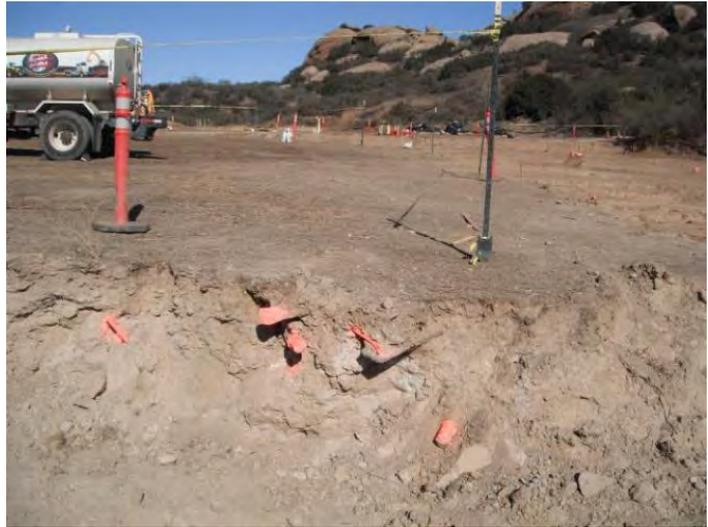
- Condition of Soil: **Not Impacted**
- PID Headspace Reading: **0.0 ppm**
- Sample Collected: **No**
- Sample ID: **N/A**
- Analyses: **N/A**
- Comments: **Feature LOX-1B-3-10 was a subsurface 1.5-inch diameter steel line found in the eastern portion of LOX-1B-3 during 2013 ISRA implementation activities. The portion of the line within the ISRA area was removed and the rest of the line outside the ISRA excavation was left in place. No staining or odors observed during removal. GPS Coordinates 269061.592 Northing - 1792840.563 Easting.**

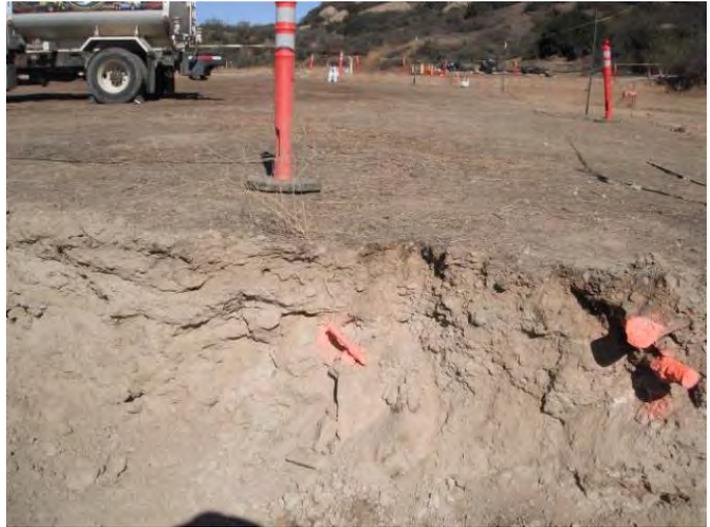
Photo 1- West

- Condition of Soil: **Not Impacted**
- PID Headspace Reading: **0.0 ppm**
- Sample Collected: **No**
- Sample ID: **N/A**
- Analyses: **N/A**
- Comments: **Feature LOX-1B-3-11 was a subsurface 1-inch diameter steel line found in the eastern portion of LOX-1B-3 during 2013 ISRA implementation activities. The portion of the line within the ISRA area was removed and the rest of the line outside the ISRA excavation was left in place. No staining or odors observed during removal. GPS Coordinates 269042.647 Northing - 1792826.172 Easting.**

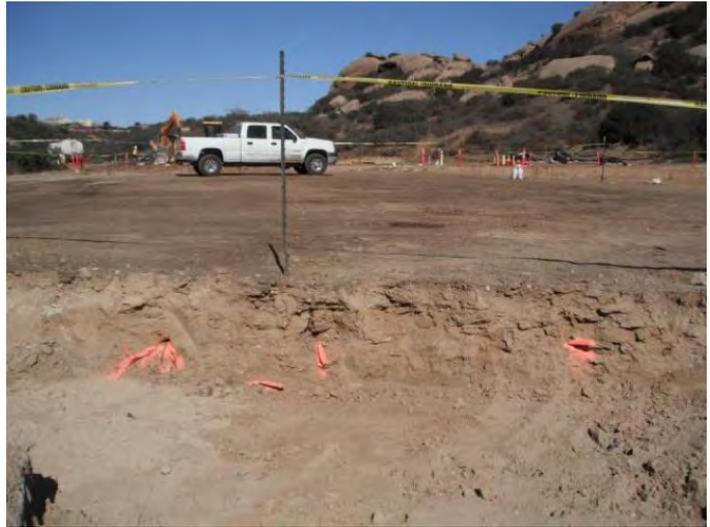
- Condition of Soil: **Not Impacted**
- PID Headspace Reading: **0.0 ppm**
- Sample Collected: **No**
- Sample ID: **N/A**
- Analyses: **N/A**
- Comments: **Feature LOX-1B-3-12 was a subsurface 1-inch diameter electrical conduit found in the eastern portion of LOX-1B-3 during 2013 ISRA implementation activities. The portion of the line within the ISRA area was removed and the rest of the line outside the ISRA excavation was left in place. No staining or odors observed during removal. GPS Coordinates 269025.955 Northing - 1792815.217 Easting.**
