Building Feature Documentation Log
Feature Number: LOX-1B-1-01
Santa Susana Field Laboratory, Ventura County, California

Building Feature Removal Log
Feature Number: LOX-1B-1-01
Santa Susana Field Laboratory, Ventura County, California

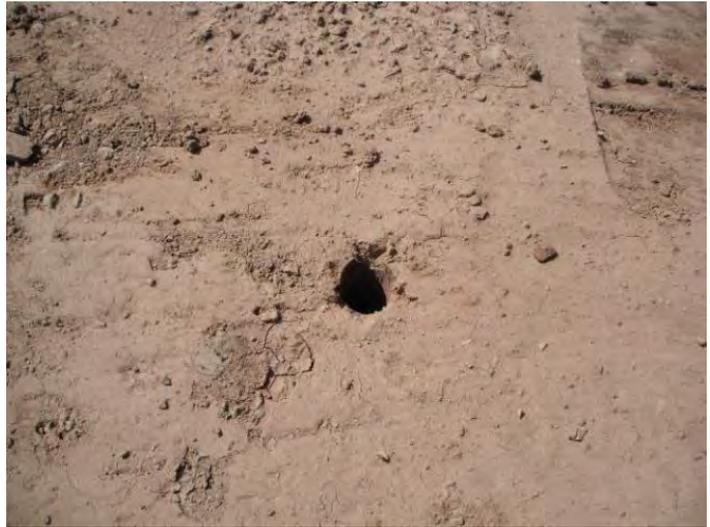
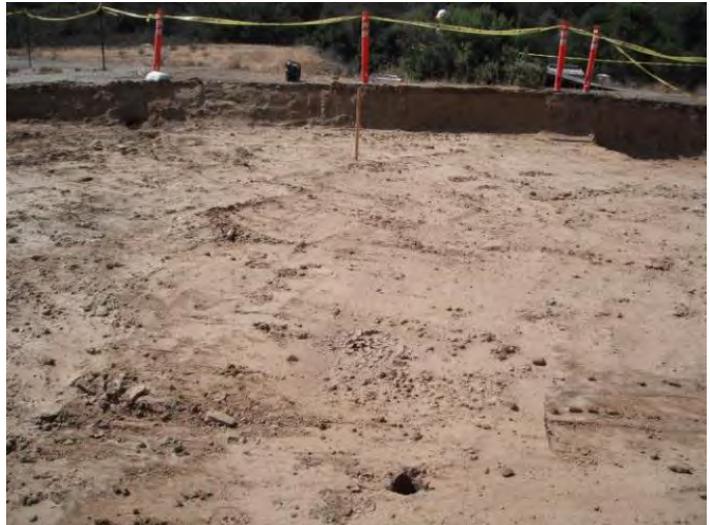
- Condition of Soil: **Not Impacted**
- PID Headspace Reading: **0.0 ppm**
- Sample Collected: **No**
- Sample ID: **N/A**
- Analyses: **N/A**
- Comments: **Feature LOX-1B-3-17 was a subsurface 4-inch diameter sewer pipe found in the eastern portion of LOX-1B-3 during 2013 ISRA implementation activities. The portion of the line within the ISRA area was removed and the rest of the line outside the ISRA excavation was left in place. No staining or odors observed during removal. GPS Coordinates 269075.813 Northing - 1792813.696 Easting.**

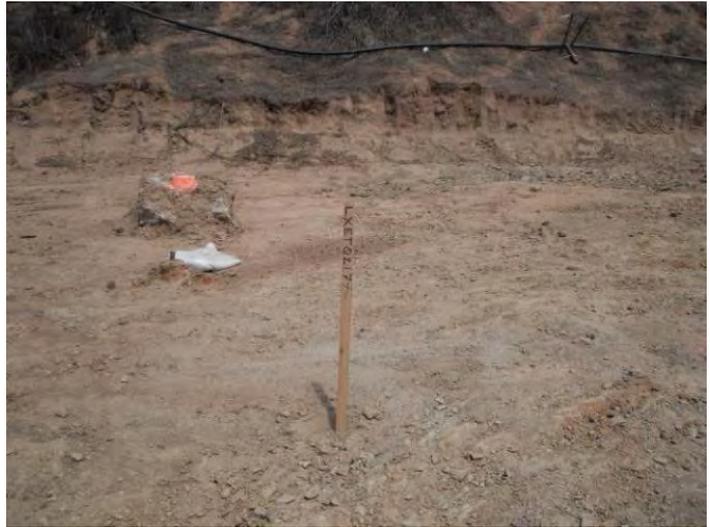
- Condition of Soil: **Not impacted**
- PID Headspace Reading: **0.0 ppm**
- Sample Collected: **No**
- Sample ID: **N/A**
- Analyses: **N/A**
- Comments: **Feature LOX-1B-3-20 was a subsurface 6-inch diameter stickup valve set in concrete found in the western portion of LOX-1B-3 during 2013 ISRA implementation activities. No staining or odors observed during removal; soil appears to be fill material. GPS coordinates 269155.517 Northing 1792825.708 Easting.**

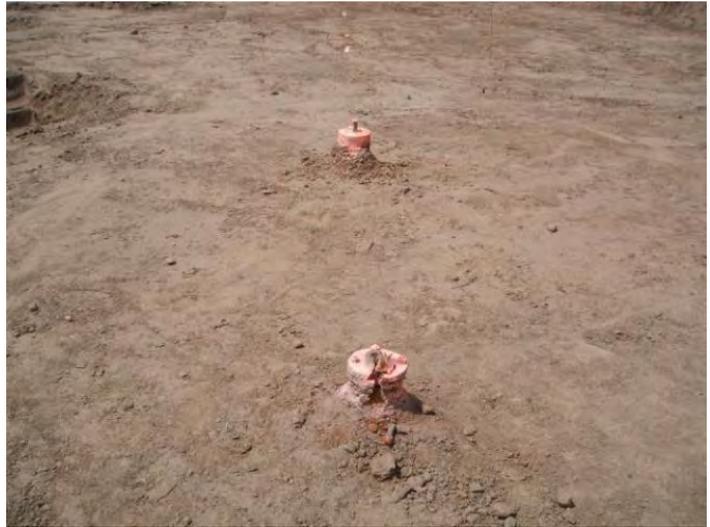
- Condition of Soil: **Not impacted**
- PID Headspace Reading: **0.0 ppm**
- Sample Collected: **No**
- Sample ID: **N/A**
- Analyses: **N/A**
- Comments: **Feature LOX-1B-3-21 was a subsurface 6-inch diameter stickup valve found in the western portion of LOX-1B-3 during 2013 ISRA implementation activities. No staining or odors observed during removal; soil appears to be fill material. GPS coordinates 269151.164 Northing - 1792780.675 Easting.**

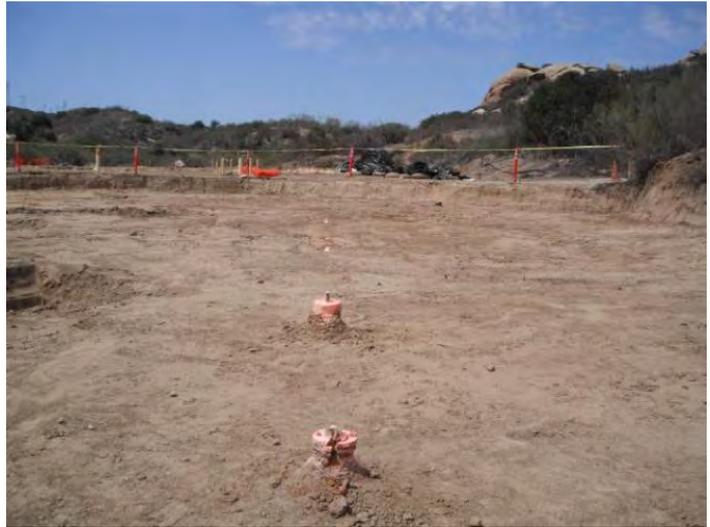
- Condition of Soil: **Not impacted**
- PID Headspace Reading: **0.0 ppm**
- Sample Collected: **No**
- Sample ID: **N/A**
- Analyses: **N/A**
- Comments: **Feature LOX-1B-3-22 was a subsurface 6-inch diameter stickup valve found in the western portion of LOX-1B-3 during 2013 ISRA implementation activities. No staining or odors observed during removal; soil appears to be fill material. GPS coordinates 269152.319 Northing 1792771.515 Easting.**

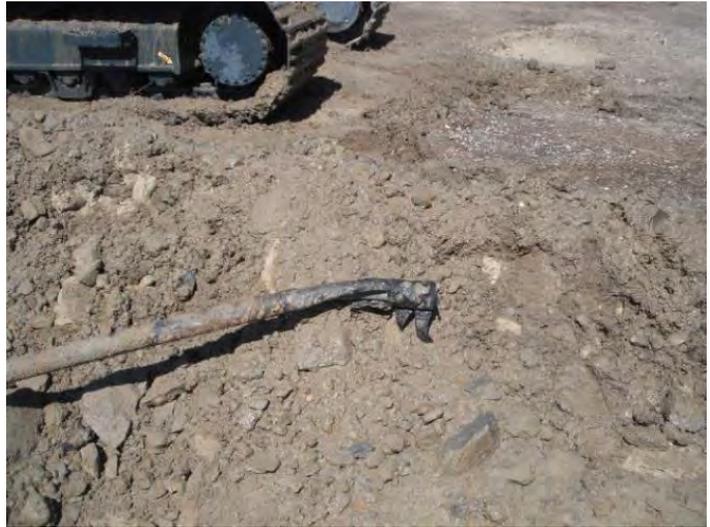
- Condition of Soil: **Not impacted**
- PID Headspace Reading: **0.0 ppm**
- Sample Collected: **No**
- Sample ID: **N/A**
- Analyses: **N/A**
- Comments: **Feature LOX-1B-3-23 was a subsurface 1.5-inch wrapped pipe found in the western portion of LOX-1B-3 during 2013 ISRA implementation activities. No staining or odors observed during removal of pipeline; soil appears to be fill material. GPS coordinates 269118.255 Northing 1791909.740 Easting.**
