Figure ES-3: CM-9 Area

Santa Susana Site
 Ventura County, CA

August 2014

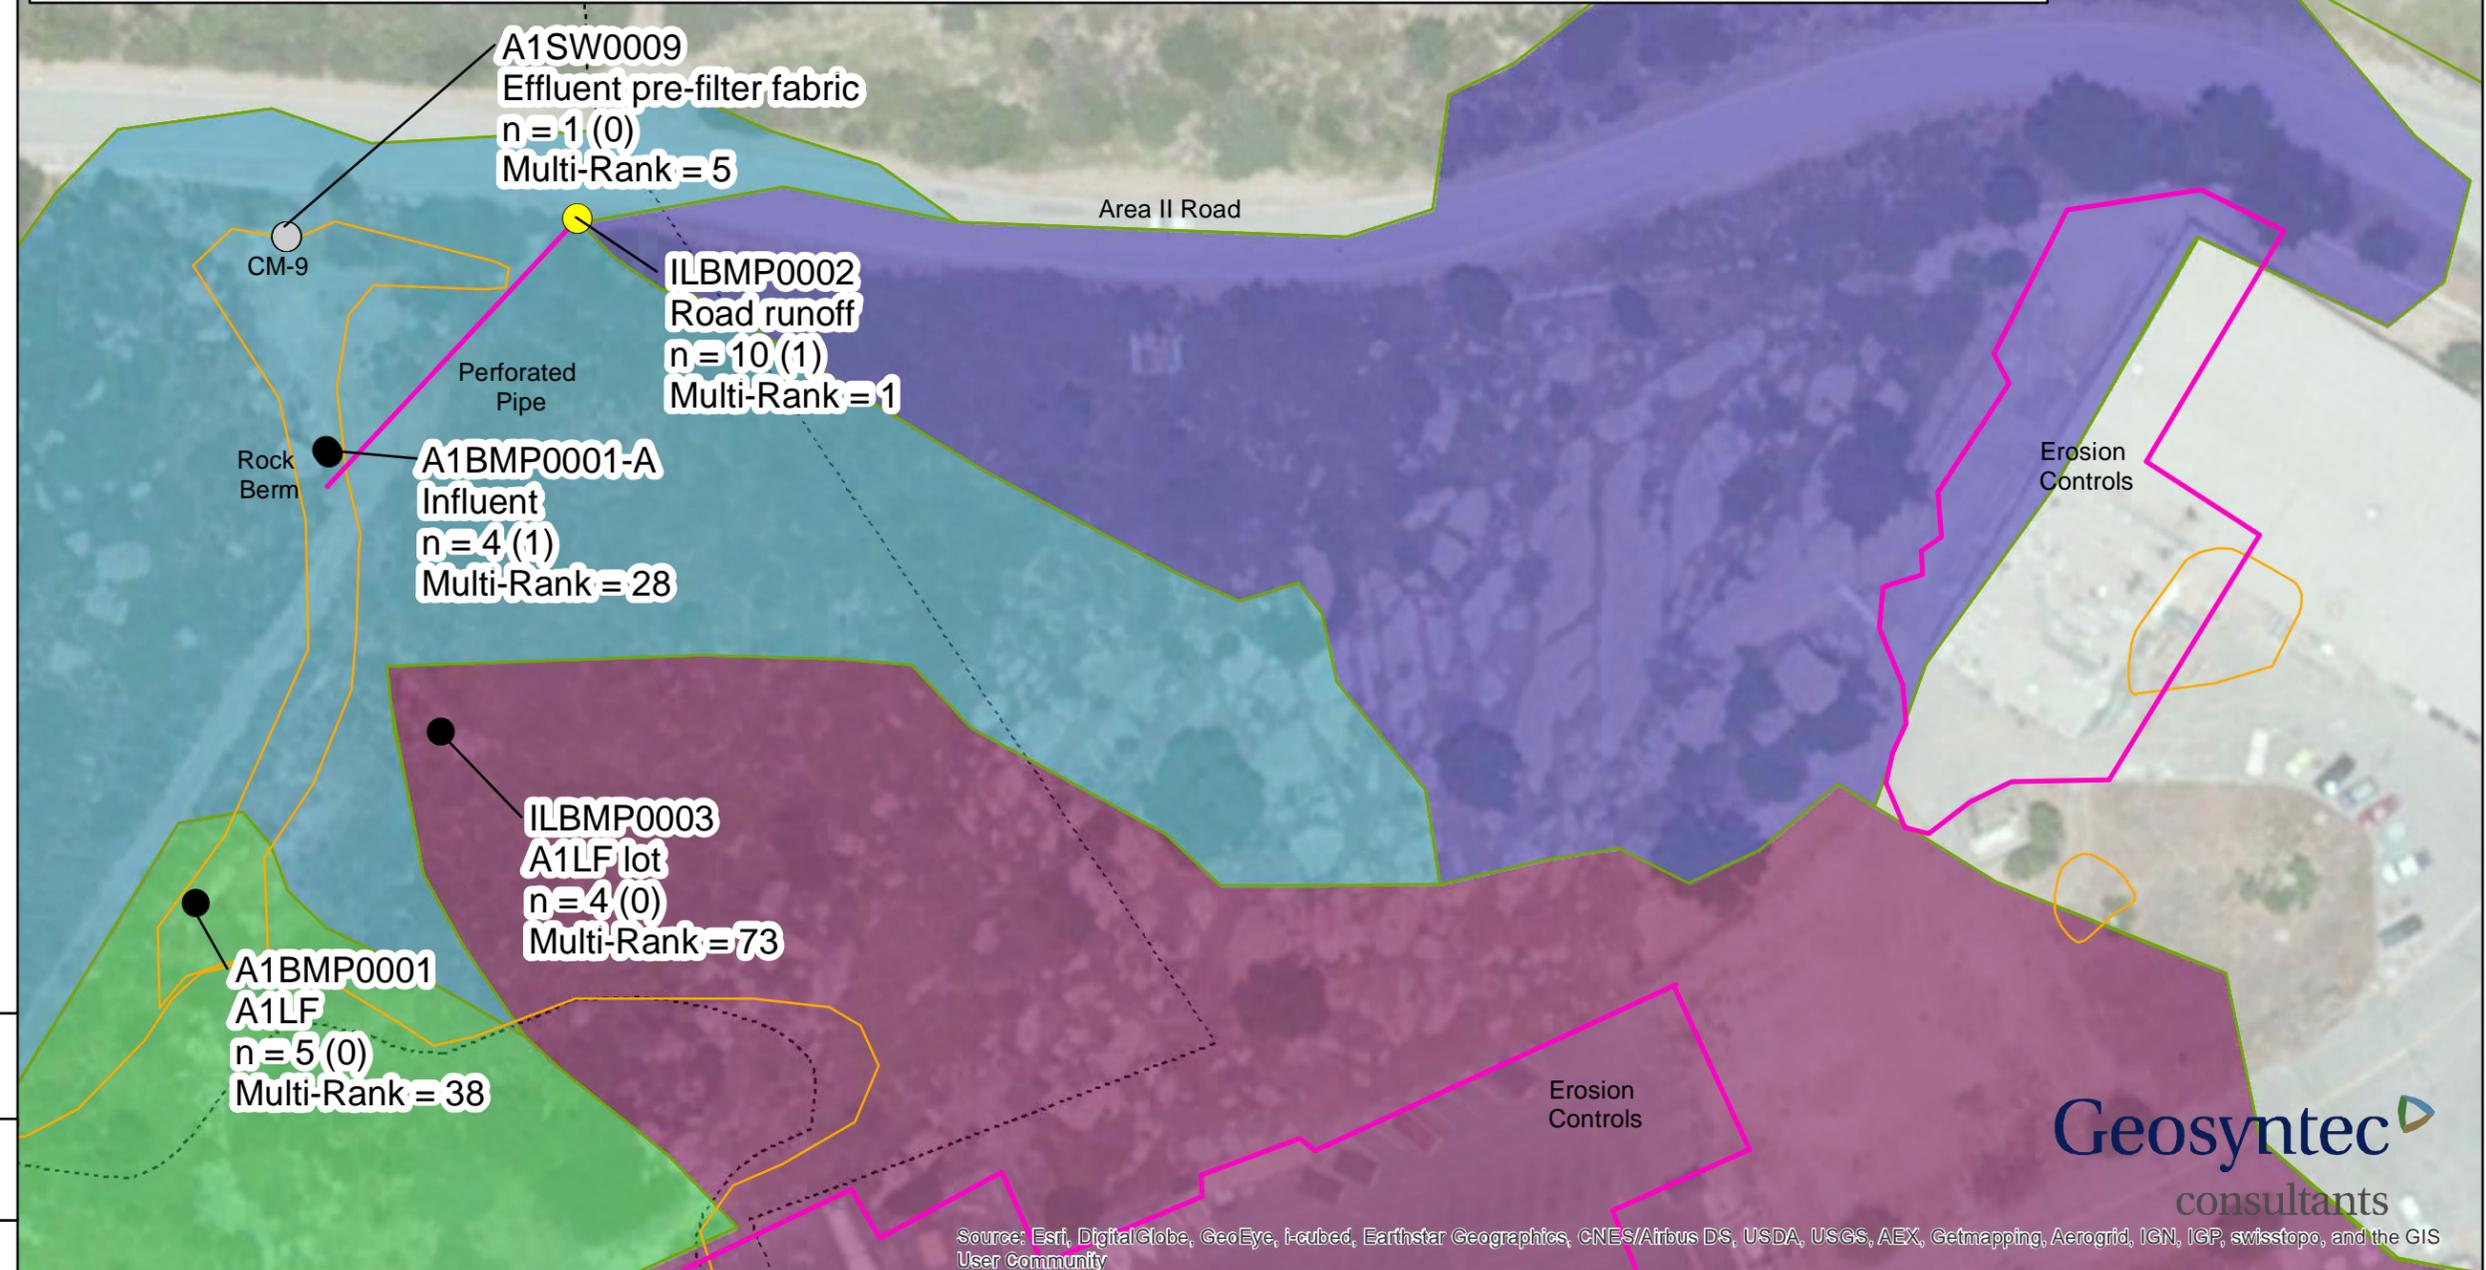
In March of 2013, improvements were made at CM-9 area including:

- Erosion control blanket and straw wattles were installed along the slopes adjacent to the Area II Road
- A low flow diversion inlet structure and a diversion pipe with perforations were installed to spread road runoff along the slope
- A rock berm was installed for ponding as pre-treatment to CM-9

In September of 2013, improvements included:

- Sediment removal at CM-9
- Mesh screen placed over culvert inlet to perforated pipe to prevent clogging.

Recommendations:

- Replace filter fabric on the CM-9 weir boards when the fabric becomes clogged or damaged
- Remove sediment accumulation at the inlet of the culvert modification and at the pretreatment rock berm
- Note any water ponded upstream of the weir board for greater than 72 hours as it may suggest that media or underdrain maintenance is needed
- Continue inspection and maintenance of BMPs

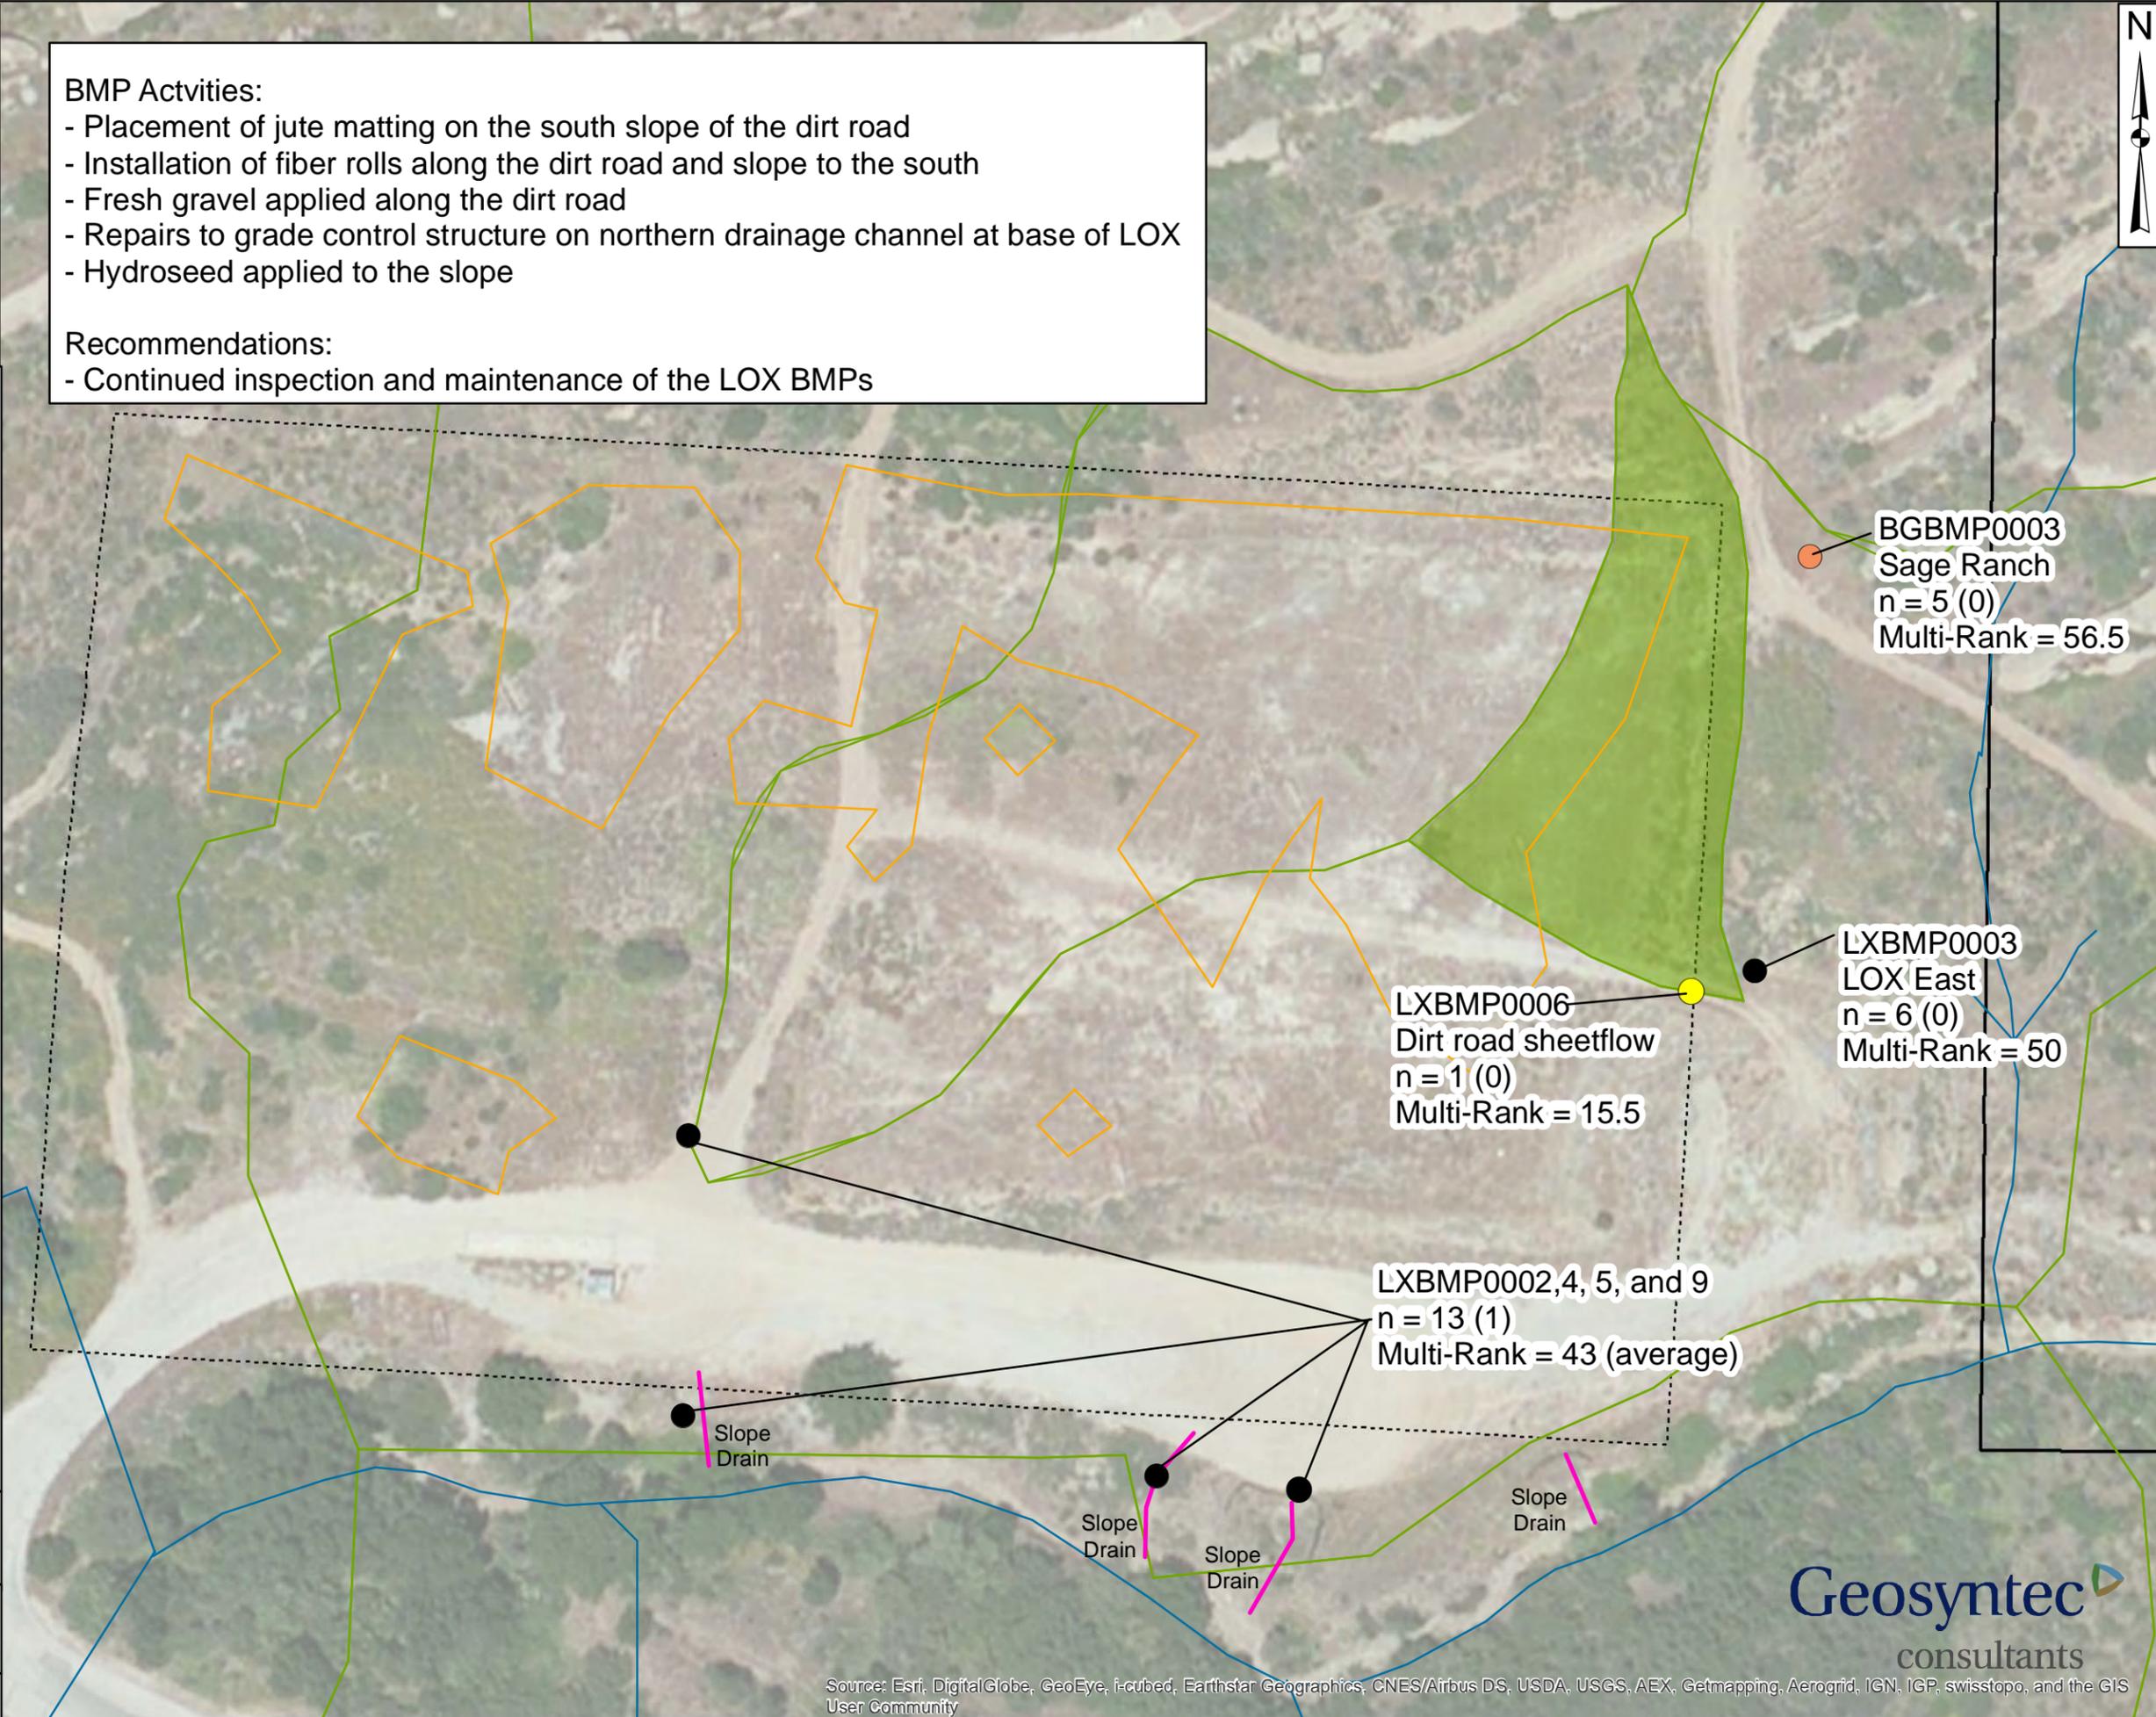
Figure ES-4: LOX Area

BMP Activities:

- Placement of jute matting on the south slope of the dirt road
- Installation of fiber rolls along the dirt road and slope to the south
- Fresh gravel applied along the dirt road
- Repairs to grade control structure on northern drainage channel at base of LOX
- Hydroseed applied to the slope

Recommendations:

- Continued inspection and maintenance of the LOX BMPs

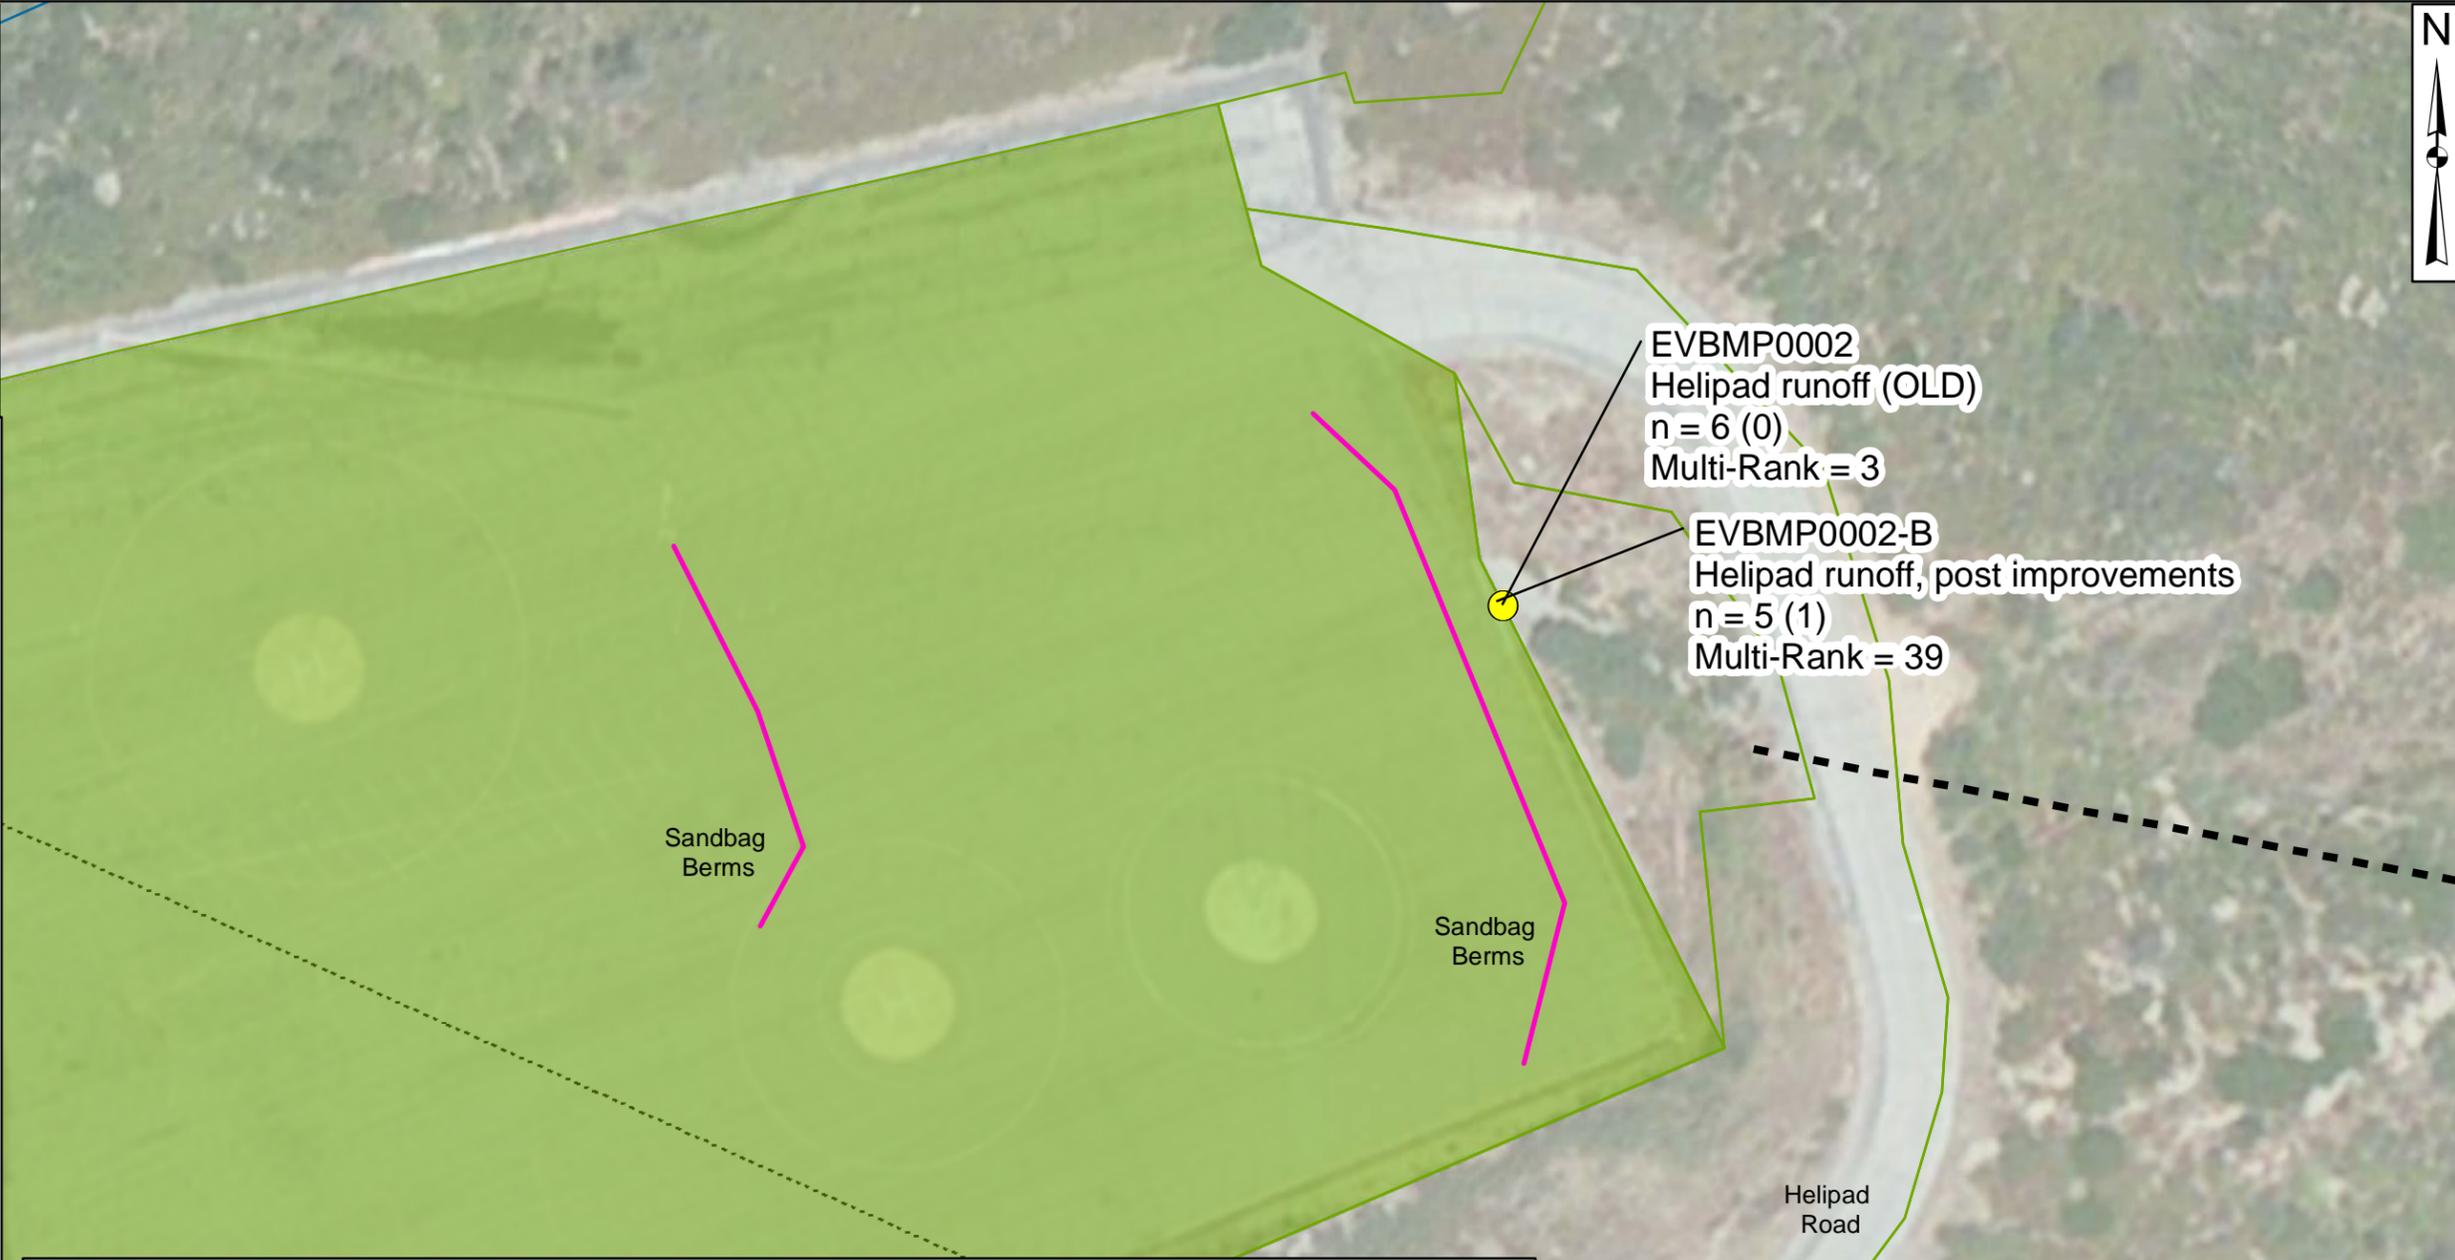
Figure ES-5: Helipad Area

EVBMP0002
Helipad runoff (OLD)
n = 6 (0)
Multi-Rank = 3

EVBMP0002-B
Helipad runoff, post improvements
n = 5 (1)
Multi-Rank = 39

Activities:

- In August of 2013 a concrete curb along the paved area west of the Helipad was constructed to route runoff from this area to the Helipad.
- Drainage from the west was modified by the installation of a lowered concrete slab, increasing flows from previous monitoring seasons.
- The sandbag berms and pumps were kept in operation during the 2013/2014 season.

Recommendations:

- Continued operation of temporary capture system or equivalent runoff capture and treatment as a temporary control strategy until NASA is able to remove asphalt from the Helipad area during the planned demolition.
- Ponded water should be pumped out to the sump area and the storm drain inlet "plug" under Helipad Road be removed when either 1) Outfall 009 is flowing or 2) the sump is overflowing onto Helipad Road.
- Continued inspection and maintenance of the Helipad sandbag berms and any future BMPs.

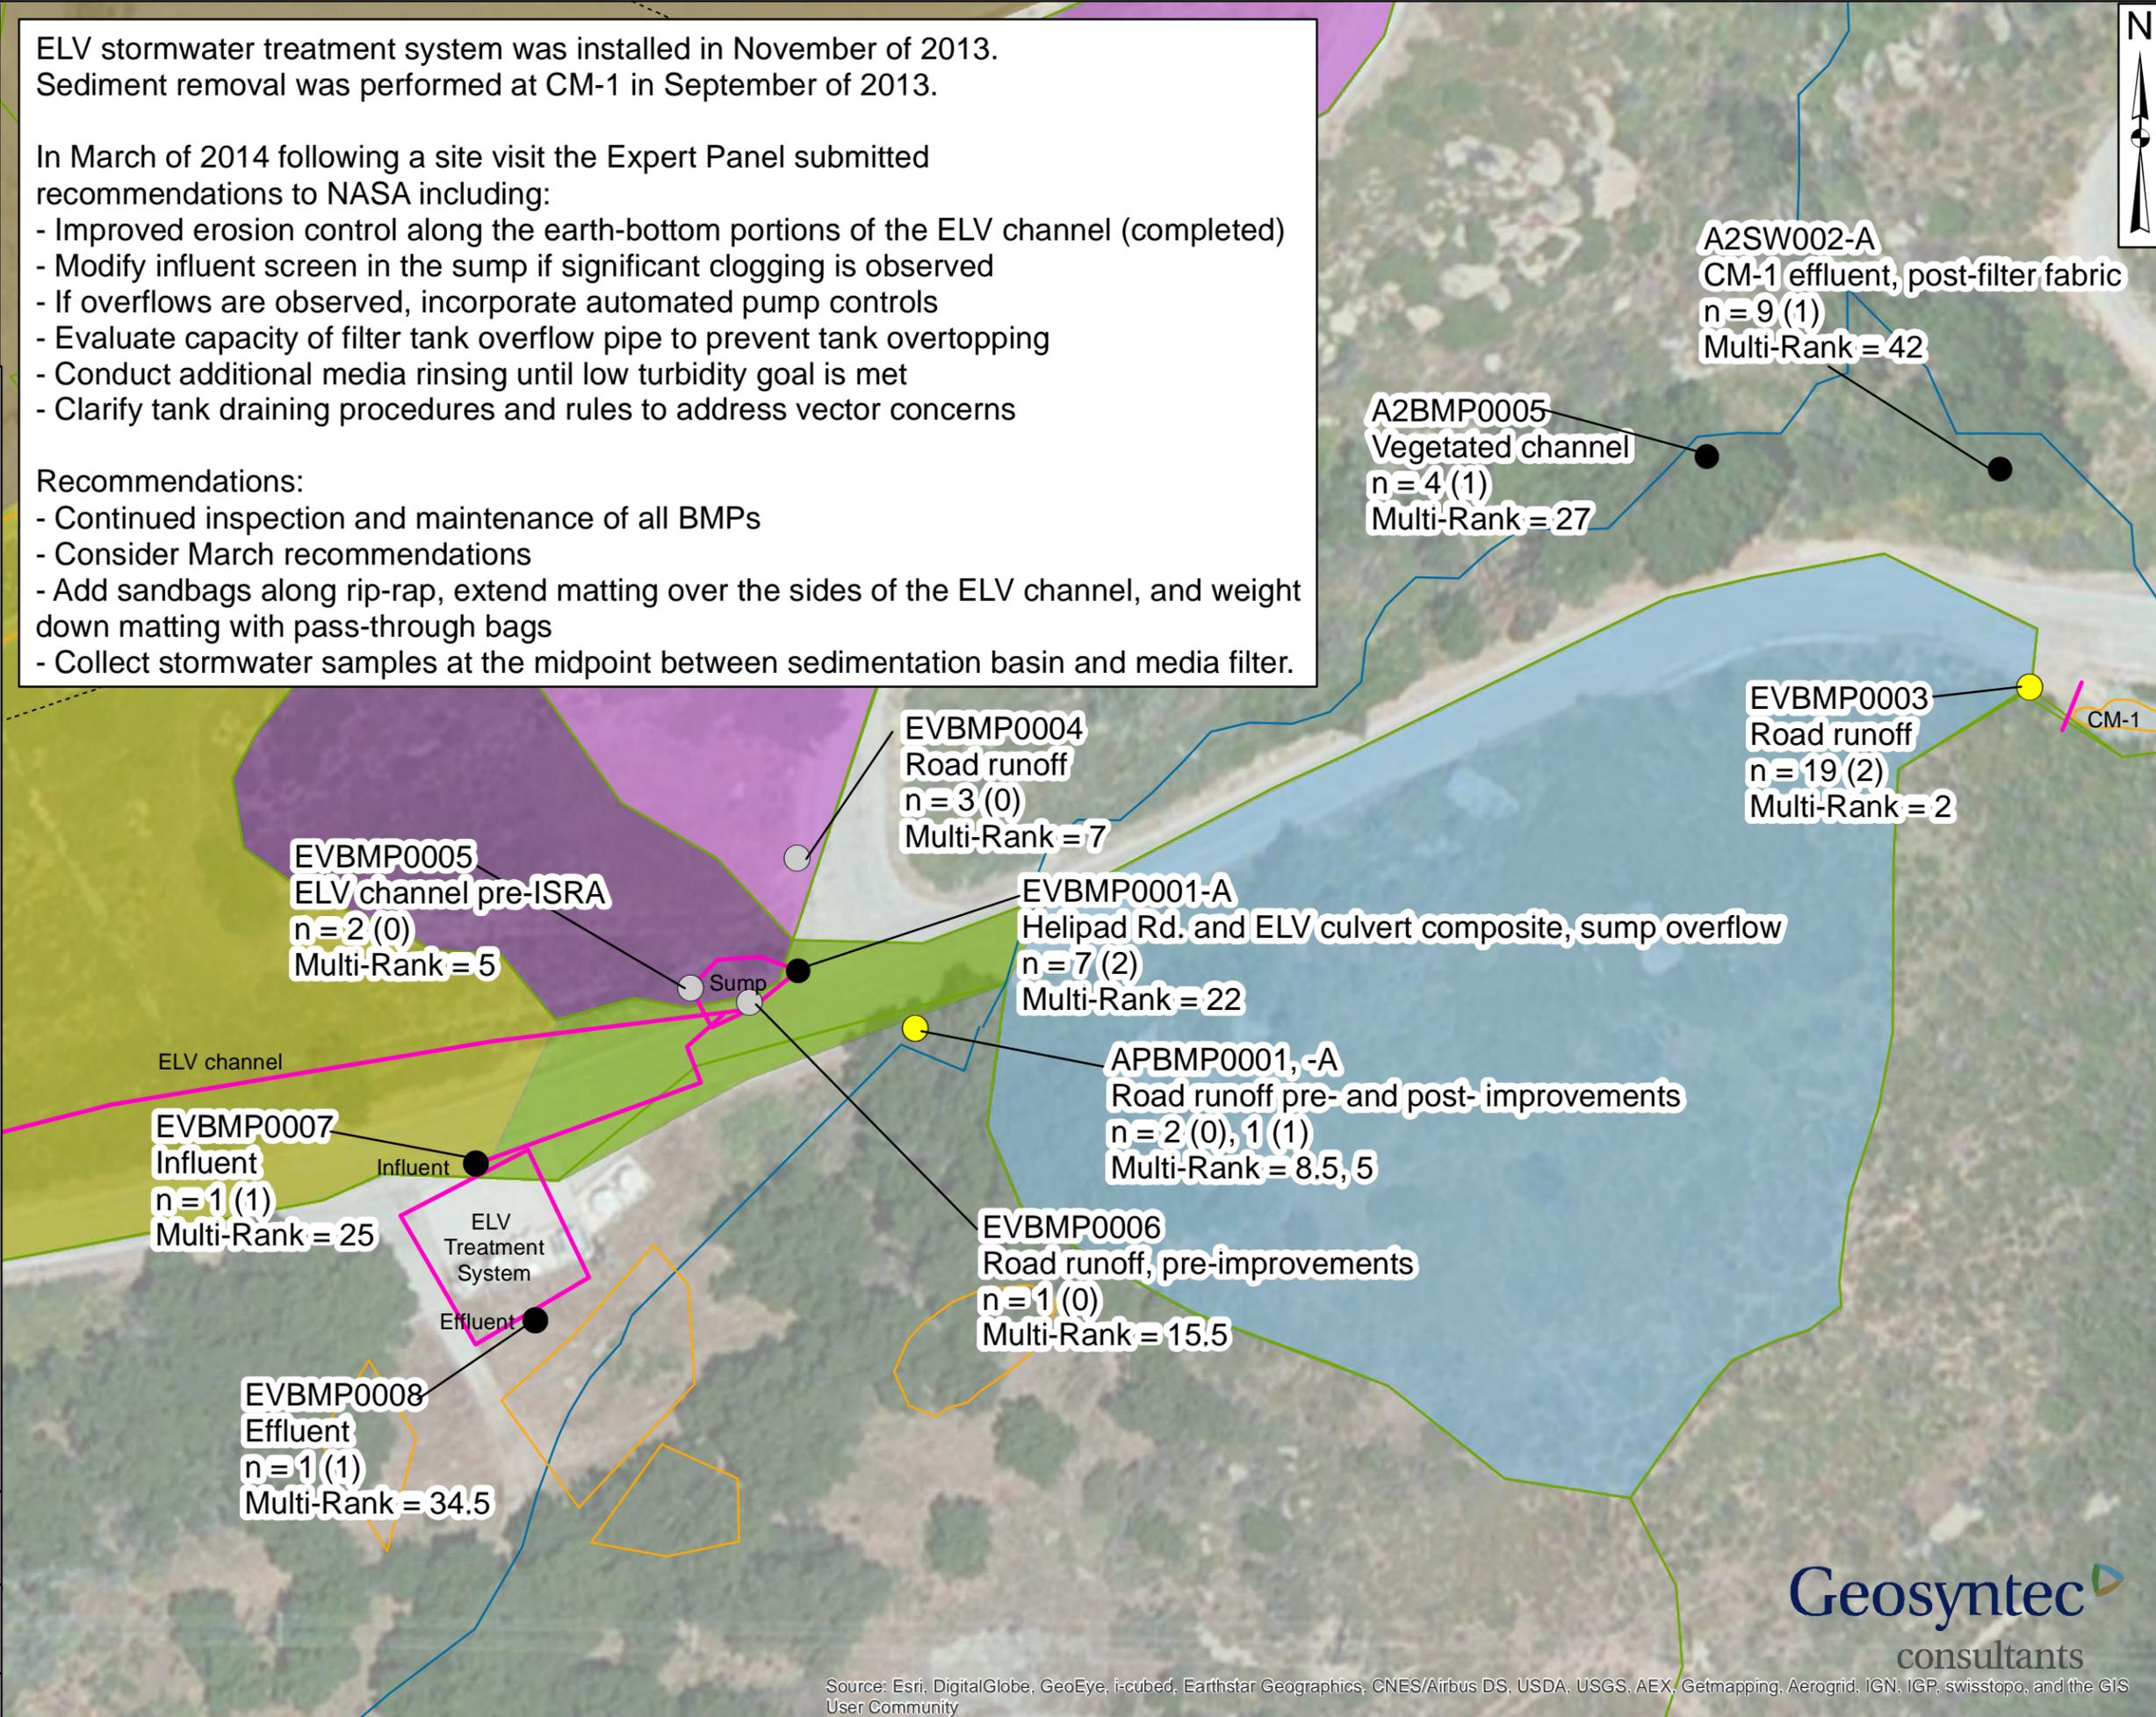
Figure ES-6: ELV/CM-1 Area

ELV stormwater treatment system was installed in November of 2013.
Sediment removal was performed at CM-1 in September of 2013.

- In March of 2014 following a site visit the Expert Panel submitted recommendations to NASA including:
- Improved erosion control along the earth-bottom portions of the ELV channel (completed)
 - Modify influent screen in the sump if significant clogging is observed
 - If overflows are observed, incorporate automated pump controls
 - Evaluate capacity of filter tank overflow pipe to prevent tank overtopping
 - Conduct additional media rinsing until low turbidity goal is met
 - Clarify tank draining procedures and rules to address vector concerns

- Recommendations:
- Continued inspection and maintenance of all BMPs
 - Consider March recommendations
 - Add sandbags along rip-rap, extend matting over the sides of the ELV channel, and weight down matting with pass-through bags
 - Collect stormwater samples at the midpoint between sedimentation basin and media filter.
