December 13, 2005 Meeting Status of NPDES Post Fire BMPs

Santa Susana Field Laboratory Regional Map

Impact To SSFL as a Result of September 2005 Fire

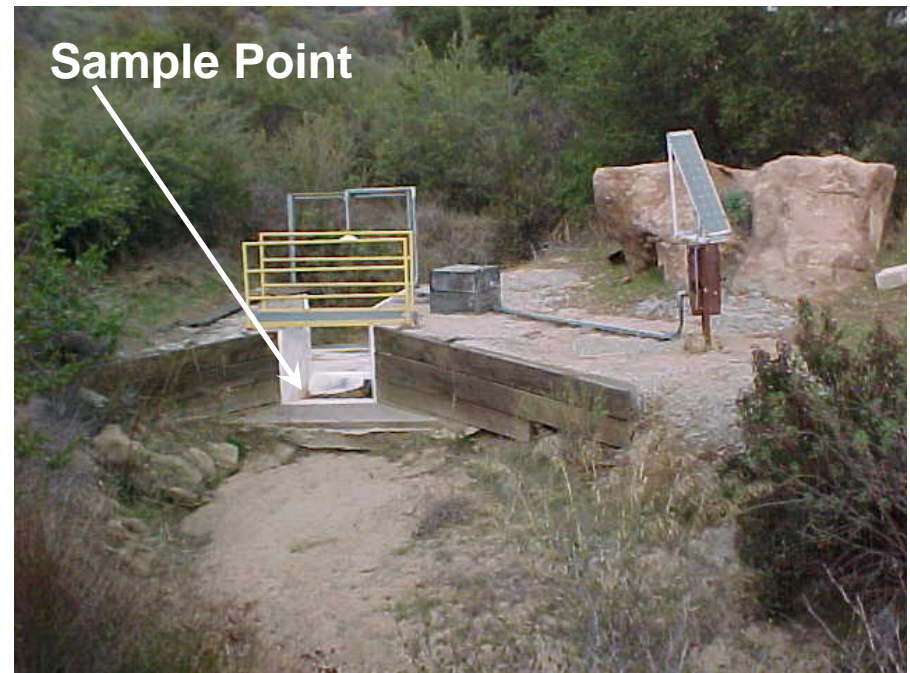
Outfall 001 (Southeast) Before 2005 Fire

- Upstream settling pond (Perimeter Pond).
- Dense natural vegetation along entire length of drainage.

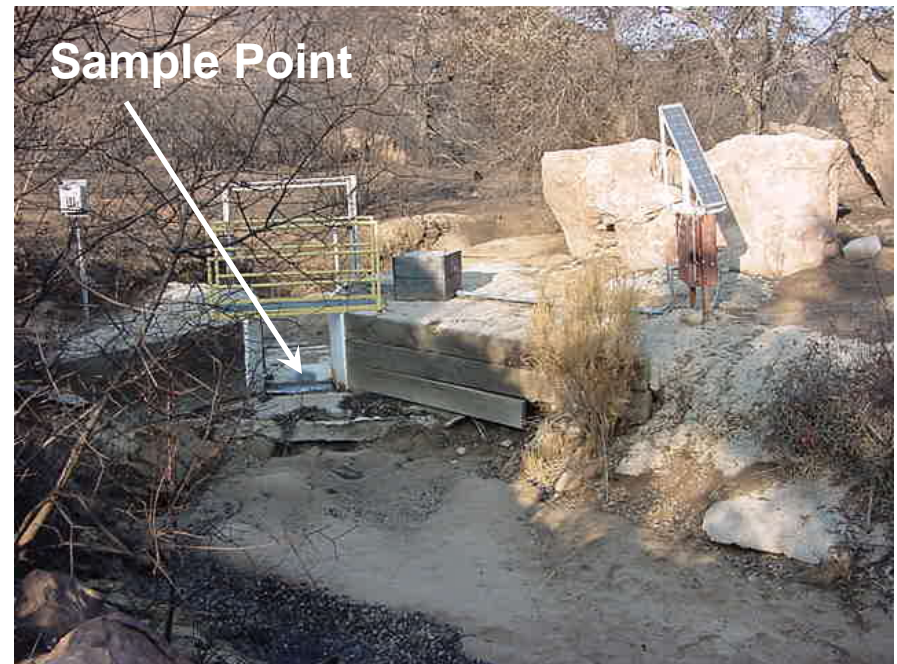
Outfall 001 (Southeast) After 2005 Fire

- Vegetation along streambed either completely destroyed or heavily damaged.
- Hillsides along drainage covered in ash that is known to contain elevated levels of naturally occurring metals and dioxins.

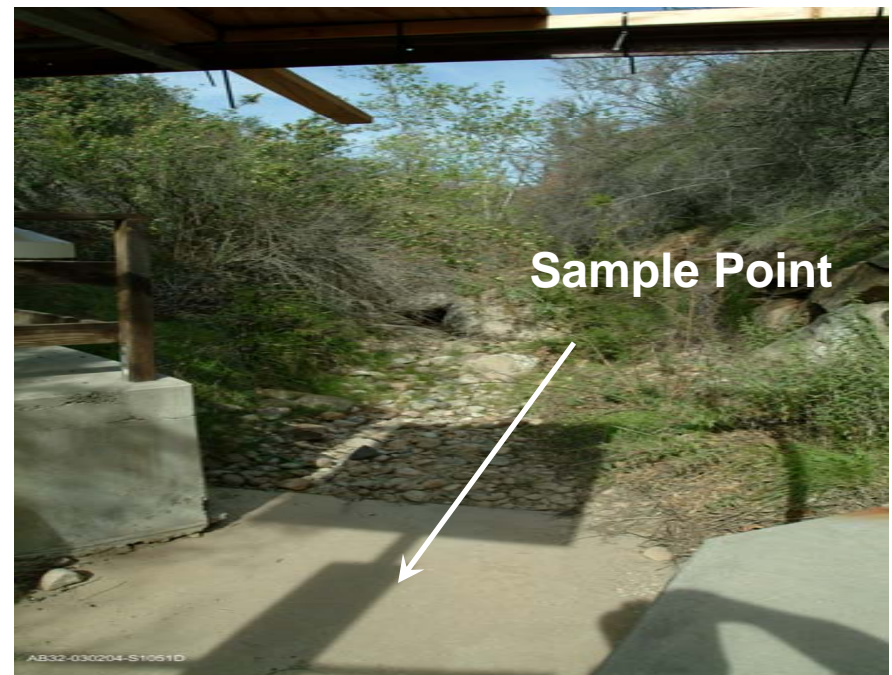
Outfall 002 (Southwest) Before 2005 Fire

- Upstream settling ponds (R-2 Pond).
- Dense natural vegetation along entire length of drainage.

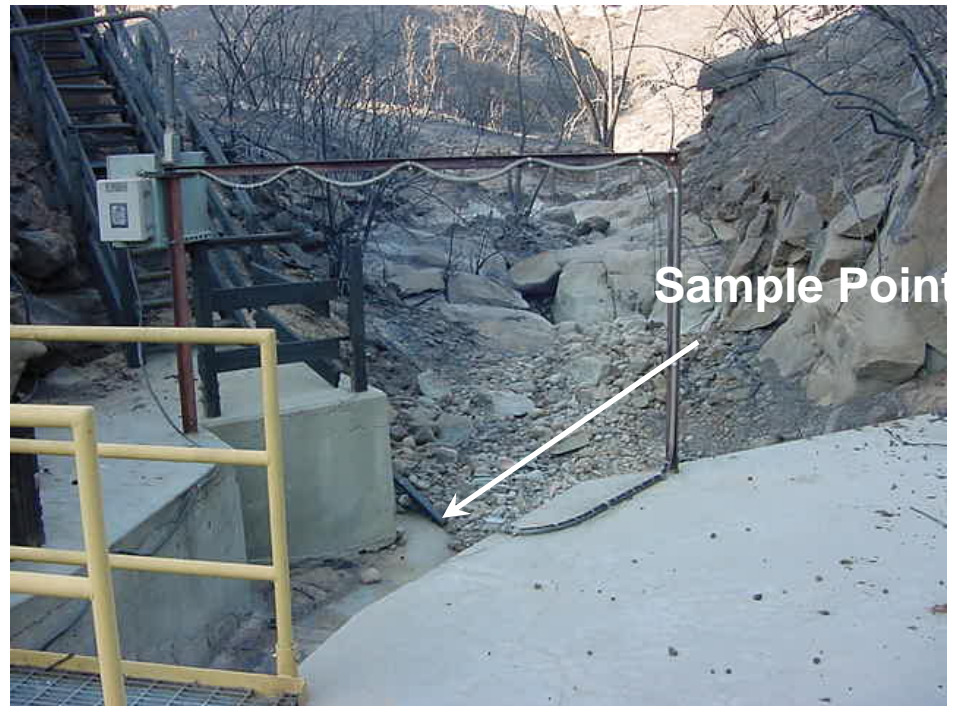
Outfall 002 (Southwest) After 2005 Fire

- All vegetation along streambed either completely destroyed or heavily damaged.
- Hillsides along drainage covered in ash known to contain elevated levels of naturally occurring metals and dioxins.

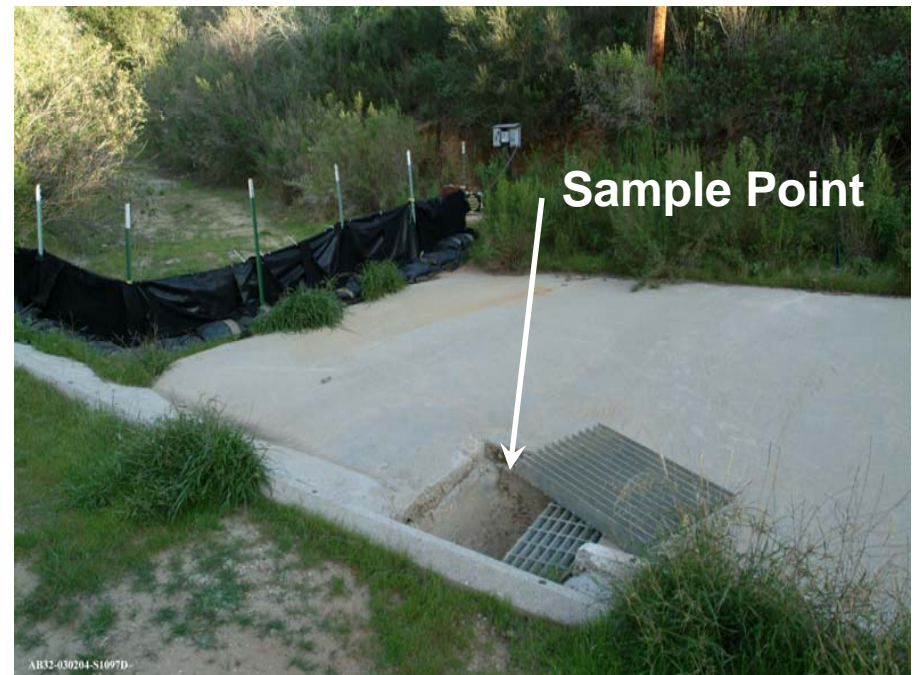
Outfall 003 (RMHF) Before 2005 Fire

- Dense natural vegetation along entire length of drainage and hillsides.
- Silt fencing in place.
- Filter bags including vermiculite and activated carbon.

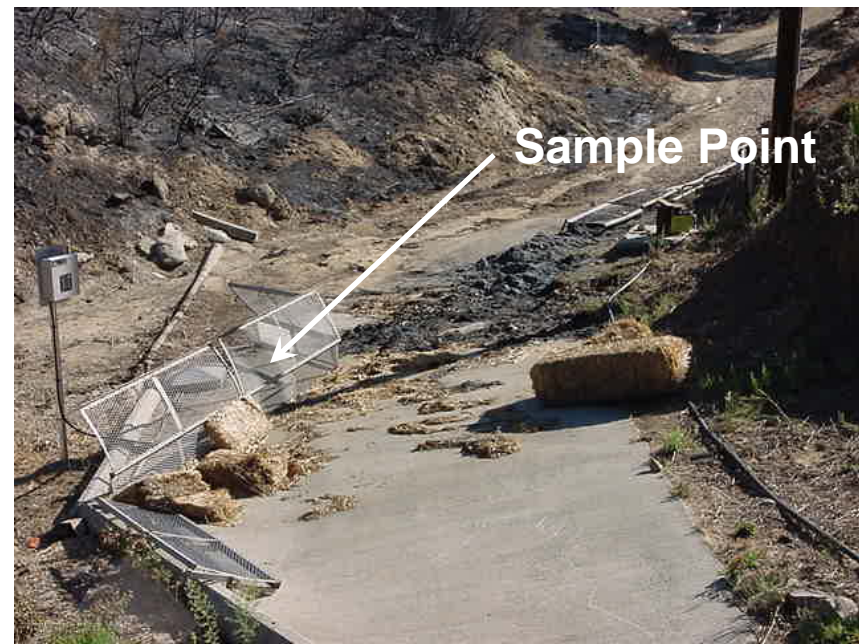
Outfall 003 (RMHF) After 2005 Fire

- All vegetation along northern side of drainage heavily damaged.
- Hillsides along drainage covered in ash known to contain elevated levels of naturally occurring metals and dioxins.
- All BMPs completely destroyed.

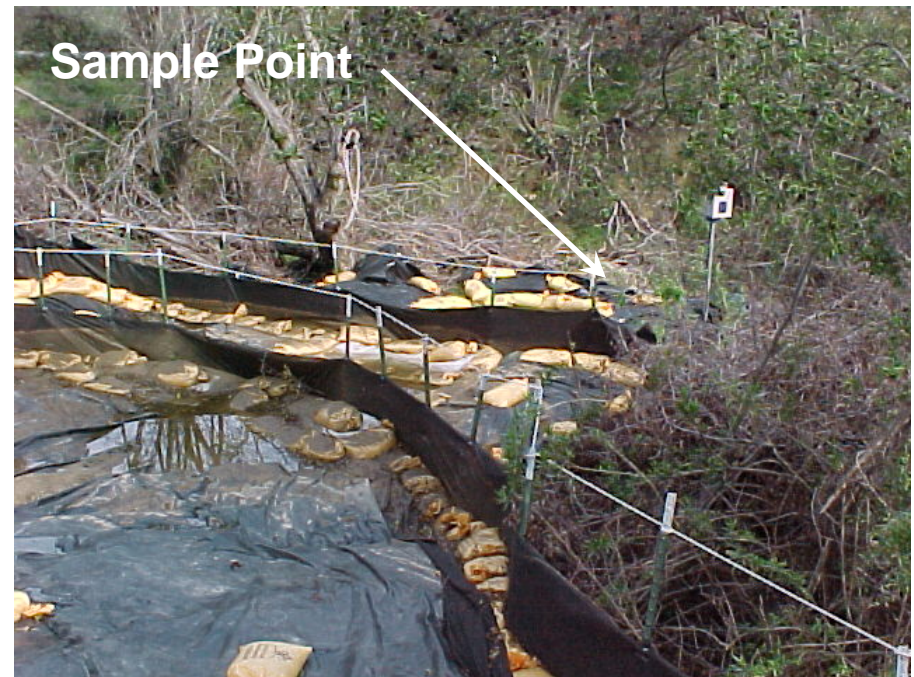
Outfall 004 (SRE) Before 2005 Fire

- Dense natural vegetation along entire length of drainage and hillsides.
- Plastic sheeting covering potentially impacted areas.
- Silt fencing in place.
- Filter bags including vermiculite and activated carbon.

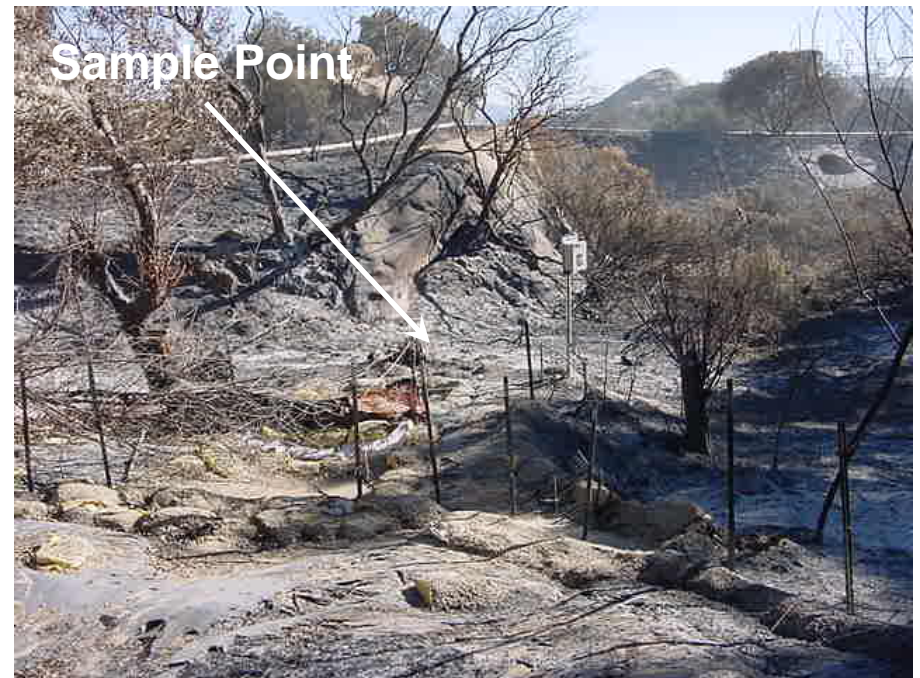
Outfall 004 (SRE) After 2005 Fire

- All vegetation around drainage heavily damaged.
- Hillsides along drainage covered in ash known to contain elevated levels of naturally occurring metals and dioxins.
- All BMPs completely destroyed.

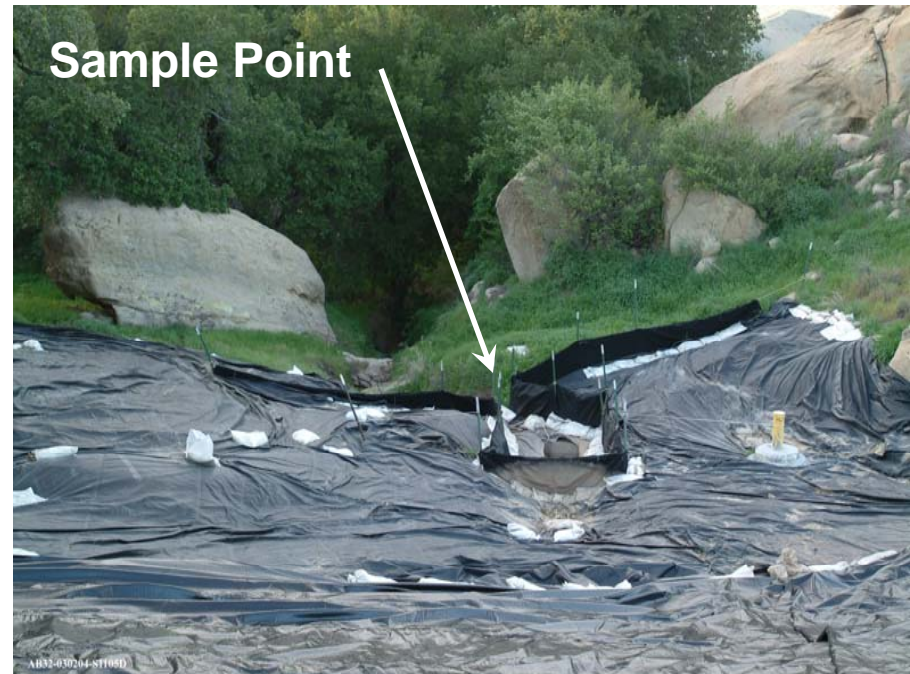
Outfall 005 (FSDF 1) Before 2005 Fire

- Dense seeded vegetation above drainage
- Plastic sheeting.
- Silt fencing in place.
- Filter bags including vermiculite and activated carbon.

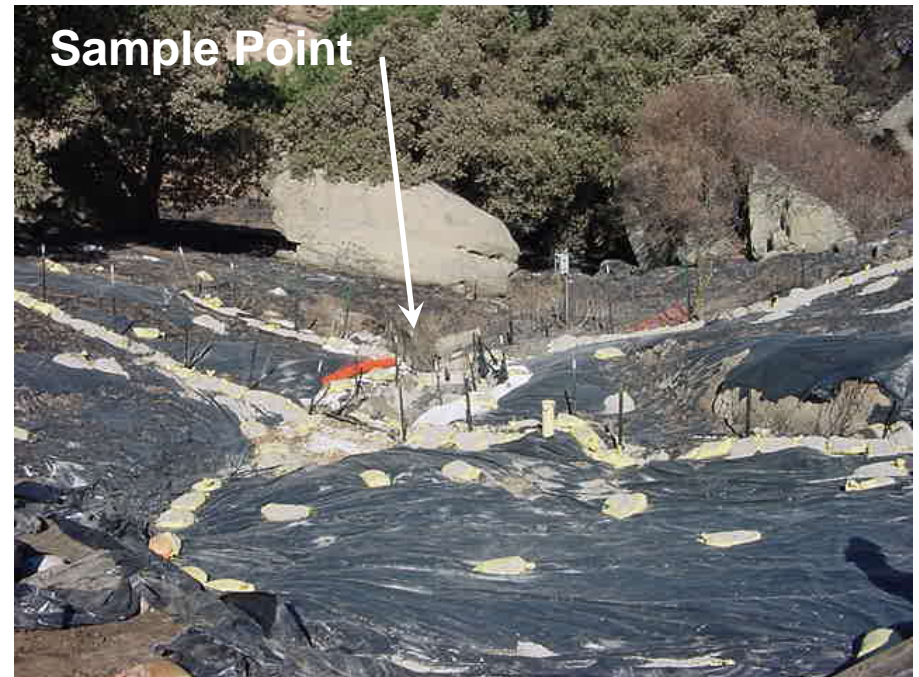
Outfall 005 (FSDF 1) After 2005 Fire

- All vegetation around drainage heavily damaged.
- Hillsides along drainage covered in ash known to contain elevated levels of naturally occurring metals and dioxins.
- All BMPs completely destroyed.

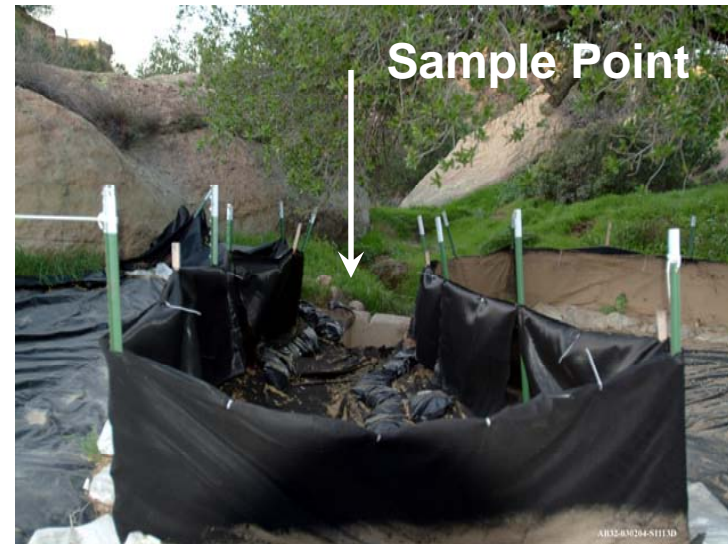
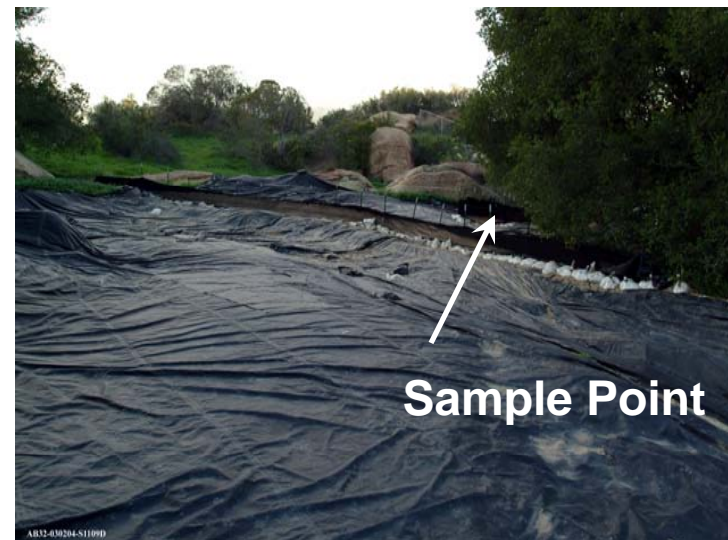
Outfall 006 (FSDF 2) Before 2005 Fire

- Rip rap swale
- Plastic sheeting.
- Multiple silt fences in place.
- Filter bags including vermiculite and activated carbon.

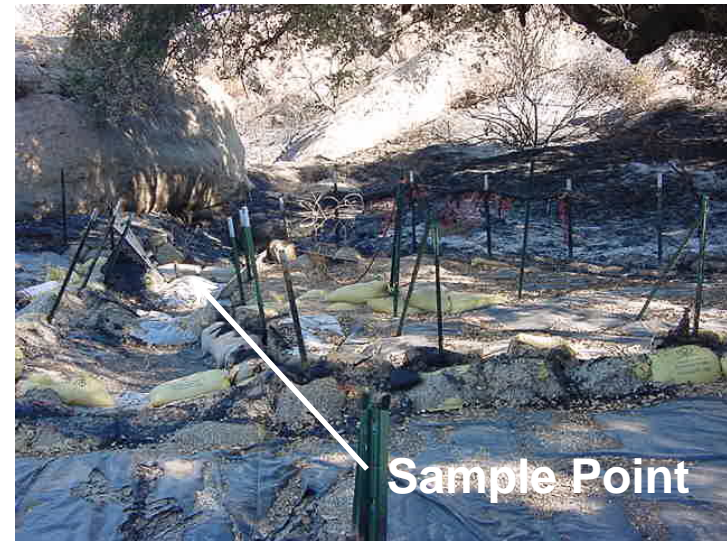
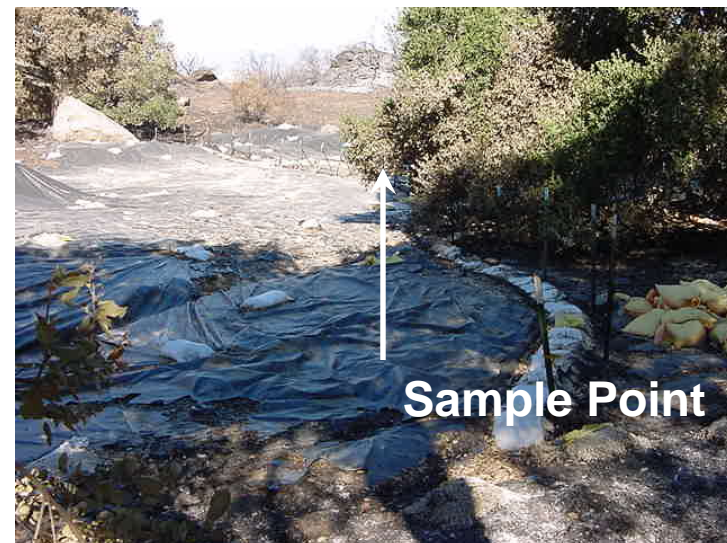
Outfall 006 (FSDF 2) After 2005 Fire

- All vegetation around drainage heavily damaged.
- Hillsides along drainage covered in ash known to contain elevated levels of naturally occurring metals and dioxins.
- All BMPs completely destroyed.

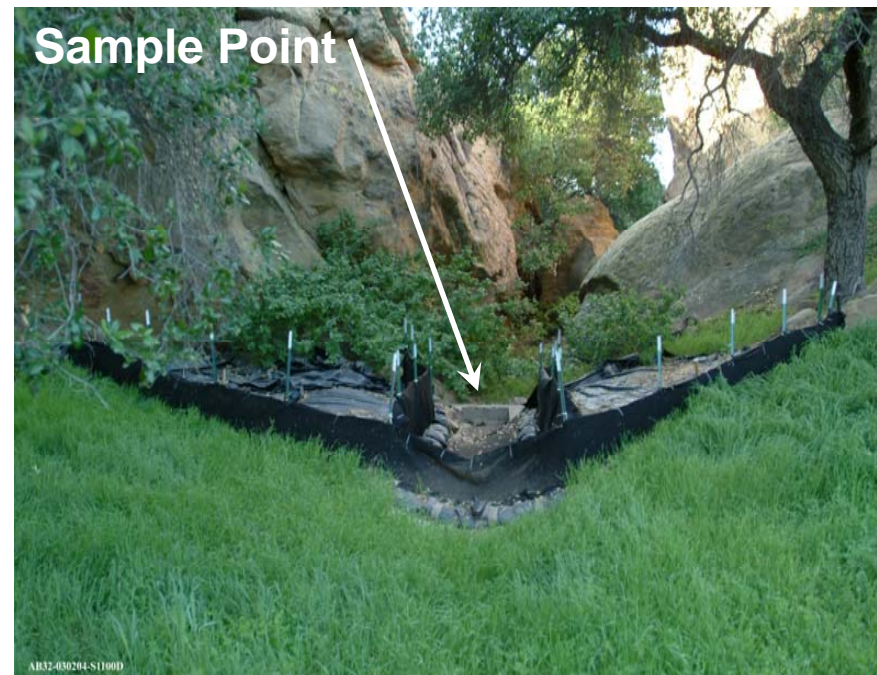
Outfall 007 (B/100) Before 2005 Fire

- Dense seeded vegetation above drainage.
- Silt fencing in place.
- Filter bags including vermiculite and activated carbon.

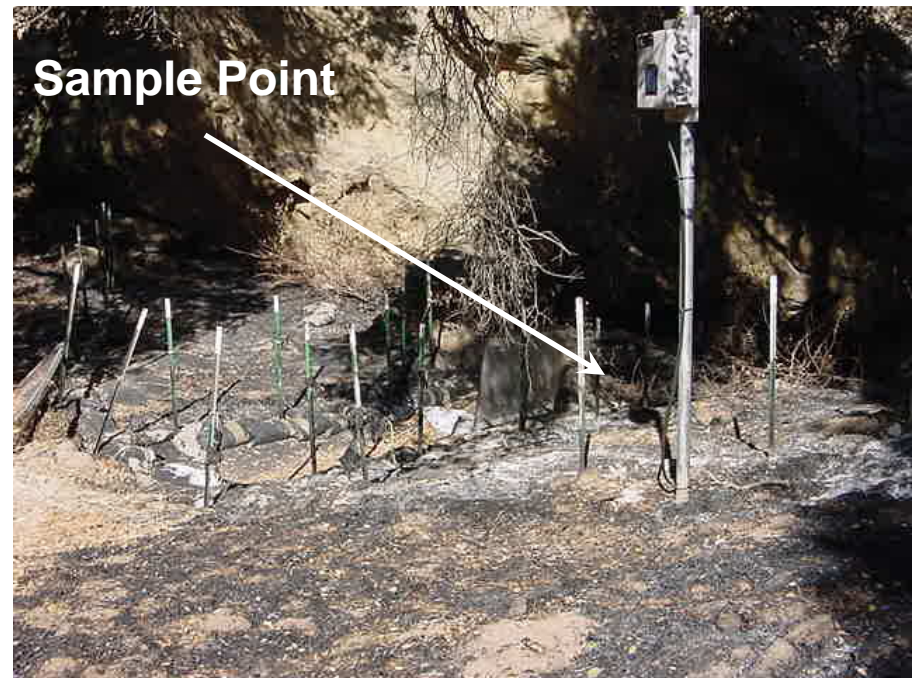
Outfall 007 (B/100) After 2005 Fire

- All vegetation around drainage heavily damaged.
- Hillsides along drainage covered in ash known to contain elevated levels of naturally occurring metals and dioxins.
- All BMPs completely destroyed.

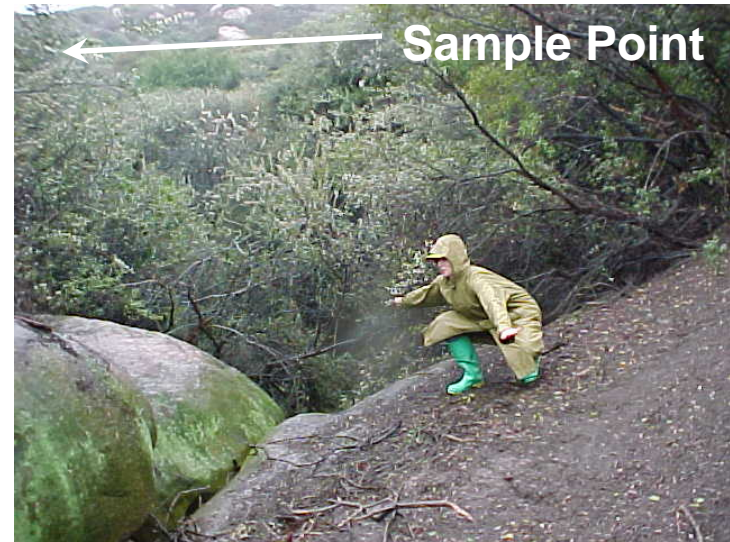
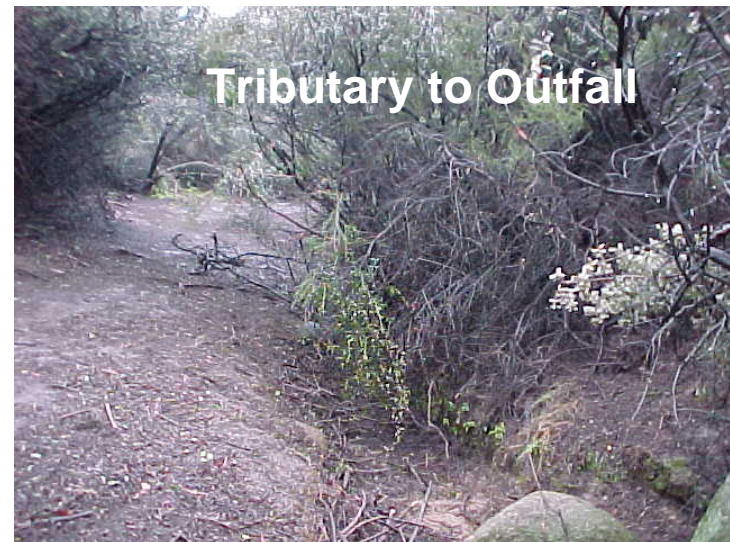
Outfall 008 (Happy Valley) Before 2005 Fire

- Extensive Interim measure perchlorate clean up.
- Rip rap beds.
- Straw hay bales installed.

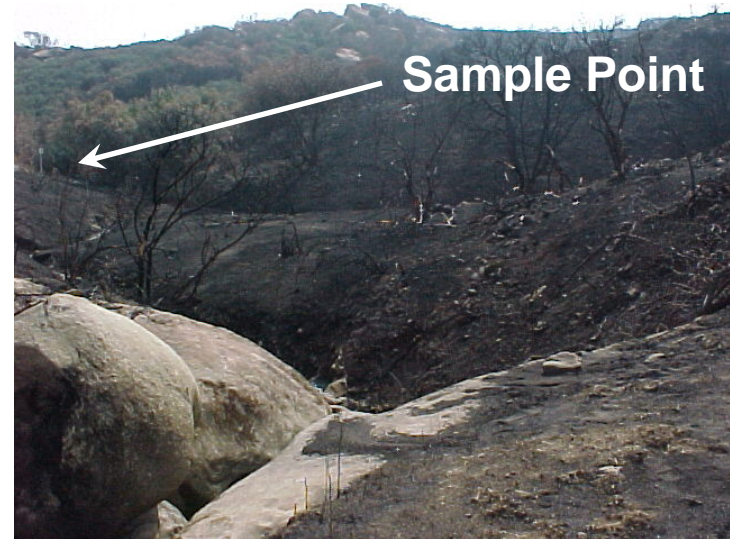
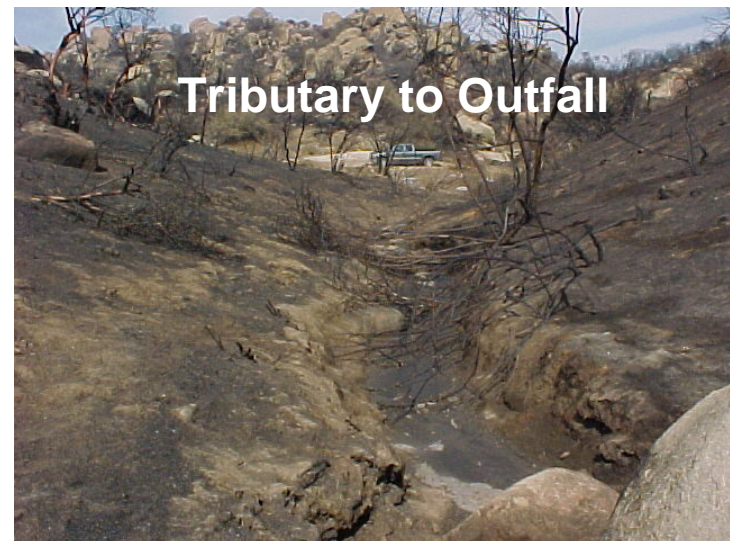
Outfall 008 (Happy Valley) After 2005 Fire

- All vegetation around drainage heavily damaged.
- Hillsides along drainage covered in ash known to contain elevated levels of naturally occurring metals and dioxins.
- All BMPs completely destroyed.

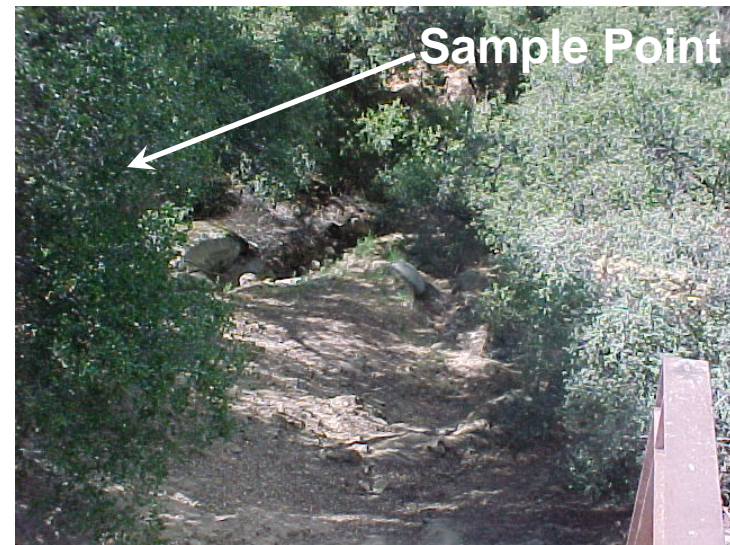
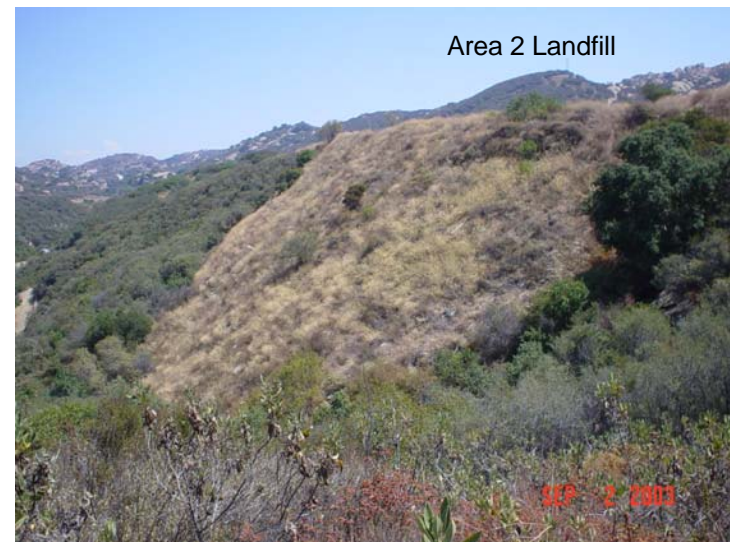
Outfall 009 (WS 13) Before 2005 Fire

- Rip rap at upstream Area 2 landfill.
- Straw wattles and straw bales at Area 2 landfill.
- Silt fences in place below Area 2 landfill.

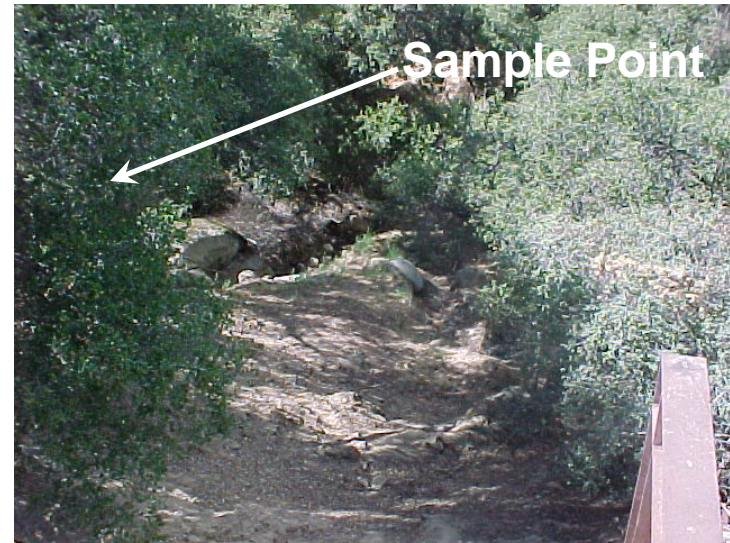
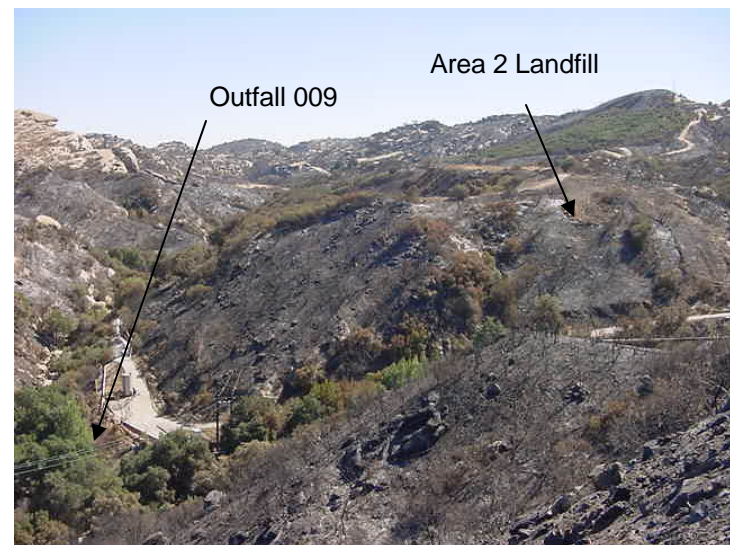
Outfall 009 (WS 13) After 2005 Fire

- All vegetation around drainage heavily damaged.
- Hillsides along drainage covered in ash known to contain elevated levels of naturally occurring metals and dioxins.
- Most BMPs completely destroyed.

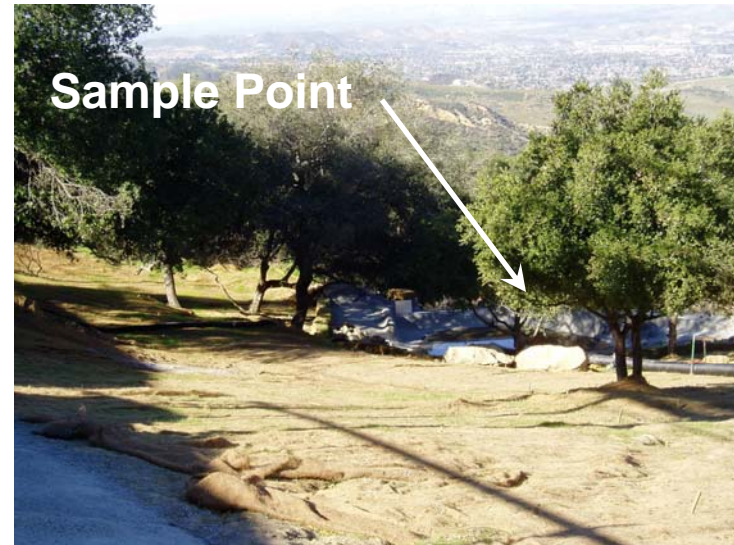
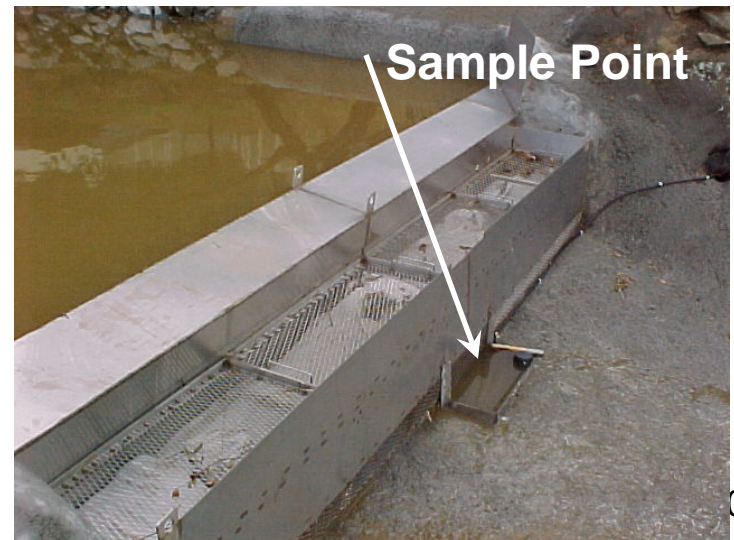
Outfall 010 (B/203) Before 2005 Fire

- Extensive Interim measure to remove mercury impacted soil.
- Gunite retaining wall and water retention basin.
- Coco mat reseeding.
- Straw bales around retention basin.
- Vermiculite filter bags in S.S. box.

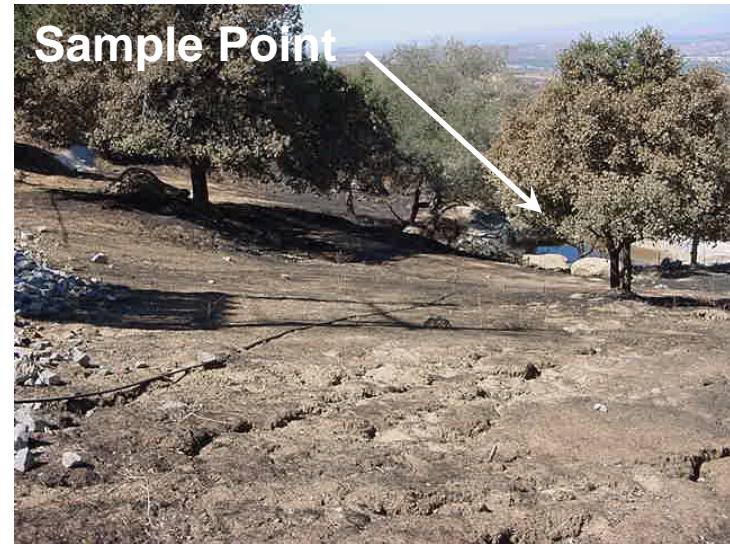
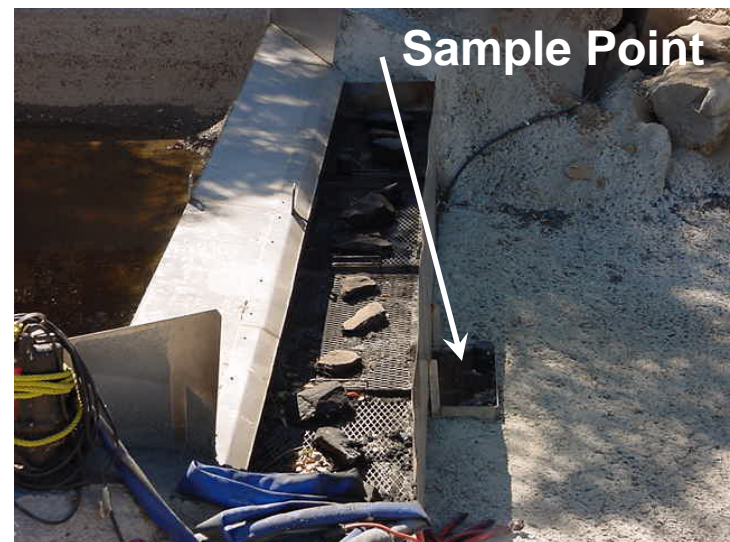
Outfall 010 (B203) After 2005 Fire

- All vegetation around drainage heavily damaged.
- Hillsides along drainage covered in ash known to contain elevated levels of naturally occurring metals and dioxins.
- All BMPs damaged.

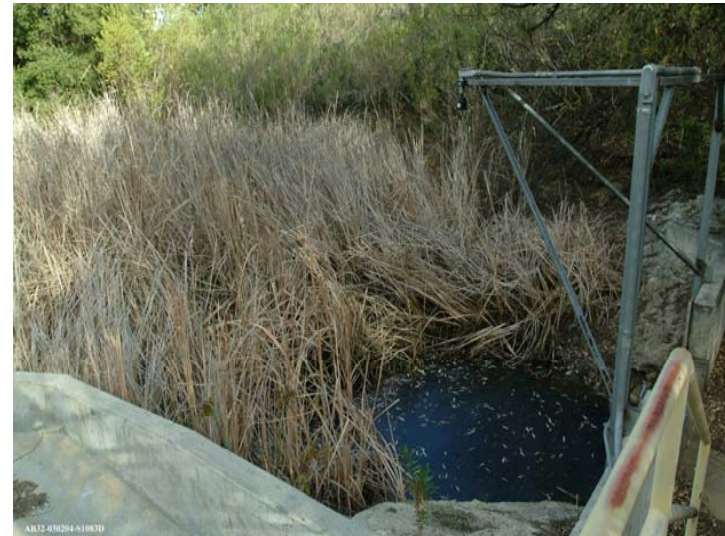
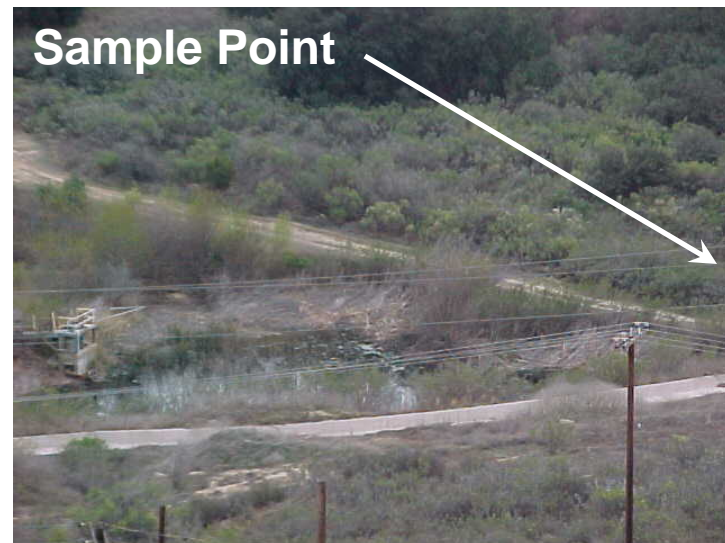
Outfall 011 (Perimeter) Before 2005 Fire

- Dense natural vegetation along entire length of drainage and hillsides.
- Settling pond to aid sediment retention.

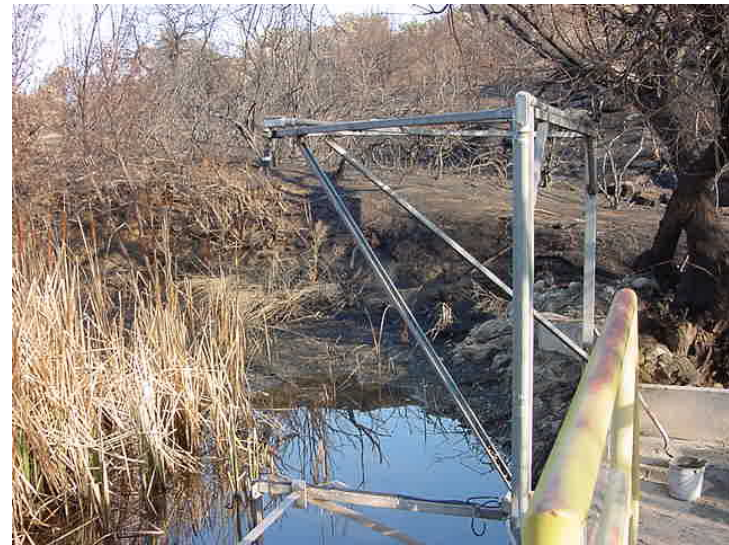
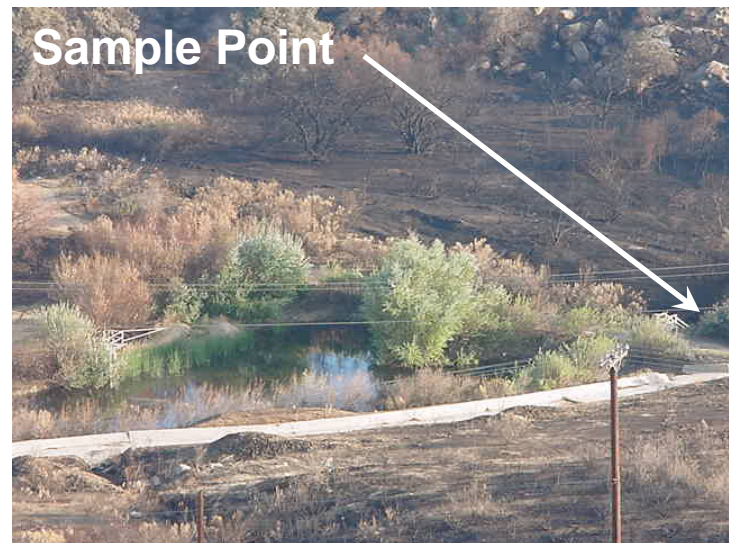
Outfall 011 After 2005 Fire

- All vegetation around drainage heavily damaged.
- Hillsides along drainage covered in ash known to contain elevated levels of naturally occurring metals and dioxins.

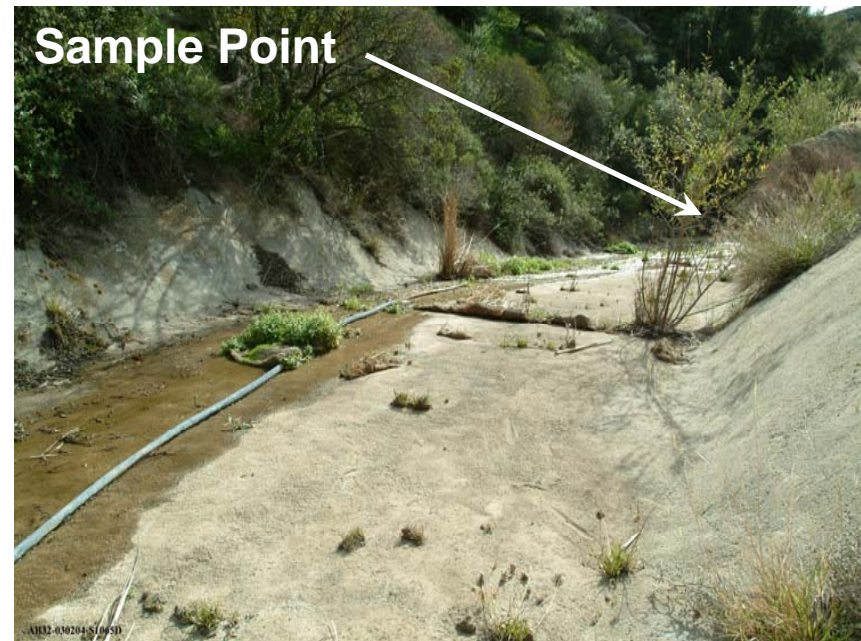
Outfall 018 Before 2005 Fire

- Dense natural vegetation along entire length of drainage and hillsides.
- Settling pond to aid in sedimentation retention.
- Pilot sand/carbon dual media filter system being tested.

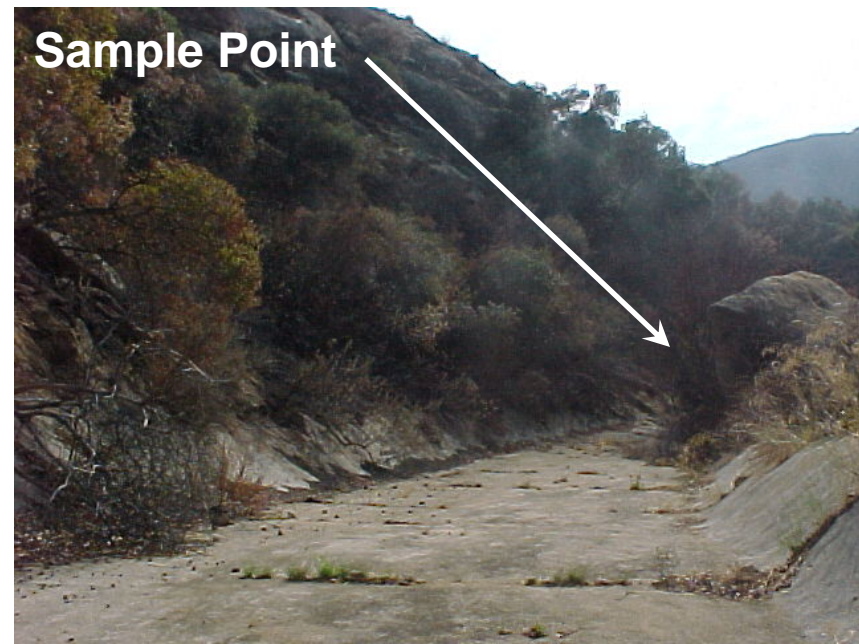
Outfall 018 After 2005 Fire

- Vegetation around drainage heavily damaged.
- Hillsides along drainage covered in ash known to contain elevated levels of naturally occurring metals and dioxins.
