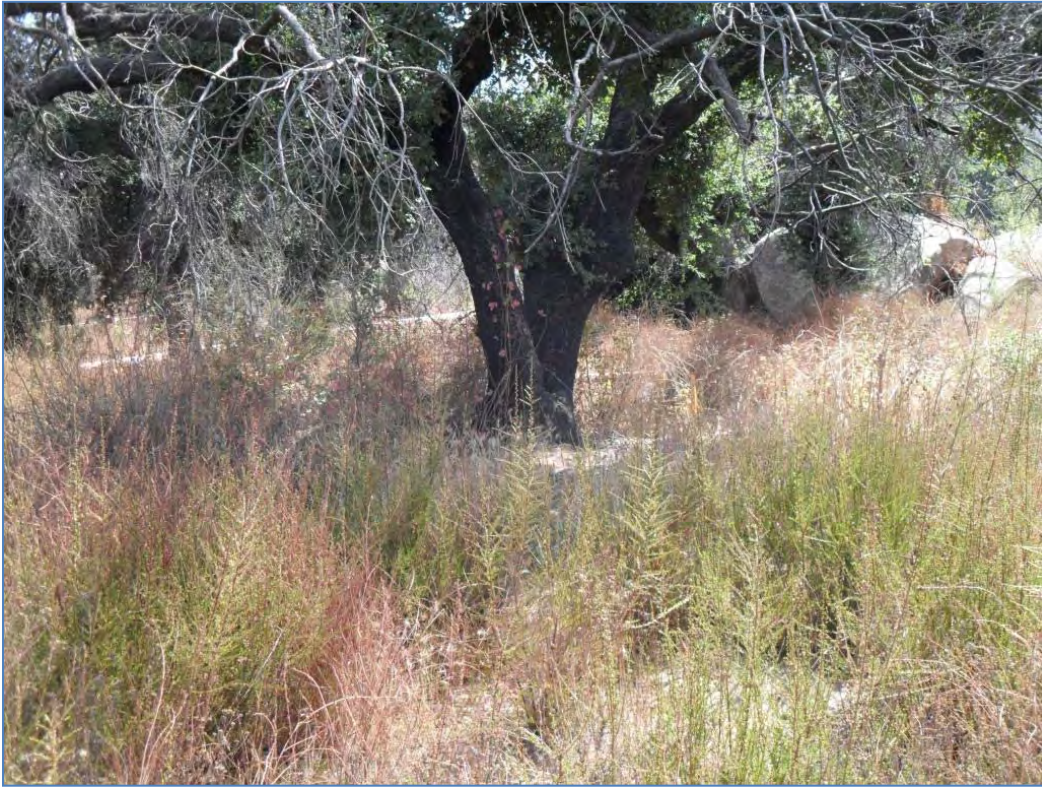
ISRA area AP/STP-1A prior to vegetation clearance (9/29/2010, looking south).

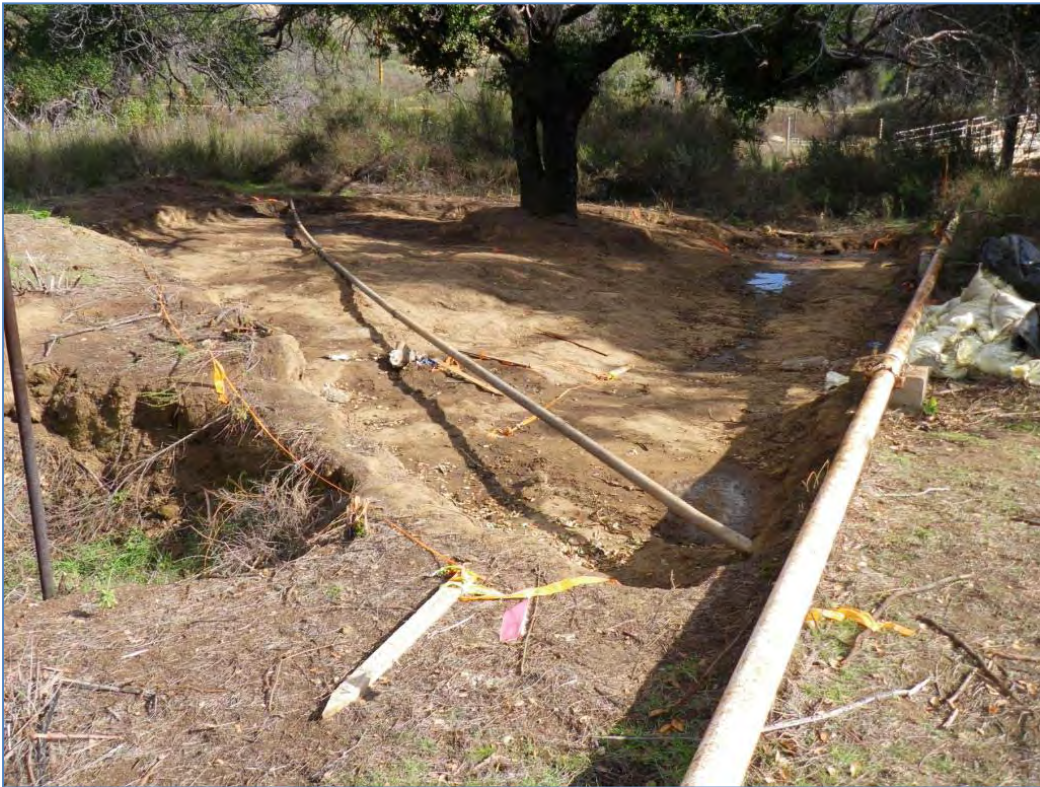
ISRA area AP/STP-1A after excavation (11/23/2010, looking east). The smaller-diameter pipeline through the excavation was subsequently removed (see Appendix H for details).

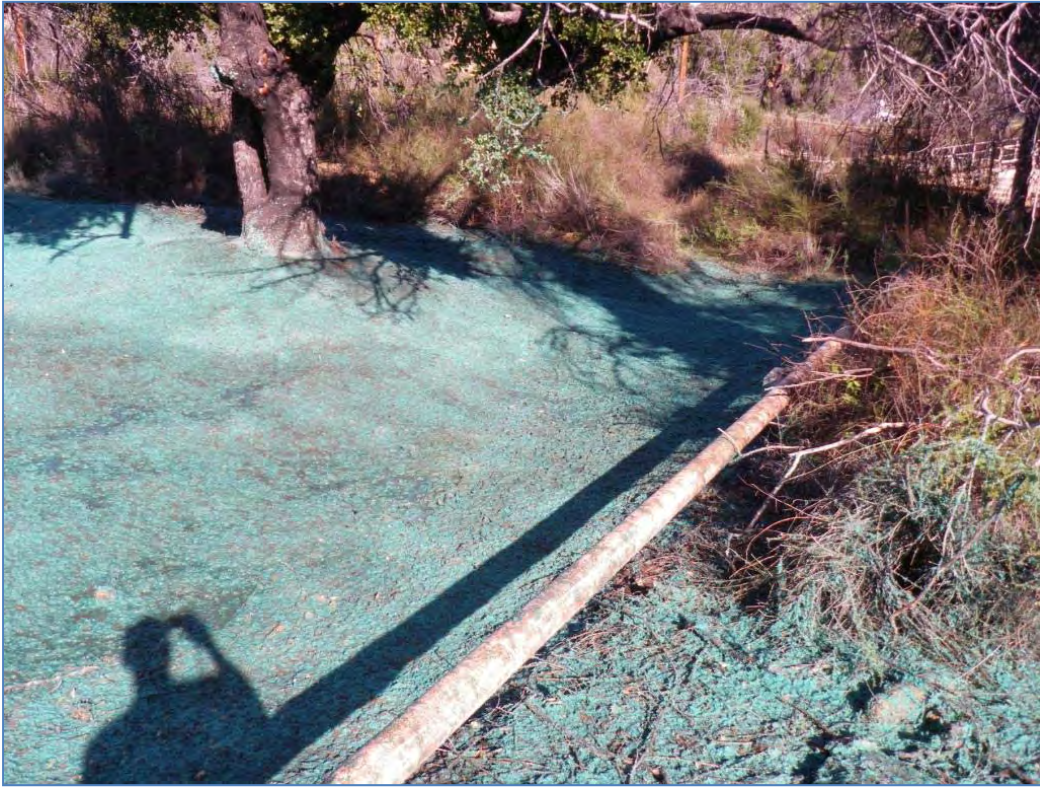
ISRA area AP/STP-1A after restoration (12/3/2010, looking northeast). Blue-green hydroseed mulch is visible.

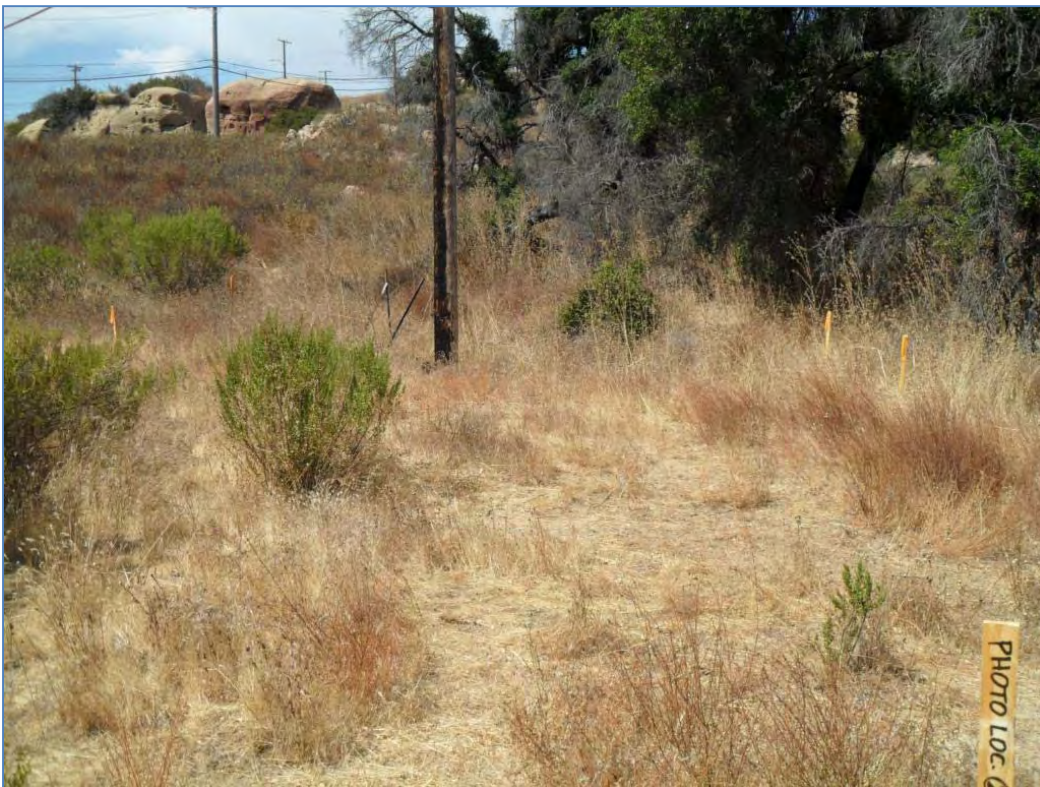
ISRA area AP/STP-1D prior to vegetation clearance (9/29/2010, looking west).

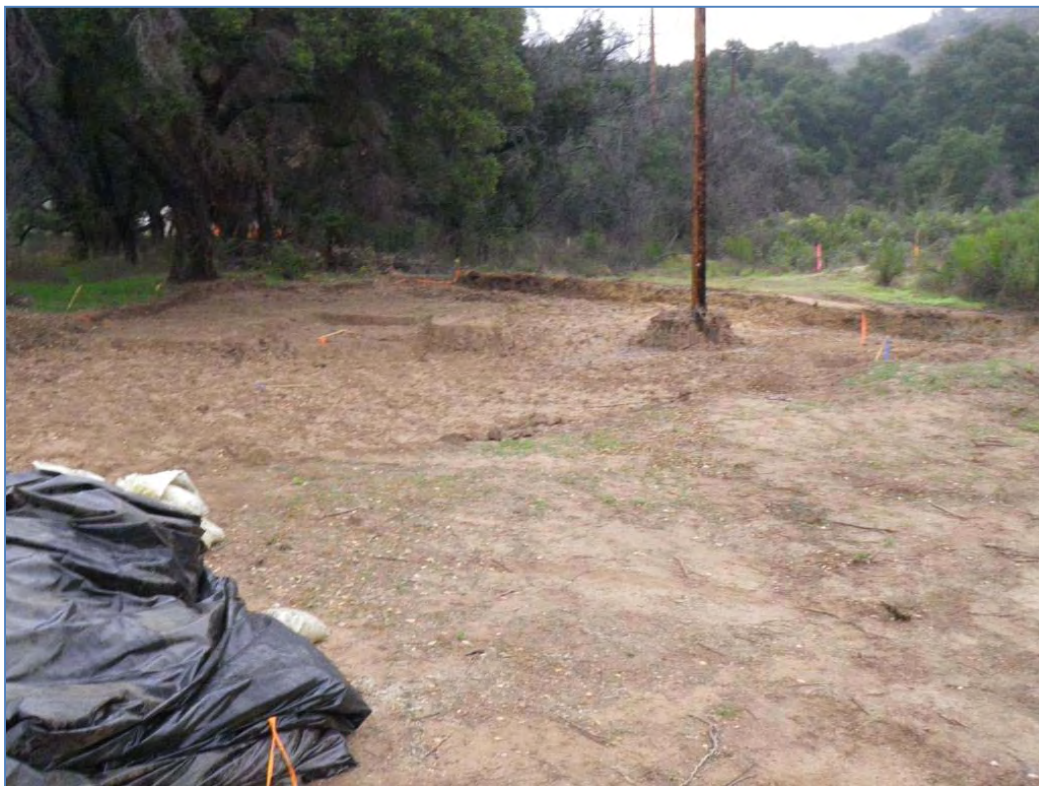
ISRA area AP/STP-1D after excavation (11/19/2010, looking east).

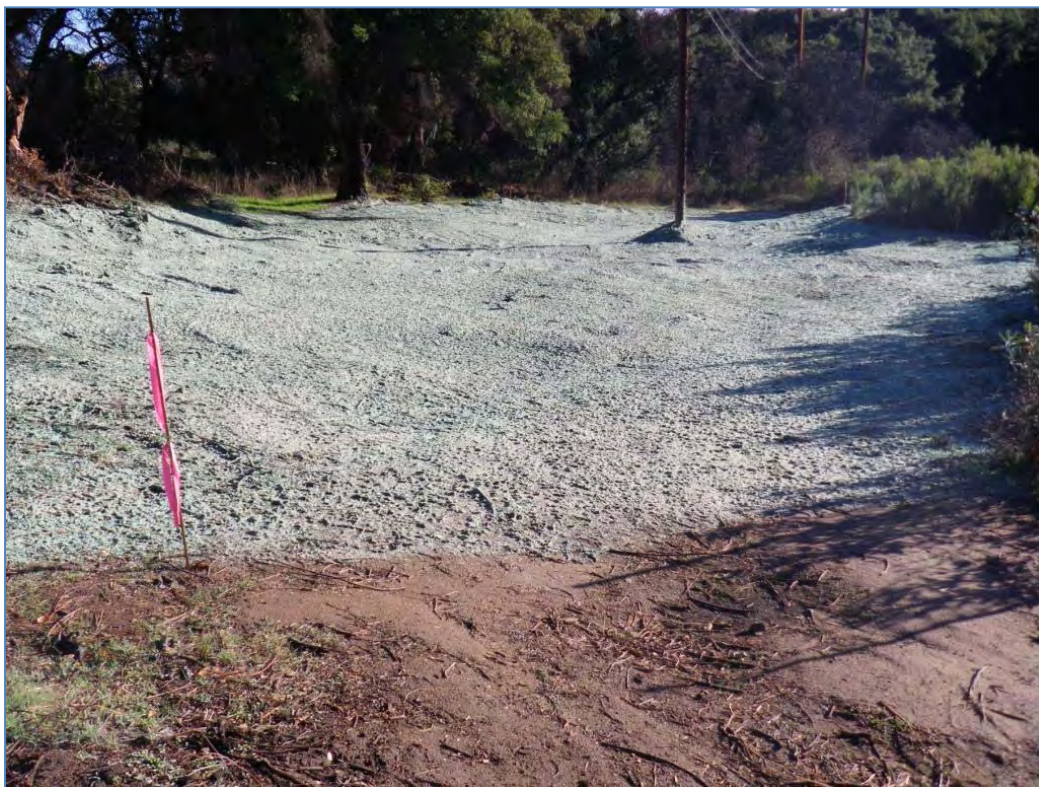
ISRA area AP/STP-1D after restoration (12/6/2010, looking east). Blue-green hydroseed mulch is visible.

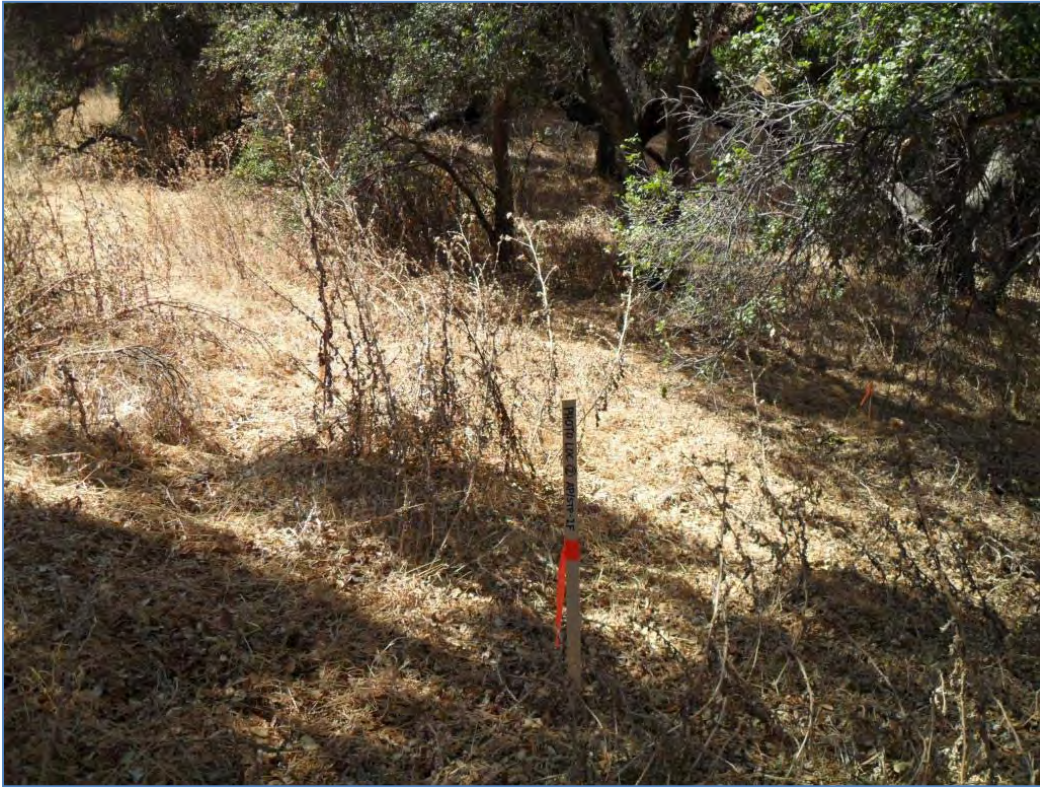
ISRA area AP/STP-1F prior to vegetation clearance (9/29/2010, looking southwest).

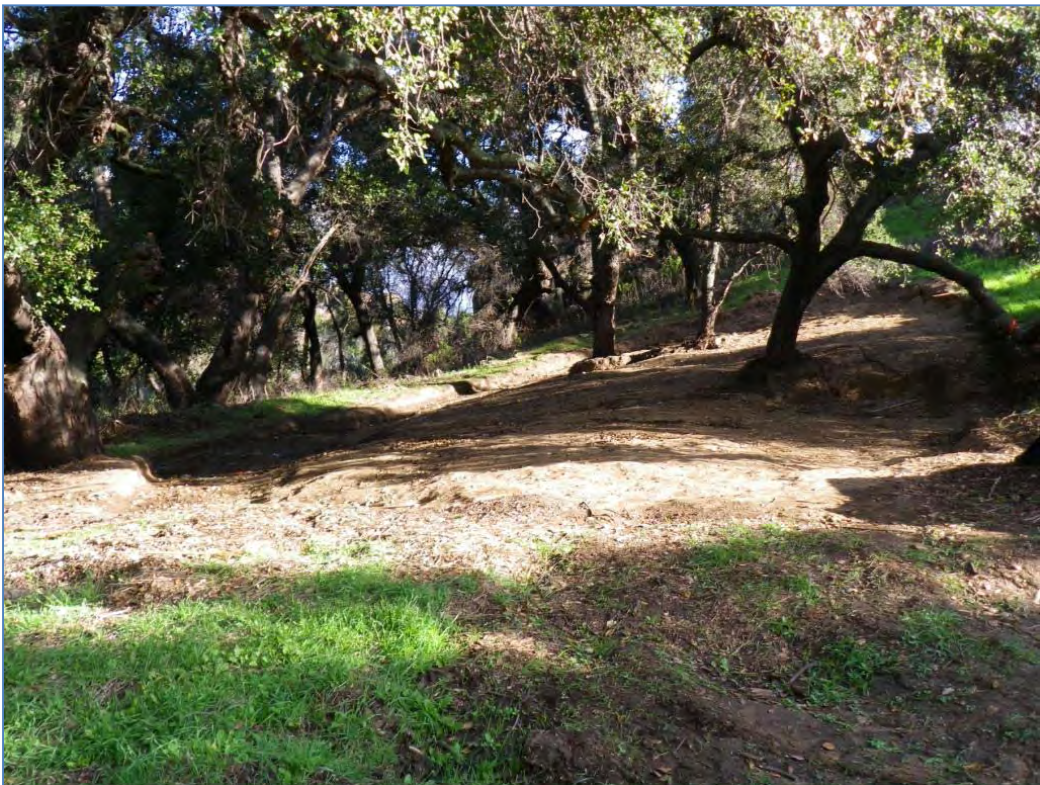
ISRA area AP/STP-1F after excavation (11/23/2010, looking northeast).

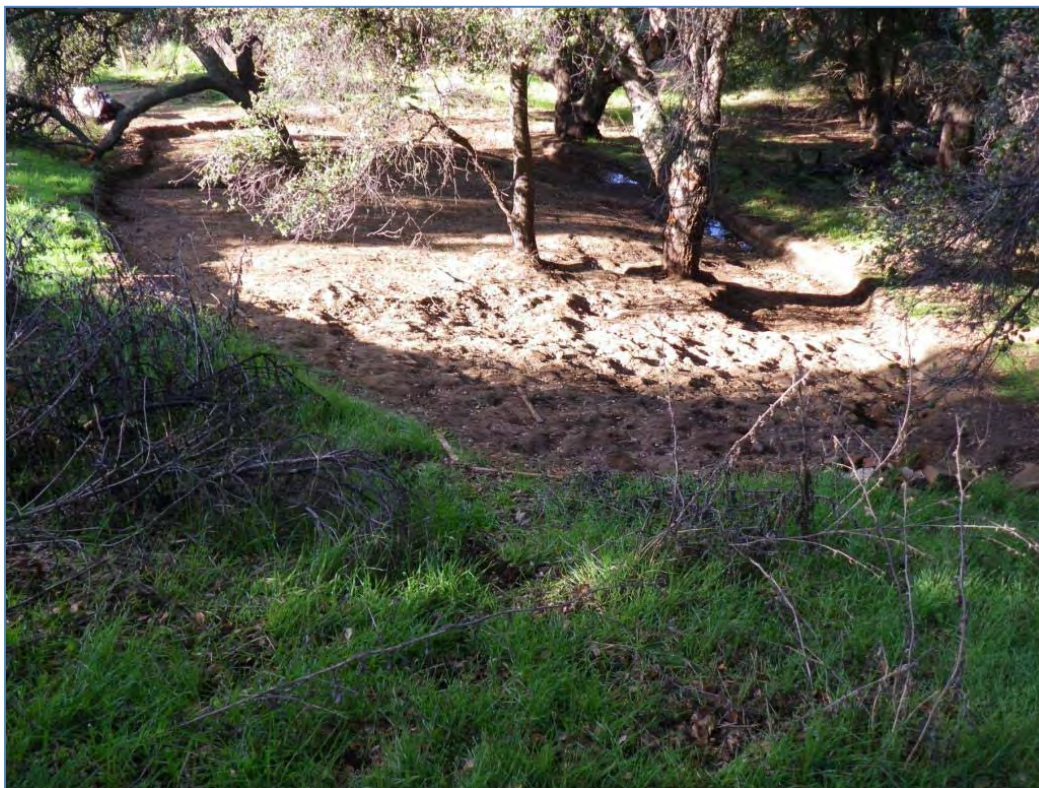
ISRA area AP/STP-1F after excavation (11/23/2010, looking southwest).

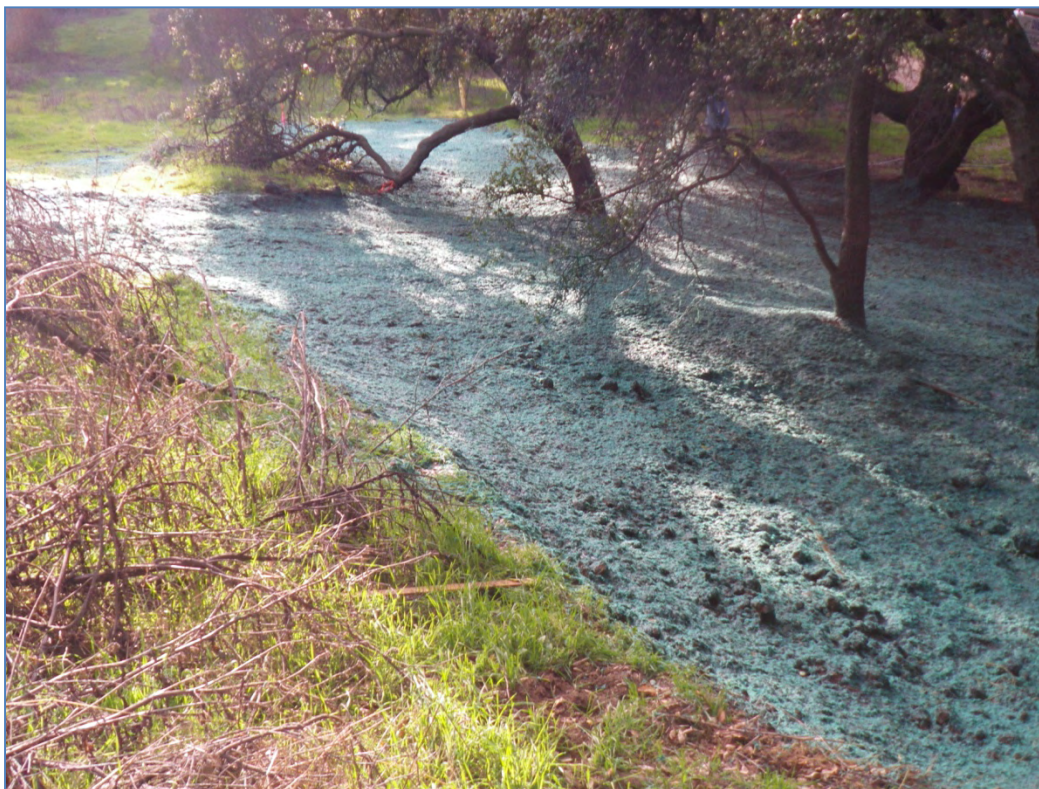
ISRA area AP/STP-1F after restoration (12/2/2010, looking southwest). Blue-green hydroseed mulch is visible.

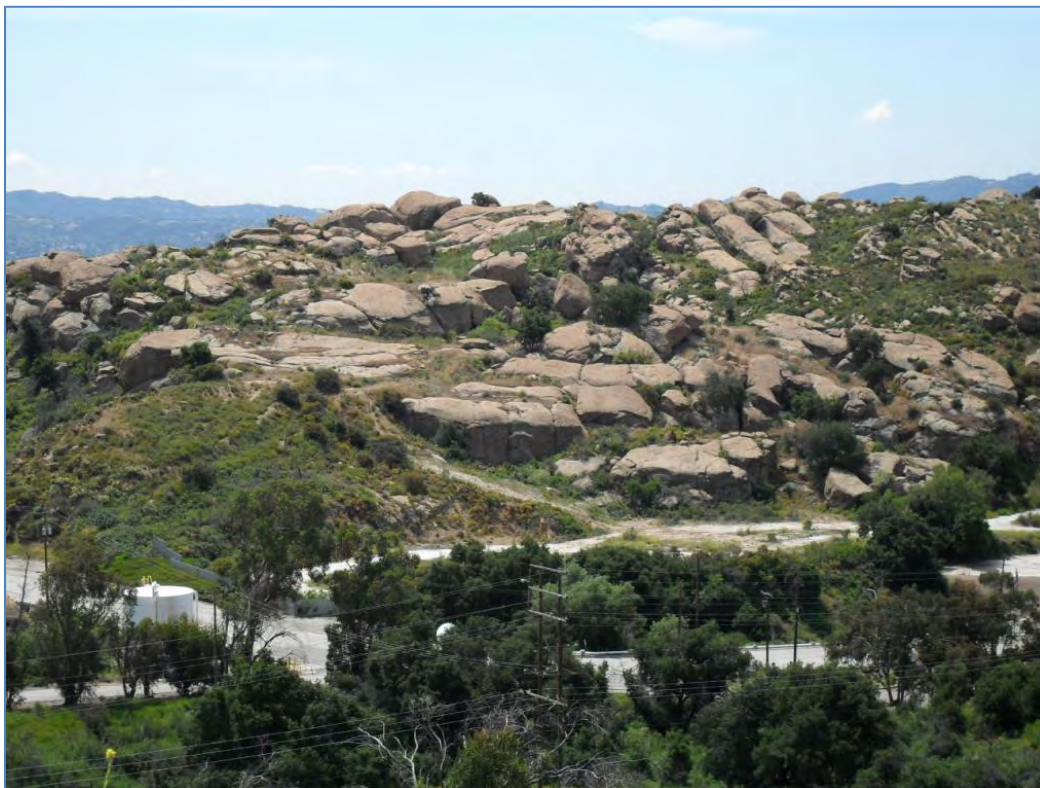
ISRA areas B1-1 and B1-2 prior to vegetation clearance (7/7/2010, looking south).

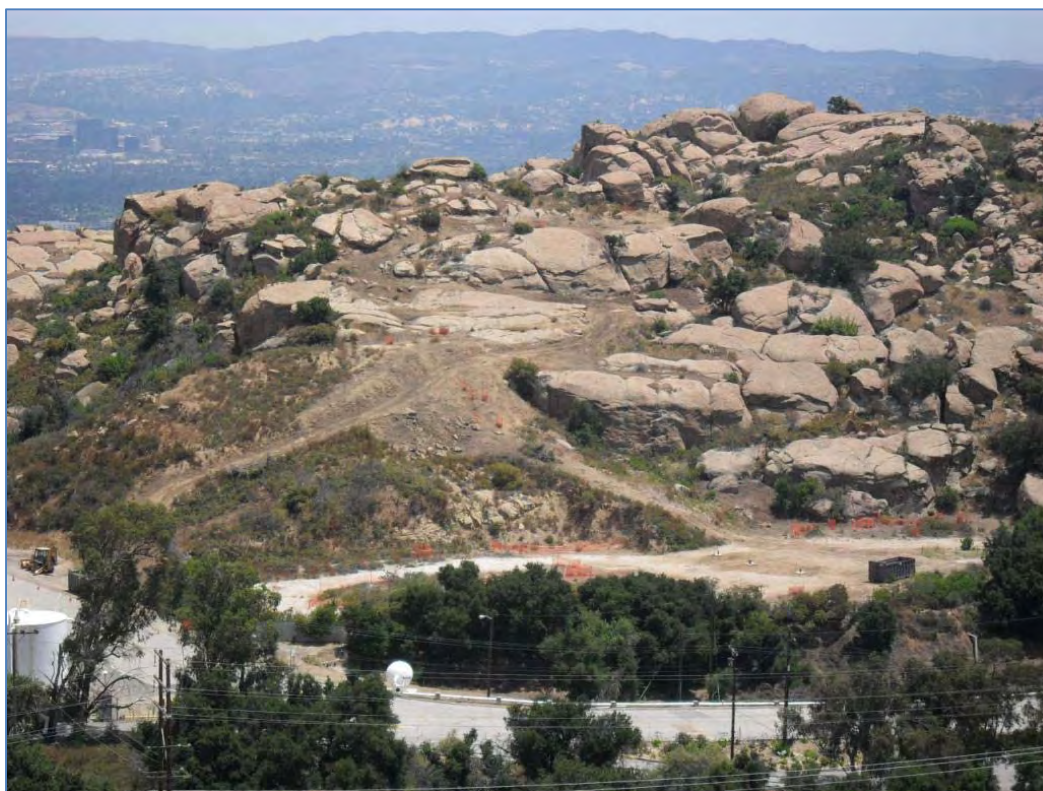
ISRA areas B1-1 and B1-2 after vegetation clearance, prior to excavation (7/16/2010, looking south). Orange fencing around Santa Susana tar plants.

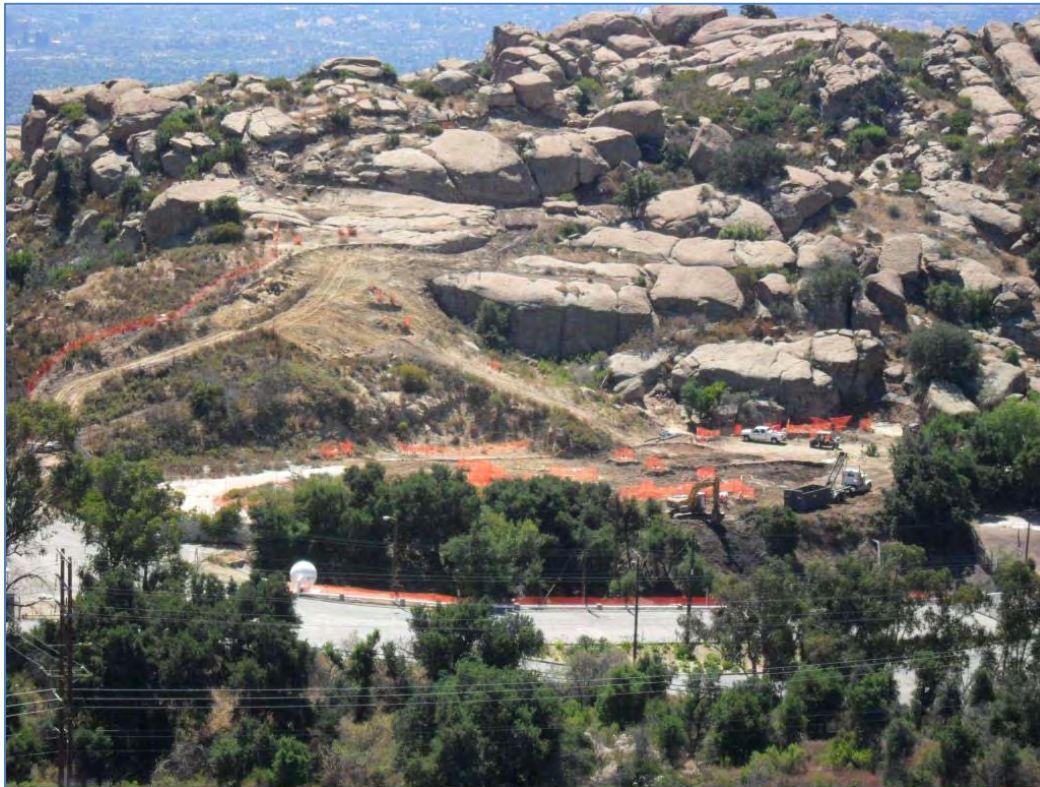
ISRA areas B1-1 and B1-2 after excavation at ISRA area B1-1, and during excavation at ISRA area B1-2 (8/23/2010, looking south).

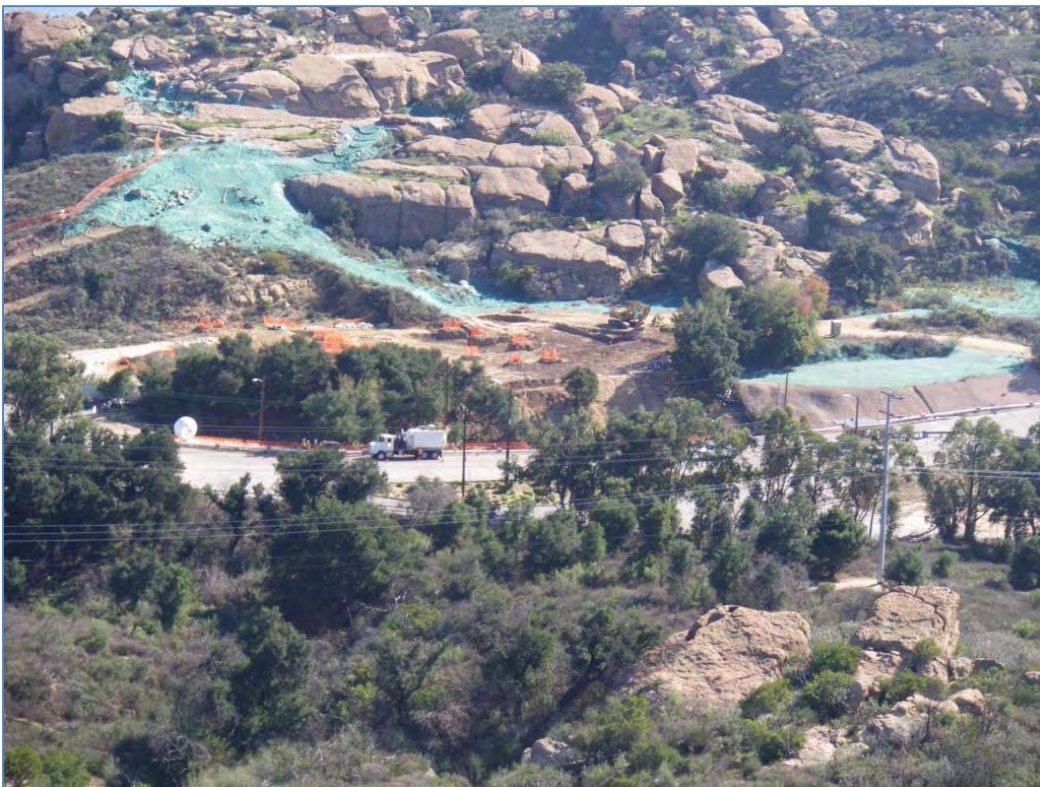
ISRA areas B1-1 and B1-2 after restoration at ISRA area B1-1, and during excavation at ISRA area B1-2 (11/16/2010, looking south). Blue-green hydroseed mulch is visible.

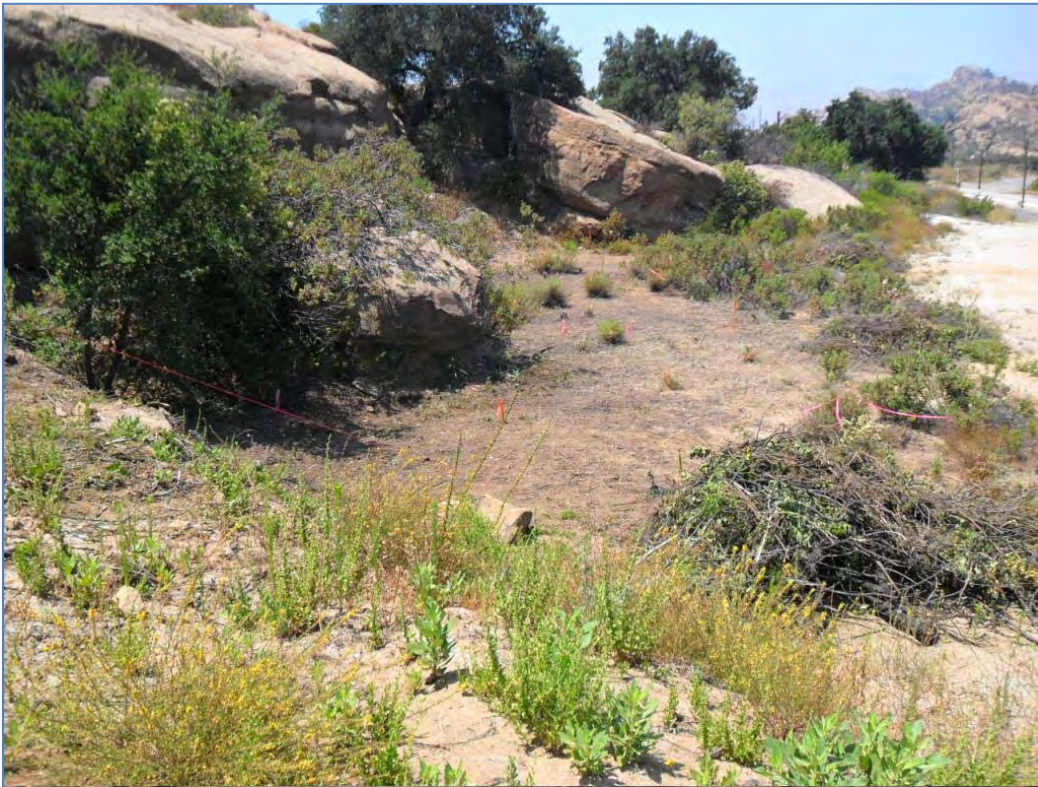
ISRA area B1-1A prior to vegetation clearance (7/7/2010, looking southwest). Orange flagging tape identifies Santa Susana tar plants.

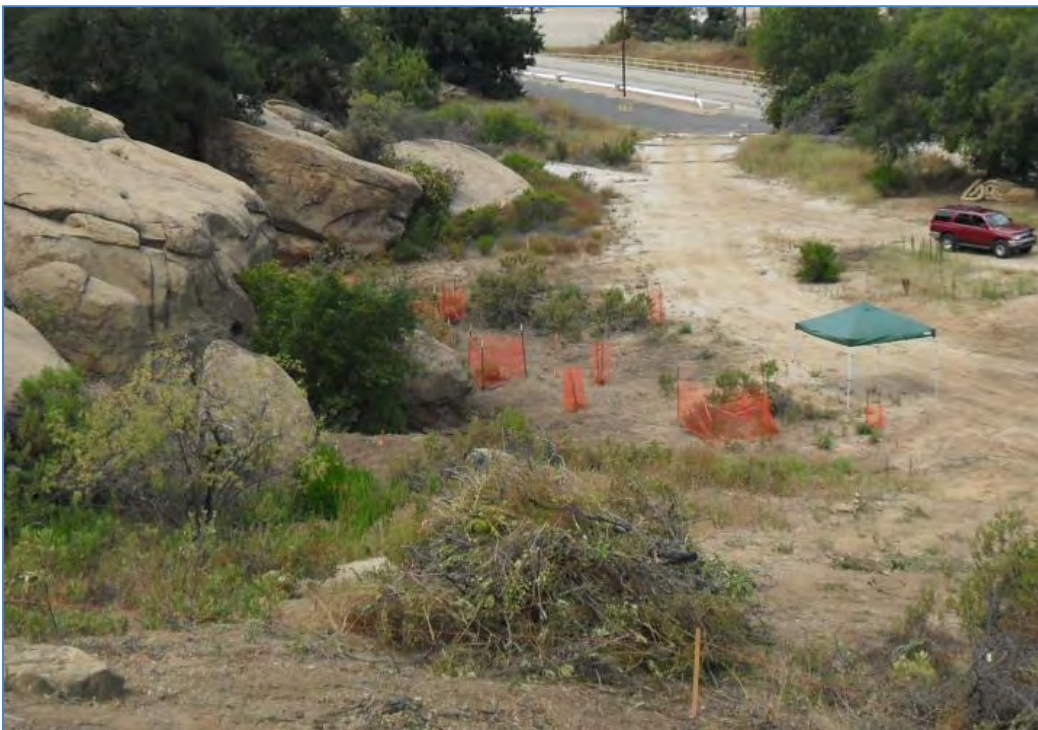
ISRA area B1-1A after vegetation clearance, prior to excavation (7/16/2010, looking southwest). Orange fencing around Santa Susana tar plants.

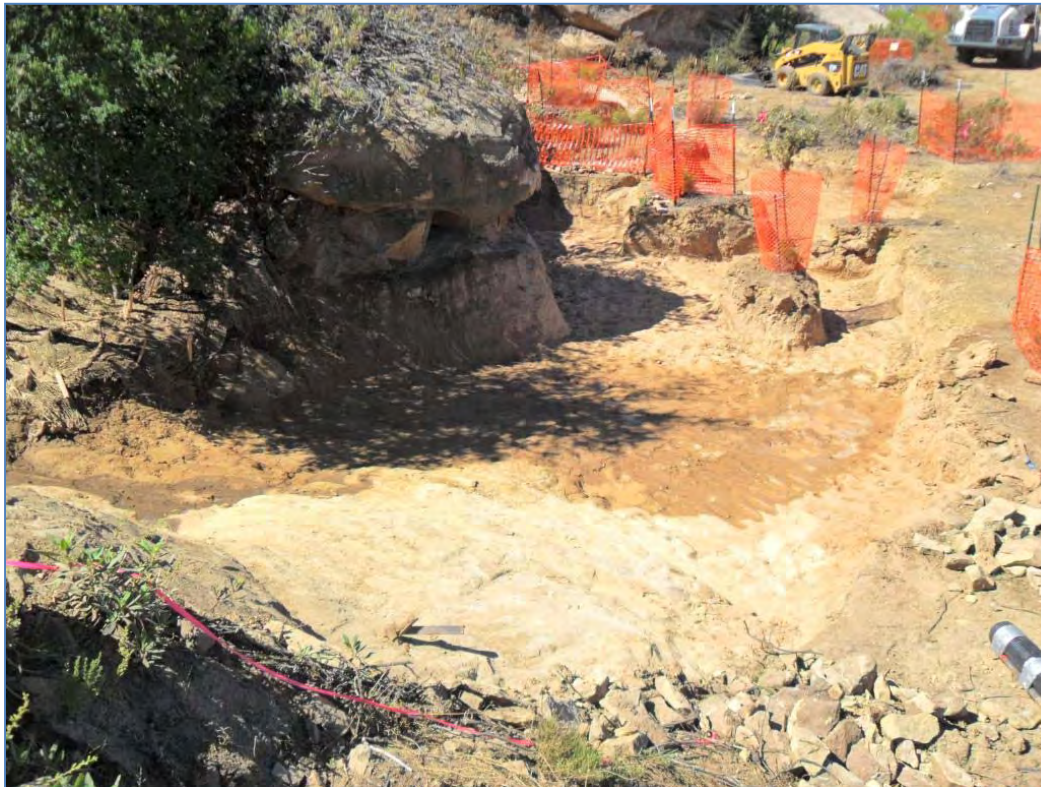
ISRA area B1-1A after excavation (8/23/2010, looking southwest). Bedrock exposed in excavation floor is visible in the foreground. Orange fencing around Santa Susana tar plants.

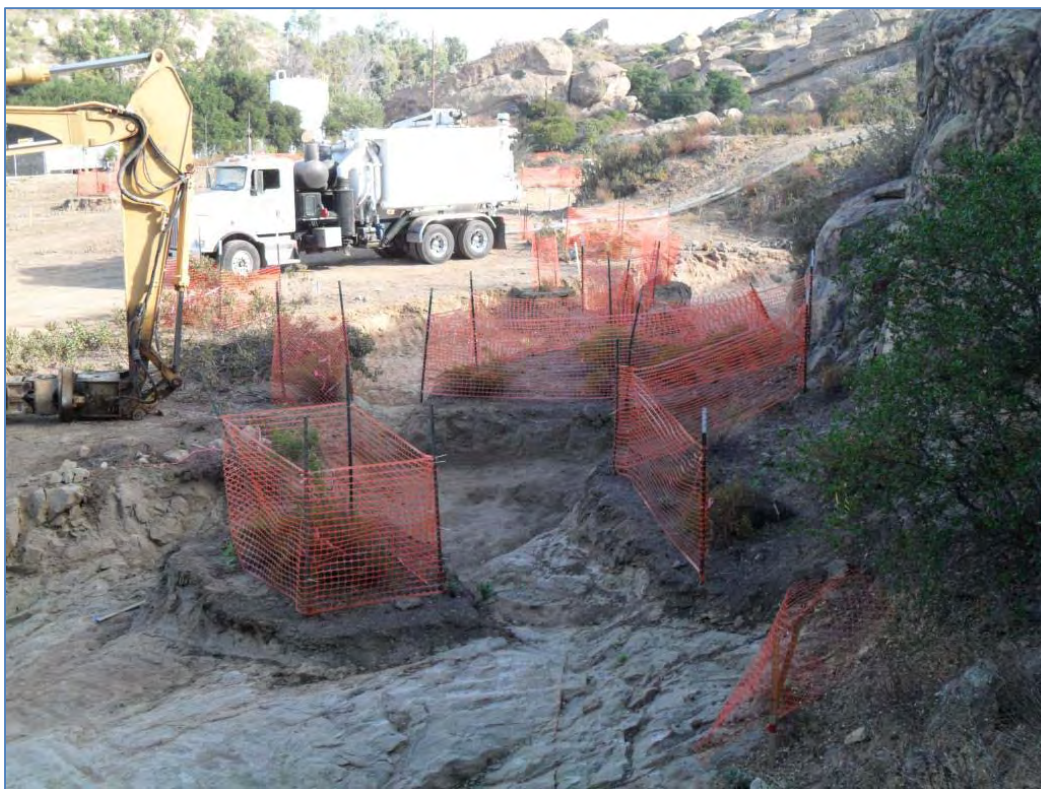
ISRA area B1-1A after excavation (10/1/2010, looking northeast). Bedrock exposed in excavation floor is visible in the foreground. Orange fencing around Santa Susana tar plants.

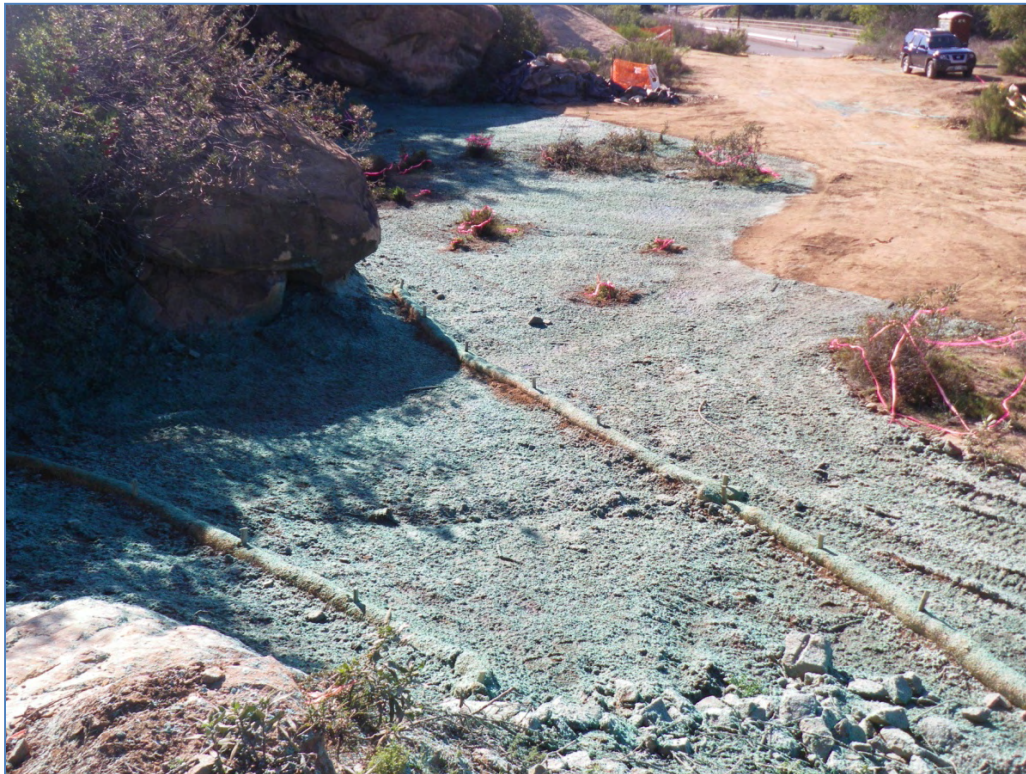
ISRA area B1-1A after restoration (11/16/2010, looking southwest). Blue-green hydroseed mulch is visible. Orange flagging tape identifies Santa Susana tar plants.

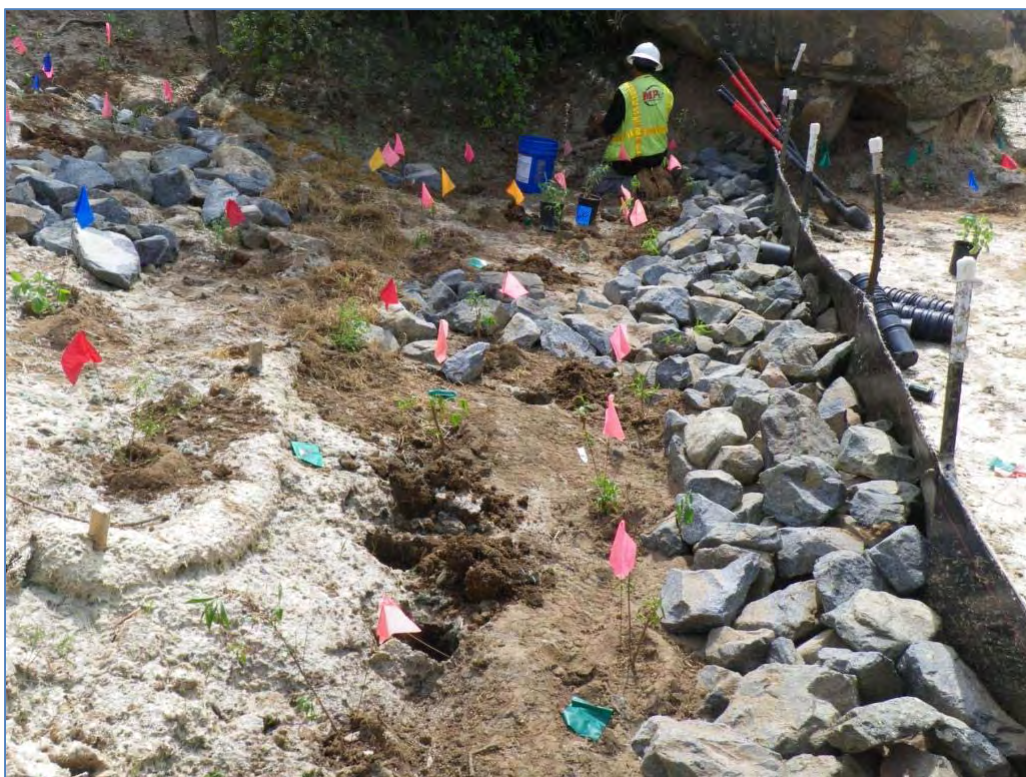
ISRA area B1-1A after restoration, during installation of containerized plants (3/17/2011, looking southwest). Pin flags mark the locations of installed plants.

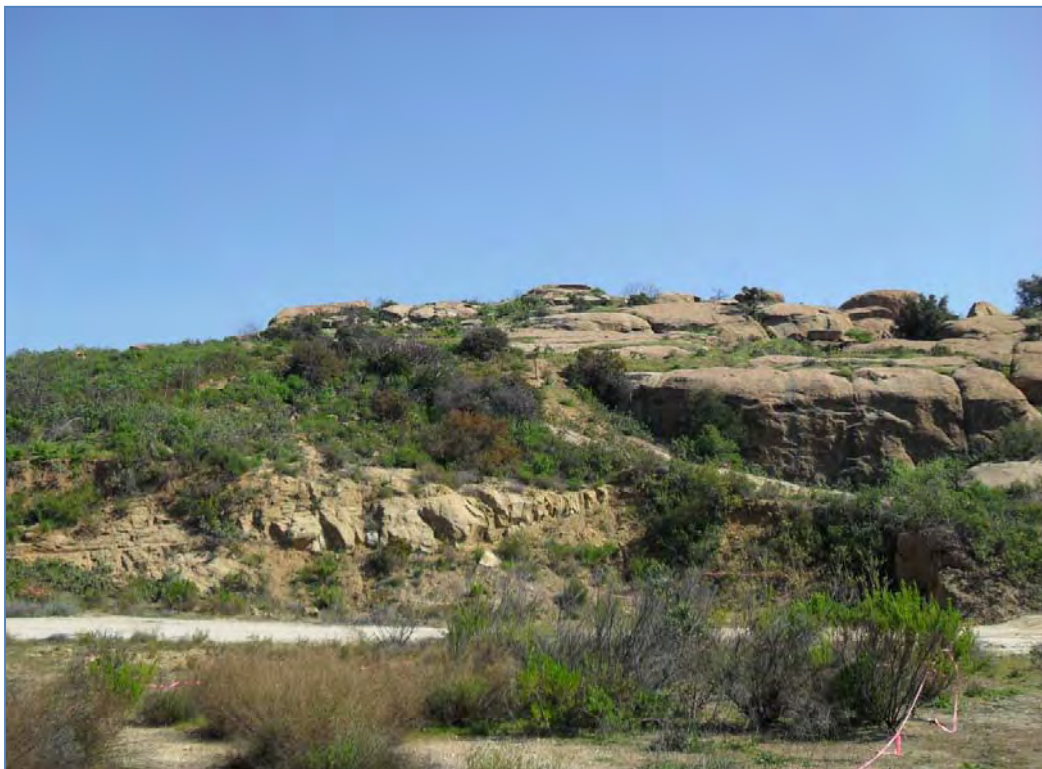
ISRA area B1-1B prior to vegetation clearance (3/19/2010, looking south).

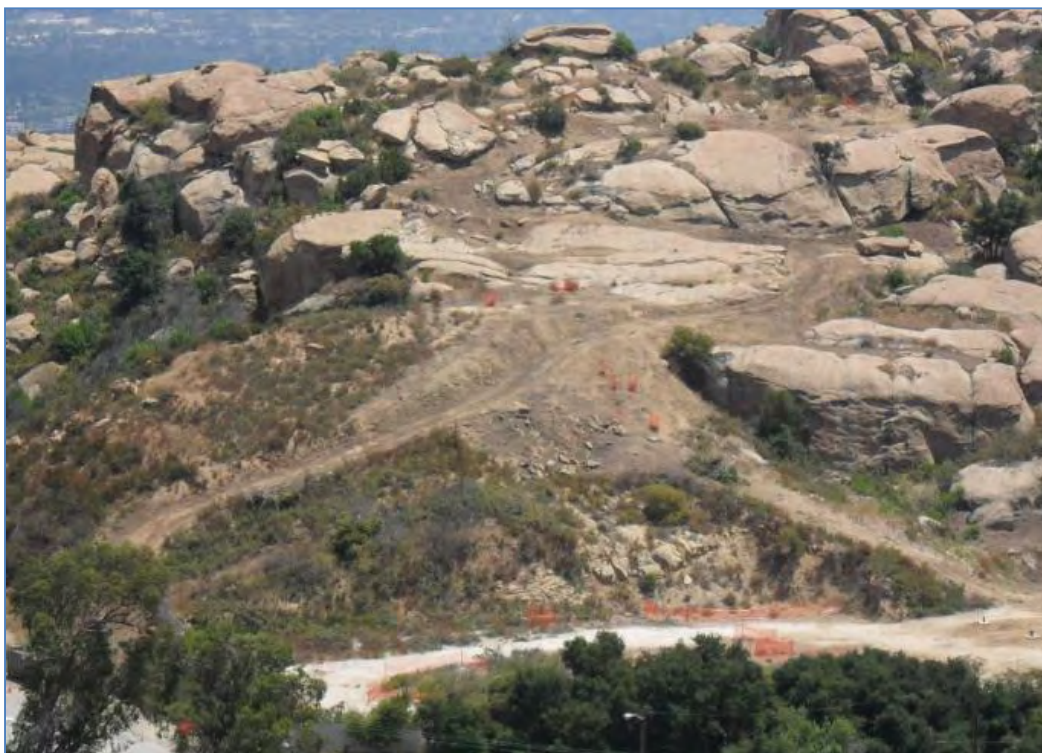
ISRA area B1-1B after vegetation clearance, prior to excavation (7/16/2010, looking south).
Orange fencing around Santa Susana tar plants.

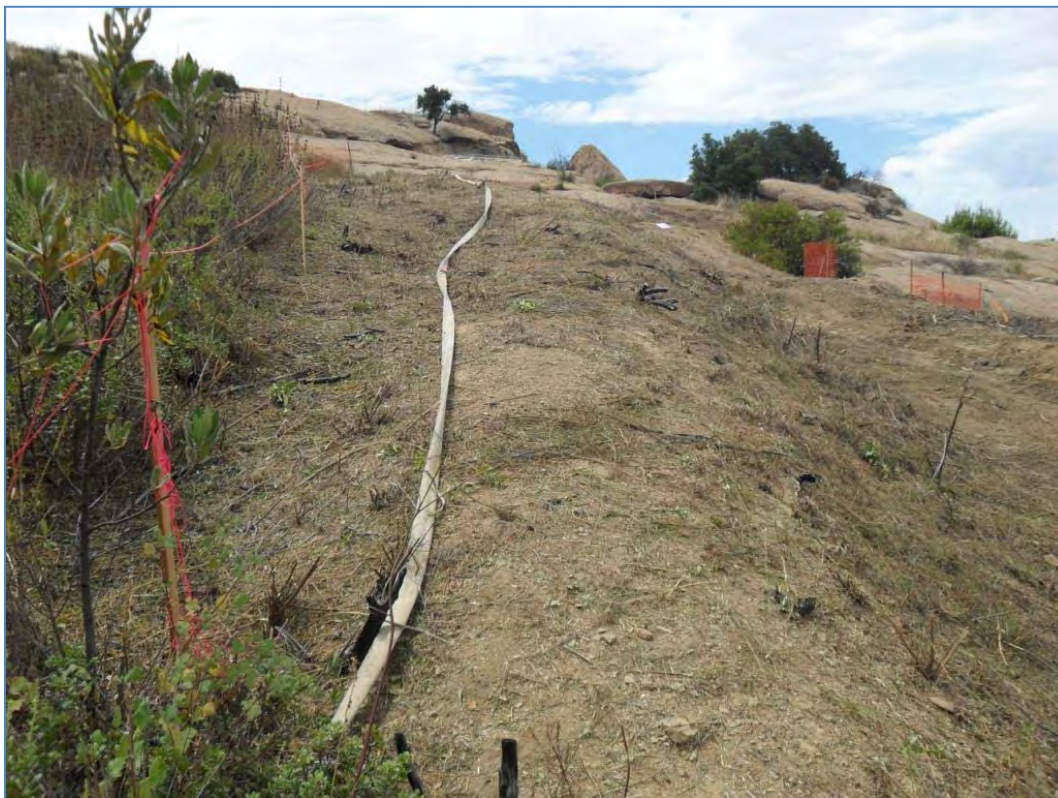
ISRA area B1-1B, after vegetation clearance, prior to excavation (7/16/2010, looking south). Orange fencing around Santa Susana tar plants.

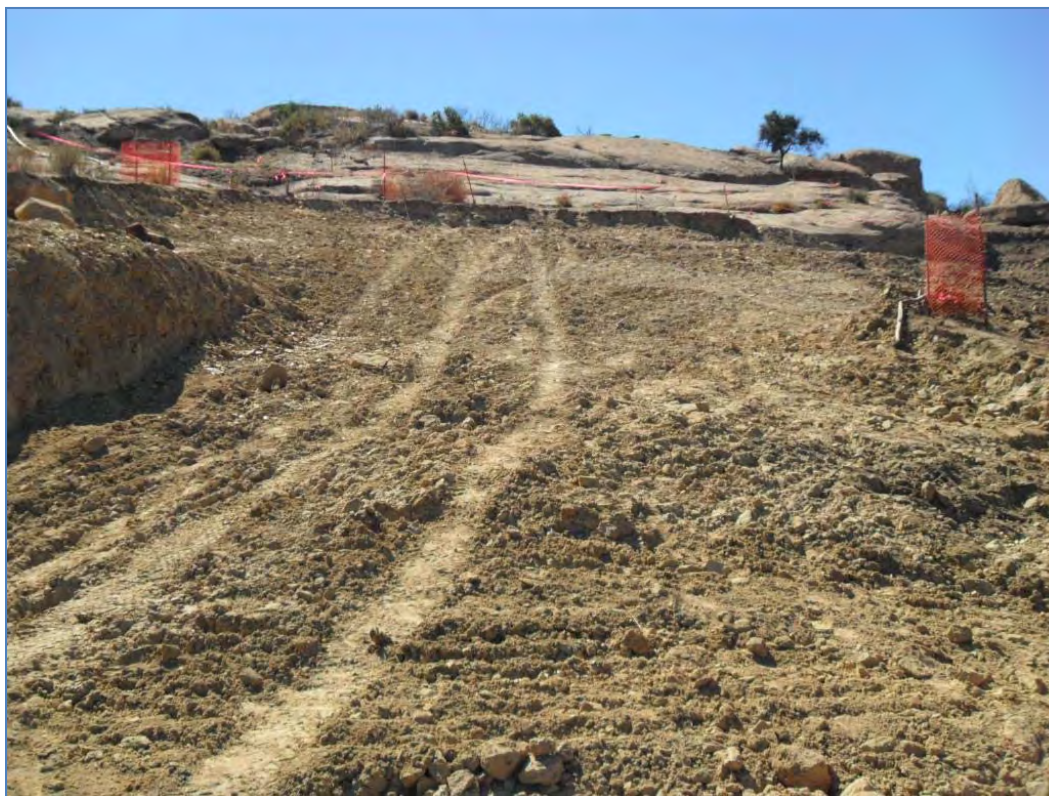
ISRA area B1-1B after excavation (8/23/2010, looking south). Orange fencing around Santa Susana tar plants.

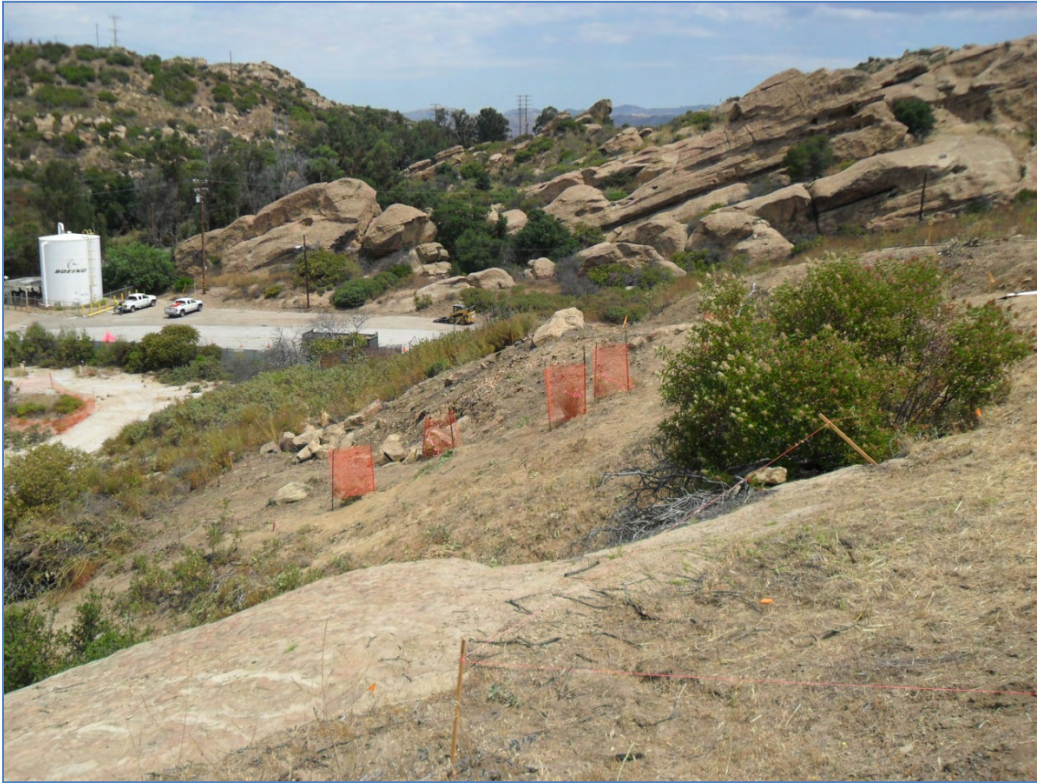
ISRA area B1-1B, after vegetation clearance, prior to excavation (7/16/2010, looking north). Orange fencing around Santa Susana tar plants.

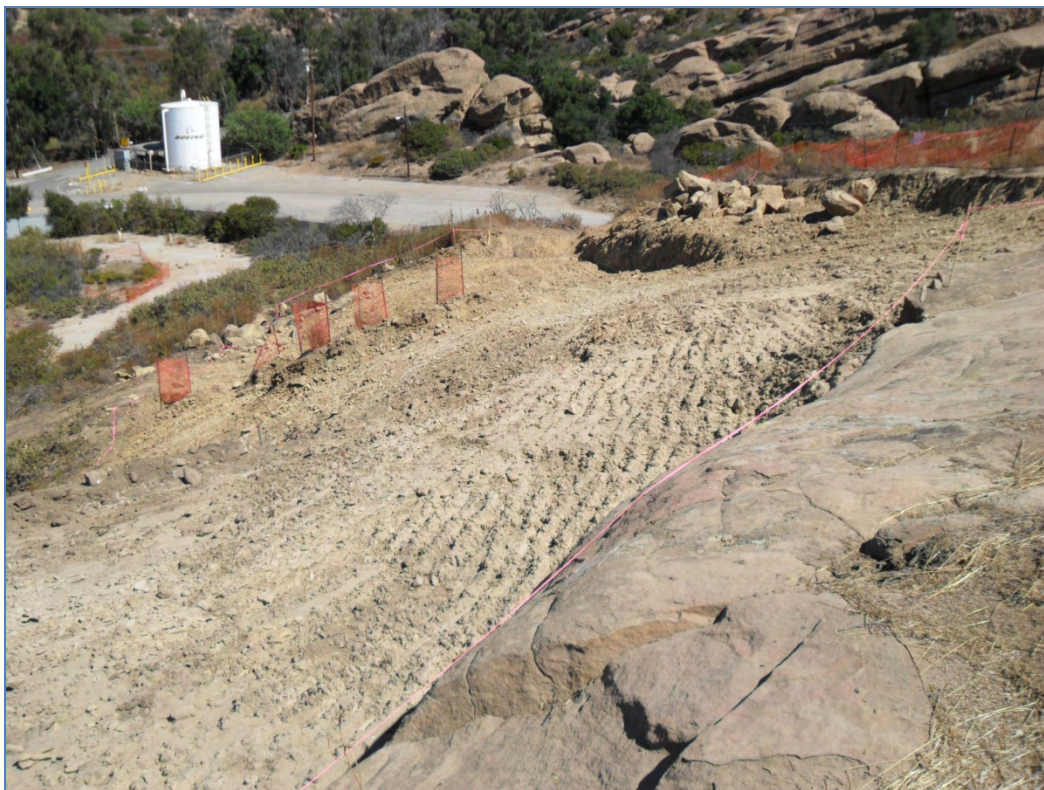
ISRA area B1-1B after excavation (8/23/2010, looking north). Orange fencing around Santa Susana tar plants.

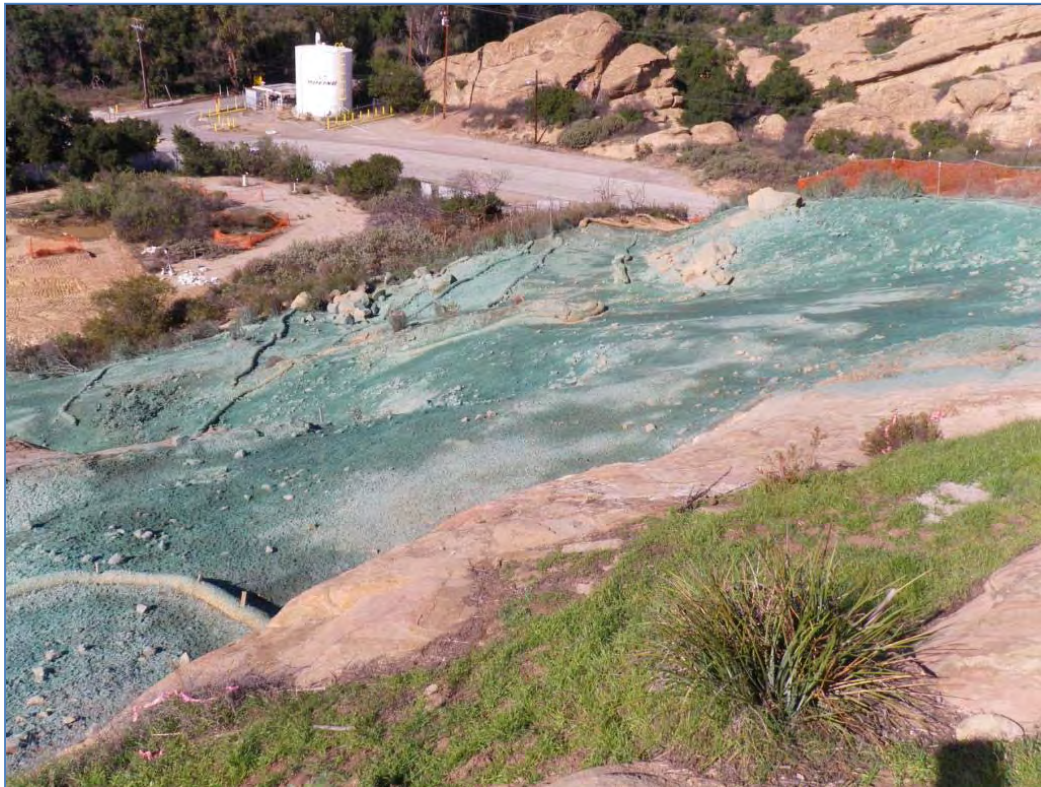
ISRA area B1-1B after restoration (11/16/2010, looking north). Blue-green hydroseed mulch is visible.
