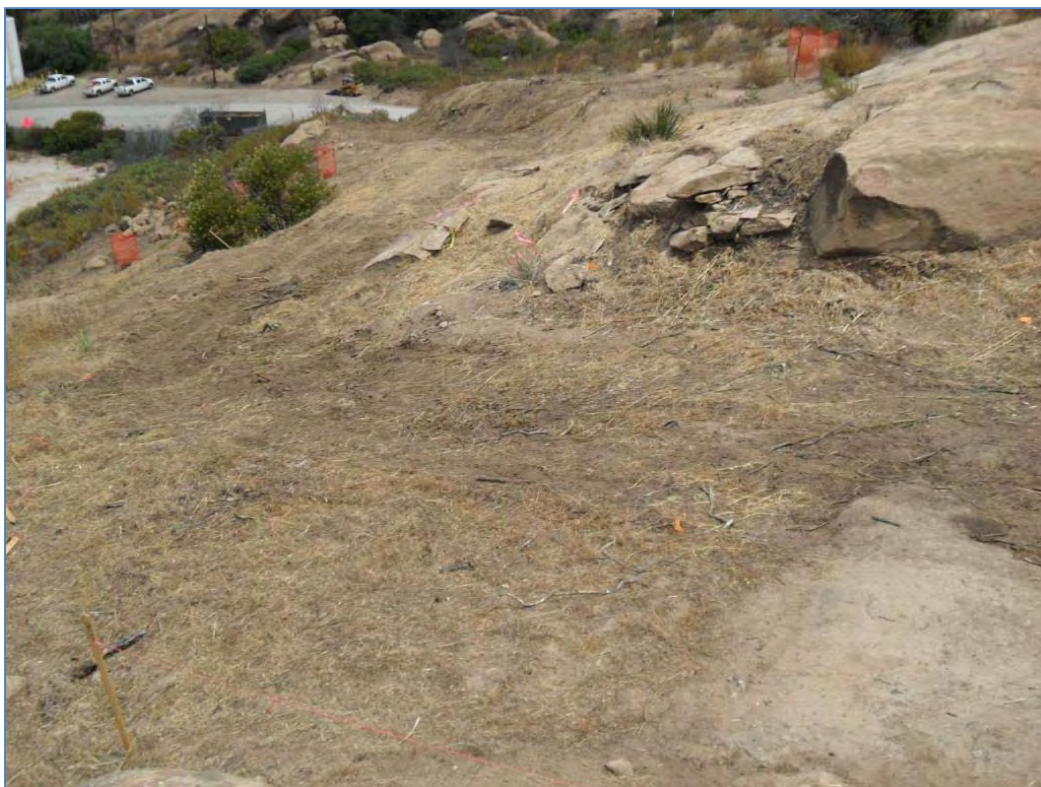
ISRA area B1-1C in foreground and ISRA Area B1-1B in background after vegetation clearance, prior to excavation (7/16/2010, looking north).

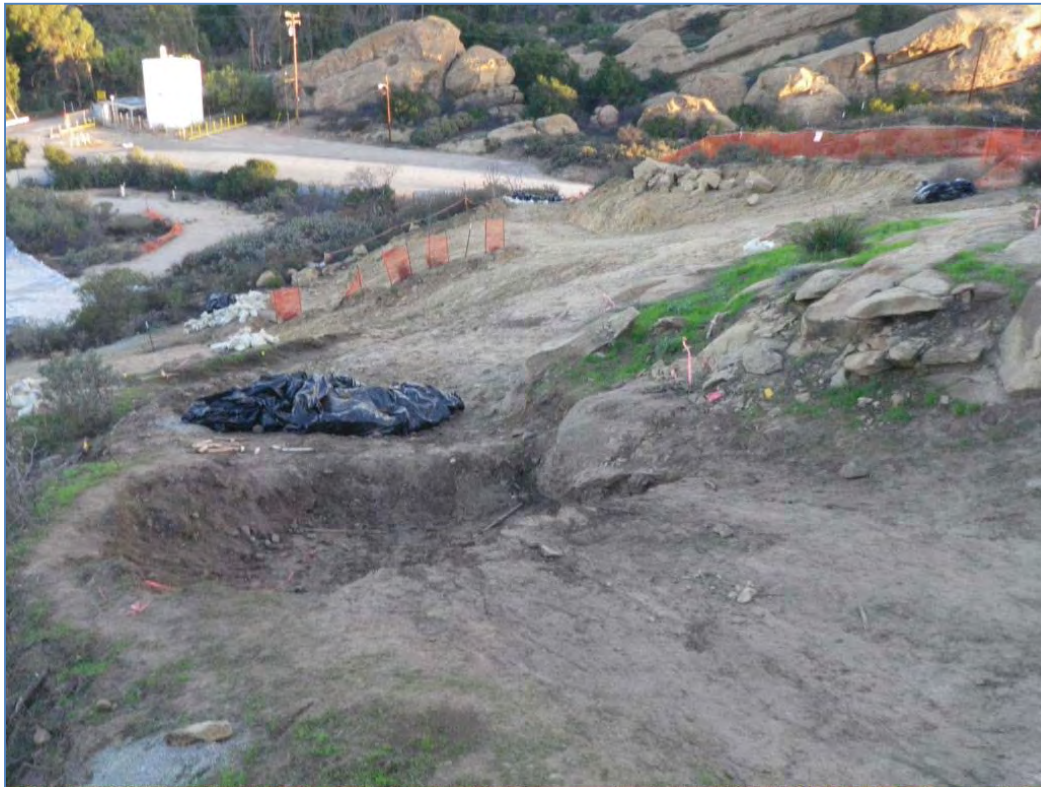
ISRA area B1-1C in foreground and ISRA area B1-1B in background after excavation (10/29/2010, looking north).

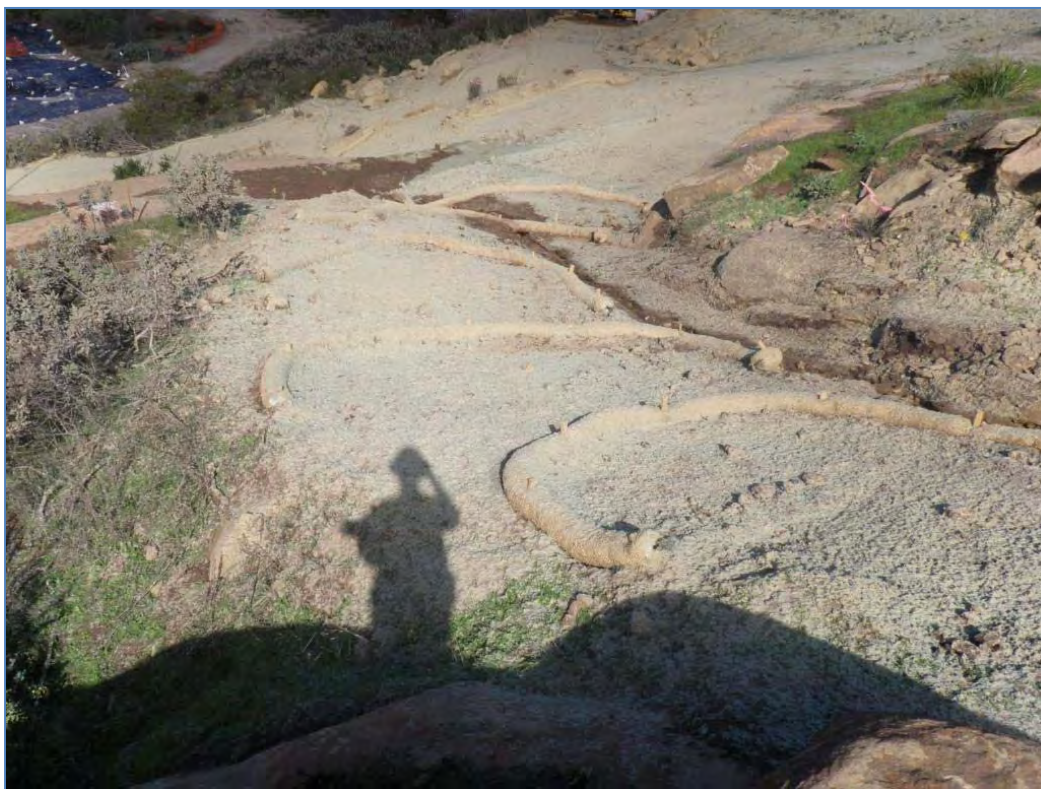
ISRA area B1-1C in foreground and B1-1B in background after restoration (11/23/2010, looking north). Faded blue-green hydroseed mulch is visible.
