APPENDIX A
RAIN EVENT AND SAMPLING CHARTS
2012/2013 RAINY SEASON

**LABORATORY AND DATA VALIDATION REPORTS
PERFORMANCE MONITORING AND BMP MONITORING SAMPLES
2012/2013 RAINY SEASON**

APPENDIX C
PERFORMANCE MONITORING CHARTS
2012/2013 RAINY SEASON

**PERFORMANCE MONITORING DATA GRAPHS VS. TIME –
BY OUTFALL**

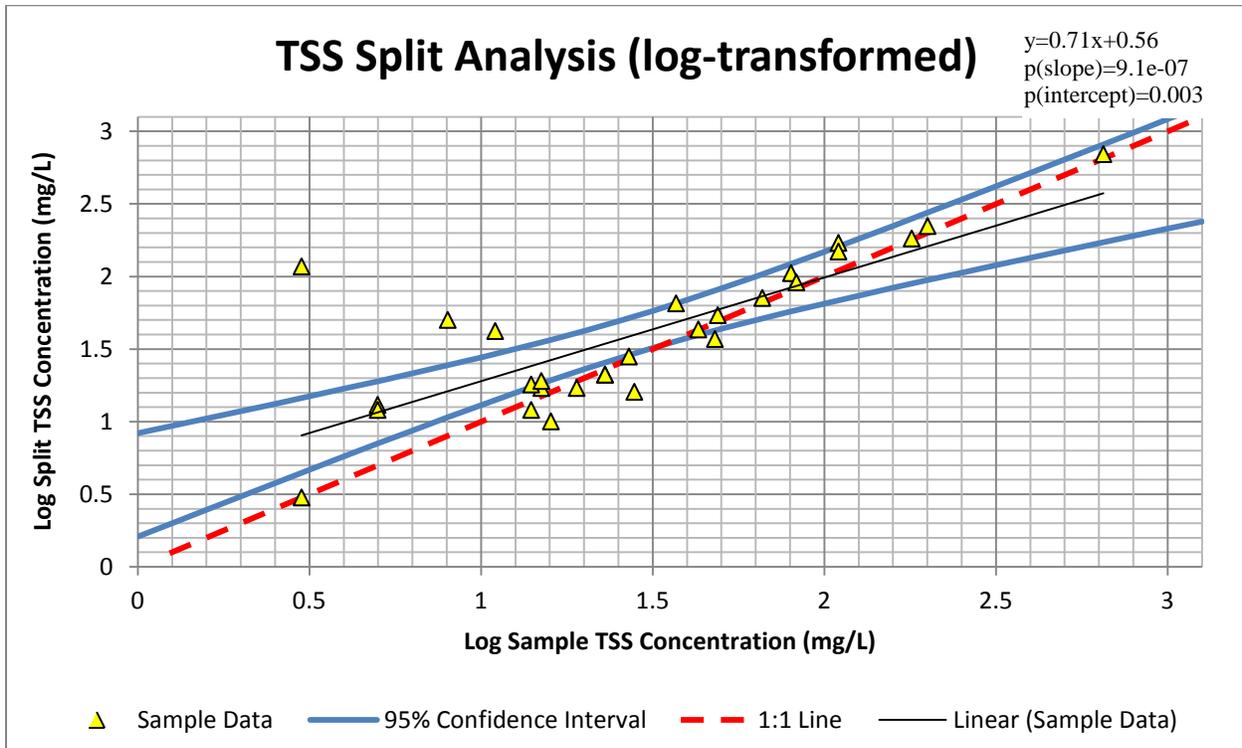
more accurate at low concentrations, only that the splits lab tends to measure higher TSS than the sample lab at low concentrations.

Figure 1. Log Sample vs. Log Split results for TSS. Non-detect results were excluded (non-detect result frequency of 38%).

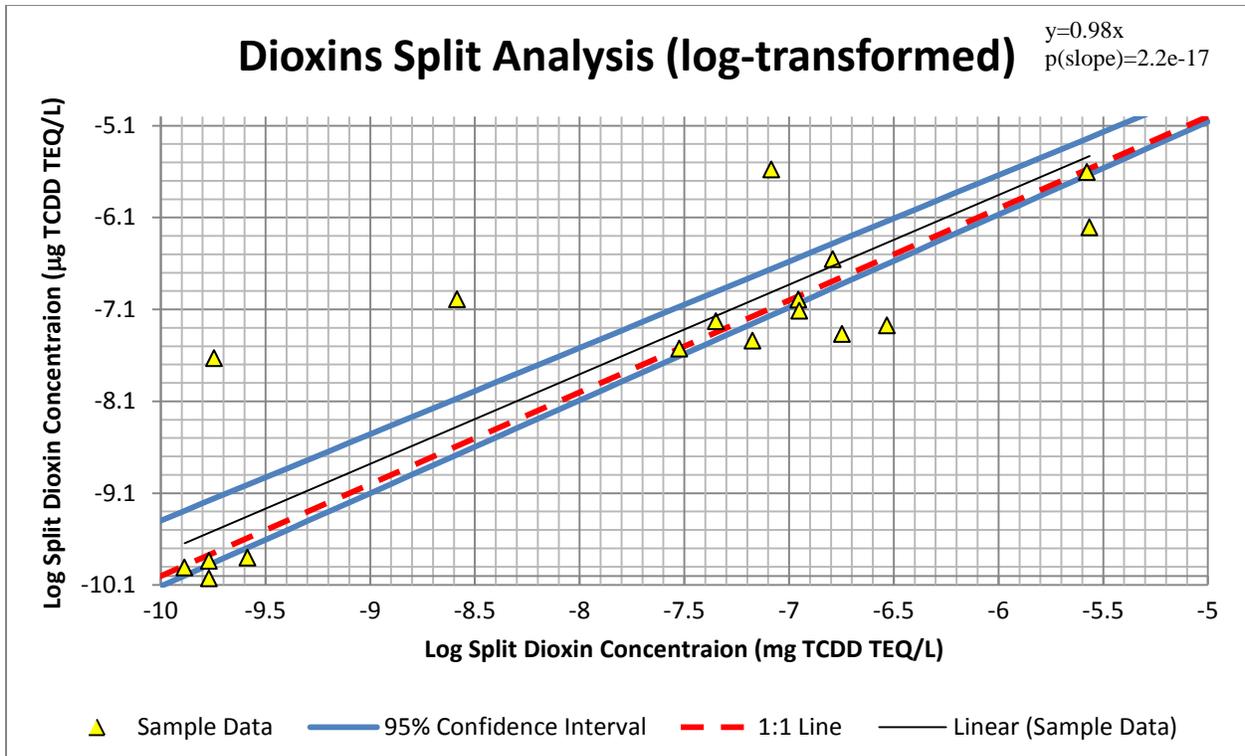
The nonparametric sign test for dioxins showed that split results were lower than sample results a statistically significant portion of the time even though the average ratio was much greater than 1. This is shown graphically in Figure 2, in which most of the data falling to the right of the 1:1 line, though several of those that fall to the left are very far left of the line. The p-value for the y-intercept was 0.25, so the regression was forced through the origin, indicating reasonable consistency between the labs at low concentrations. The slope of the regression is very close to 1 (0.98), and the 1:1 line falls within the confidence intervals of the regression throughout the entire range of measured data. Therefore, a correlation close to 1:1 cannot be ruled out for dioxins, indicating good consistency between the two labs. However, there is considerably more scatter in the data for dioxins than for TSS, even at higher concentrations, suggesting somewhat lower precision. TSS is much easier to measure than dioxins, so a lower precision for dioxins is not unexpected.

Figure 2. Log Sample vs. Log Split results for dioxins. Non-detect results were excluded (non-detect result frequency of 57%).

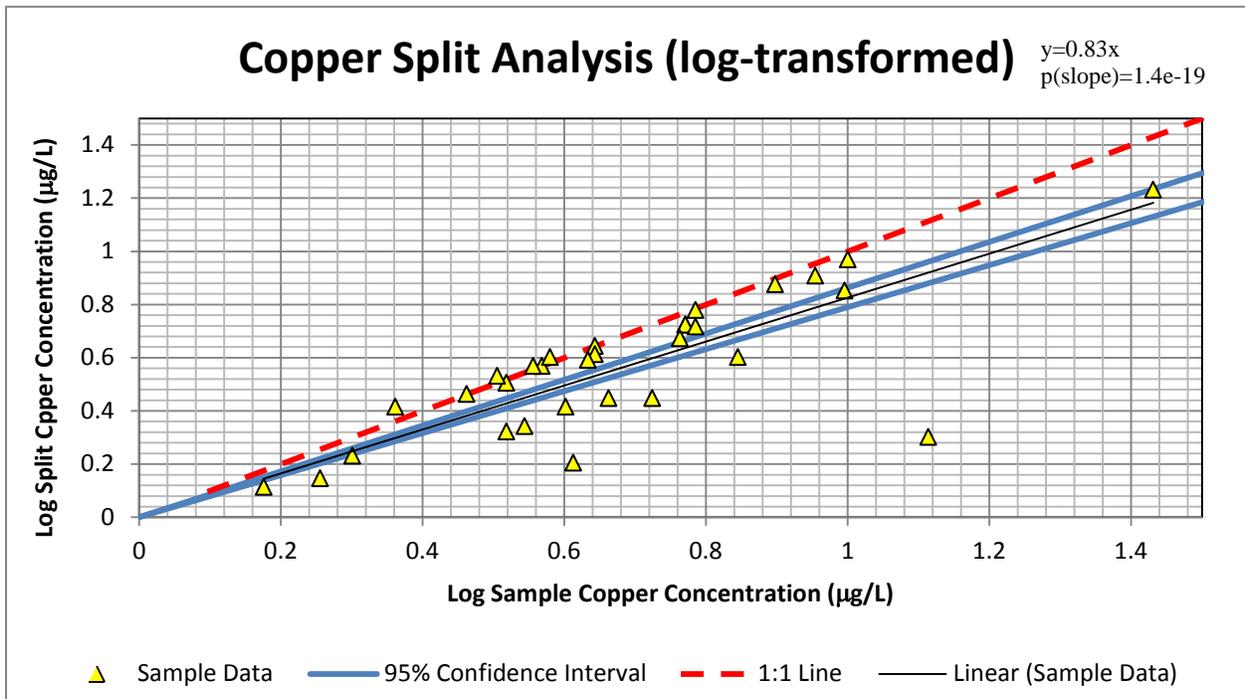
Figure 3. Log Sample vs. Log Split results for copper. No samples were below detection limits.

The nonparametric sign test for copper showed that split results were lower than sample results a statistically significant portion of the time. This is shown graphically in Figure 3, in which the vast majority of the data falling to the right of the 1:1 line. The p value for the y-intercept was 0.57, so the regression was forced through the origin, indicating that background concentrations were similar between the two labs. The slope of the regression is much less than 1 (0.83), indicating a likely bias towards lower split results compared to sample results. The 1:1 line is outside the confidence intervals throughout the entire range of values, indicating the high likelihood that there is a systematic bias towards lower split results compared to sample results for copper. This bias appears to be relatively constant throughout the range of values. This analysis does not tell us which is more accurate, only that the splits lab consistently measured lower concentrations than the sample lab for the same sample.

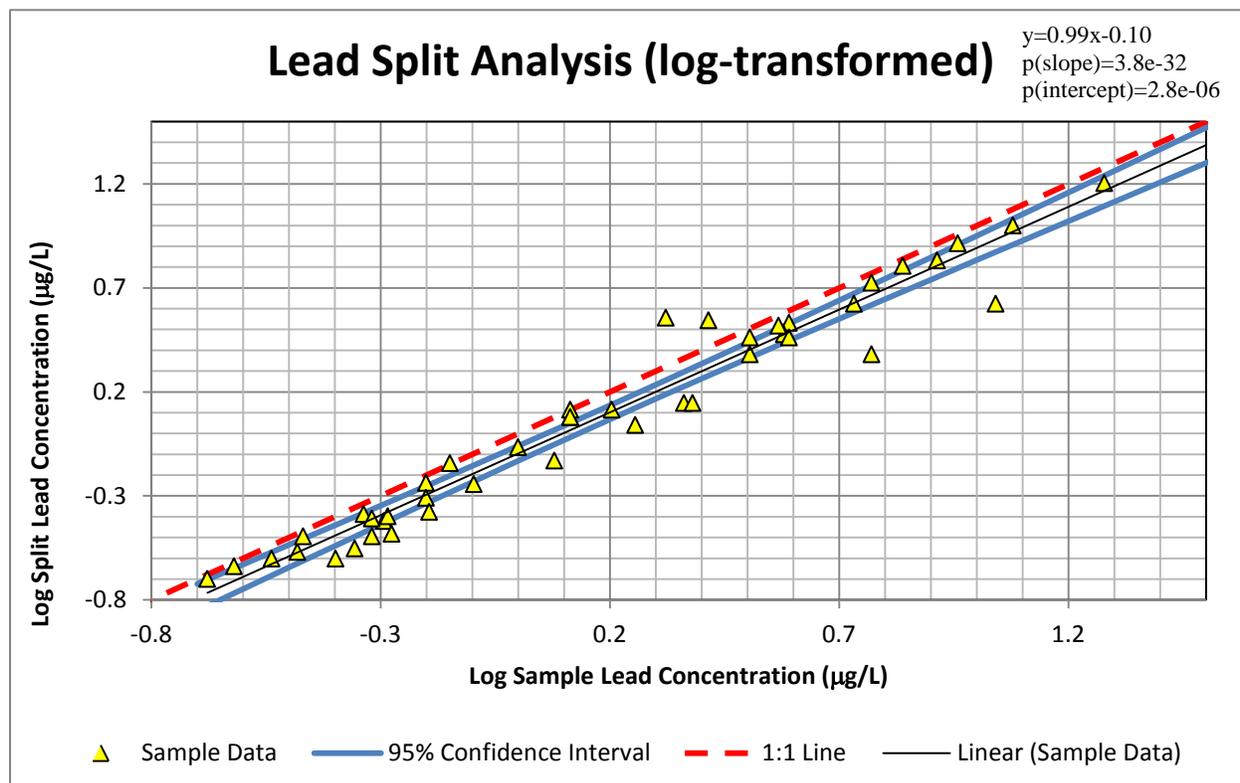
Figure 4. Log Sample vs. Log Split results for lead. Non-detect results were excluded (non-detect result frequency of 1%)

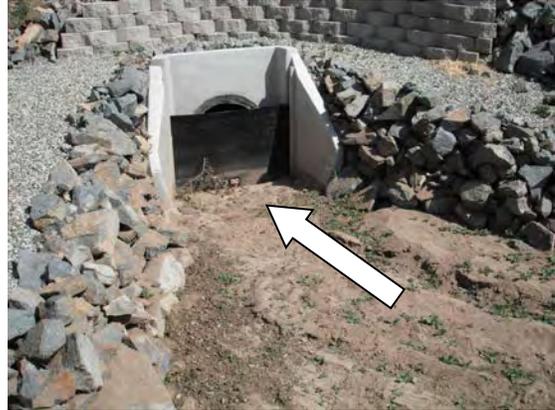
Figure 36. Sediment accumulated behind weir boards at CM-9.

1. Based on evaluation of CM performance, the Panel recommends there be continued inspection and maintenance including the following:
 - Inspection after large storms and at the start of the rainy season, removal of accumulated sediment and debris in ponded footprints above the weir boards (particularly when accumulation depth exceeds 10% of weir board height);
 - Inspection of underdrain flows during storms to ensure water is still flowing effectively through media beds;
 - Replacement of filter fabric when they are damaged or non-functioning;
 - Collection of field notes during sampling to note whether weirboard overflow is occurring, etc.

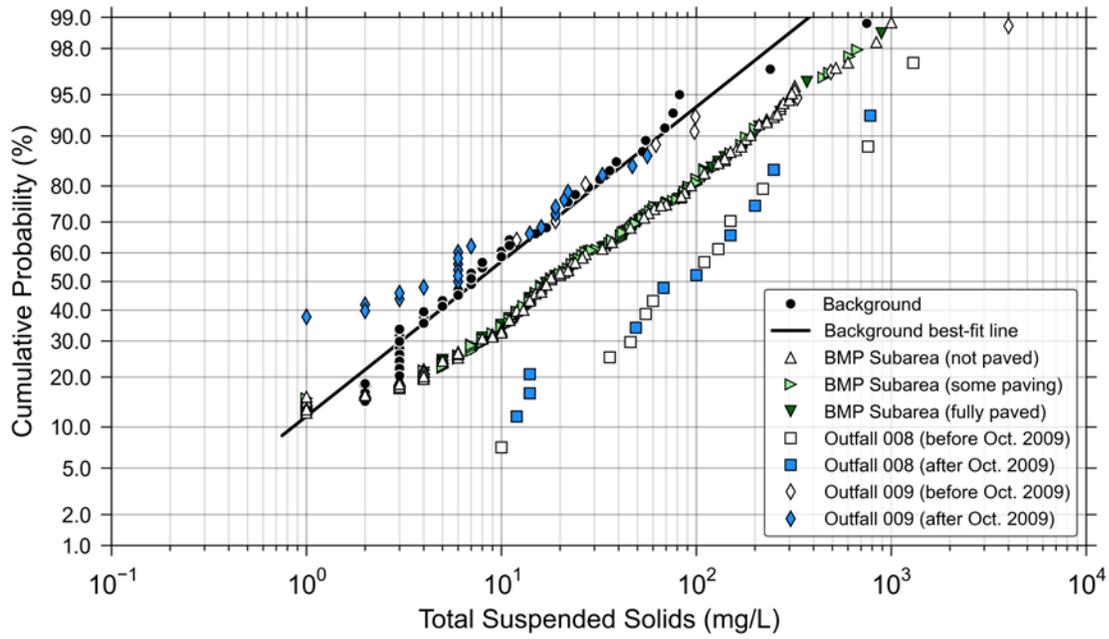
Figure 2. Probability plot for TSS concentrations¹⁹

¹⁹ Note: Following the 2005 wildfire, an uncharacteristically high TSS value (4000 mg/L) was measured at Outfall 009 on 10/17/2005. This data point is shown near the upper right corner of Figure 2.

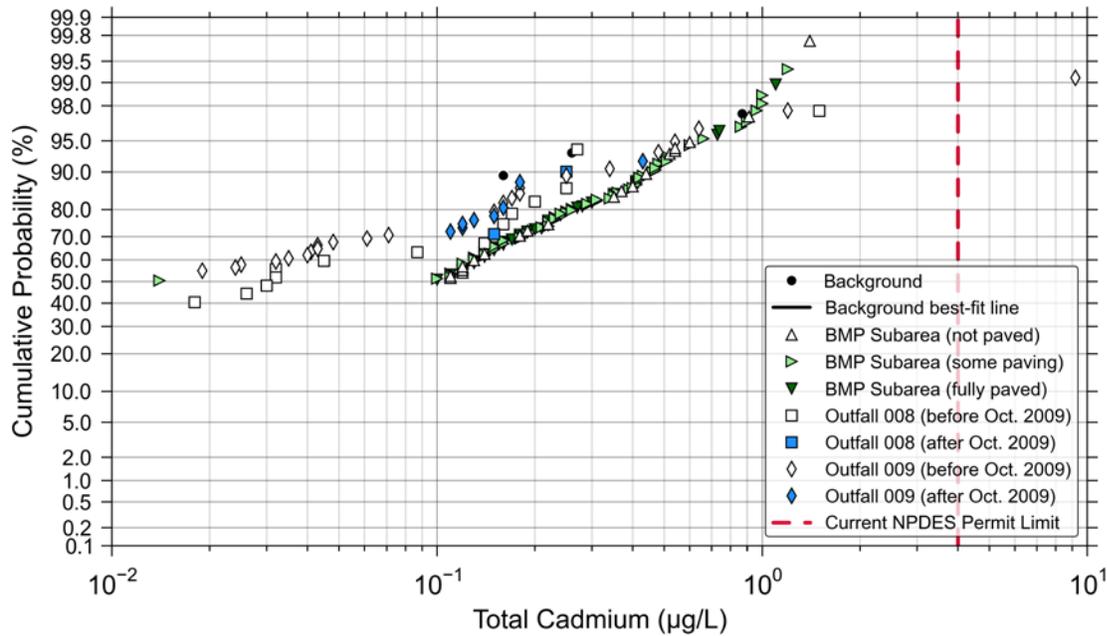
Figure 3. Probability plot for cadmium concentrations^{20, 21}

²⁰ Following the 2005 wildfires, an uncharacteristically high cadmium concentration (9.2 µg/L) was measured at Outfall 009 on 10/17/2005. This data point is shown in the upper right corner of Figure 3.

²¹ A background best-fit line was not provided for total cadmium due to the limited number of detected results.

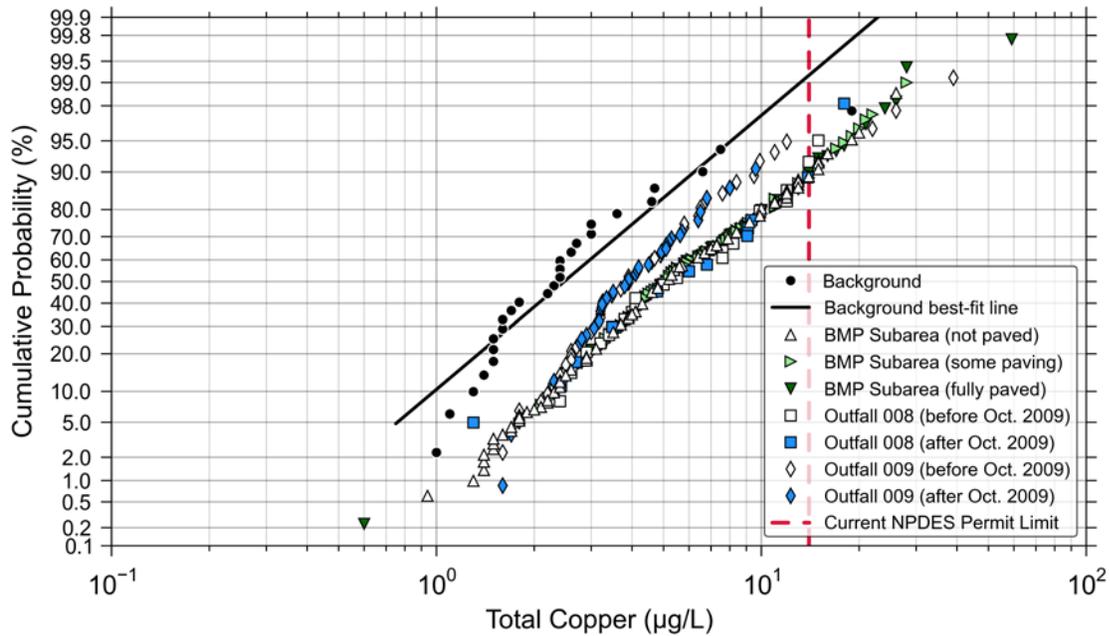
Figure 5. Probability plot for copper concentrations²²

²² Following the 2005 wildfires, an uncharacteristically high copper concentration (212 µg/L) was measured at Outfall 009 on 10/17/2005. This data point is shown near the upper right corner of Figure 5.

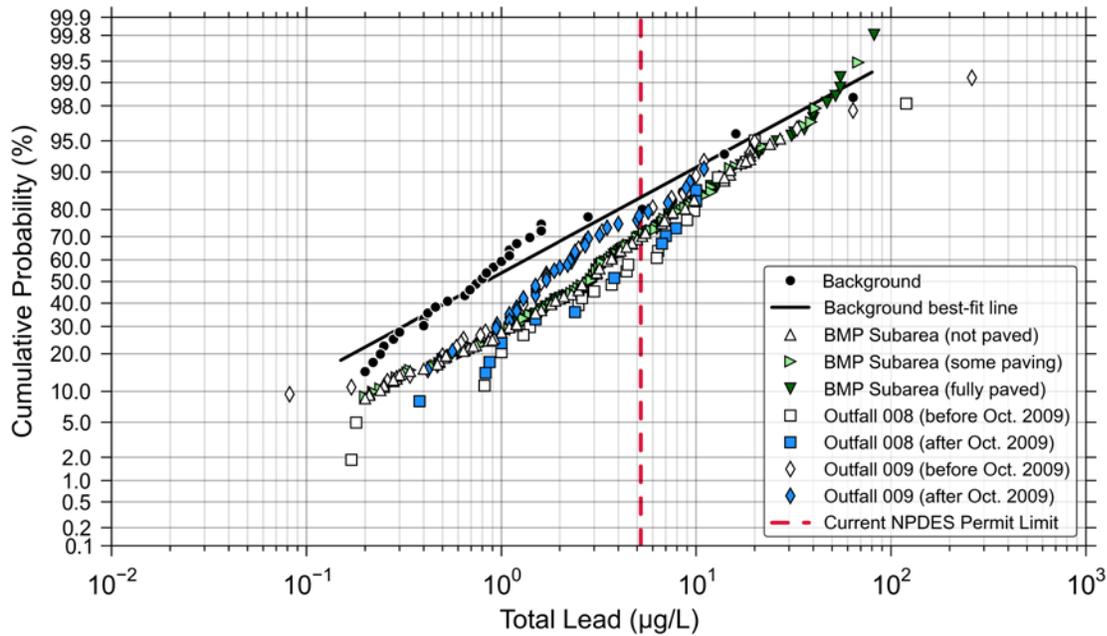
Figure 7. Probability plot for lead concentrations²³

²³ Following the 2005 wildfires, an uncharacteristically high lead concentration (260 µg/L) was measured at Outfall 009 on 10/17/2005. This data point is shown near the upper right corner of Figure 7.

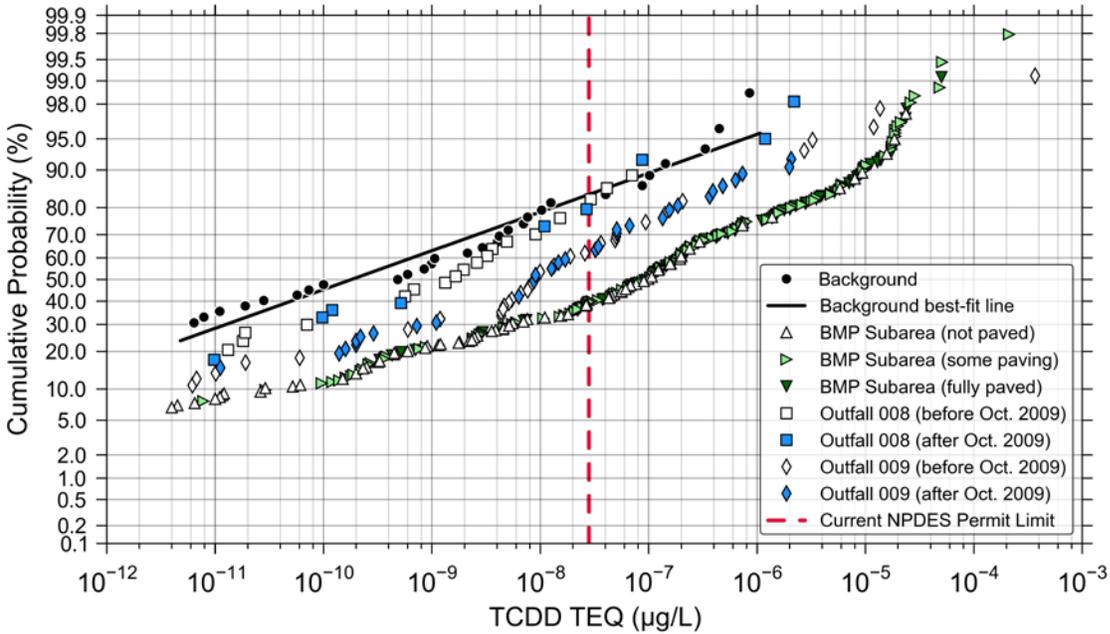
Figure 9. Probability plot for TCDD TEQ concentrations²⁴

²⁴ Following the 2005 wildfires, an uncharacteristically high TCDD TEQ concentration ($3.6 \times 10^{-4} \mu\text{g/L}$) was measured at Outfall 009 on 10/17/2005. This data point is shown in the upper right corner of Figure 9.

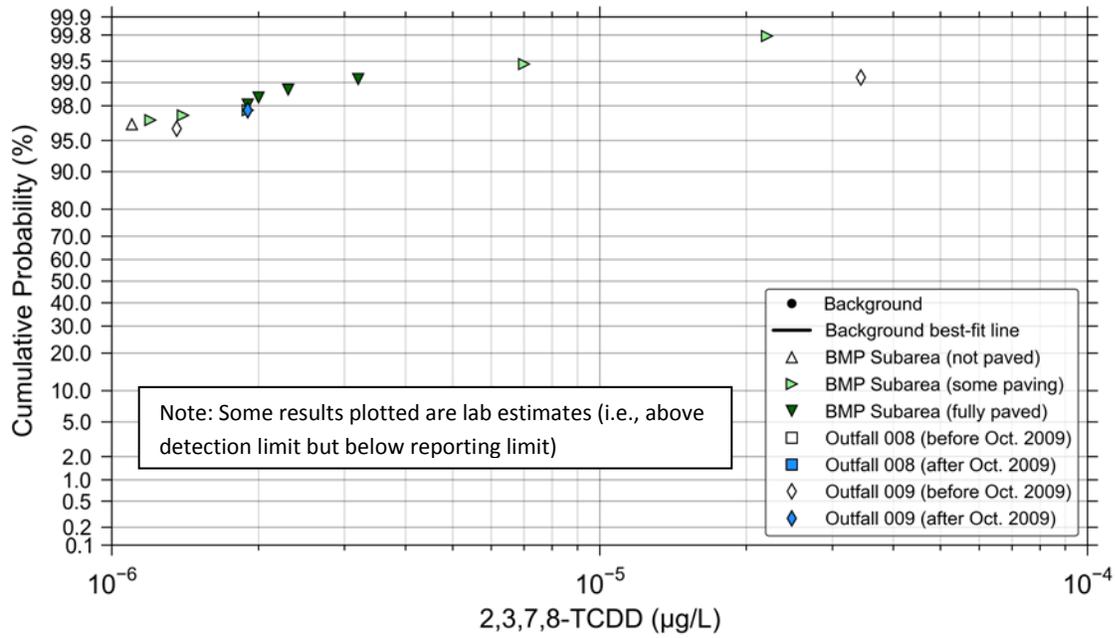
Figure 11. Probability plot for 2,3,7,8-TCDD concentrations²⁵

²⁵ Following the 2005 wildfires, an uncharacteristically high 2,3,7,8-TCDD concentration (3.4×10^{-5} µg/L) was measured at Outfall 009 on 10/17/2005. This data point is shown in the upper right corner of Figure 11.
