PHASE II IMPLEMENTATION BIOLOGICAL REPORT

February 28, 2011
 Project No. 1102-0161

Subject: Santa Susana Field Laboratory Outfall 009 ISRA Biological Survey and Construction Monitoring Report – June 2010 to February 2011

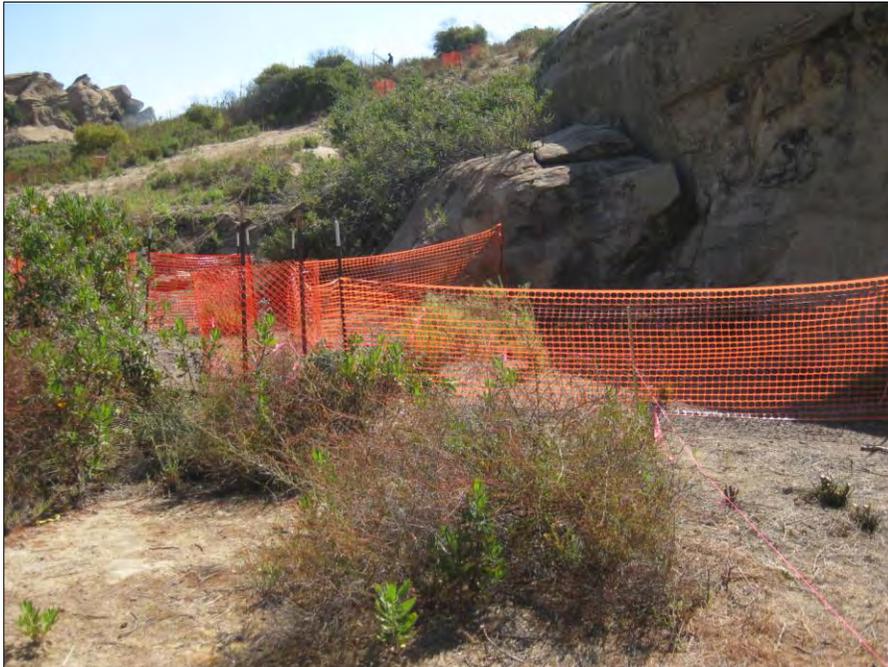
Figure 1. View of B1-1A prior to ISRA activities. Photograph is toward the north, taken on July 15, 2010. Orange construction fencing in place for Santa Susana tarplant protection.

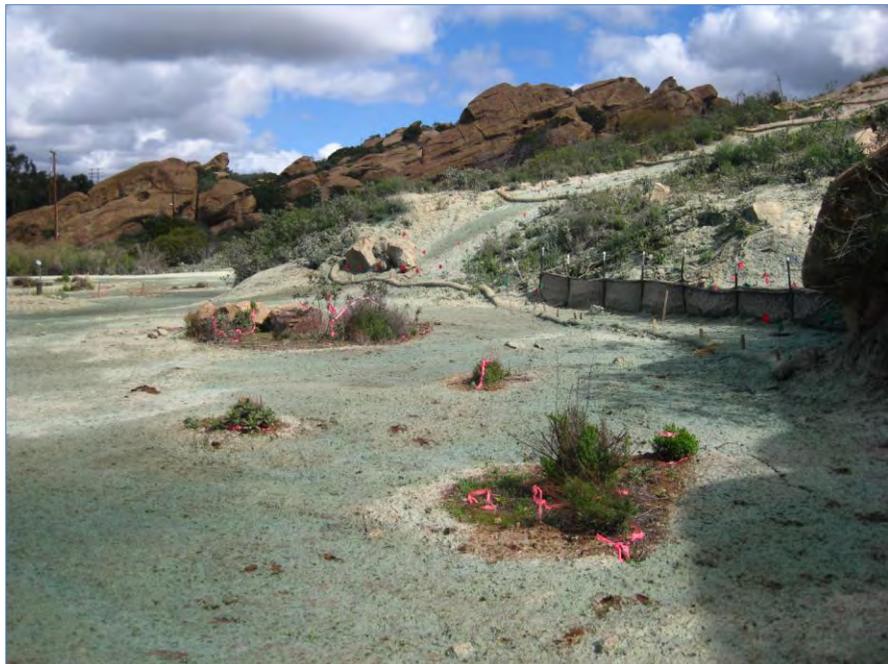
Figure 2. View of B1-1A subsequent to ISRA activities. Photograph is toward the north, taken on February 17, 2011. Site is hydroseeded, Santa Susana tarplants are present (marked by pink flagging) and BMPs are placed on hillside.

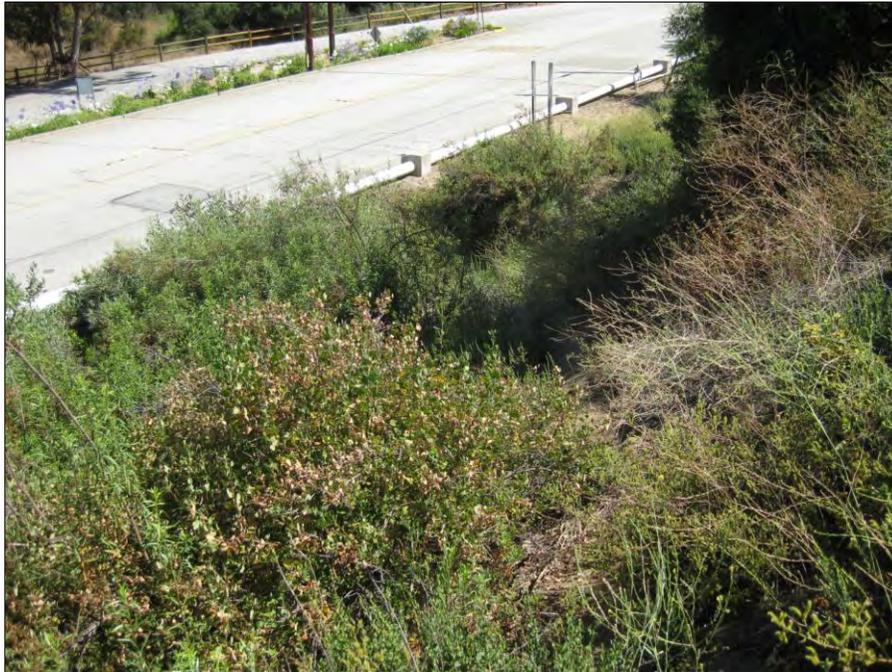
Figure 3. View of lower portion of B1-2, prior to ISRA activities. Photograph is toward the northeast, taken on July 2, 2010.

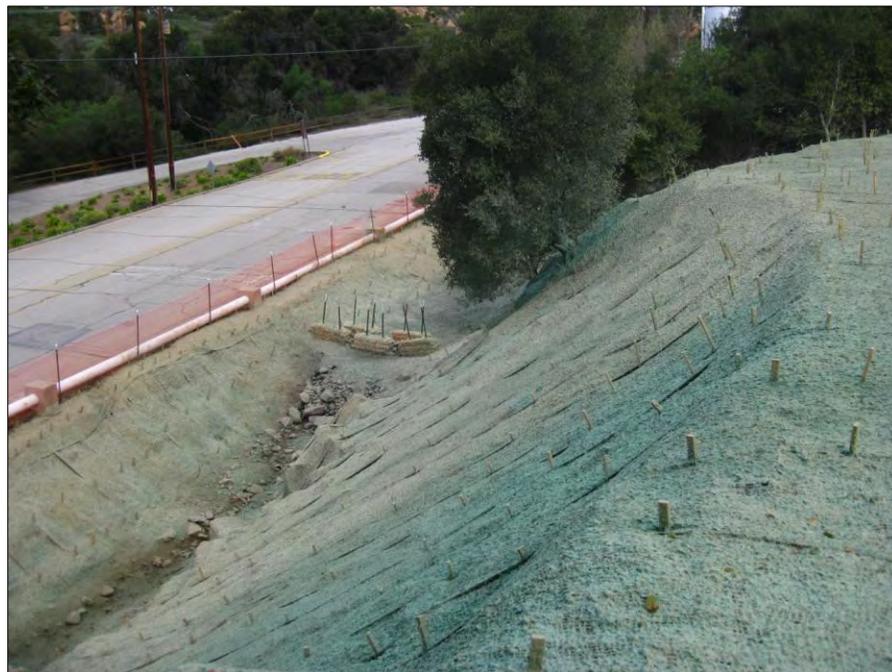
Figure 4. View of lower portion of B1-2, subsequent to ISRA activities. Photograph is toward the northeast, taken on February 17, 2011. Slopes are covered in jute netting and are hydroseeded.

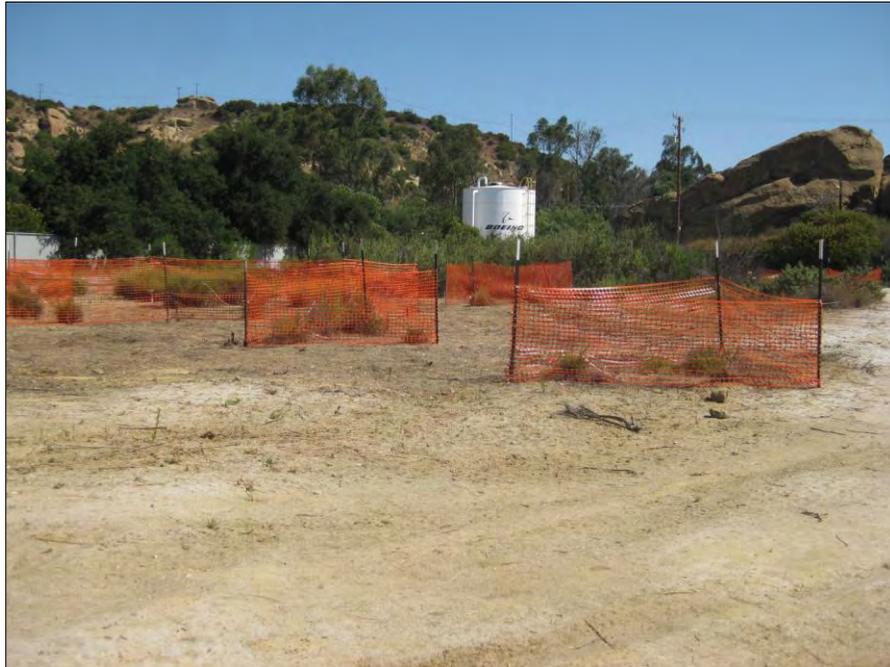
Figure 5. View of upper portion of B1-2, prior to ISRA activities. Photograph is toward the north, taken on July 15, 2010. Orange construction fencing in place for Santa Susana tarplant protection.

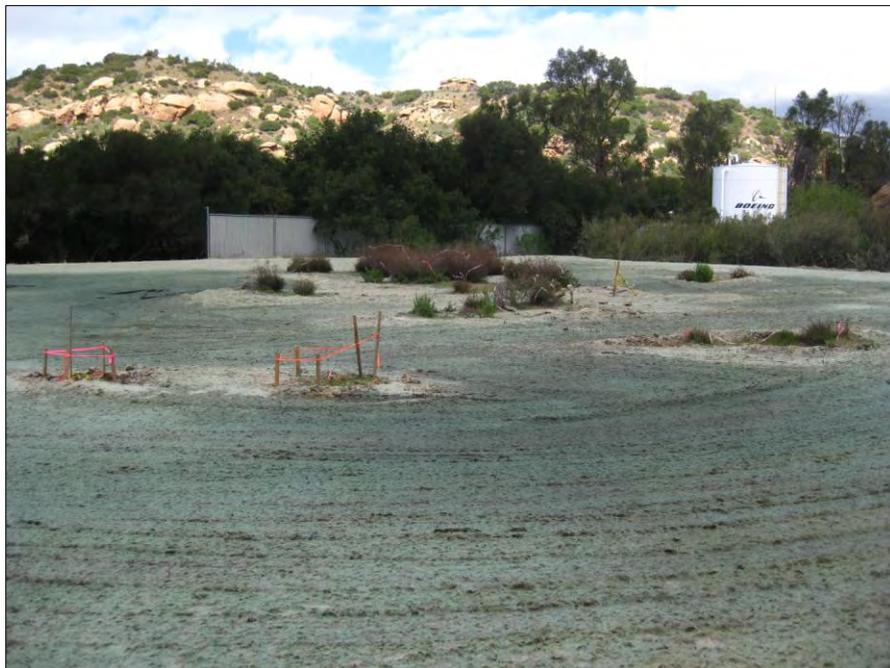
Figure 6. View of upper portion of B1-2, subsequent to ISRA activities. Photograph is toward the northeast, taken on February 17, 2011. Site is hydroseeded and Santa Susana tarplants are present (marked by pink flagging).

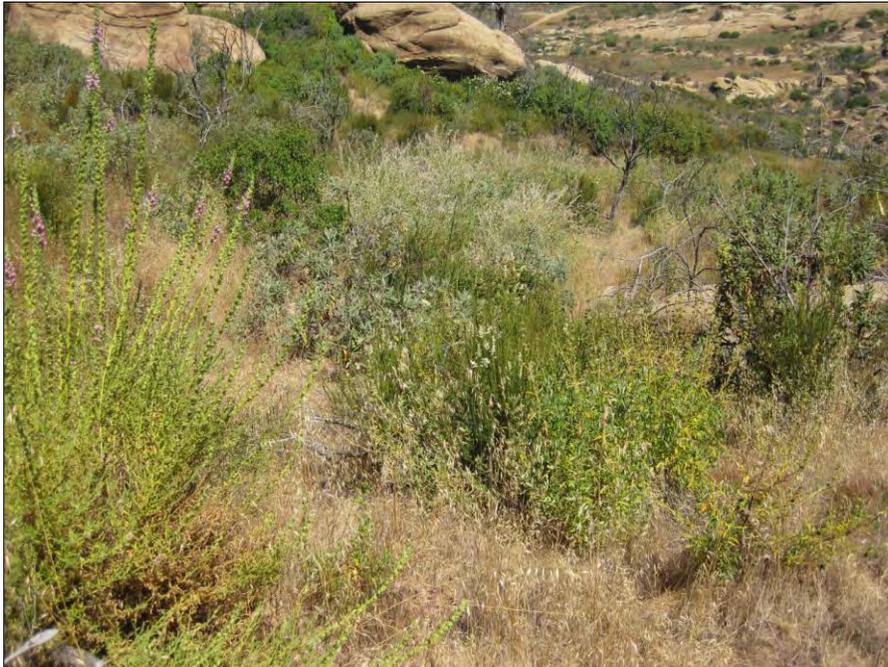
Figure 7. View of CTL-1, prior to ISRA activities. Photograph is toward the north, taken on July 1, 2010.

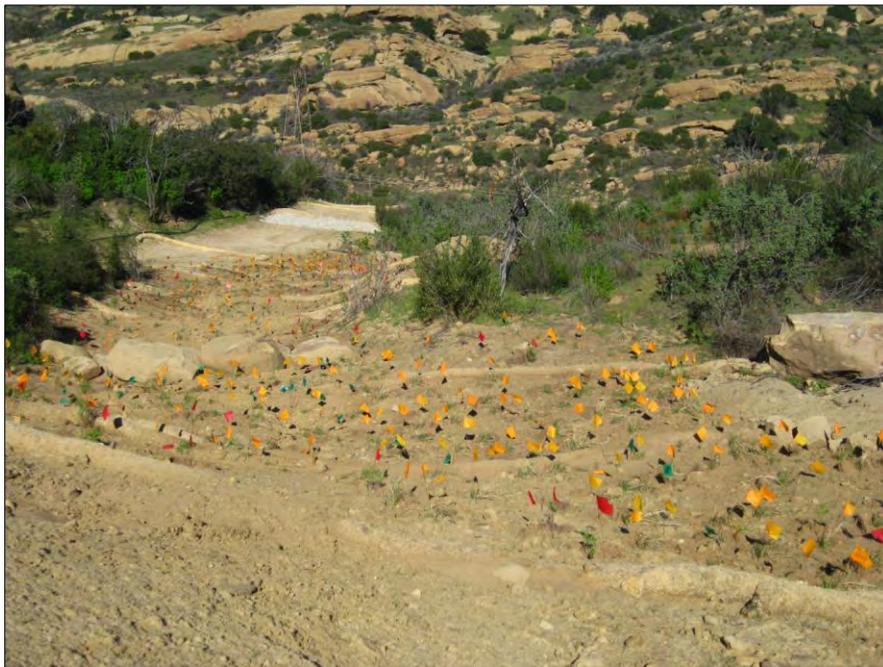
Figure 8. View of CTL-1, subsequent to ISRA activities, including installation of containerized plants (marked by pinflags, which were subsequently removed), but prior to hydroseeding. Photograph is toward the north, taken on January 27, 2011.

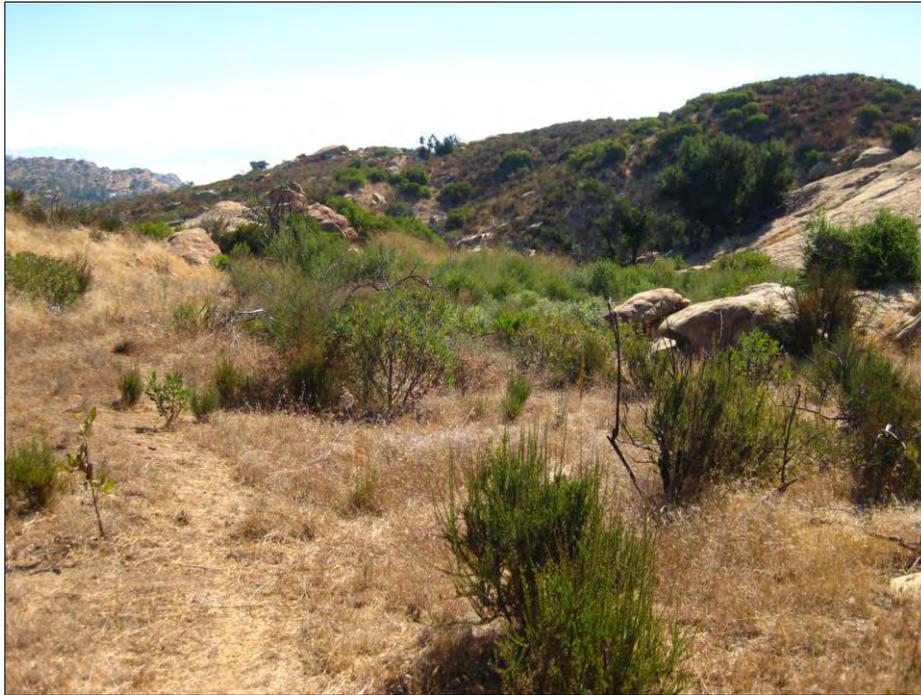
Figure 9. View of Soil Borrow Area, prior to ISRA activities. Photograph is toward the east, taken on August 27, 2010.

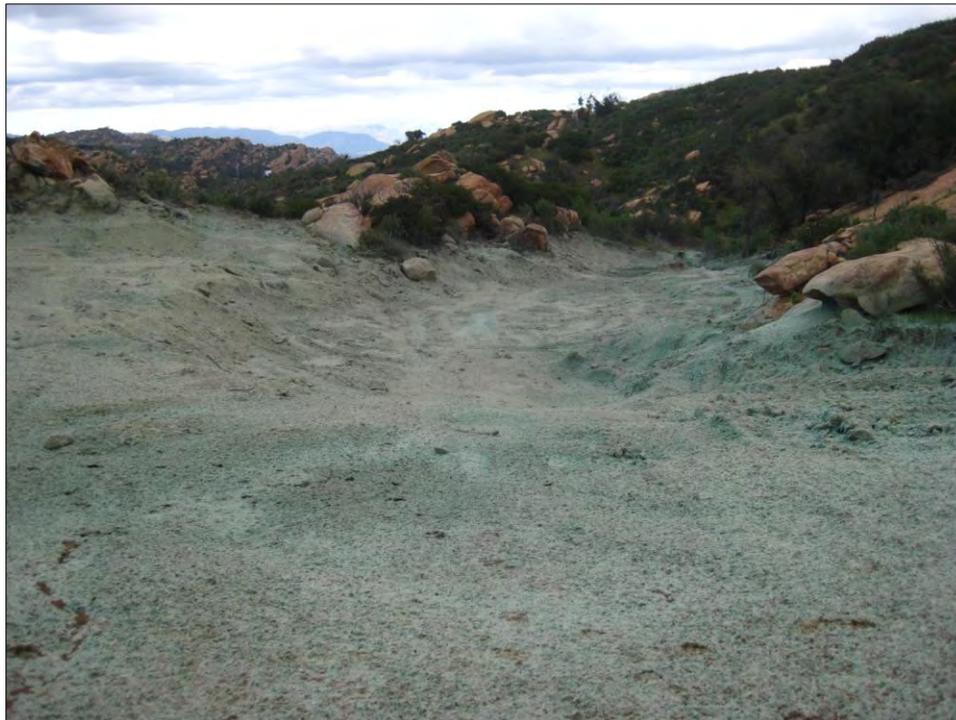
Figure 10. View of Soil Borrow Area, subsequent to ISRA activities, including hydroseeding. Photograph is toward the east, taken on February 17, 2011.

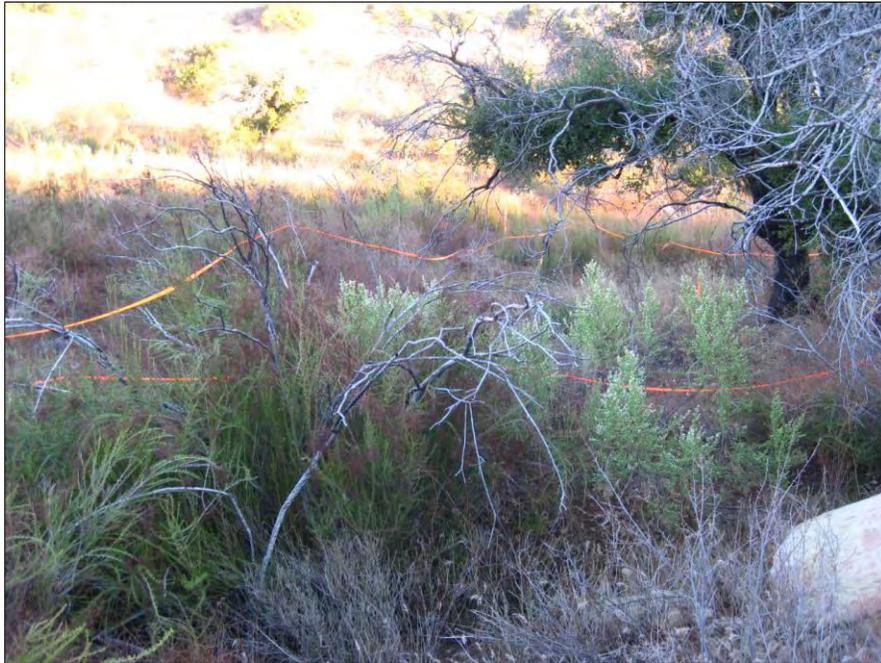
Figure 11. View of AP/STP-1A prior to ISRA activities. Photograph is toward the north, taken on October 11, 2010.

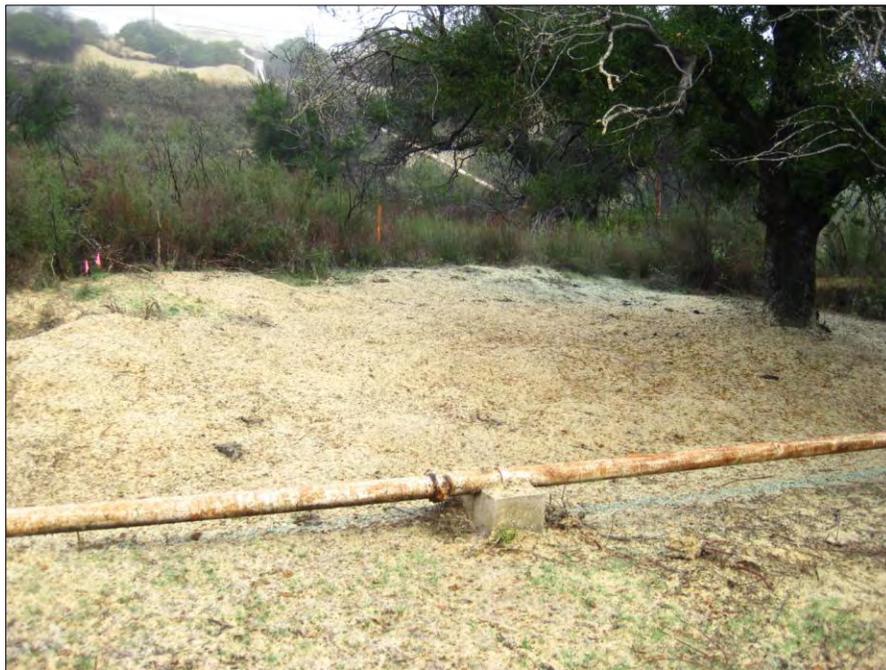
Figure 12. View of AP/STP-1A subsequent to ISRA activities. Photograph is toward the north, taken on December 15, 2010.

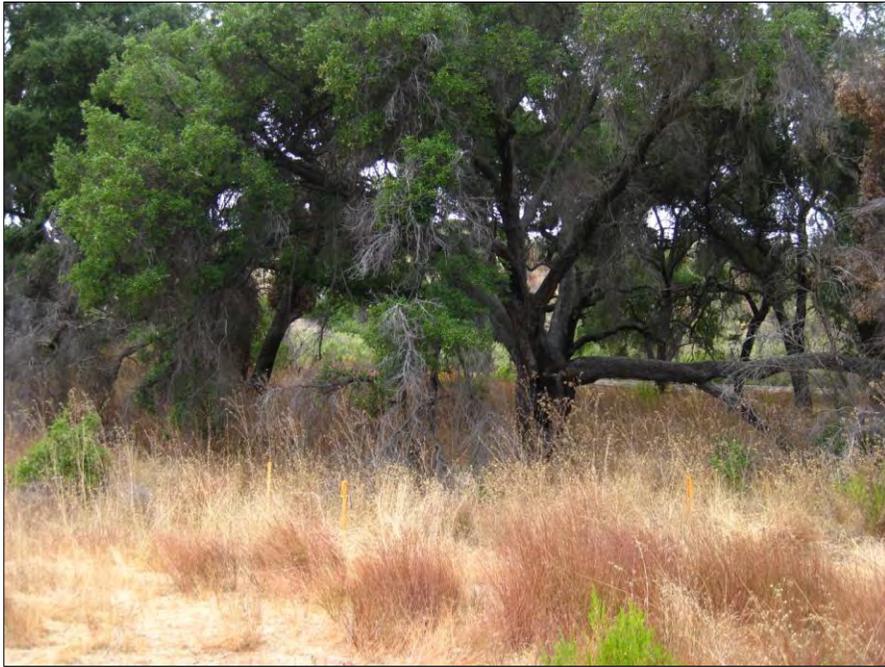
Figure 13. View of AP/STP-1D prior to ISRA activities. Photograph is toward the north, taken on September 28, 2010.

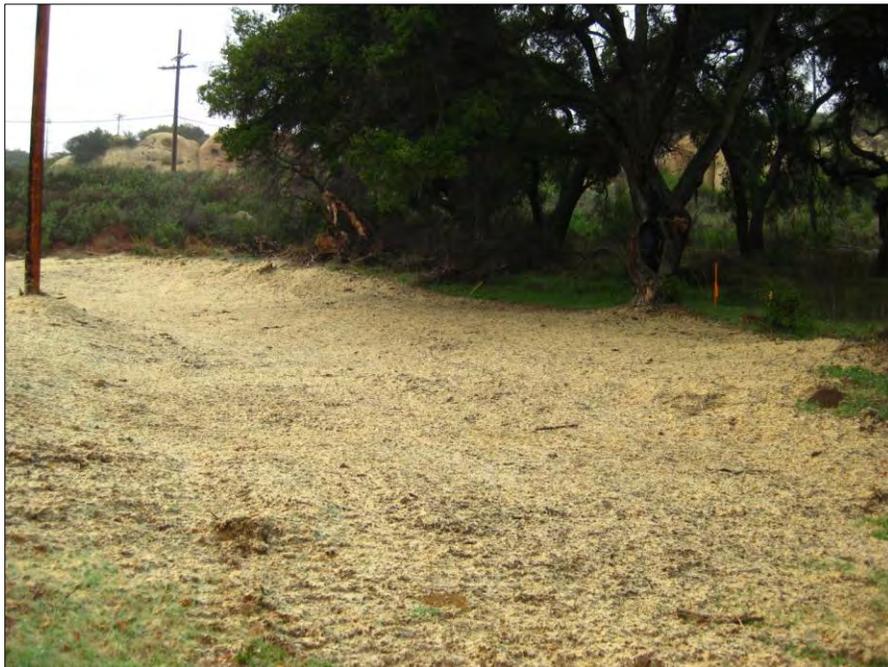
Figure 14. View of AP/STP-1D subsequent to ISRA activities. Photograph is toward the northwest, taken on December 15, 2010.

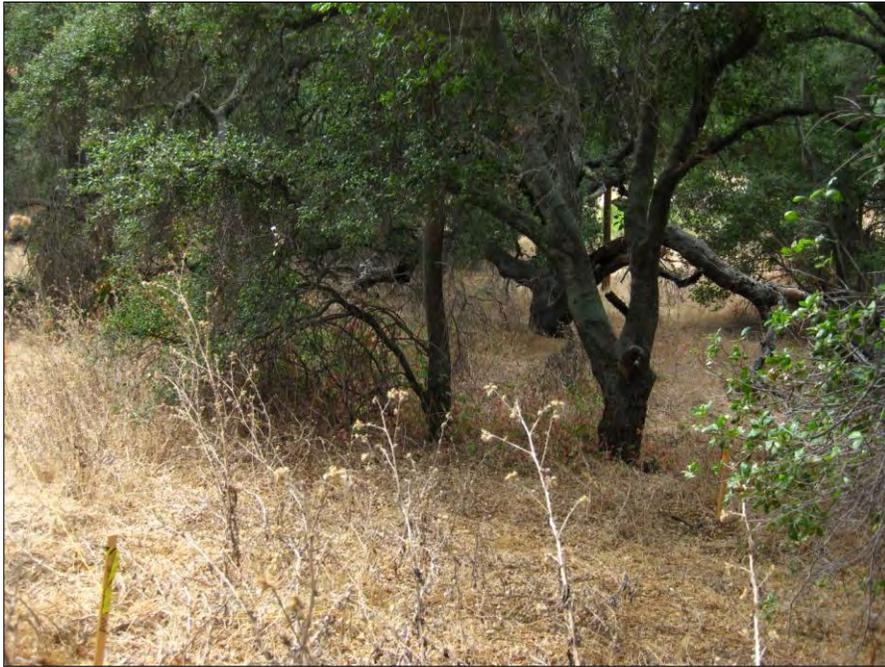
Figure 15. View of AP/STP-1F prior to ISRA activities. Photograph is toward the southwest, taken on September 28, 2010.

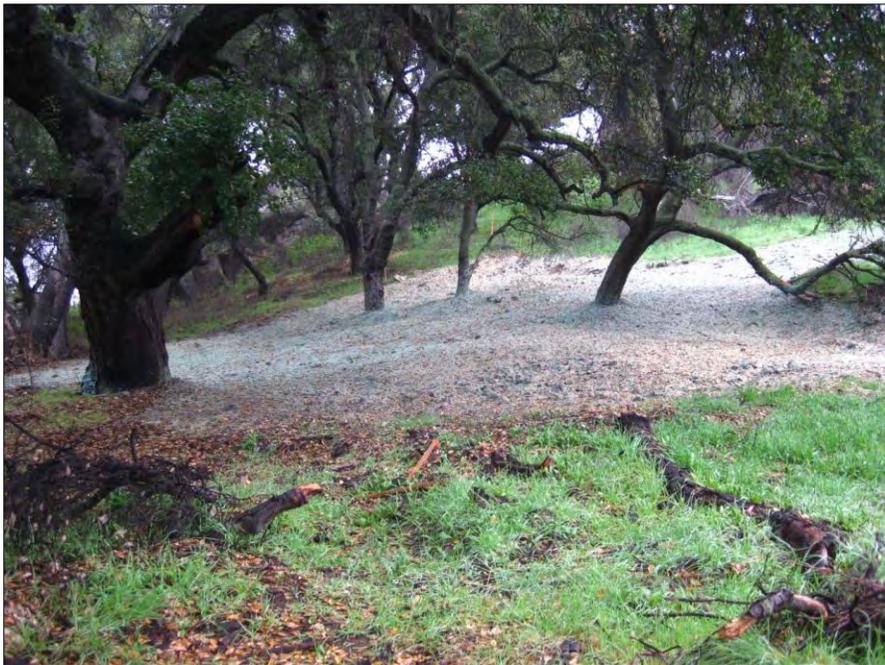
Figure 16. View of AP/STP-1F subsequent to ISRA activities. Photograph is toward the northeast, taken on December 15, 2010.
