**SANTA SUSANA SITE WATERSHED 008 AND
009 BMP SUBAREA RANKING ANALYSIS**

August 2015

Santa Susana Field Laboratory

Surface Water Expert Panel

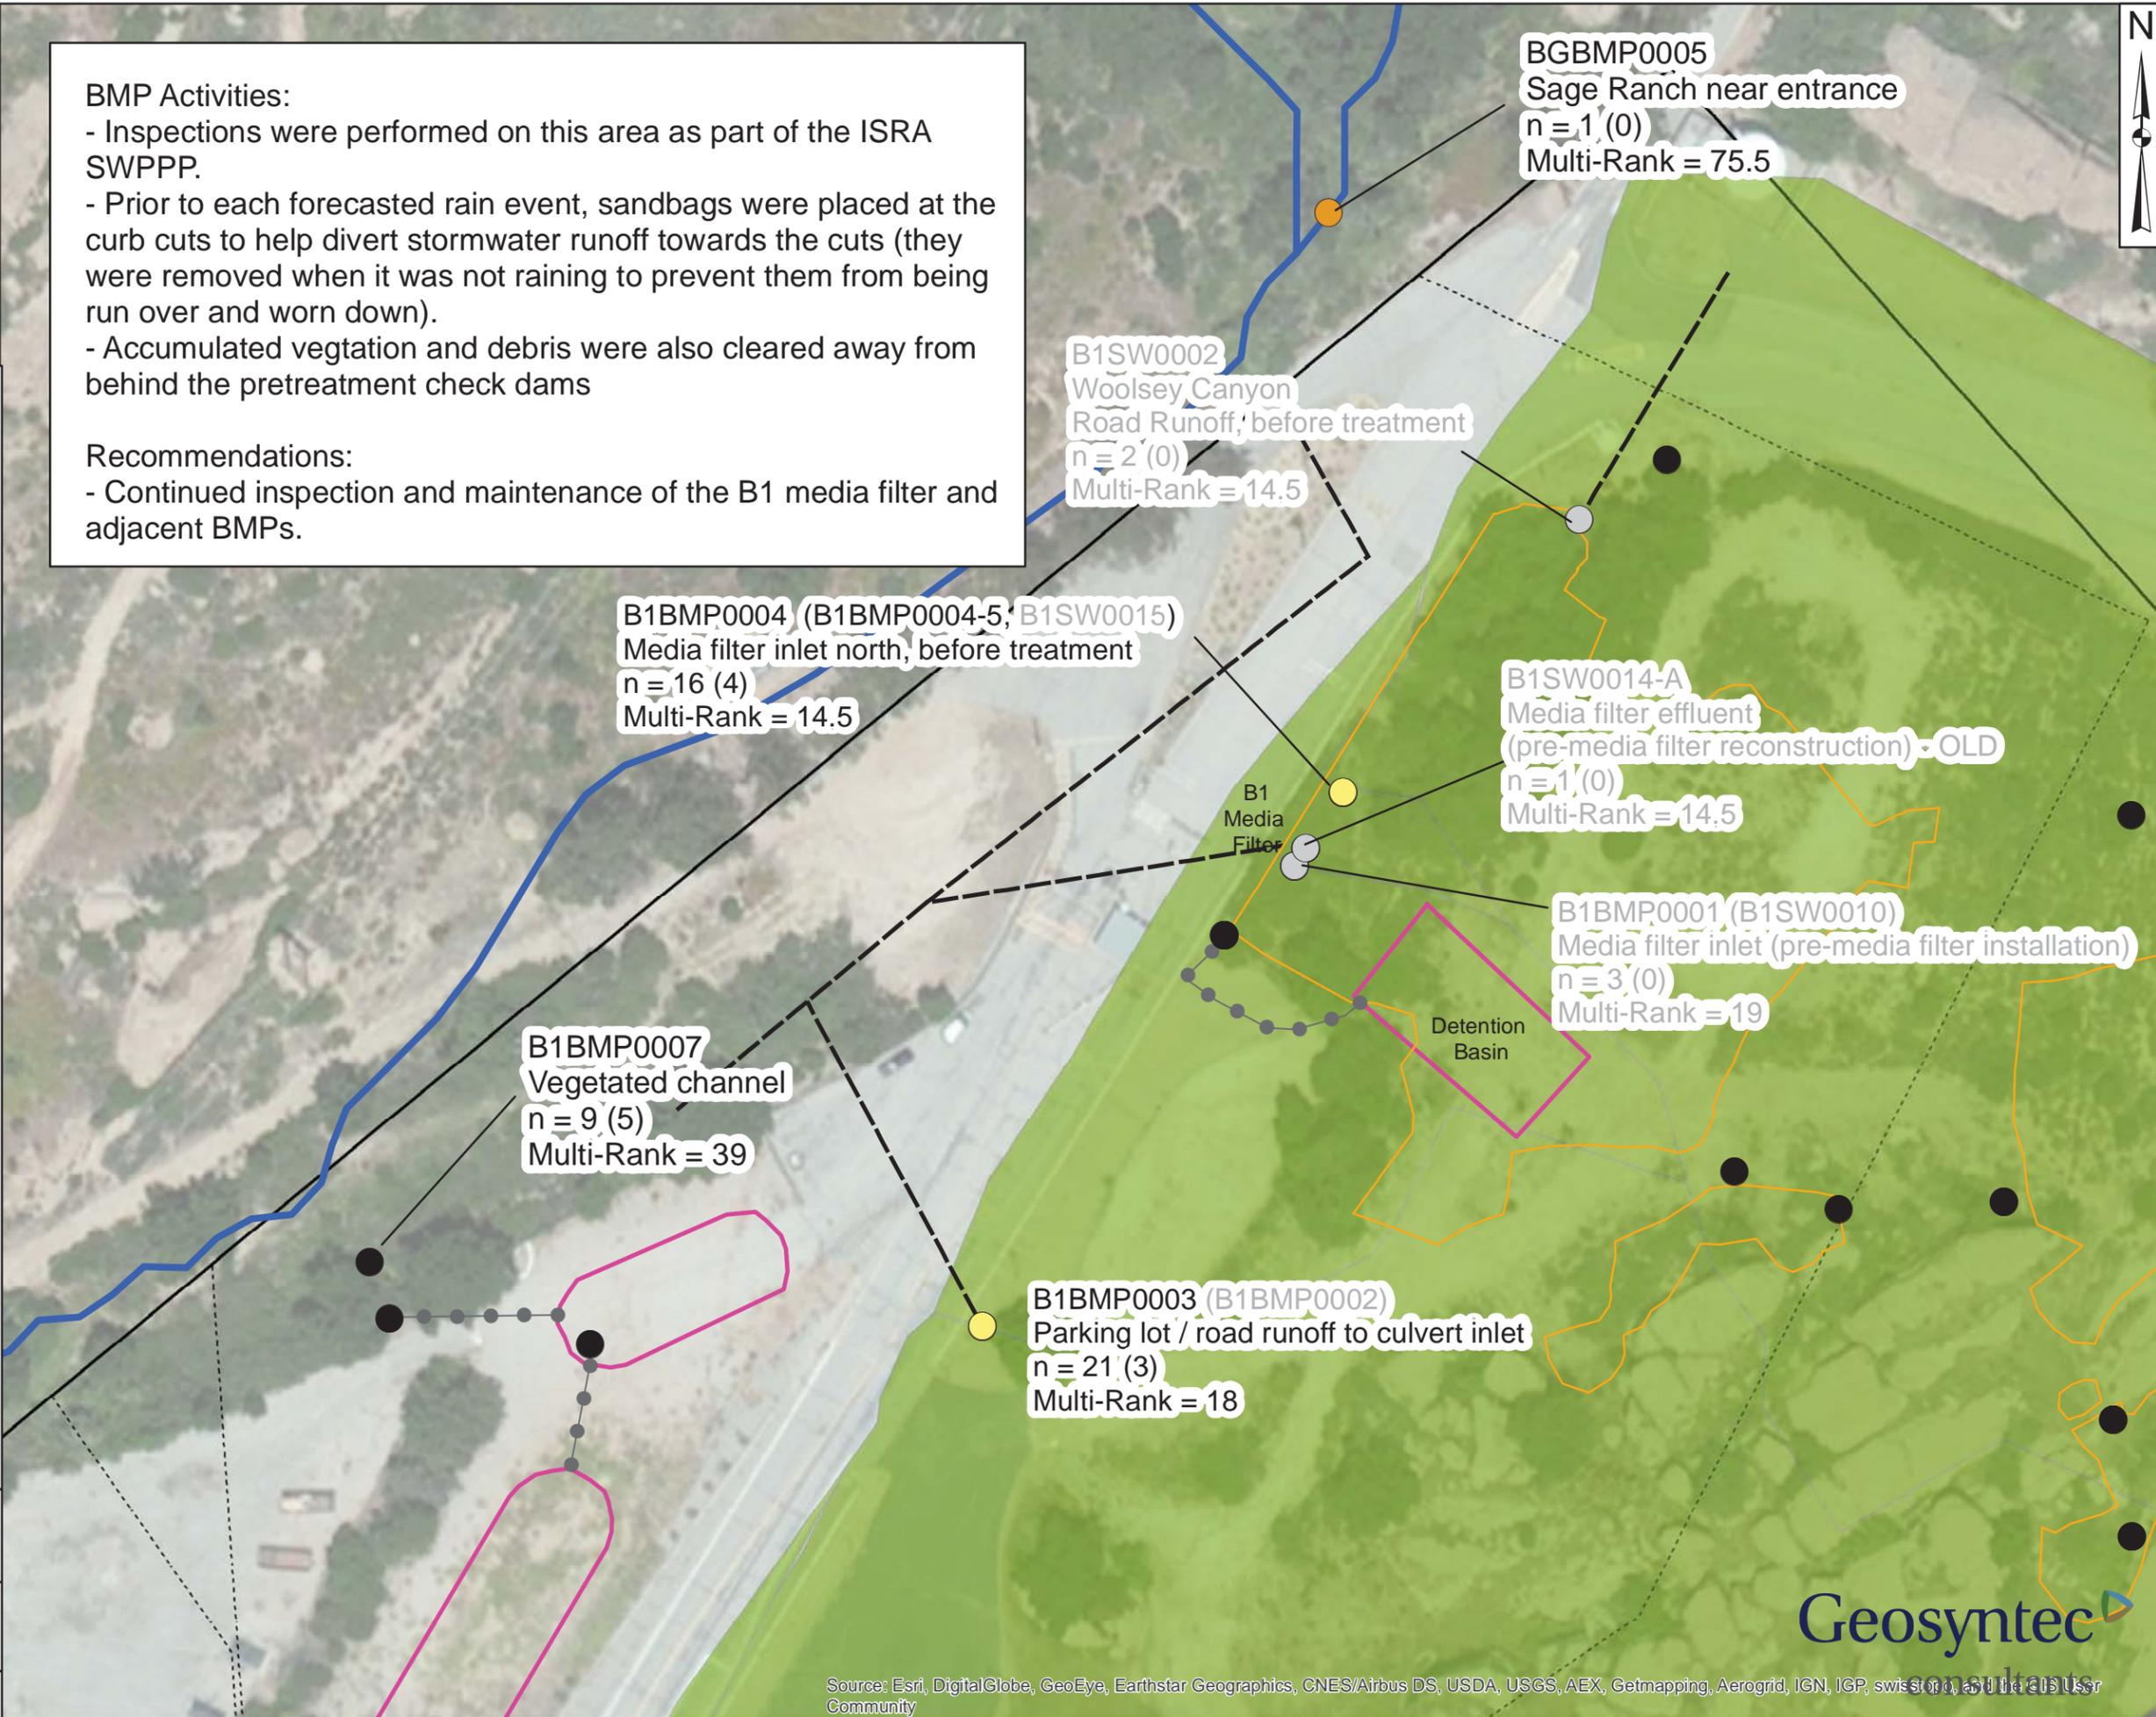
Figure ES-1: B1 Area

- (3) Stormwater runoff from B1BMP0003 is "unaddressed" because it flows directly to the Northern Drainage and the Panel has yet to provide a BMP recommendation for this site.

- Inspections were performed on this area as part of the ISRA SWPPP.
- Prior to each forecasted rain event, sandbags were placed at the curb cuts to help divert stormwater runoff towards the cuts (they were removed when it was not raining to prevent them from being run over and worn down).
- Accumulated vegetation and debris were also cleared away from behind the pretreatment check dams

- 7. Upper Lot (Boeing):** The Expert Panel recommends new stormwater capture above the culvert inlet at B1BPM0003. This could occur in a temporary form like sand bag berms that are currently found at the Helipad .

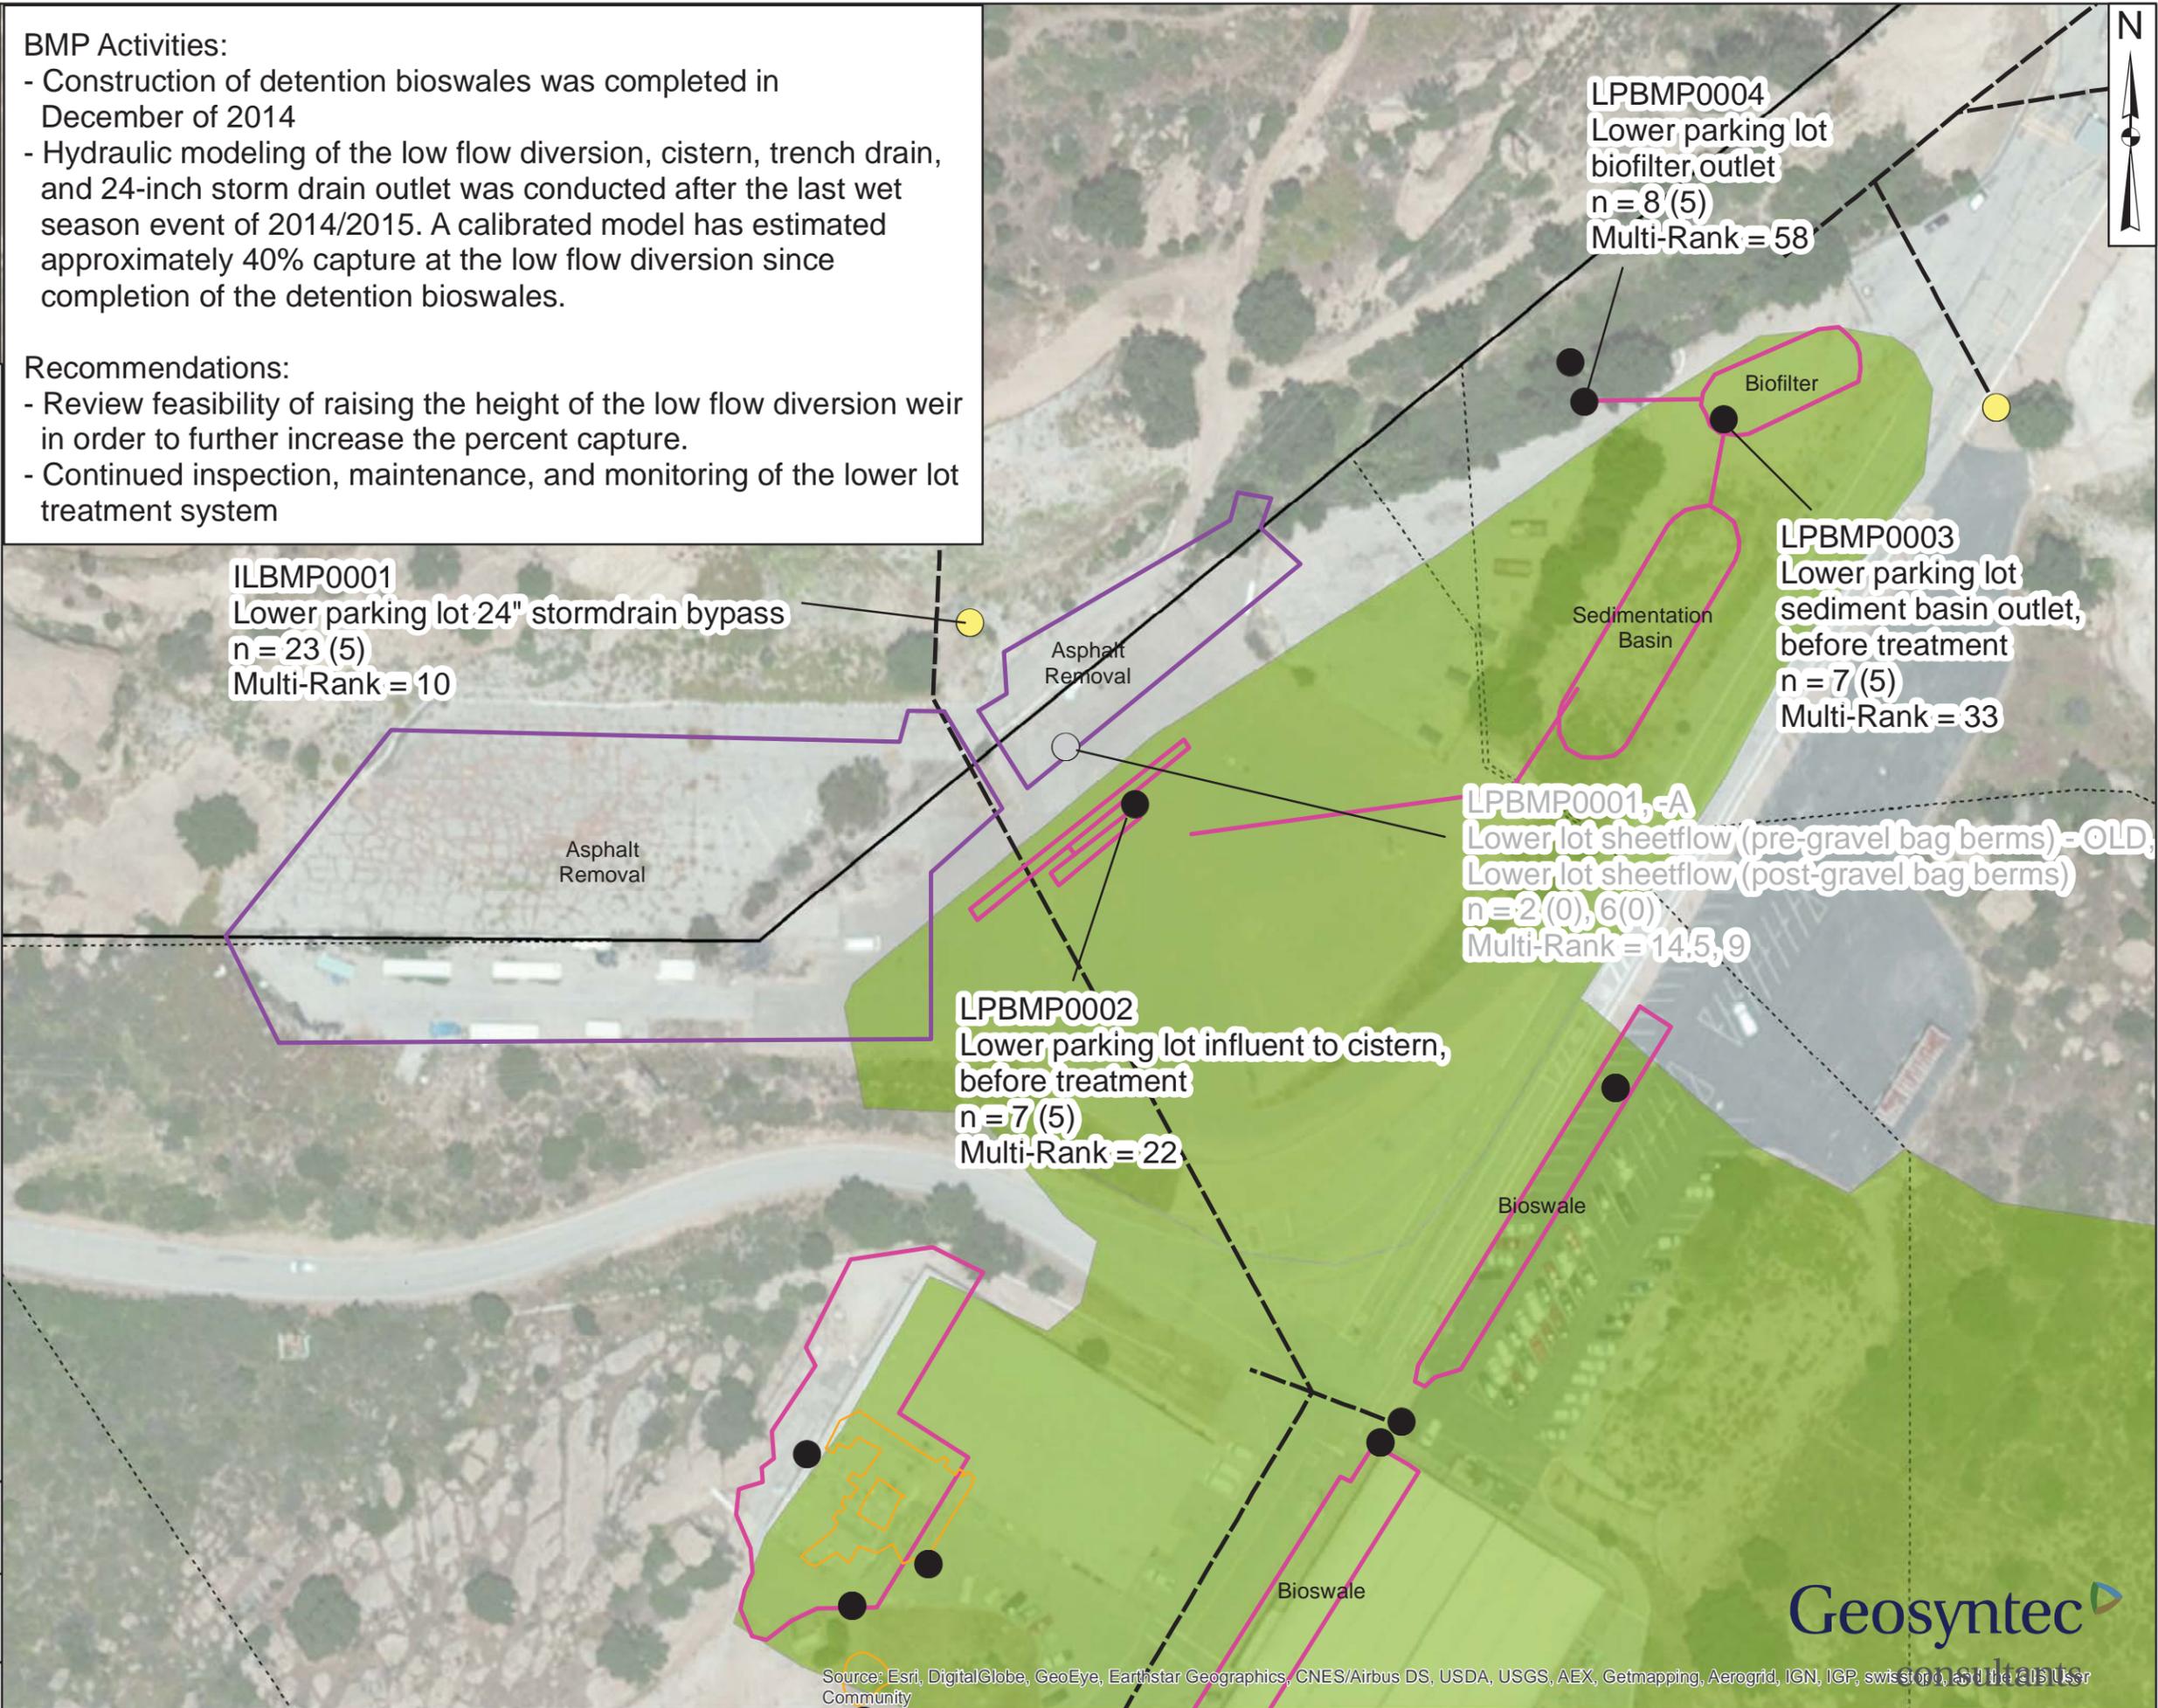
Figure ES-2: Lower Lot
 Santa Susana Field Laboratory
 Ventura County, CA
 August 2015

- Construction of detention bioswales was completed in December of 2014
- Hydraulic modeling of the low flow diversion, cistern, trench drain, and 24-inch storm drain outlet was conducted after the last wet season event of 2014/2015. A calibrated model has estimated approximately 40% capture at the low flow diversion since completion of the detention bioswales.

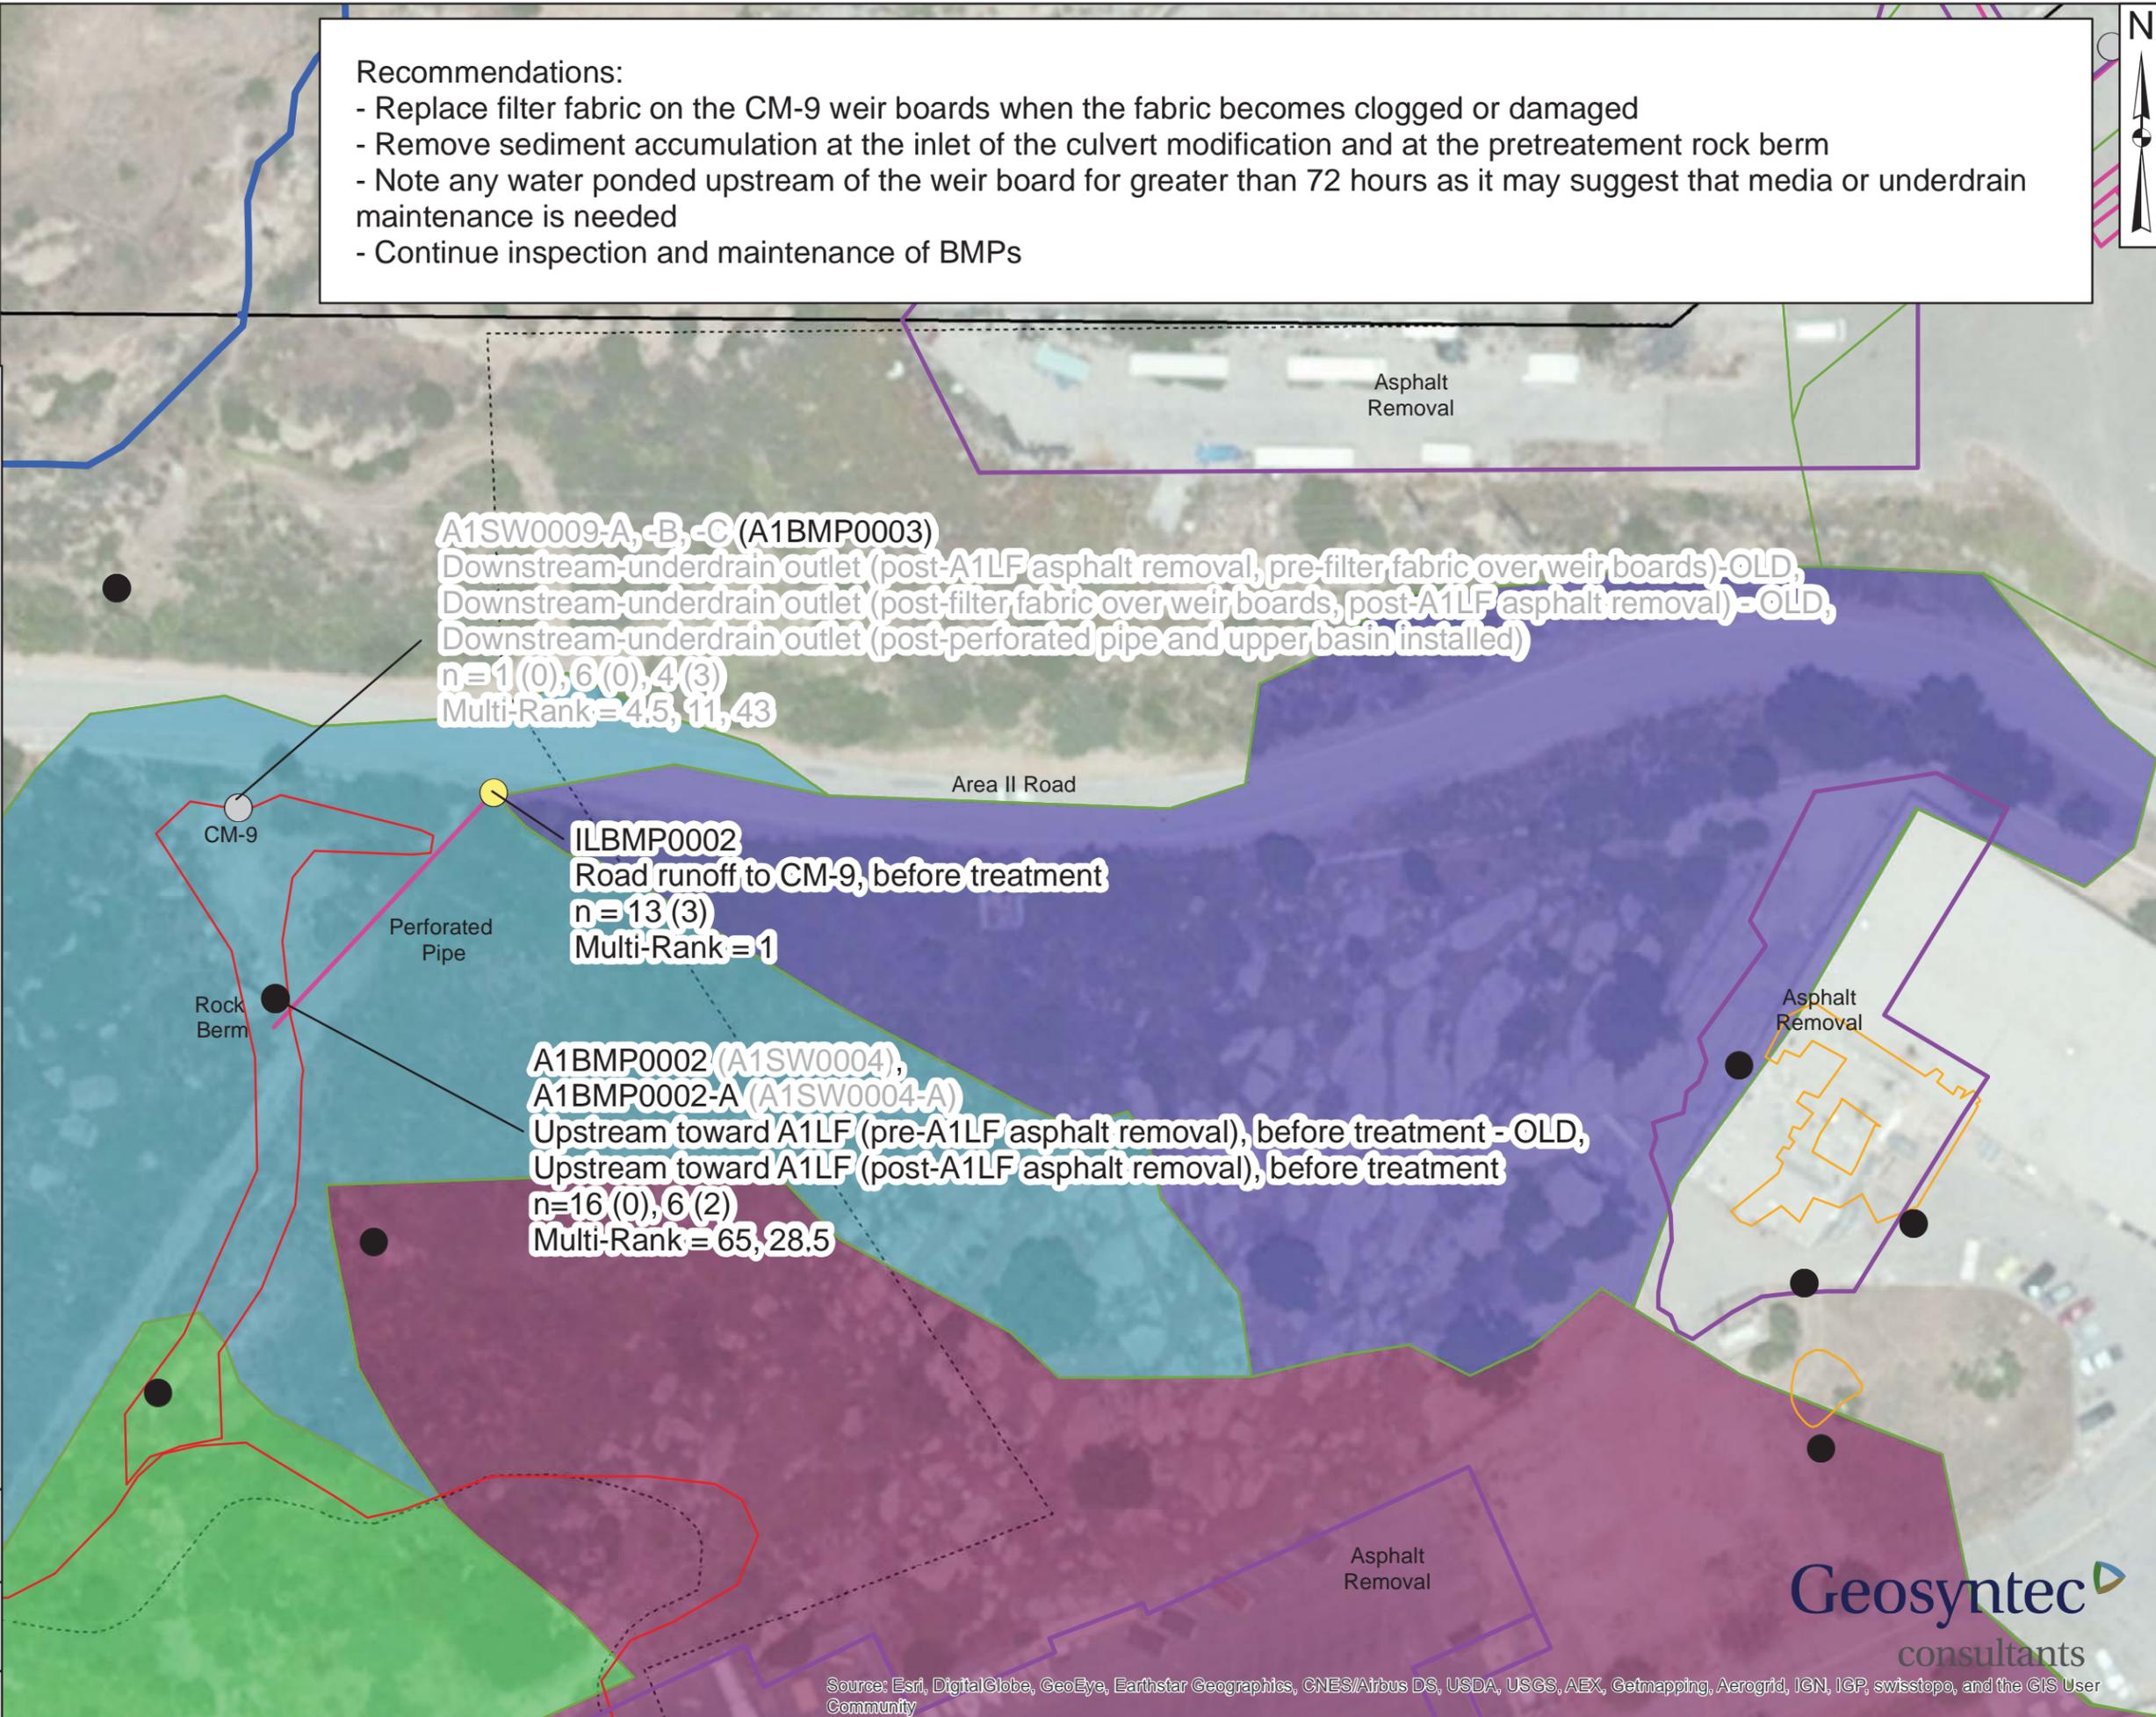
A1SW0009-A, -B, -C (A1BMP0003)
 Downstream-underdrain outlet (post-A1LF asphalt removal, pre-filter fabric over weir boards) - OLD,
 Downstream-underdrain outlet (post-filter fabric over weir boards, post-A1LF asphalt removal) - OLD,
 Downstream-underdrain outlet (post-perforated pipe and upper basin installed)
 n = 1 (0), 6 (0), 4 (3)
 Multi-Rank = 4.5, 11, 43

ILBMP0002
 Road runoff to CM-9, before treatment
 n = 13 (3)
 Multi-Rank = 1

2. **CM-9 (Boeing):** Last year the Panel recommended ongoing maintenance of previously installed BMPs as well as replacement of the filter fabric on the CM-9 weir boards when the fabric became clogged or damaged; monitoring of sediment accumulation at the inlet of the CM and at the new pretreatment rock berm; observation of the duration of water ponding upstream of the weir boards (ponding for greater than 72 hours may suggest that media or underdrain maintenance is needed); and continued performance monitoring, inspection, and maintenance of the underdrain outlets and sedimentation areas, such as in accordance with sedimentation basin maintenance guidance from the CASQA Construction Handbook. All of these recommendations were implemented in the 2014/2015 rainy season. This year the Expert Panel recommends continued implementation of these inspection and maintenance recommendations.

- Replace filter fabric on the CM-9 weir boards when the fabric becomes clogged or damaged
- Remove sediment accumulation at the inlet of the culvert modification and at the pretreatment rock berm
- Note any water ponded upstream of the weir board for greater than 72 hours as it may suggest that media or underdrain maintenance is needed
- Continue inspection and maintenance of BMPs

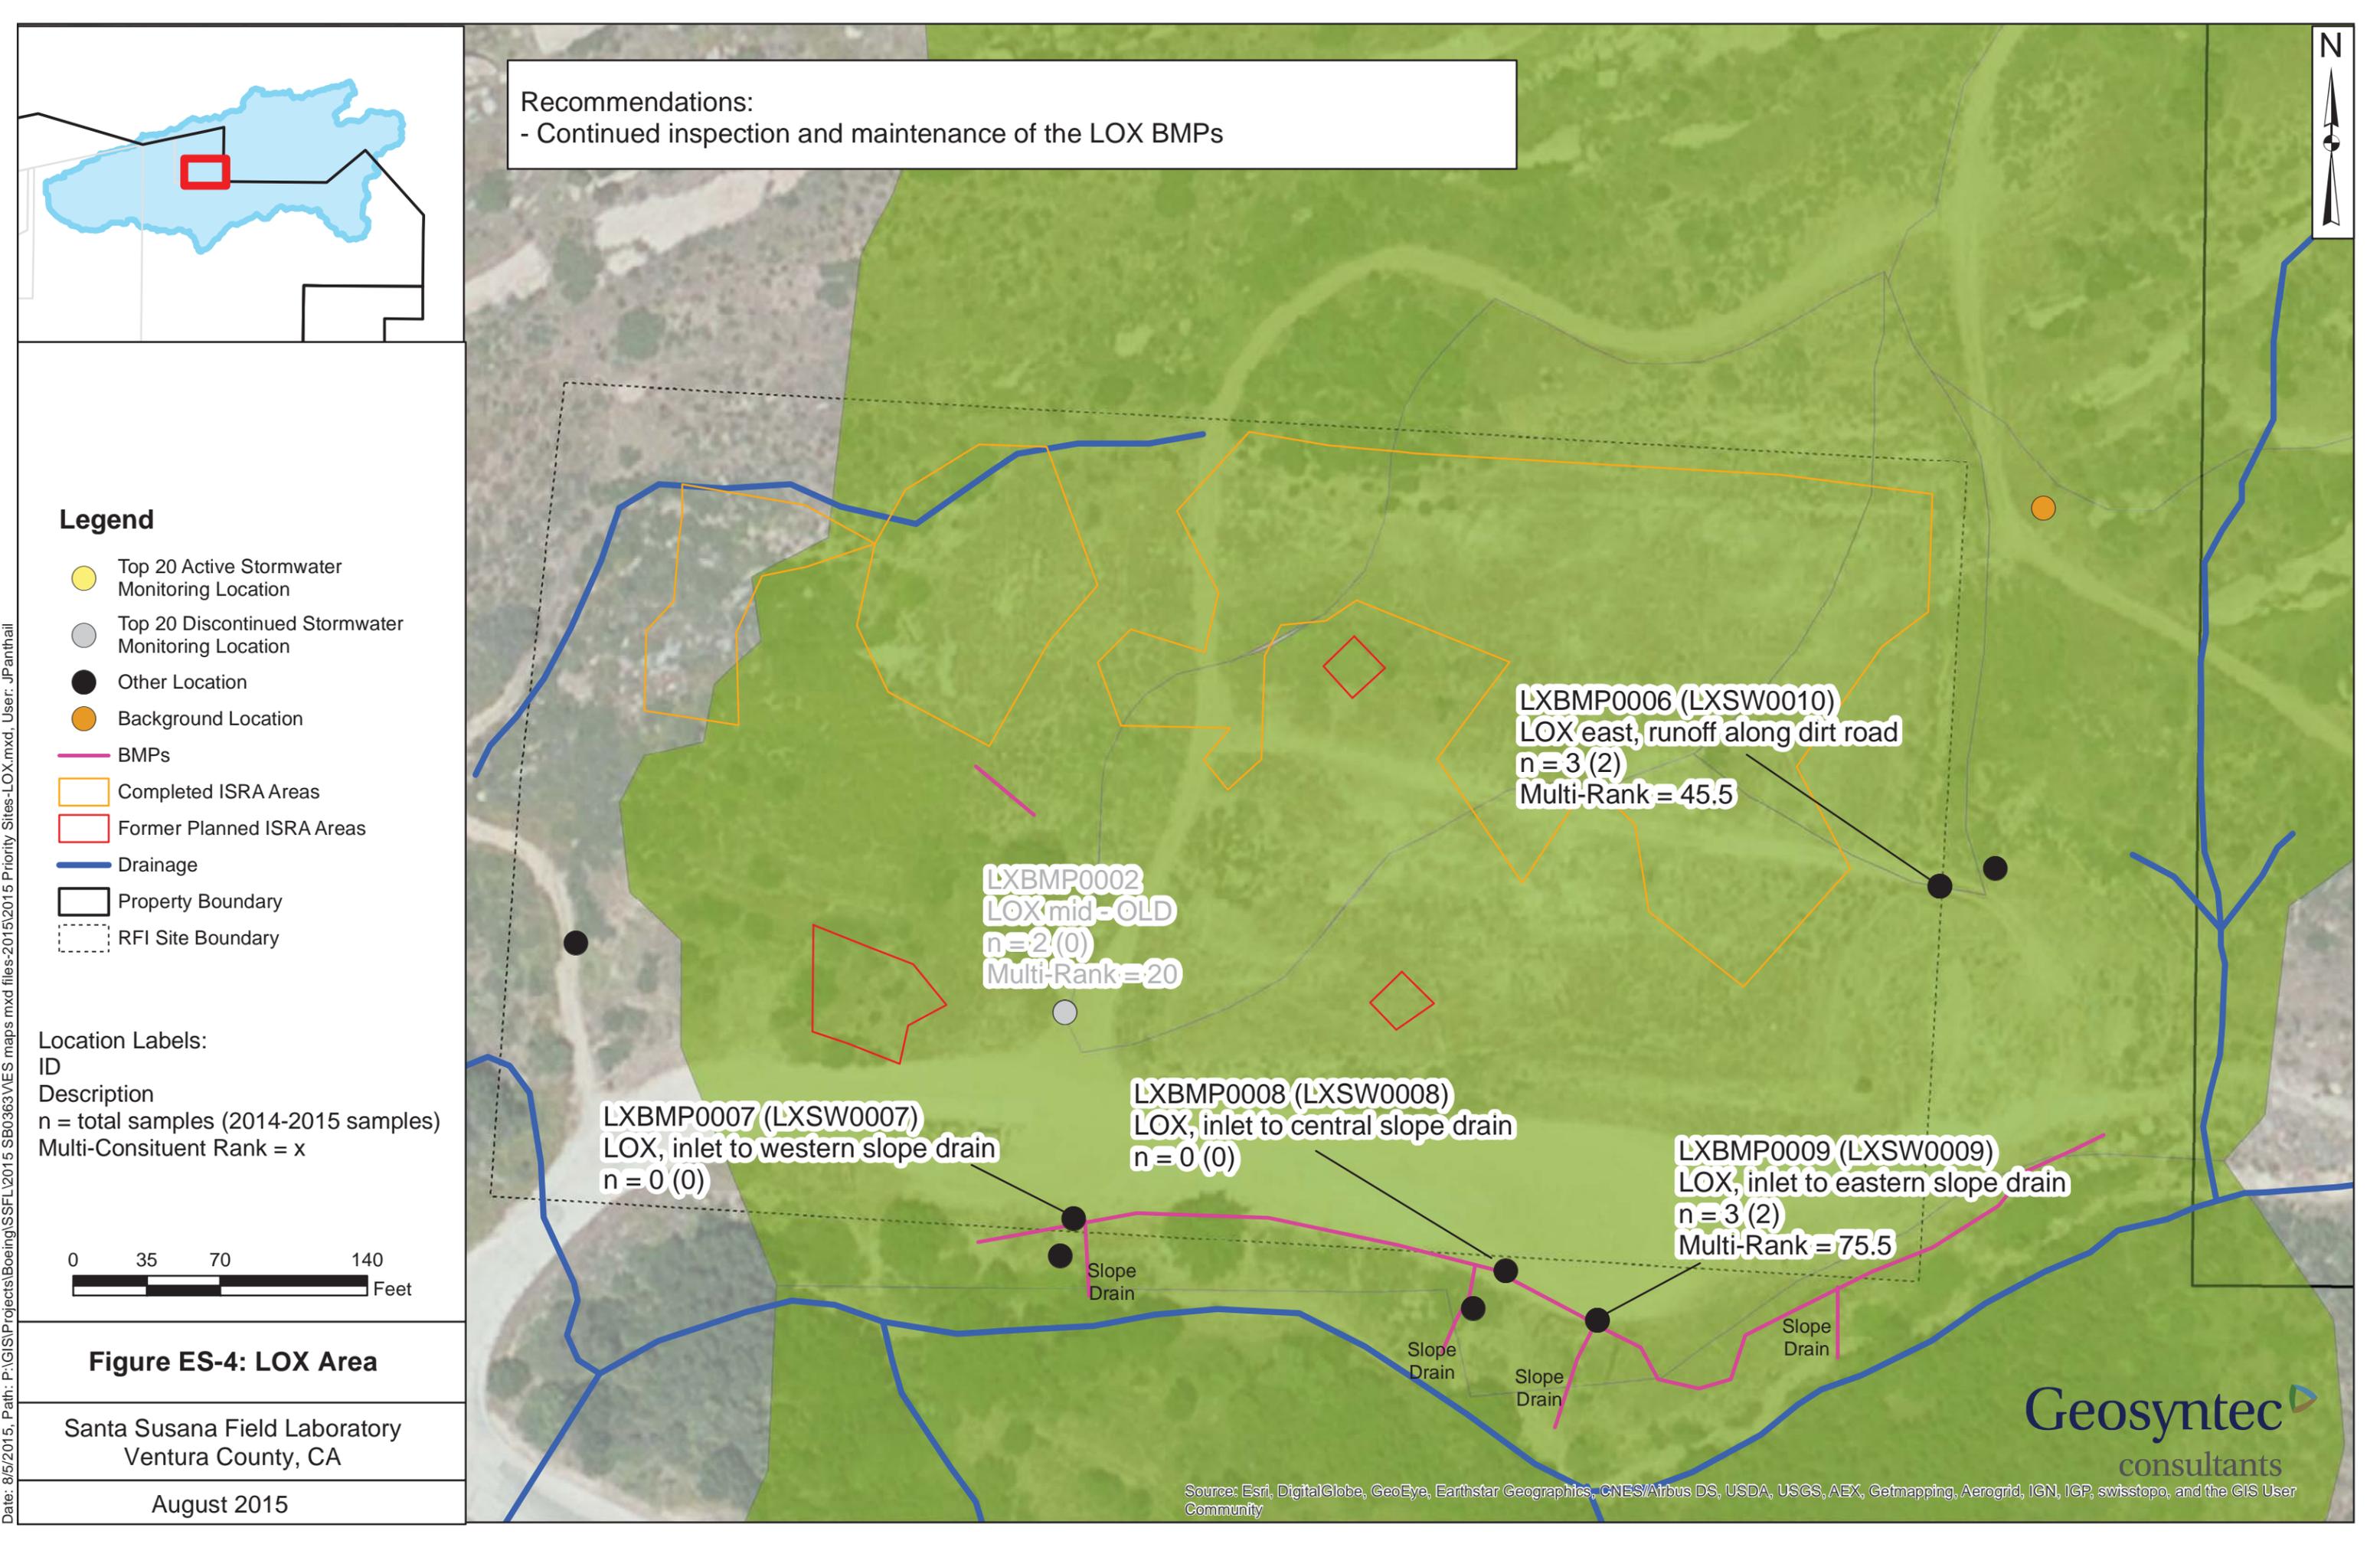
LXBMP0006 (LXSW0010)
 LOX east, runoff along dirt road
 n = 3 (2)
 Multi-Rank = 45.5

LXBMP0009 (LXSW0009)
 LOX, inlet to eastern slope drain
 n = 3 (2)
 Multi-Rank = 75.5

Recommendations:
 - Continued inspection and maintenance of the LOX BMPs

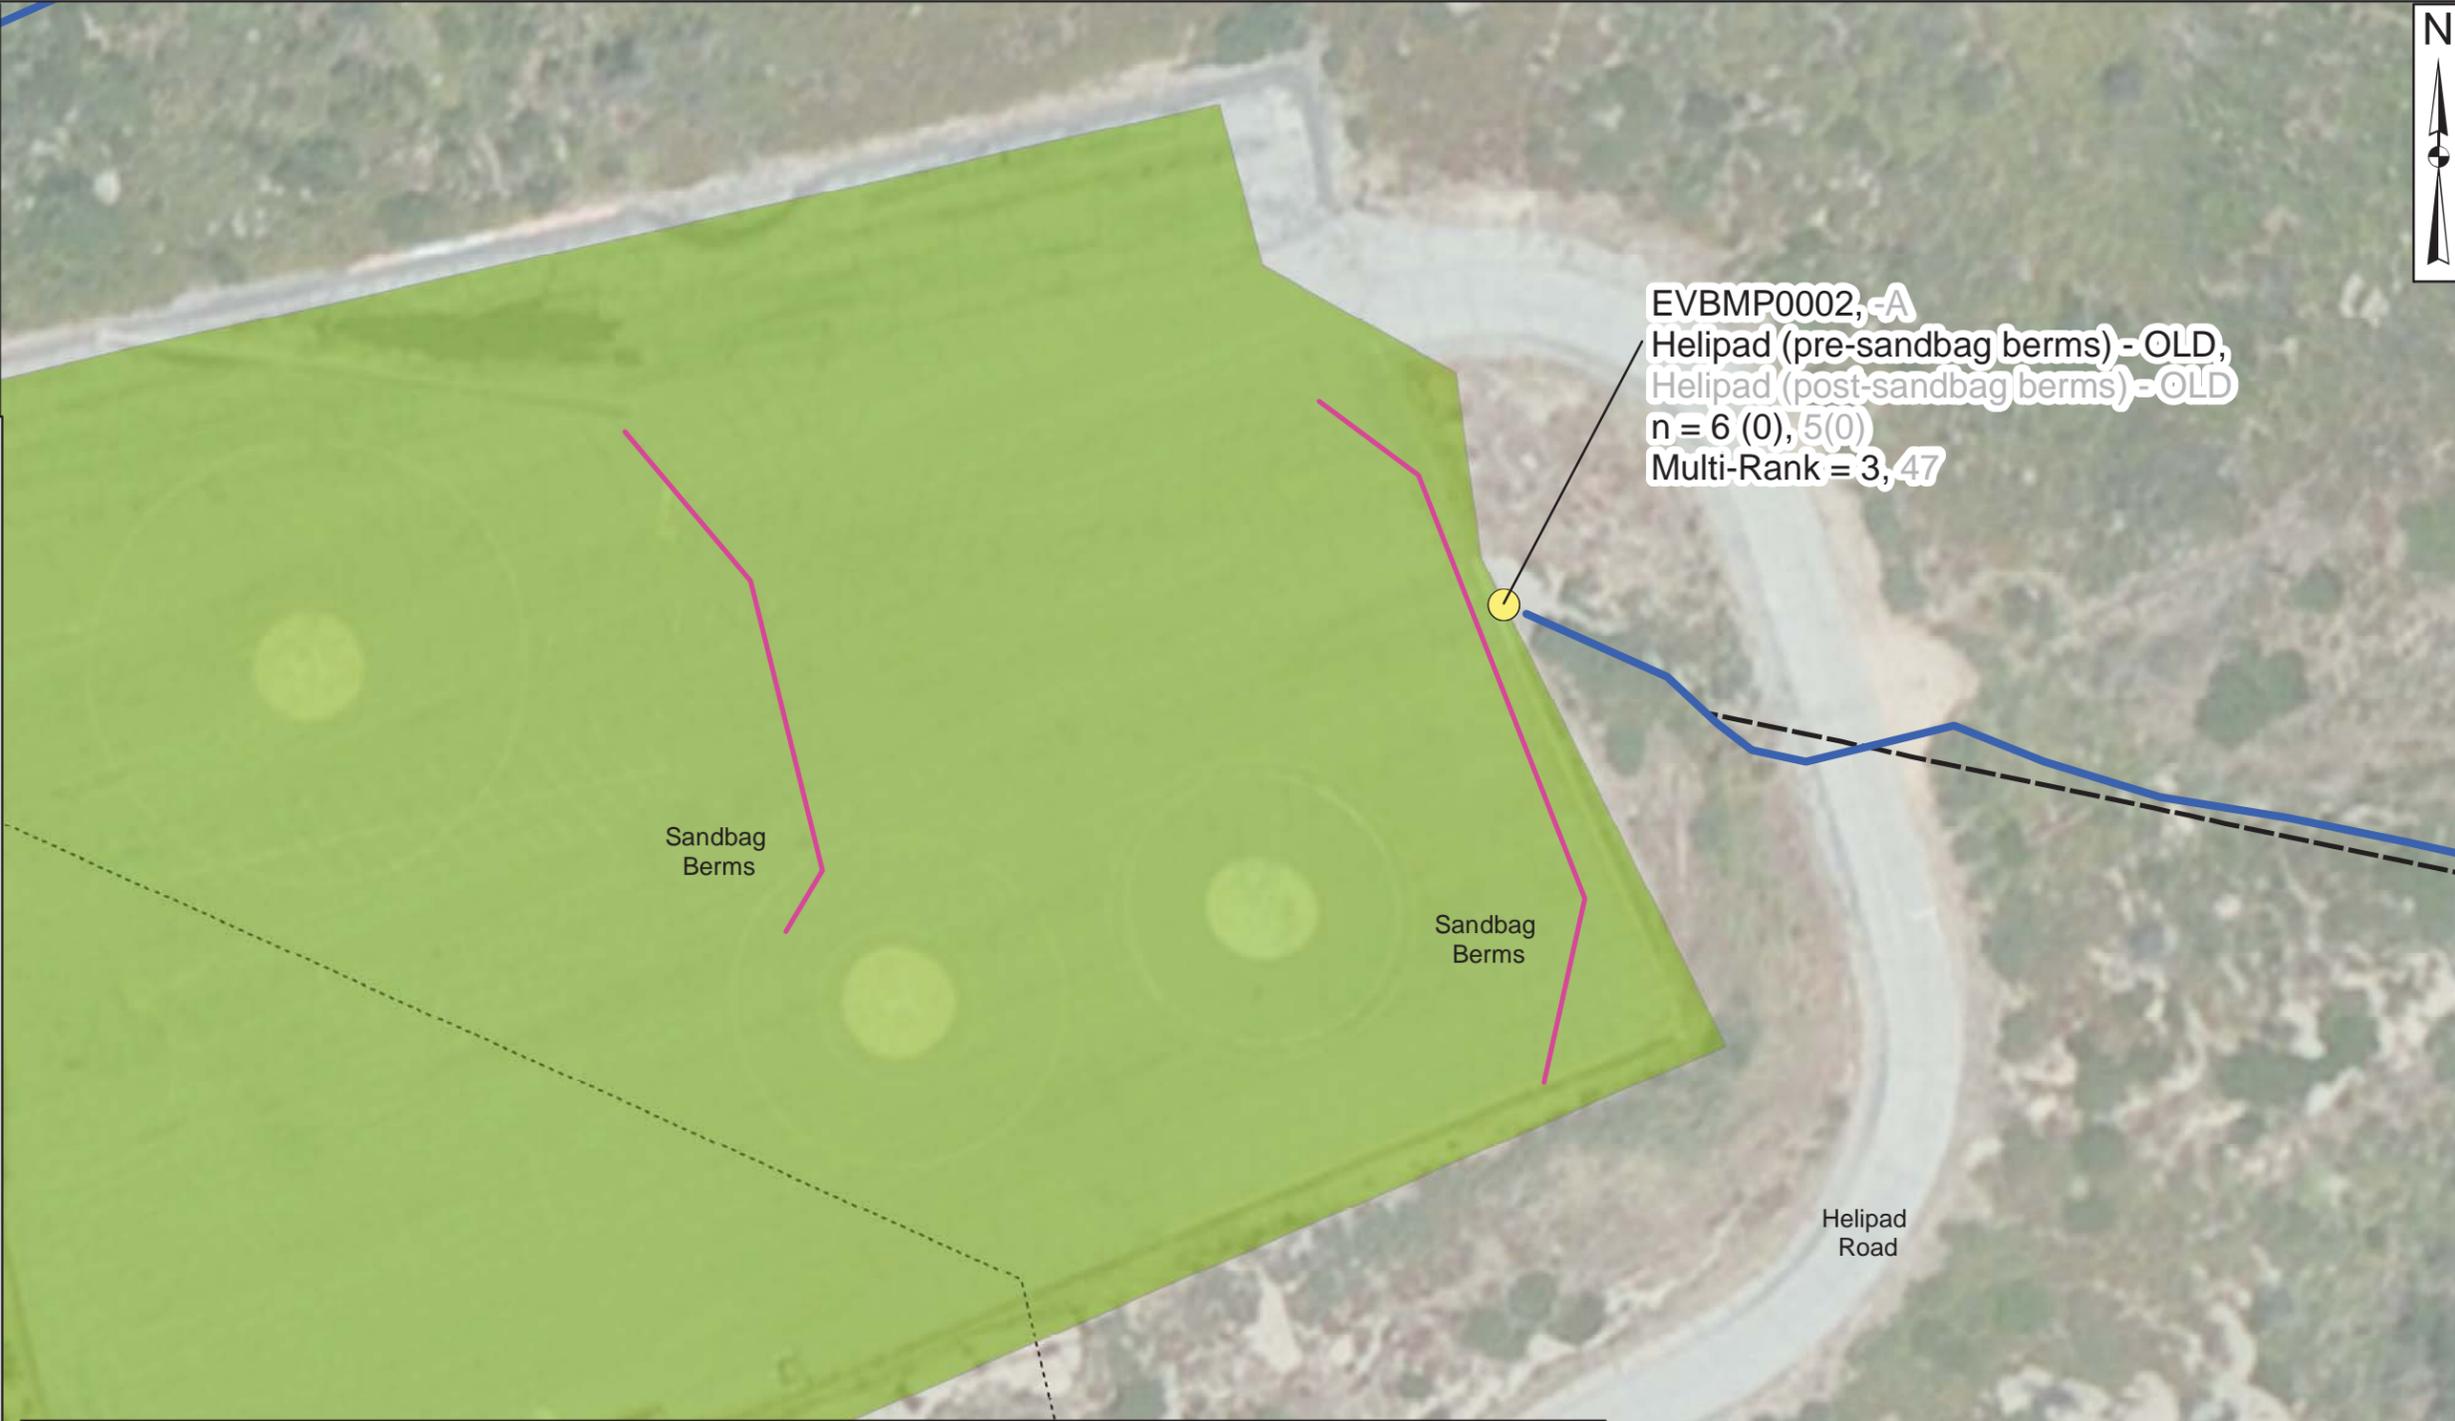
EVBMP0002, -A
 Helipad (pre-sandbag berms) - OLD,
 Helipad (post-sandbag berms) - OLD
 n = 6 (0), 5(0)
 Multi-Rank = 3, 47

Activities:
 - The sandbag berms and pumps were kept in operation during the 2014/2015 season.

- 4. Helipad (NASA):** The sandbag berms were kept in operation during the 2014/2015 season. Last year, the Panel recommended continued operation of this temporary pumping system or equivalent runoff capture and treatment as a temporary interim control strategy until NASA was able to remove asphalt from the Helipad area during planned demolition; this recommendation still stands as the asphalt has not yet been removed and is not expected to be removed until the soil remediation is completed. Last year the Expert Panel also recommended that ponded water be pumped out of the sump area and the storm drain inlet “plug” under Helipad Road be removed when either 1) Outfall 009 is flowing or 2) the sump is overflowing onto Helipad road. The plug was not removed for any events in the 2014/2015 monitoring season. This year, the Panel continues this recommendation and also recommends that representative runoff from the Helipad be collected for analyses at either 1) the slope drain where the plug is located, or 2) where runoff flows into the Helipad road culvert (which would overflow the ELV stormwater treatment BMP and discharge directly into the creek). The Panel also recommends continued inspection and maintenance of the helipad sandbag berms and any future BMPs. The storage volumes behind the sandbag berms is approximately equivalent to runoff volumes from a quarter inch event.

Recommendations:
 - Continued operation of temporary capture system or equivalent runoff capture and treatment as a temporary control strategy until NASA is able to remove asphalt from the Helipad area during the planned demolition.
 - Ponded water should be pumped out of the sump area and the storm drain inlet "plug" under Helipad Road should be removed when either 1) Outfall 009 is flowing or 2) the sump is overflowing onto Helipad Road.
 - Continued inspection and maintenance of the Helipad sandbag berms and any future BMPs.
