**SANTA SUSANA SITE WATERSHED 008 AND
009 BMP SUBAREA RANKING ANALYSIS**

August 2015

Santa Susana Field Laboratory

Surface Water Expert Panel

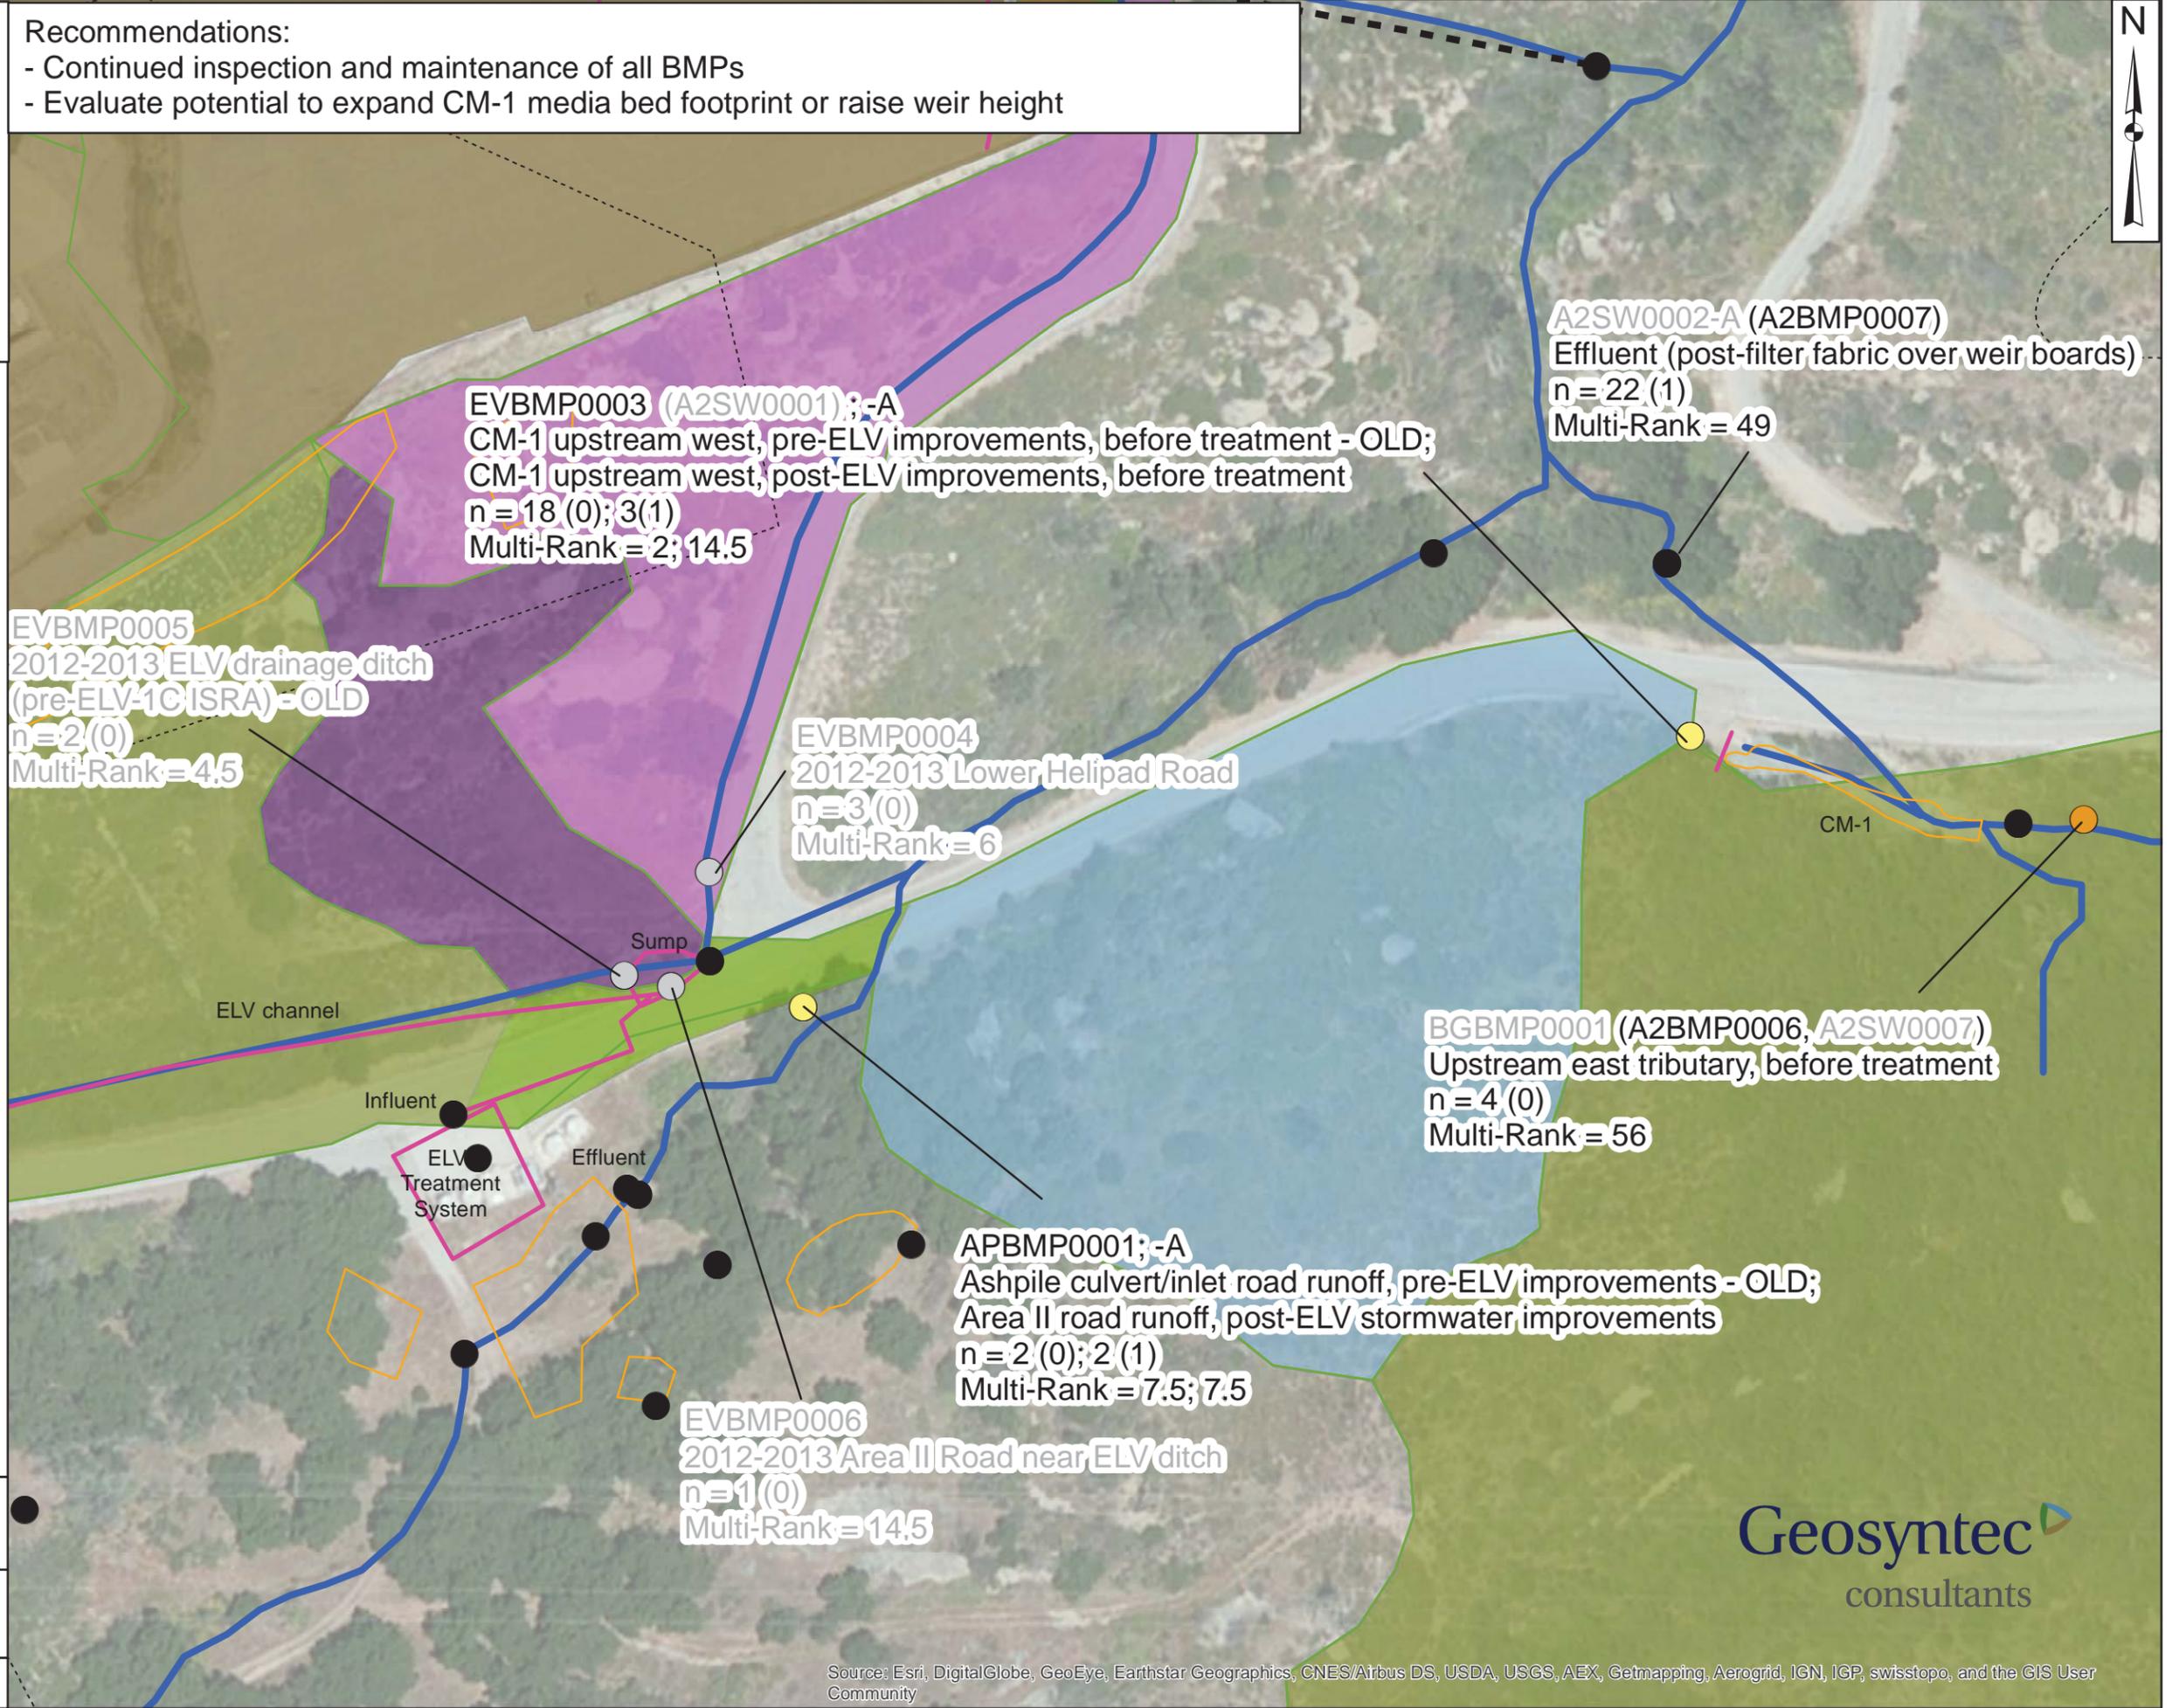
Figure ES-6: ELV/CM-1 Area
 Santa Susana Field Laboratory
 Ventura County, CA
 August 2015

3. **CM-1 (NASA):** In February of 2015, the sandbag berm near CM-1 west was raised and recovered with filter fabric material; no samples have been collected since this improvement. Last year the Expert Panel recommended continued inspection and maintenance of CM-1. The Panel continues to make this recommendation, in addition to potentially increasing the CM-1 capacity by raising the overflow weir or expanding/enhancing the media bed, as deemed feasible. The

Recommendations:
 - Continued inspection and maintenance of all BMPs
 - Evaluate potential to expand CM-1 media bed footprint or raise weir height
