Exceeding Tire Speed Rating During Takeoff

By **Ingrid Wakefield**, Flight Operations Engineer; and **Chris Dubuque**, Service Engineer, Landing Gear Systems

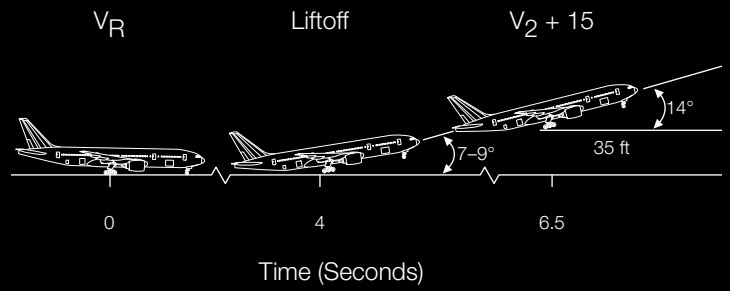
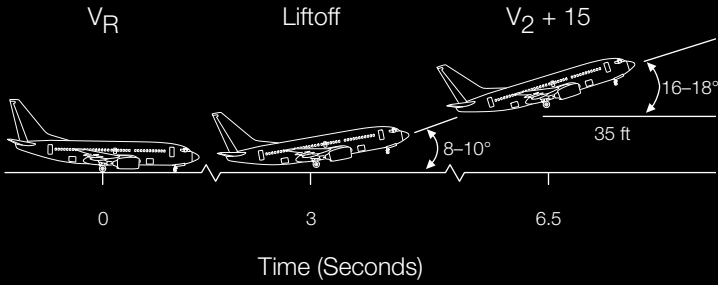
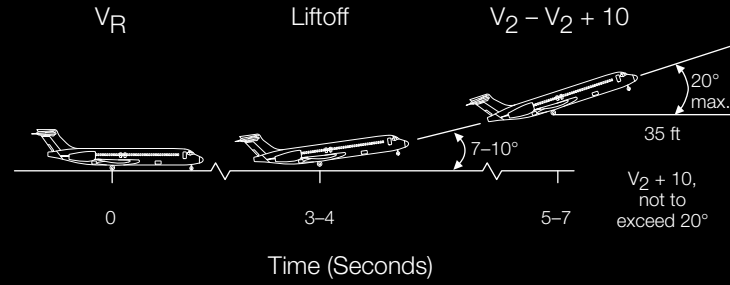
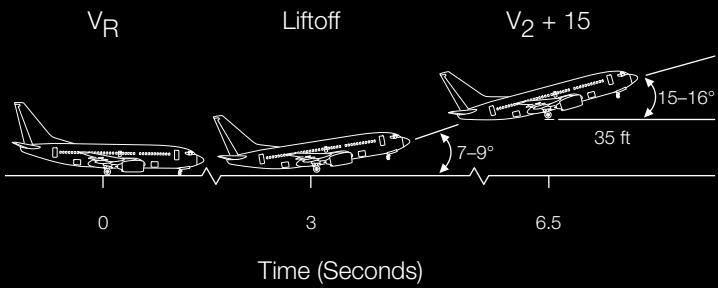
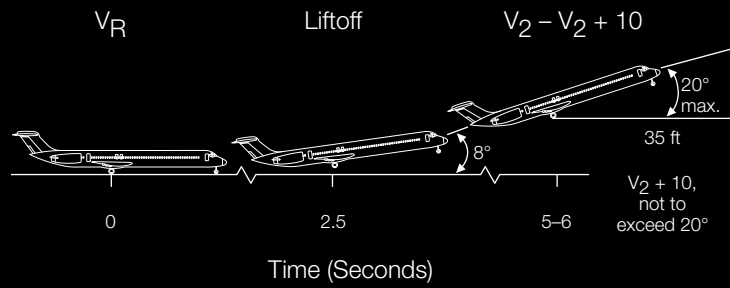
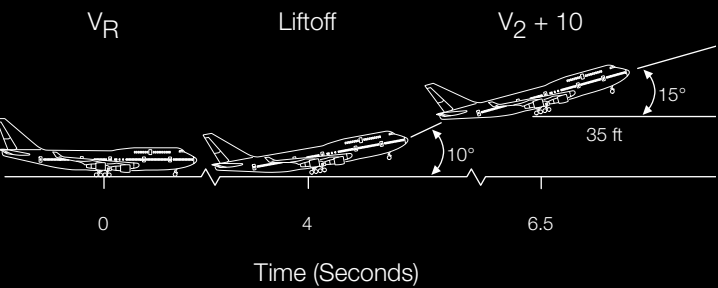
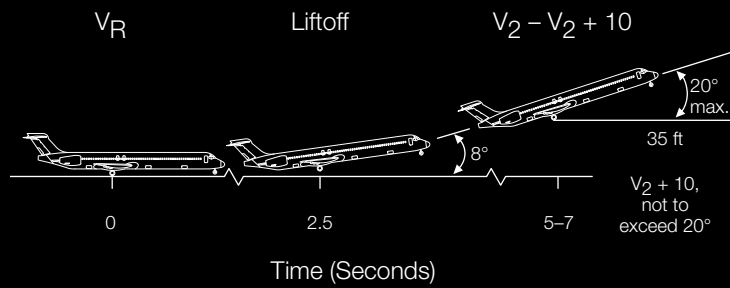
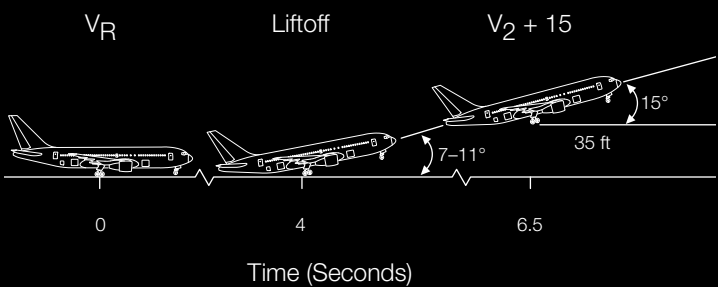
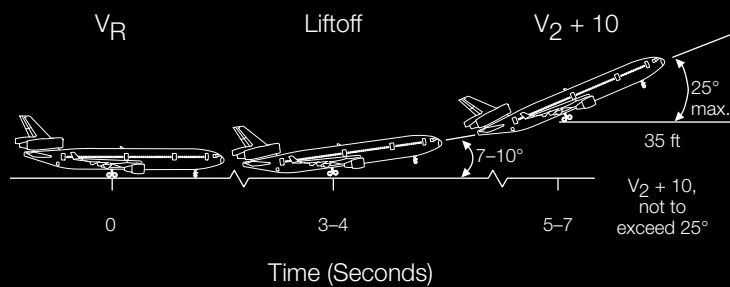
Figure 1: Typical rotation, all engines

The recommended rotation rate of 2 to 3 degrees per second provides adequate tail clearance margins with a target liftoff attitude reached after approximately 3 to 4 seconds.

Boeing publishes a recommended all-engine normal takeoff procedure in the Flight Crew Training Manual (FCTM) for 727, 737 Classic, and Next-Generation 737, 747, 757, 767 and 777 models and in the Flight Crew Operations Manual for 717, MD, and DC models. In order to avoid tire-speed-limit exceedance during takeoff, Boeing stresses adhering to the recommended average all-engine takeoff rotation rate of 2 to 3 degrees per second, which provides adequate tail clearance margins with a target liftoff attitude reached after approximately 3 to 4 seconds (see fig. 1).

When dispatching at or near the tire-speed-limit weight, which is most likely to occur at hot temperatures and high elevations, a slower rotation than the Boeing-recommended 2- to 3-degrees-per-second average may increase the actual groundspeed at liftoff beyond the certified tire speed limit. In addition, a slow rotation or under-rotation could significantly increase the runway distance required to reach the 35-foot point, which is another important reason for adhering to the Boeing-recommended rotation procedure.

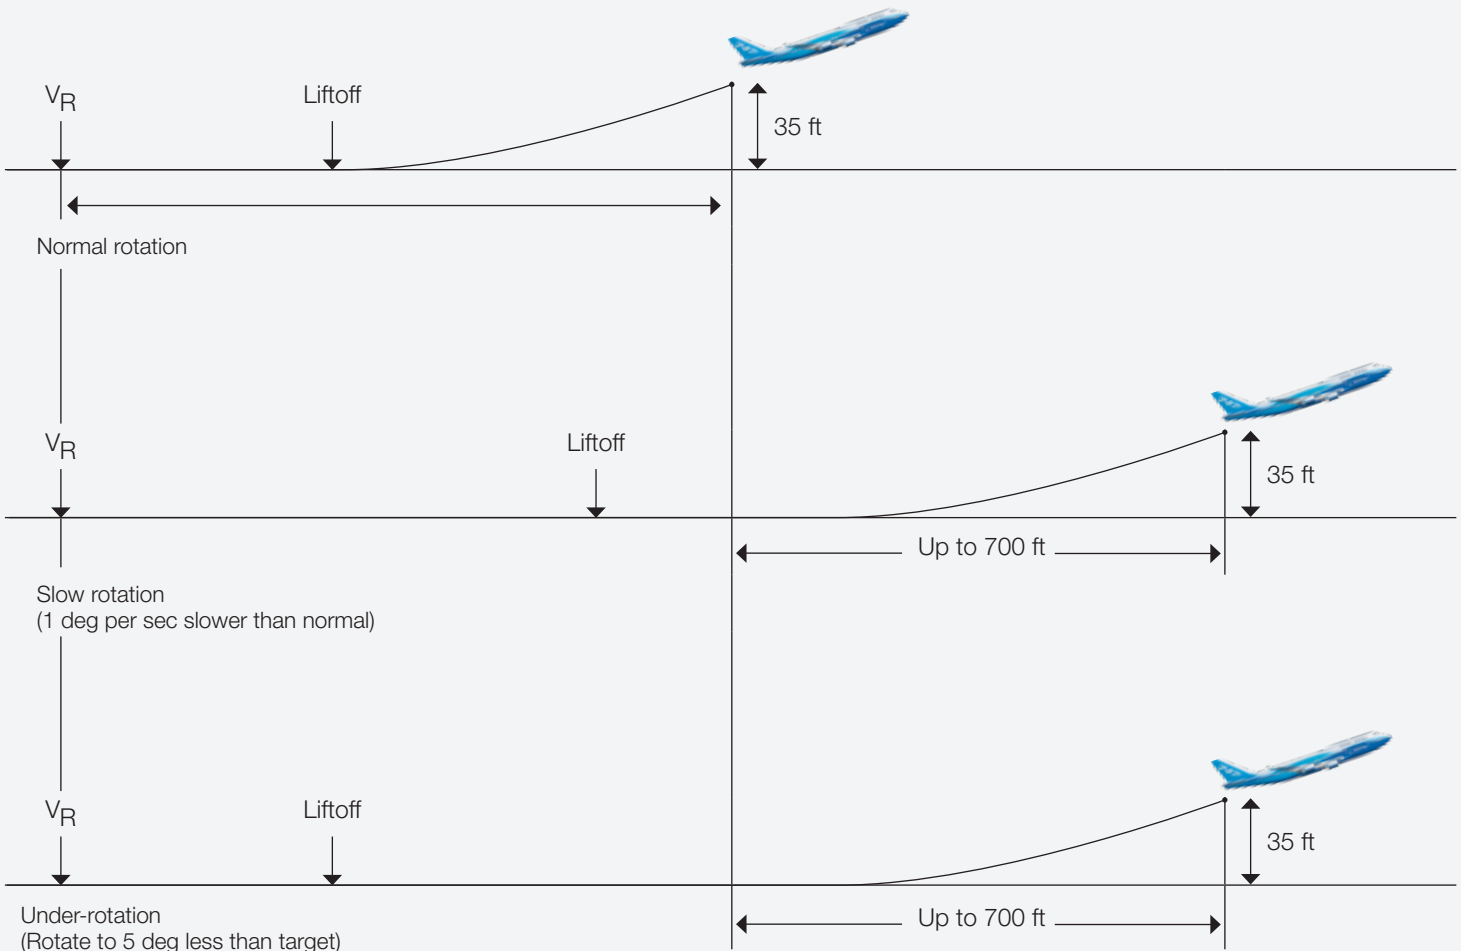
Figure 3: Effect of slow or under-rotation on all-engine takeoff distance

A 747-400 taking off with a rotation rate that is 1 degree per second slower than normal can result in a 4- to 5-knot liftoff speed increase.

The same case study showed that a rotation rate that is 1 degree per second slower than normal can result in a 4- to 5-knot liftoff speed increase. This is in addition to the increase in all-engine takeoff distance associated with the slow takeoff rotation (see fig. 3).

This illustrates how a slower-than-normal rotation rate can easily use up what may seem like a large tire-speed-limit margin, especially if paired with a higher tailwind component than accounted for in the takeoff analysis used for dispatch.
