Improving the Service Life of

FLIGHT DECK

WINDSHIELDS

JOHN HUFF
SERVICE ENGINEER
COMMERCIAL AVIATION SERVICES
BOEING COMMERCIAL AIRPLANES

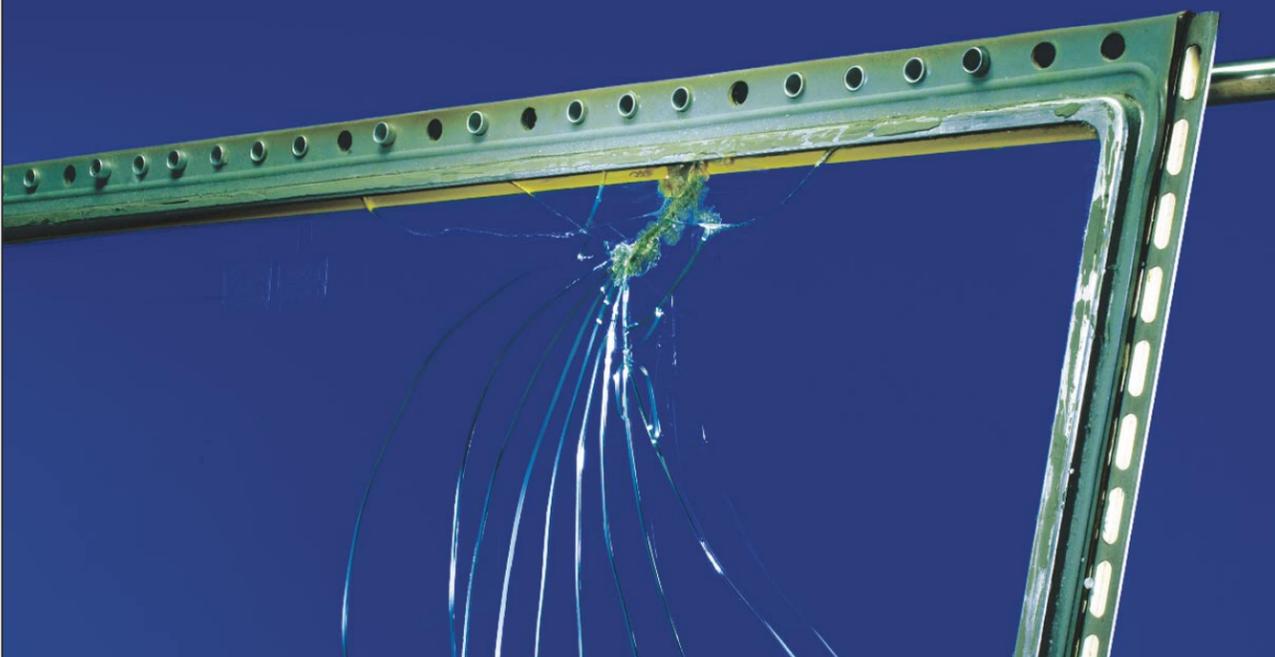
4 BROKEN OUTER FACE PLY CAUSED BY ARCING

- The most common problem with flight deck windshields is in-flight cracking of the outer ply (fig. 4).
- Scheduled inspection of windows is the most effective means to reduce system interruptions caused by unscheduled windshield removals.

The most common problem that airlines have with flight deck windows is in-flight cracking of the outer ply (fig. 4). Conditions that lead to cracking begin with moisture around the aerodynamic seal (also referred to as the aero seal, moisture seal, or hump seal).

Moisture ingress eventually causes delamination, heat-coating problems, and arcing, which—if not corrected—lead to cracking of the outer ply. The aerodynamic seal around the perimeter of a window is subject to erosion by wind and rain. Maintaining the aerodynamic seal in good condition is critical in preventing erosion and moisture ingress and improving the windshield service life. The recommended visual inspection of the aerodynamic seal for erosion, cuts, nicks, and overall

Airlines should ensure that the power connections are tight and sealed properly to help prevent arcing. Typical information on maintenance procedures can be found in the AMM or SRM.

Each airline should review all applicable Boeing-, Douglas-, and supplier-issued service bulletins, service letters, and similar advisories to evaluate the potential effects of windshield-related issues on its fleet. For example, Boeing service bulletin 737-56-1010 (Sept. 2, 1999) recommends replacement of windshields on certain models if they do not pass a dielectric leak check. Replacement helps prevent electrical arcing and reduces system schedule interruptions.

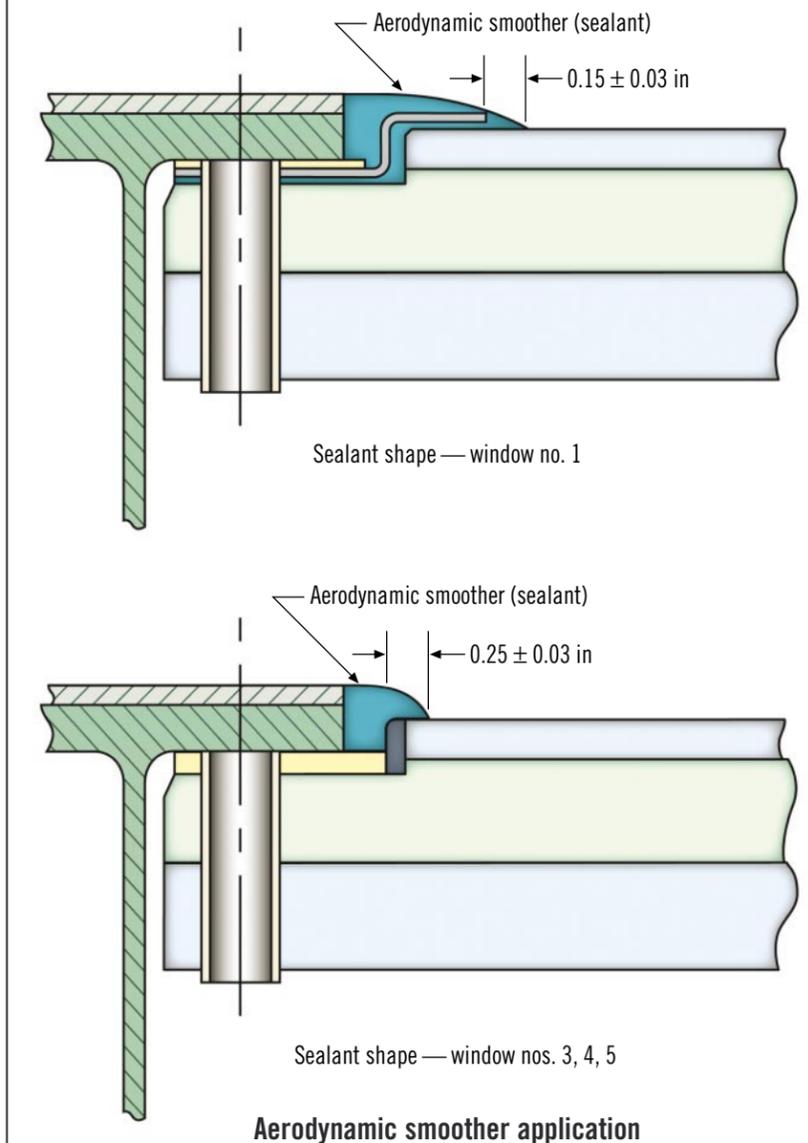
condition and repair is discussed in the applicable sections of the AMM or SRM for each airplane model. Figure 5 shows a typical repair diagram of the aerodynamic seal.

5 TYPICAL REPAIR DIAGRAM — 737-300/-400/-500 AIRCRAFT MAINTENANCE MANUAL

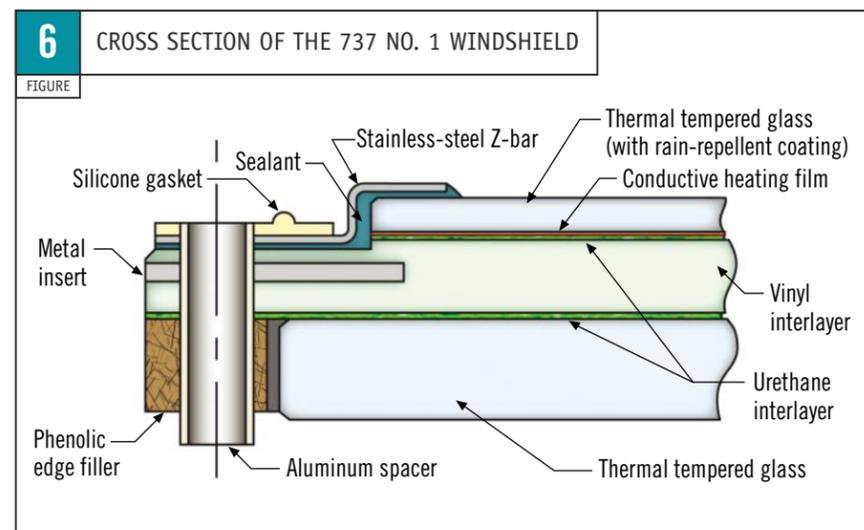
Changes to the 737 no. 1 windshield illustrate how design improvements can significantly improve service life (fig. 6). As mentioned earlier, Boeing data collected from reporting operators show a significant improvement in service life for 737 no. 1 windshields manufactured after November 1992. This corresponds with several important design changes implemented by Boeing that eliminated cracking of the vinyl interlayer and slowed moisture ingress into the windshield, thereby reducing the incidence of delamination, electrical arcing, and outerpane breakage. The design changes included the following:

- Adding no-slip planes in the vinyl interlayer to help prevent vinyl cracks.
- Adding a urethane interlayer between the vinyl and glass to act as a buffer for mechanical and thermal stresses.
- Adding a stainless-steel Z-bar to form a barrier against moisture.
- Improving the sealant used under the Z-bar to perform better when exposed to ultraviolet light, low temperatures, and moisture.
