Correcting the Effects of Magnetic Variation

Airlines should make sure they update their inertial reference systems to the latest magnetic variation (MagVar) tables in order to avoid potentially hazardous magnetic heading-related navigation errors.

By **Benjamin Weinstein**, Avionics Design Engineer

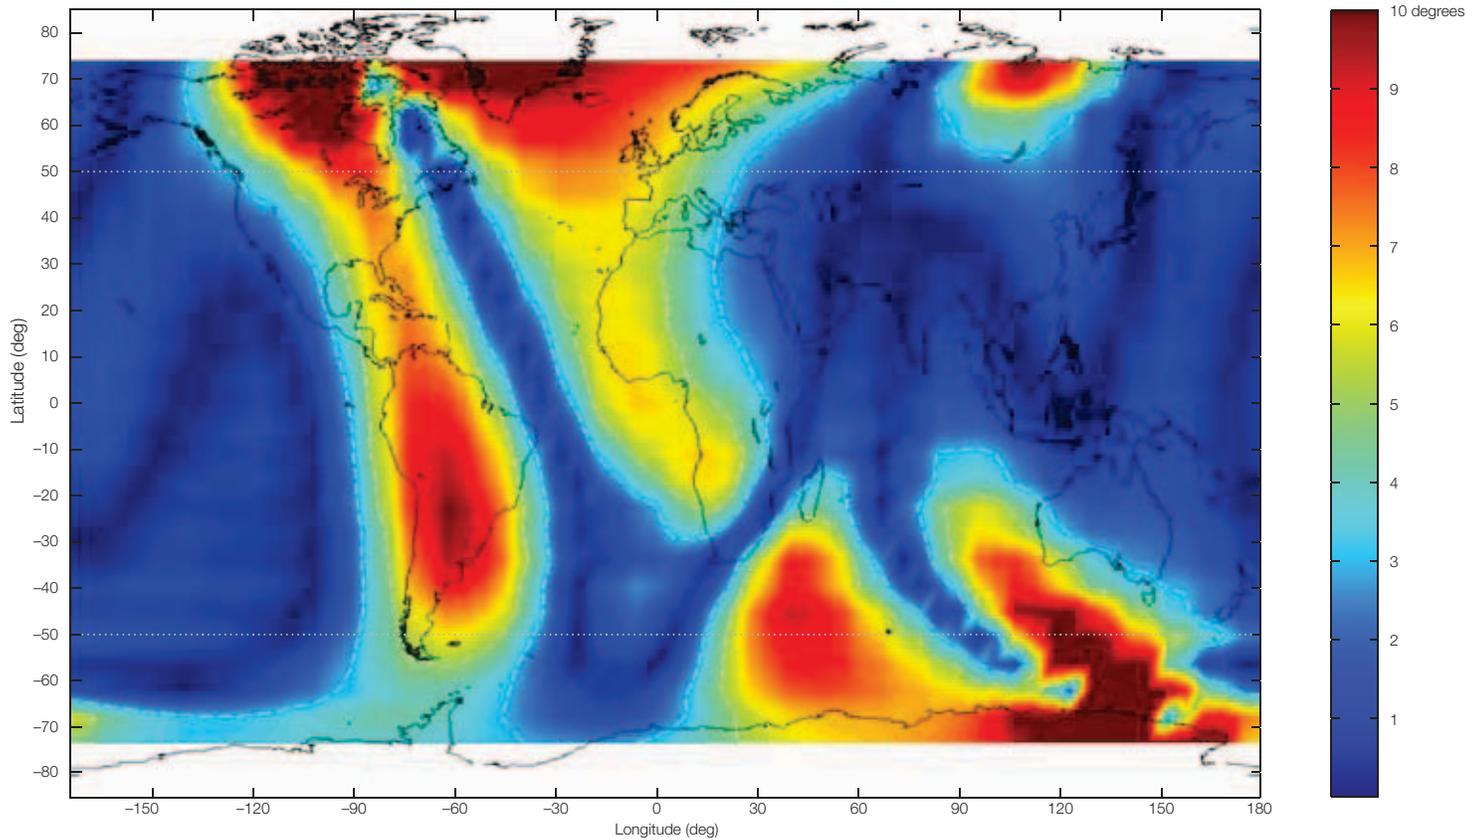
Figure 1: Deviation in degrees of magnetic variation tables, 2005 vs. 1980

Airplanes operating in certain areas of the world — primarily South America and northern parts of North America — can have heading errors exceeding 10 degrees. (Dark red indicates greater than 10 degrees of error; dark blue indicates 0 degrees of error.)

approaches in certain parts of the world can experience heading errors exceeding 10 degrees (see fig. 1).

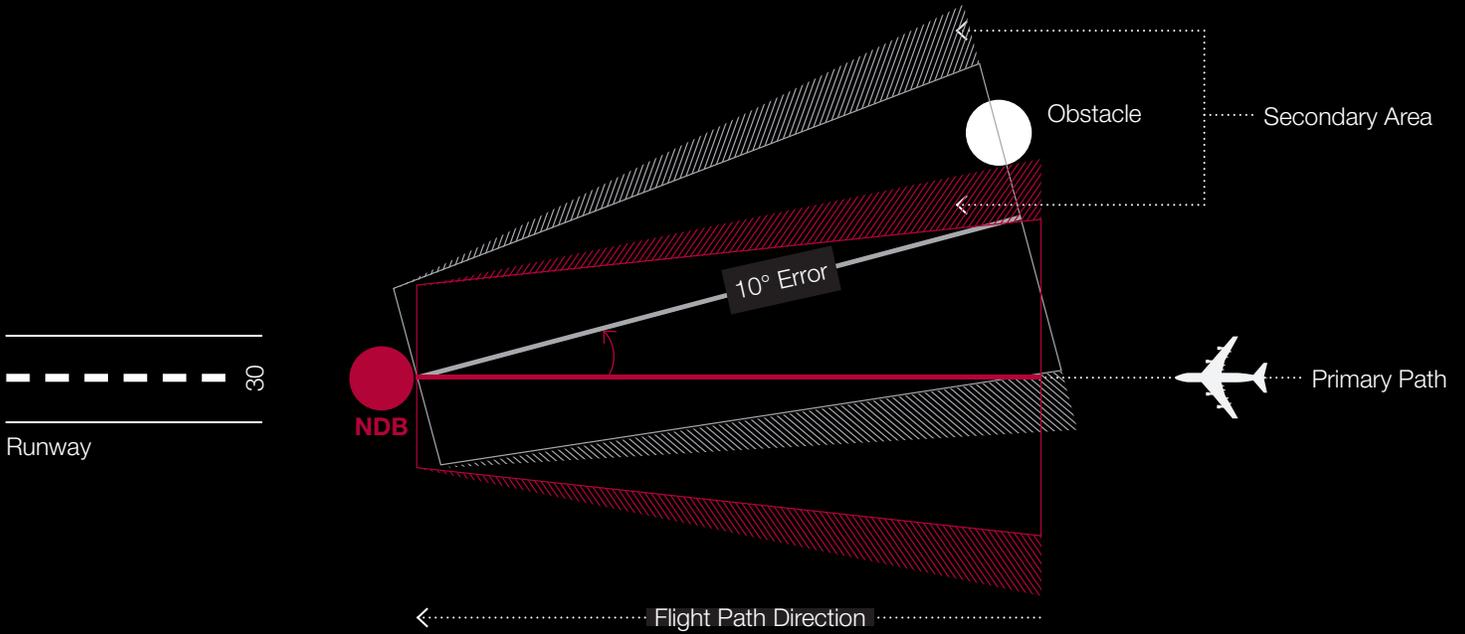
Figure 2: Effect of 10-degree MagVar error when flying toward NDB

When flying toward the NDB: Can rotate the perceived approach into the secondary area, which may allow the airplane to be outside the secondary area and increases the hazard to the airplane (see fig. 2).

Flying toward the NDB with MagVar information that is off by 10 degrees may cause a pilot to be in the path of obstacles or other dangers.

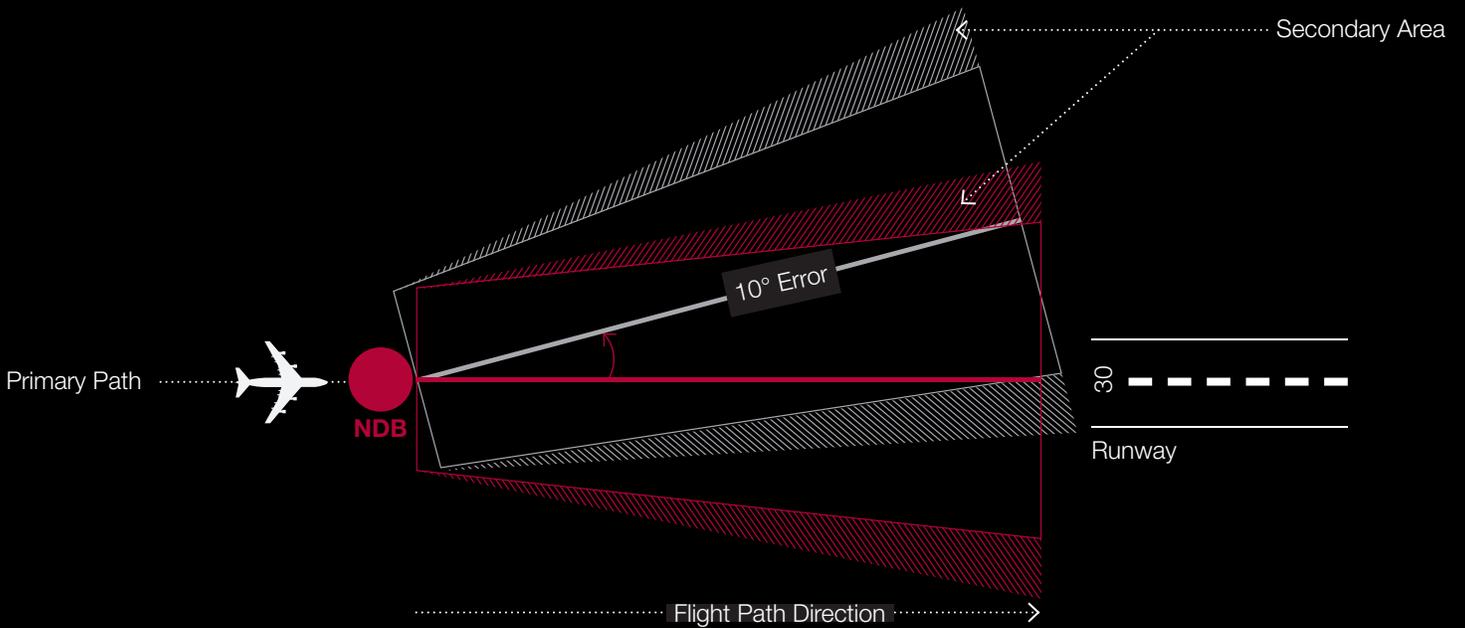
Figure 3: Effect of 10-degree MagVar error when flying away from NDB

Flying away from the NDB with MagVar information that is off by 10 degrees can cause the pilot to be off course up to 2.5 miles to the right or left of the runway on final approach.

When flying away from the NDB: Can cause the pilot to be off course up to 2.5 miles to the right or left of the runway on final approach (see fig. 3).

Boeing strongly recommends that airlines flying with 1980 MagVar upgrade to the latest MagVar tables. IRU MagVar software updates are performed by Honeywell at its service centers, by approved third-party repair centers, or by airlines approved by Honeywell. Airlines should incorporate these updates into their established

maintenance schedule. The MagVar update is also necessary to maintain certification compliance in areas of large magnetic change. Consult your local regulatory agency for local compliance requirements.
