**Subject: Post-Fire Vegetation Recovery – Phase 1
Boeing Santa Susana Field Laboratory
Geosyntec Project: SB0363A**

Post-Fire Vegetation Recovery Reconnaissance Survey	1
Report for Boeing Santa Susana Field Laboratory	1
Purpose and Scope	1
Introduction.....	1
Methodology.....	1
Qualitative Survey Methodology.....	4
Visual Observation.....	4
Photographs.....	5
Quantitative Survey Methodology.....	7
Results.....	8
Vegetation Community Descriptions.....	8
Chaparral/Scrub	8
Oak Woodland	10
Coast Live Oak Riparian Forest.....	10
Southern Willow Scrub, Mulefat Scrub, and Freshwater Marsh	14
Drainages and Open Water	14
Non-Native Grassland/Ruderal.....	16
Burned Shrub Stem Diameter	16
Burned Shrub Regeneration.....	16
Mulched Areas	19
Transect Data	19
Summary of Preliminary Findings of Post-Fire Vegetation Recovery.....	23
Time to Recovery: Literature Review.....	25
Time to Recovery: Preliminary Evaluation of Project Site	26
Literature Cited and Reviewed	29

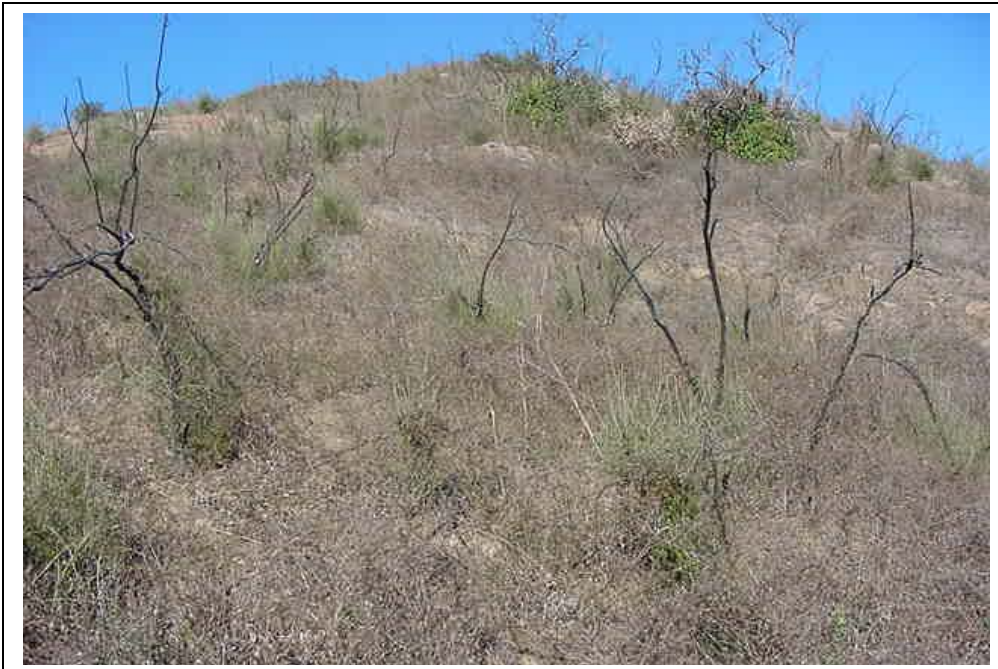
FIGURE 3

*Burned Chaparral/Scrub (Aerial Mulched) – Southeast Facing Slope in Outfall 2 Watershed
N 34.21731°, W 118.70590°*

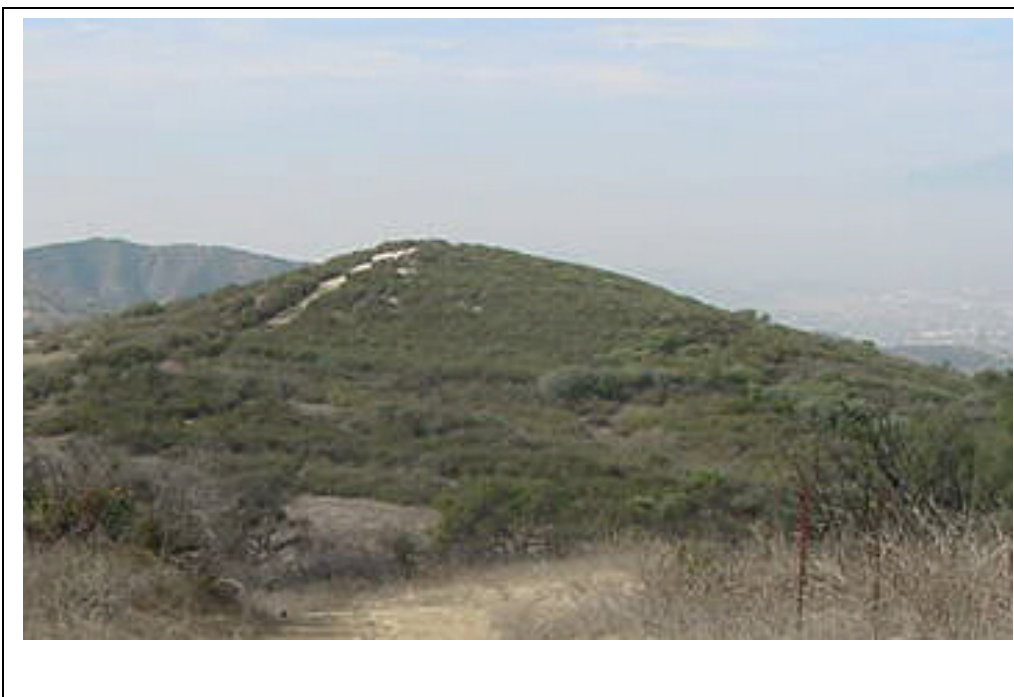
*Unburned Chaparral/Scrub –South Facing Slope in Outfall 6
N 34.22623, W 118.71686*

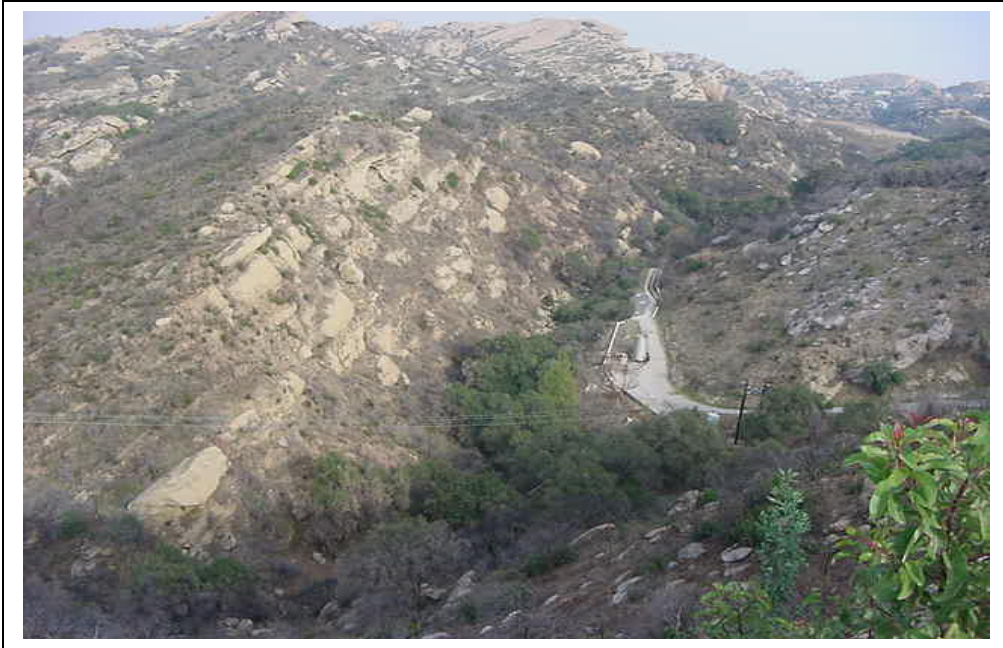
FIGURE 4

*Looking East from Helipad at Outfall 9 Drainage; Oak Woodland up Canyon Burned; Large Patch In Center (Coast Live Oak Riparian Forest) Mild Burn Damage
N 34.23825°, W 118.69604°*

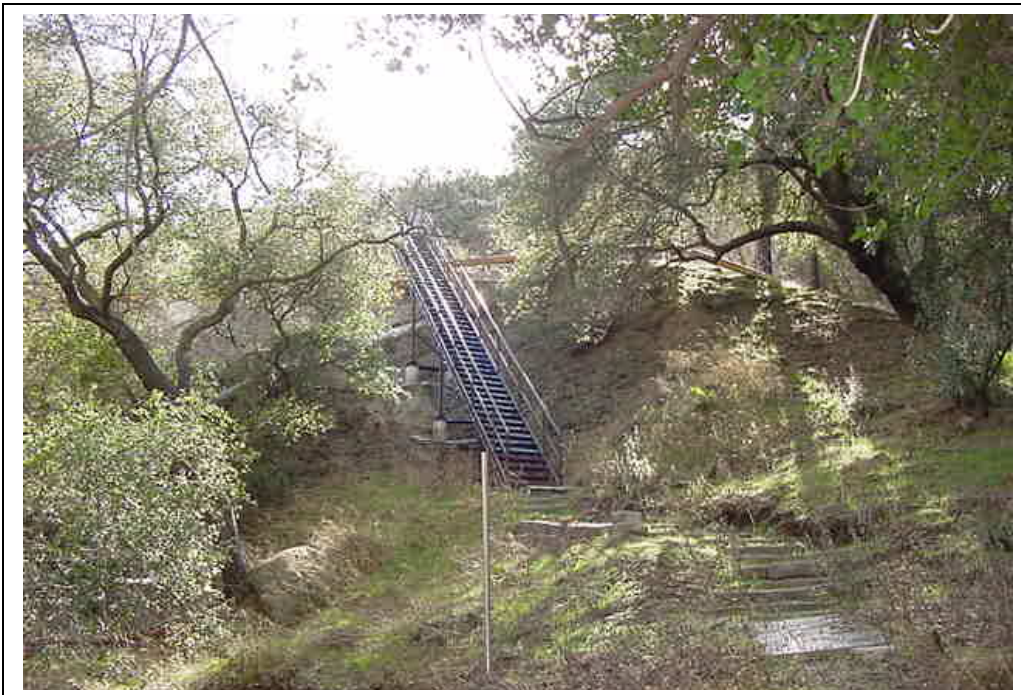
annual grasses. The oak trees in this area sustained little fire damage as only the fringes of the lower canopy were burned; there was no evidence of fire damage to the understory at the time of the survey. Oak trees in the oak woodland areas upstream and downstream from this area sustained more burn damage to their canopies and understory.

*Coast Live Oak Riparian Forest – Along Creek at Outfall 9 (Mildly Burned on Edges of Oak Canopy, No evidence of Burn in Understory)
N 34.23851°, W 118.69463°*

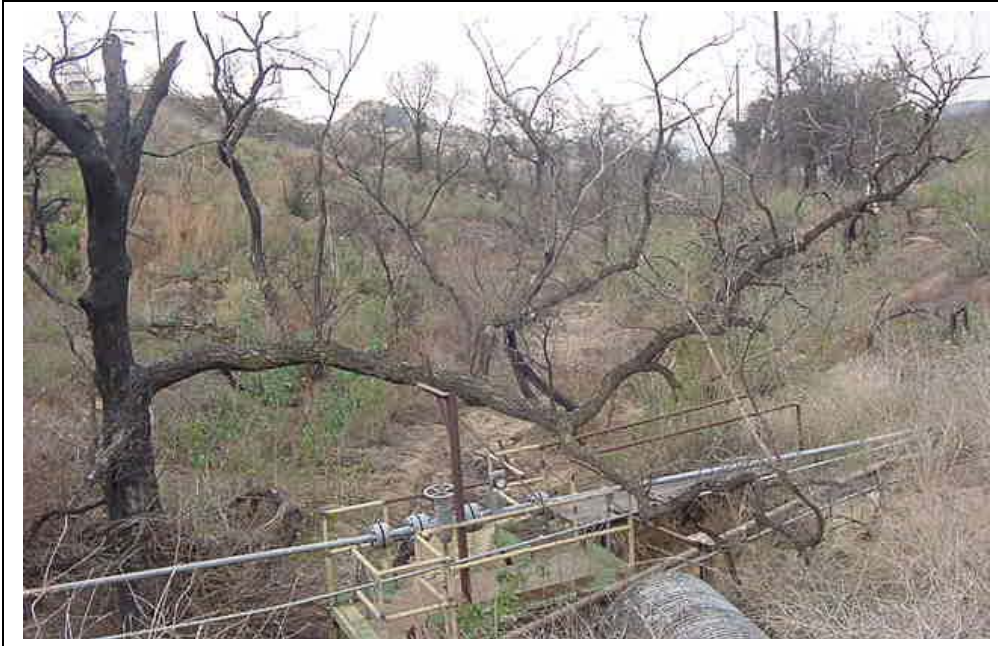
FIGURE 5

Burned Southern Willow Scrub – Drainage above Outfall 11 (Burned Willow in Front Represents High Heat of Fire in this Area) N 34.22726°, W 118.68668°

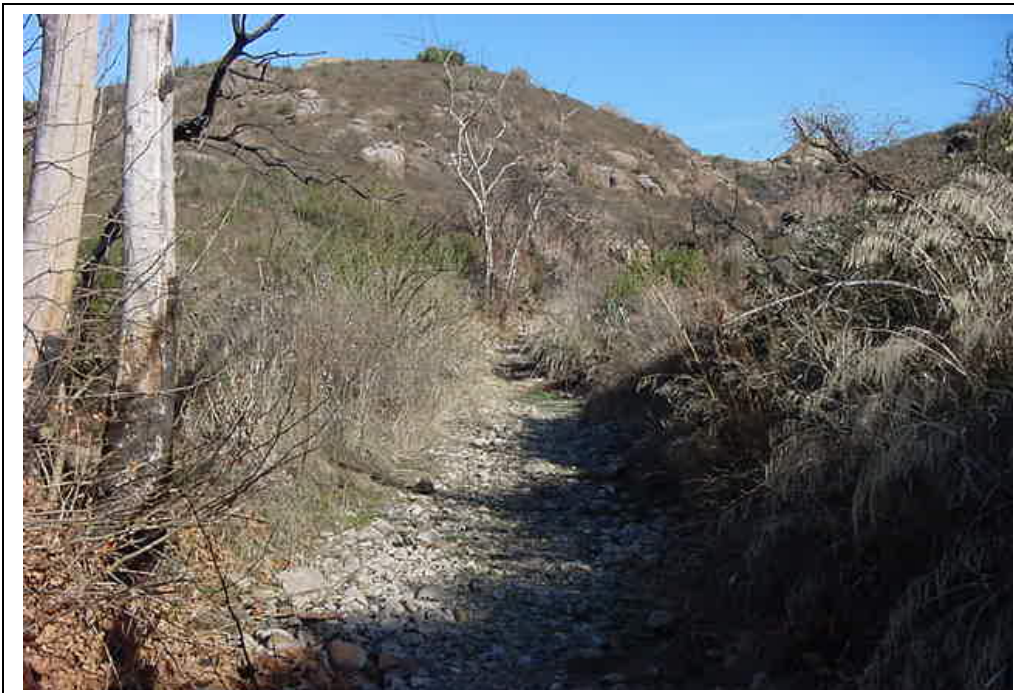
Burned Southern Willow Scrub – Drainage above Outfall 2 (Burned Sycamore Shown on Front Left) N 34.21750°, W 118.70519°

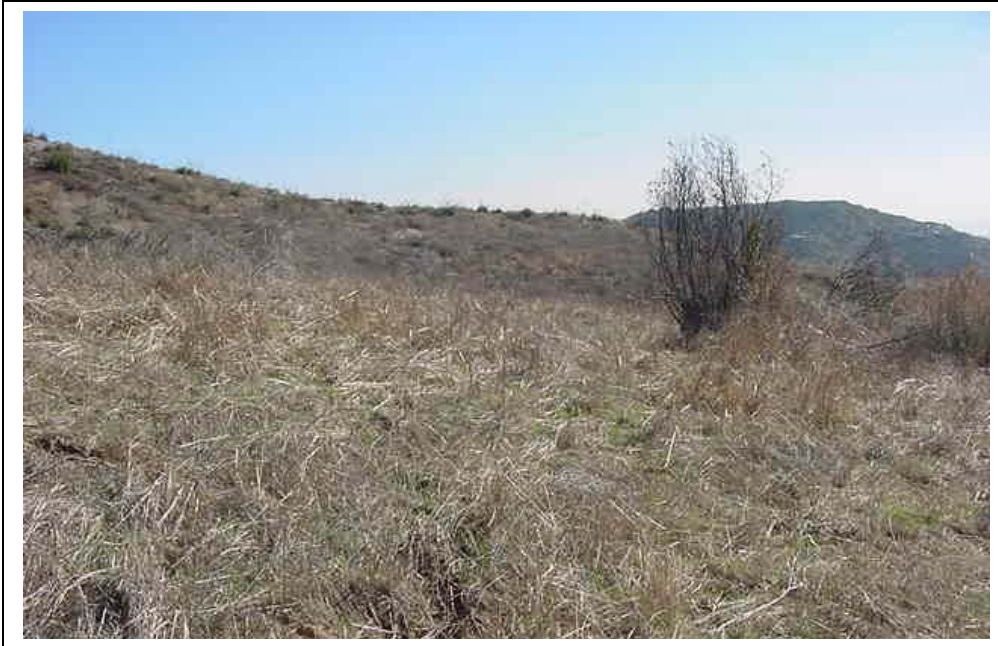
FIGURE 6

Burned Non-Native Grassland/Ruderal – West of Outfall 2
N 34.22230°, W 118.71117°

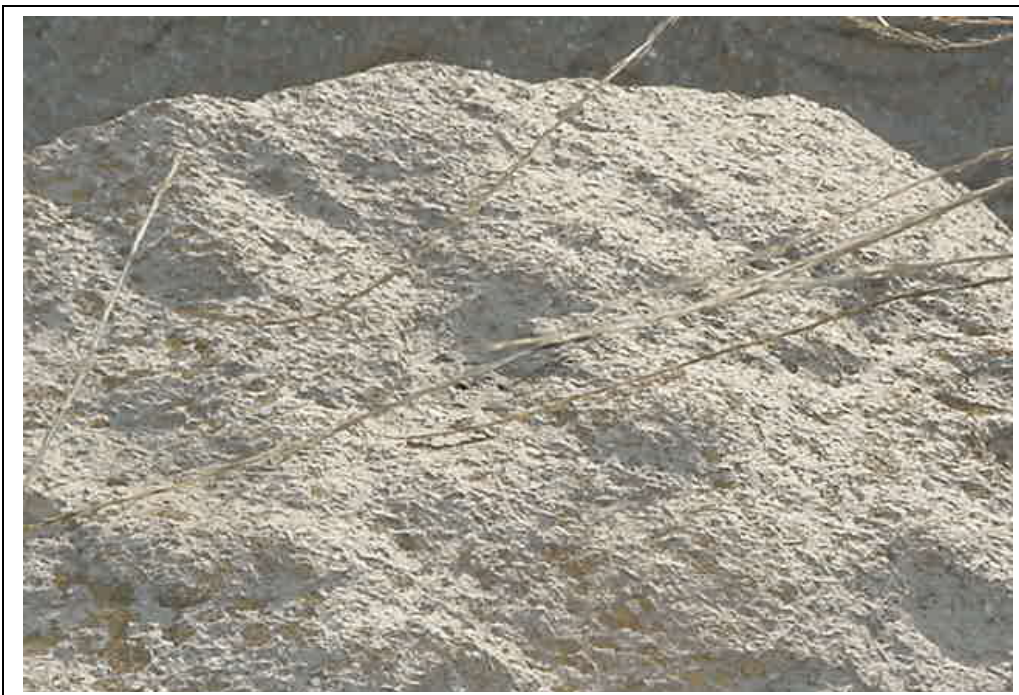
Residual Mulch on Rock and Plant from December 2005 Aerial Mulching – Happy Valley
N 34.23096°, W 118.67420°

Mulch is still present in patches of varying densities in burned areas that received truck and aerial-applied mulch. The mulch is mostly visible on rock outcroppings (Figure 6), but patches of mulch are still present in some of the areas. Wood fiber mulch over cryptogammic species as lichen can inhibit growth by reducing photosynthesis and transpiration.

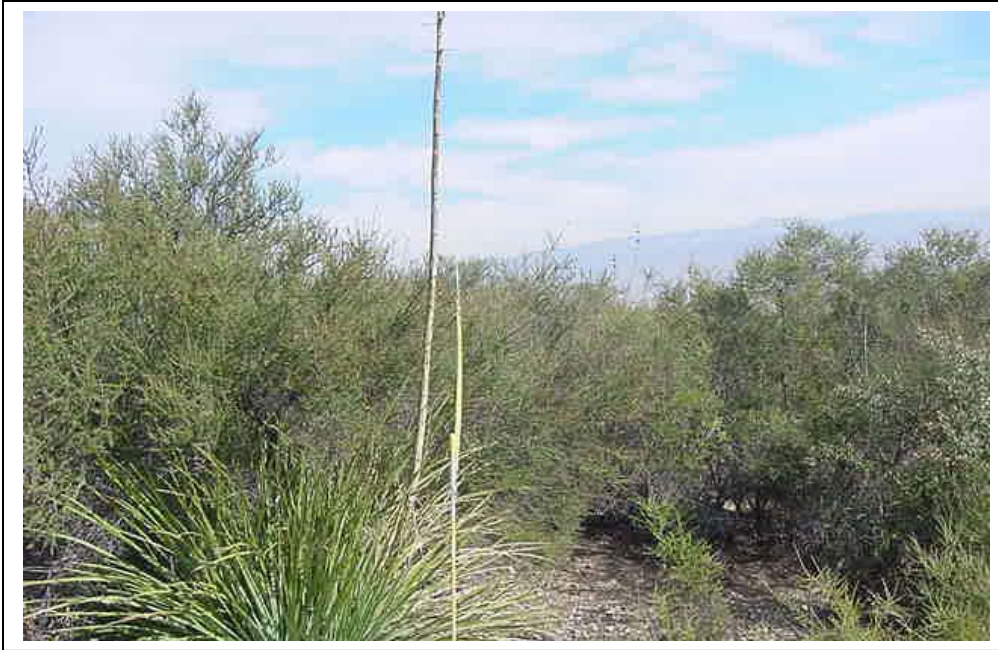
FIGURE 7

*Control Transect – Unburned South Facing Slope Chaparral/Scrub
N 34.22725°, W 118.72001°*

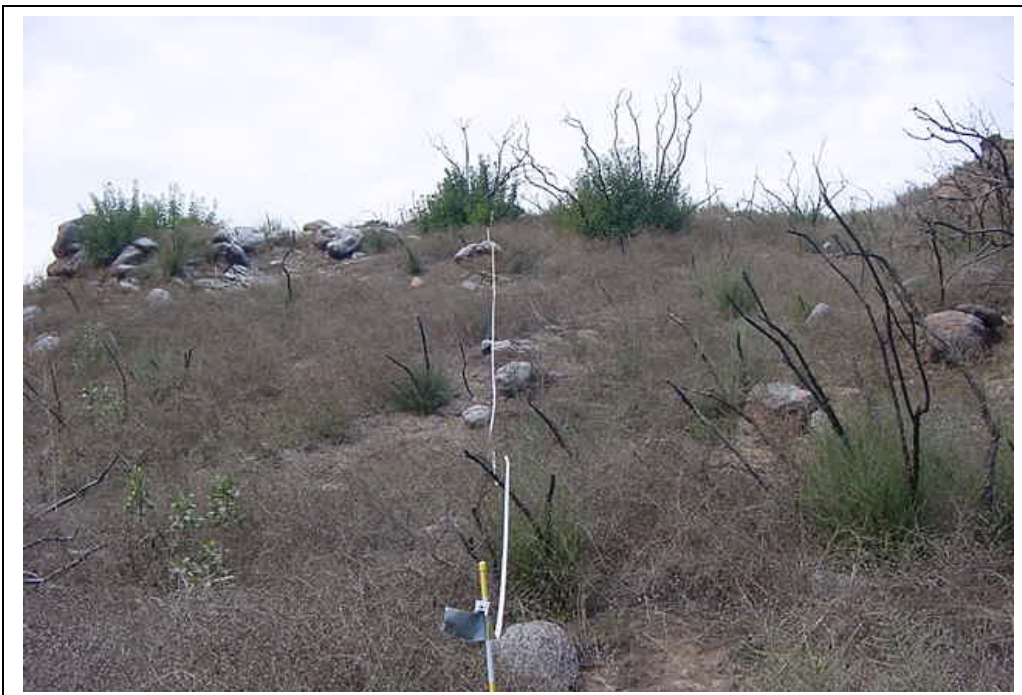
*Transect 1 – Burned South Facing Chaparral/Scrub, Aerial Mulched Area
N 34.21935°, W 118.70536°*

The data from the two transects in this area were averaged. The burned (aerial mulched) south facing slope transect (Figure 7) is dominated by California morning glory with an average of 74 percent relative cover. California deerweed and wild cucumber (*Marah macrocarpa*) each occur on less than 1 percent relative cover (average) on the transect, bare ground constitutes 21 percent relative cover (average) of the transect areas, and litter averages less than 2 percent relative cover. The shrub layer is comprised of 2.5 percent relative cover on average by chamise along these transect. The chamise shrubs have resprouted and are approximately two feet tall on average, with burned stems ranging in width from ¼-1” in diameter. Mulch is still present and constitutes approximately 1.5 percent relative cover of the transect not covered by vegetation. Other species present in the surrounding areas include hoary-leaved ceanothus, toyon, laurel sumac, Yerba Santa, scrub oak, and annual phacelia. Numerous native shrub seedlings are also present in pockets surrounding the transects.

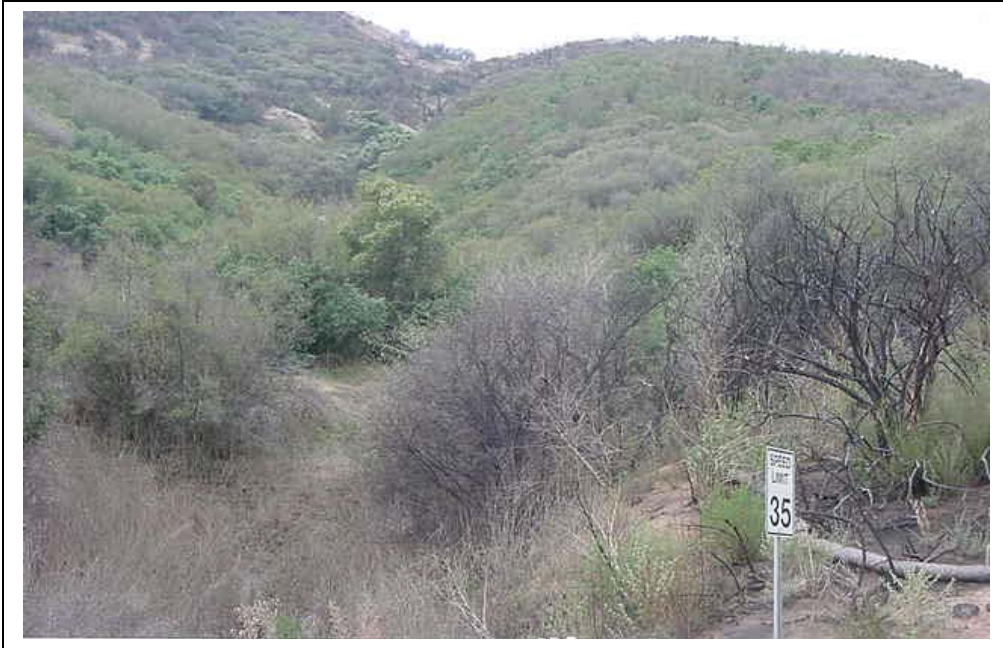
FIGURE 8

The chaparral control transect on the north facing slope (Figure 8) was randomly set in a north to south direction. This location is one of six (6) pockets of unburned chaparral on the north facing slopes that are part of the Outfall 9 watershed. This pocket of chaparral is approximately 10 acres in size. The soil type in this area is Gaviota rocky sandy loam. The shrub layer on this transect constitutes approximately 70.3 percent relative cover of this transect, of which approximately 34 percent relative cover is by mountain mahogany, 19 percent relative cover is by toyon, 19 percent relative cover is by holly-leaved cherry, and 1 percent relative cover is by sugarbush (*Rhus ovata*). The shrub layer along this transect is approximately 7-9 feet tall on average. Dead branches of holly-leaved cherry comprise approximately 1 percent relative cover of the transect. Approximately 4 percent relative cover of the transect is bare ground and 13 percent is covered with leaf litter. This transect has an herb layer of approximately 13 percent relative cover and

Control Transect – Unburned North Facing Chaparral/Scrub (burned up front)
N 34.23631°, W 118.68769°

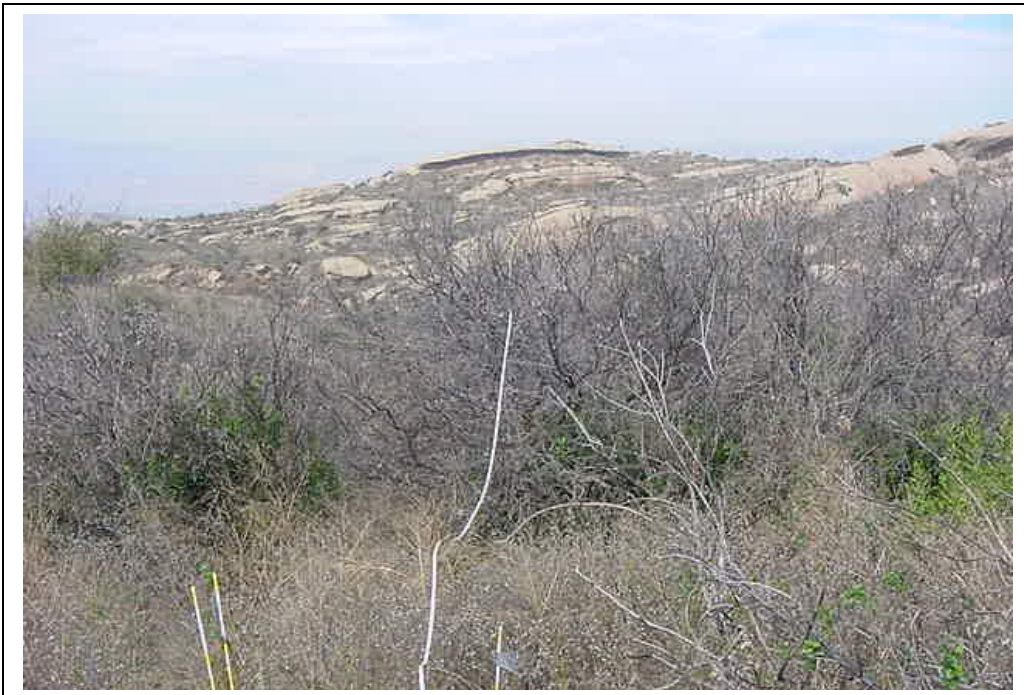
Transect 1 – Burned North Facing Chaparral/Scrub, Unmulched Area
N 34.23462°, W 118.68996°

The north facing slope chaparral burned transect areas has a shrub layer of approximately 19.3 percent relative cover which is comprised of resprouting toyon shrubs, averaging four (4) feet in height. Approximately 15.4 percent of the transect is covered by burned toyon branches with stems ranging in width from ¼ - 1 inch in diameter. The 44.9 percent understory layer on this transect is comprised of non-native species including tocalote (16.2 percent relative cover) and thistle (5.4 percent relative cover). These two species are annuals and therefore only dead stalks were present at the time of the survey. Native species include heart-leaved snapdragon (*Keckiella cordifolia*) with 6.2 percent relative cover, grass seedlings with 8.5 percent relative cover, yellow yarrow with 3.9 percent relative cover, chaparral nightshade with 0.8 percent relative cover, and phacelia with 0.8 percent relative cover. Approximately 7 percent of the transect area is bare ground and 14 percent is covered with leaf litter. Other species present adjacent to the transect include chamise, black sage, chaparral bush mallow (*Malacothamnus fasciculatus*), California deerweed, laurel sumac, California buckwheat, and red brome grass (*Bromus madritensis rubens*).
