Subject: 2014 Best Management Practices (BMP) Plan Addendum to the October 2010 Santa Susana Site Outfalls 008/009 Watersheds BMP Plan, Santa Susana Field Laboratory, Ventura County, CA (Order No. R4-2010-0090; NPDES No. CA0001309, CI No. 6027)

**2014 BMP PLAN ADDENDUM**

**SANTA SUSANA SITE**

September 30, 2014

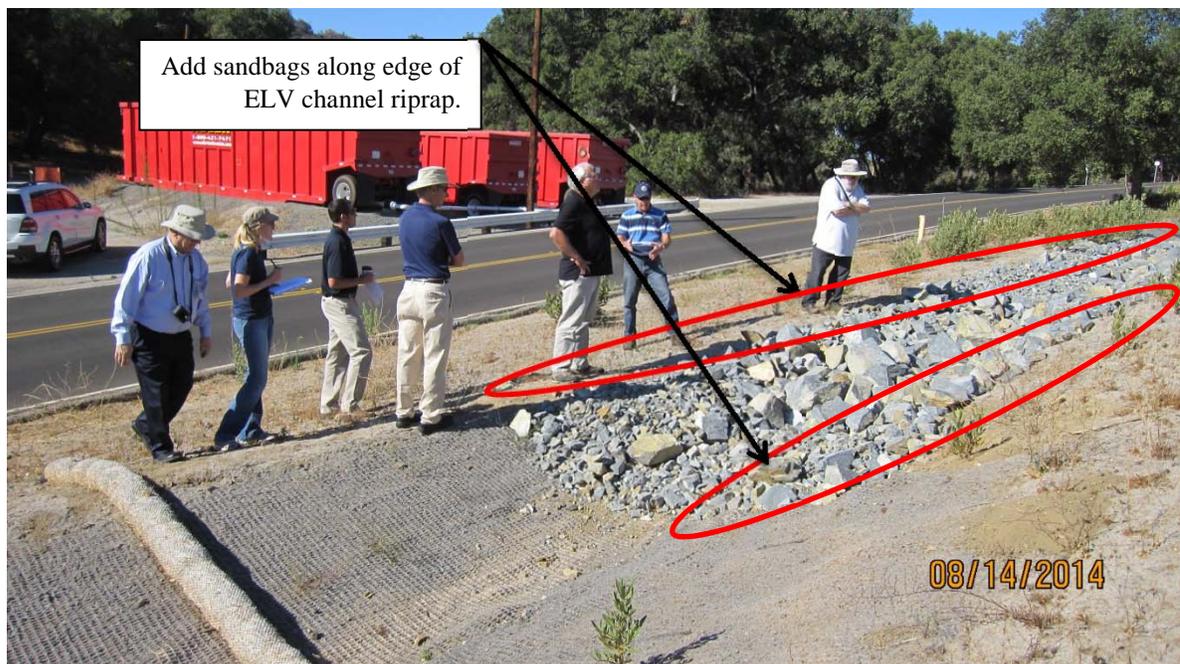
**Figure 1: ELV Channel Recommendation 1**

Recommended actions for the ELV area follow NASA's completion of the treatment system installed in November of 2013. During a field meeting on August 14, 2014 amongst NASA and the Panel, recommendations were made regarding modifications to the ELV channel to further improve the existing erosion controls. Recommendations included: adding sandbags along the edge of the ELV channel riprap [Recommendation 1] (Figure 1), extending the matting over the side of the ELV channel especially where rodent holes were observed, and adding pass-through bags parallel to the ELV channel to hold matting down but allow runoff to enter the channel [Recommendation 2] (Figure 2). In addition, the Panel recommends adding wattles to parallel the slope contours along the hillside north of the ELV channel to slow down the hillside runoff before

**Add sandbags along edge of the riprap in the ELV channel (See Figure 1 in text). Extend matting over the sides of the channel and weigh down with pass-through bags (See Figure 2 in text). Add wattles to parallel the slope contours along the hillside north of the ELV channel to slow down the hillside runoff before entering the channel (currently they're perpendicular) (See Figure 3 in text).**

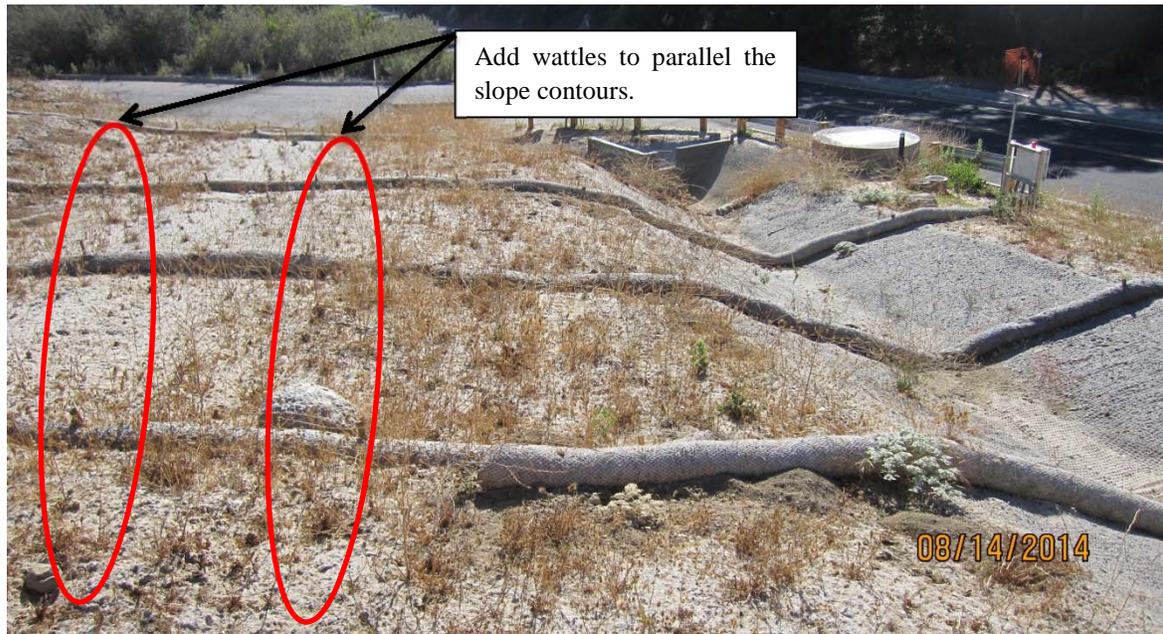
**Figure 3: ELV Channel Recommendation 3**

entering the channel [Recommendation 3] (Figure 3). It is also important to note that new operational procedures at the Helipad are expected to reduce flows along Helipad road into the ELV channel sump (as compared to the monitored 2013-2014 event), thus improving the ELV treatment capacity.

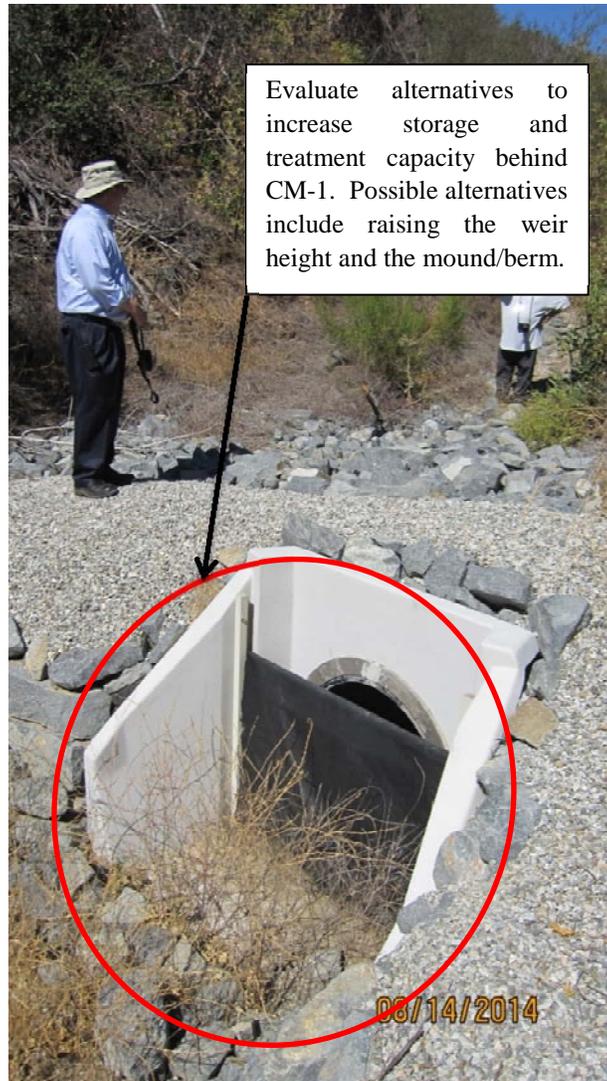
**Figure 4: CM-1 Recommendation 1**

In addition to continued inspection and maintenance at CM-1, the Expert Panel recommends that alternatives for increasing the ponding volume and treatment capacity behind CM-1 should be evaluated. It is recommended that NASA solicit consultant or contractor recommendations for potential alternatives such as increasing the weir and mound/berm heights that will achieve this goal [Recommendation 1] (Figure 4). The Expert Panel also recommends bolstering pretreatment by adding sandbag berms (or equivalent) upstream of the weir boards to create tiered mini-basins along the slope, with spill points mid-berm [Recommendation 2] (Figure 5).

**Solicit contractor's recommendations for increasing the ponding volume and treatment capacity behind CM-1 such as increasing the height of the weir board and the media mound/berm (See Figure 4 in text)**

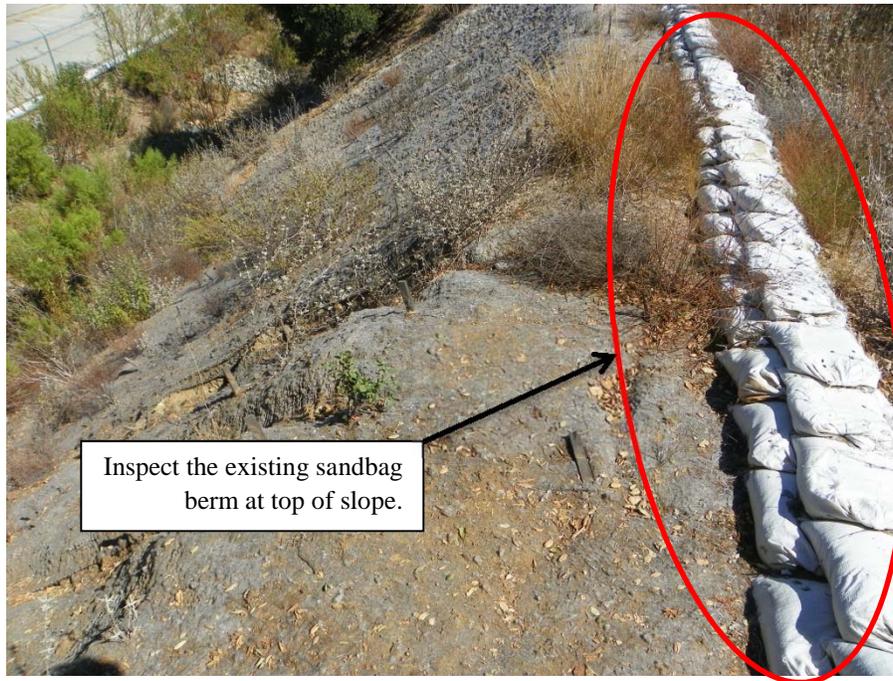
**Figure 6: B-1 Media Filter Recommendation 1 (Top of slope)**

During a site visit in August 2014, the Expert Panel observed erosion rills at the top of the slope adjacent to and upstream of the B-1 media filter. When evaluating solutions to prevent erosion at this location, extensive reworking of the hillside was considered but deemed infeasible since this would require removing existing vegetation and performing major grading on a very steep slope in close proximity to the B-1 media filter. Therefore, to prevent the rills from expanding and additional erosion from occurring, the Expert Panel recommends the following robust inspection and maintenance procedures (Figure 6):

- Inspect the existing sandbag berm at the top of the slope upstream of the media filter to ensure it has no gaps; repair/replace as necessary [Recommendation 1] (Figure 6).
- Inspect the existing slope protection measures (and condition of any rills beneath the erosion control blanket that can be observed from the surface) and check dams along the channel; repair/replace or perform maintenance as necessary [Recommendation 2] (Figure 7).
- Inspect the existing silt fence around the B-1 media bed and outlet structure; repair/replace as necessary [Recommendation 3].
