BMP Installations 2010-2013 Outfall 008 Watershed

SANTA SUSANA FIELD LABORATORY

BMP Installations 2010-2013

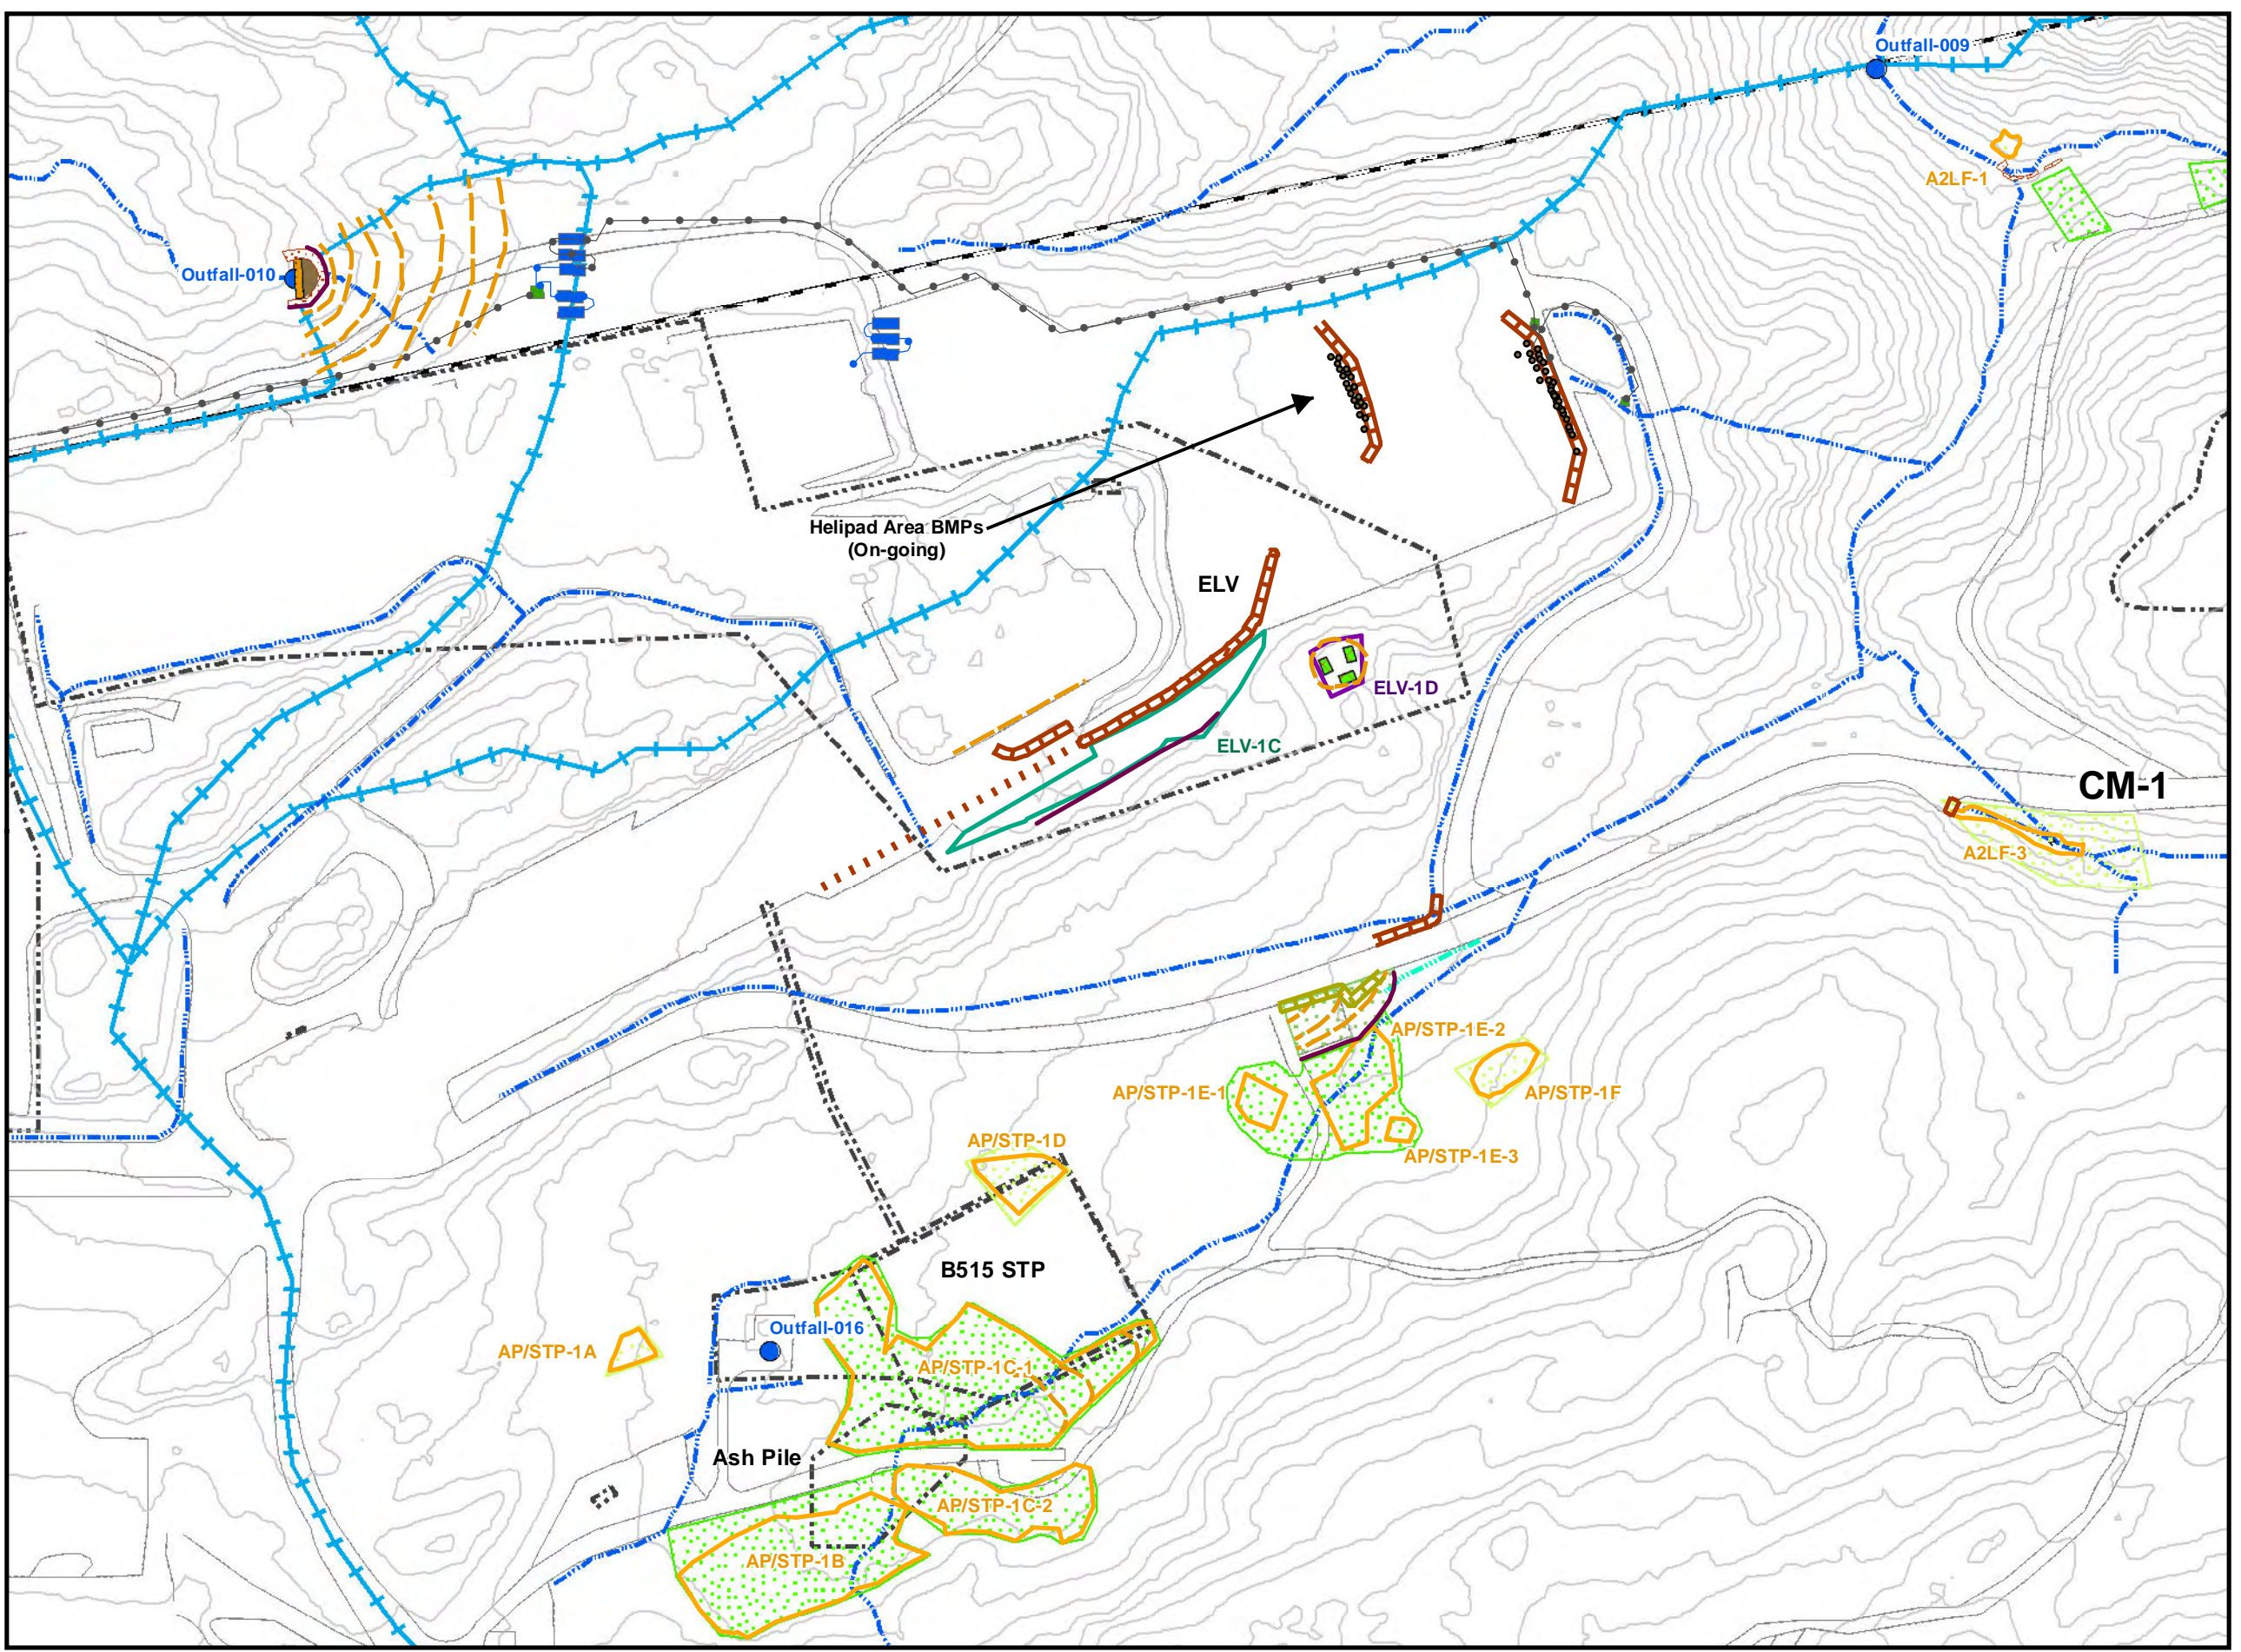
FIGURE 1-7

BMP Installations 2010-2013 AP/STP Outfall 009 Watershed

- Topographic contours from 2010 Sage Consultants, Inc
- Covered the weir boards at CM-1, CM-2, CM-3, CM-4, CM-6, CM-8, CM-9, and CM-10 with filter fabric to facilitate ponding behind the boards and increase flow through filter media beds (Fall 2011).
