# Memorandum

Date: October 9, 2017  
To: Cassandra D. Owens, Los Angeles Regional Water Quality Control Board  
Copies to: Paul Costa, Michael Bower, and Jeff Wokurka, The Boeing Company  
From: SSFL Surface Water Expert Panel and Geosyntec Consultants  
Subject: Area I Former Shooting Range (NPDES Outfall 009 Watershed)

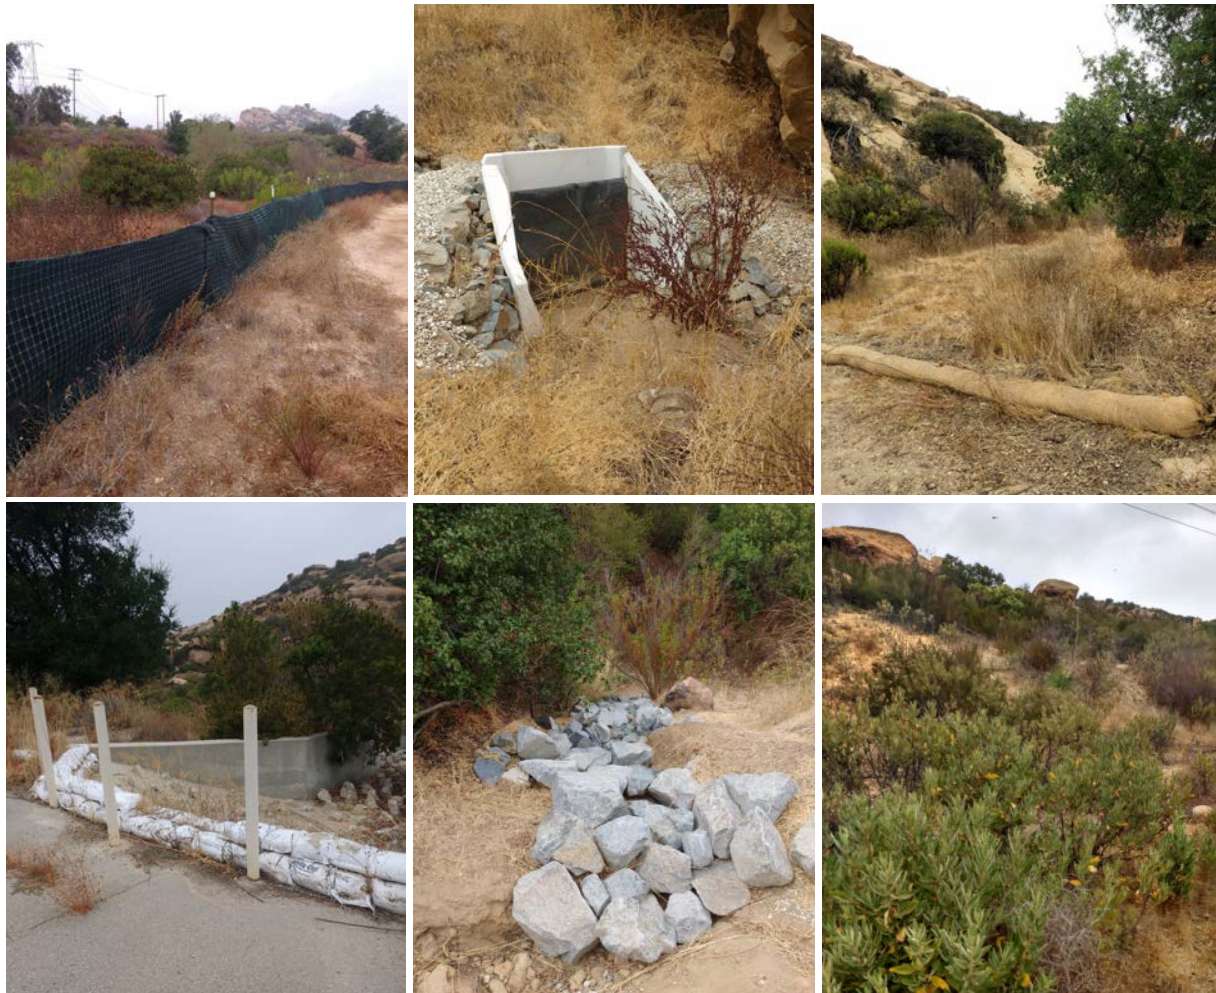
Existing BMPS in the shooting range area (see photos in Figure 3 below) include bioengineering slope stabilization measures (i.e., vegetation planting areas), rip-rap berms along the Northern Drainage, a culvert maintenance media filter, fiber rolls, and approximately 1,400 feet of silt fencing. Drainage areas to existing treatment BMPs are shown in Figure 4 below. Furthermore, maintenance and inspection of the downstream Northern Drainage BMPs is ongoing, such as the recent cleanout of sediment accumulated behind rip-rap berms during the 2016/2017 rainy season (Figure 5). This recently deposited sediment was analyzed prior to disposal and found to have lead concentrations similar to background soil concentrations.

In addition, based on visual observation, the Former Shooting Range area is well vegetated and naturally undulating, with depressions in the topography that further reduce the transport of lead shot and runoff from this area. This visual observation is confirmed by the fact that in 2017 no appreciable sediment was accumulated or removed from the six rip-rap berms that are most immediately downstream of the Former Shooting Range, indicating that the Former Shooting Range area, like the rest of the upper 009 watershed, is well stabilized from a sediment yield and an erosion/sediment control perspective.

**Figure 3. Selection of Existing BMPs at the Former Shooting Range Area (Top row: Silt fence, culvert modification media filter, and fiber rolls; Bottom row: Sand bag berm, rip-rap, and vegetation)**

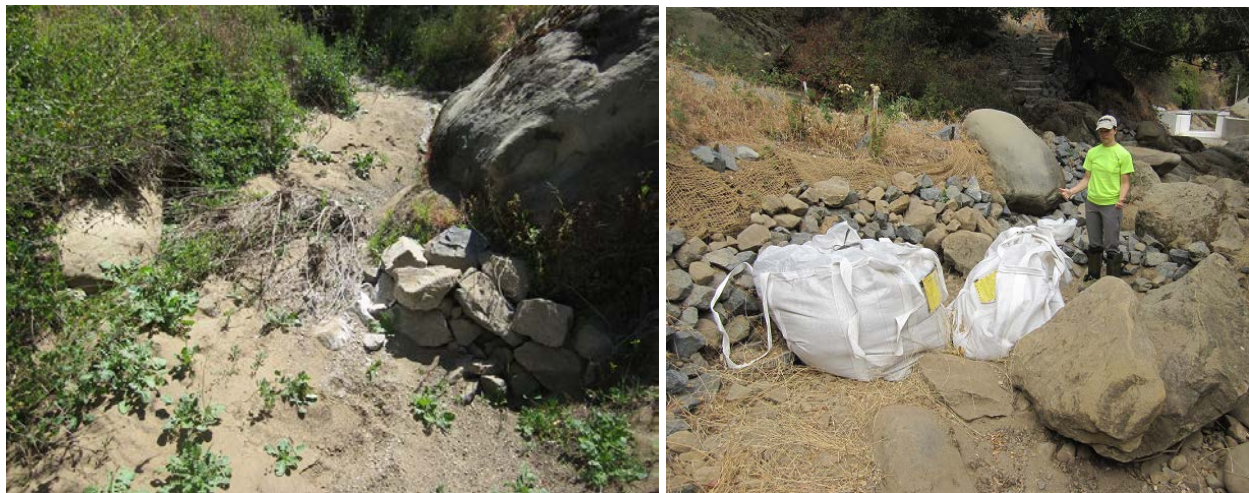
Figure 5. Northern Drainage Accumulated Sediment (left) and Sediment Collected in Super Sacks for Removal (right)

- To further bolster the erosion and sediment controls that are in place and intended to function until cleanup is complete, additional BMP improvements have been recommended and sediment has been removed from the downstream BMPs to increase the sediment capacity for the next rainy season.

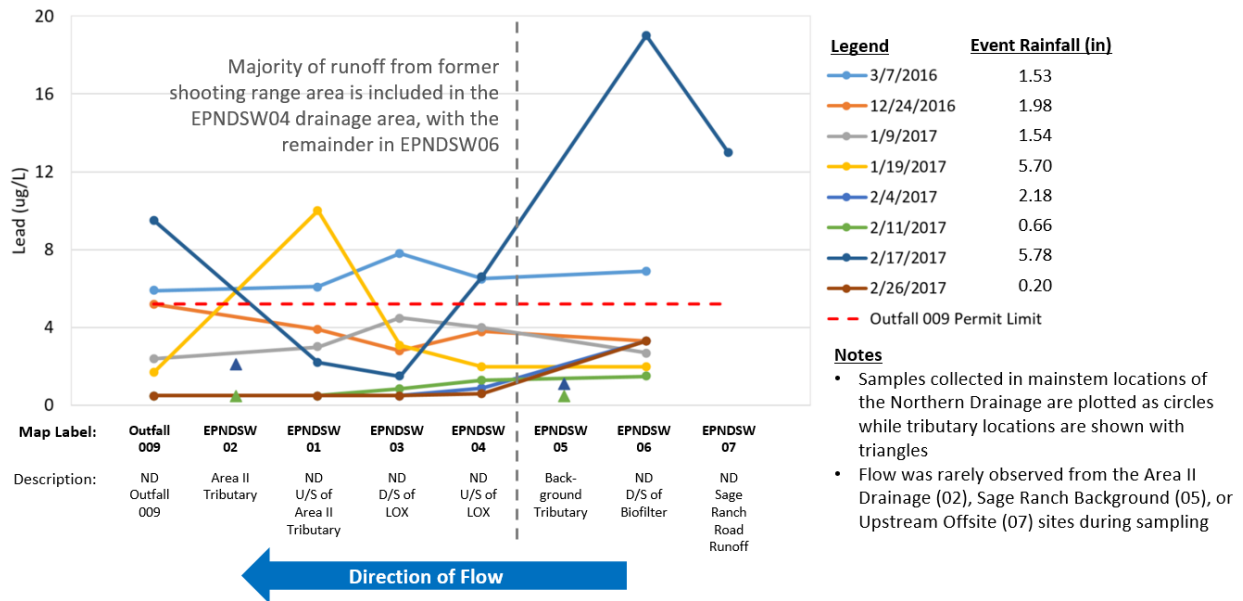
Besides stormwater samples collected at Outfall 009, lead concentrations in stormwater and sediment samples along the Northern Drainage during 2016/2017 were also low, including immediately downstream of the Former Shooting Range area (see Figures 10 through 12 below). There is no apparent indication of highly concentrated upstream sources contributing to increasing concentrations below the

Furthermore, an attempt was made to compare “upstream” (which, relative to the shooting range, represents a blend of runoff locations) versus downstream stormwater concentrations, to further evaluate whether the Former Shooting Range soils and lead shot fragments are impacting stormwater in this watershed. Stormwater samples from subareas that flow into the Former Shooting Range section of the Northern Drainage were compiled, and relative runoff volumes were computed for each location based on drainage area properties. Together, these concentrations and relative runoff volumes were mass balanced to compute an “upstream” weighted average concentration (Figure 12). Based on this comparison, no statistically significant difference<sup>2</sup> was found in lead concentrations in stormwater between the contributing areas upstream of the Former Shooting Range area (consisting of several paved areas, which as noted above are considered to be a potential lead source; measured concentrations used in the weighted average range from 0.50 to 13 µg/L) and the Northern Drainage mainstem sampling location EPNSW04, downstream of the Former Shooting Range area (measured concentrations at this site range from 0.61 to 6.6 µg/L). This upstream/downstream comparison of lead stormwater concentrations further suggests that lead shot is not being significantly mobilized and transported in stormwater along the Northern Drainage. This comparison is consistent with field observations of 1) topography (the microtopography includes many small areas with mild to flat slopes, despite an overall slope toward the Northern Drainage Channel), 2) well developed shrub and ground vegetation in many areas, and 3) numerous stormwater BMPs and areas of revegetation.

Figure 11. Stormwater Lead Concentrations Along Northern Drainage

The Panel recommends that this condition continue to be monitored. Therefore, the Panel has recommended that two rounds of stormwater and one round of bed sediment samples be collected again along the Northern Drainage during storms in the 2017/18 wet season. This is reflected in the 2017/18 Sampling and Analysis Plan.
