# **Santa Susana Field Laboratory**

## **Site-Wide Stormwater Annual Report**

### **2020/21 Reporting Year**

CWR0654  
October 2021

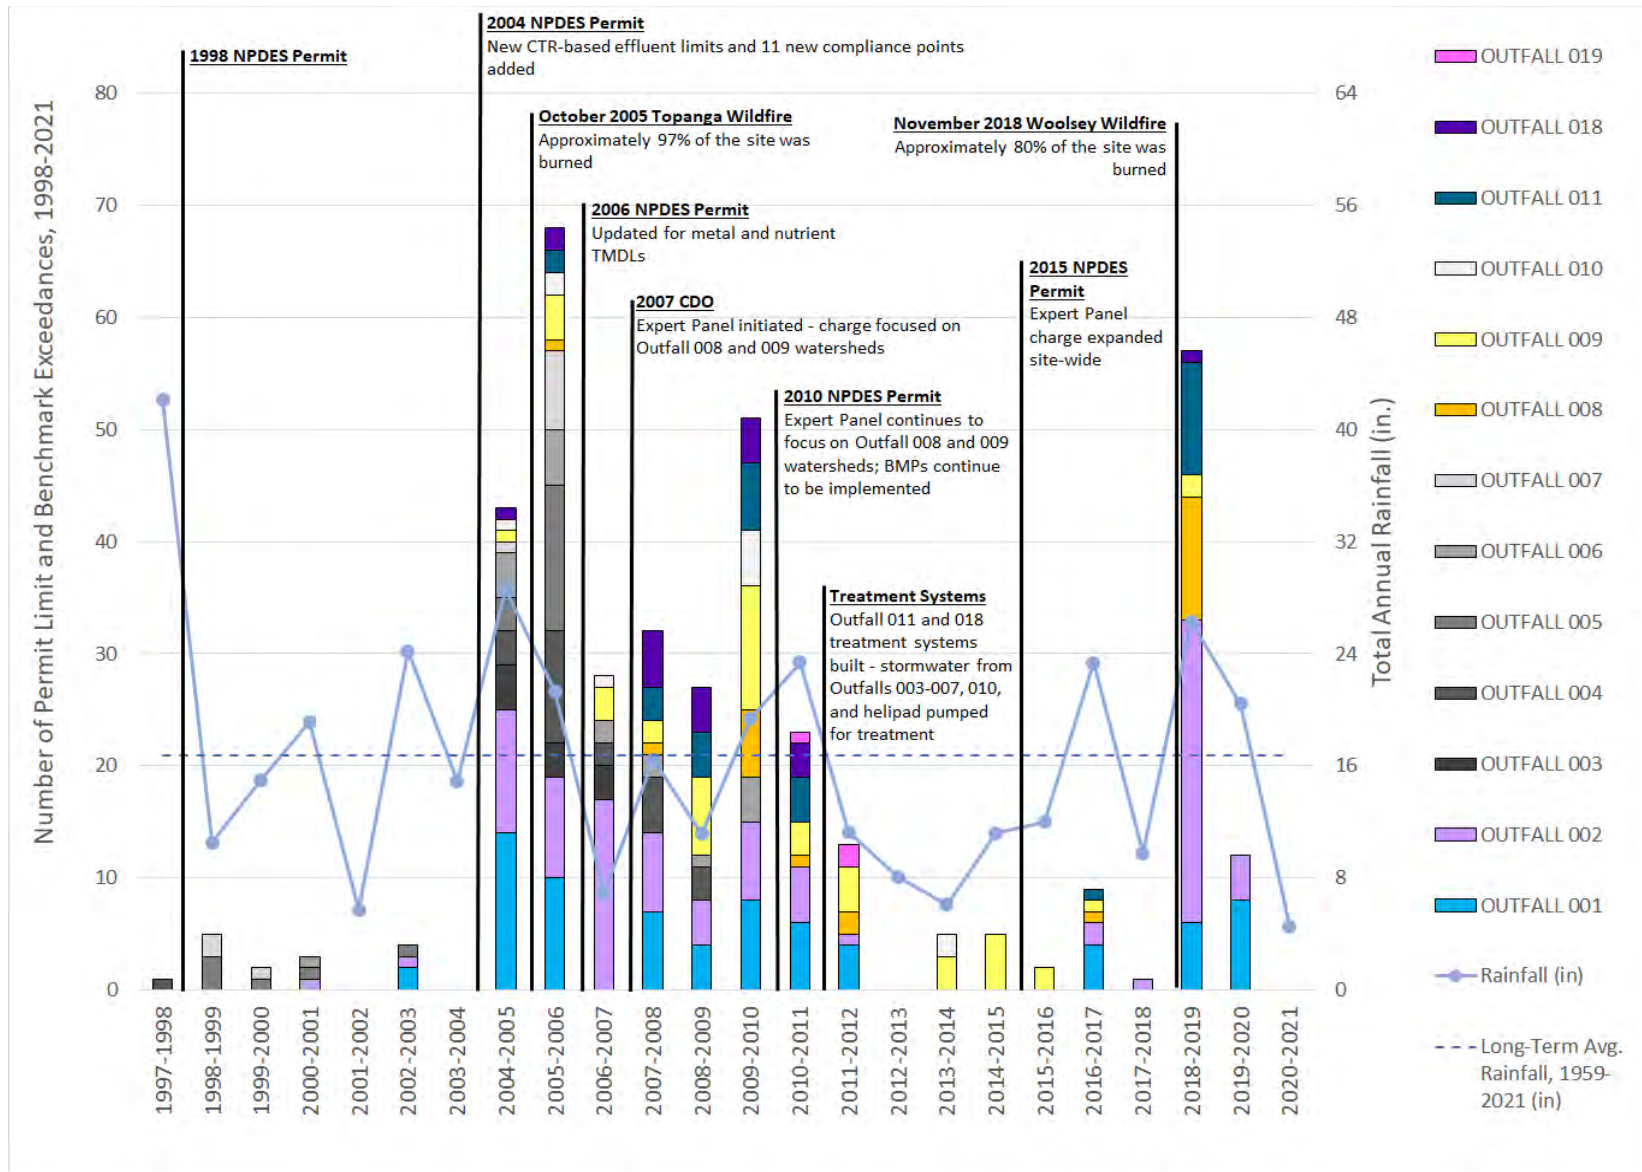
Figure 3. Summary of SSFL Permits, Surface Water Expert Panel Involvement, and Water Quality, 1998-2021

- **2005 Topanga wildfire:** Approximately 97% of SSFL was burned resulting in an increased number of Permit limit exceedances compared to reporting years with similar rainfall.

- **2007 Cease and Desist Order (CDO):** Through the CDO, the RWQCB required “the assembly of a panel to review site conditions, modeled flow, contaminants of concern, and evaluate the BMPs capable of providing treatment to meet the final effluent limits.” The CDO also required BMP planning, performance evaluation, and reporting requirements.

- **2010 NPDES Permit:** No major changes to Permit. The Expert Panel continued to make data-informed BMP recommendations in the Outfall 008 and 009 watersheds, which were implemented at SSFL (see Section 1.3).

- **2015 NPDES Permit:** Permit expanded the Expert Panel’s charge to all regulated SSFL Outfalls. In response, the Panel reviews Permit limit and benchmark exceedances for all Outfalls and makes data-driven BMP recommendations on a site-wide basis. In the 2015-2018 drought period, the number of Permit limit and benchmark exceedances fell compared to years with similar rainfall.

- **2018 Woolsey wildfire:** Approximately 80% of SSFL was burned and above-average rainfall was measured. Because of the hydrophobicity<sup>7</sup> of the soil and the loss of vegetative cover due to the wildfire event, rain events after the fire produced significantly greater amounts of runoff compared to similar sized rains during non-fire years. There were an increased number of benchmark and Permit limit exceedances in the year immediately following the wildfire compared to reporting years with similar rainfall, however, water quality recovered to typical non-wildfire levels in the following year.

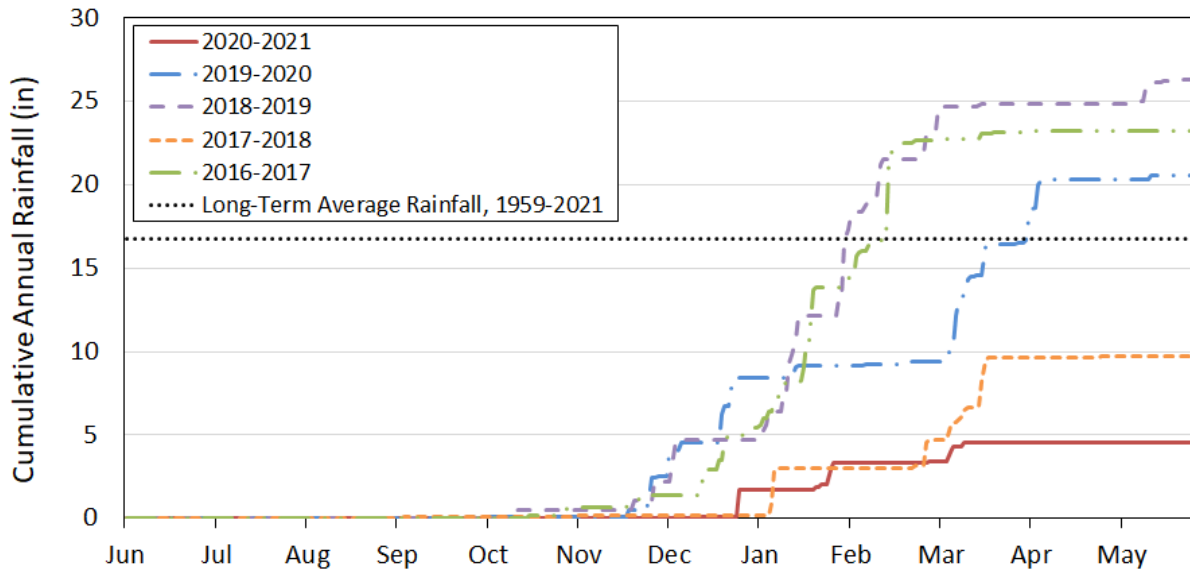
Figure 4. Annual Cumulative Rainfall, 2016-2021

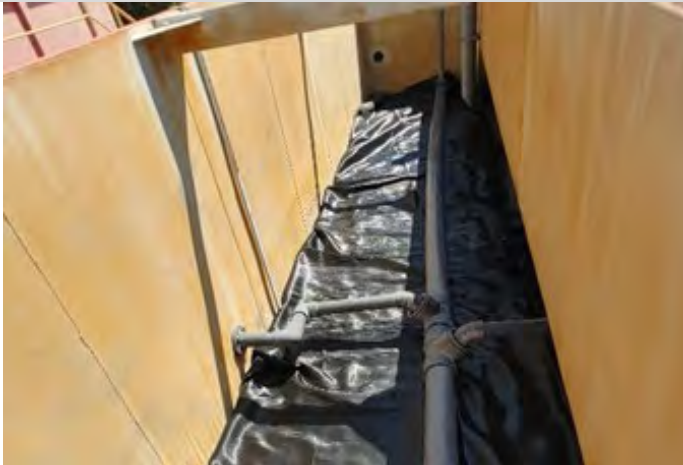
Figure 6. Reconstructed ELV Media Bed Showing Flow Distributing Geotextile on Top of Media

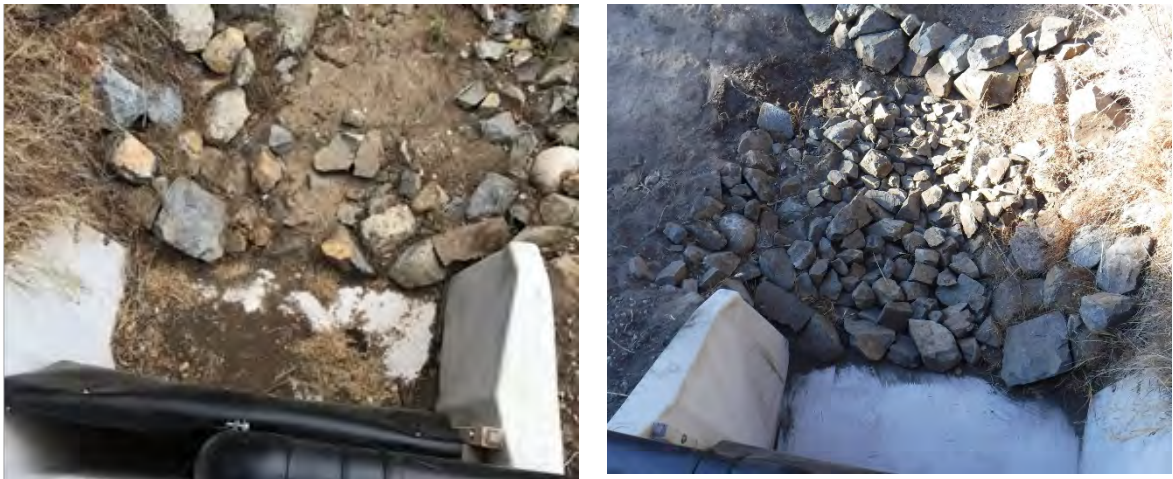
- **Outfall 009 CM-4 check dam reconstruction:** Riprap check dams were rebuilt upstream of CM-4 to capture sediment and debris before the CM and the riprap in the ponding area was replaced as shown in Figure 10.

Figure 7. Check dam and ponding area upstream of CM-4 before (left) and after (right) reconstruction

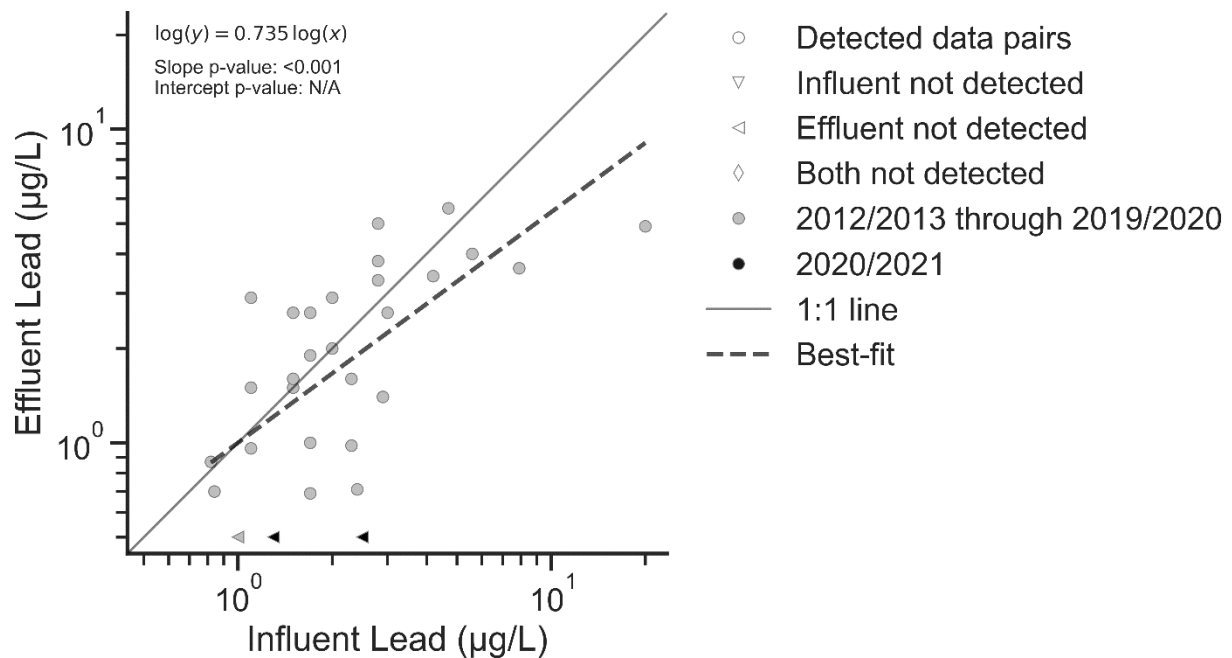
Figure 68. Paired Lead Concentrations at Lower Lot Biofilter

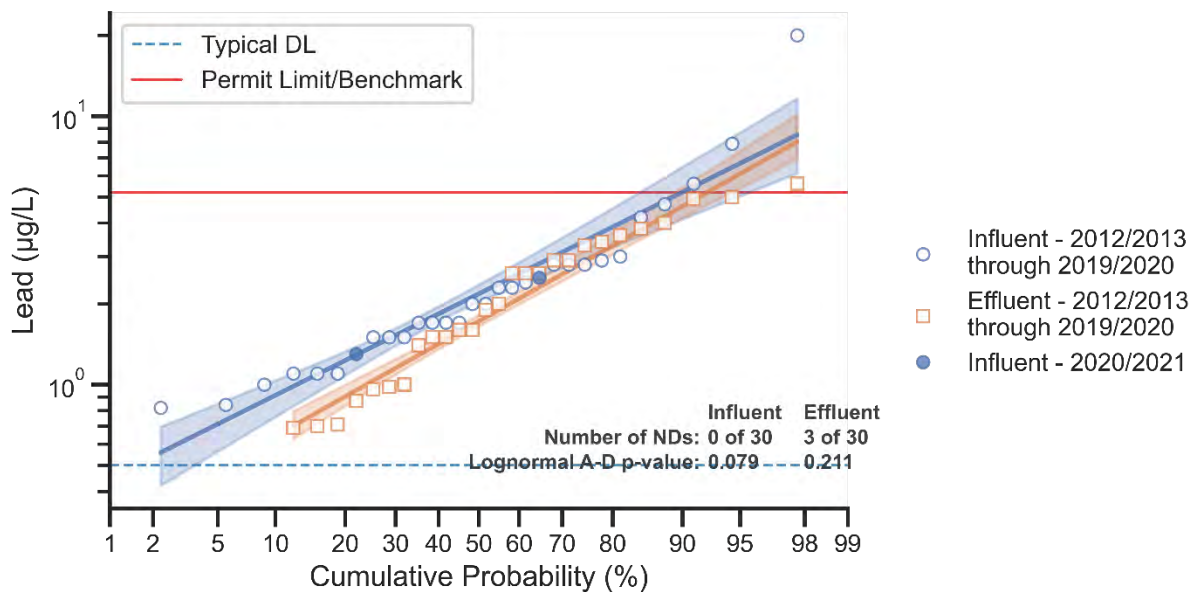
Figure 83. Log-normal Probability Plot of Lead at Lower Lot Biofilter

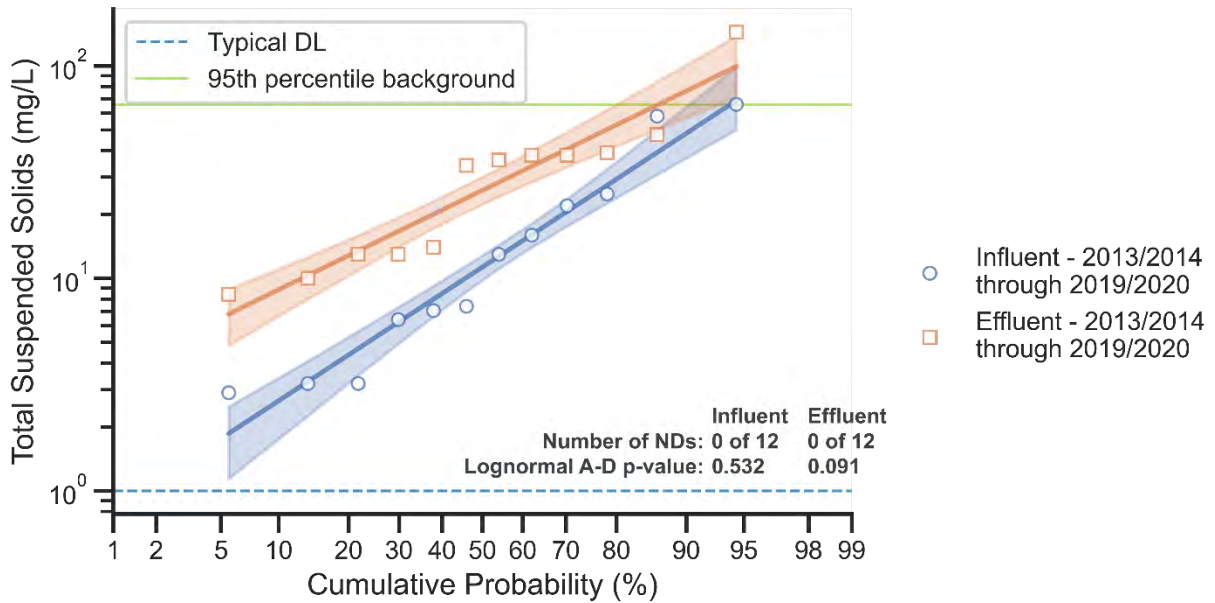
Figure 84. Log-normal Probability Plot of TSS at ELV Treatment BMP
