Subject: Second Quarter 2016 NPDES Discharge Monitoring Report  
Compliance File CI-6027 and NPDES No. CA0001309  
Santa Susana Field Laboratory  
Ventura County, California

## SECOND QUARTER 2016 DMR CONTENTS

## DISCHARGE SUMMARY

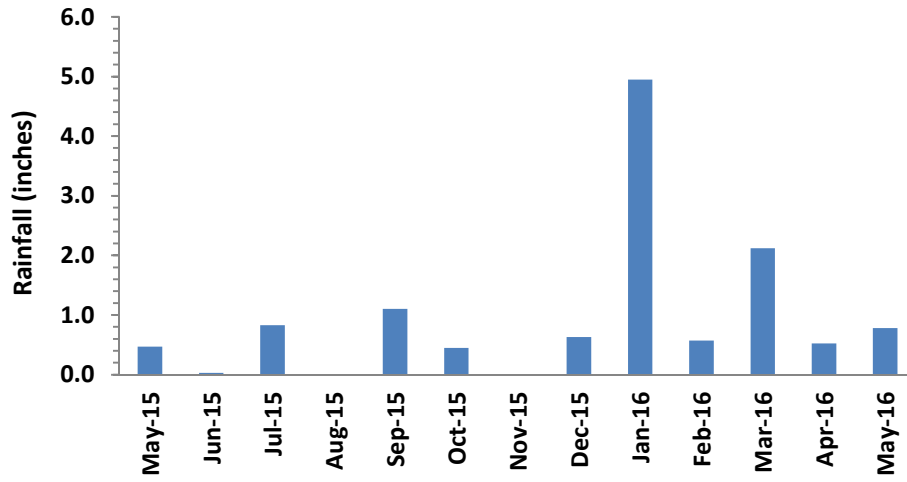
The 2015 to 2016 rain year was characterized by extreme drought conditions with a total of 11.97 inches of rain falling between July 2015 and May 2016. The last storm with significant rainfall occurred on May 6<sup>th</sup> (total = 0.77 inches) with trace rain falling on May 9<sup>th</sup> (Figure 1). On May 18<sup>th</sup>, 2016, almost two weeks after the last small rain event, the two NPDES permitted sites on the SSFL were visited by Aquatic Bioassay and Consulting Laboratory Biologists to determine if bioassessment samples could be collected. Neither SSFL-001 nor SSFL-006 had flow and both were completely dry across their entire reaches (see photos).

Figure 1. Rainfall (inches) measured May, 2015 thru May 18<sup>th</sup>, 2016 on SSFL.

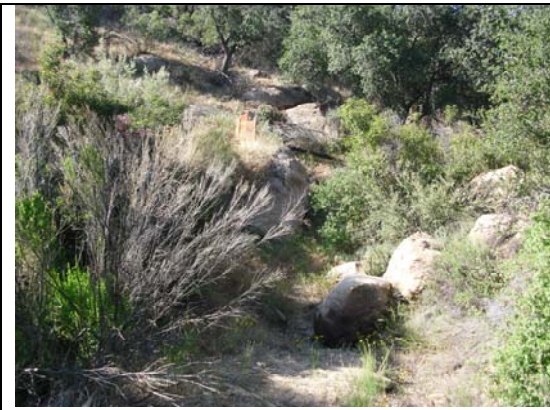
SSFL-001, downstream

Figure 2. Photos taken downstream and upstream of each permitted discharge point from the SSFL property (2016).
