**HAPPY VALLEY SOUTH SEPTIC TANK  
REMOVAL DOCUMENTS**

## Appendix H – Happy Valley South Septic Tank Removal Documents

**Subject: Happy Valley South Underground Septic Tank Removal Plan, California Water Code Section 13304 Order (NPDES NO. CA0001309, CI NO. 6027, SCP NO. 1111, SITE ID NO. 2040109)**

**APPROVAL OF PLAN TO REMOVE SEPTIC TANK NEAR FORMER BUILDING 1399  
SUBMITTED IN RESPONSE TO A CALIFORNIA WATER CODE SECTION 13304 ORDER –  
THE BOEING COMPANY, SANTA SUSANA FIELD LABORATORY, CANOGA PARK, CA  
(NPDES NO. CA0001309, CI NO. 6027, SCP NO. 1111, SITE ID NO. 2040109)**

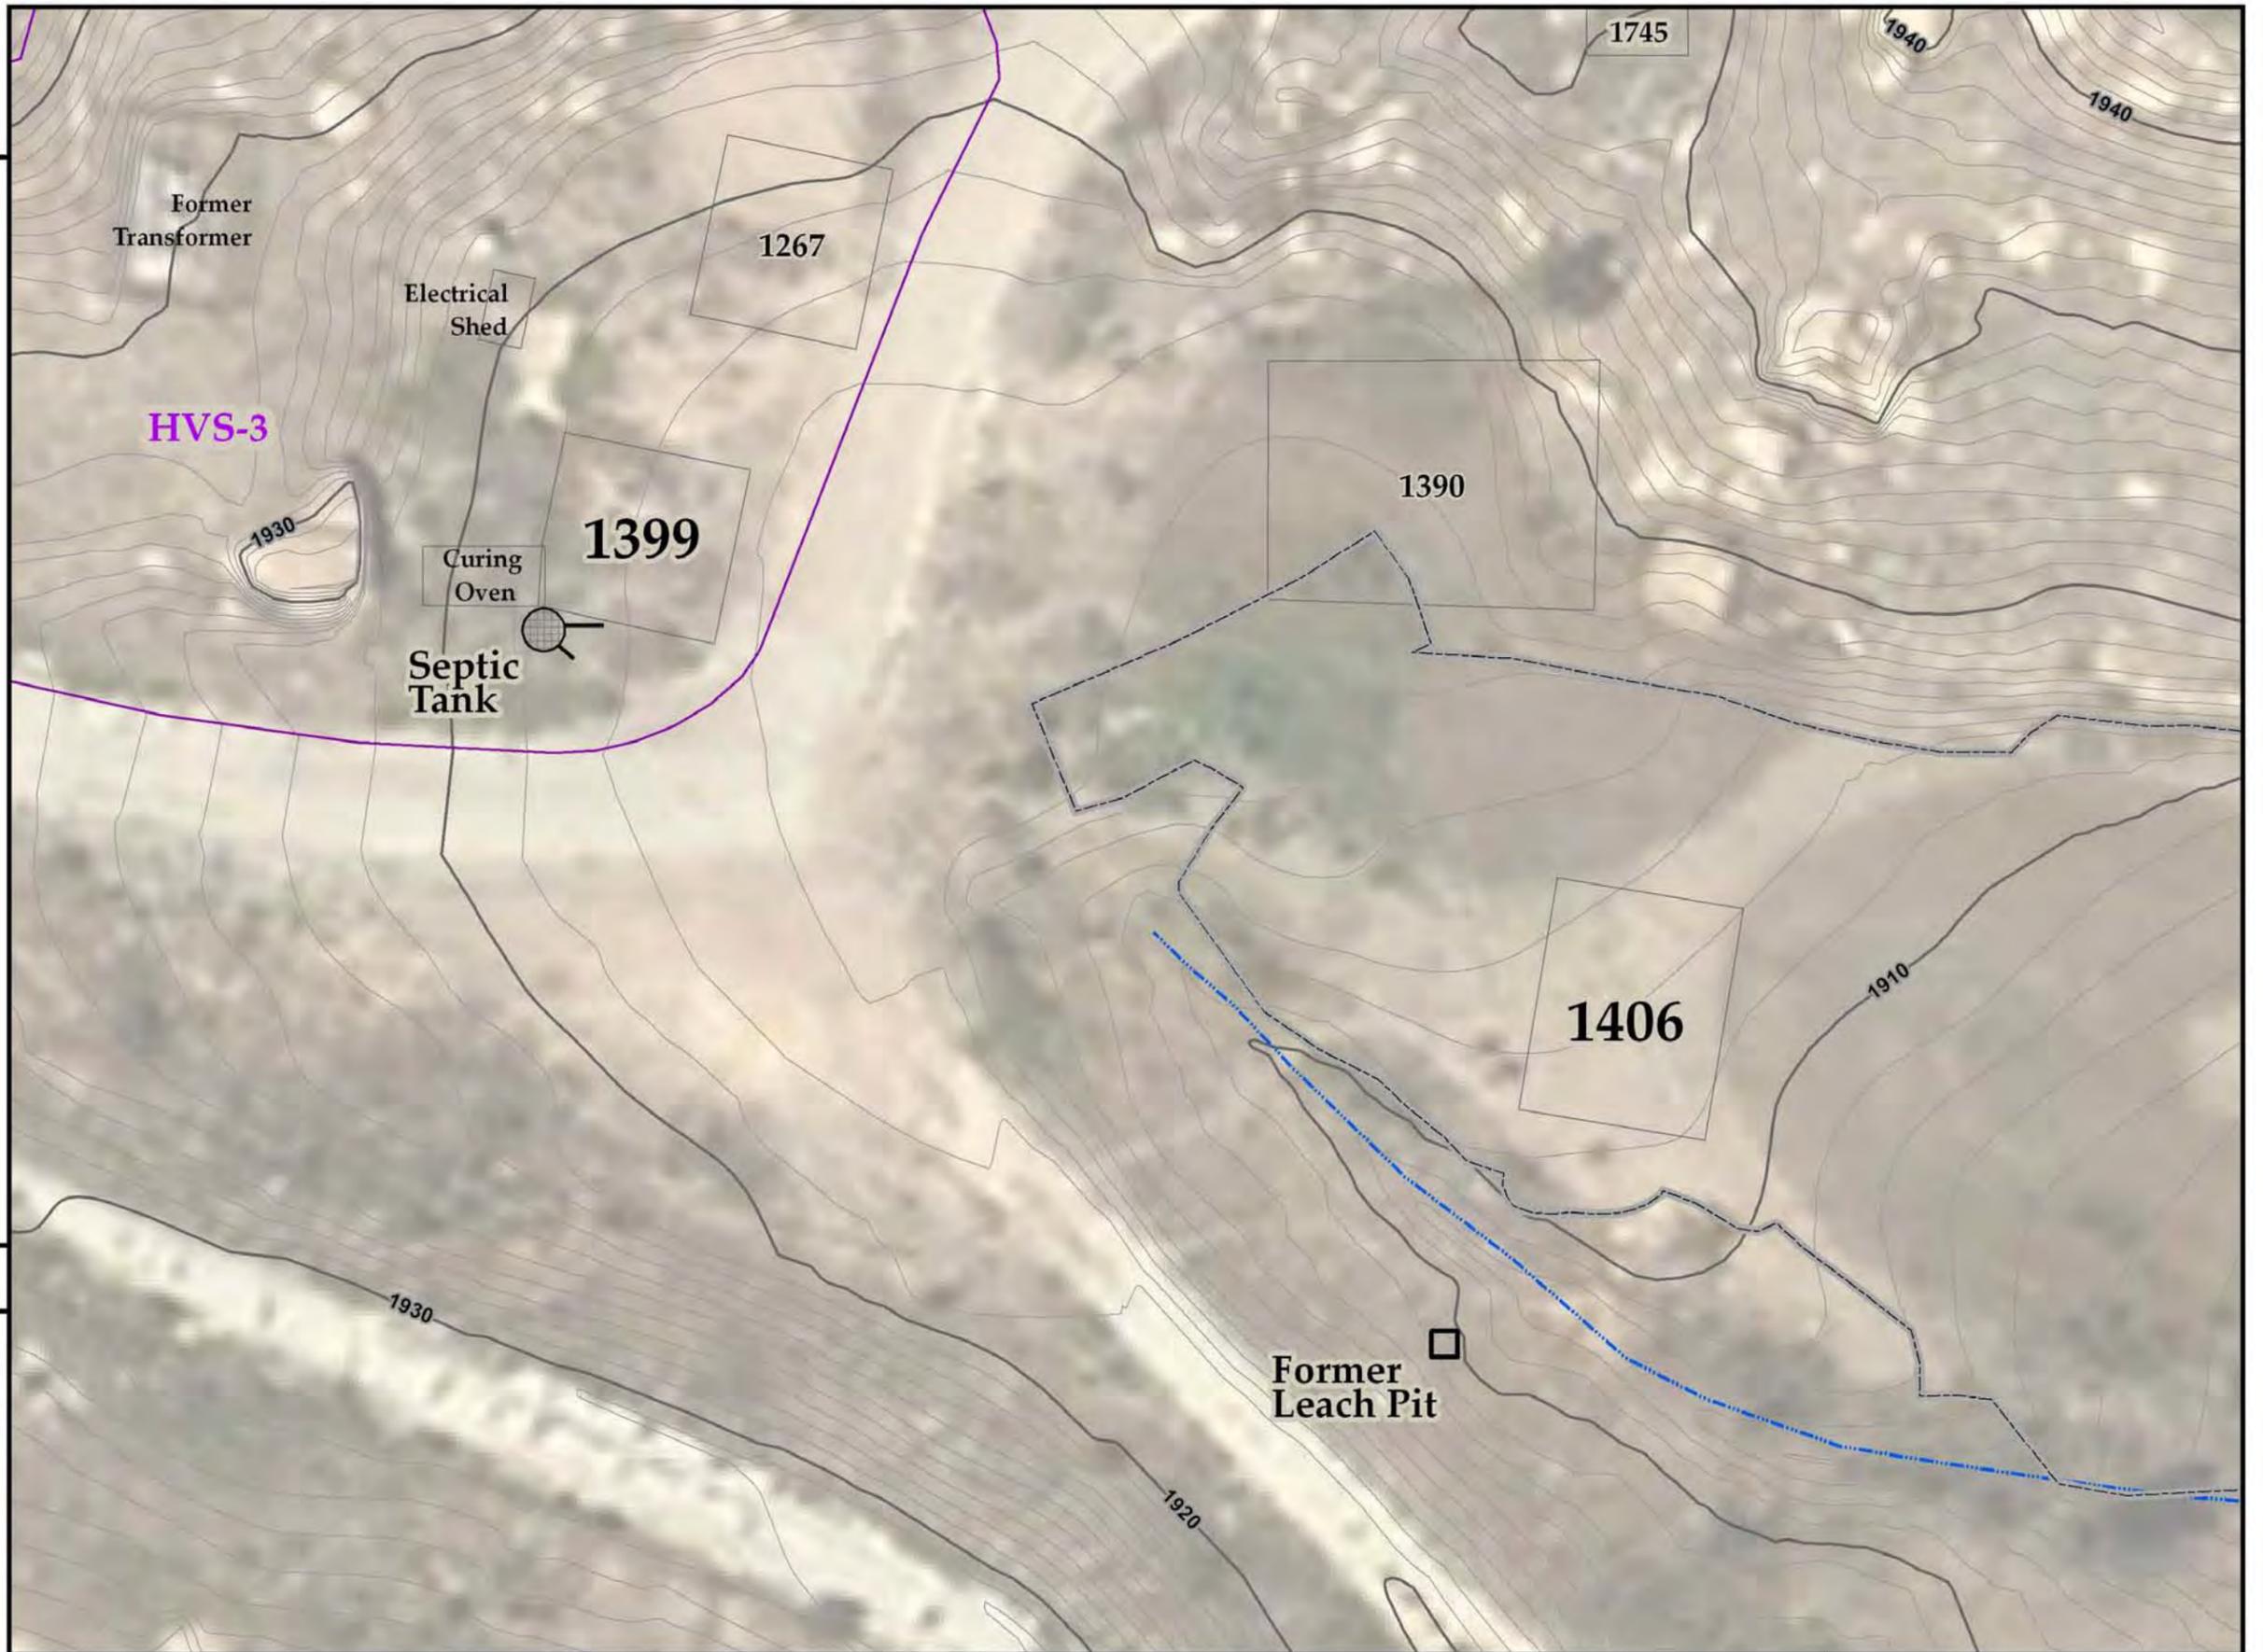
# Location of Happy Valley South Underground Septic Tank

tank. The locations of the septic tank, former leach pit, and Building 1399 are shown on Figure 1. Historical facility records reviewed for the RFI indicate the presence of the leach pit, but not the existence of the septic tank at this location (MWH, 2009a).

The former location of the leach pit for Building 1399 is located approximately 150 feet to the southeast of the septic tank (Figure 1). This location was inspected on September 30, 2009, where a slight depression still exists, and terra cotta pipe was observed. Surface exposures of the terra cotta pipe were also observed between the leach pit and the septic tank. Photographs of the leach pit in 1999 and in 2009 are provided as attachments to this letter.

Following tank removal, the excavation will be inspected and logged by a Professional Geologist, noting soil type and thickness, bedrock, and if any odor, debris, or staining is present. If any portions of the removed tank are observed to be structurally compromised during or immediately after removal, confirmation samples will be collected from soil that was adjacent to structurally compromised tank areas when the tank was in the ground. If the tank is in good condition upon removal and soil is present, one confirmation soil sample will be collected from the floor of the excavation and two confirmation samples collected from opposing sidewalls of the excavation. Please note, initial observation suggests the tank was installed into a bedrock excavation. Additionally, one confirmation sample will be collected from soils beneath at the terminus of the 3-foot discharge pipeline leading away from the septic tank. Planned septic tank confirmation samples are shown on Figure 1.

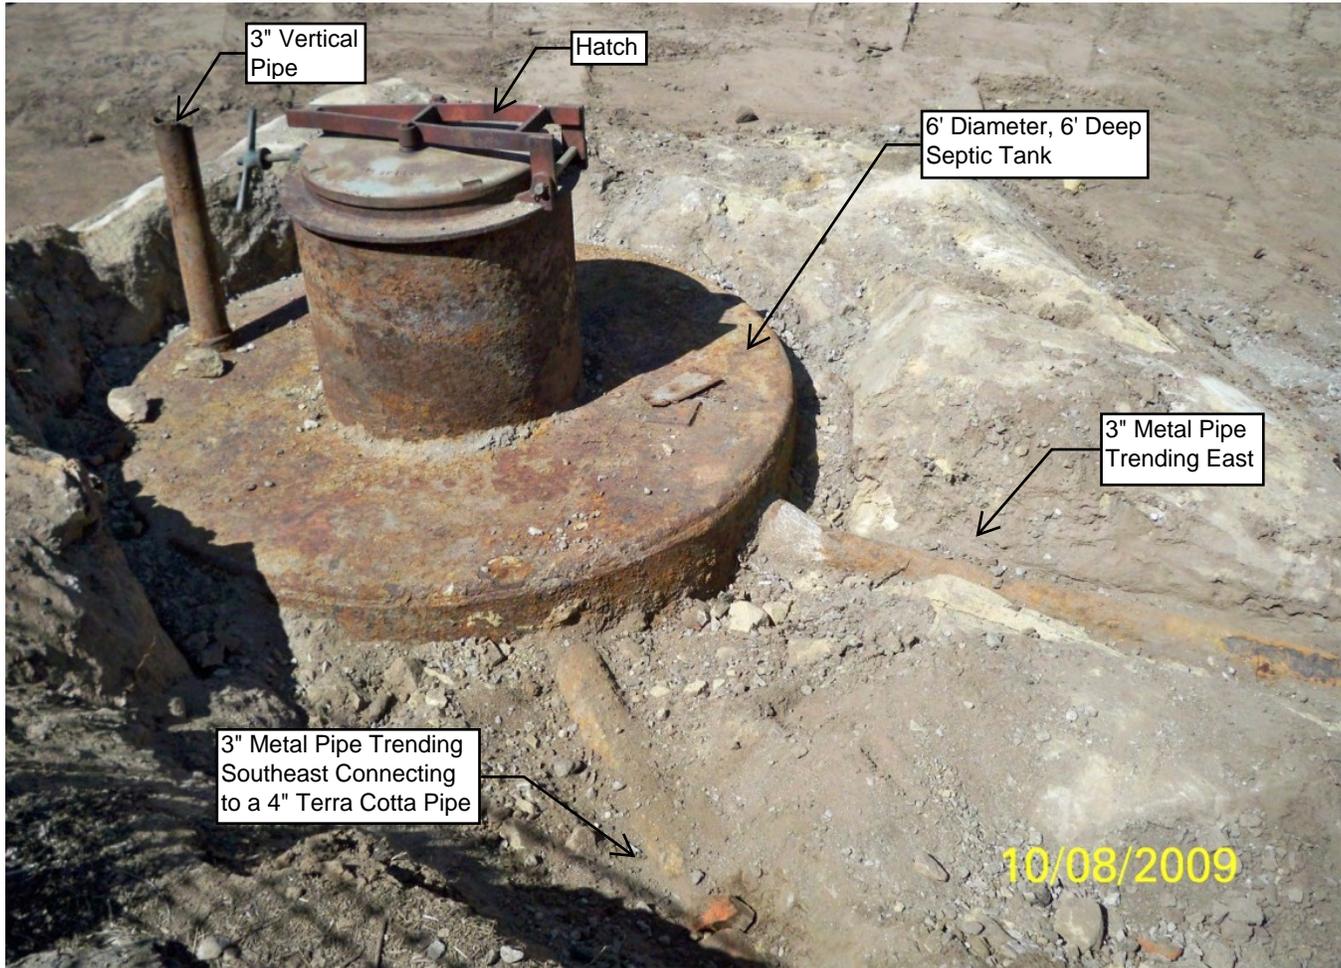
2009 Photograph of the Septic Tank and Associated Piping, Looking North

The septic tank is constructed of steel, cylindrical in shape, and approximately 6 feet in diameter and 6 feet deep. Its estimated capacity is approximately 1,300 gallons based on observations to date. It was installed vertically below grade into an excavation made predominantly into bedrock, and surrounded by sandy gravel. A 3-inch diameter vertical metal pipe has also been identified about 1 foot northwest of the hatch that connects to the septic tank, and may have been an inlet to the tank. This vertical pipeline is cut flush with ground surface. The hatch also had a grounding wire attached.

The septic tank hatch was opened and the tank interior was visually inspected on September 18, 2009. The tank seemed intact with no visible damage, and was filled with approximately 6 feet of clear liquid with no visible hydrocarbon sheen. A photo ionization detector did not detect volatile organic compounds within the tank. Samples were collected of the liquid contained in the tank for waste characterization purposes (results presented below).

Once the feature was confirmed as a septic tank and ambient screening performed, excavation of surficial soils in vicinity of the tank continued (ISRA Area HVS-3). Excavation activities carefully removed surficial soils around the vertical access pipe and the upper portion of the tank was exposed on September 25, 2009. During excavation activities, no vapors were detected with the PID and no staining observed. Bedrock was observed surrounding the cemented sandy gravel surrounding the metal tank. Two downward sloping, 3-inch diameter metal pipes connecting to the top of the eastern side of the tank were identified. One of the pipes continues east from the tank for approximately 6 feet before terminating. Near the terminus of this pipe fragments of terra cotta pipe were observed. The other pipe continues southeast from the tank for approximately 3 feet before connecting to a 4-inch diameter terra cotta pipe. Approximately 6 inches of the terra cotta pipe were exposed and the pipe appears to continue underground to the southeast. The tank and associated piping are shown on attached photographs.

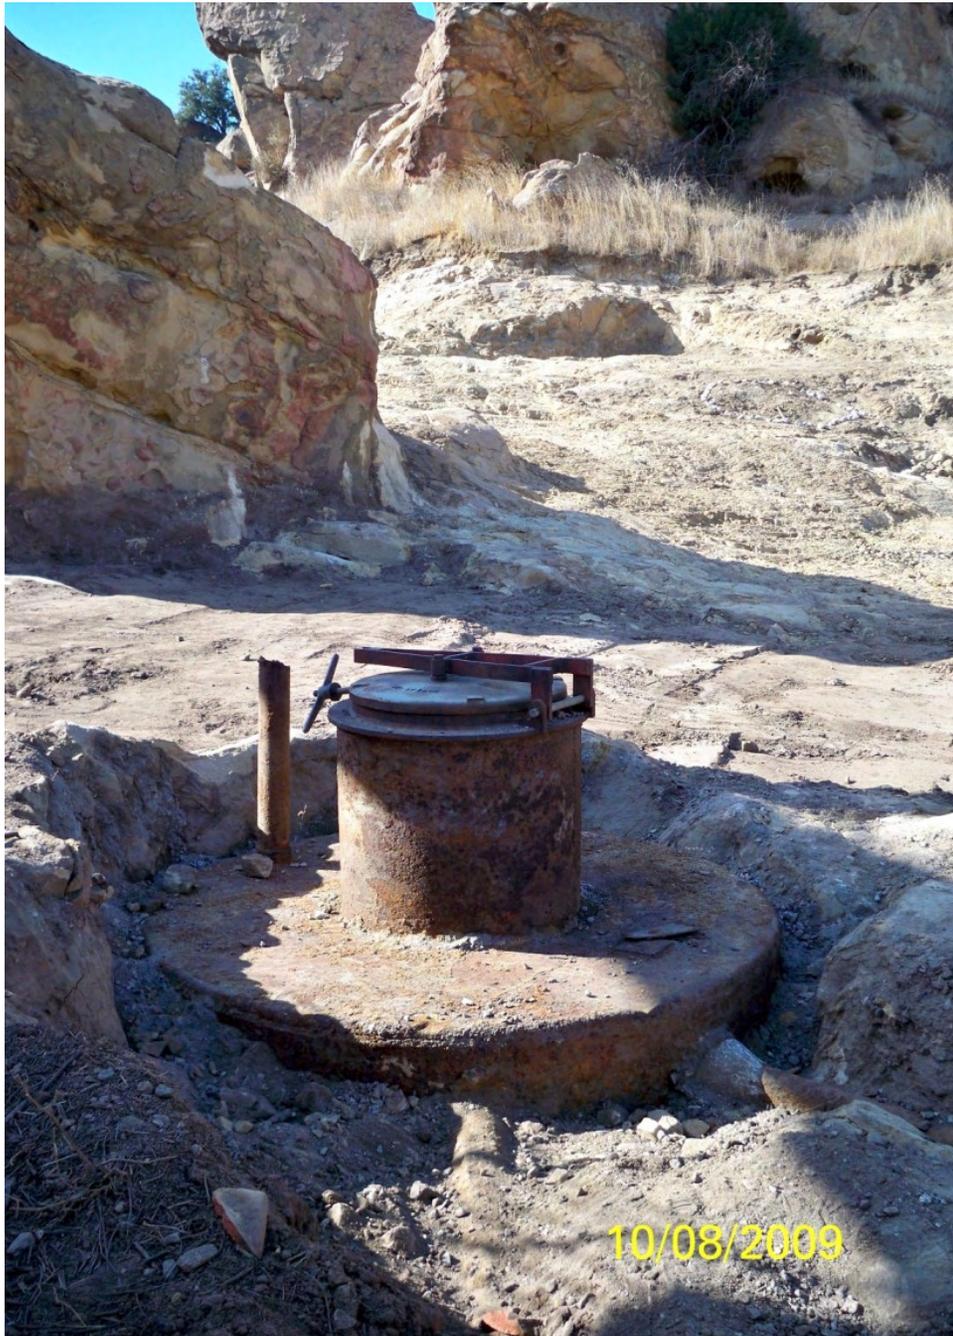
2009 Photograph of the Septic Tank and Associated Piping, Looking Northwest

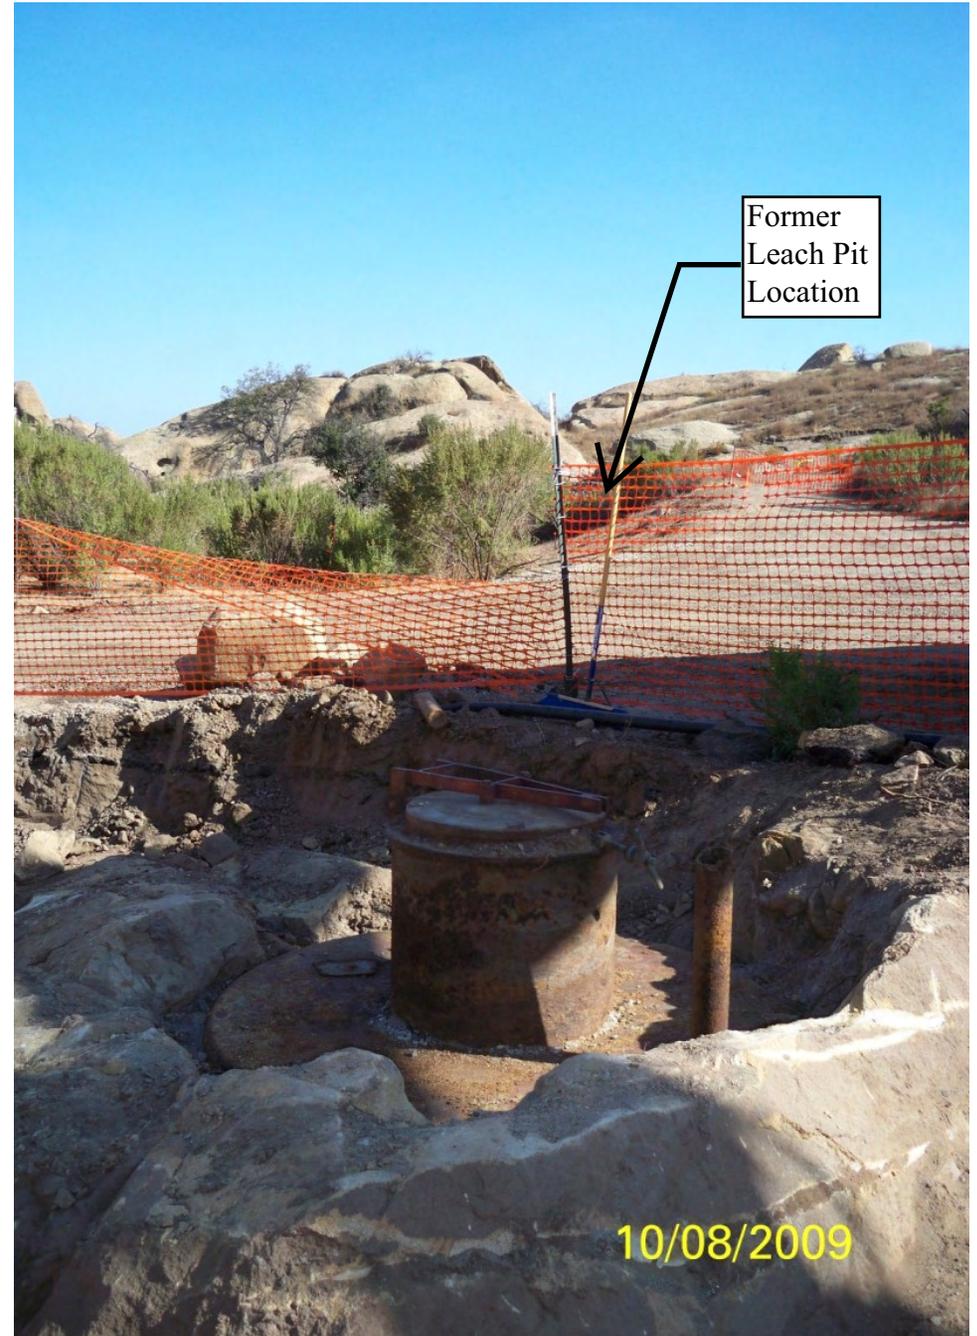
2009 Photograph of the Septic Tank and Associated Piping, Looking Southeast Towards the Leach Pit

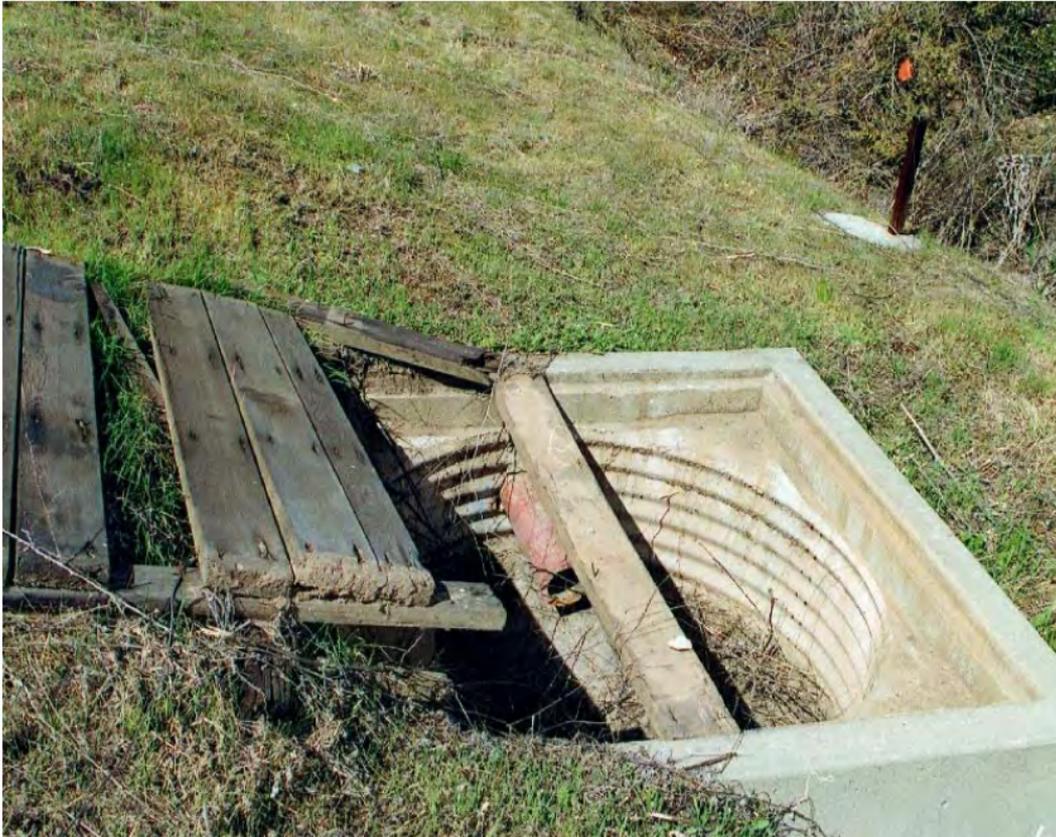
1999 Photograph of the Leach Pit, Looking North (UXB, 2002)

In 1999, a domestic waste leach pit was identified southwest of former Building 1406 during an interim measure remediation project overseen by DTSC to investigate the Happy Valley site for suspect unexploded ordnance items. The location of the leach pit is shown on Figure 1 and photographs of the leach pit are attached. The leach pit was approximately 4 feet deep and 3 feet wide, and constructed of concrete walls with an earthen floor and a wooden cover. As shown in the leach pit photograph, a terra cotta pipe connects to the northern side of the leach pit, the general direction of the septic tank adjacent to Building 1399. Based on the presence and direction of the terra cotta pipe in the leach pit and the terra cotta pipe connecting to the 3-foot long metal pipe that connects to the eastern side of the septic tank, it is believed that waste liquids from the septic tank drained to the leach pit. The vertical pipe and the eastern trending metal pipe that connect to the septic tank are believed to be inlets to the septic tank, possibly from Building 1399 and Building 1390, respectively.

During implementation of the 1999/2000 interim measure, the leach pit was excavated to bedrock, combined and characterized with other excavated materials from Building 1372, and disposed as non-RCRA hazardous waste at Chemical Waste Management Kettleman Hills facility (UXB, 2002). Approximately 10 cubic yards of material were removed during the excavation of the waste leach pit, including soil and leach field gravels.

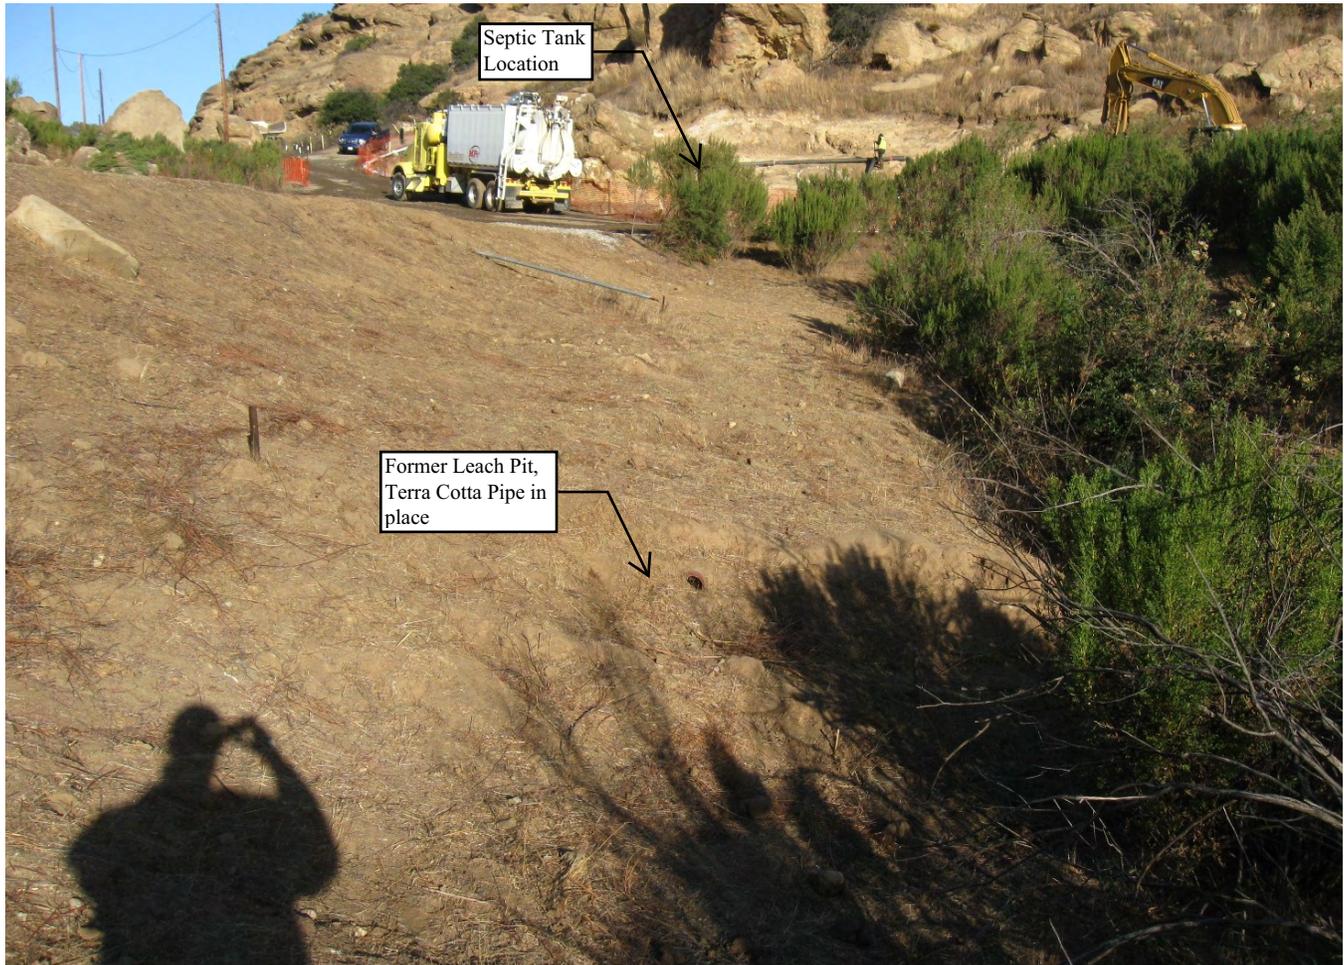
2009 Photograph of the Former Leach Pit, Looking North

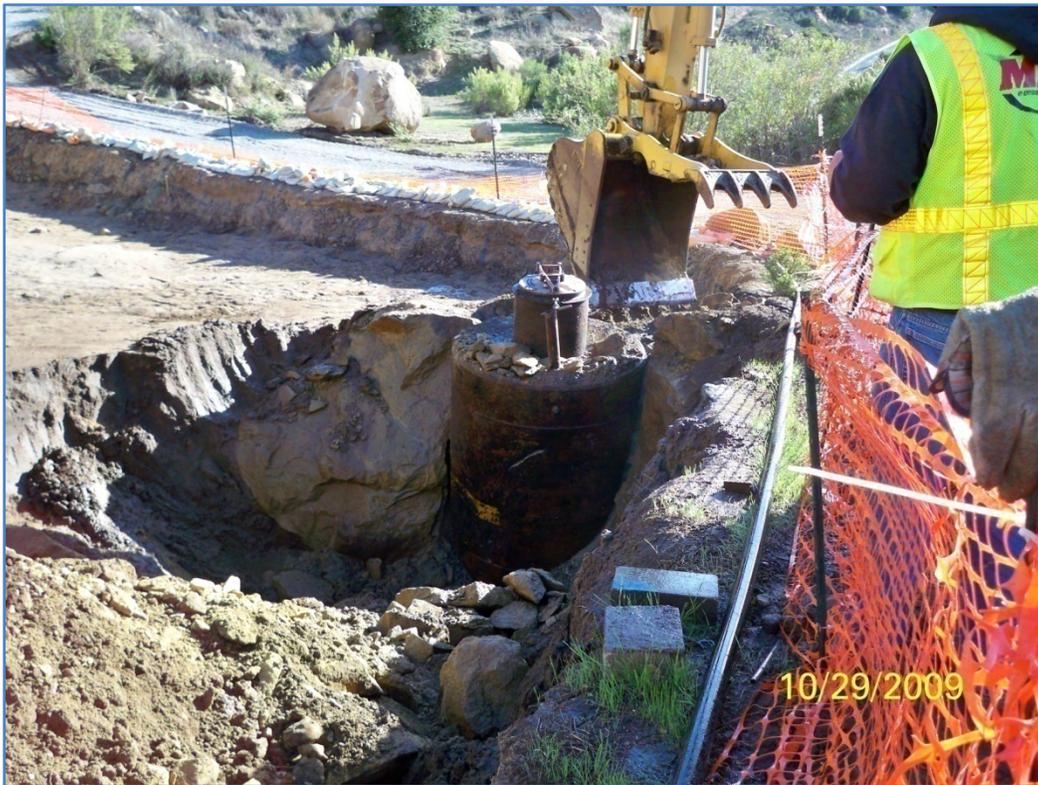
View looking east across septic tank removal area at ISRA Area HVS-3 , Happy Valley South, 10-29-2009.

Following septic tank removal, the excavation was inspected and logged by a California State Professional Geologist. Trench logs are provided in Appendix D. No soil staining was observed in the septic tank excavation walls. Dust control, using a fire hose, was used throughout the excavation and septic tank removal to suppress airborne dust. During excavation activities no vapors were detected with the PID.

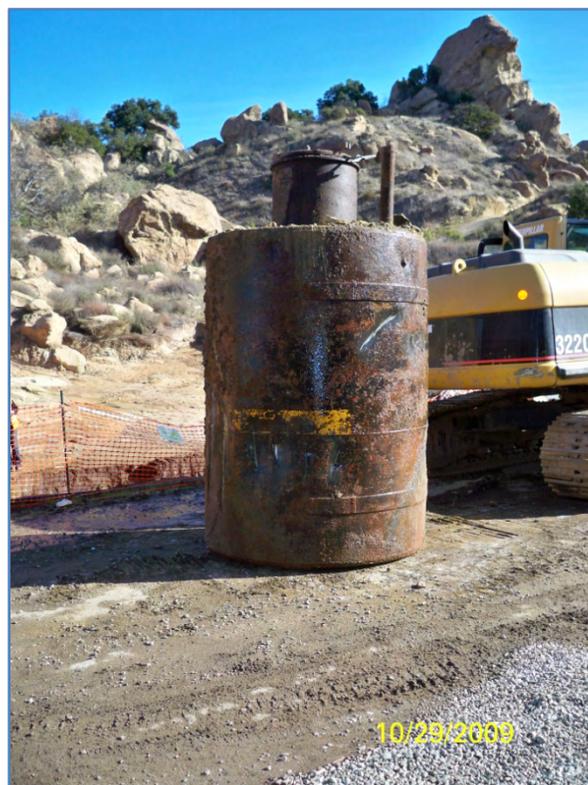
View of septic tank after removal, Happy Valley South, 10-29-2009.

The septic tank removal occurred on October 29, 2009. Jim O'Tousa (Ventura County), Paul Carpenter (DTSC), and Peter Raftery (RWQCB) were on site and oversaw the removal of the septic tank. The tank was uncovered and tilted to the side within the excavation using a Cat 322 excavator. The tank was then removed in one piece, inspected, and securely placed on a trailer. No sludge or material was observed inside the septic tank at the time of removal. A faint yellow stripe was observed on the sidewall of the septic tank. A metal detector was used to sift soil from around the septic tank excavation. The metal detector sensed gravel with elevated iron content, but no additional metal pipes near the septic tank excavation. The septic tank was stored at the Area I lower parking lot located near the SSFL front gate until it was transported offsite for recycling at SA Recycling in Sun Valley, California on November 17, 2009.

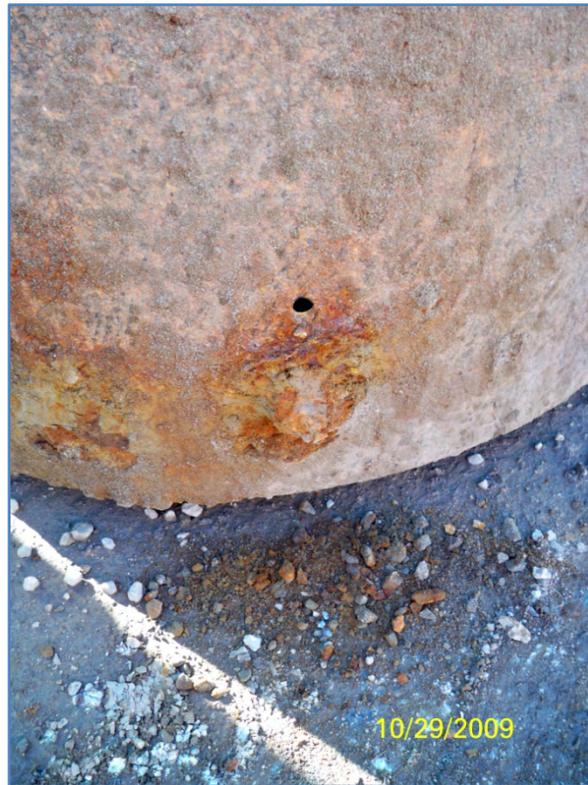
Close-up view of bottom of septic tank, Happy Valley South, 10-29-2009.

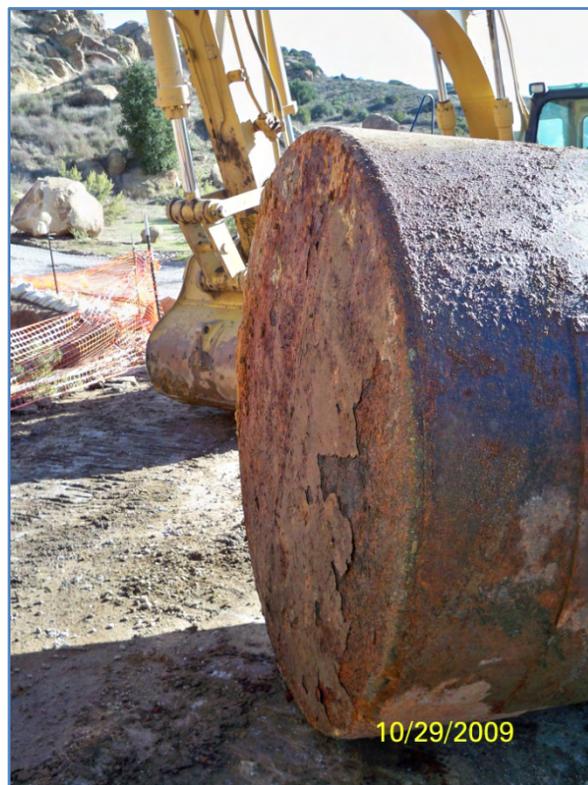
Close-up view of bottom of septic tank, Happy Valley South, 10-29-2009.

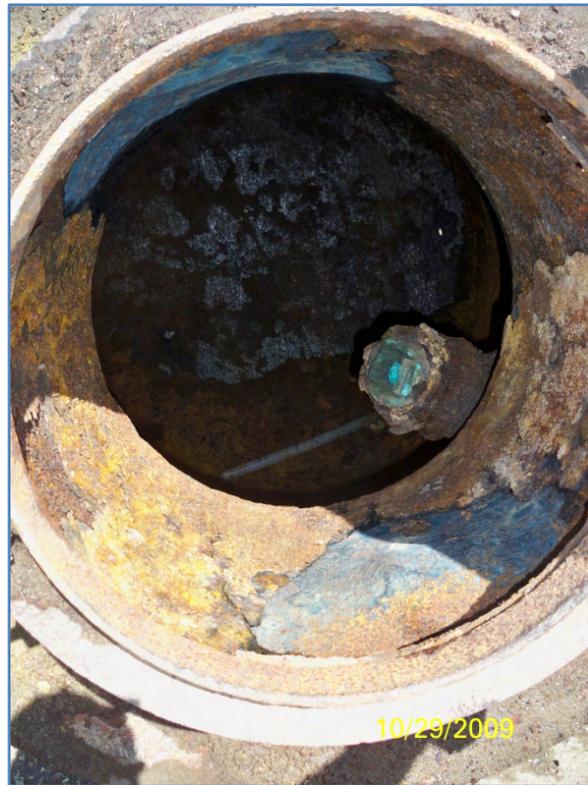
View looking down into the open hatch at top of septic tank, Happy Valley South, 10-29-2009.

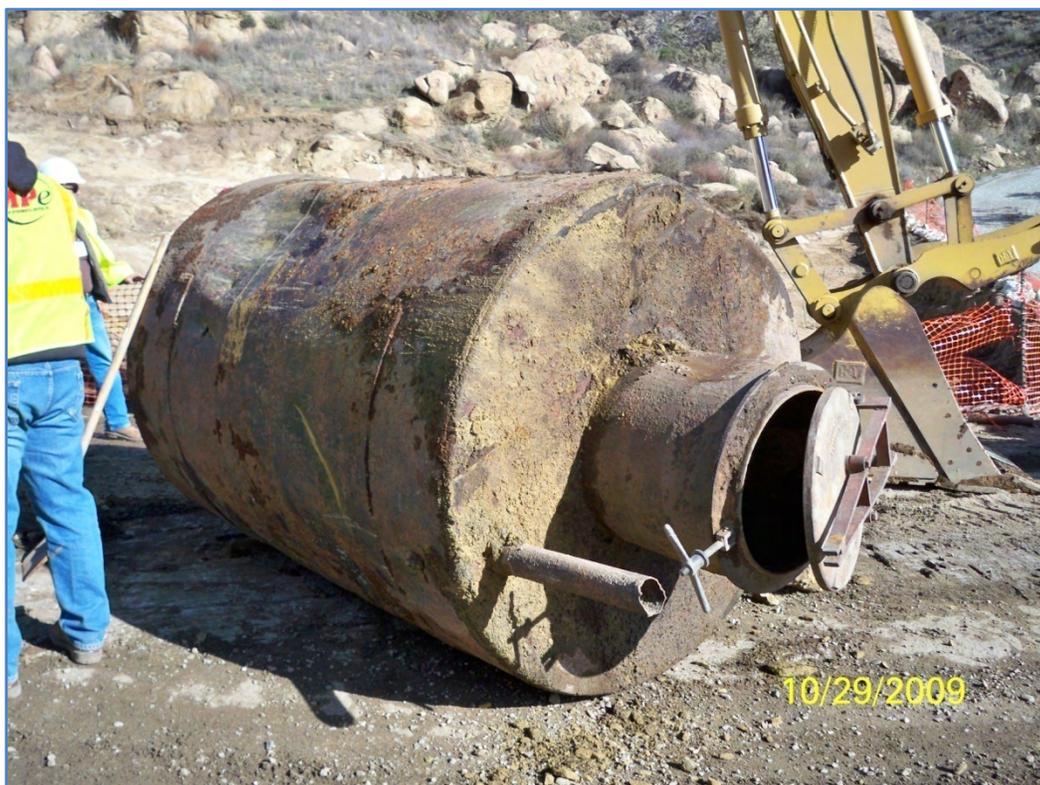
View of removed septic tank, Happy Valley South, 10-29-2009.

Based on the non-hazardous nature of the water contained in the Happy Valley South and the non-hazardous soil conditions surrounding it, no hazardous waste issues are associated with disposal of the steel tank itself.

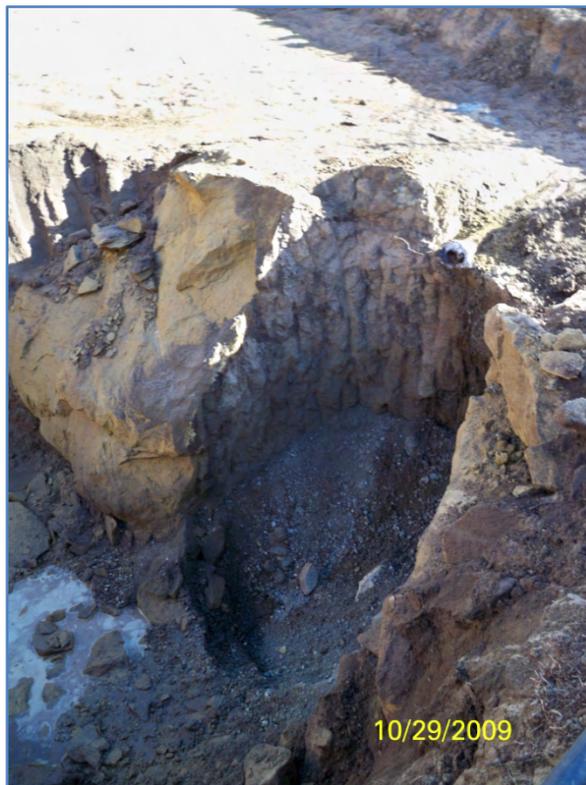
View looking east across septic tank removal excavation at ISRA Area HVS-3, Happy Valley South, 10-29-2009.

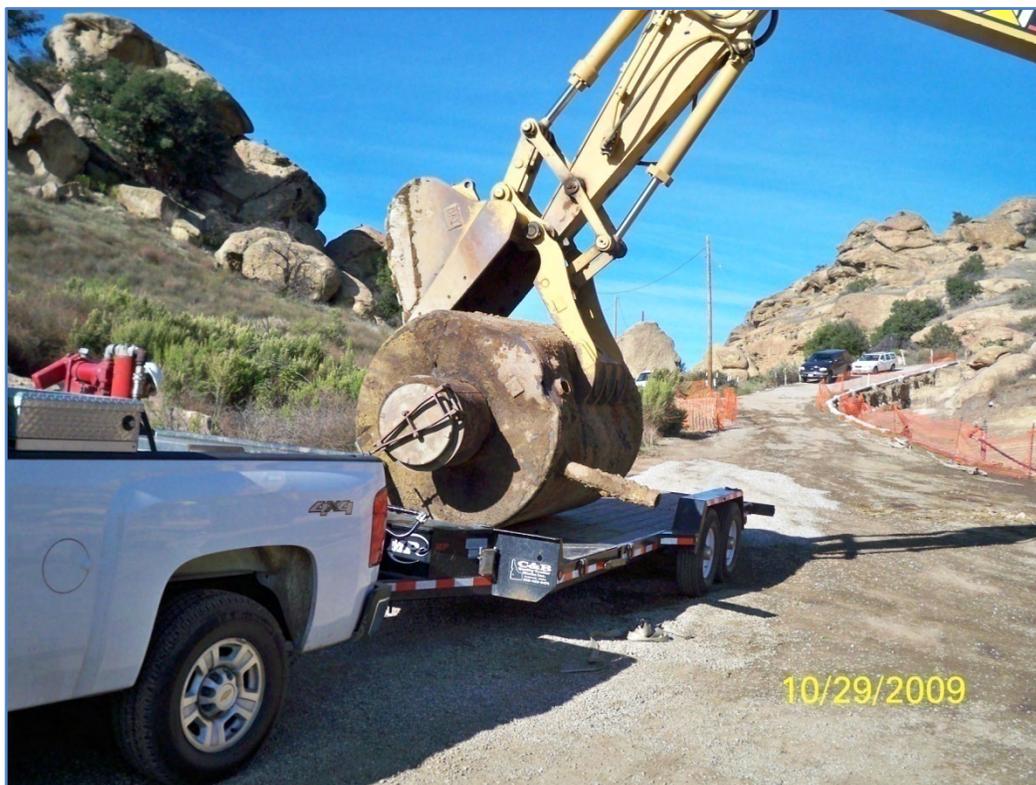
View of septic tank being loaded onto a flatbed truck for transport offsite, Happy Valley South, 10-29-08.
