APPENDIX A
REGULATORY CORRESPONDENCE

APPENDIX A – Regulatory Correspondence

Correspondence Related to ISRA Corrective Action Order

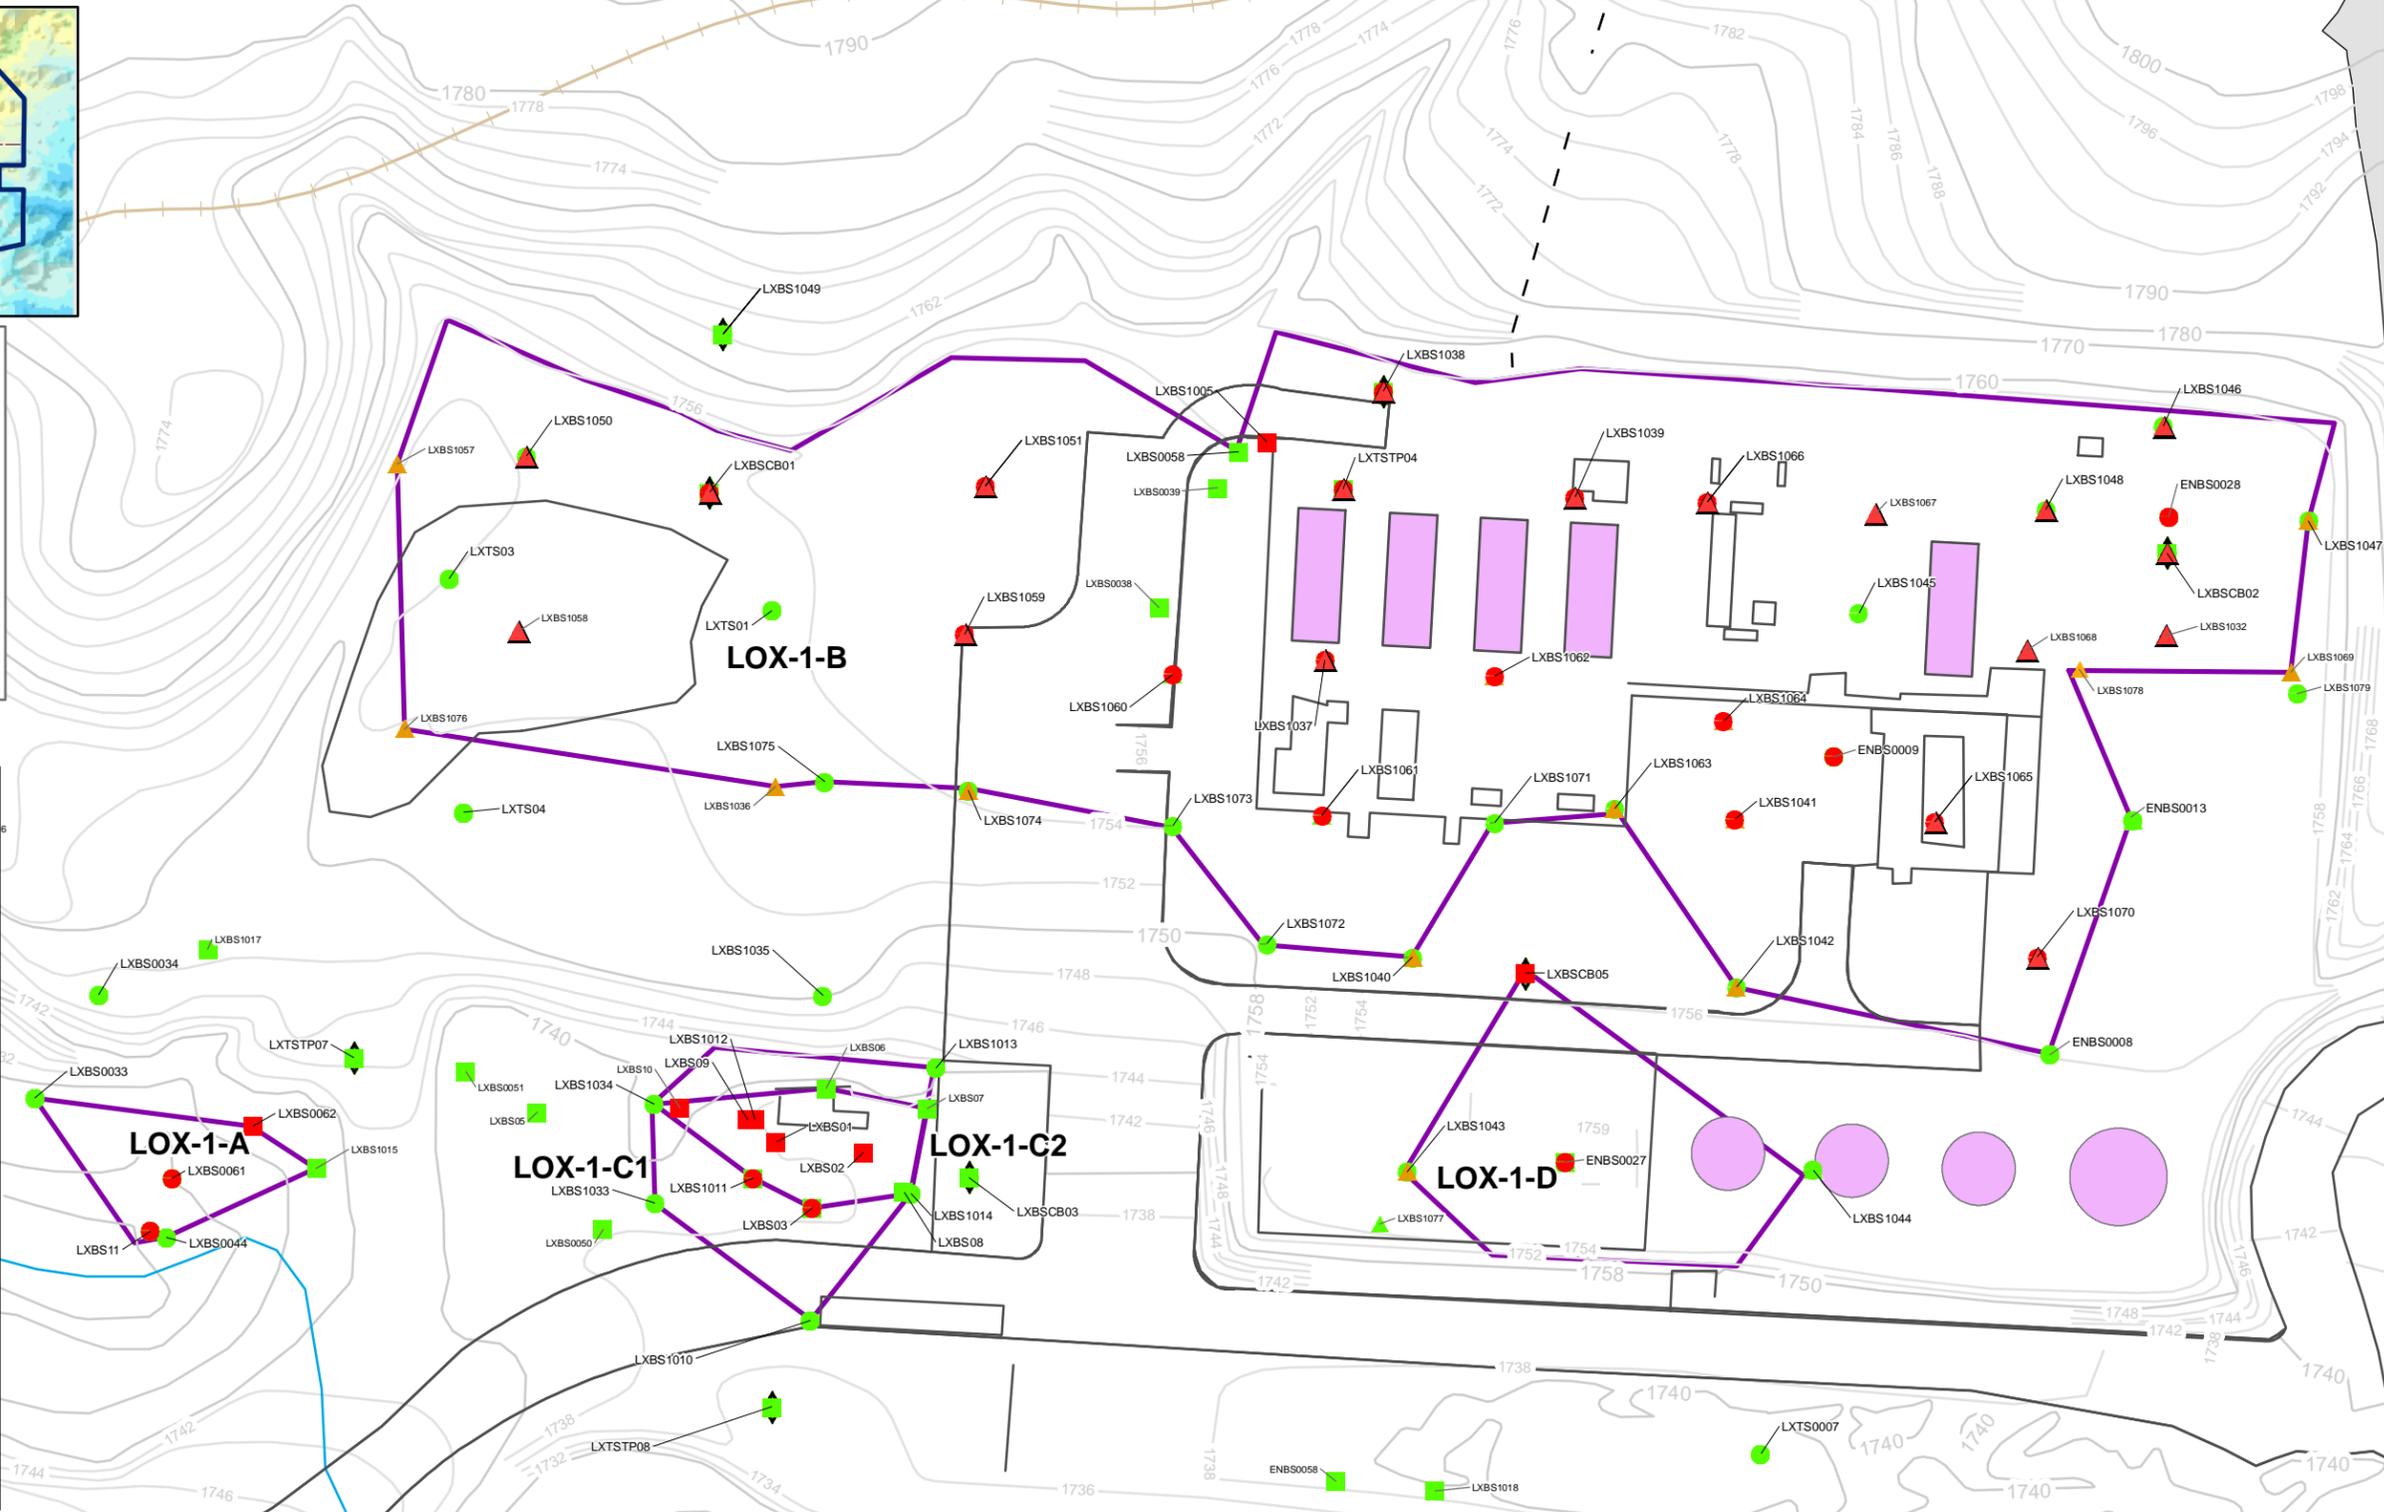
Figure 2-14 (Revised)
Refined Preliminary ISRA Evaluation Areas
LOX-1 PEA, Outfall 009
Santa Susana Field Laboratory

Figure 2-14 was revised to replace the black triangles with yellow triangles.
