**Subject: Addendum to Biological Resources Study for ISRA Outfall 009 – Pre-Activity Biological Survey Results for Proposed Soil Borrow Area adjacent to RD-47**

## PHOTOGRAPHIC APPENDIX AUGUST 27, 2010

**Subject: Santa Susana Field Laboratory Outfall 009 ISRA Biological Survey and Construction Monitoring Report – June 2010 to February 2011**

## **APPENDIX A. PHOTOGRAPHIC DOCUMENTATION**

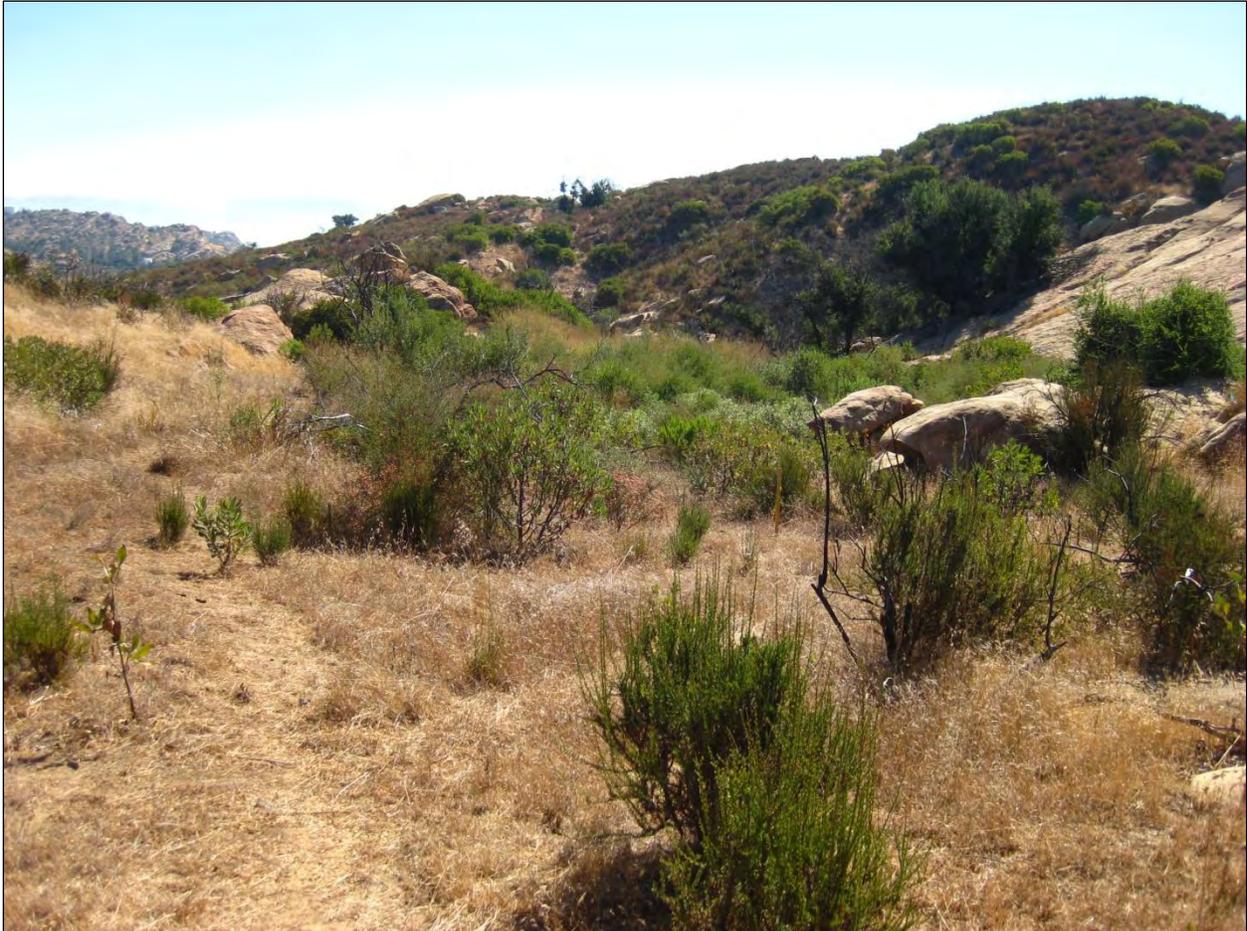
Figure 1. View of the soil borrow area from its western end.

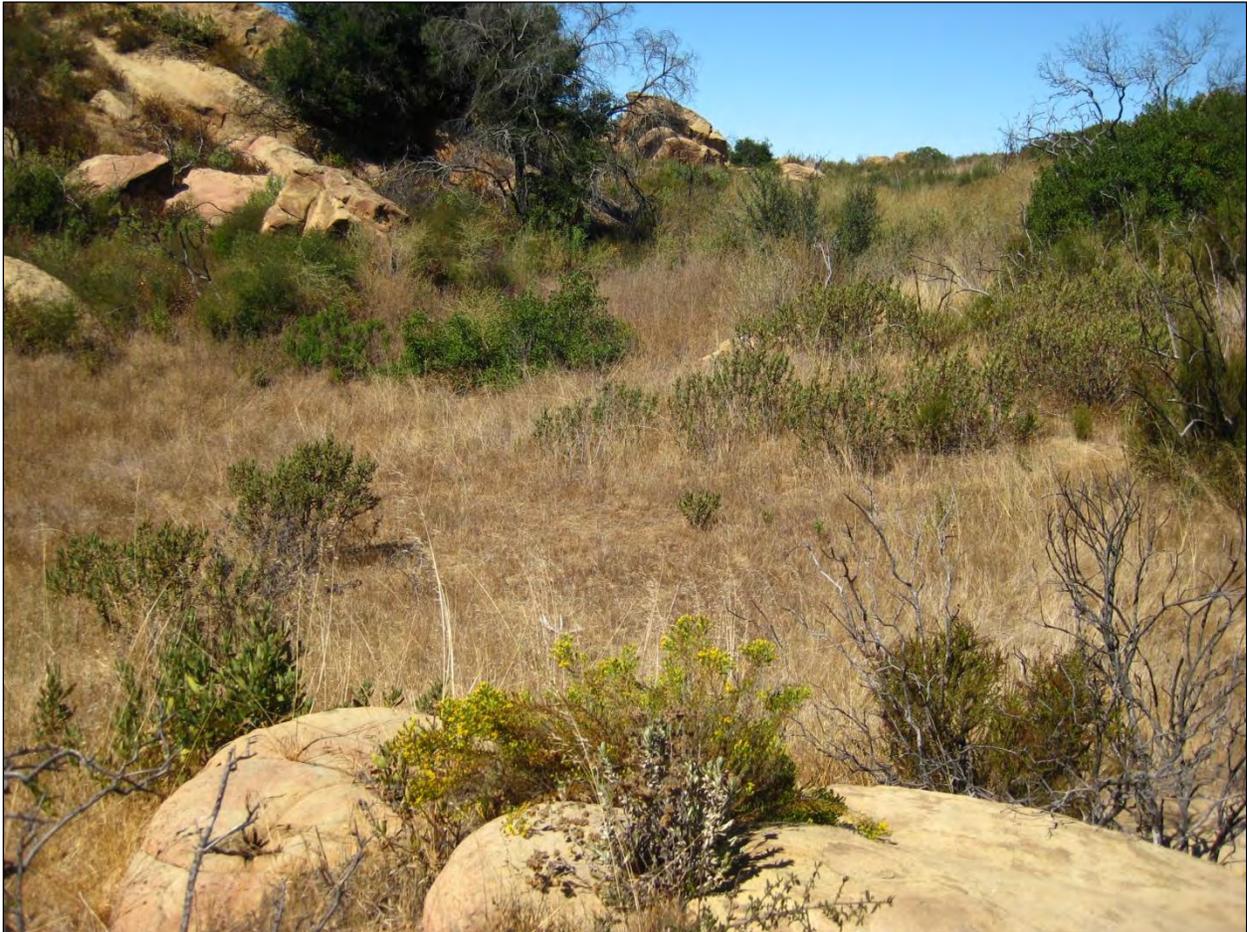
Figure 2. View of the soil borrow area from its eastern end. Note Santa Susana tarplant in foreground on an adjacent sandstone rock outcrop.

All Site access, vegetation clearing and soil borrow activities should avoid the Santa Susana tarplants along the access road and on adjacent sandstone rock outcrops. All Santa Susana tarplants along the access road should be fenced with orange construction fencing prior to commencement of soil borrow activities.

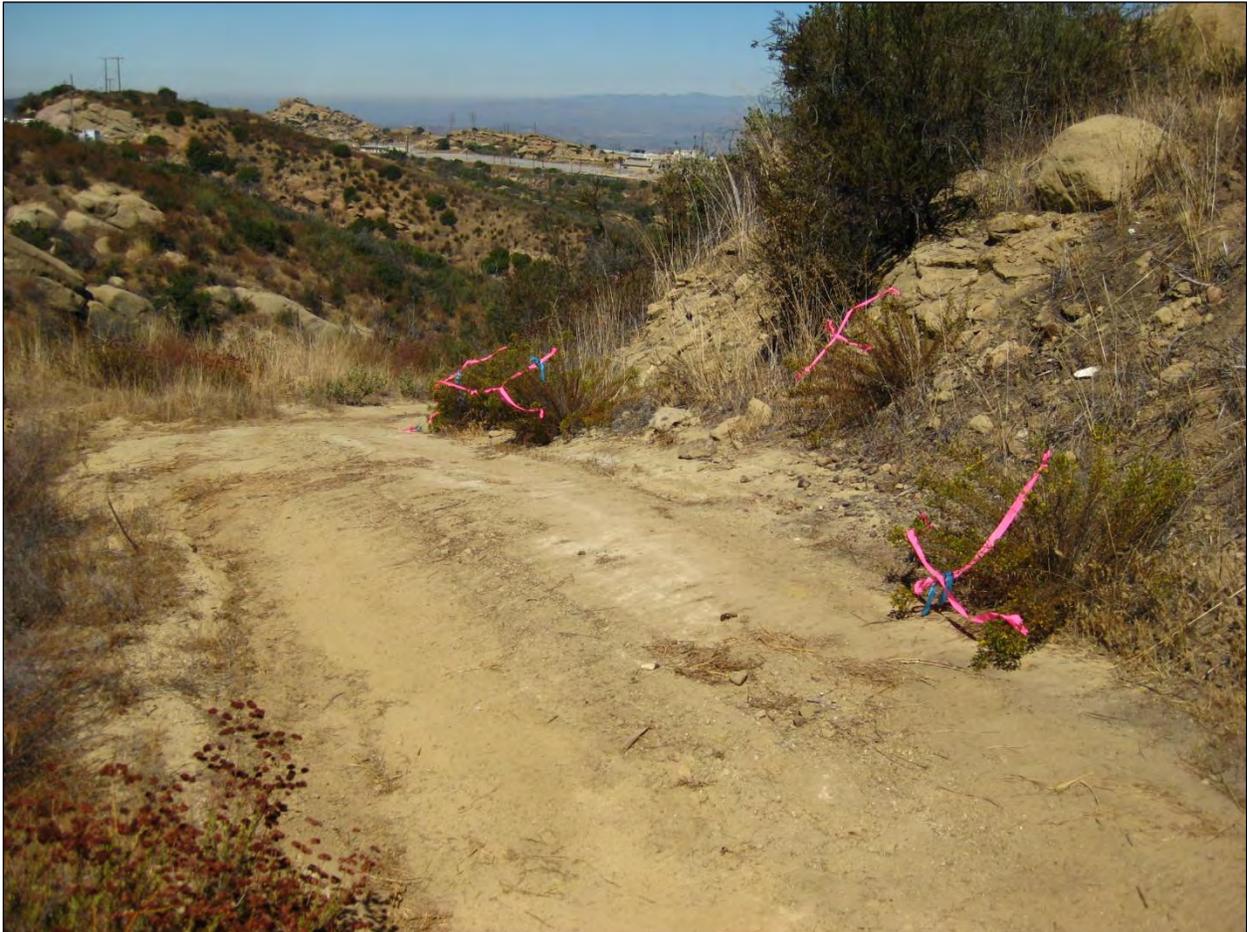
Special-status plants observed at the Site include nine (9) Santa Susana tarplants along the north edge of the access road, approximately 1,500 feet above the entrance off Service Area Road (500 feet below the entrance to the soil borrow area), and scattered Santa Susana tarplants on rock outcrops adjacent to the soil borrow area. In addition, as stated above, 4 coast live oak trees (protected by Ventura County tree protection ordinance) are located

Figure 3. View of access road, approximately 1,500 feet above the entrance off of Service Area Road (and 500 feet below the soil borrow area), at the location of 9 flagged Santa Susana tarplants. Photograph is toward the northwest.

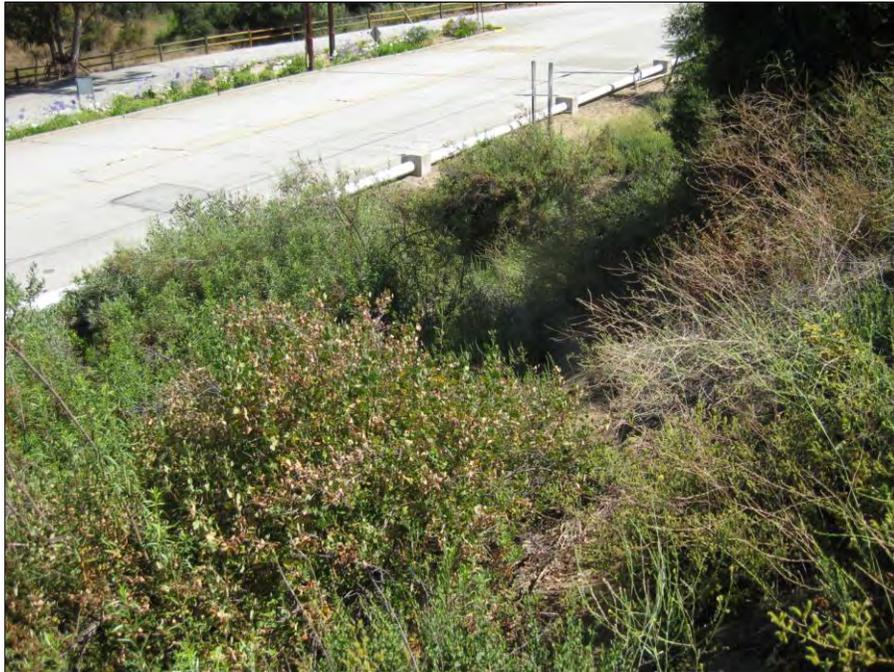
Figure 3. View of lower portion of B1-2, prior to ISRA activities. Photograph is toward the northeast, taken on July 2, 2010.

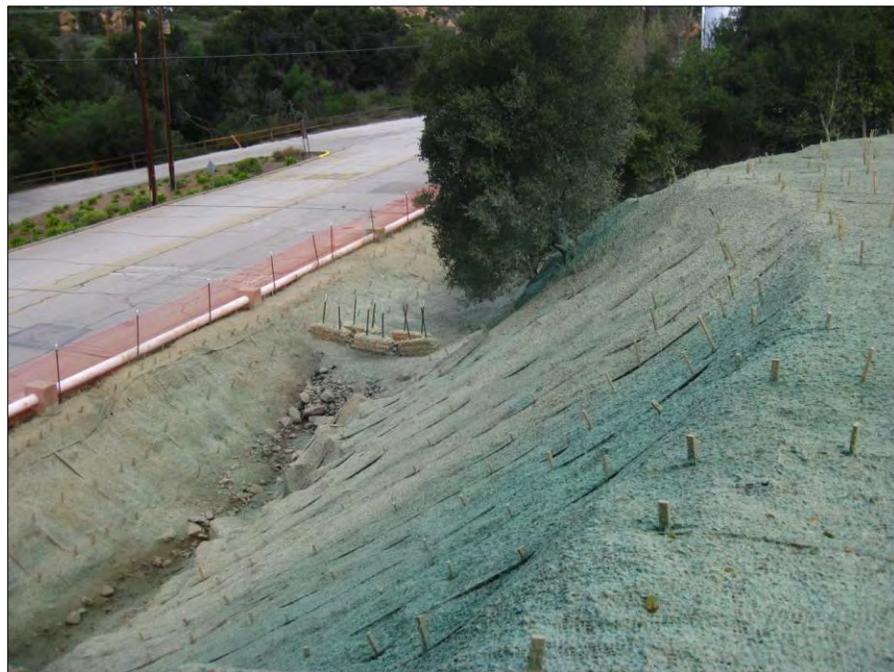
Figure 4. View of lower portion of B1-2, subsequent to ISRA activities. Photograph is toward the northeast, taken on February 17, 2011. Slopes are covered in jute netting and are hydroseeded.

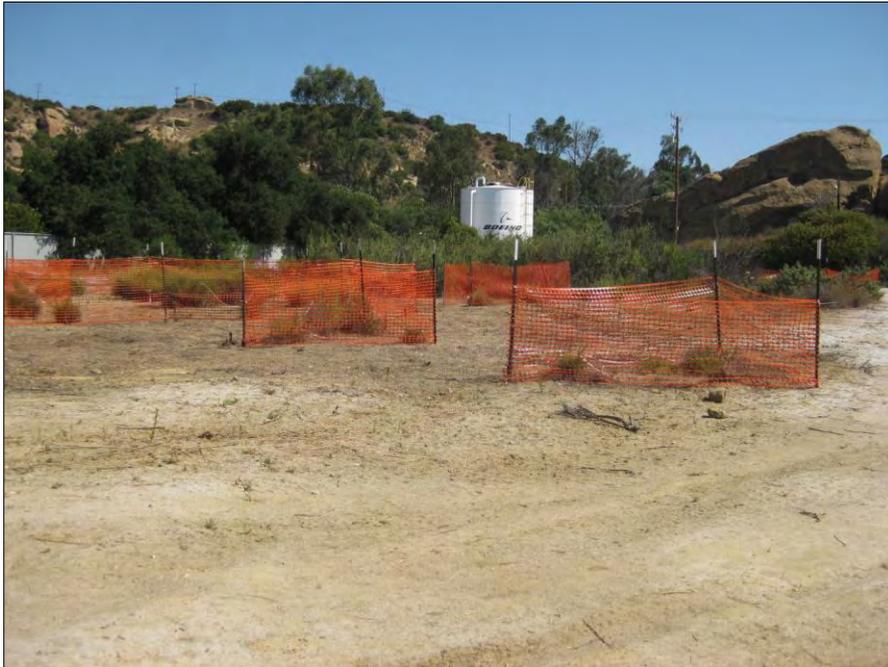
Figure 5. View of upper portion of B1-2, prior to ISRA activities. Photograph is toward the north, taken on July 15, 2010. Orange construction fencing in place for Santa Susana tarplant protection.

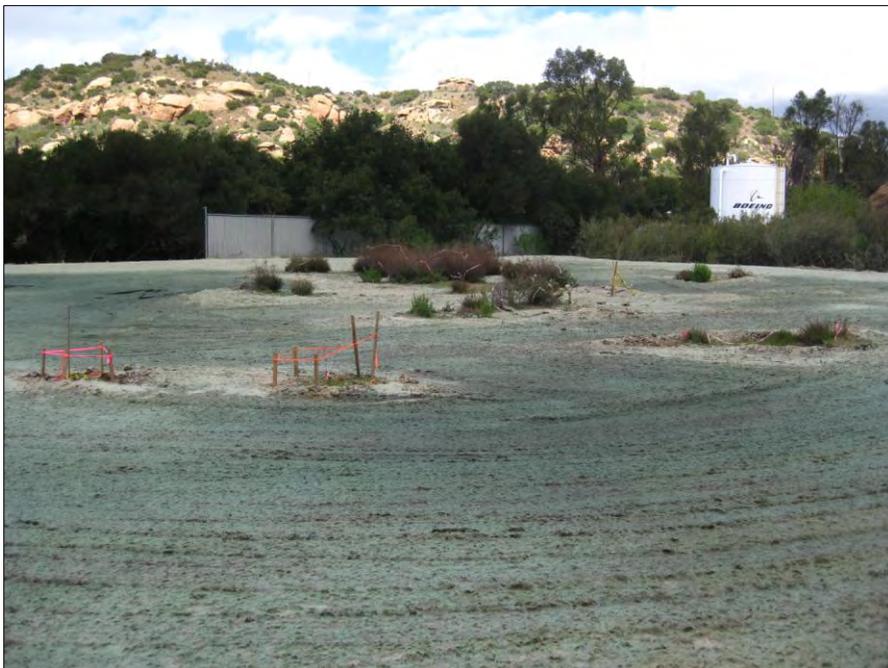
Figure 6. View of upper portion of B1-2, subsequent to ISRA activities. Photograph is toward the northeast, taken on February 17, 2011. Site is hydroseeded and Santa Susana tarplants are present (marked by pink flagging).

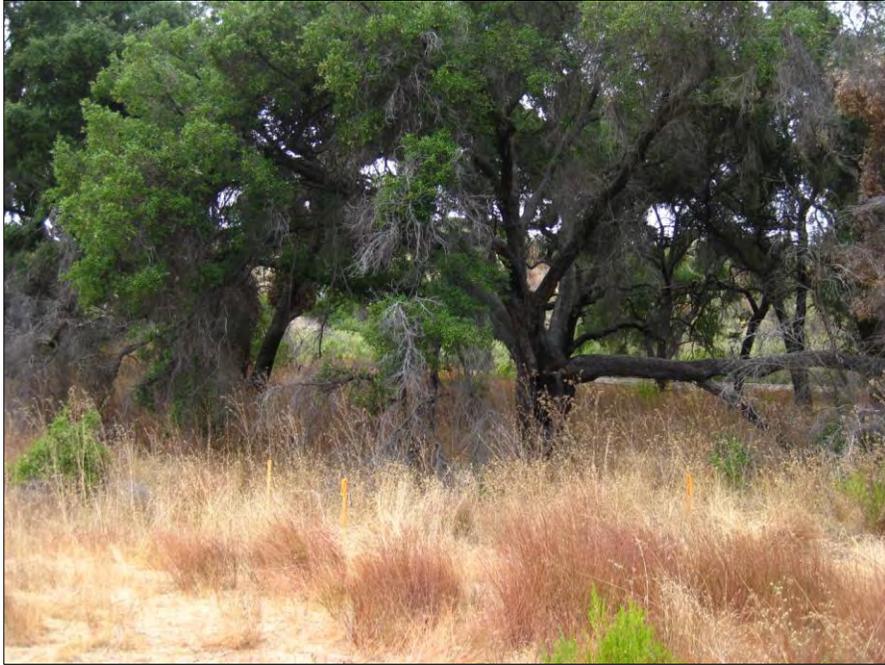
Figure 13. View of AP/STP-1D prior to ISRA activities. Photograph is toward the north, taken on September 28, 2010.

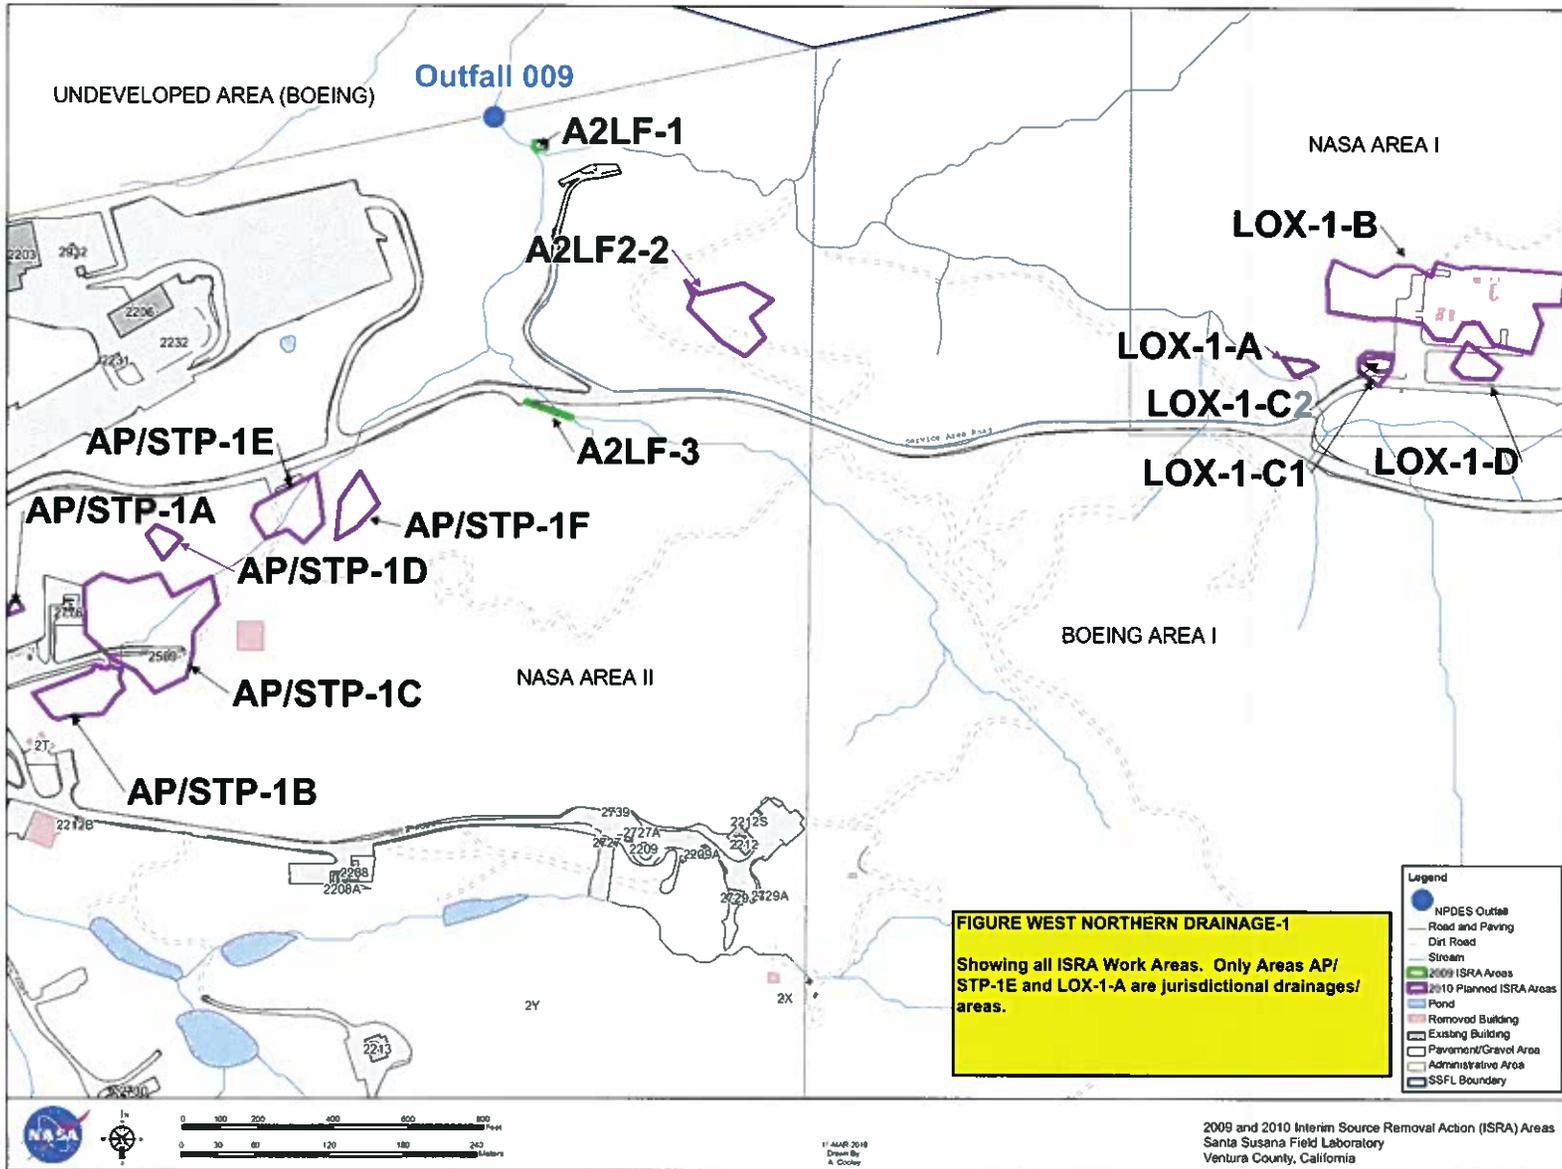
**FIGURE WEST NORTHERN DRAINAGE-1**  
 Showing all ISRA Work Areas. Only Areas AP/STP-1E and LOX-1-A are jurisdictional drainages/ areas.

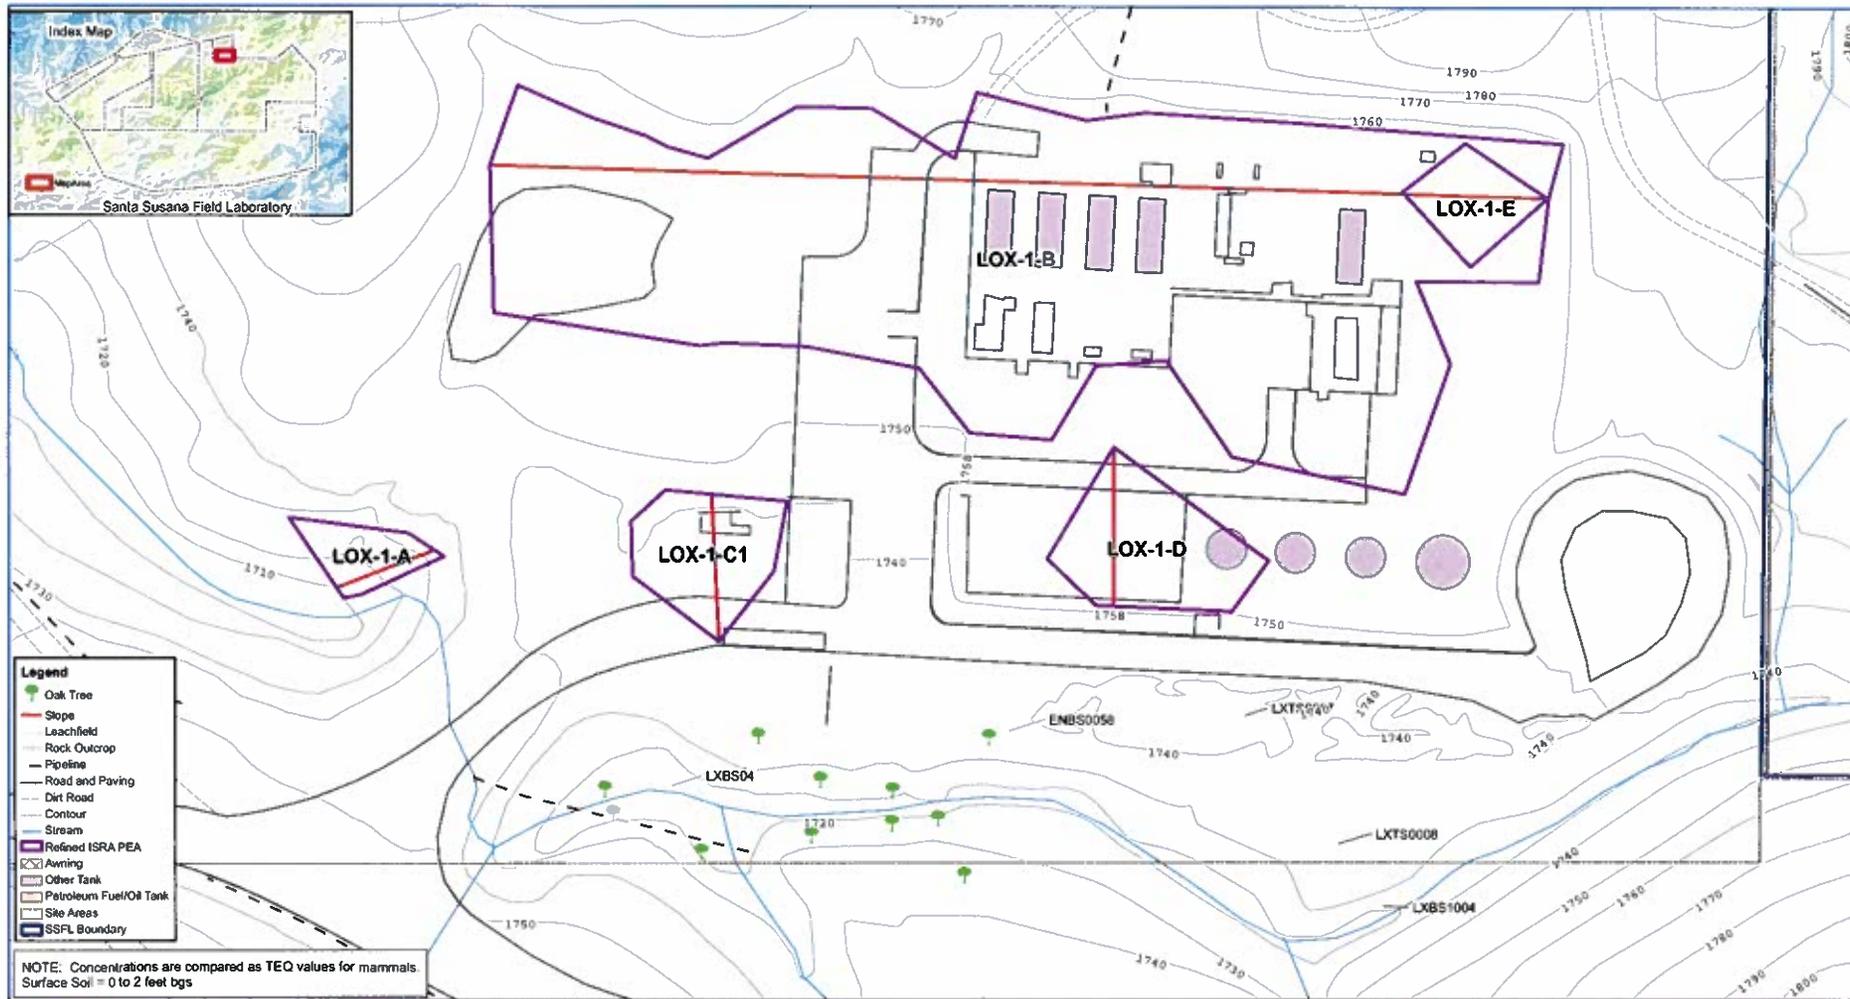
**Figure 4-2**  
AP/STP Refined ISRA PEAs and ISRA Areas  
Santa Susana Field Laboratory

Figure 4-2  
 AP/STP Refined ISRA PEAs and ISRA Areas  
 Santa Susana Field Laboratory

**Western Northern Drainage Areas, see FIGURE WEST NORTHERN DRAINAGE-1 and Figures 4-2 (2 sheets), Area-1E, and Area LOX-1-A**

Excavation/removal areas are approximately 20,000 square feet (approximately 0.5 acres) in Area 1E, and 2,500 square feet (approximately 0.06 acres) in Area LOX-1-A. Based on the described Project, temporary impacts to jurisdictional drainages are insignificant, and it is anticipated jurisdictional drainages will essentially be restored to their pre-construction condition, with the exception that topographic grade may be slightly lower and/or sediment or erosion control features may be present.

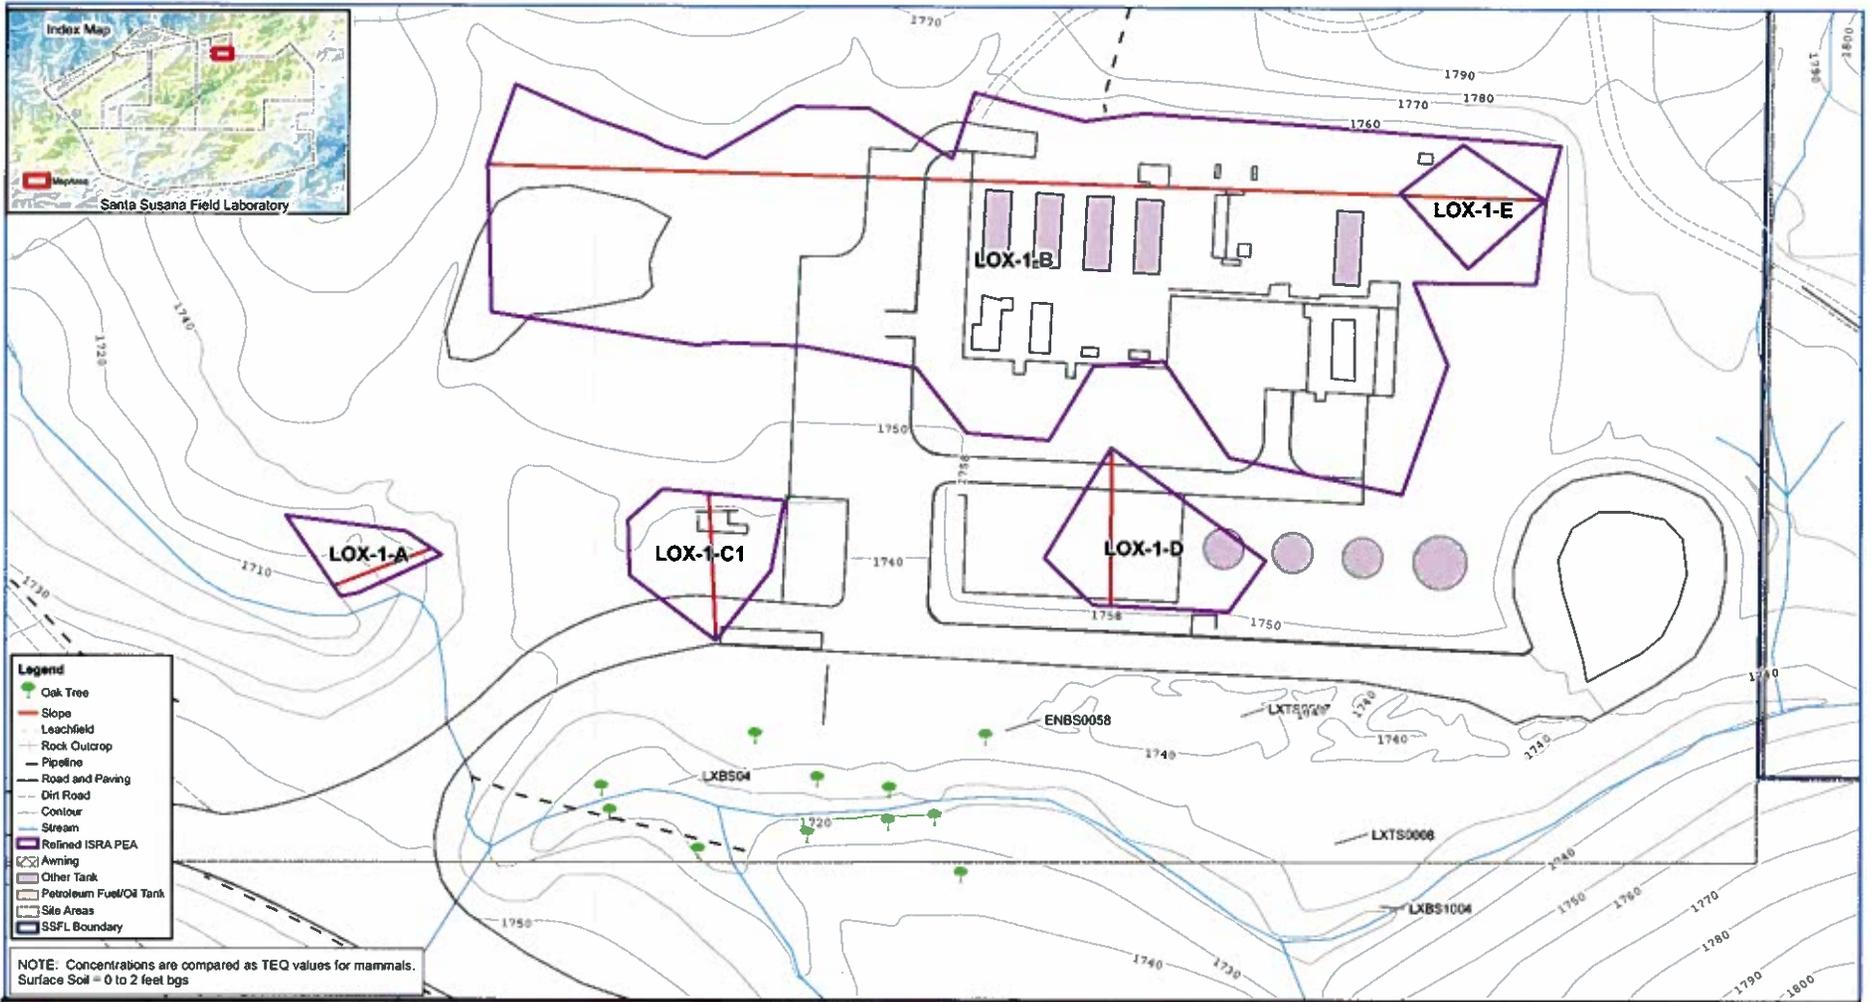
**Figure 4-2**  
AP/STP Refined ISRA PEAs and ISRA Areas  
Santa Susana Field Laboratory

Figure 4-2  
 AP/STP Refined ISRA PEAs and ISRA Areas  
 Santa Susana Field Laboratory

**Western Northern Drainage Areas, see Figure West Northern Drainage 1 and Figures 4-2 (2 sheets), Area-1E, and Area LOX-1-A**
