Subject: Interim Source Removal Action (ISRA) 2010 Boeing Soil Borrow Area submitted in response to California Water Code Section 13304 Order (NPDES No. CA0001309, CI No. 6027, SCP No. 1111, SITE ID No. 2040109)

SUBJECT: ISRA 2010 Boeing Soil Borrow Area

**Outfall 009**  
**2010 Boeing Soil Borrow Area Location**  
**SANTA SUSANA FIELD LABORATORY**

**Outfall 009  
2010 Boeing Soil Borrow Area  
Sample Locations**

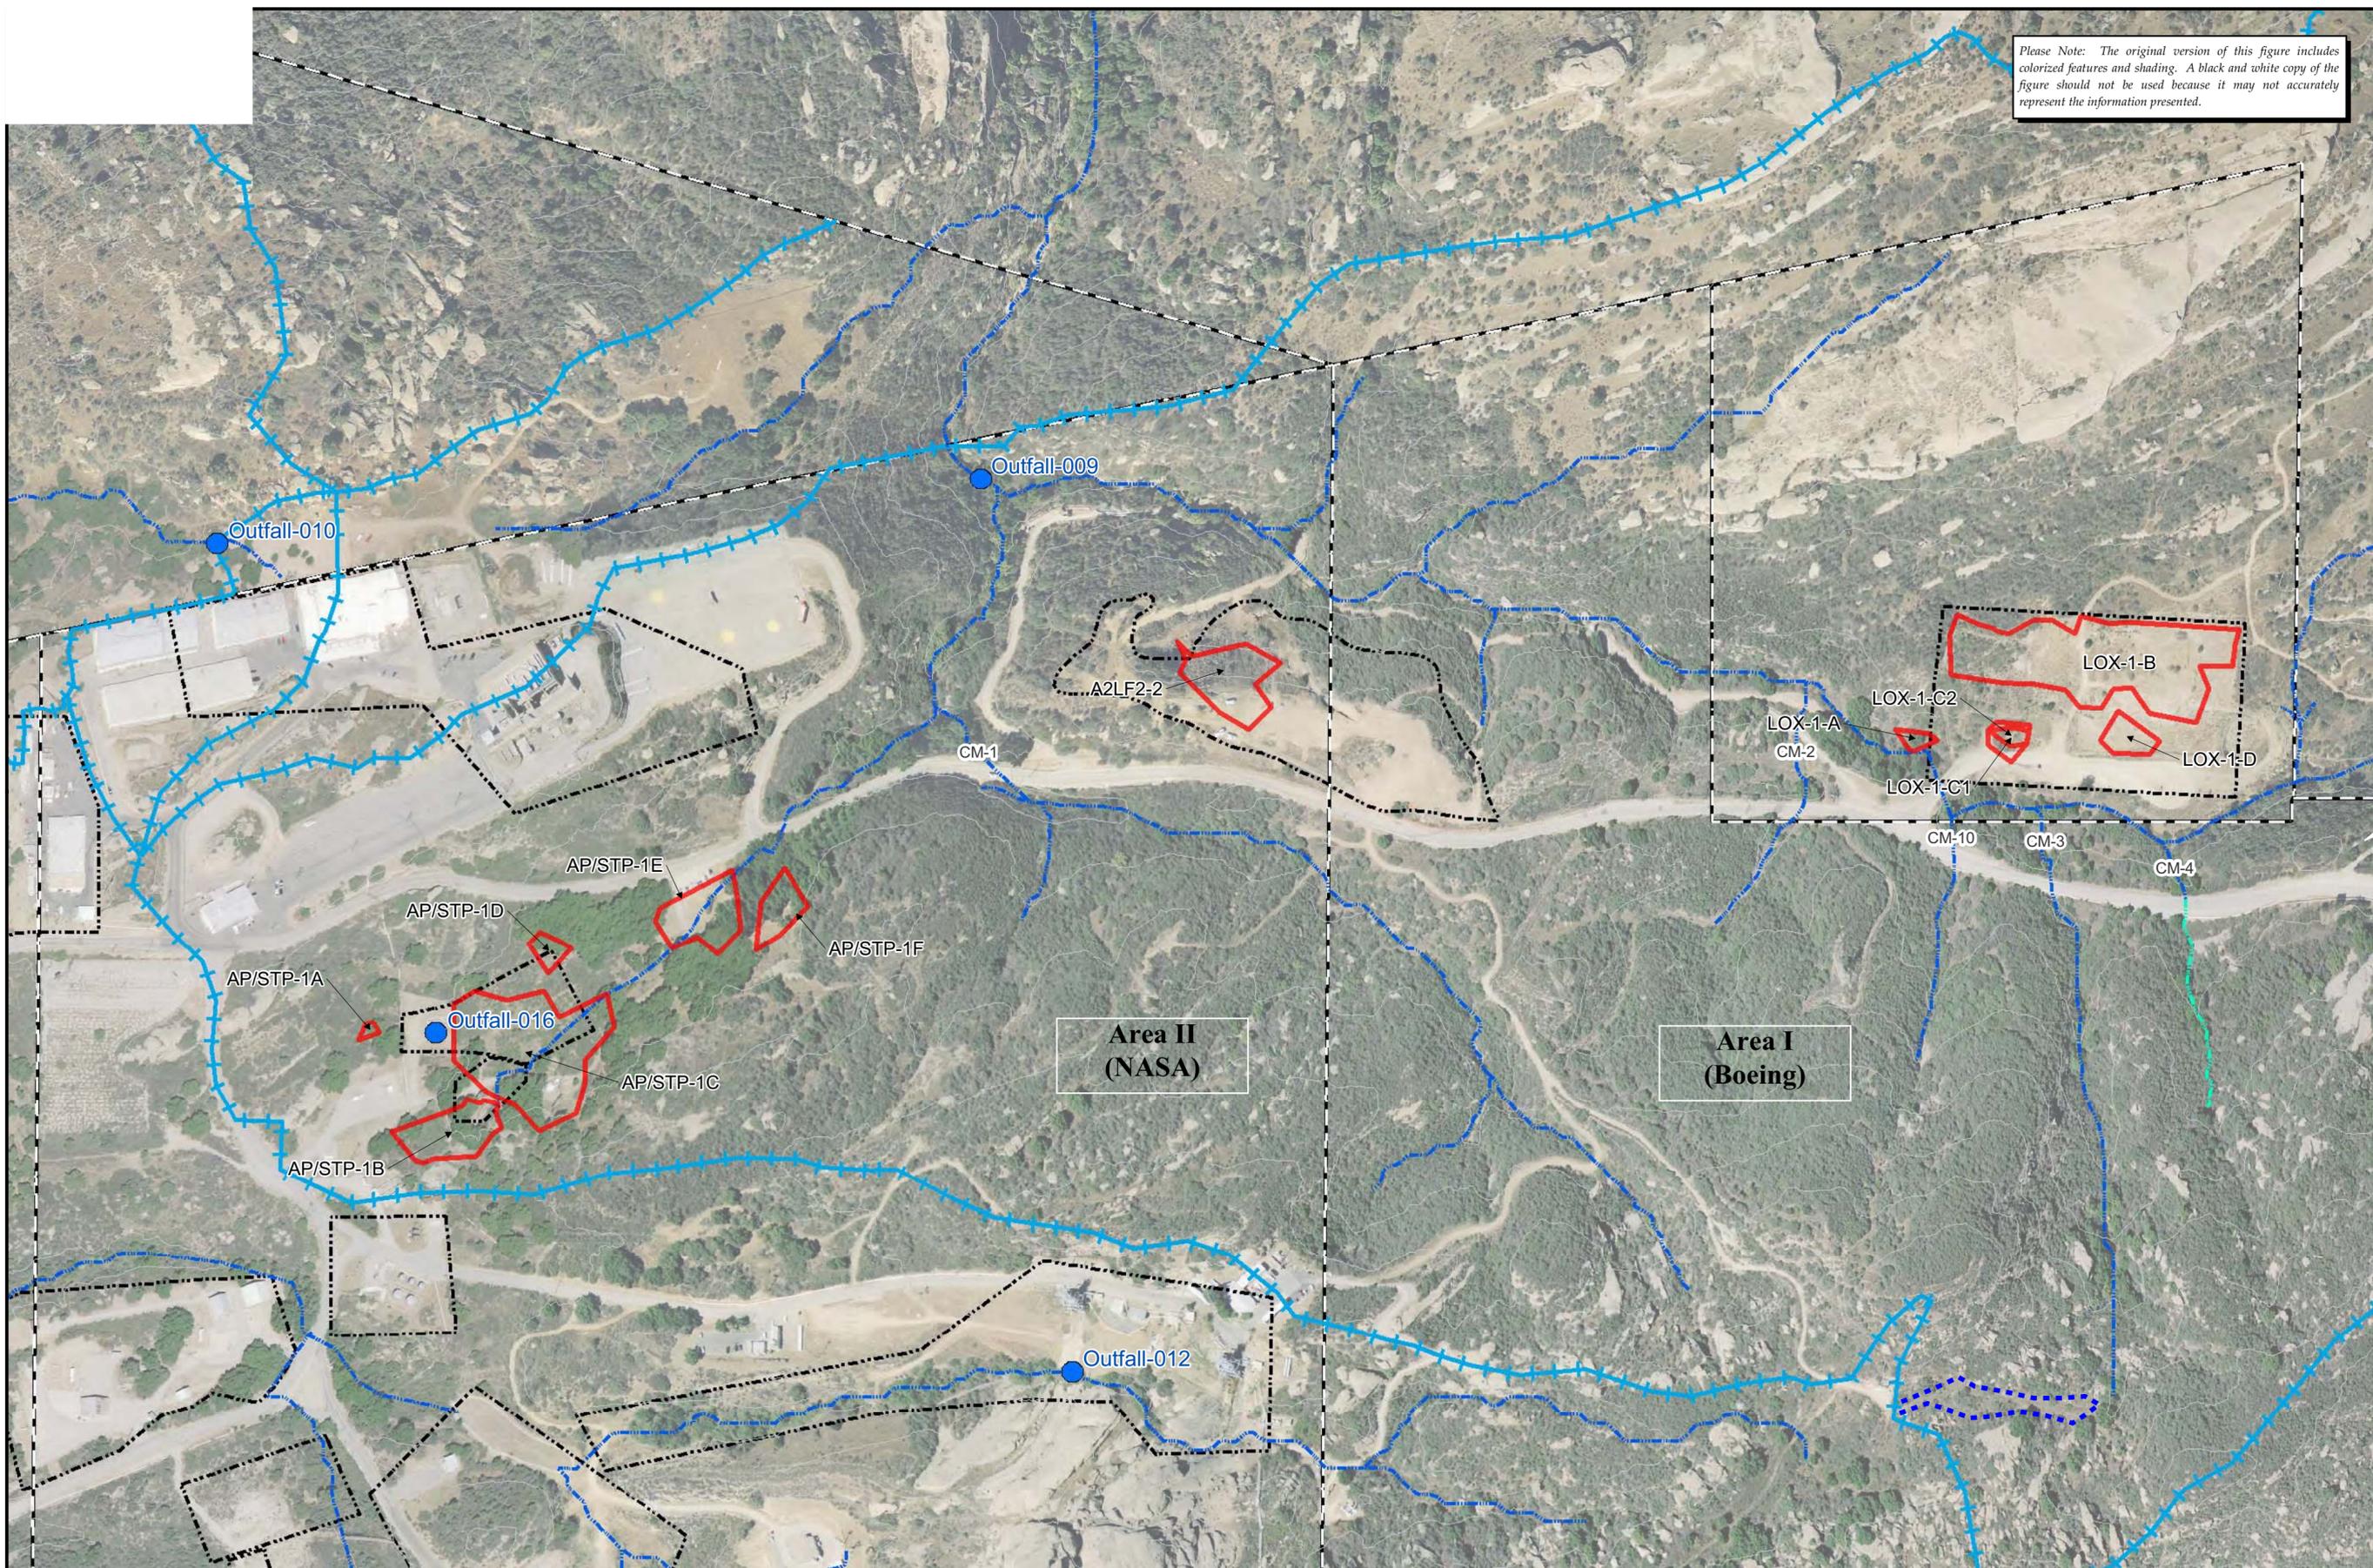
**MWH** **FIGURE 1**

The selected soil borrow area is located on Boeing property within the Outfall 009 watershed approximately 1,400 feet south of the LOX Plant and approximately 1,250 feet northeast of the Alfa (Figure 1). The soil borrow area is easily accessible via a dirt road that is currently used to access monitoring well RD-47. The soil borrow area is an east-west trending feature located within a small valley (Figure 2). The soil borrow area is approximately 450 feet long, has a maximum width of approximately 120 feet, and has a surface area of approximately 29,000 square feet (0.66 acres). The volume of available soil within the soil borrow area is estimated to be 8,000 cubic yards, based on the depth bedrock was encountered in the borings advanced during chemical characterization. Tar plant and oak trees are not present within the soil borrow area, although three oak trees are located near the southeast boundary of the area.

Approximate extent of 2010 Boeing Soil Borrow Area

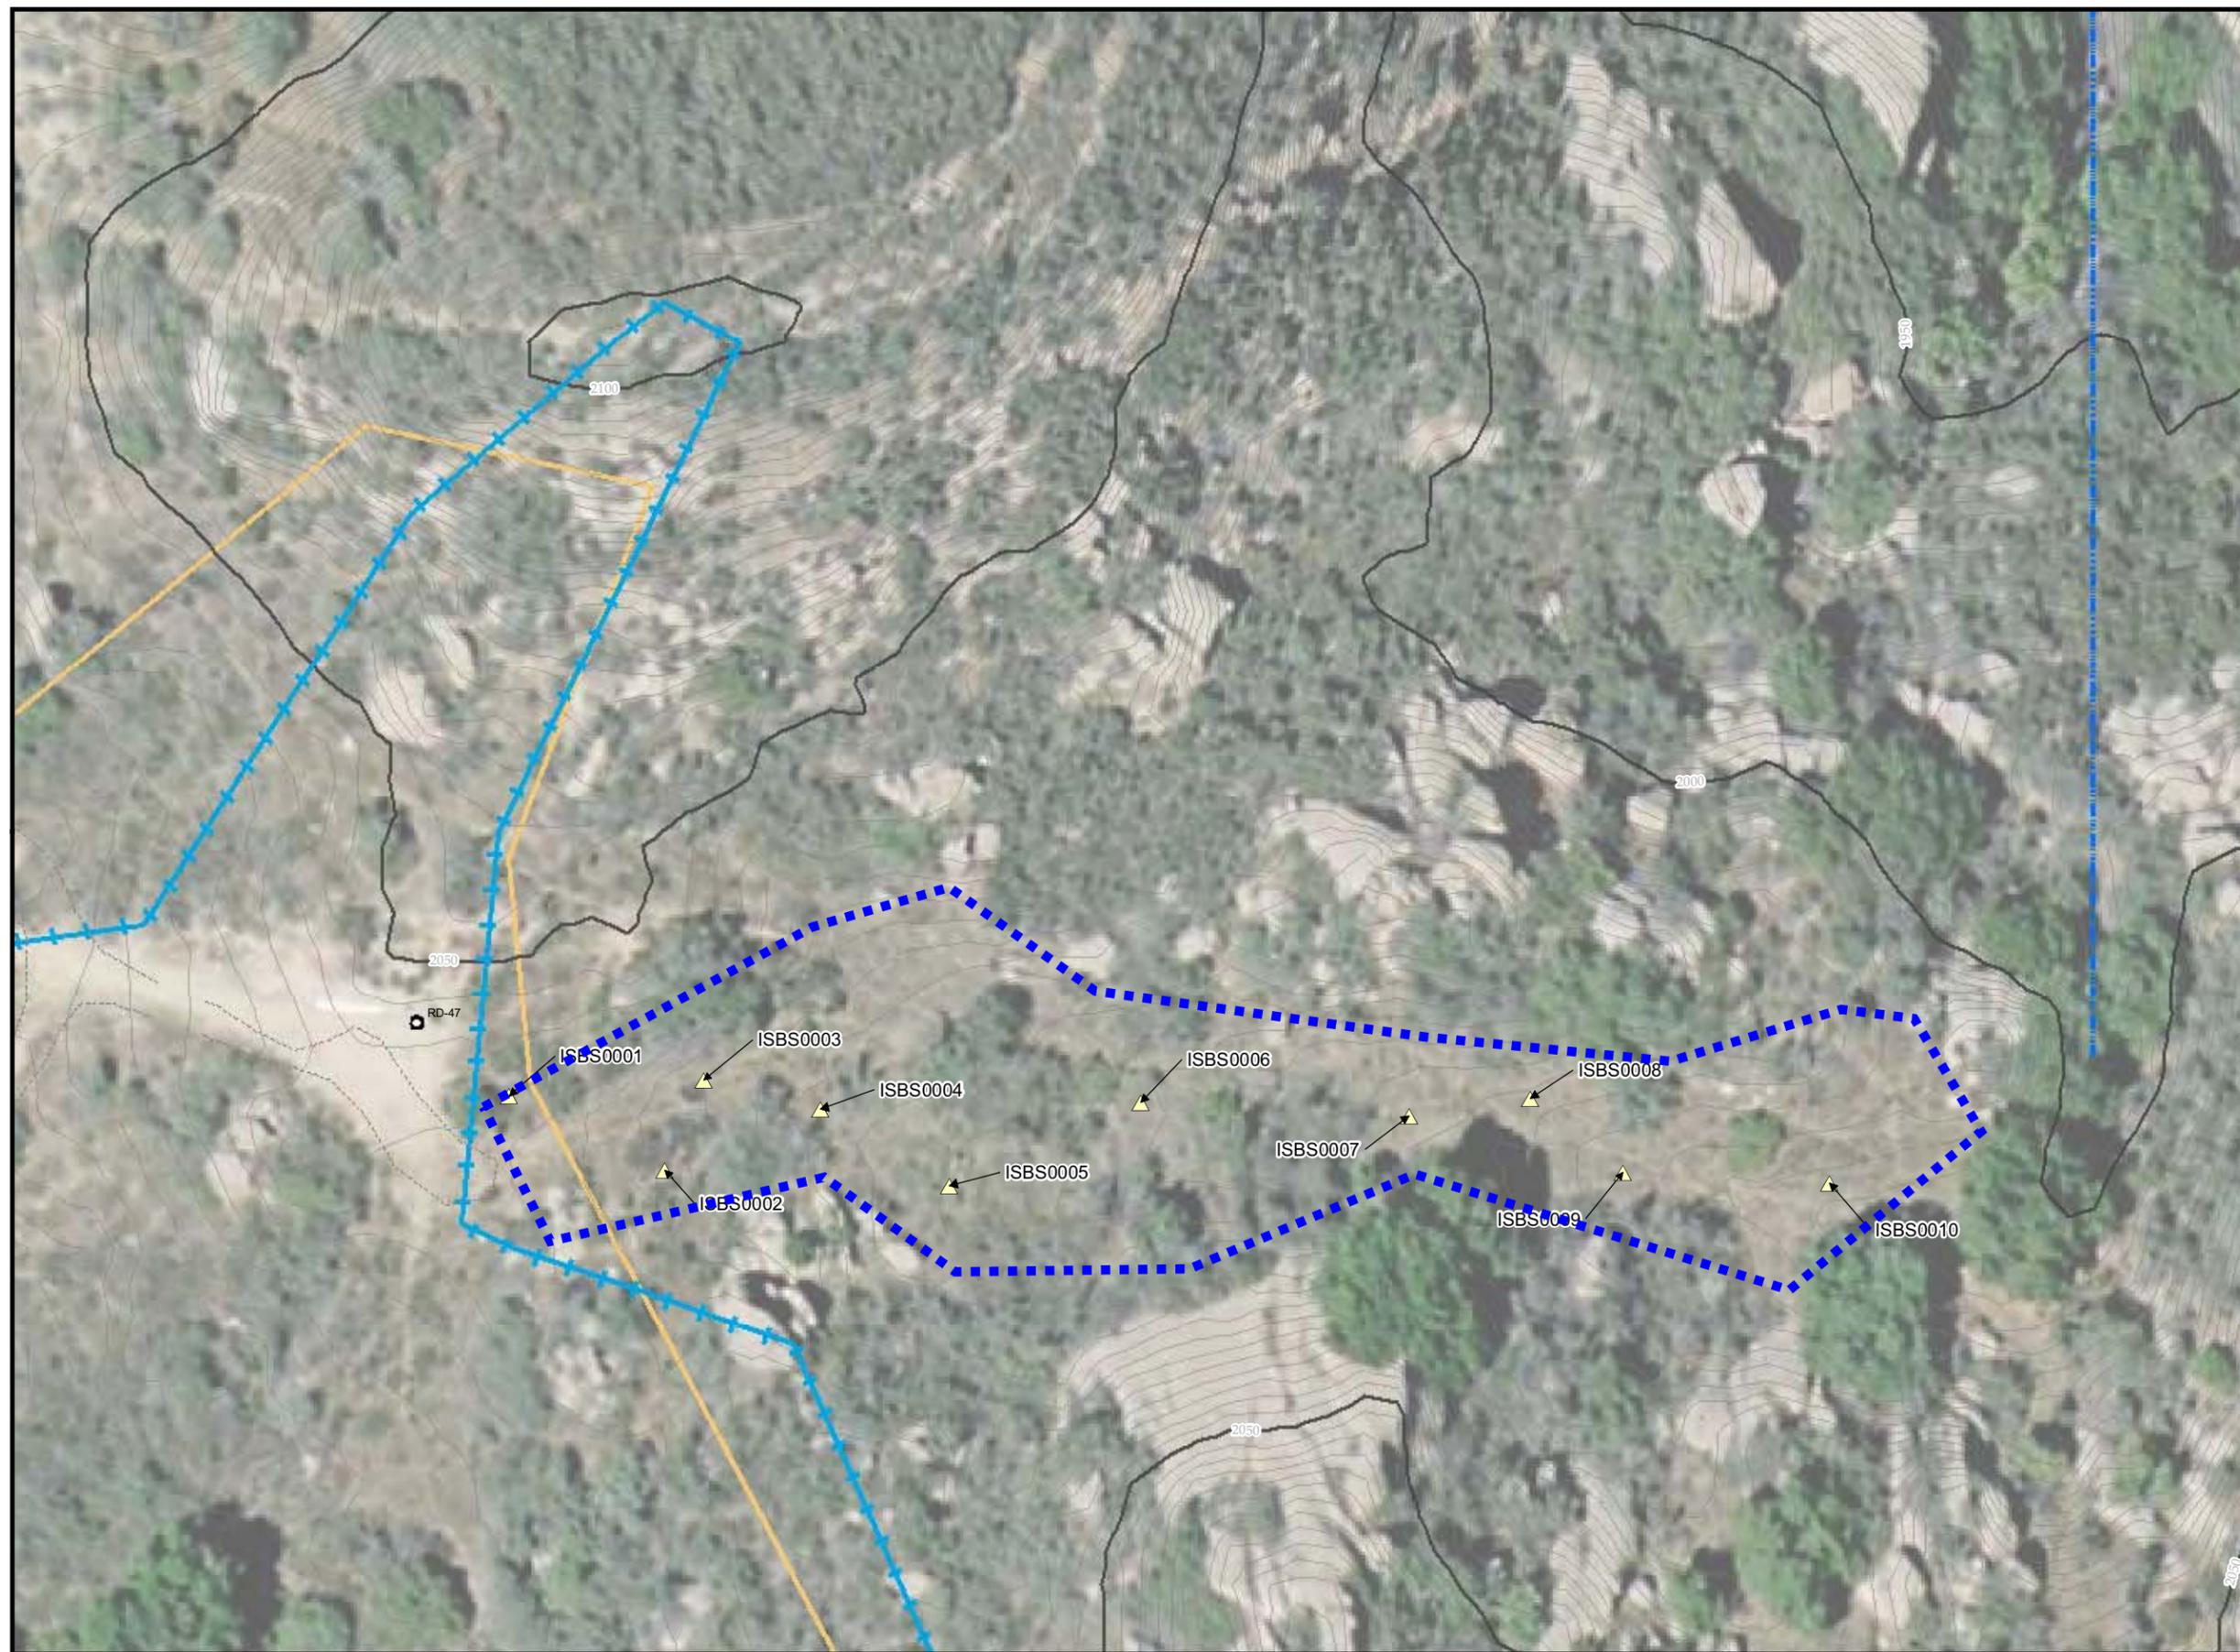
FIGURE 2

As stated above, an estimated 2,000 cubic yards of soil will be required to restore the 2010 ISRA excavations on Boeing property. Twenty soil samples from 10 locations were proposed to characterize 2,000 cubic yards of soil, one sample for every 100 cubic yards. The 10 boring locations are shown on Figure 2. Two discrete soil samples were planned at each sample location, including one surface soil sample (0 to 0.5 feet bgs) and one subsurface soil sample (4.5 to 5 feet bgs). A total of 17 soil samples were collected from the 10 boring locations, deeper samples were not collected from locations ISBS0001, ISBS0002, and ISBS0003 because bedrock was encountered at 3 feet bgs or less. Sample analysis included the following:

Characterization Sample Location
-

Approximate extent of 2010 Boeing Soil Borrow Area

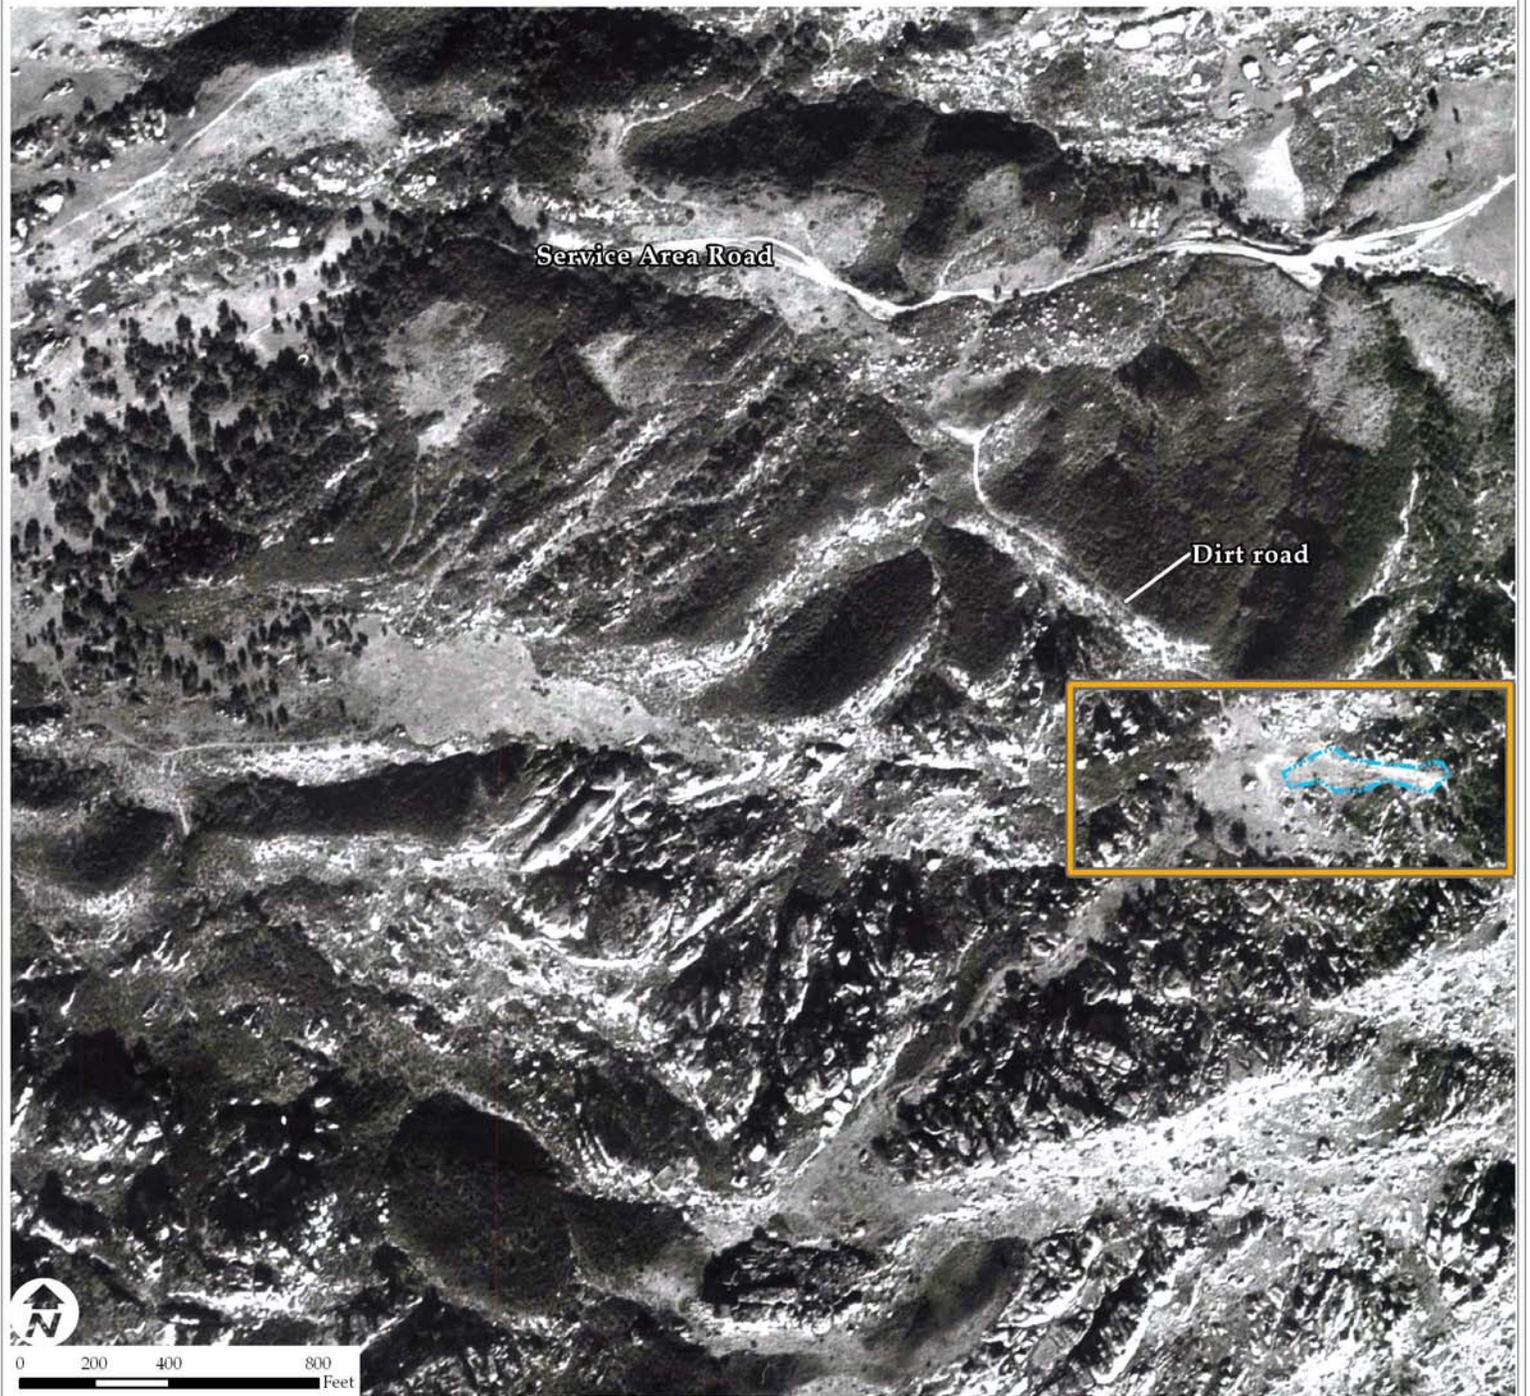
**1953 Aerial Photograph  
Santa Susana Field Laboratory**

2010 Boeing Soil Borrow Area

The review of aerial photographs provided insight into the history of the operational activities in the area and the dirt road that passes by the soil borrow area. Construction of the operational areas in the vicinity of the soil borrow area had not begun by 1953. The dirt road existed prior to 1953 and connected to Service Area Road to the north, but was likely not used frequently because it was poorly defined. By 1957, operational areas, including the LOX Plant, ELV, and Alfa, were constructed or were being constructed, and the dirt road had been widened and connected Service Area Road to Skyline Drive. By 1965, a dirt road loop was present, a section of which runs through the western portion of soil borrow area. The purpose of this road is unknown, but it may have been used as a turnaround for vehicles travelling between Service Area Road and Skyline Drive. By 1972, this dirt road loop was becoming overgrown with vegetation. Around that time, another dirt road spur was constructed to the north of the dirt loop road. The purpose of this spur is also unknown. By 1980, both the dirt loop road and the spur

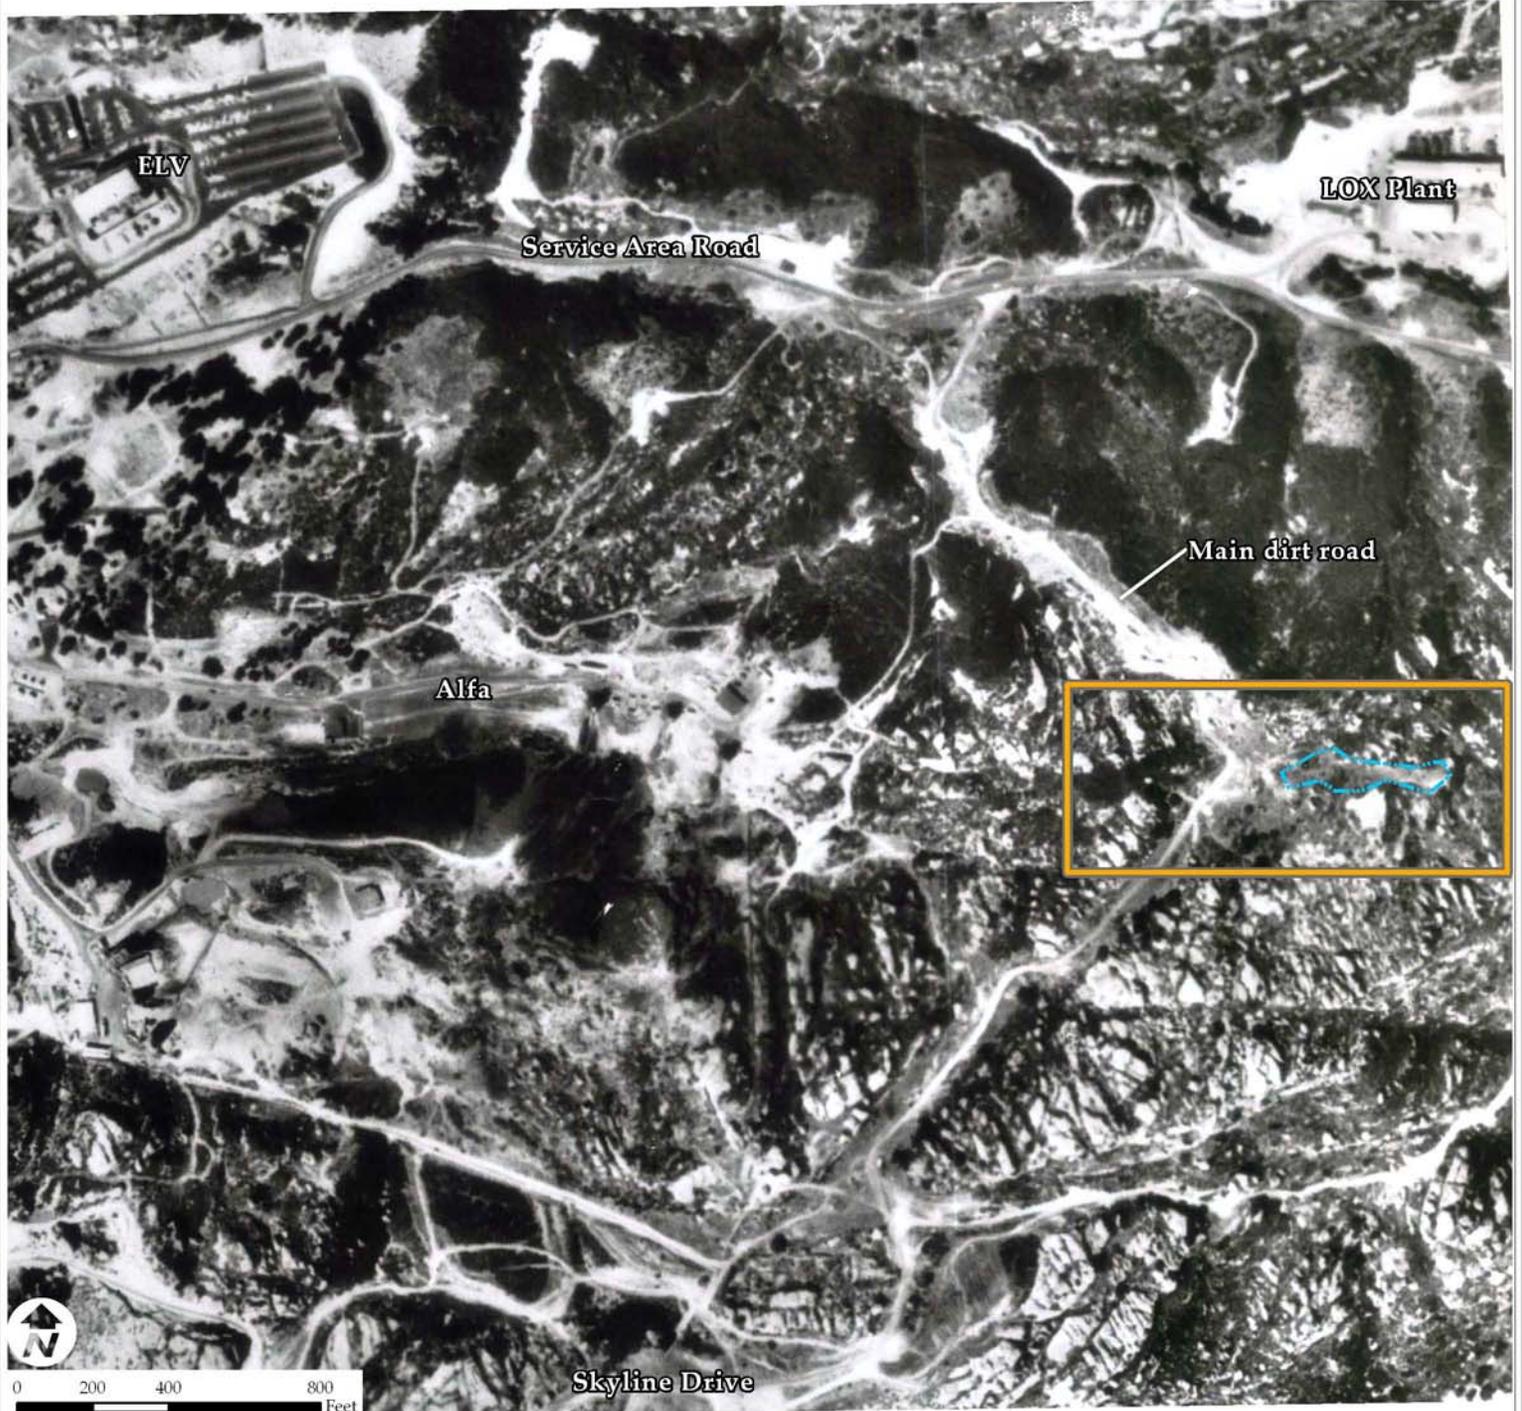
**1957 Aerial Photograph  
Santa Susana Field Laboratory**

2010 Boeing Soil Borrow Area

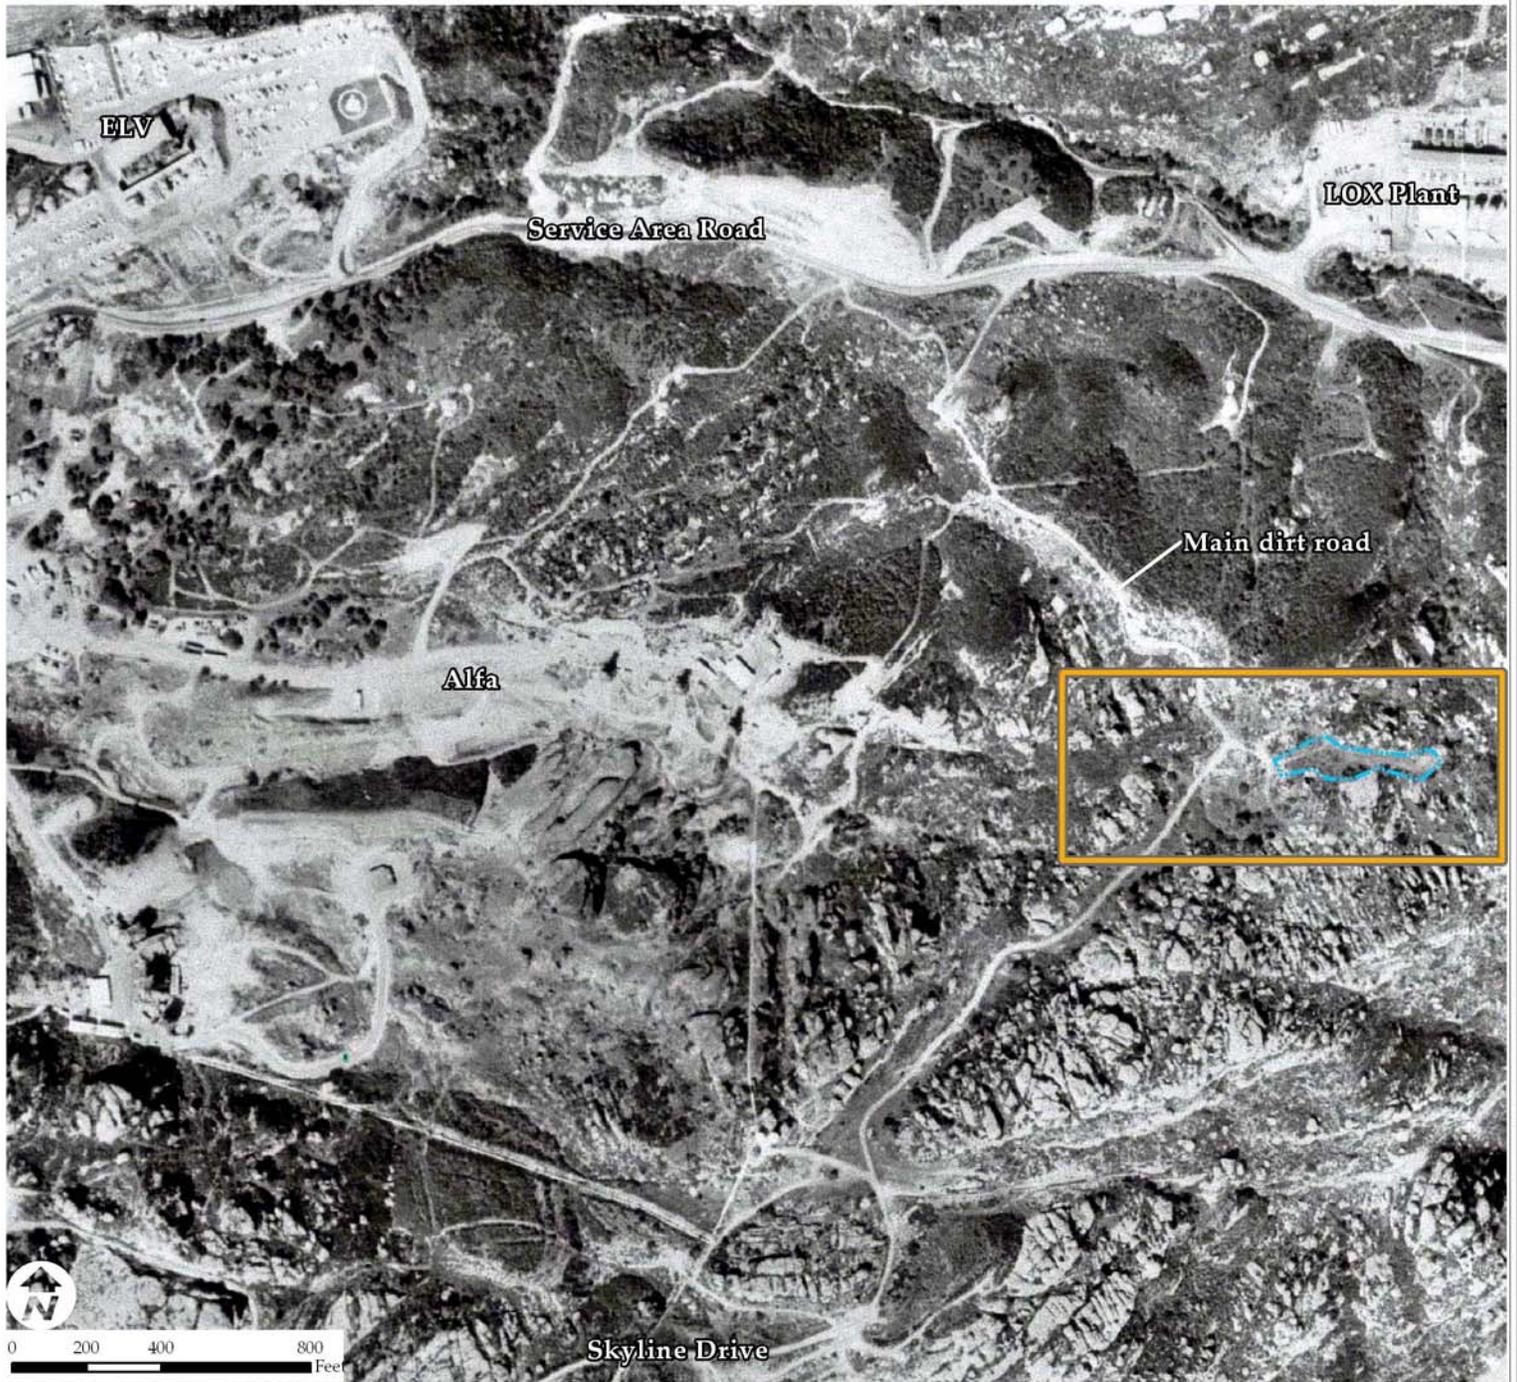
**1965 Aerial Photograph  
Santa Susana Field Laboratory**

2010 Boeing Soil Borrow Area

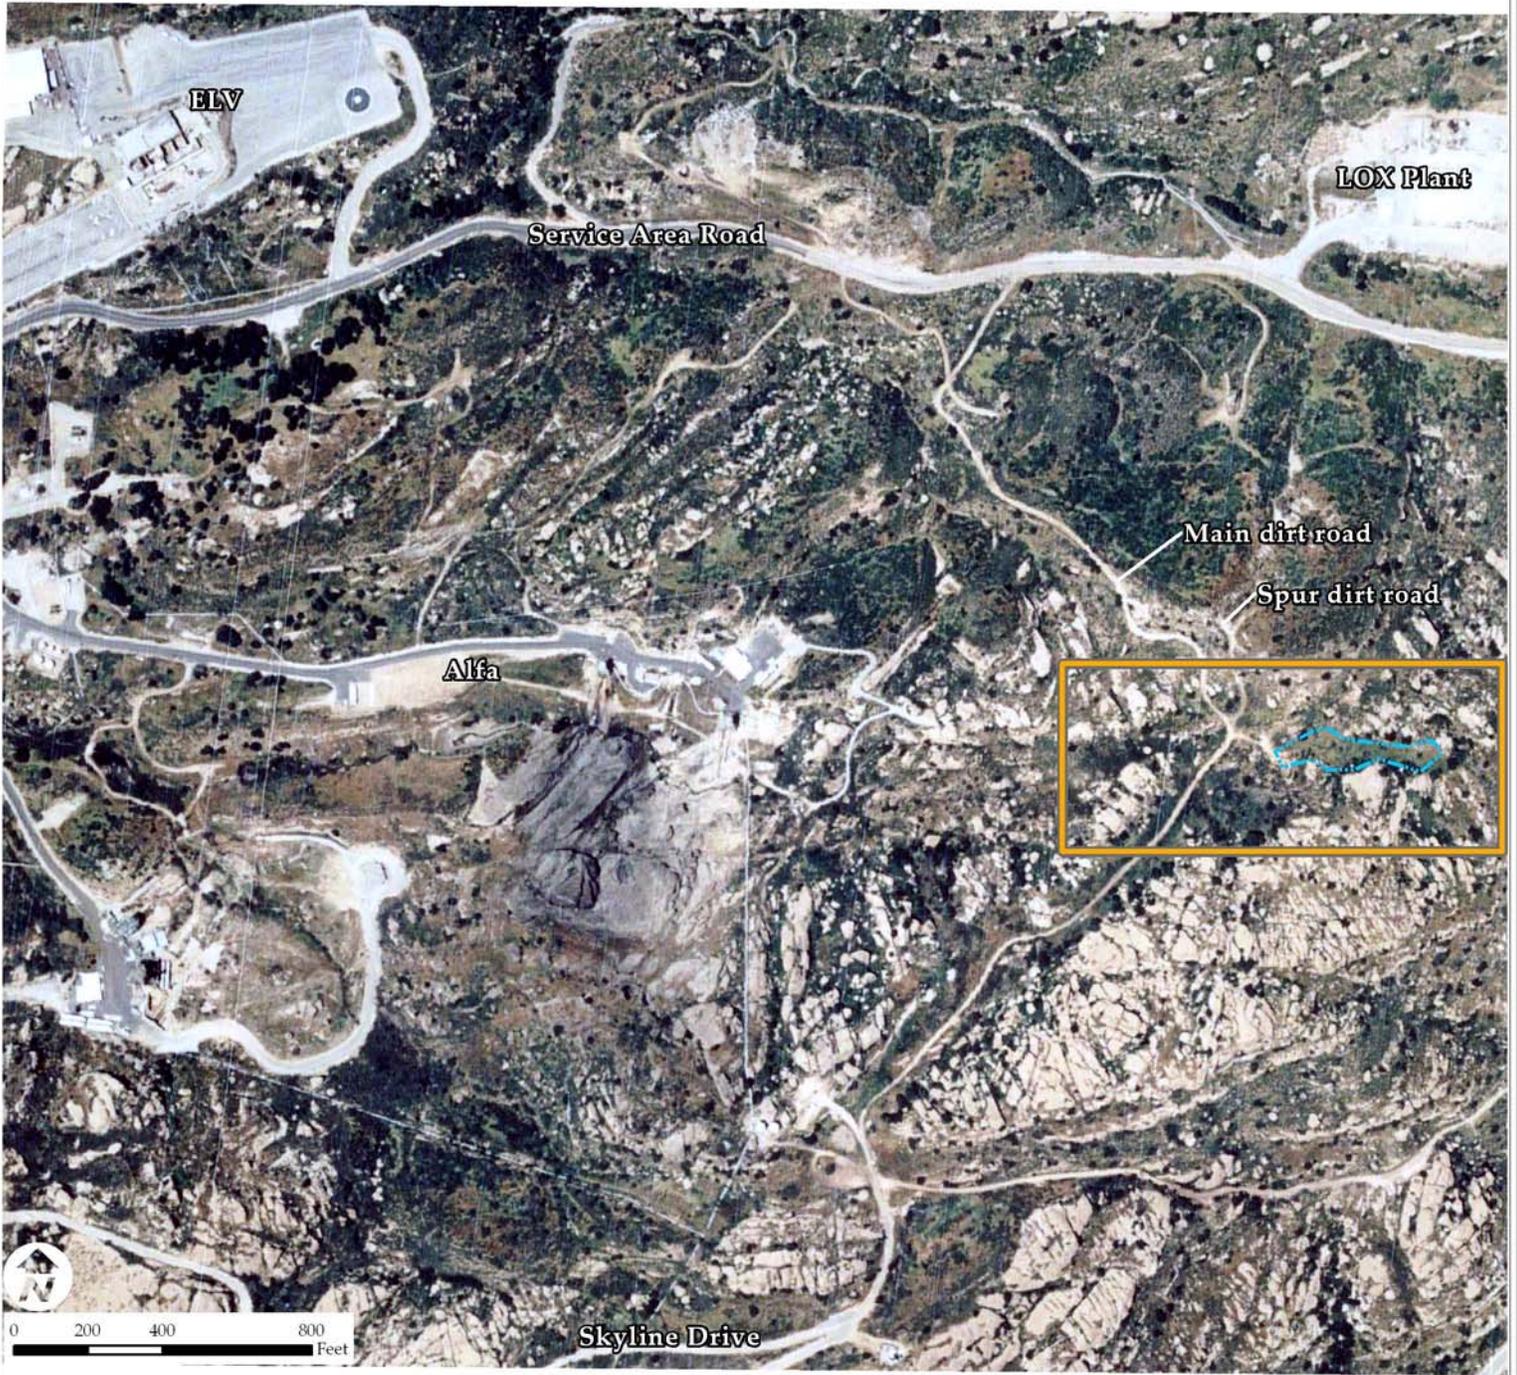
**1978 Aerial Photograph  
Santa Susana Field Laboratory**

2010 Boeing Soil Borrow Area

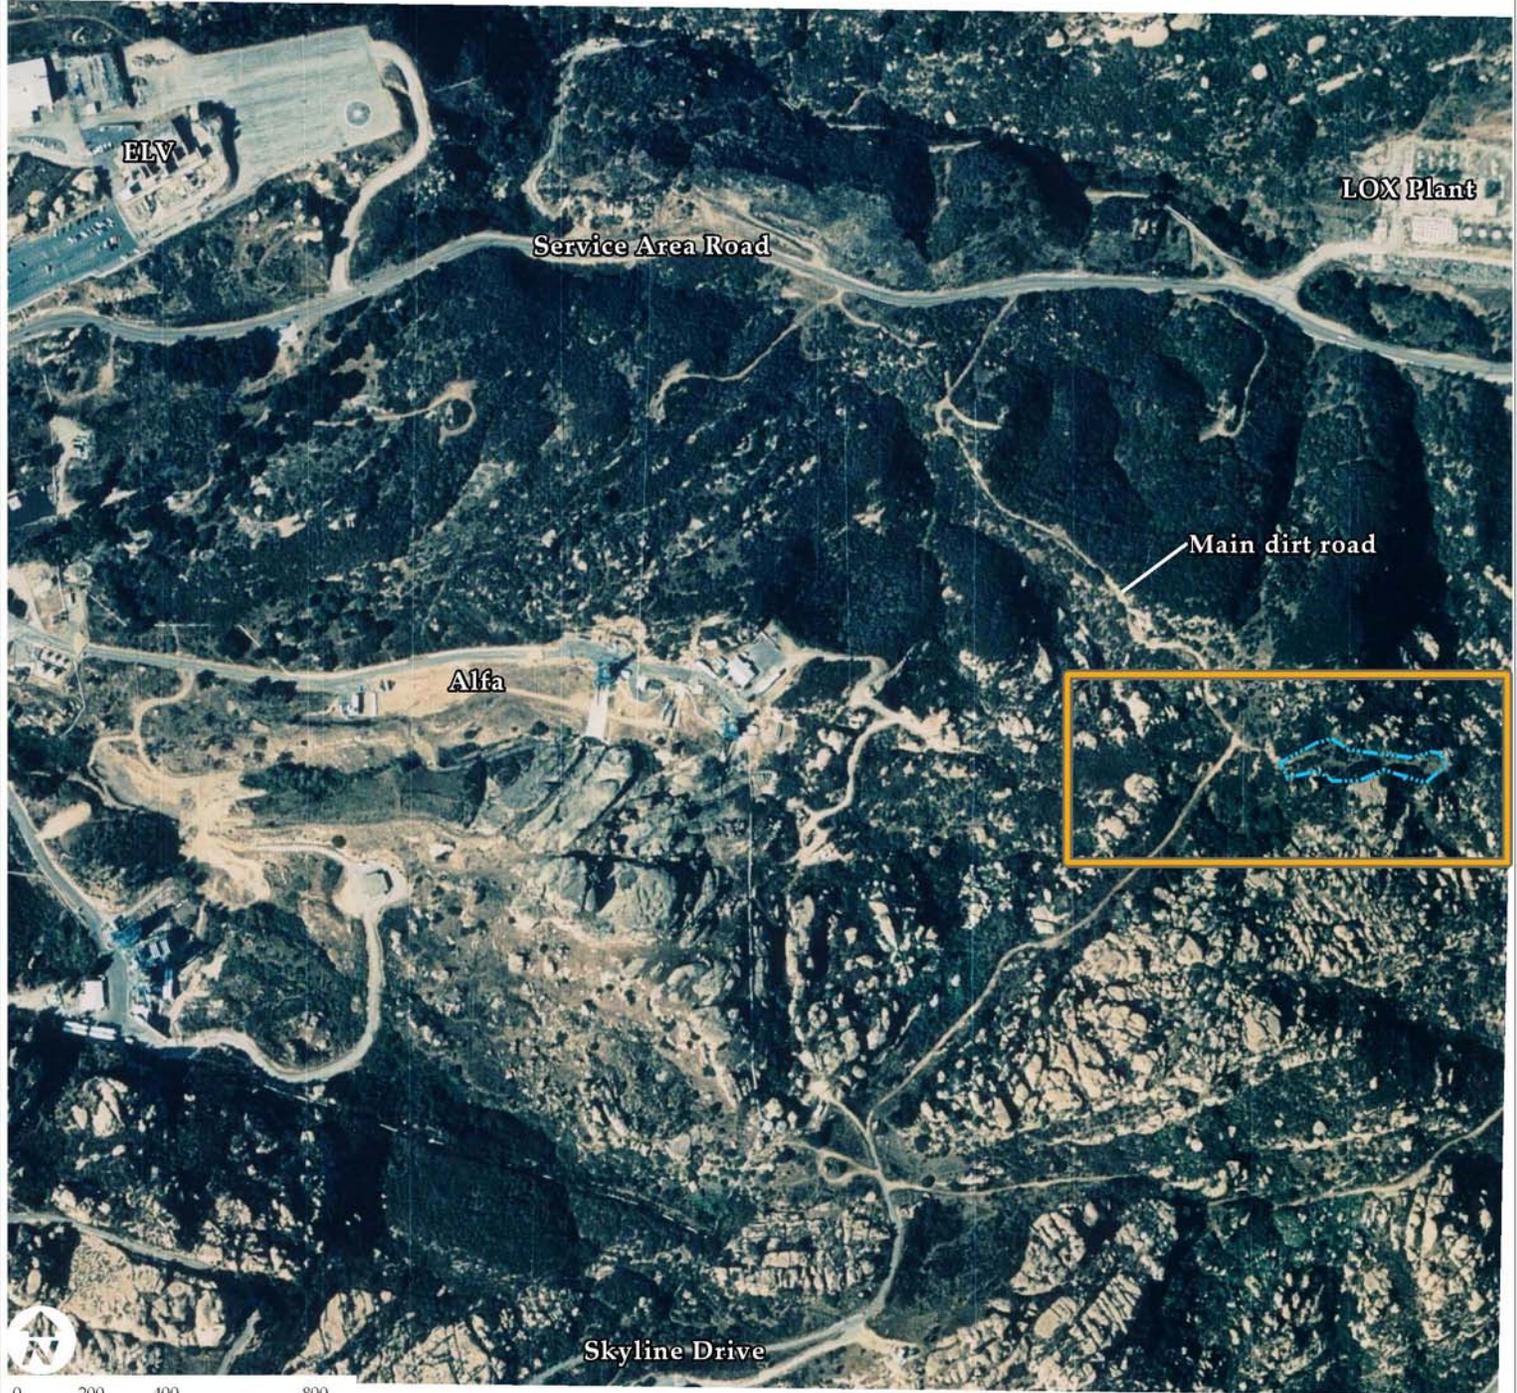
**1988 Aerial Photograph  
Santa Susana Field Laboratory**

2010 Boeing Soil Borrow Area

were overgrown with vegetation. By 1993, the portion of the dirt road beginning due west of the soil borrow area and connecting to Skyline Drive to the south was overgrown with vegetation. Also in 1993, well RD-47 was installed due west of the soil borrow area, the vegetation clearance associated with the installation of this well is present in the 1995 photograph. There are no new observations after 1995.

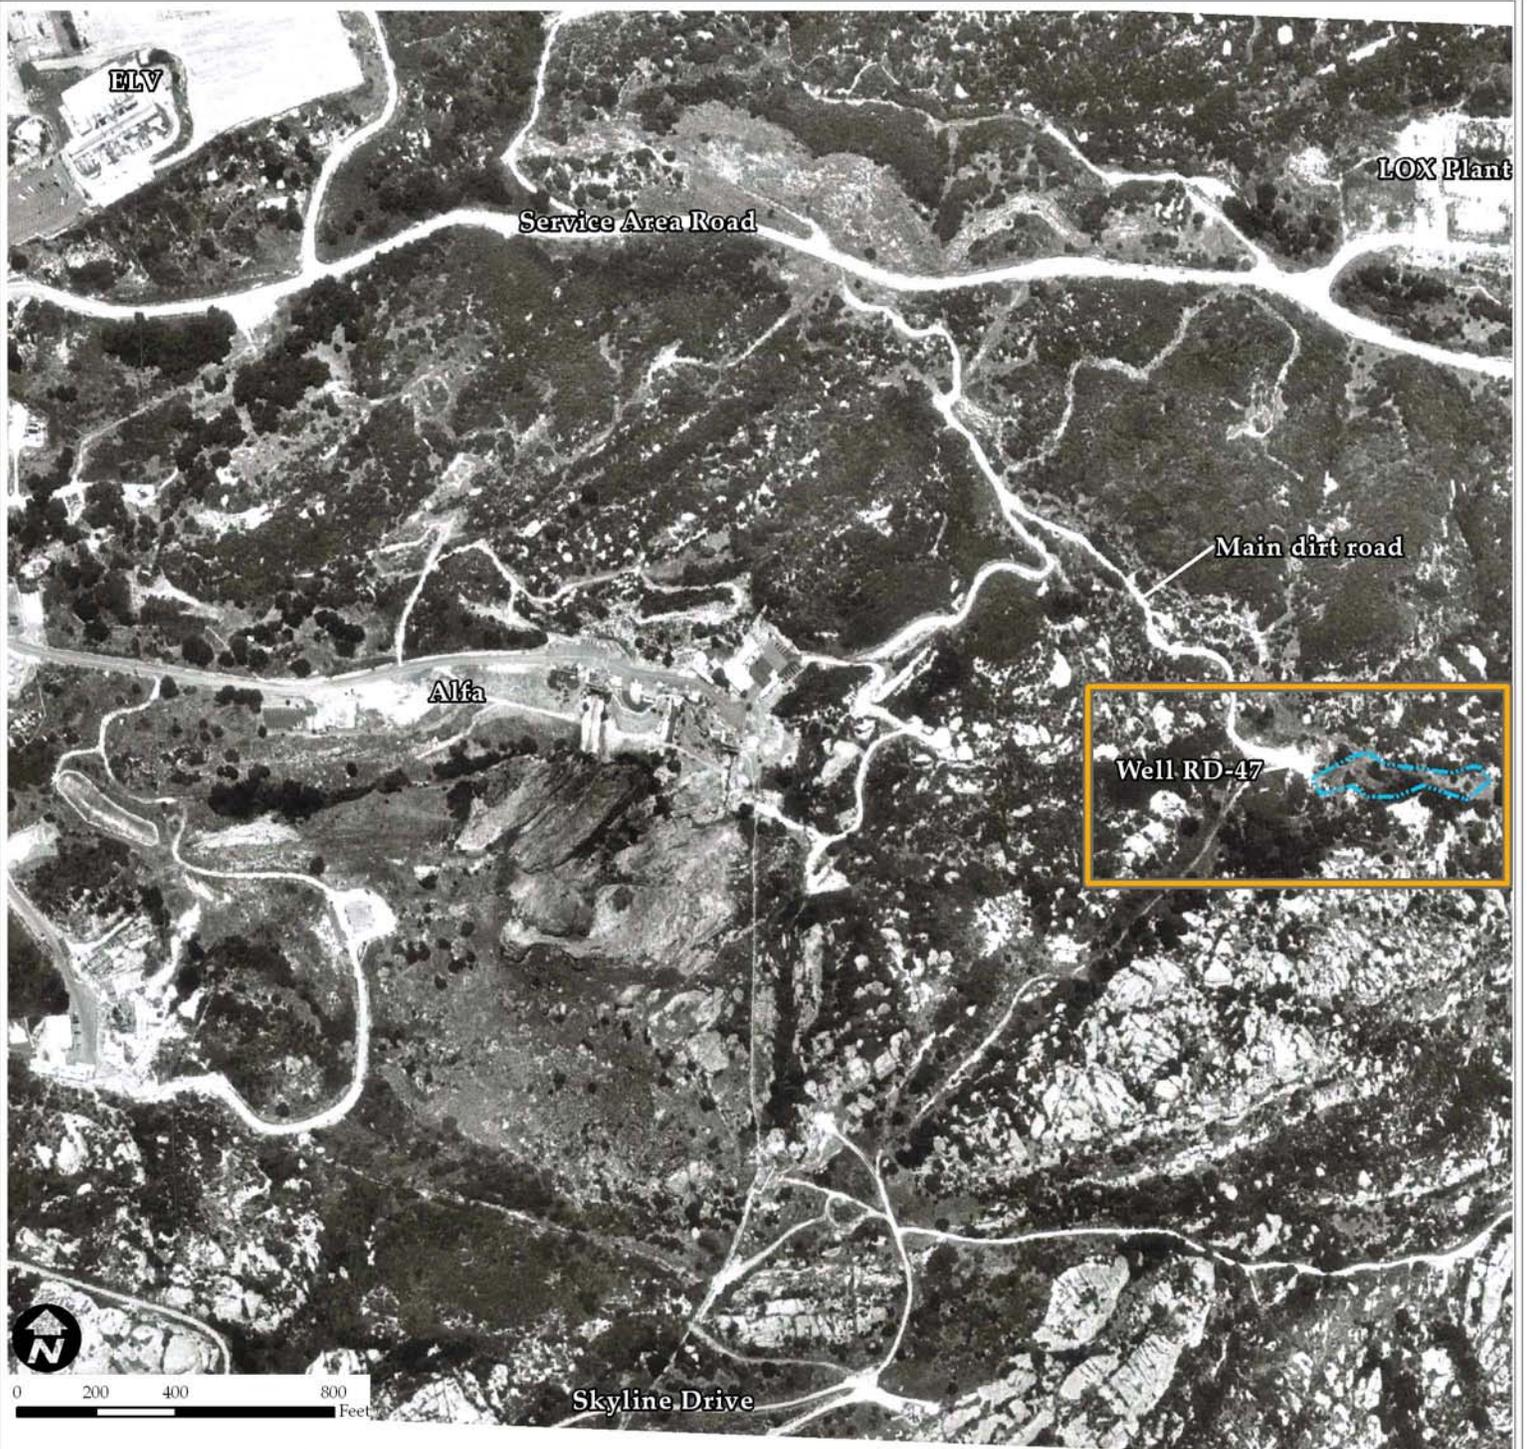
**1995 Aerial Photograph  
Santa Susana Field Laboratory**

2010 Boeing Soil Borrow Area
