Subject: Interim Source Removal Action (ISRA) 2010 Boeing Soil Borrow Area submitted in response to California Water Code Section 13304 Order (NPDES No. CA0001309, CI No. 6027, SCP No. 1111, SITE ID No. 2040109)

SUBJECT: ISRA 2010 Boeing Soil Borrow Area

**Outfall 009**  
**2010 Boeing Soil Borrow Area Location**  
**SANTA SUSANA FIELD LABORATORY**

**Outfall 009  
2010 Boeing Soil Borrow Area  
Sample Locations**

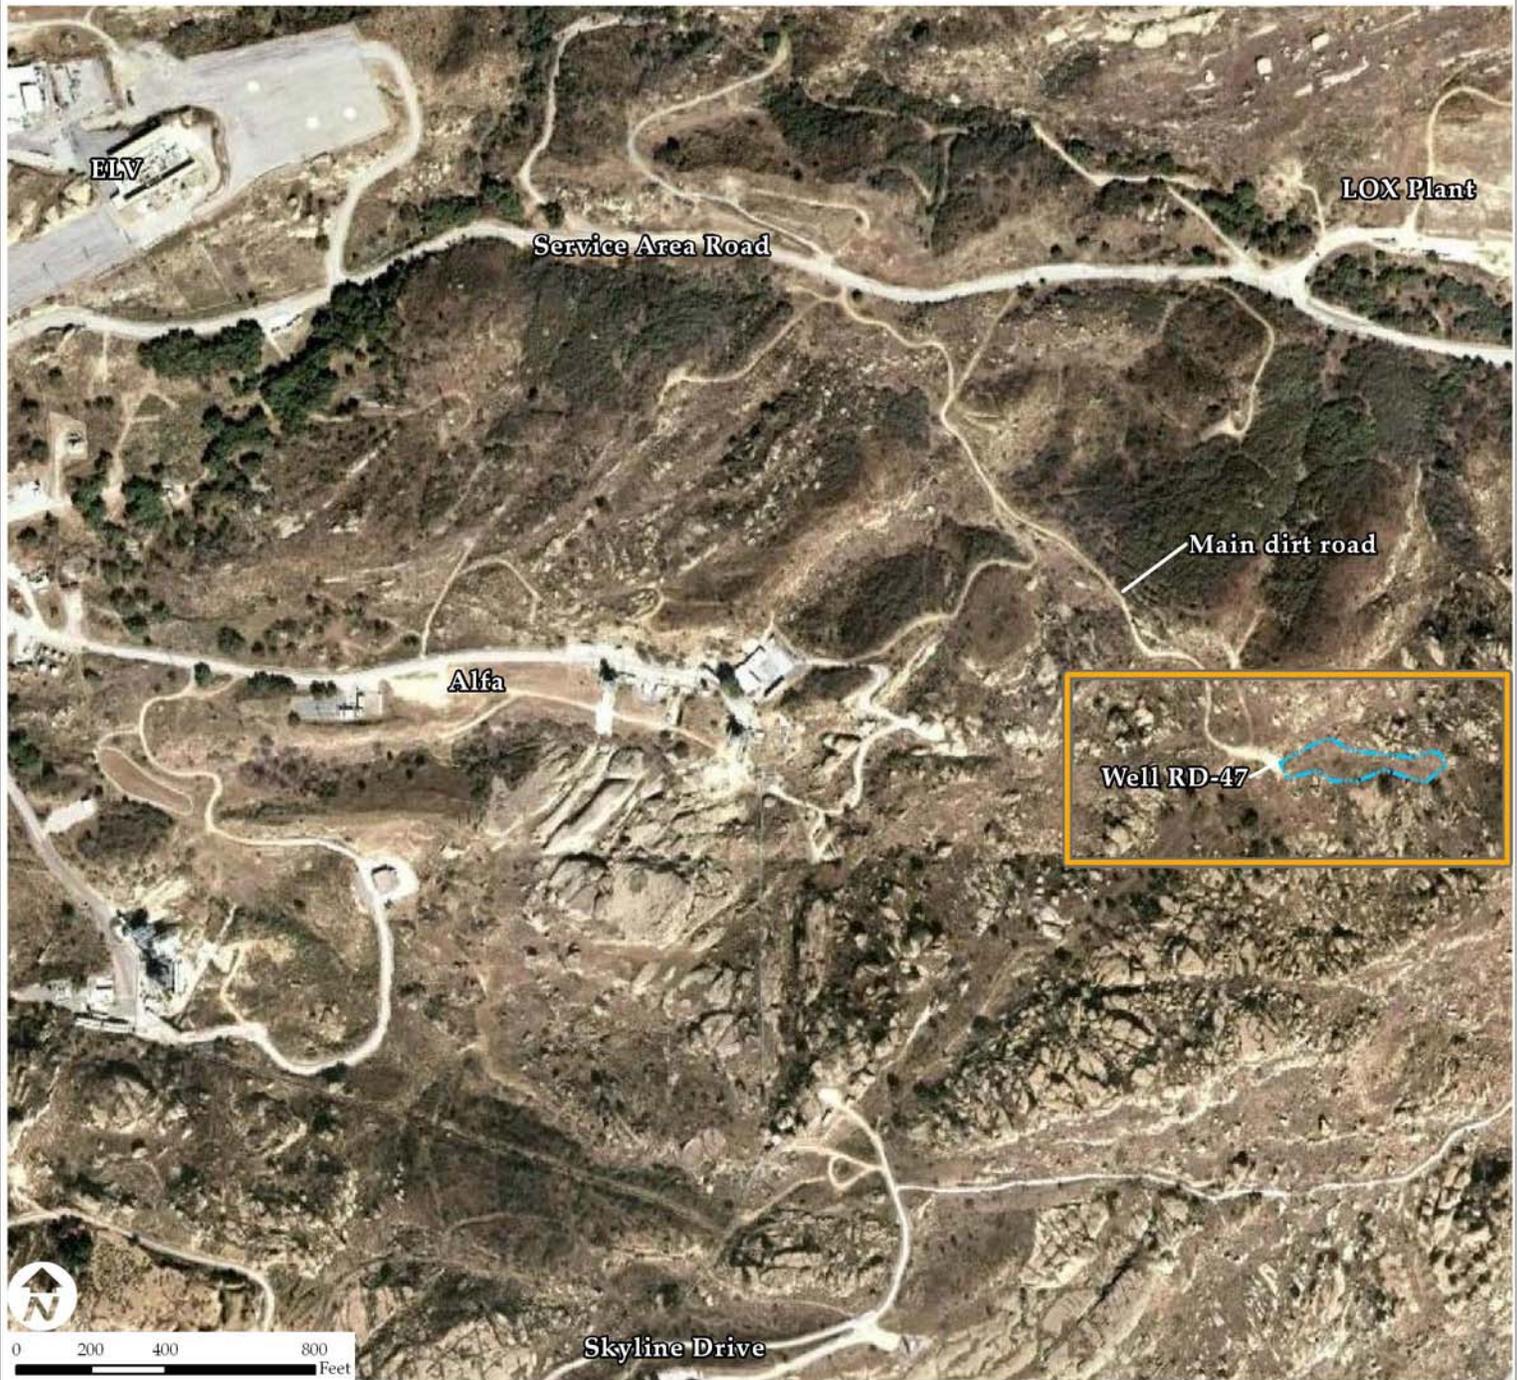
**2009 Aerial Photograph  
Santa Susana Field Laboratory**

2010 Boeing Soil Borrow Area
