# OVERVIEW OF EXPERT PANEL ACTIVITIES

October 6, 2011

ISRA PERFORMANCE MONITORING AND POTENTIAL BMP  
SUBAREA MONITORING FOR THE OUTFALLS 008 AND 009  
WATERSHEDS, 2010/2011 RAINY SEASON  
SANTA SUSANA FIELD LABORATORY  
VENTURA COUNTY, CALIFORNIA

**FINAL 2011 BMP PLAN ADDENDUM**  
**SANTA SUSANA FIELD LABORATORY**  
**VENTURA COUNTY, CALIFORNIA**

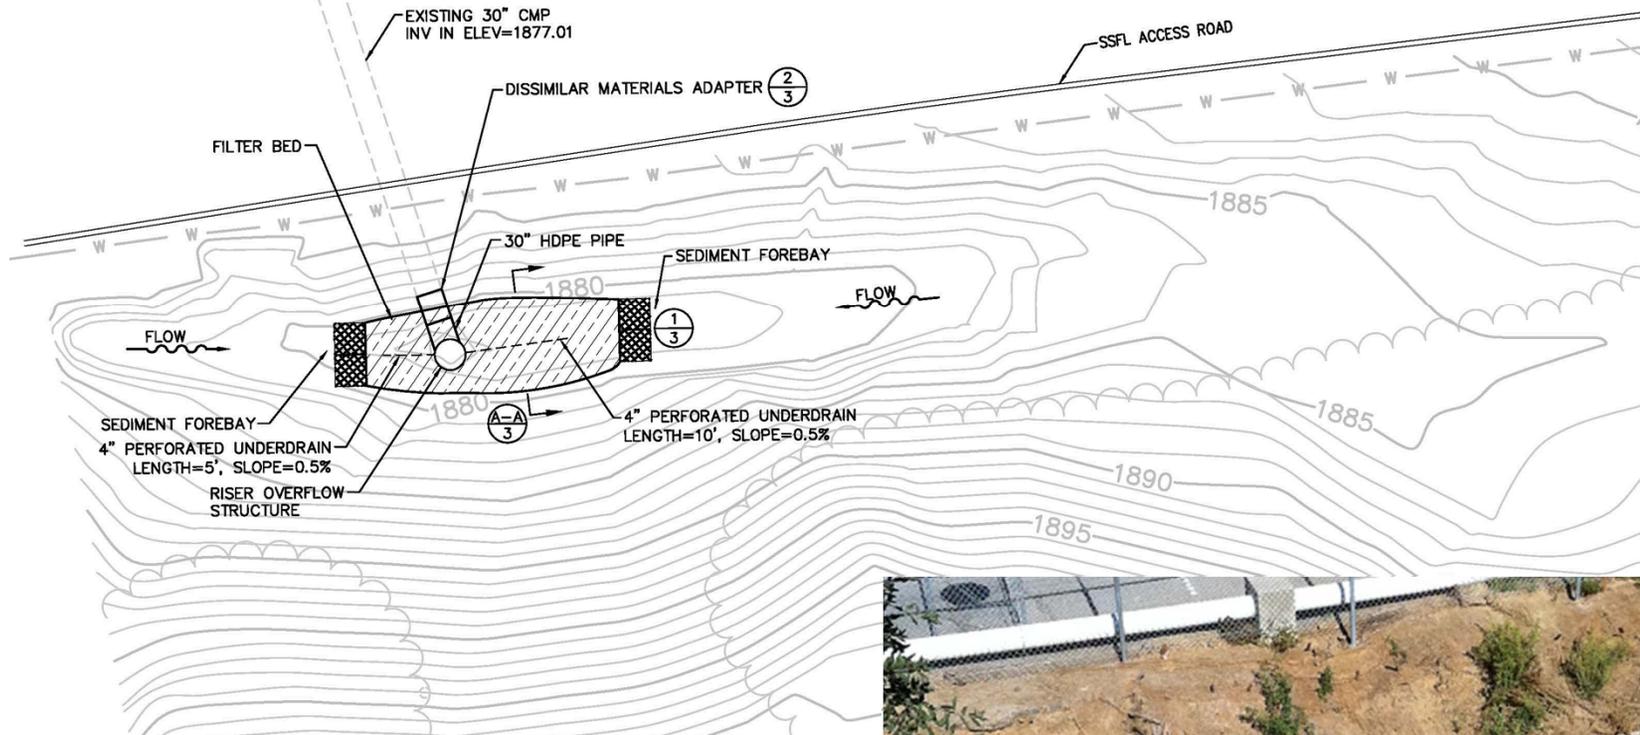
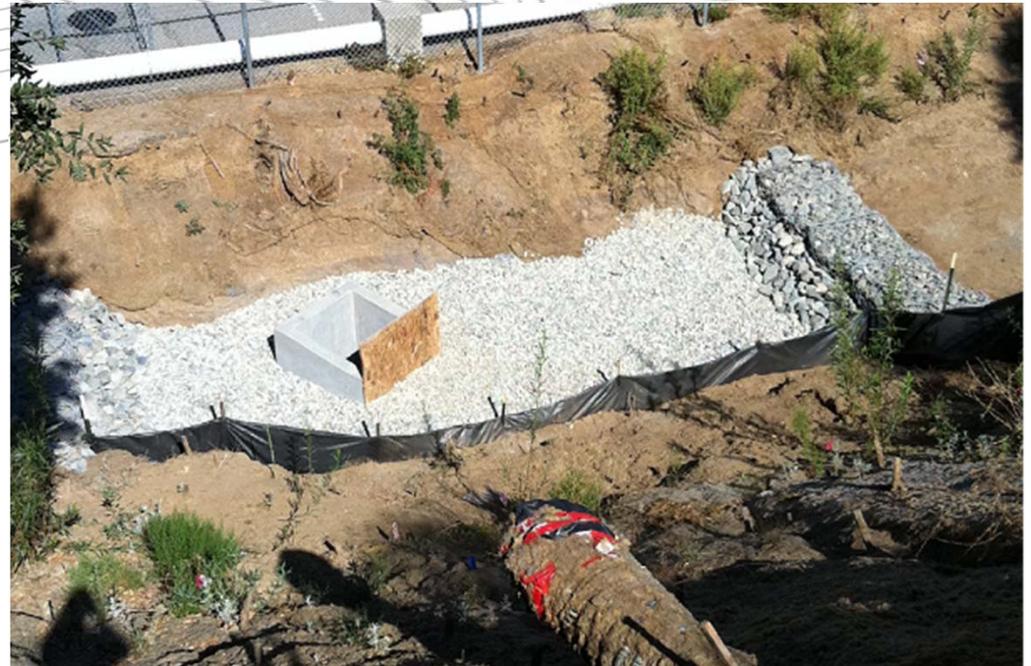
# B1 Culvert Modification

- Treat runoff from 4.4 acres including RFI/ISRA area
- Construction near complete

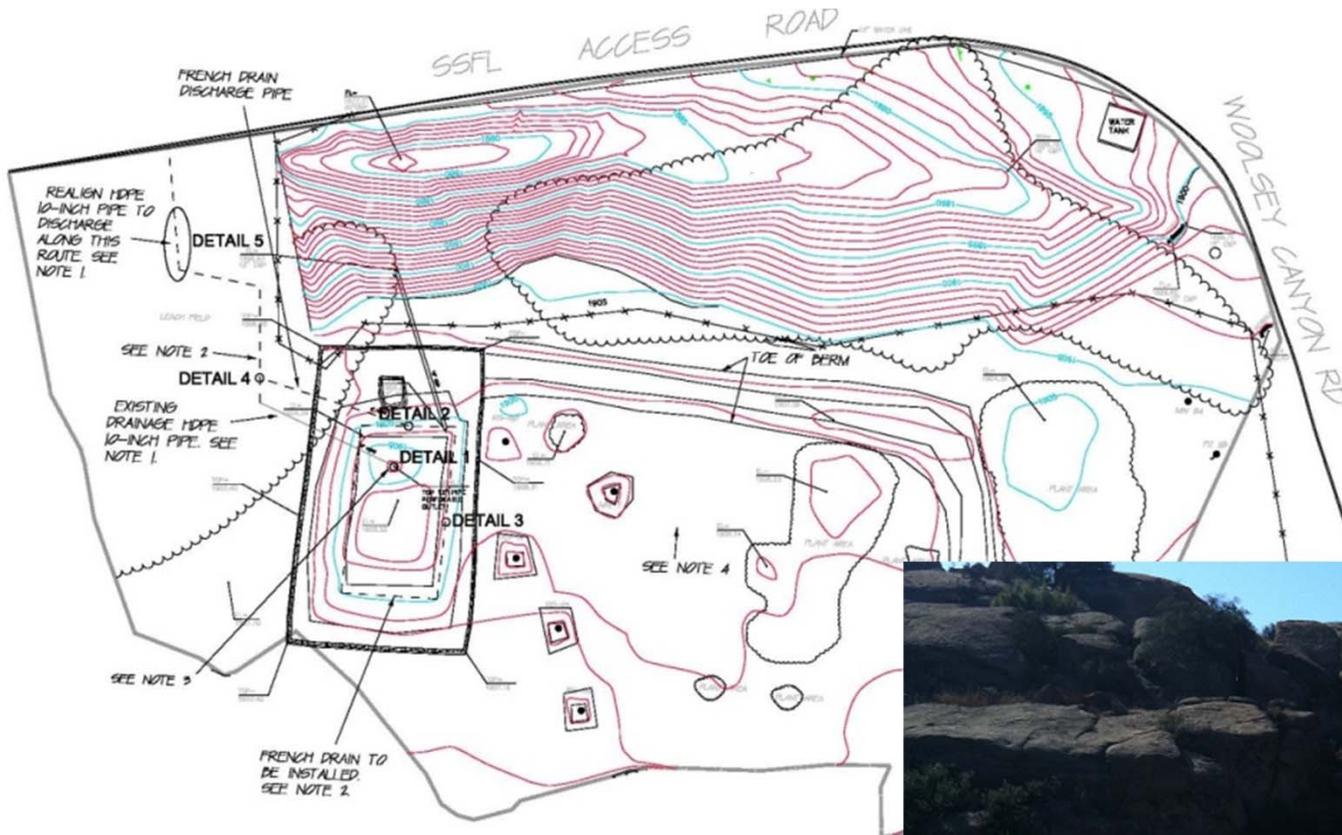
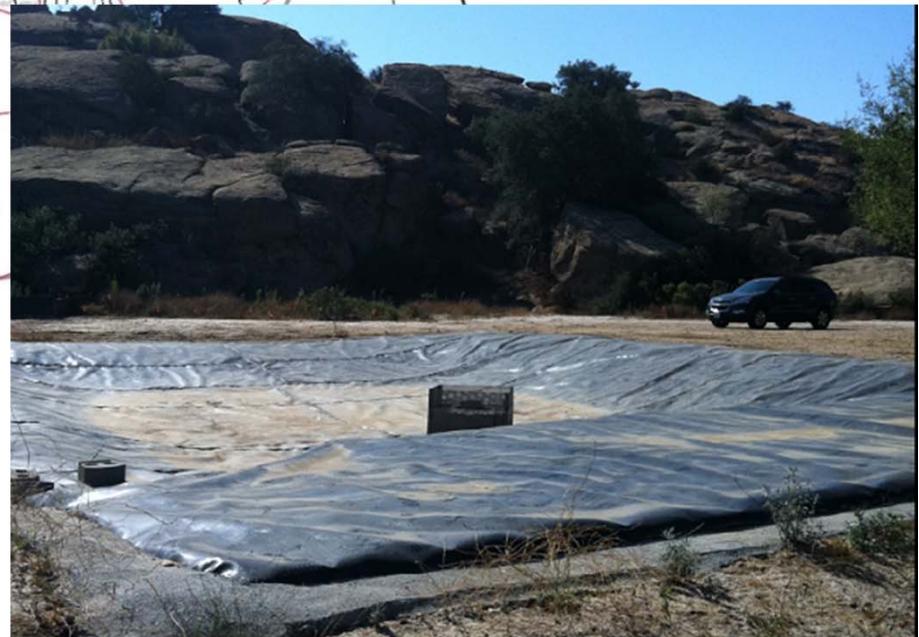
# B1 Sediment Basin

- Treat runoff from ~2 acres including RFI & ISRA areas
- Construction near complete

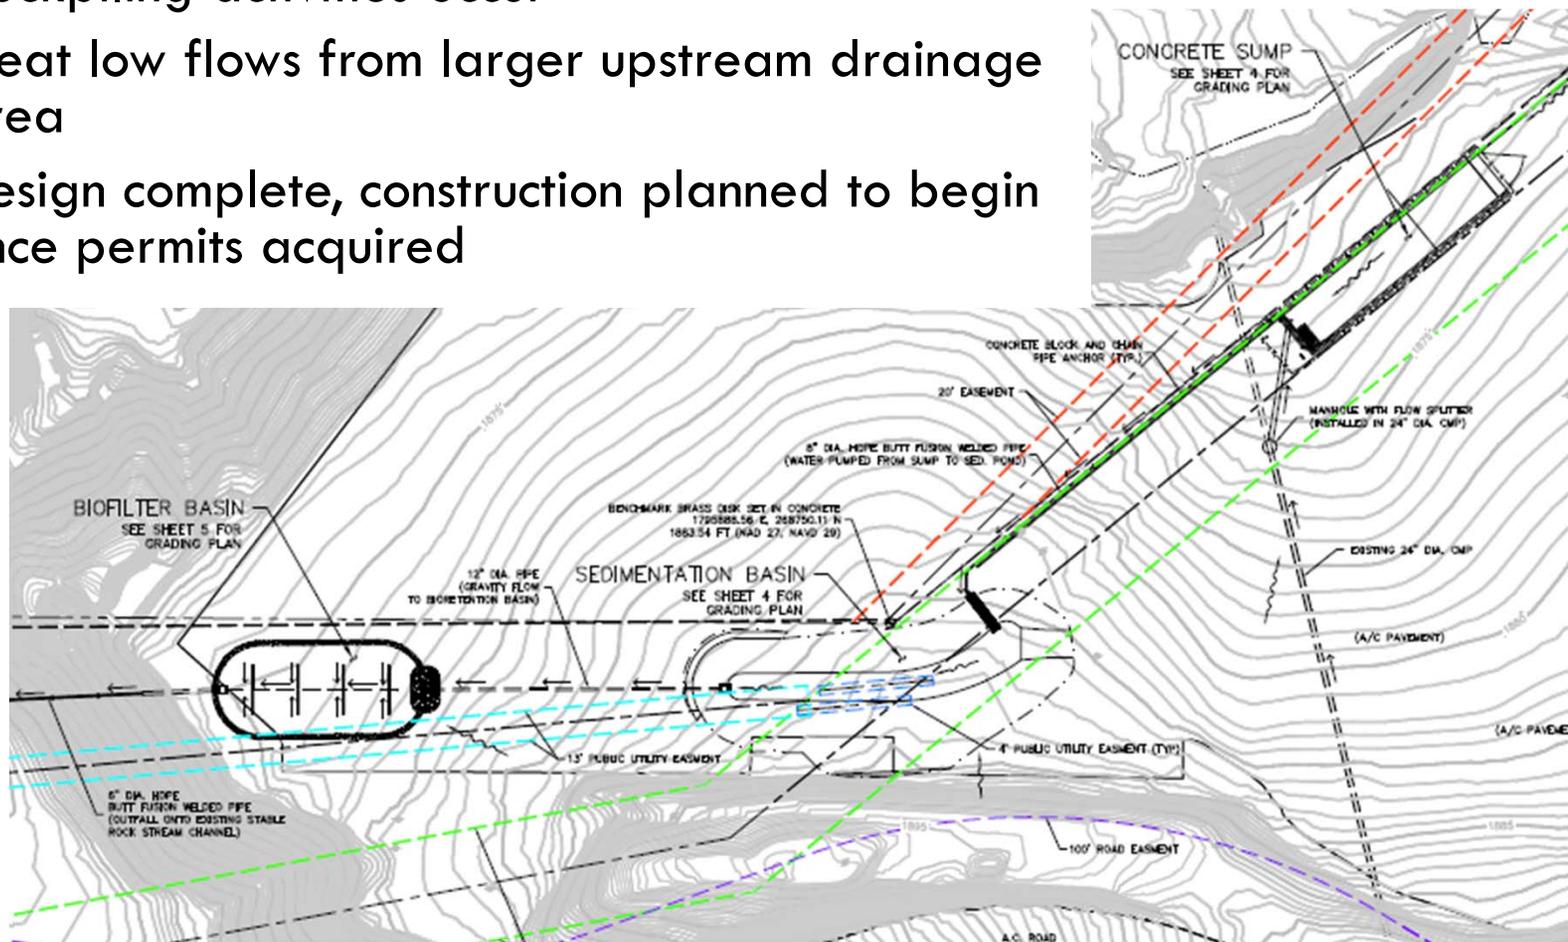
# Soil Stockpile Biofilter

- Treat runoff from 5 acre paved lot where soil stockpiling activities occur
- Treat low flows from larger upstream drainage area
- Design complete, construction planned to begin once permits acquired

View south onto the lower lot from Sage Ranch property.

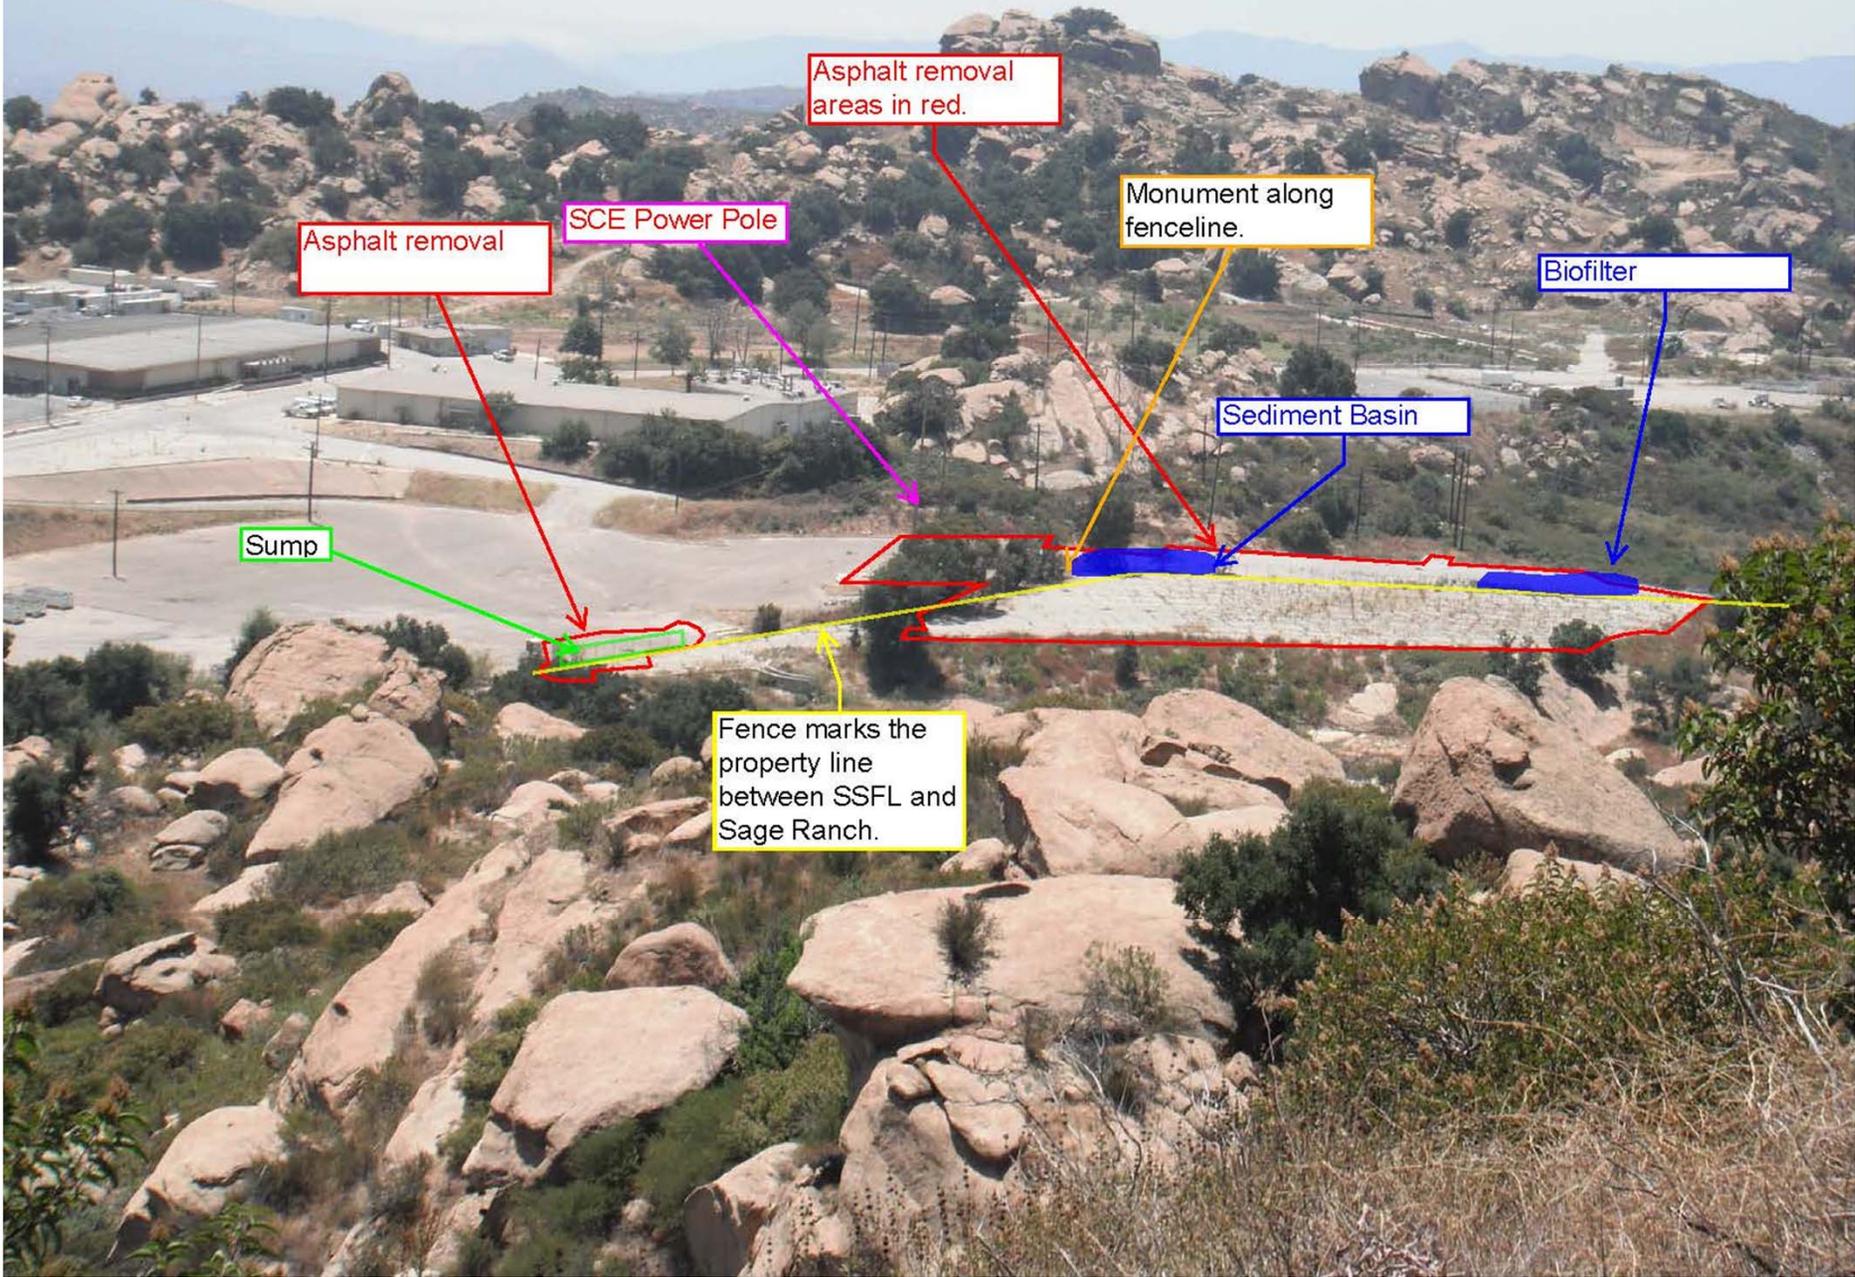
Asphalt removal

Asphalt removal areas in red.

Biofilter

Sediment Basin

Fence marks the property line between SSFL and Sage Ranch.

- Asphalt removal is expected to reduce runoff volumes and contaminant loads
- 1.5 acres near Building 324
- 1.8 acres near lower parking lot
- Additional building and pavement areas to be demolished in 2012 and beyond

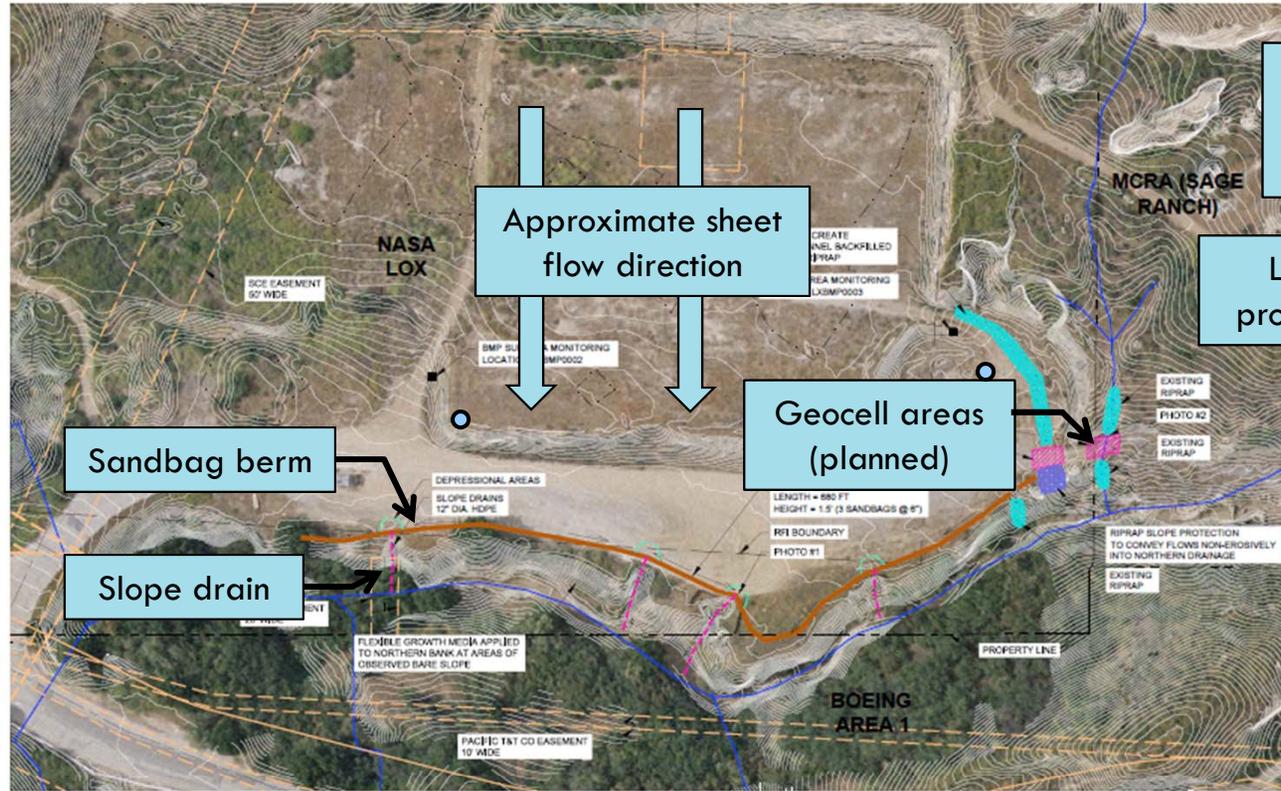
# LOX BMP

Location of proposed slope drain

Location of proposed berm

- SLOPE DRAINS SHOULD BE KEVED IN TO THE SAND BAG BERM SO THAT WATER FLOW AROUND THE PIPE IS PREVENTED.
  - GRADED DITCH SHOULD BE CONSTRUCTED ON UPSLOPE SIDE OF BERM TO ENSURE PROPER DRAINAGE TOWARDS SLOPE DRAIN INLETS, UNLESS EXISTING GRADE ALREADY ALLOWS FOR THIS.

- EXISTING RIPRAP SHOULD BE REINSTALLED WITH FILTERED ROCK BEDDING, AND PROPOSED RIPRAP SHOULD BE SIMILARLY INSTALLED WITH FILTERED ROCK BEDDING.
  - GEOCELL TRIBUTARY CROSSINGS SHOULD BE SHAPED INTO A CHANNEL TO ALLOW FOR CONVEYANCE OF CONCENTRATED FLOWS ACROSS THEM.

- Concepts developed for new recommended BMPs
  - ▣ LOX (NASA): Erosion controls and slope protection.
  - ▣ ELV Area (NASA): Channel restoration, detention, and media filtration.
  - ▣ Helipad (NASA): Asphalt removal, erosion control, and active re-vegetation.
  - ▣ Area 1 Landfill: New BMPs under consideration.

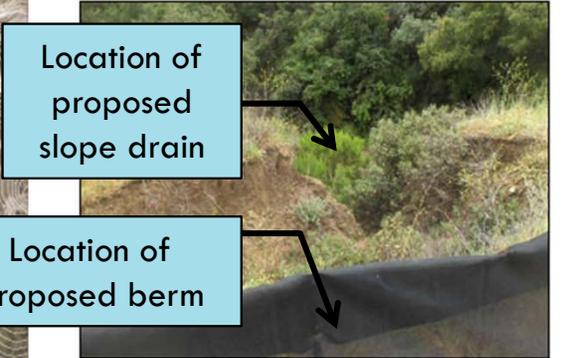
PHOTO #1: LOOKING DOWN EROSION GULLY FROM TOP OF SLOPE. SEE MAP.

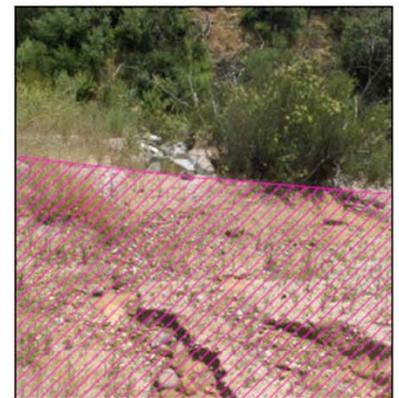
PHOTO #2: ACCESS ROAD LOOKING TOWARD SOUTH. SITE OF PROPOSED GEOCELL SHALLOW CROSSING (IN HATCHED AREA ON PHOTO). SEE MAP.

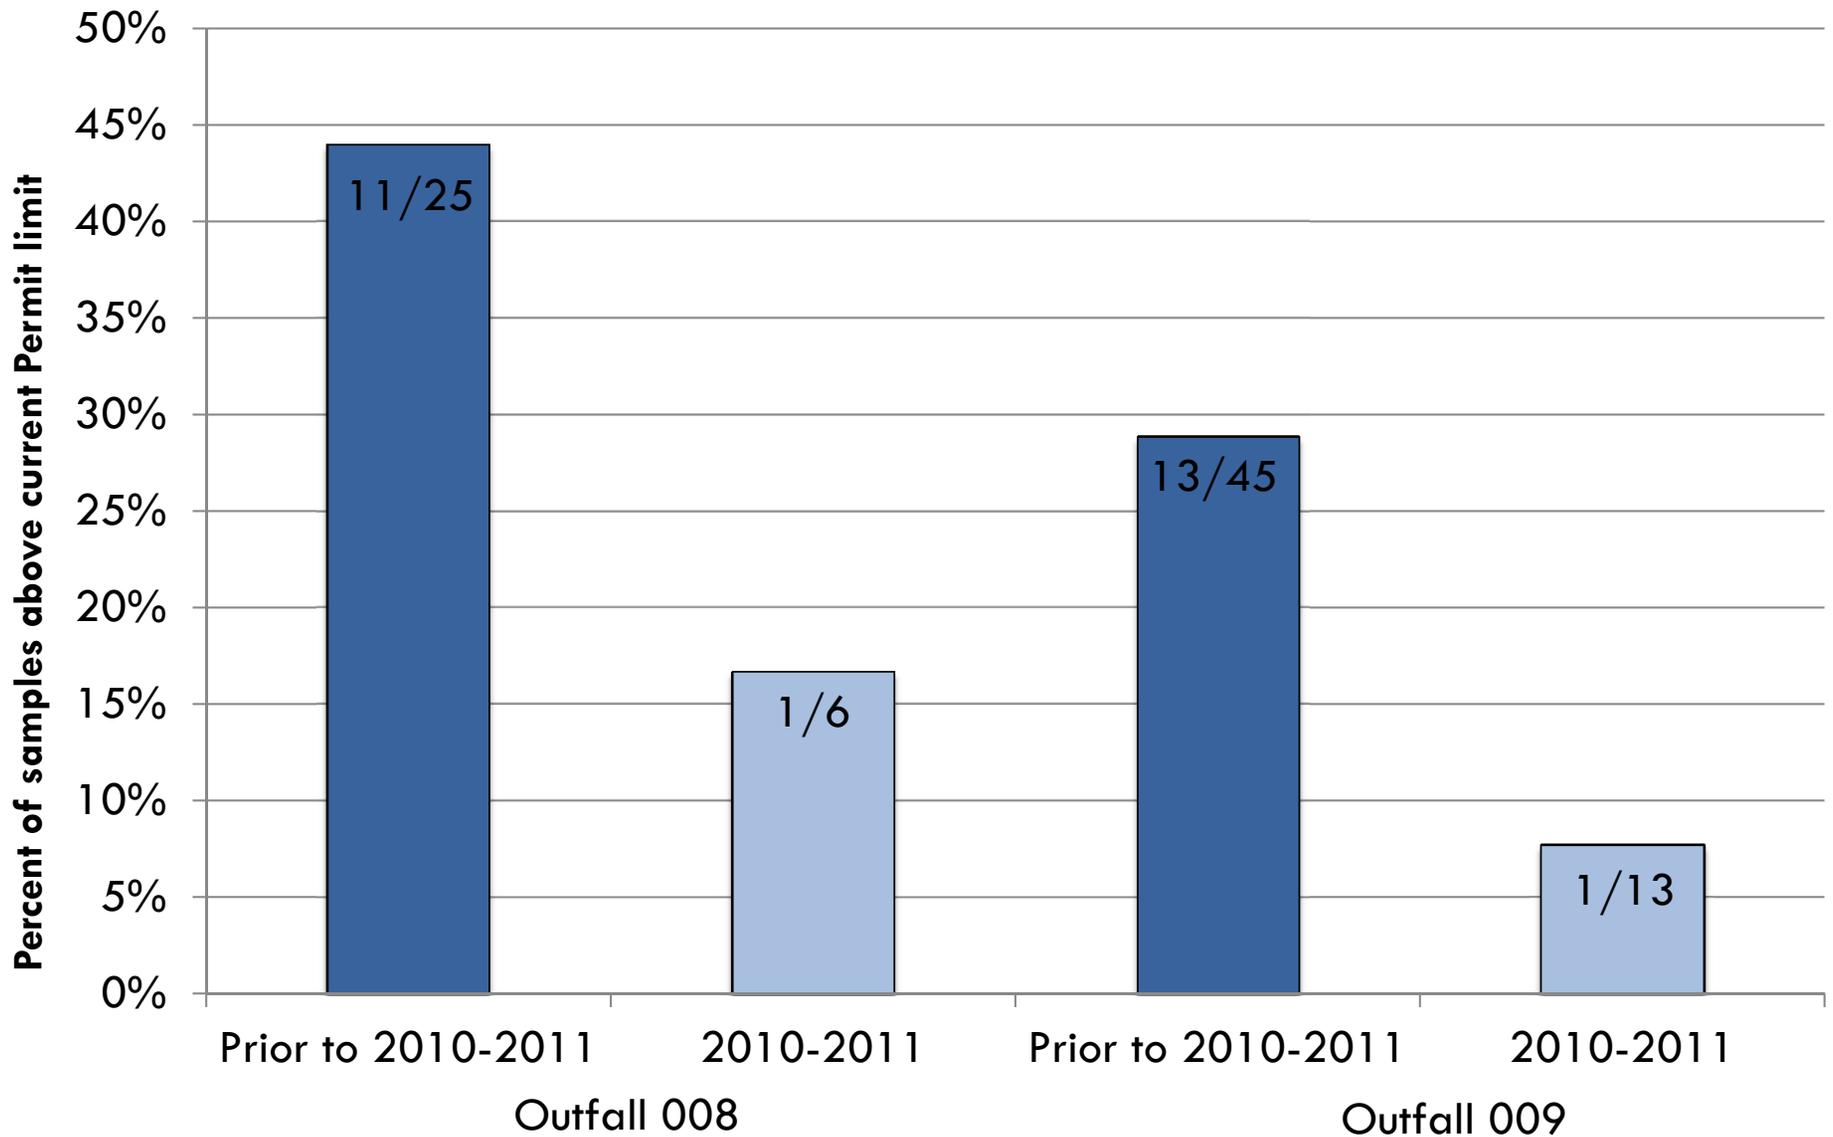
# NPDES Exceedances Total Lead

- Positive results in 2010/2011
  - ▣ Just one exceedance at Outfall 008 (lead)
  - ▣ Three exceedances at Outfall 009 (lead, dioxin [twice])
- 100% compliance is challenging due to background sources and/or natural variability.

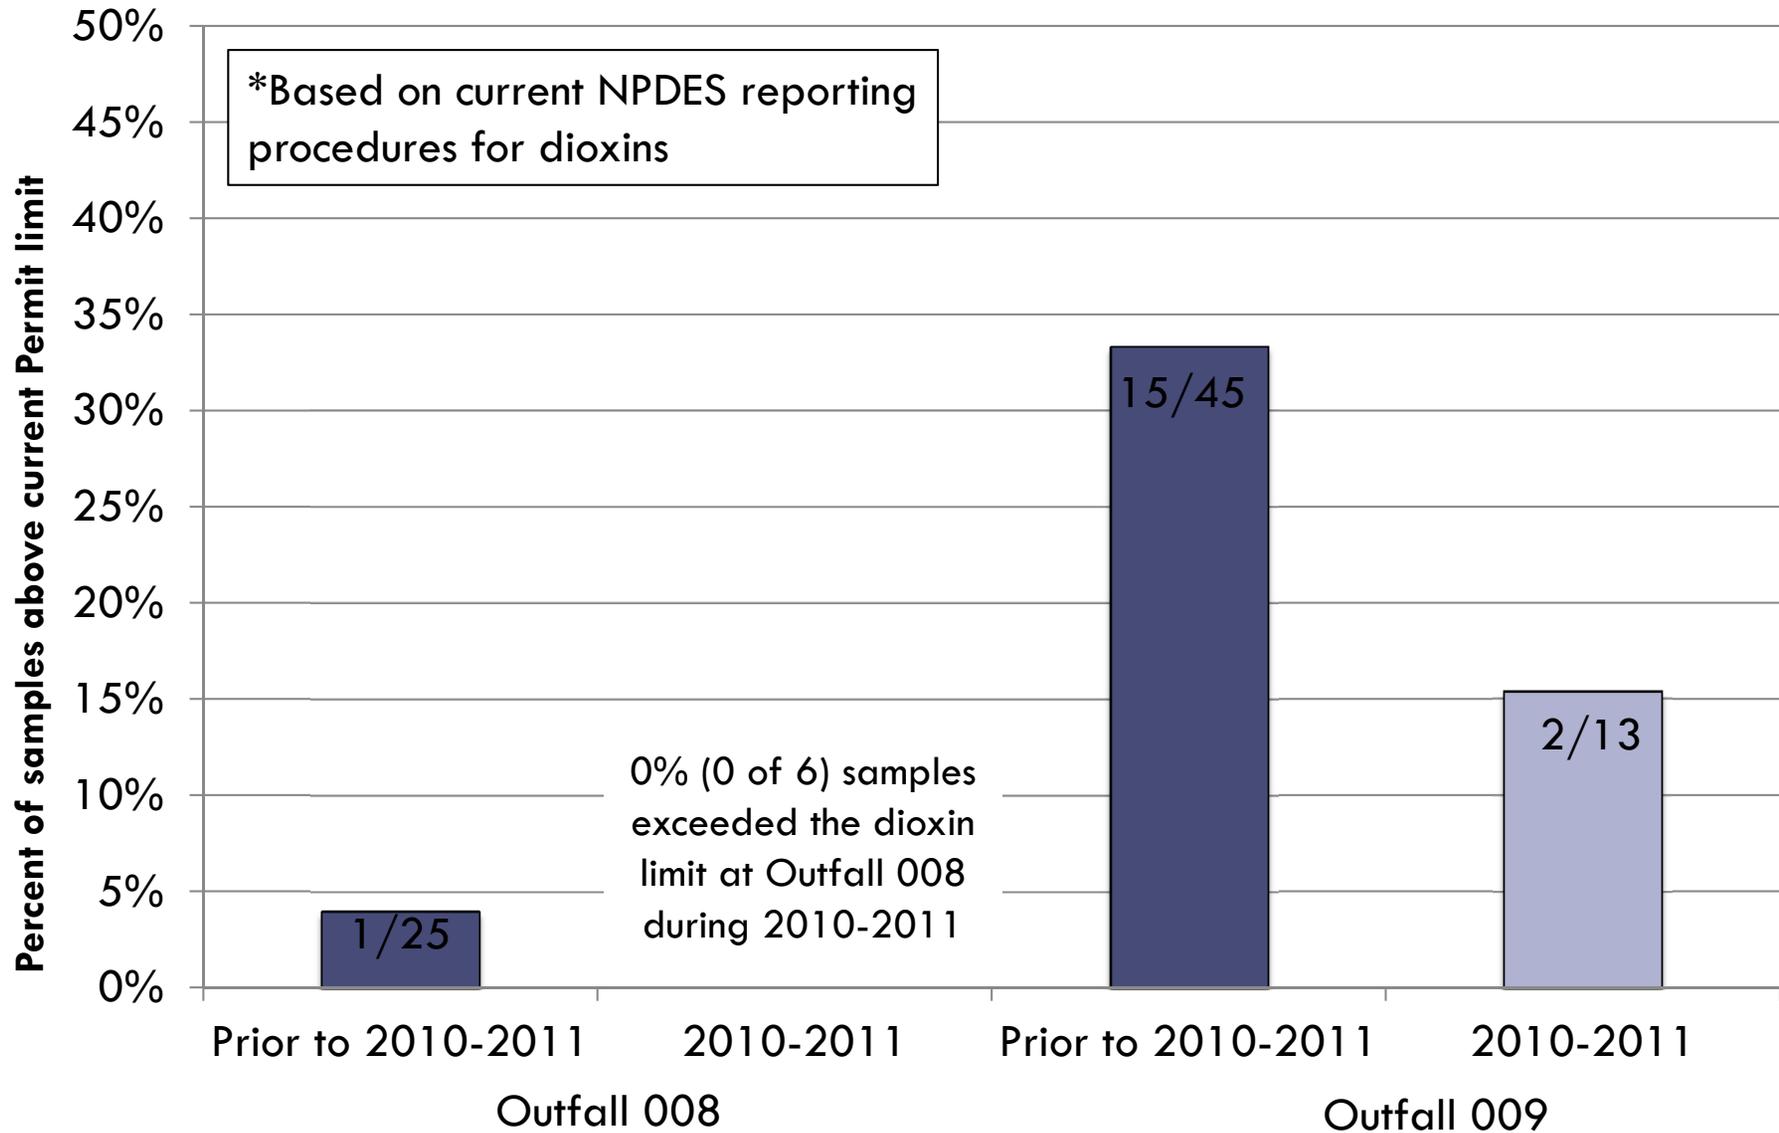
# NPDES Exceedances

## Dioxin (TCDD TEQ [no DNQ])\*
