APPENDIX D
BIOLOGICAL SURVEYS

Subject: Santa Susana Field Laboratory Outfall 009 ISRA Biological Survey and Construction Monitoring Report – March 2011 to June 2011

**APPENDIX A. PRE-ACTIVITY BIOLOGICAL FIELD SURVEY
FORM (IEL-2, April 20, 2011)**

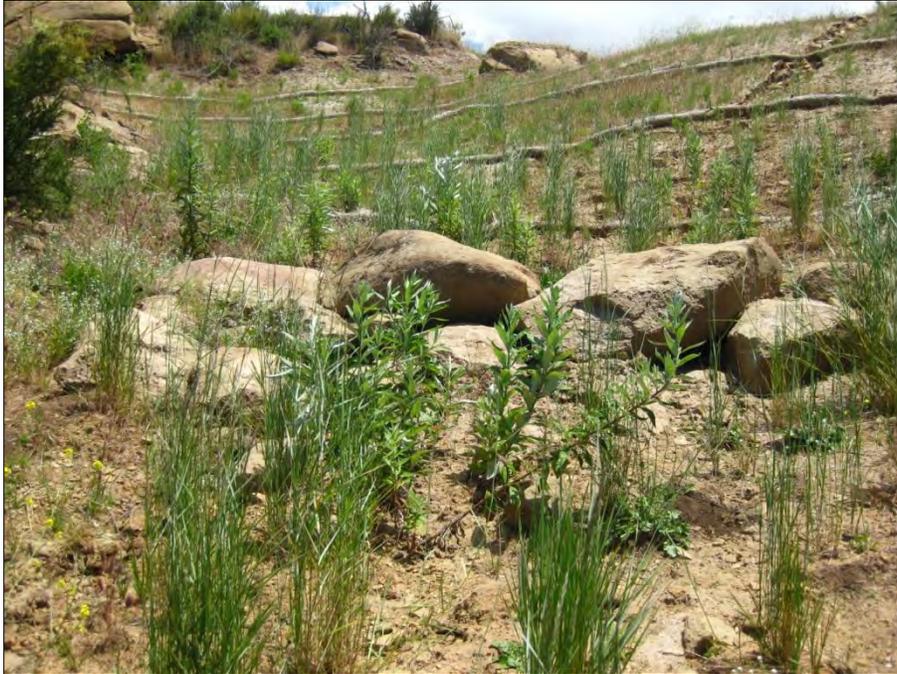
Figure B1. View of CTL-1A with substantial growth of plantings and germinated hydroseed. Photograph is toward the south, taken on June 1, 2011.

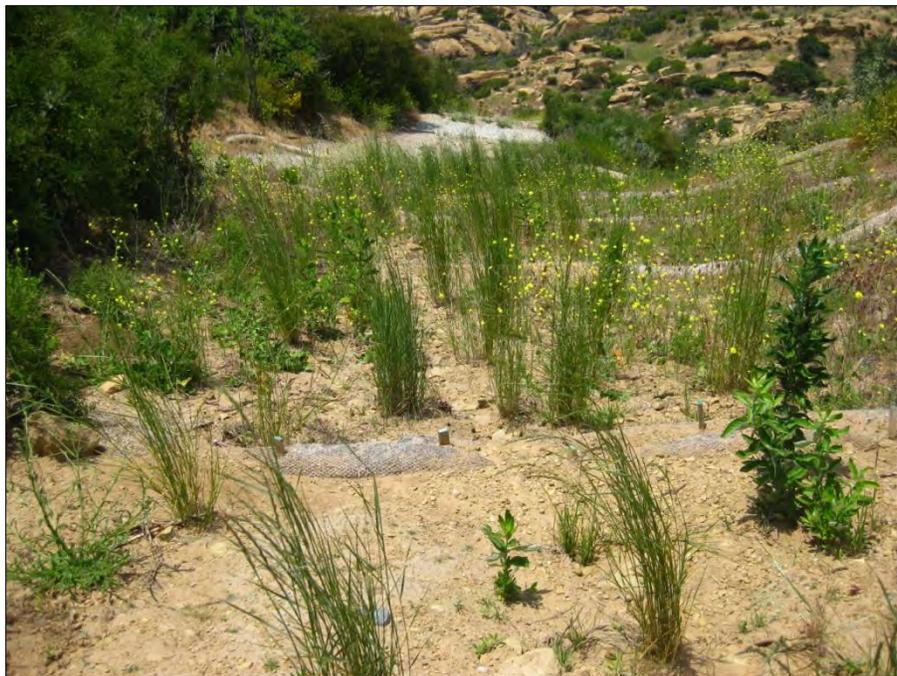
Figure B2. View of CTL-1B with substantial growth of plantings and some summer mustard infestation. Photograph is toward the north, taken on June 1, 2011.

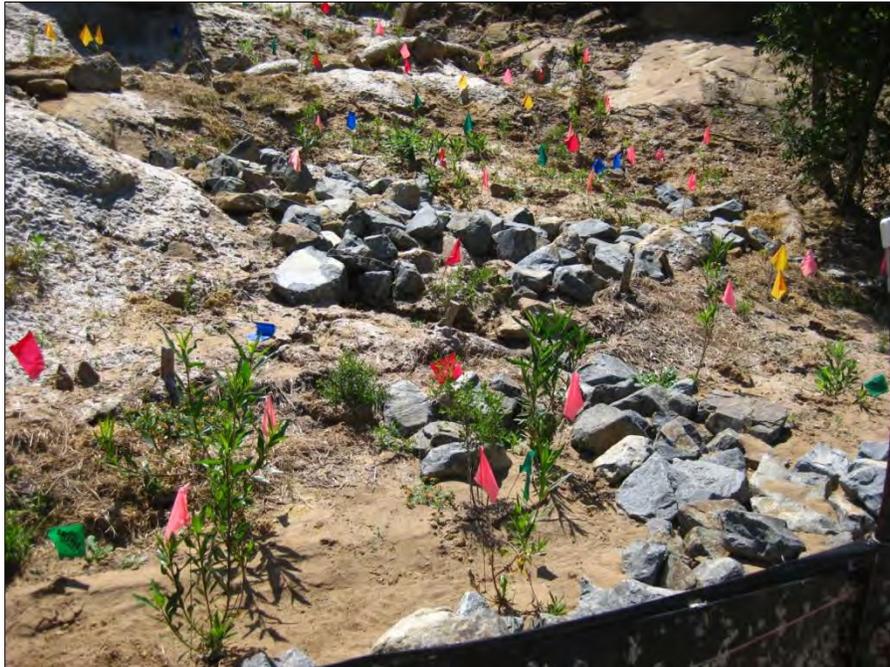
Figure B3. View of B1-1A planting area on May 25, 2011.

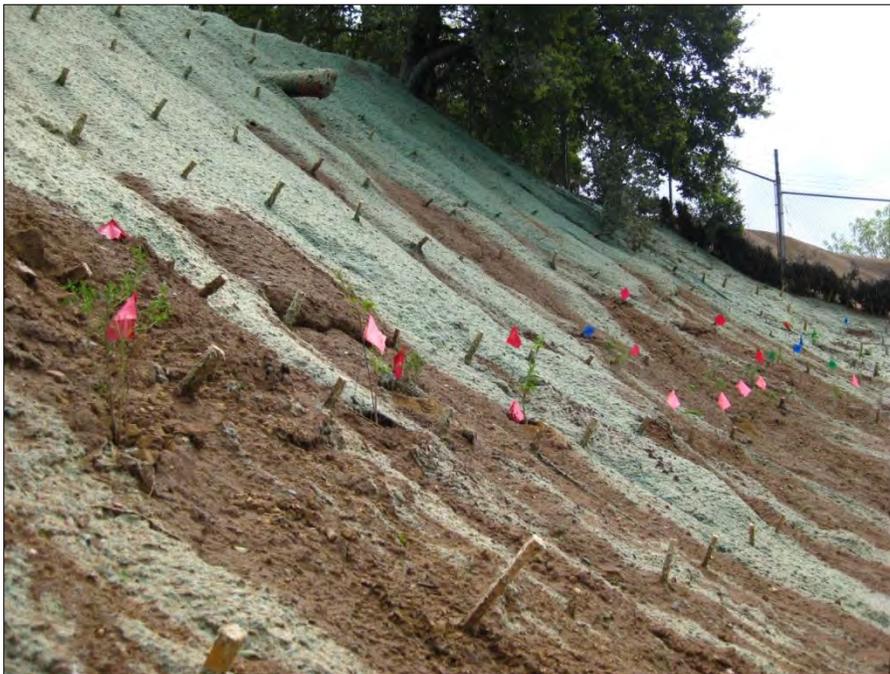
Figure B4. View of B1-2 planting area on March 21, 2011. Plantings were installed, and slope was covered in jute netting and hydroseeded.

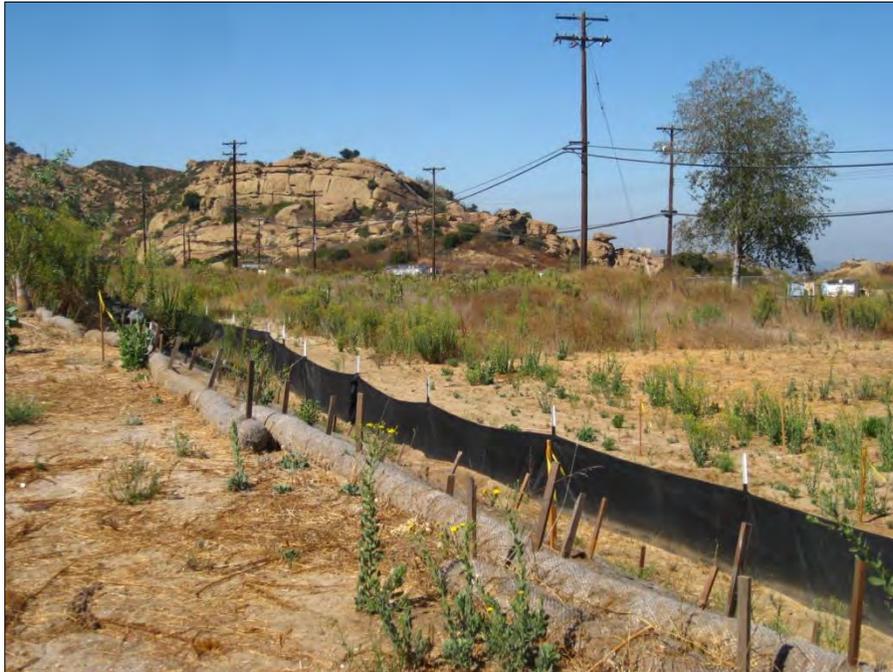
Figure B5. View of IEL-2 on September 23, 2010, prior to ISRA activities. Photograph is toward the southwest.

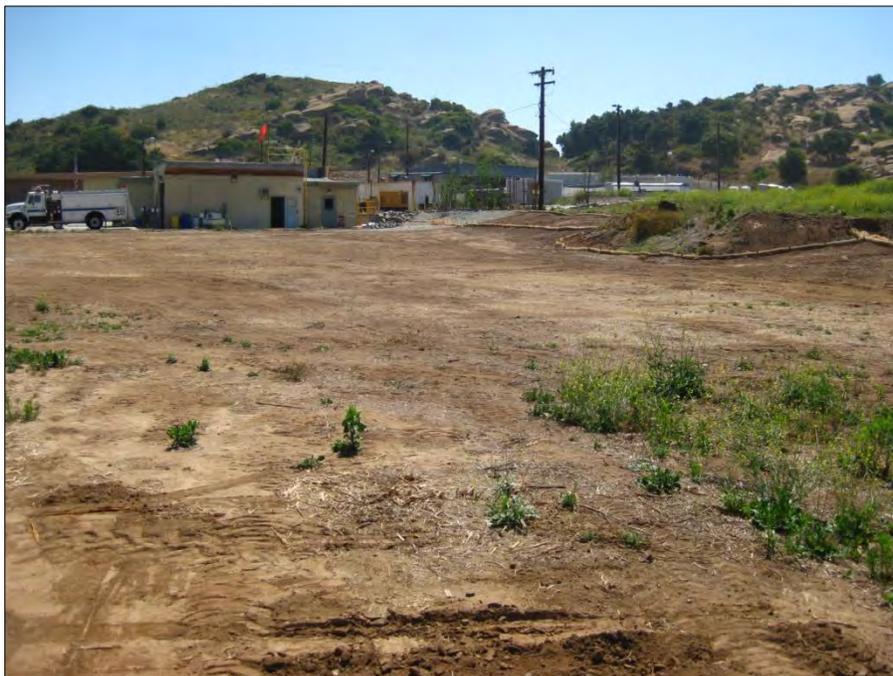
Figure B6. View of IEL-2 on June 22, 2011, subsequent to ISRA activities. Photograph is toward the northeast. Hydroseeding will be completed upon receipt of soil analytical results.

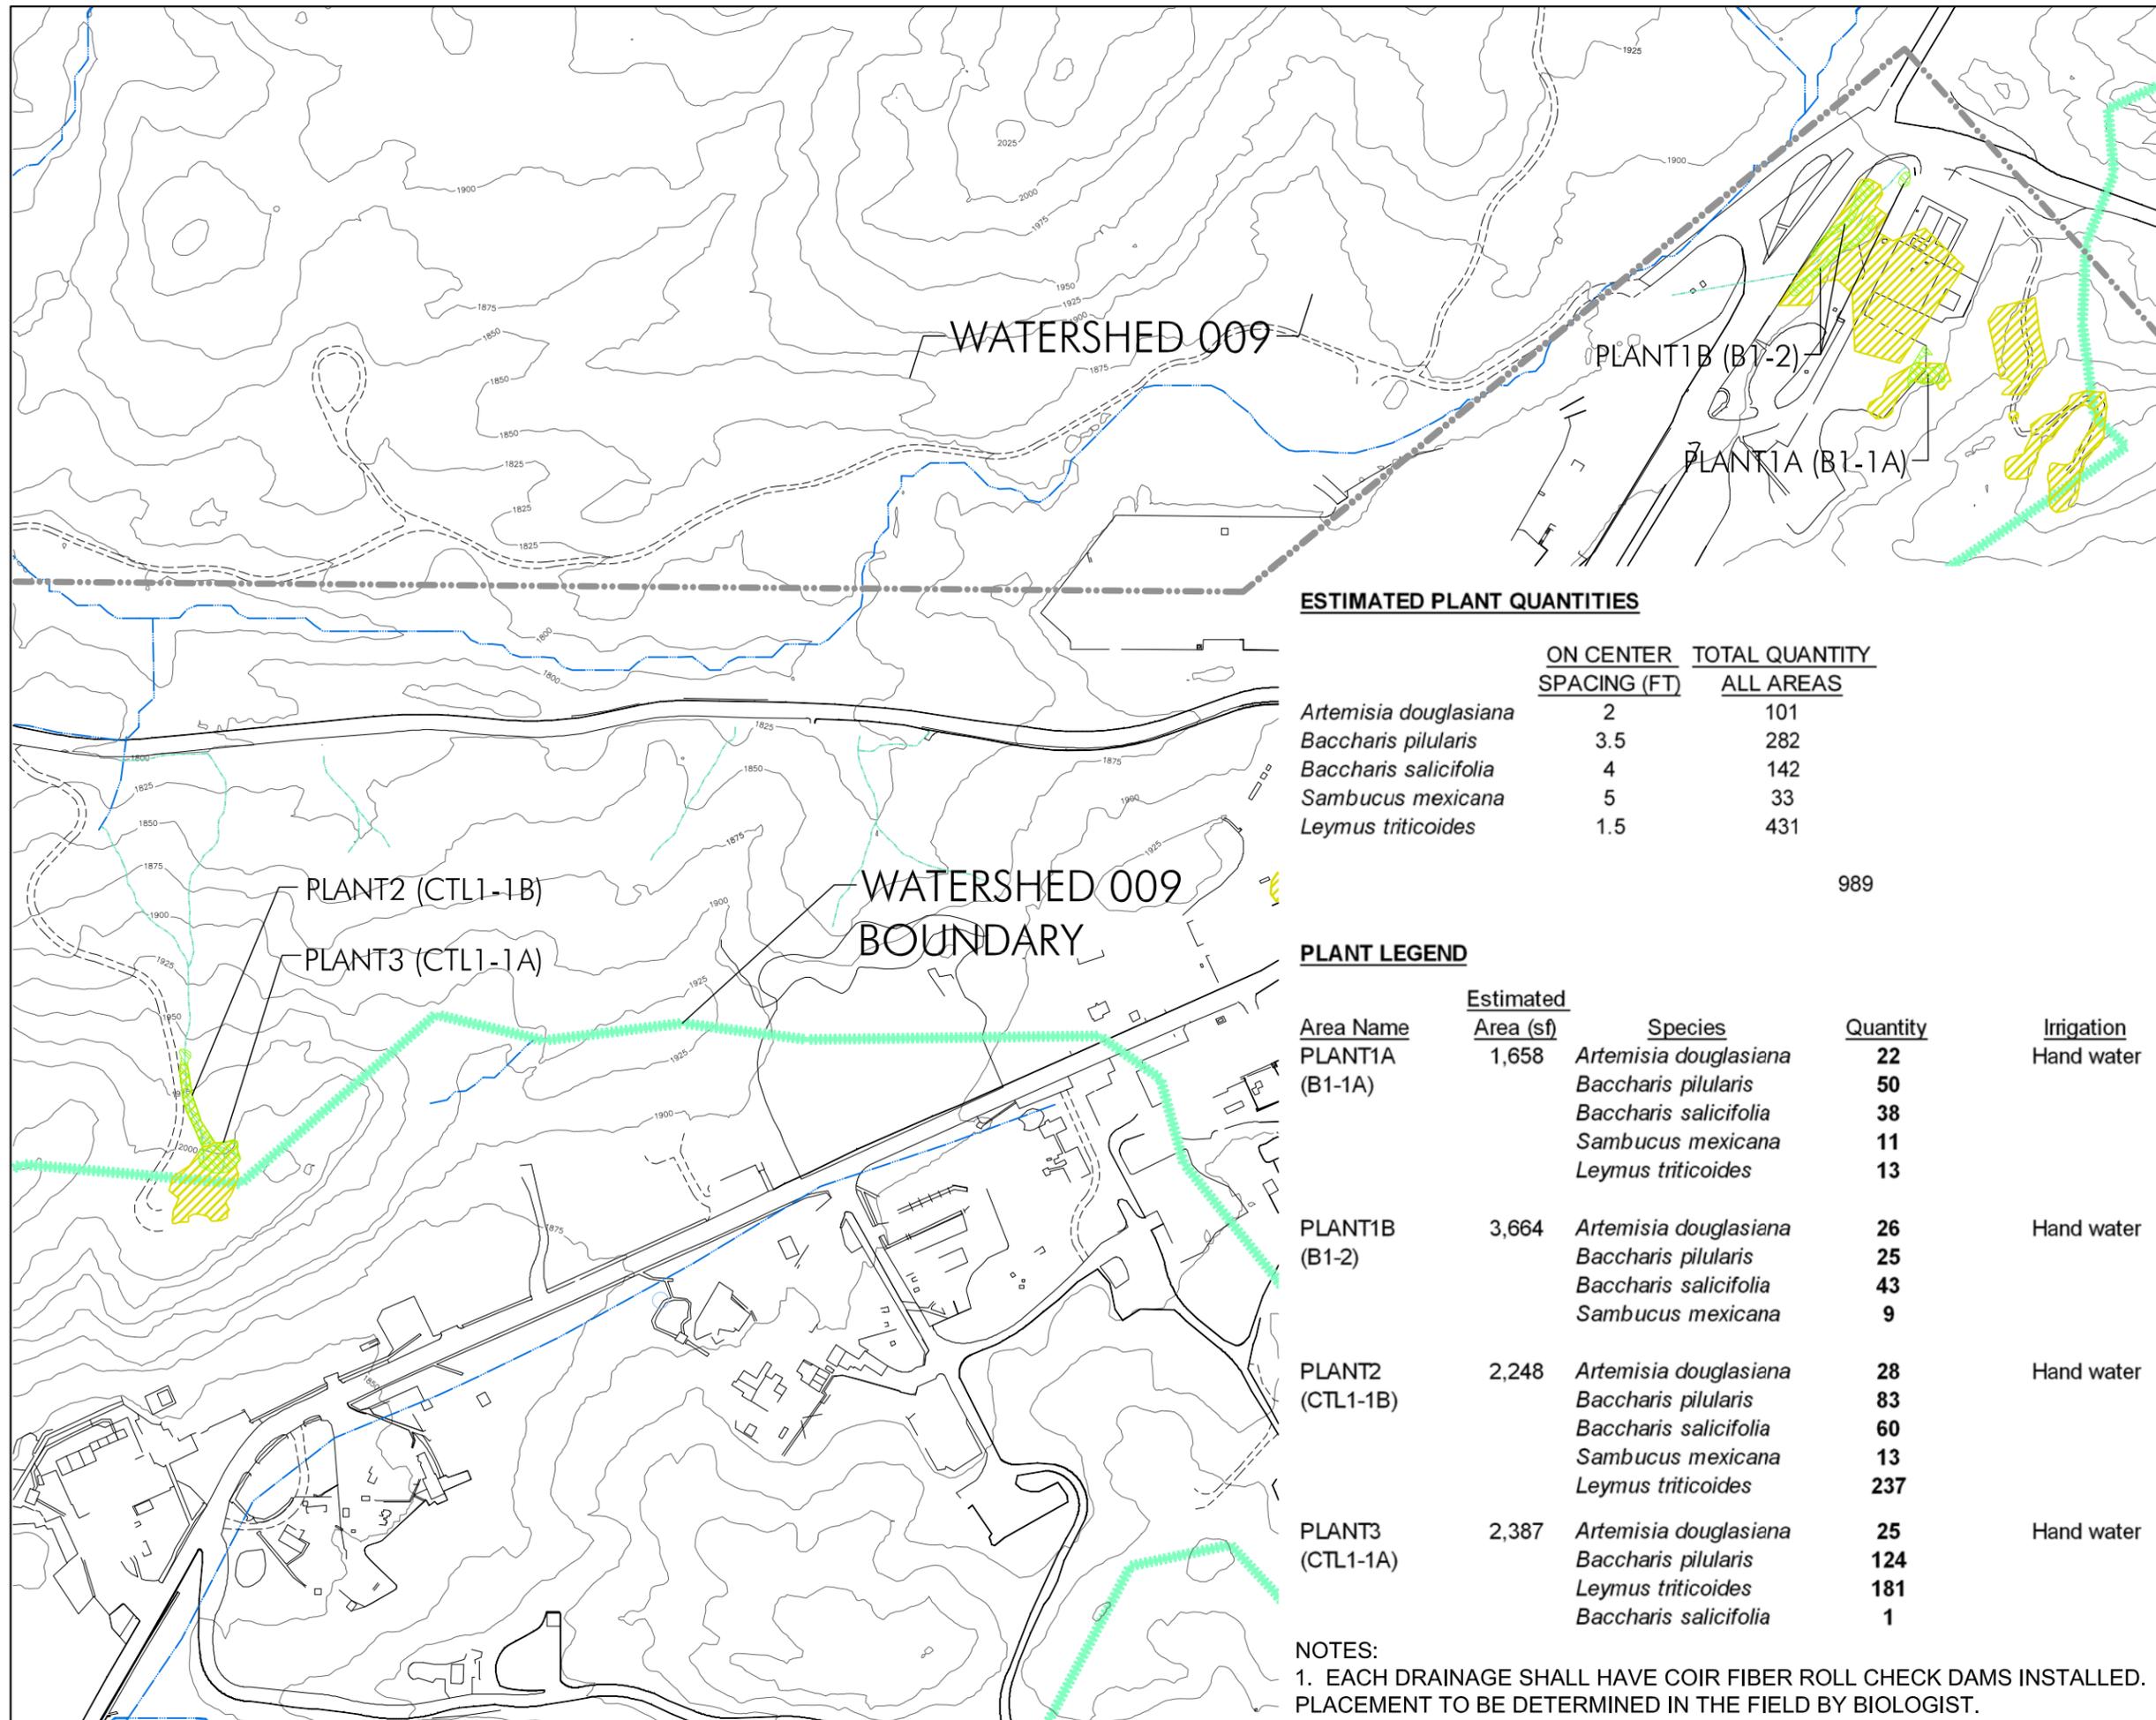
AS-BUILT
Figure 1A
ISRA 2010
Revegetation Areas

Containerized
Planting Plan

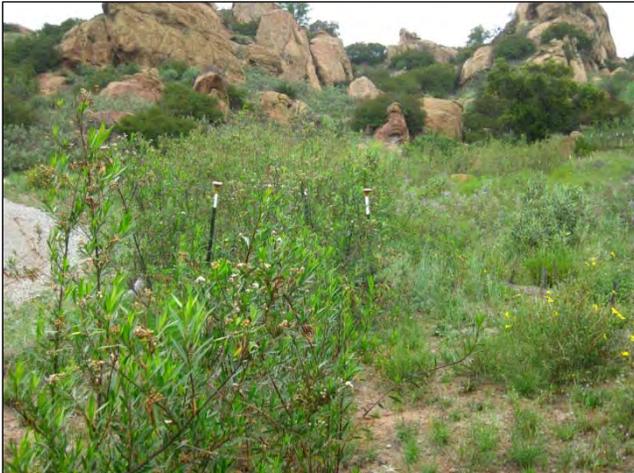
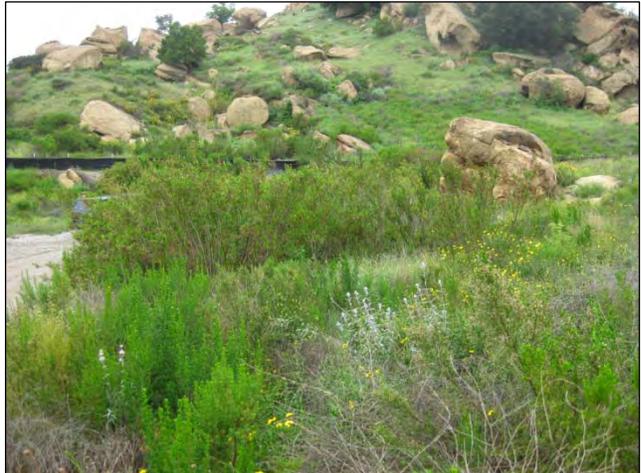
HVS-2A: Mulefat (*Baccharis salicifolia*) plants in excess of the 127 plantings were tallied, and observed as mature and flowering. Plant cover within the planting area exceeds 100 percent, with the understory being comprised of creeping wild rye (*Leymus triticoides*) in excess of the 100 individuals planted, and other natives such as purple needlegrass (*Nassella pulchra*). No blue elderberry (*Sambucus mexicana*) plants were observed (4 originally planted), but this may be due to the thick cover obscuring their presence. The adjacent hydroseeded area was estimated at 85 percent overall cover, and is maturing into coastal sage scrub vegetation comprised mainly of native species including yerba santa (*Eriodictyon crassifolium*), coyote brush (*Baccharis pilularis*), California bush sunflower (*Encelia californica*), deerweed (*Lotus scoparius*), golden yarrow (*Eriophyllum confertifolium*), black sage (*Salvia mellifera*), purple sage (*Salvia leucophylla*), and laurel sumac (*Malosma laurina*). Prevalent non-native species includes summer mustard (*Hirschfeldia incana*). Three (3) previously absent Santa Susana tarplants (*Deinandra minthornii*, a State Rare species) were observed growing in the swale and the adjacent hydroseeded area.

Views of HVS-2A and HVS-3, respectively, with plantings mainly on left side and hydroseeding on the right side of each photo.

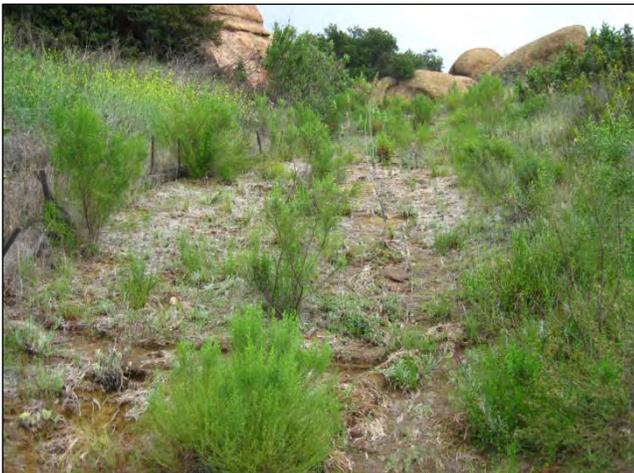
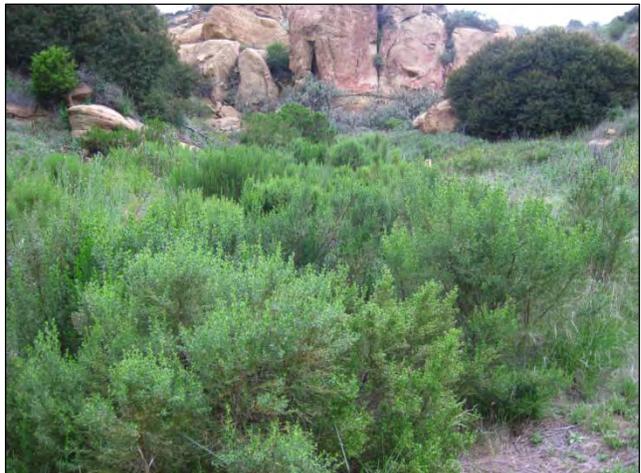
HV-PLANT1: This steep, former unpaved access road exhibits extremely shallow soils (with exposed bedrock), but has attained a high level of survival and approximately 60 percent cover in comparison to previously bare ground, and in spite of difficult growing conditions. A total of 80 coyote brush were tallied (85 originally planted), and 9 mulefat (11 originally planted). Creeping wild rye is present as a result of plantings, but in low concentration. Other natives occupying the planting area include California aster (*Lessingia filaginifolia*), telegraph weed (*Heterotheca grandiflora*), black sage, deerweed, yerba santa, and a total of eight Santa Susana tarplant (1 mature, along with 7 seedlings previously not observed).

Views of HV-PLANT1 and HV-PLANT2, respectively, exhibiting colonization in remnant unpaved roadways.

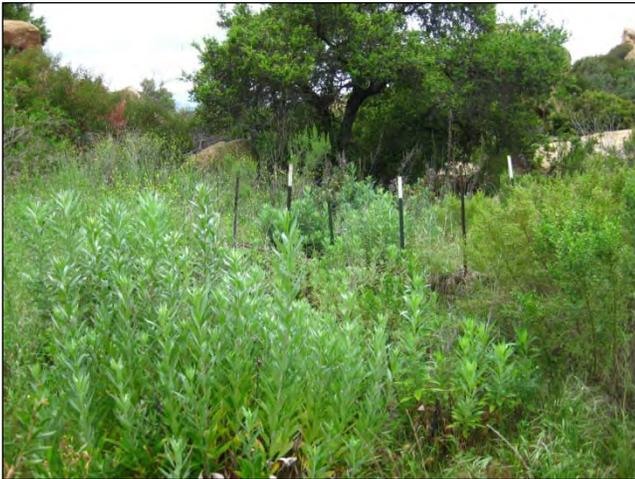
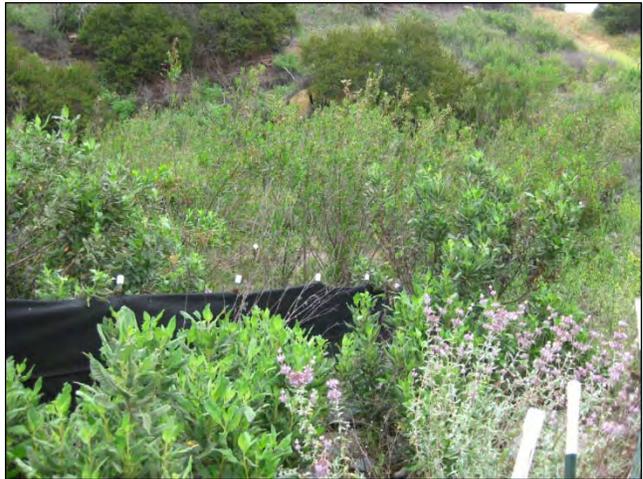
Views of HV-PLANT3 and HV-PLANT5, respectively, of mugwort and mulefat-dominated thickets.

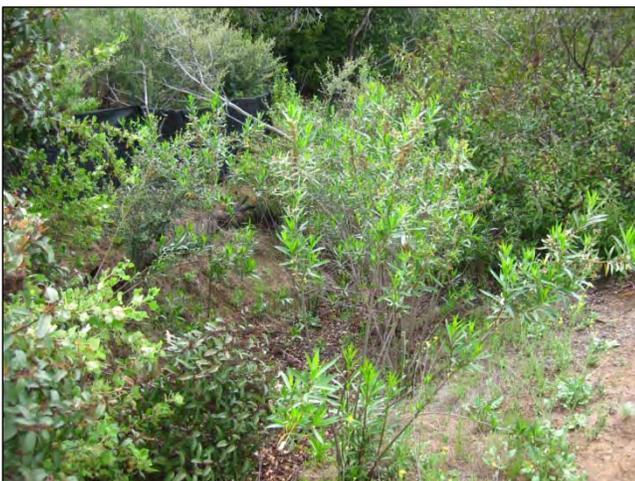
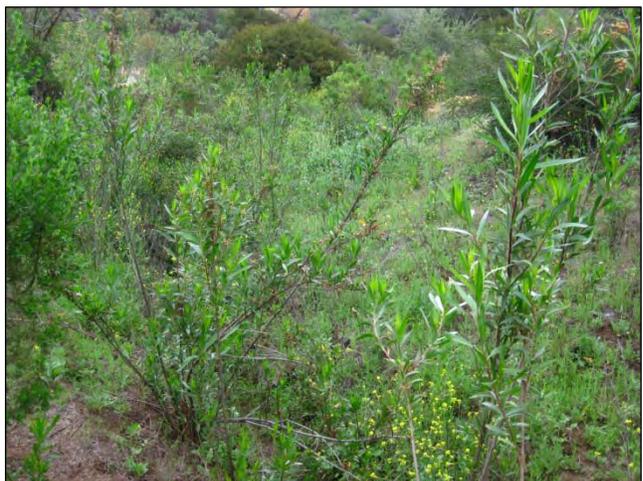
HV-PLANT9: This planting area exhibits approximately 90 percent cover by combination of plantings and existing natural vegetation. A substantial number of mulefat plantings were tallied (at least 55), along with naturally occurring species including buckbrush, black sage, chamise (*Adenostoma fasciculatum*), coyote brush, and non-native summer mustard.

Views of HV-PLANT7 and HV-PLANT9, respectively, of mulefat colonization mixed with natural scrub regeneration.

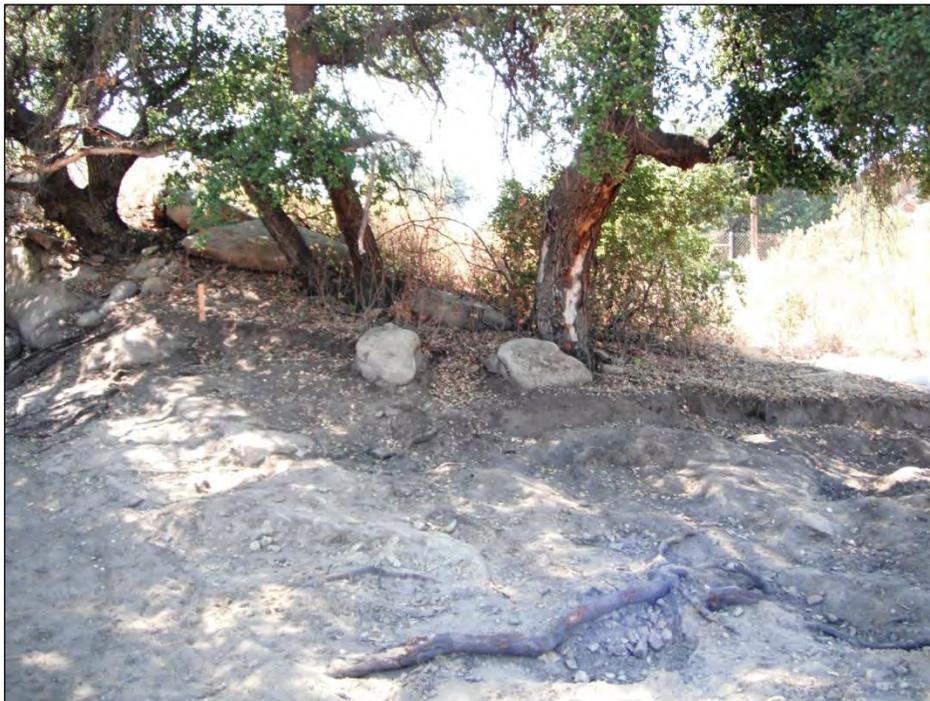
Based on our site observations, it is our professional recommendation that additional soil removal be curtailed in the excavation areas within the dripline of the oak trees located within or overhanging the two subject ISRA areas. Currently, it is evident that there are significant exposed roots and further depth of soil removal will not only expose roots, but also potentially cause instability of the major tree support structure. Continued root removal will cause a lack of absorptive transport of water and nutrients to the canopy branch and foliage structure, and thereby can cause the decline and potential demise of the trees. The presence of depressions around the base of certain trees may also result in excessive ponding of water beneath the trees, potentially introducing oak root fungus disease. Attached are example photographs of the existing site conditions beneath the tree canopies.

Figure 1. Excavation area beneath oak trees located along the western margin of AP/STP-1C-1. View is toward the west.

It is also our recommendation that a source of clean soil material be selected to provide backfill material for areas beneath the trees' canopies. Re-establishment of the original contours is ideal, but even the placement of at least 6 inches of soil will help to provide stability, provide a substrate for the regeneration of the trees' absorptive roots, reduce ground temperatures, reduce the potential for ponding, and restore habitat for silvery legless lizard (*Anniella pulchra pulchra*), a special-status fossorial (burrowing) reptile known to rarely occur beneath oak trees at SSFL.

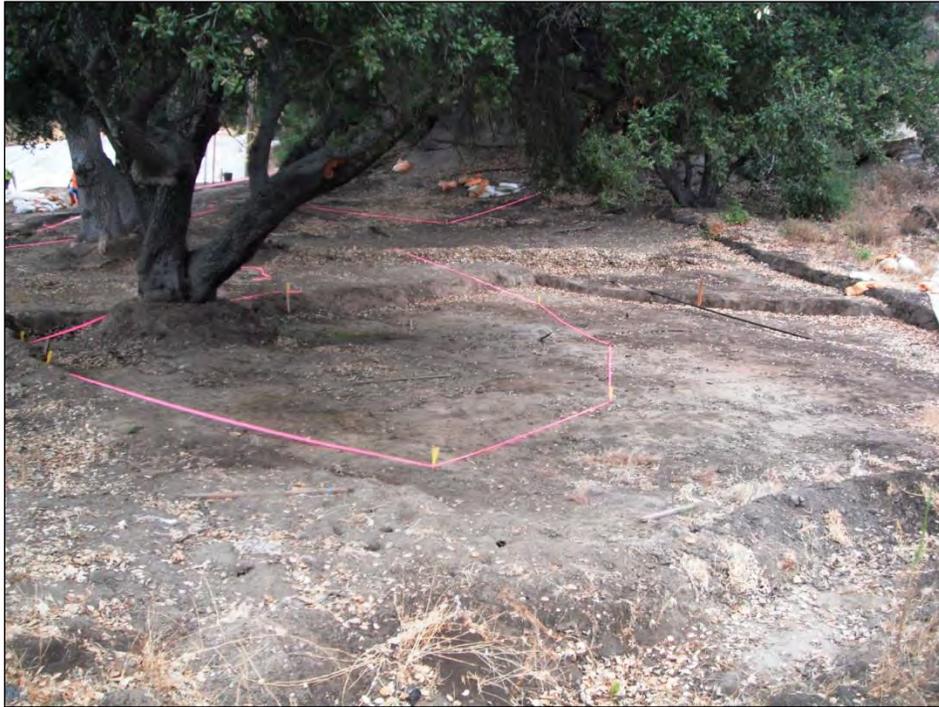
Figure 2. Excavation area beneath oak trees located within the western section of AP/STP-1C-2. View is toward the east.

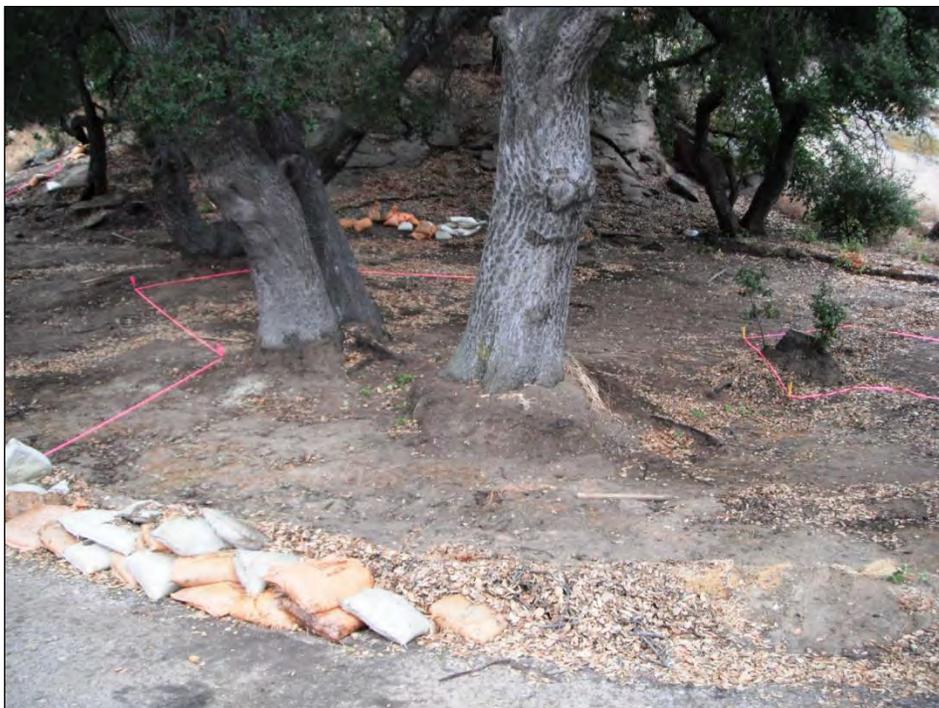
Figure 3. Excavation area beneath oak trees located within the middle section of AP/STP-1C-2. View is toward the south.

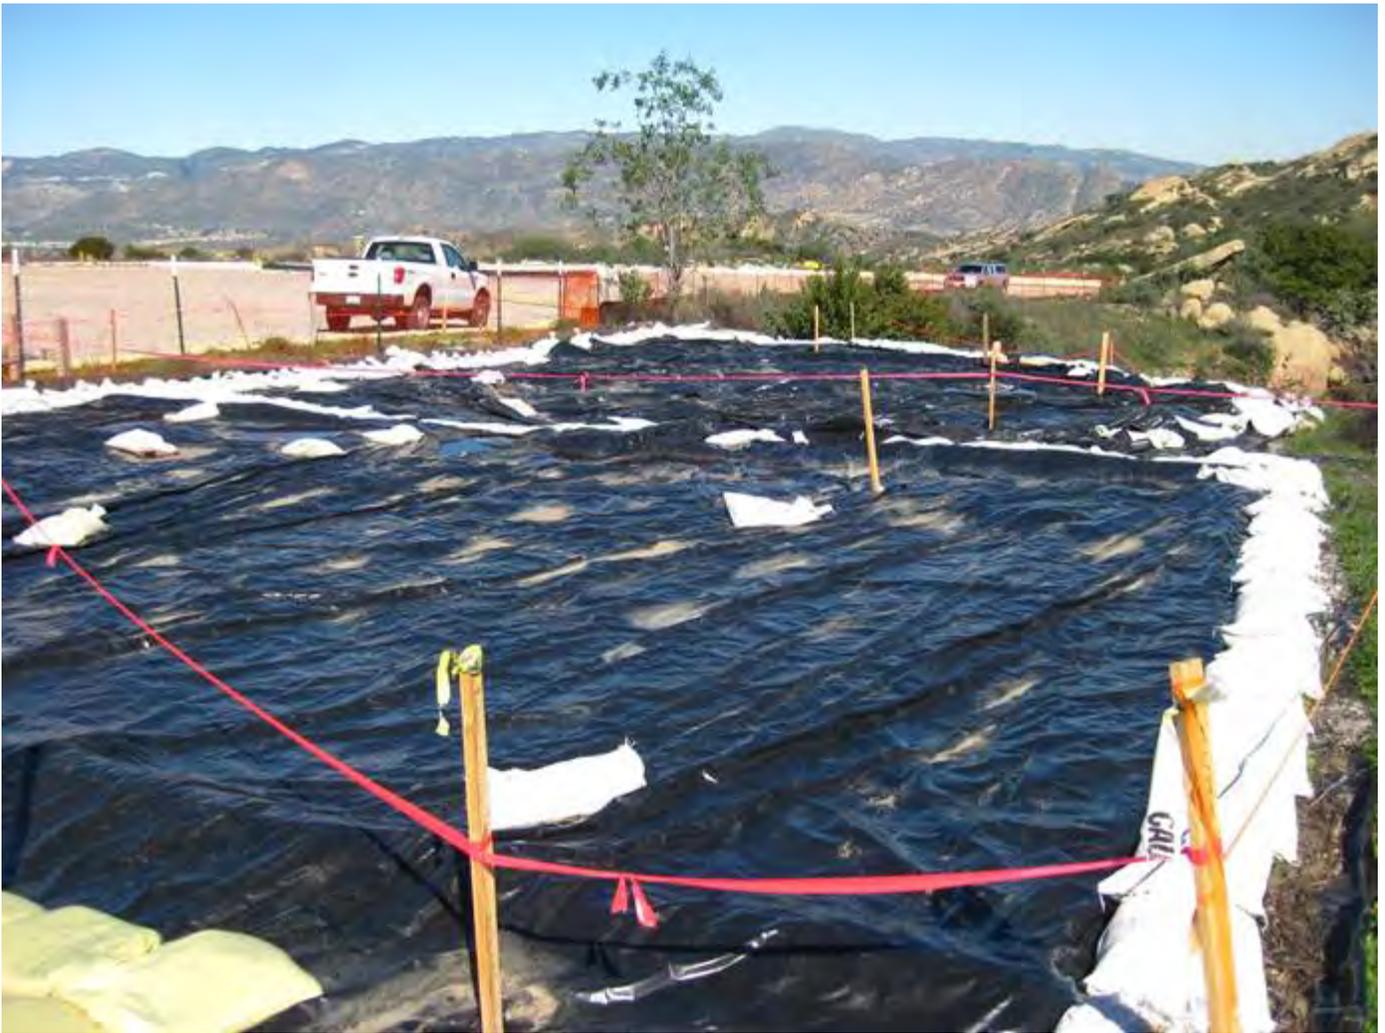
ELV-1C excavation within ribbon boundary (beneath visqueen).

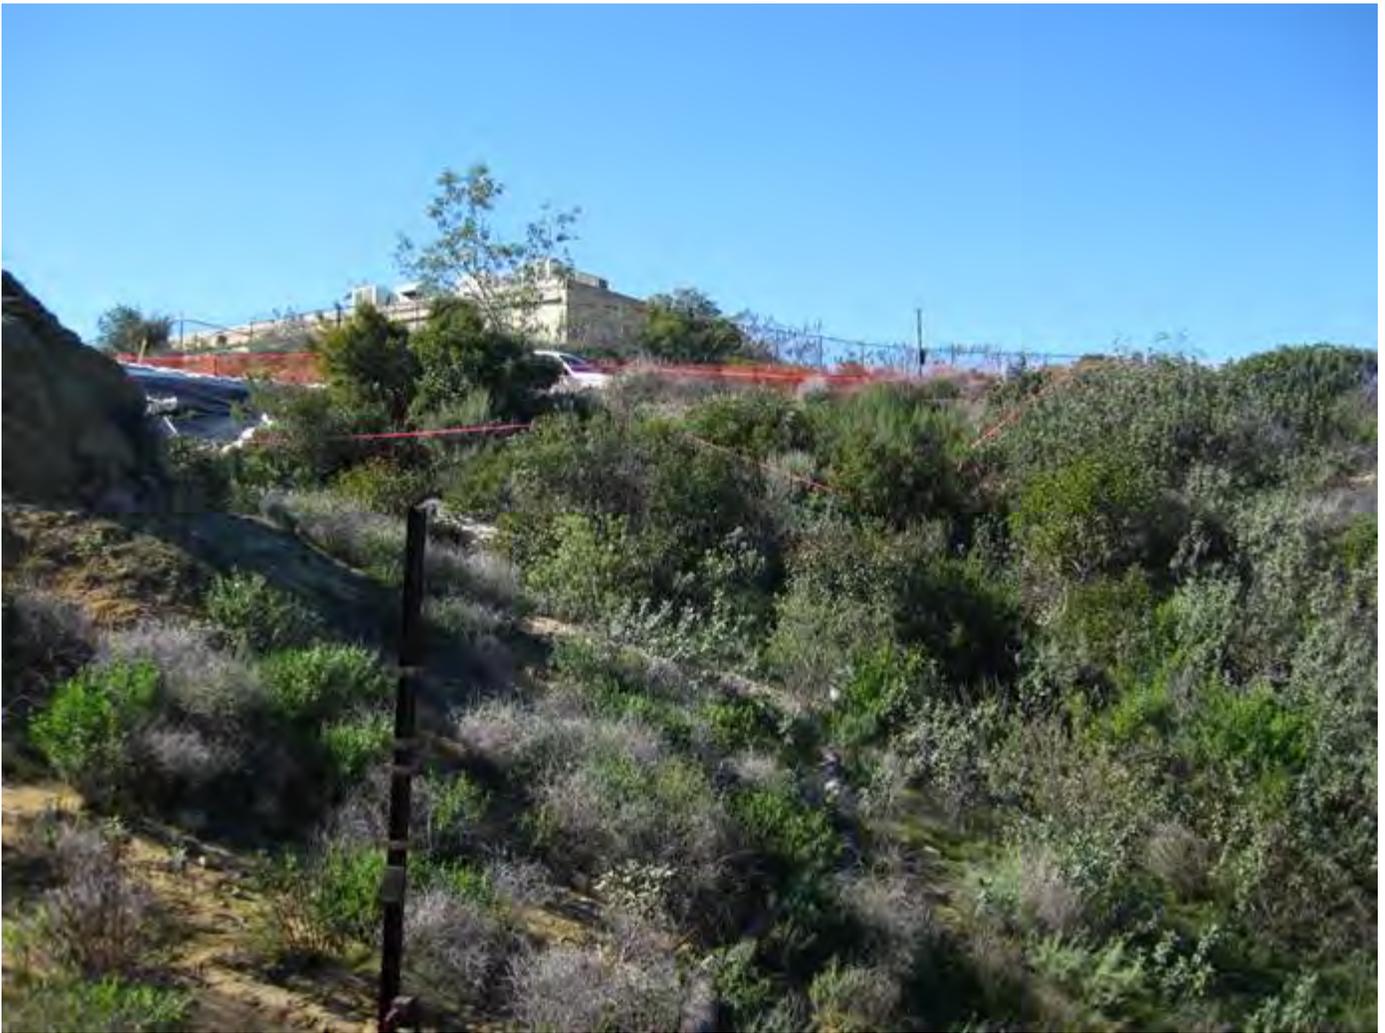
ELV-1C second excavation atop slope (within ribbon), and access route to ELV-1D.

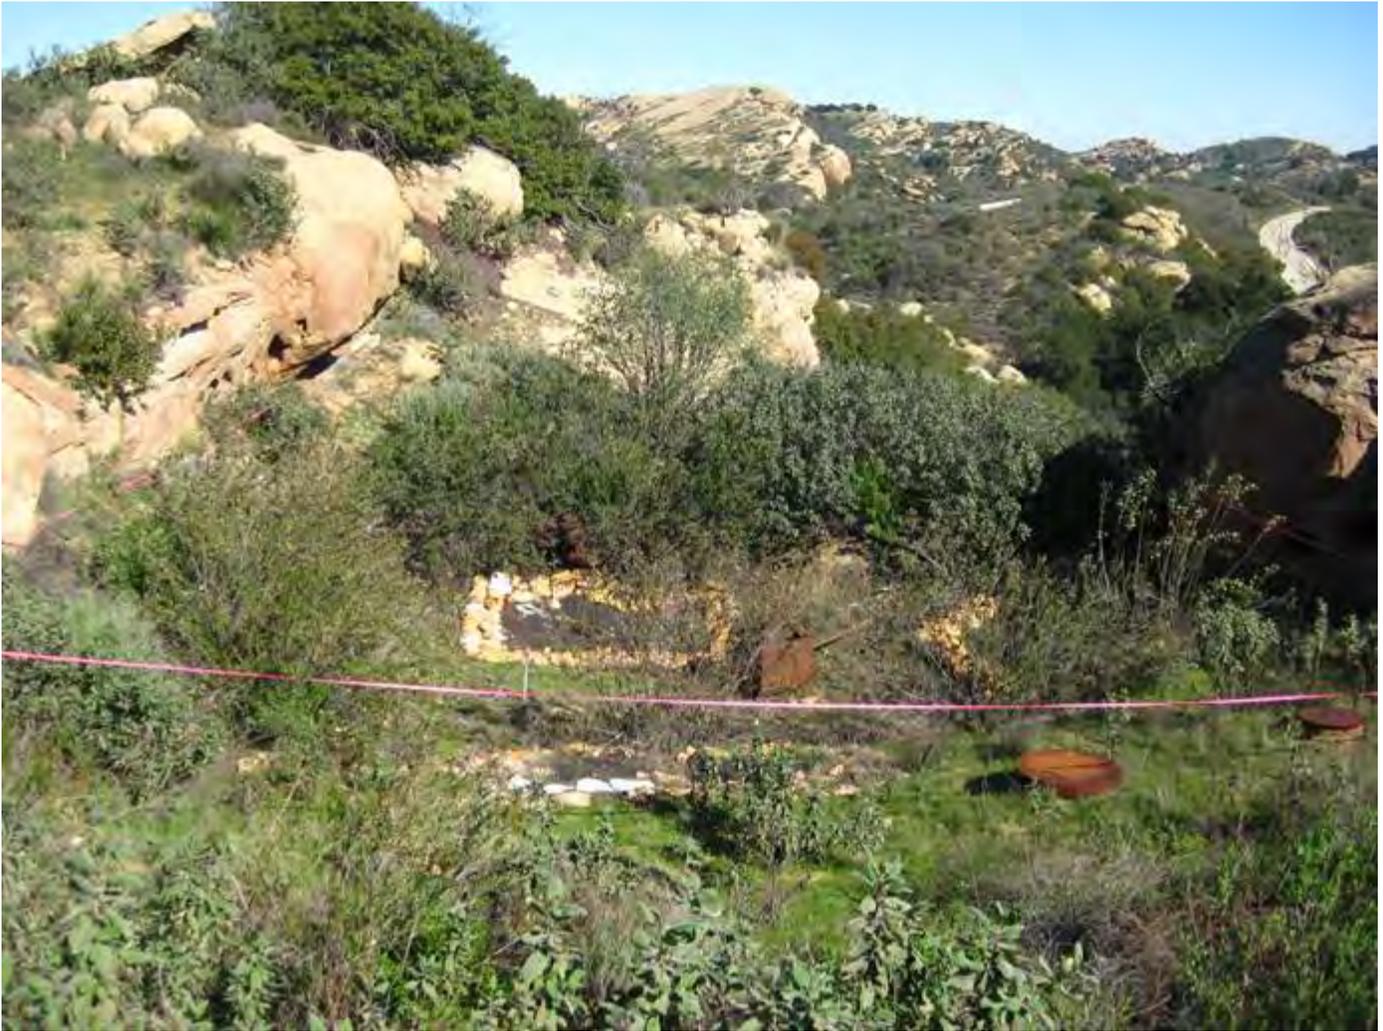
ELV-1D excavation area (general limits of former detention pond).

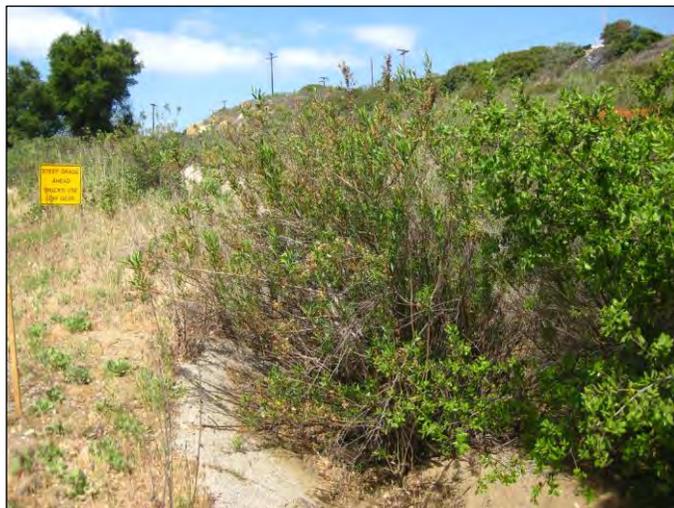
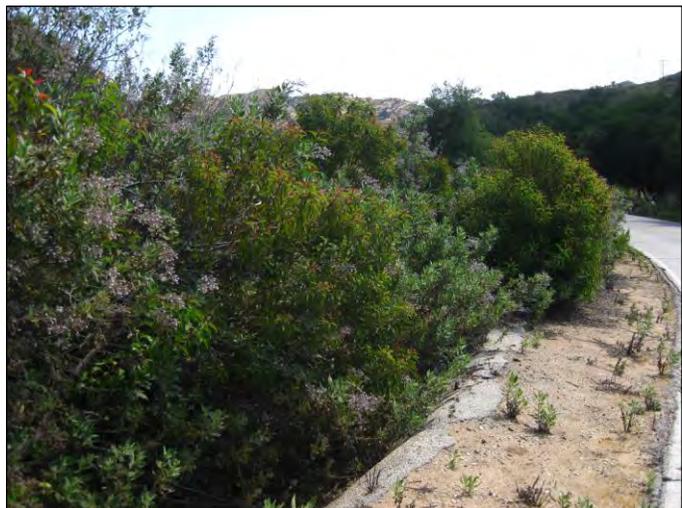
<p>Vegetation Types and/or Notable Plant Species:</p> <p>The subject area exhibits some evidence of past disturbances including the original construction of the drainage ditch, and a former unpaved access road that winds its way up to a former detention basin located at the ELV ISRA area and the Helipad. Vegetation has recolonized the entire area, including along the margins or through the cracks of the drainage ditch. Native species that are prevalent throughout the survey area included coyote brush (<i>Baccharis pilularis</i>), yerba santa (<i>Eriodictyon crassifolium</i>), mulefat (<i>Baccharis salicifolia</i>), black sage (<i>Salvia mellifera</i>), laurel sumac (<i>Malosma laurina</i>), branching phacelia (<i>Phacelia ramosissima</i>), telegraph weed (<i>Heterotheca grandiflora</i>), holly-leaved cherry (<i>Prunus ilicifolia</i>), California aster (<i>Corethrogyne filaginifolia</i>), poison oak (<i>Toxicodendron diversilobum</i>), blue elderberry (<i>Sambucus nigra</i>), California brickellbush (<i>Brickellia californica</i>), bush monkeyflower (<i>Mimulus aurantiacus</i>), white chaparral currant (<i>Ribes indecorum</i>), four-spot (<i>Clarkia purpurea ssp. quadrivulnera</i>), our lord's candle (<i>Hesperoyucca whipplei</i>), and telegraph weed (<i>Heterotheca grandiflora</i>). Coast live oak (<i>Quercus agrifolia</i>) trees are also present along both margins of the drainage. Non-native species are present mainly in the understory or gaps including riggut brome (<i>Bromus diandrus</i>), red brome (<i>Bromus madritensis ssp. rubens</i>), and yellow sweet clover (<i>Melilotus indicus</i>).</p> <p>No special-status plants including, but not limited to Santa Susana tarplant (<i>Deinandra minthornii</i>), a State Rare species, or Braunton's milkvetch (<i>Astragalus brauntonii</i>), a Federal Endangered species were observed onsite. Coast live oak is a County-protected tree, and it is our understanding that NASA will implement tree protections where feasible. Based on our assessment of the Site, it is our estimation that three (3) coast live oaks measuring 4 inches, 5 inches, and 3 inches in diameter at breast height, respectively will require removal to complete the proposed activity. Five (5) coast live oaks appear to be located in areas where they could be protected in place and measure 12 inches, 6 & 8 inches (multi-trunk), 3, 3, 3, & 3 inches (multi-trunk), 9 inches, and 2, 2, 2, & 2 inches (multi-trunk) in diameter at breast height.</p>

Views of the overgrown ELV drainage ditch from its downstream and upstream ends, respectively.

1. A special-status species placard display should be placed at the Site to remind workers of the potential presence of these species; or at a minimum, the placards should be kept with field crews and periodically reviewed during morning tailgate meetings.
2. Observation of any special-status reptiles or amphibians should be brought to the attention of a qualified biologist, who can properly capture, identify and document, and release the animals to suitable nearby habitat.
3. Observation of any nesting bird activities in vegetation or on the ground should be given ample space until a biologist can identify the bird species and determine an appropriate buffer.
4. Protection in place of as many coast live oak trees as feasible is recommended to stay consistent with conservation measures and the long-term restoration goals set forth for SSFL.
