SANTA SUSANA FIELD LABORATORY

PUBLIC MEETING SITE-WIDE SUMMARY OF ACTIVITIES

August 11, 2020

SSFL Stormwater Expert Panel

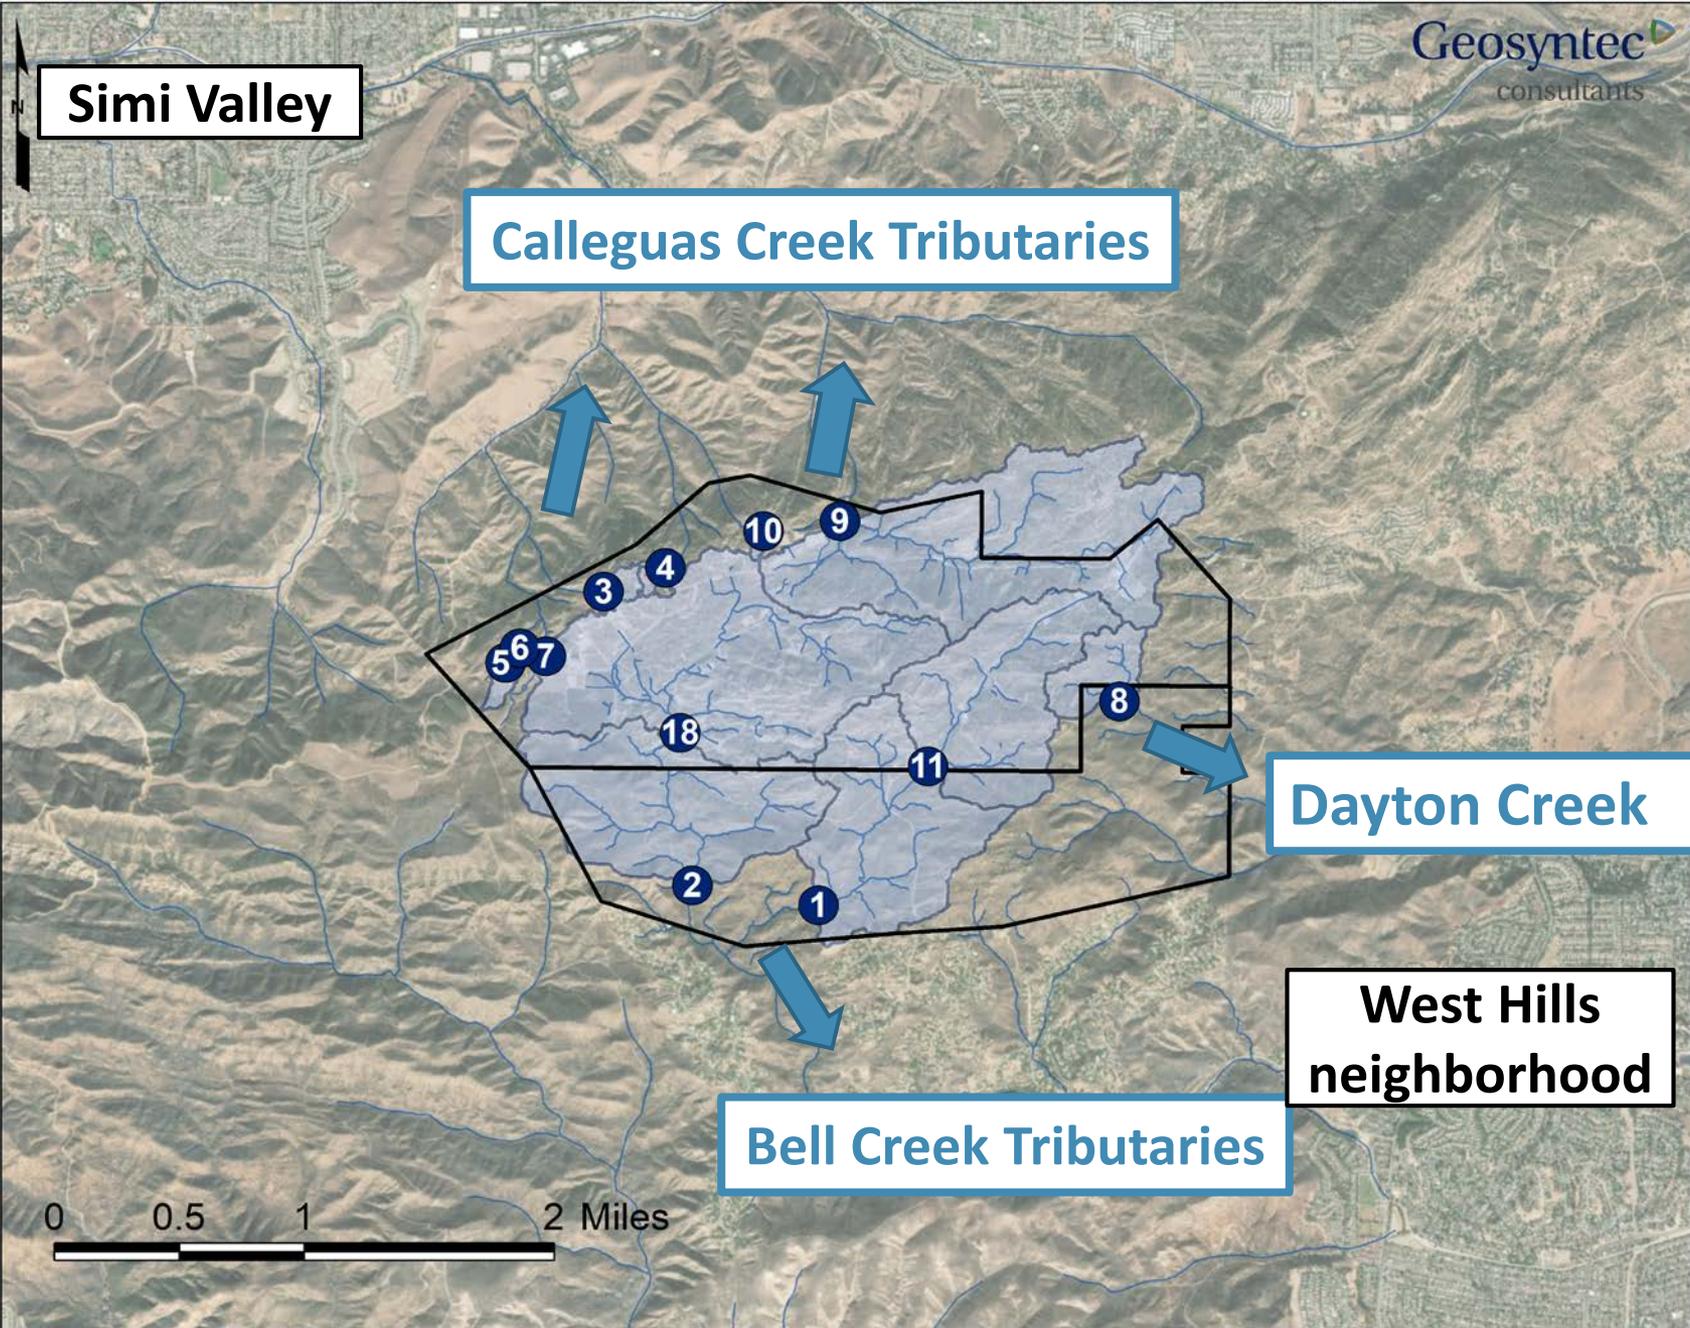
2019-2020 was a wetter than average year

- Nine qualifying rain events (>0.10 inch in 24-hrs)
 - 21 discharge samples and 5 seven-day follow up samples
 - Only one storm was larger than the 24-hr 1-year recurrence interval storm (2.5-in) and had a 24-hr storm depth of 2.65 inches (1-yr event)
- Total annual rainfall 20.54 inch (vs. 17.02 inch average)

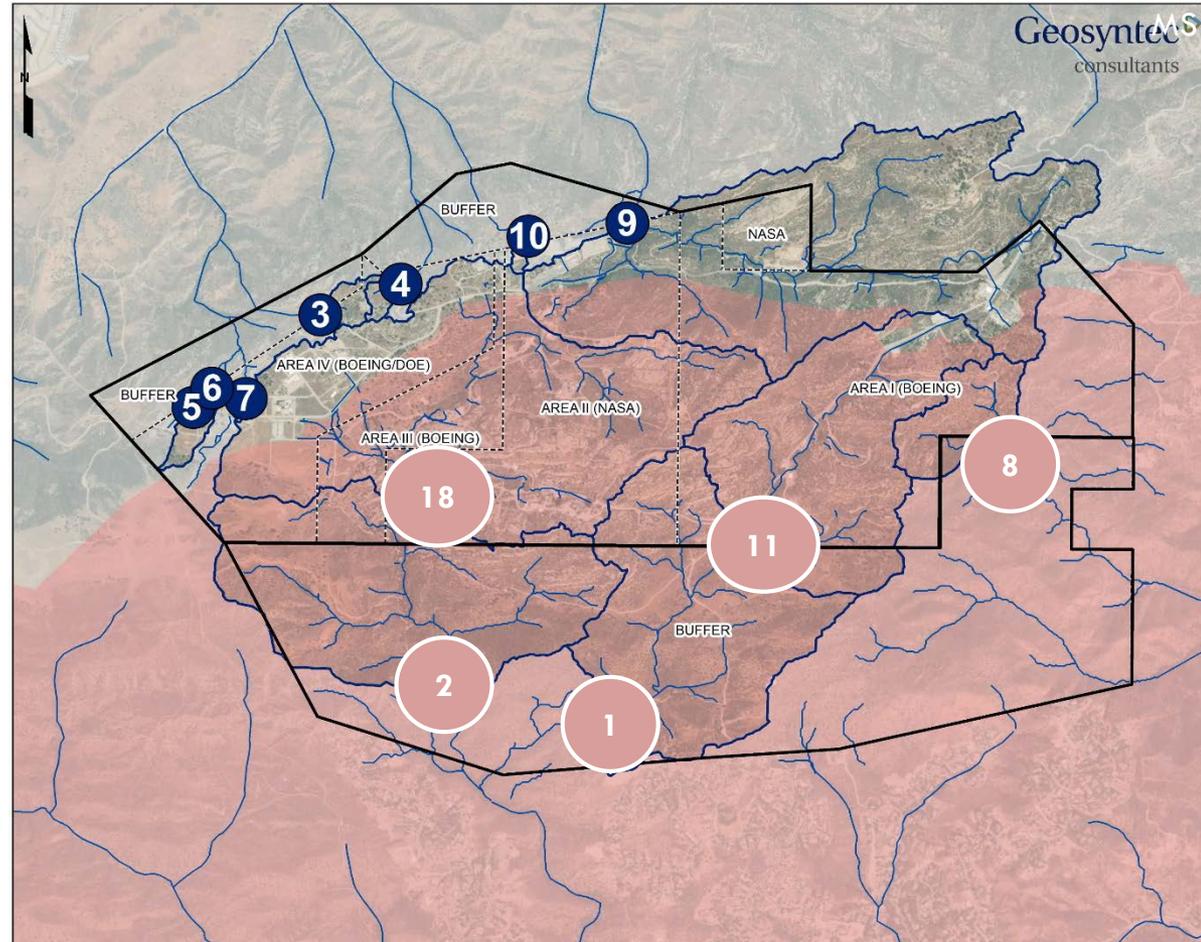
Woolsey Wildfire Extent

- 79% of site burned in November 2018
- Outfall watersheds most impacted:
 - Outfall 011/001
 - Outfall 018/002
 - Outfall 008
- Last wildfire was in 2005 (Topanga)

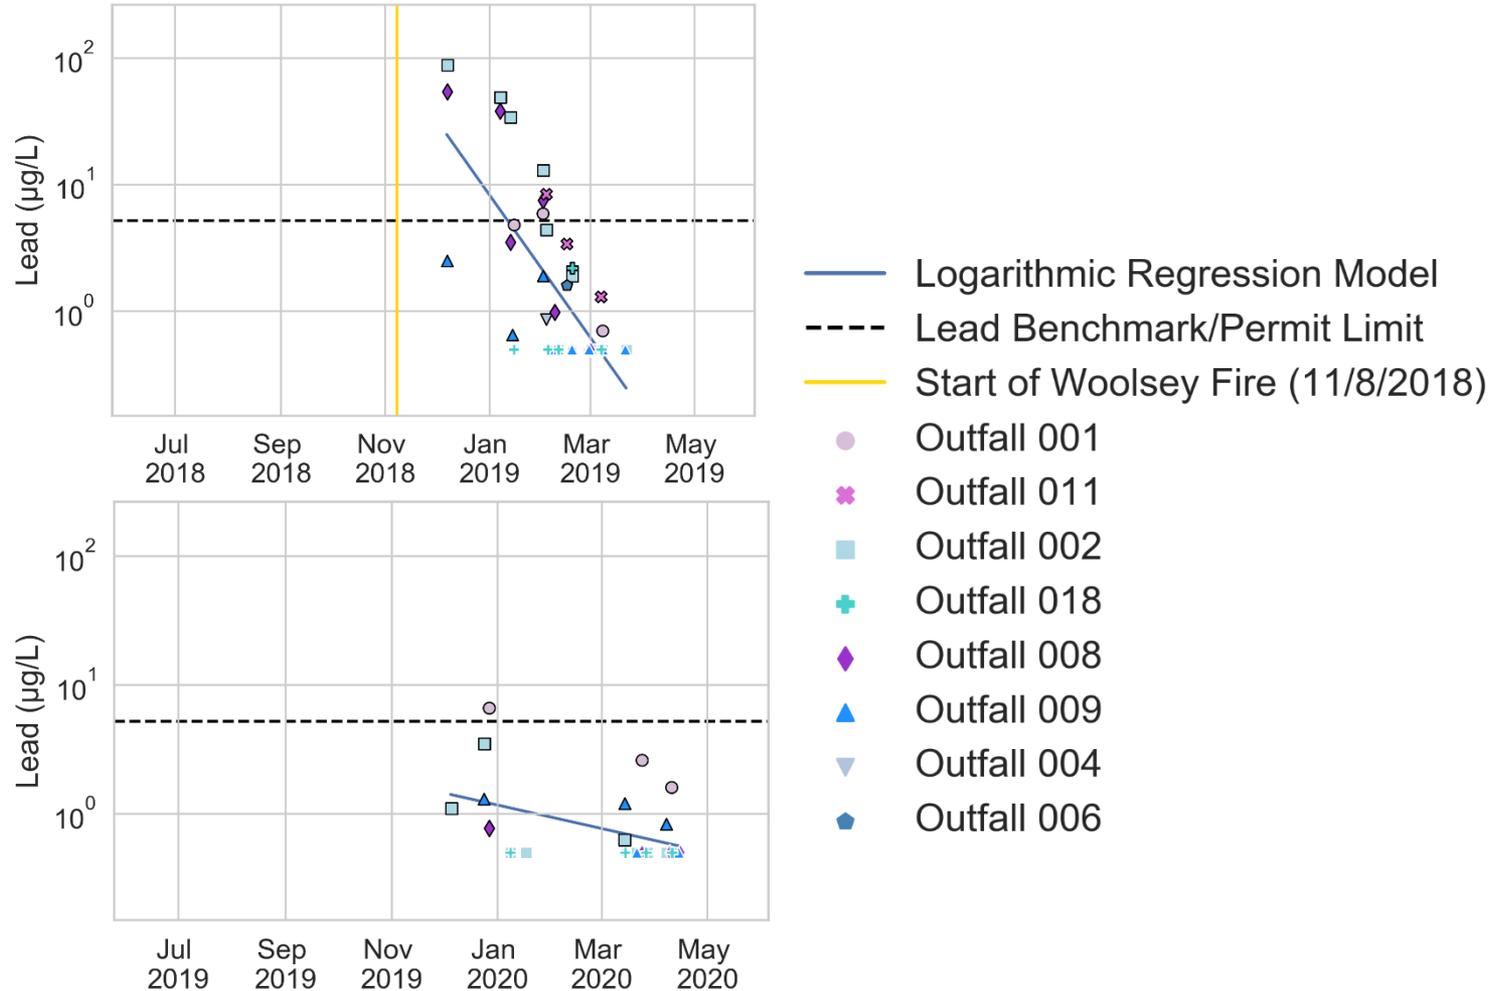
Concentrations are Decreasing With Time (Lead Example)

Note: Markers with a black border signify detected results.
 Markers without a border signify non-detected result and are shown at the method detection limit.

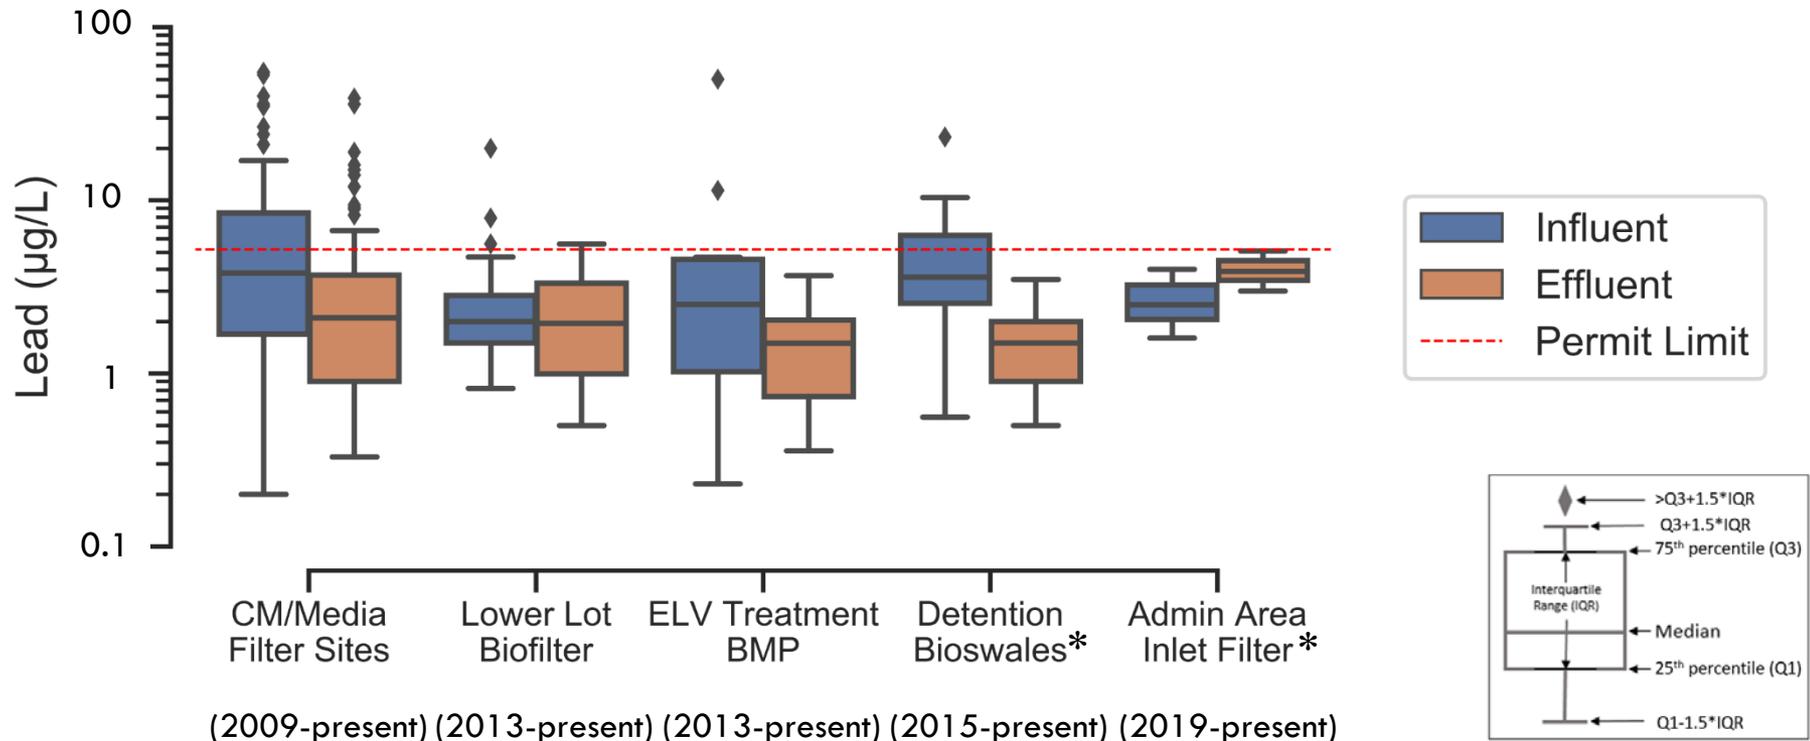
009 Watershed BMP Performance Results (Lead Example)

Lead concentrations are significantly reduced for most BMP types with performance monitoring

Most of the storms less than 1-inch are contained in the lower lot biofilter and not discharged to the Northern Drainage.

* Effluent flows to Lower Lot Biofilter as part of BMP treatment train

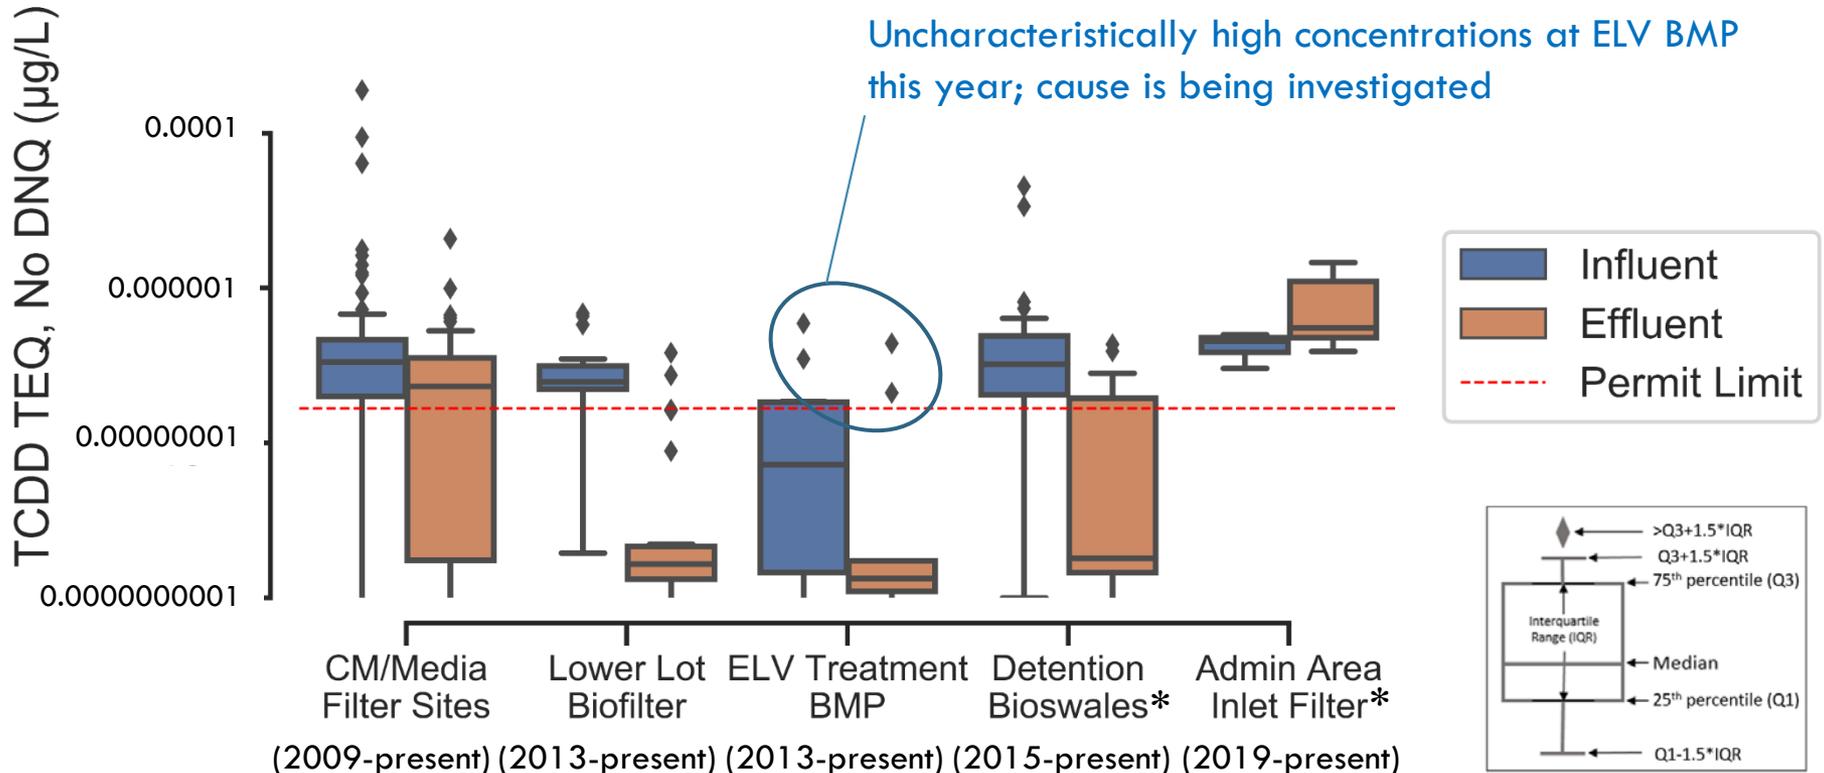
009 Watershed BMP Performance Results (Dioxins Example)

* Effluent flows to Lower Lot Biofilter as part of BMP treatment train

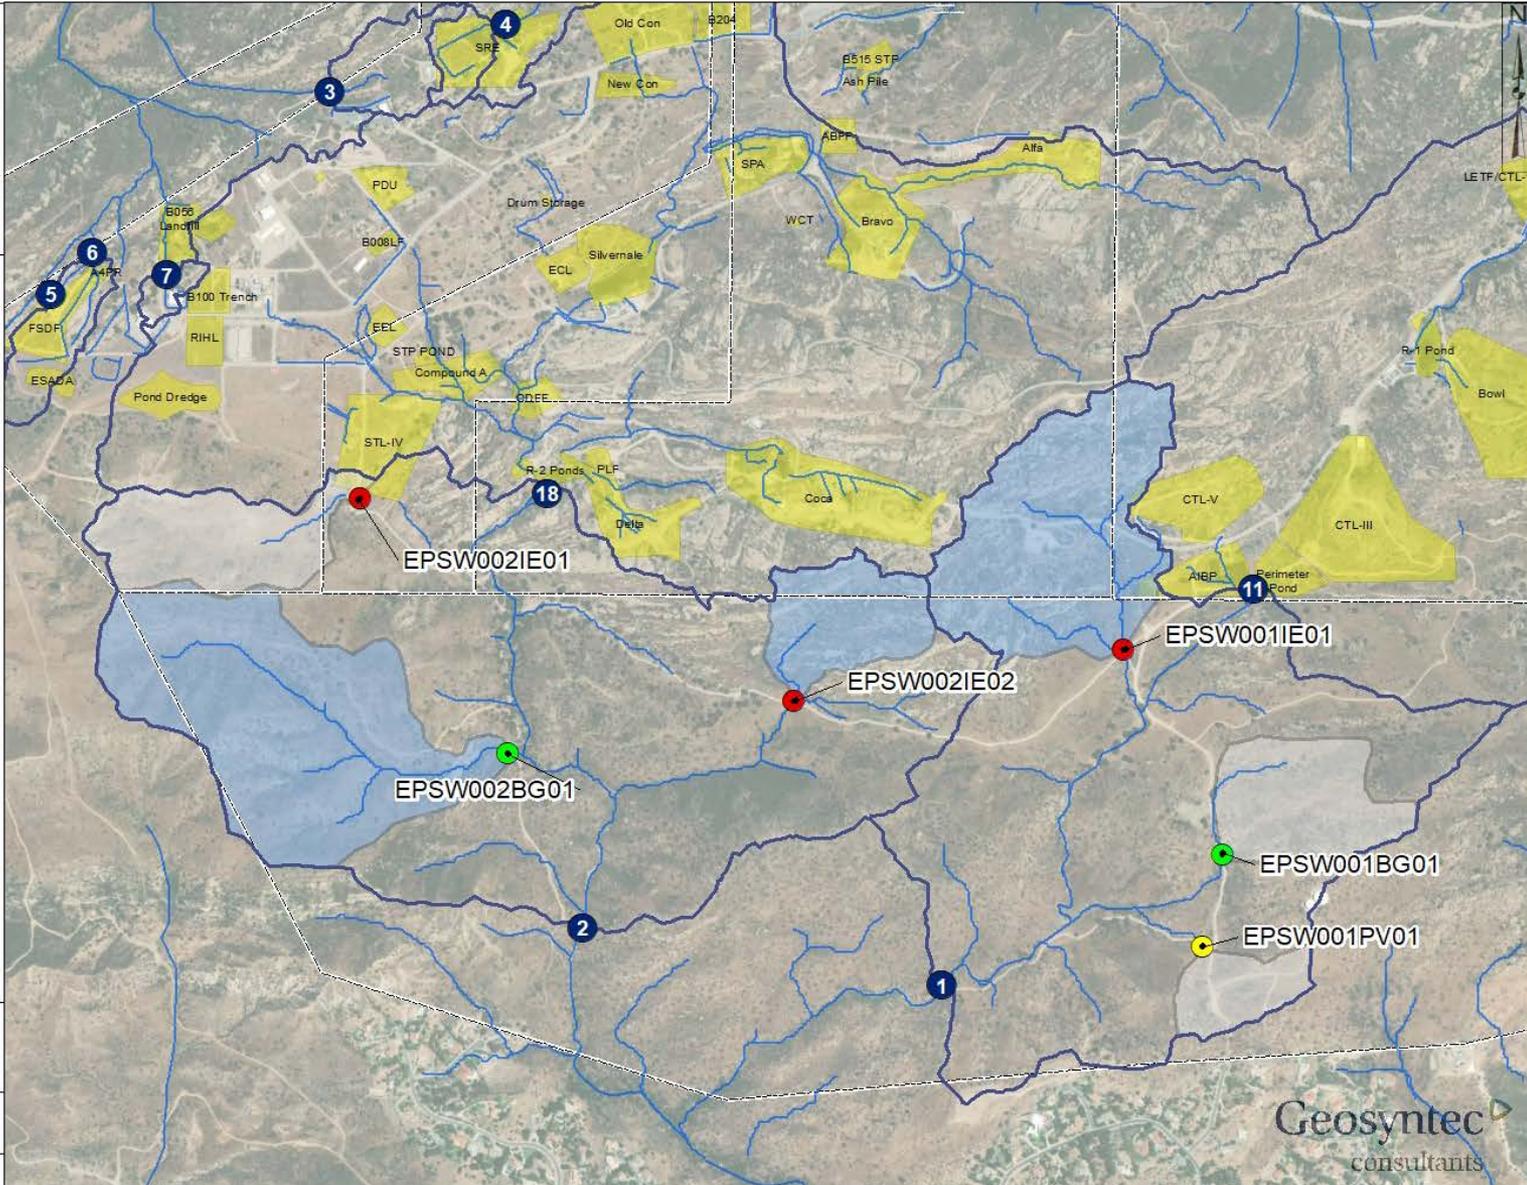
2019-2020 RFI Areas and Outfall 001 and 002 Subarea Monitoring Locations

Southern Buffer Zone Subarea Monitoring Study

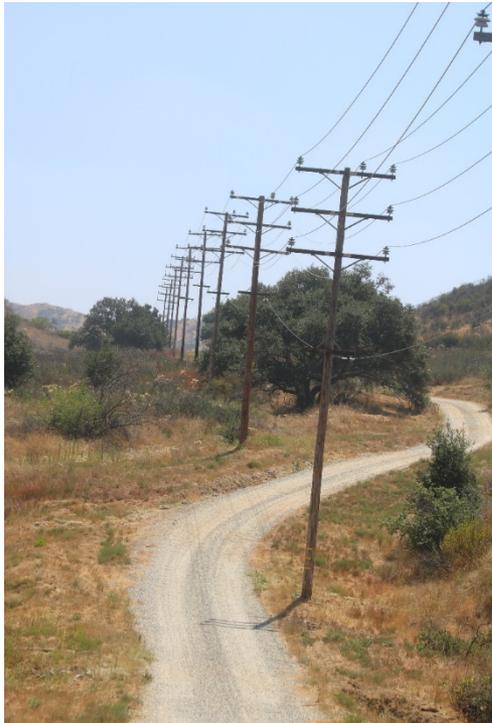
Utility Poles (dioxin source)
Wattles later added

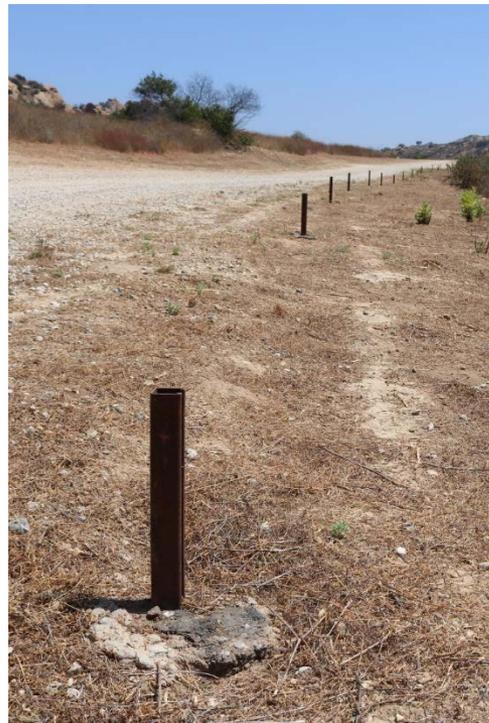
Metal Stakes (iron source)

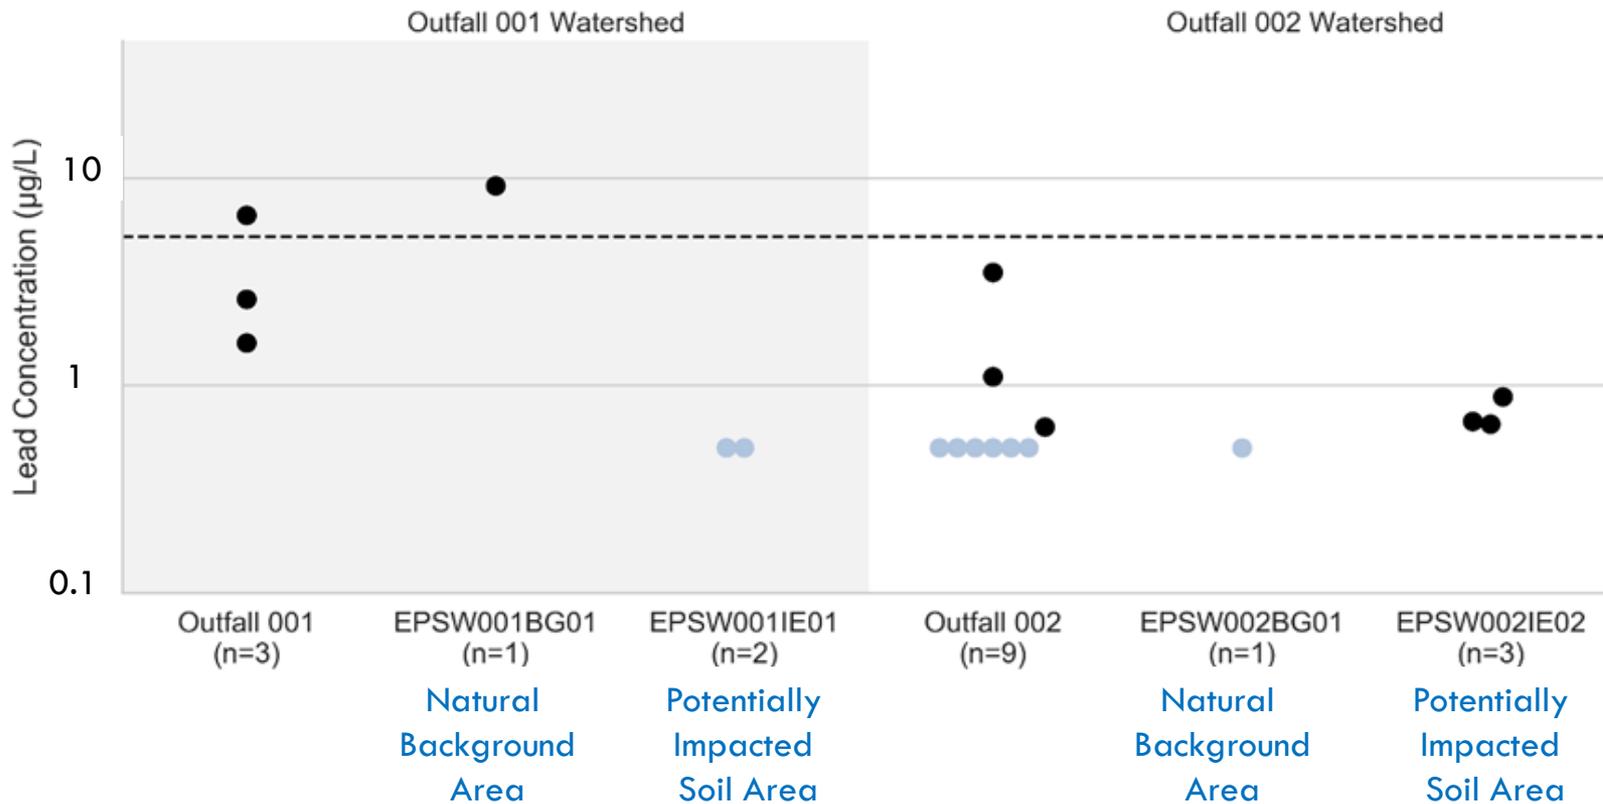
BUFFER ZONE SUBAREA SAMPLING RESULTS: Lead Example (2019/2020 Season)

Potentially impacted soils do not appear to be contributing to exceedance at downstream outfall (001).

---- Lead Benchmark/Effluent Limit

Note: Black markers signify detected results.

Light gray markers signify non-detected results and are shown at the method detection limit.

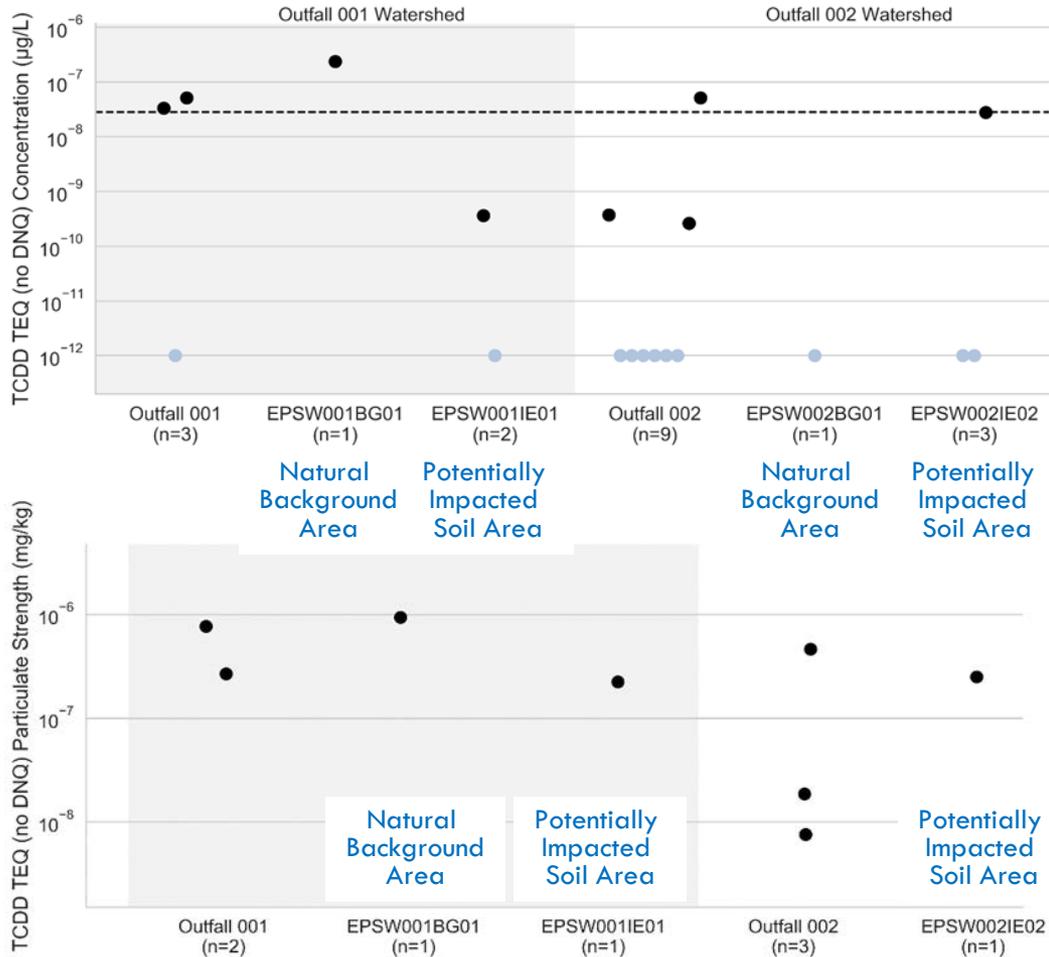
BUFFER ZONE SUBAREA SAMPLING RESULTS: Dioxin Example (2019/2020 Season)

----- TCDD TEQ (no DNQ) Benchmark/Effluent Limit
 Note: Black markers signify detected results.
 Light gray markers signify non-detected results and are shown at the method detection limit.

Potentially impacted soils do not appear to be contributing to exceedance at downstream outfalls (001, 002). Highest concentration and particulate strength seen at background subarea.

Note: Black markers signify detected results. Gray markers signify estimated particulate strengths calculated using the method detection limit for the non-detected dissolved fraction results. Particulate strengths are not shown for samples where the total concentrations were not detected.

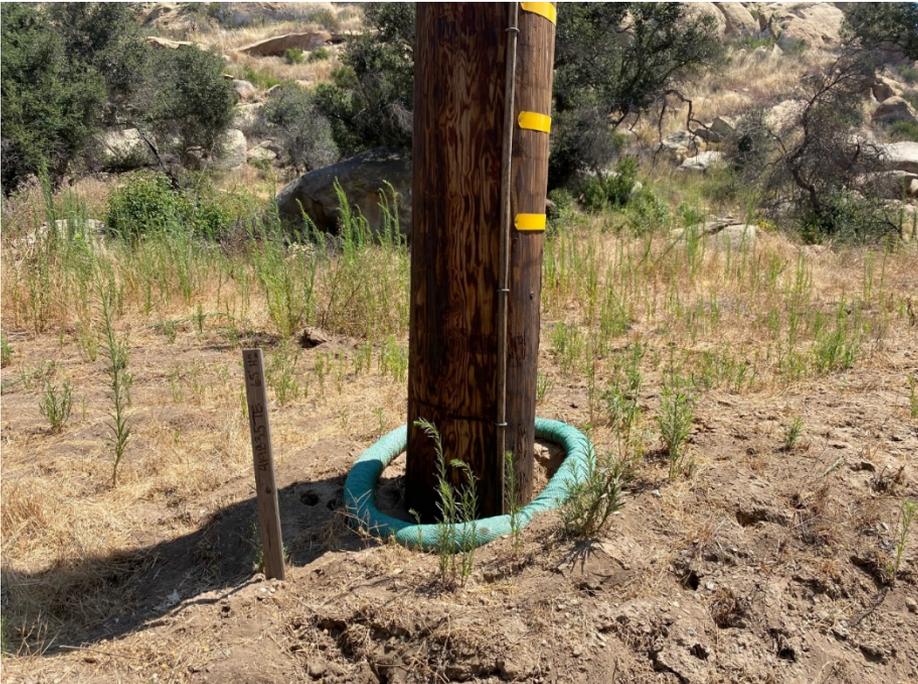
Wattles added to approximately 115 Poles

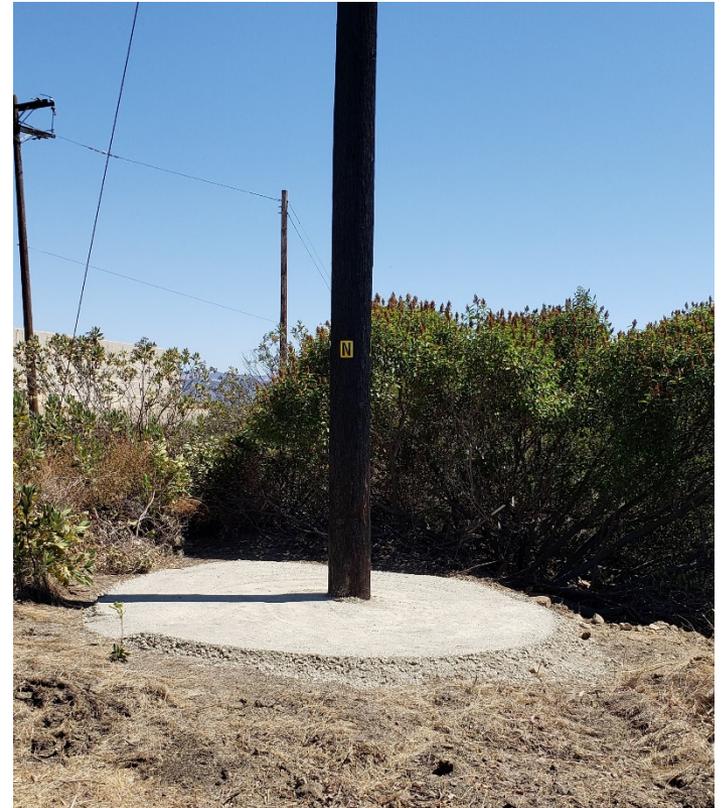
Cleared bases at 88 Poles

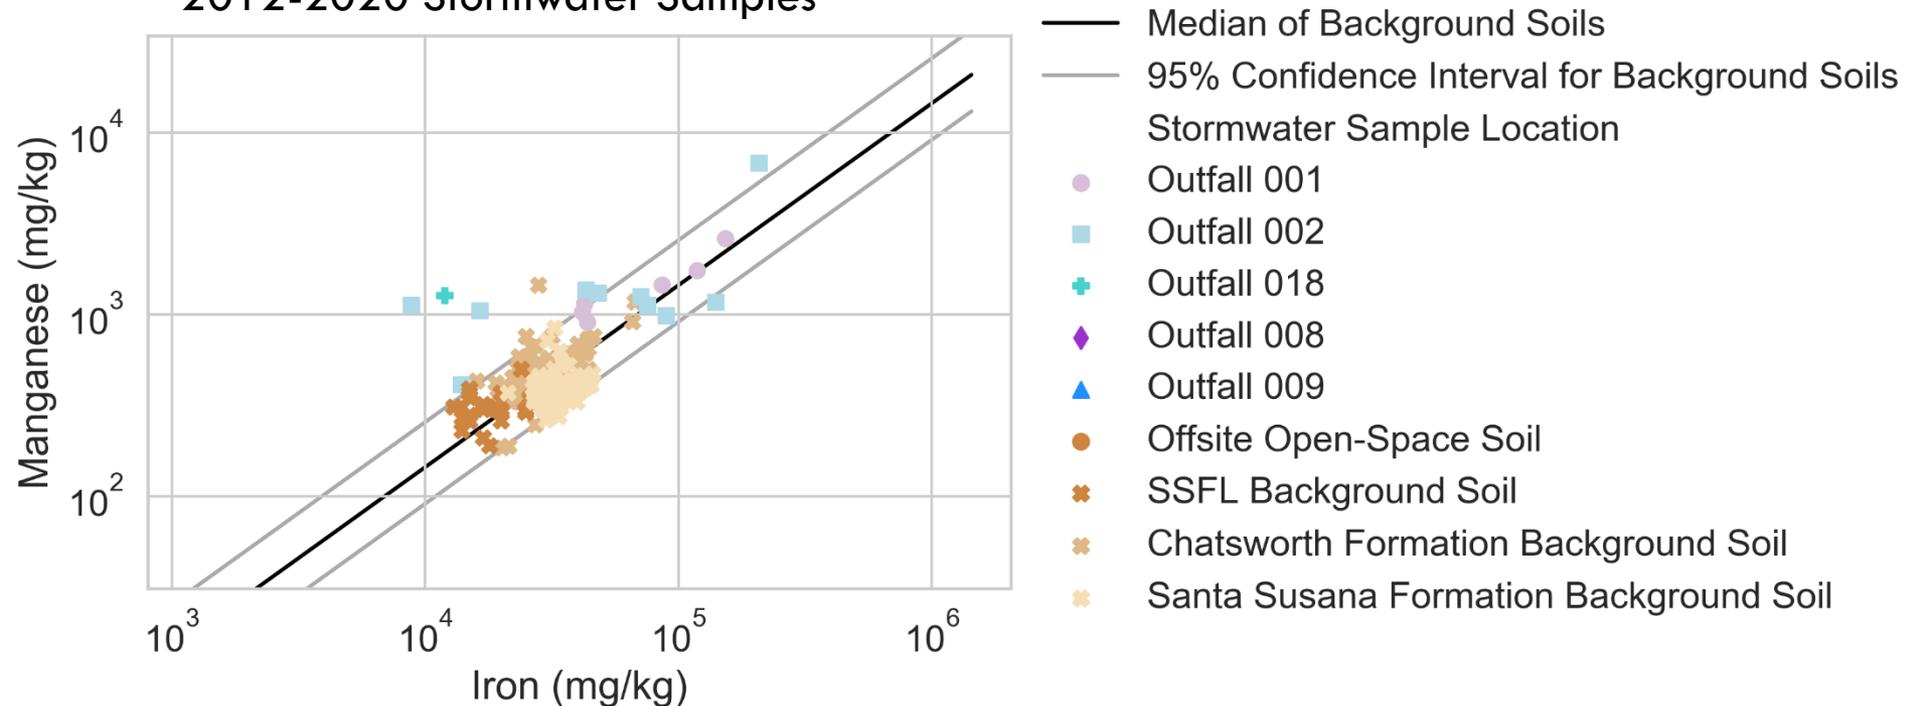
Iron Ratios Analysis of
2012-2020 Stormwater Samples

Linear background soil data show soils have a consistent Mn:Fe ratio, thereby supporting the basis of using other constituent ratios to Mn or Fe as a tool to assess whether background soils are a primary source

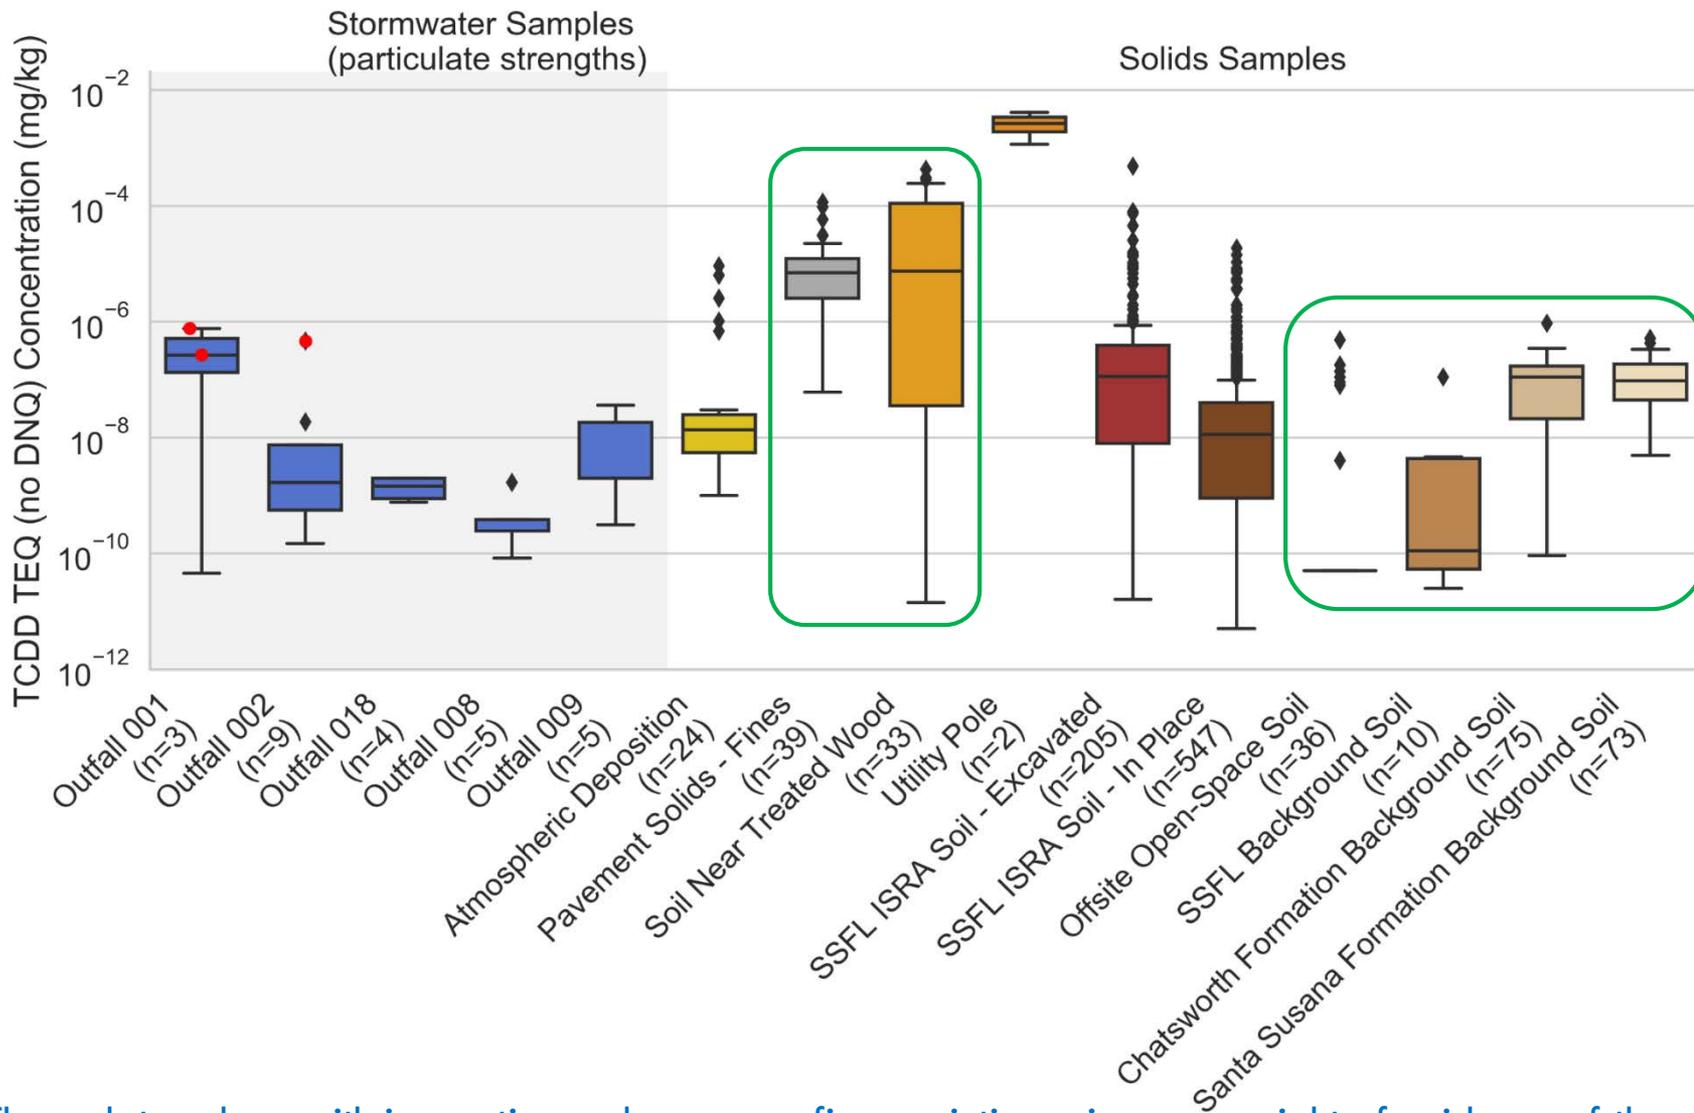
Example Source Analysis: Dioxins

These data, along with iron ratios and congener fingerprinting, give us a weight of evidence of the sources

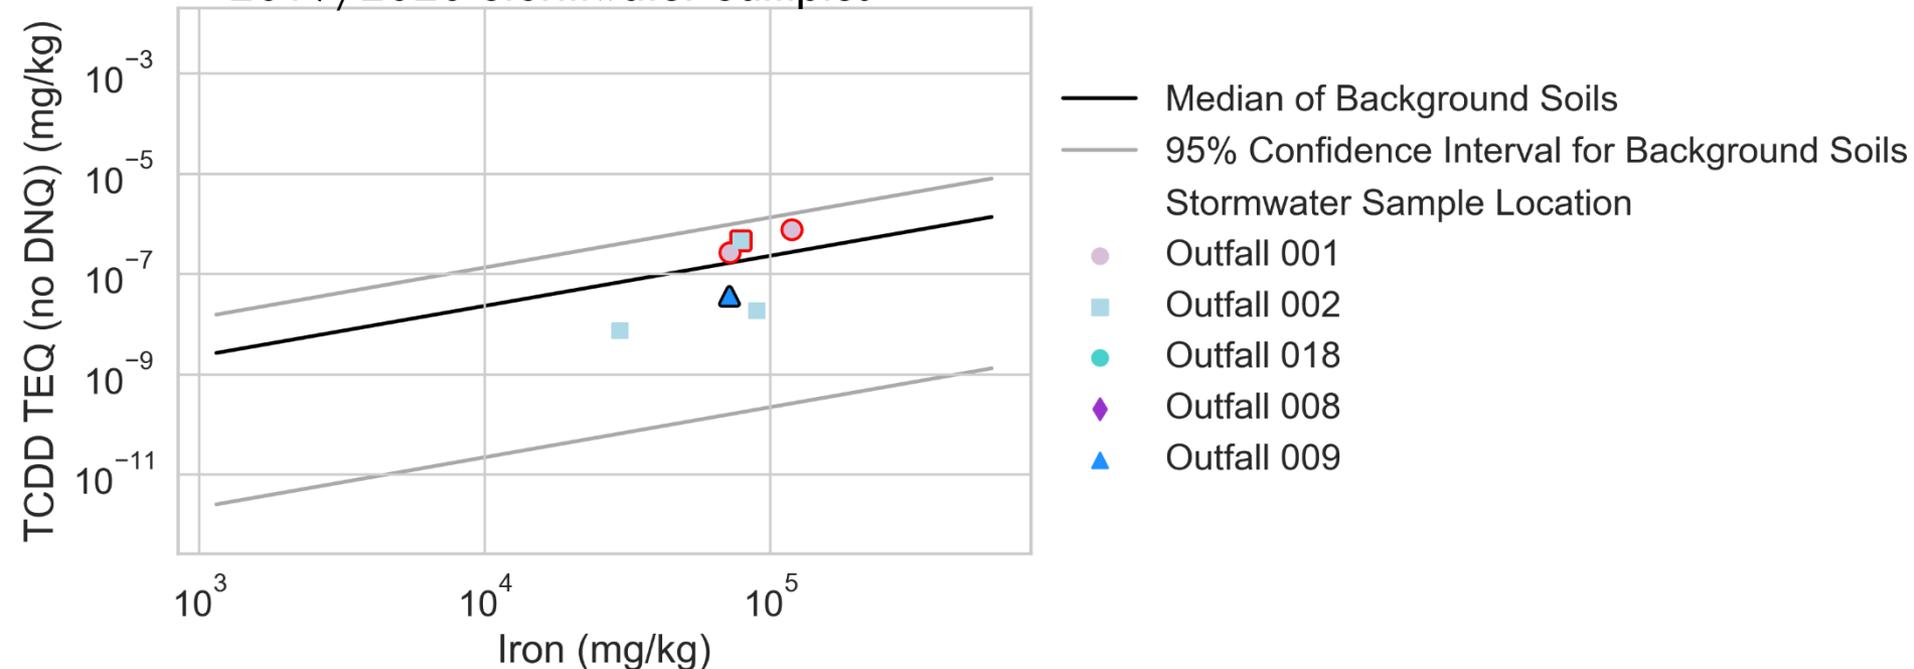
Iron Ratios Analysis of
2019/2020 Stormwater Samples

Dioxin:Iron ratios confirm background soils as primary source of recent exceedances at OF001, 002

Red marker border = exceedance, Black marker border = detected
