# Spinal Tap

## What Boeing teams did to get B-1B bomber *Swift Justice* flying again

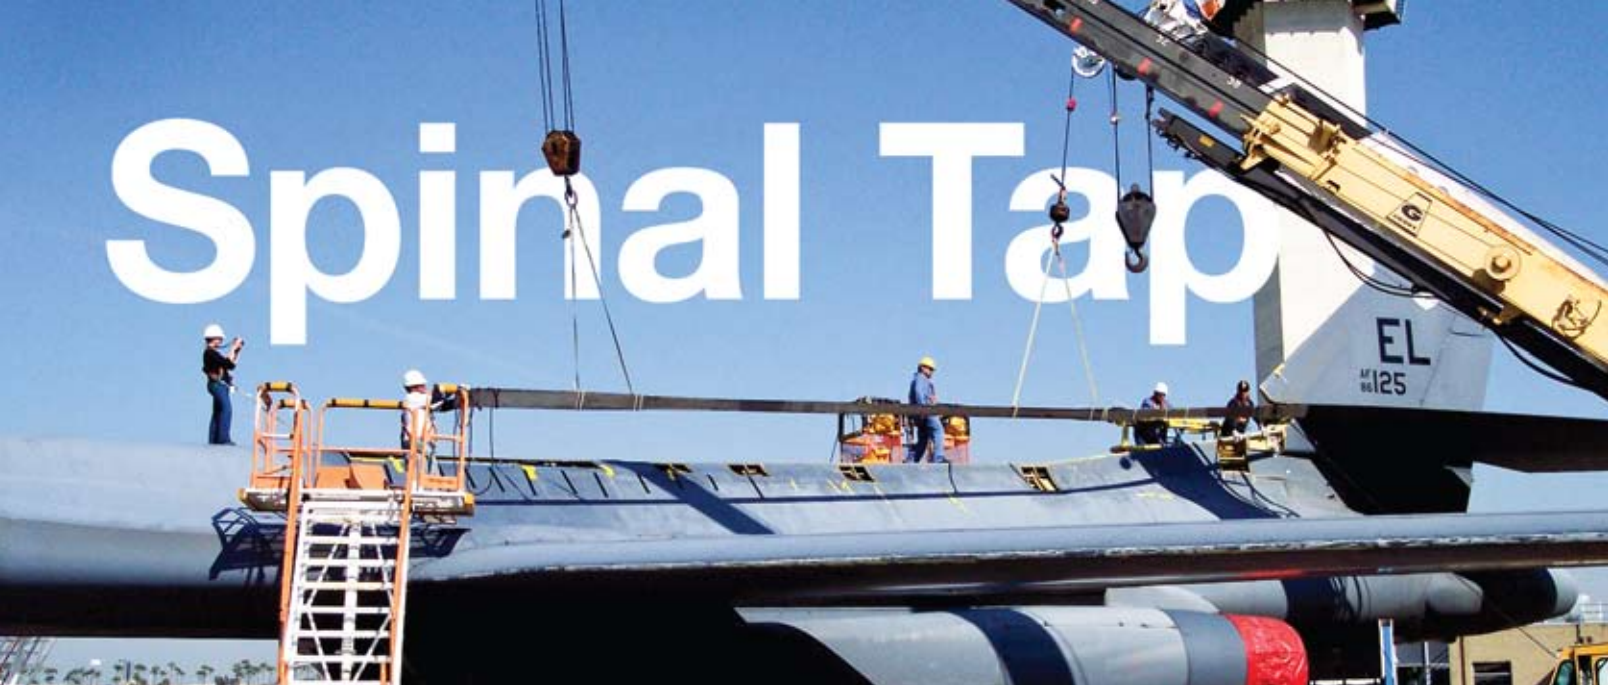
**PHOTO:** The 47.5-foot-long (14.5-meter-long) replacement longeron was installed on B-1 bomber *Swift Justice* at the Boeing Recovery and Modification Services Center in Long Beach, Calif. MICHELLE VOORHEIS/BOEING

After the bomber landed at Ellsworth, mechanics discovered that an engine bleed air duct had ruptured, severely damaging the jet's "backbone," its upper center longeron. But that 47.5-foot-long (14.5-meter-long) part, made from boron-epoxy composite, is unique to each aircraft, with no spares available.

Boeing's Composite Fabrication & Assembly Center near Seattle performed the layup and cured the part in its 90-foot-deep (27-meter-deep) autoclave. The center's layup crews worked around the clock for 11 days to meet deadline.

The B-1 was flown (under ferry-flight restrictions) to the Boeing Recovery and Modification Services Center in Long Beach, Calif. There, a team led by Mark Hayes, a C-17 Maintenance Operations Support manager, removed the damaged part and installed the new one as well as associated structural panels and other components. "We appreciate the opportunity to showcase our talents," Hayes said. "It gave us a sense of pride that the B-1 team wanted to work with us. Hopefully, this will open doors for future modification jobs with other programs at Boeing."
