Subject: Revision 1, Second Quarter 2015 NPDES Discharge Monitoring Report
Compliance File CI-6027 and NPDES No. CA0001309
Santa Susana Field Laboratory
Ventura County, California

The Boeing Company (Boeing) hereby submits Revision 1 of the Discharge Monitoring Report (DMR) for the Santa Susana Field Laboratory (Santa Susana Site) for the period of 1 April through 30 June 2015 (Second Quarter 2015). This DMR was prepared as required by and in accordance with National Pollutant Discharge Elimination System (NPDES) Permit No. CA0001309 (Permit) and under regulatory oversight of the Los Angeles Regional Water Quality Control Board (Regional Board). The Regional Board issued a revised permit on 23 February 2015 with an effective date of 01 April 2015 (Order R4-2015-0033). Included are summary tables of best management practices (BMPs), stormwater sample analytical results, rainfall quantities, liquid waste shipments, and laboratory analytical reports for stormwater samples.

RE: BIOASSESSMENT SAMPLING FOR THE BOEING COMPANY AT THE SANTA SUSANA FIELD LABORATORY (2015)

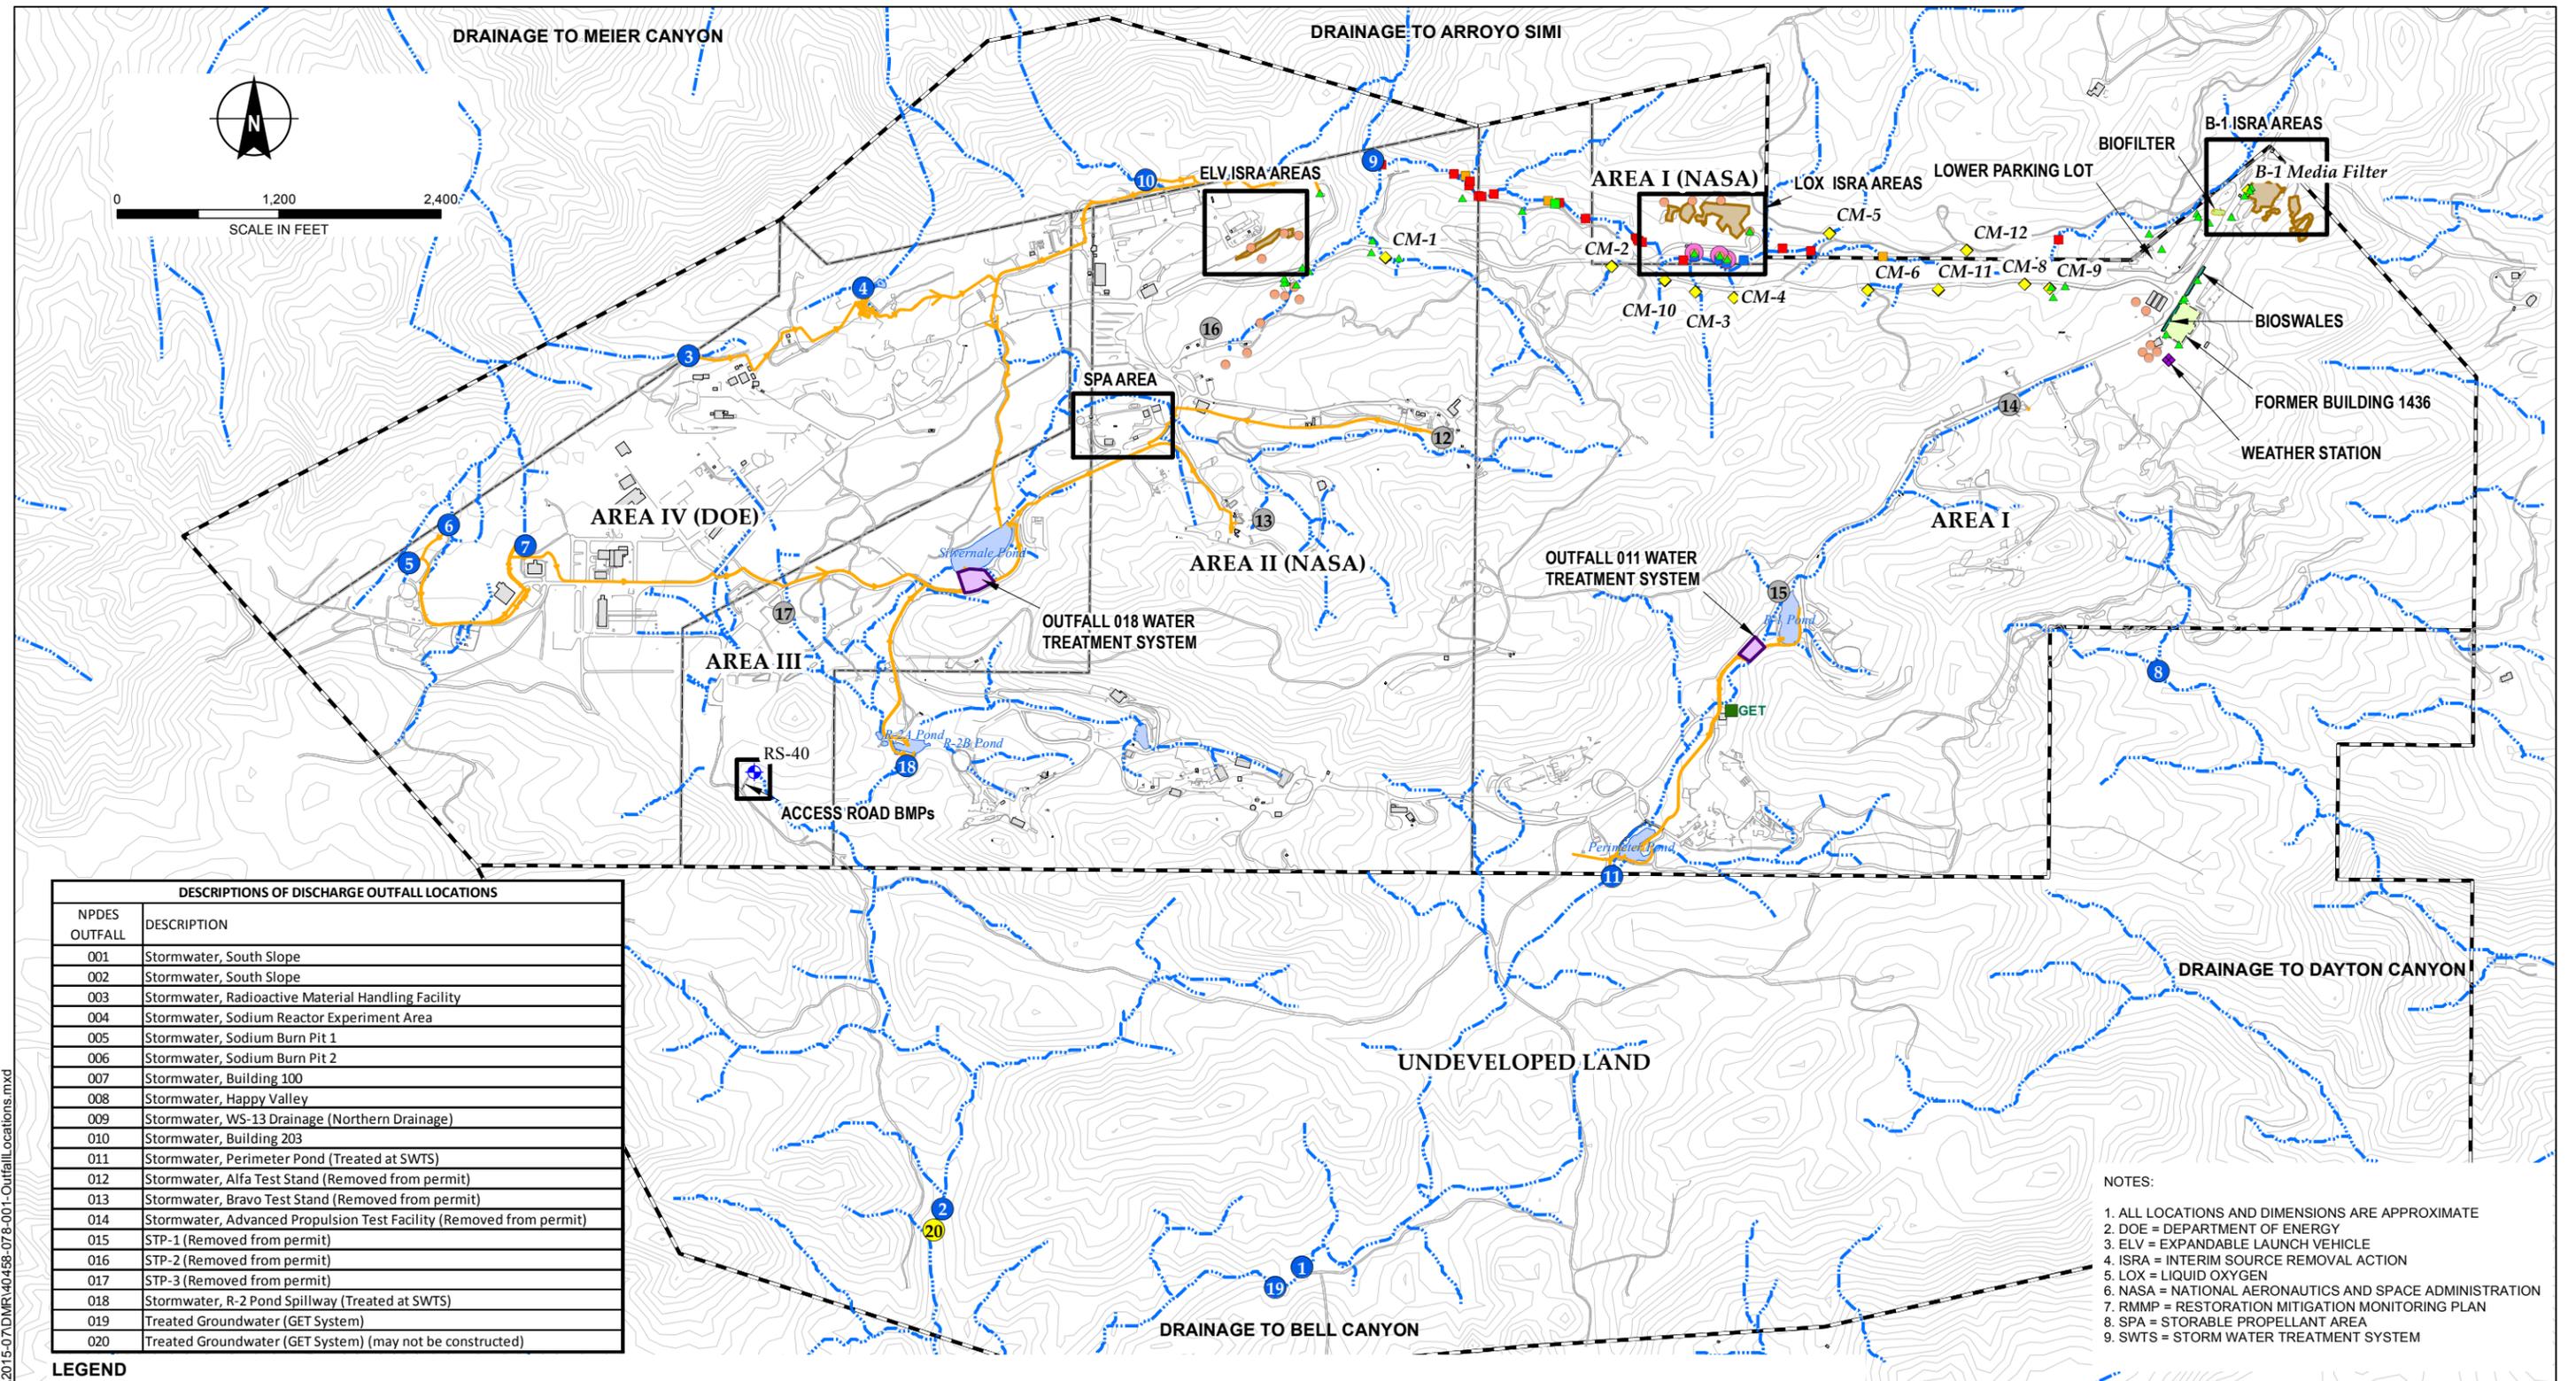
FIGURE 1

- **Figure 1** shows site features and **Figure 2** shows the Arroyo Simi – Frontier Park (RSW-002) sampling location.

Figure 1 - Site Map with Stormwater Collection, Conveyance System, and Site Features

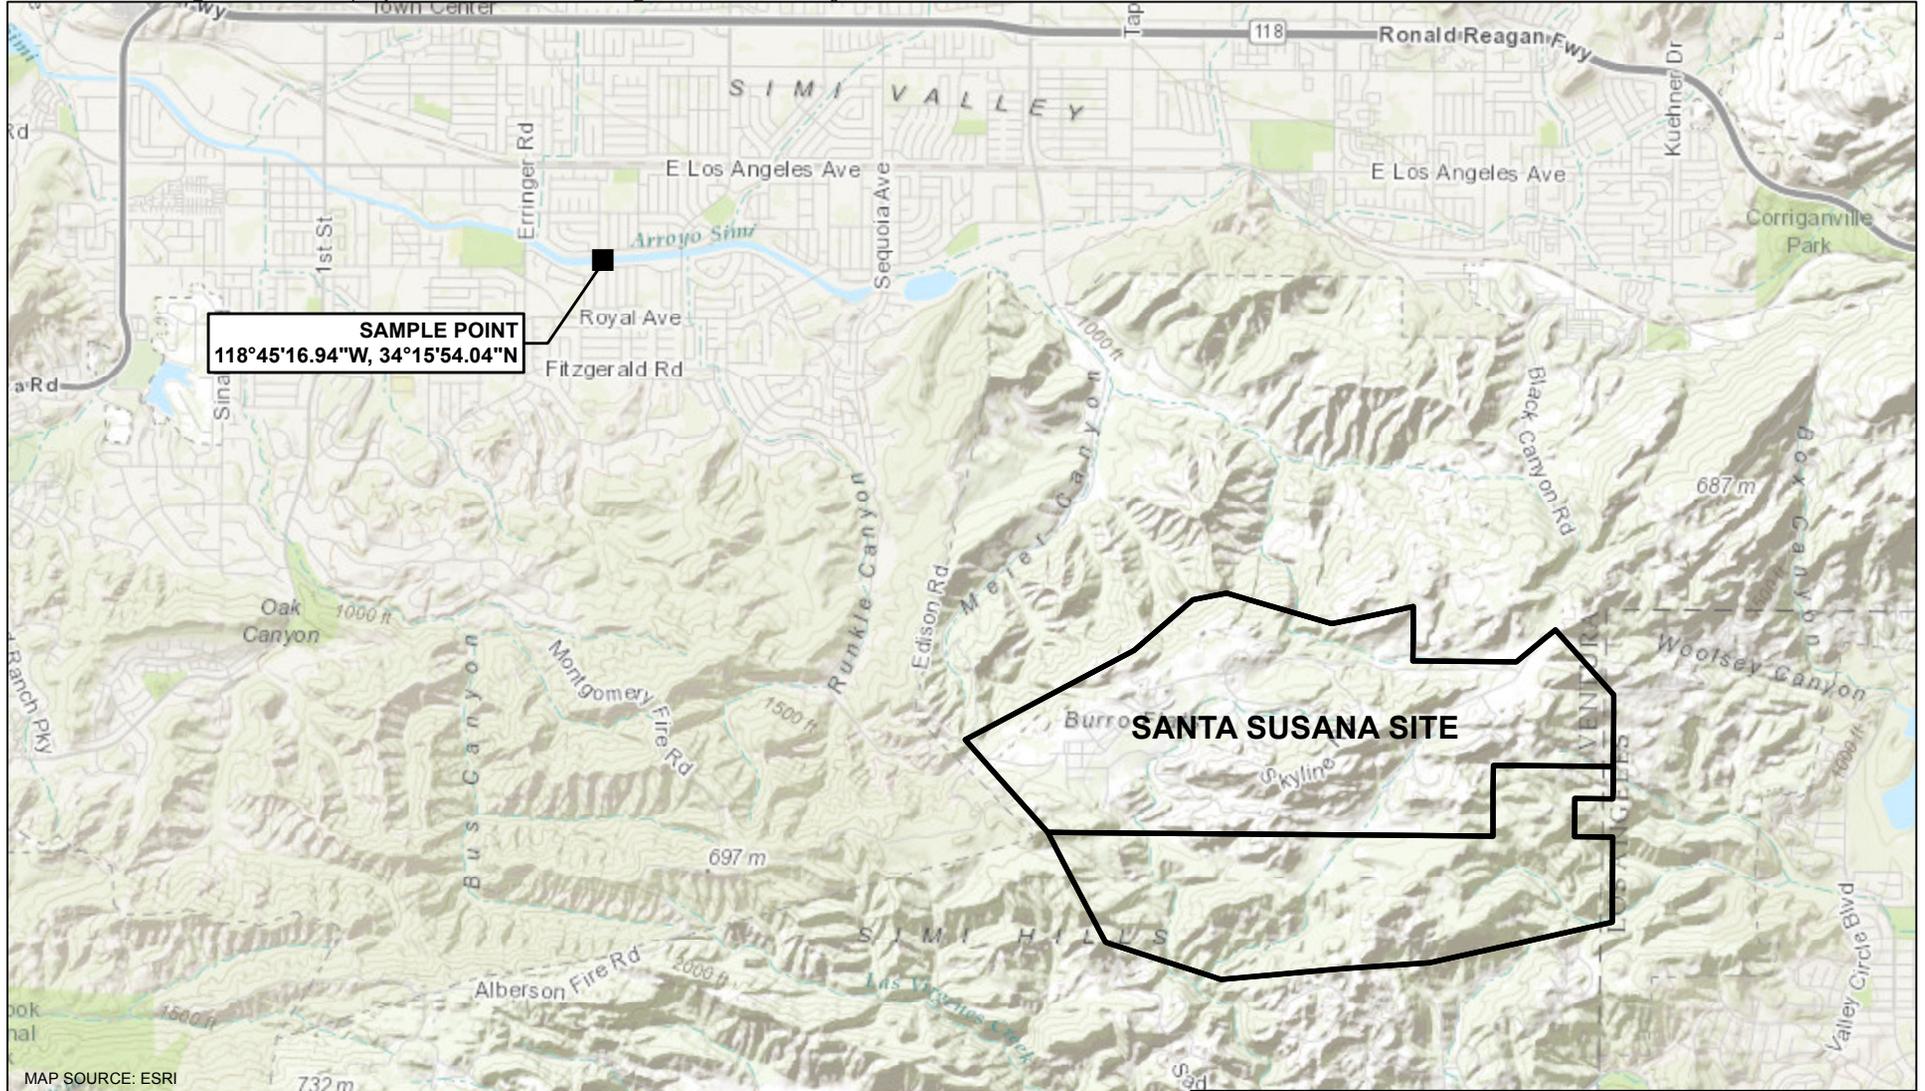
Figure 2 - Arroyo Simi – Frontier Park (RSW-002) Sampling Location

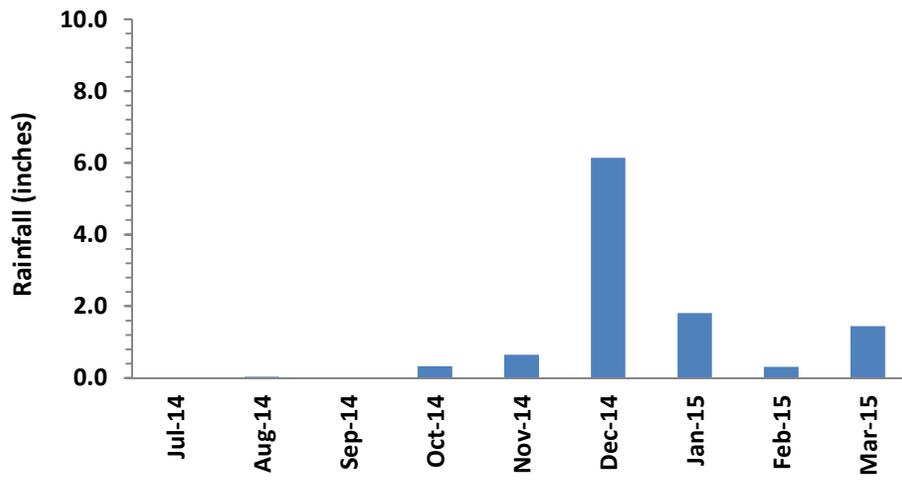
SSFL Rainfall (July 2014 thru March 2015)

Figure 1. Rainfall (inches) measured July, 2014 thru March, 2015 on SSFL.

The 2014 to 2015 rain year was characterized by extreme drought conditions with a total of 10.79 inches of rain falling between July 2014 and April 2015. The last storm with significant rainfall occurred from March 1st thru 2nd (total = 1.37 inches) with trace rain falling on March 13th (Figure 1). On April 29th, 2015, over seven weeks after the last major rain event, the two NPDES permitted sites on the SSFL were visited by Aquatic Bioassay and Consulting Laboratory Biologists to determine if bioassessment samples could be collected. Neither SSFL-001 nor SSFL-006 had flow and both were completely dry across their entire reaches (see photos).

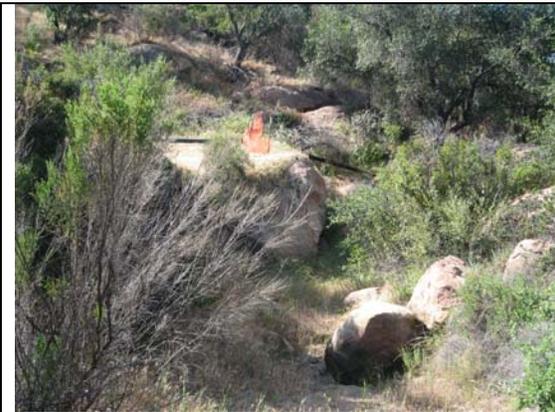
SSFL-001, downstream

Figure 2. Photos taken downstream and upstream of each permitted discharge point from the SSFL property (2015).
