The Boeing Company
Santa Susana Field Laboratory
5800 Woolsey Canyon Road
Canoga Park, CA 91304-1148

Subject: Second Quarter 2019 NPDES Discharge Monitoring Report
Compliance File CI-6027 and NPDES No. CA0001309
Santa Susana Field Laboratory
Ventura County, California

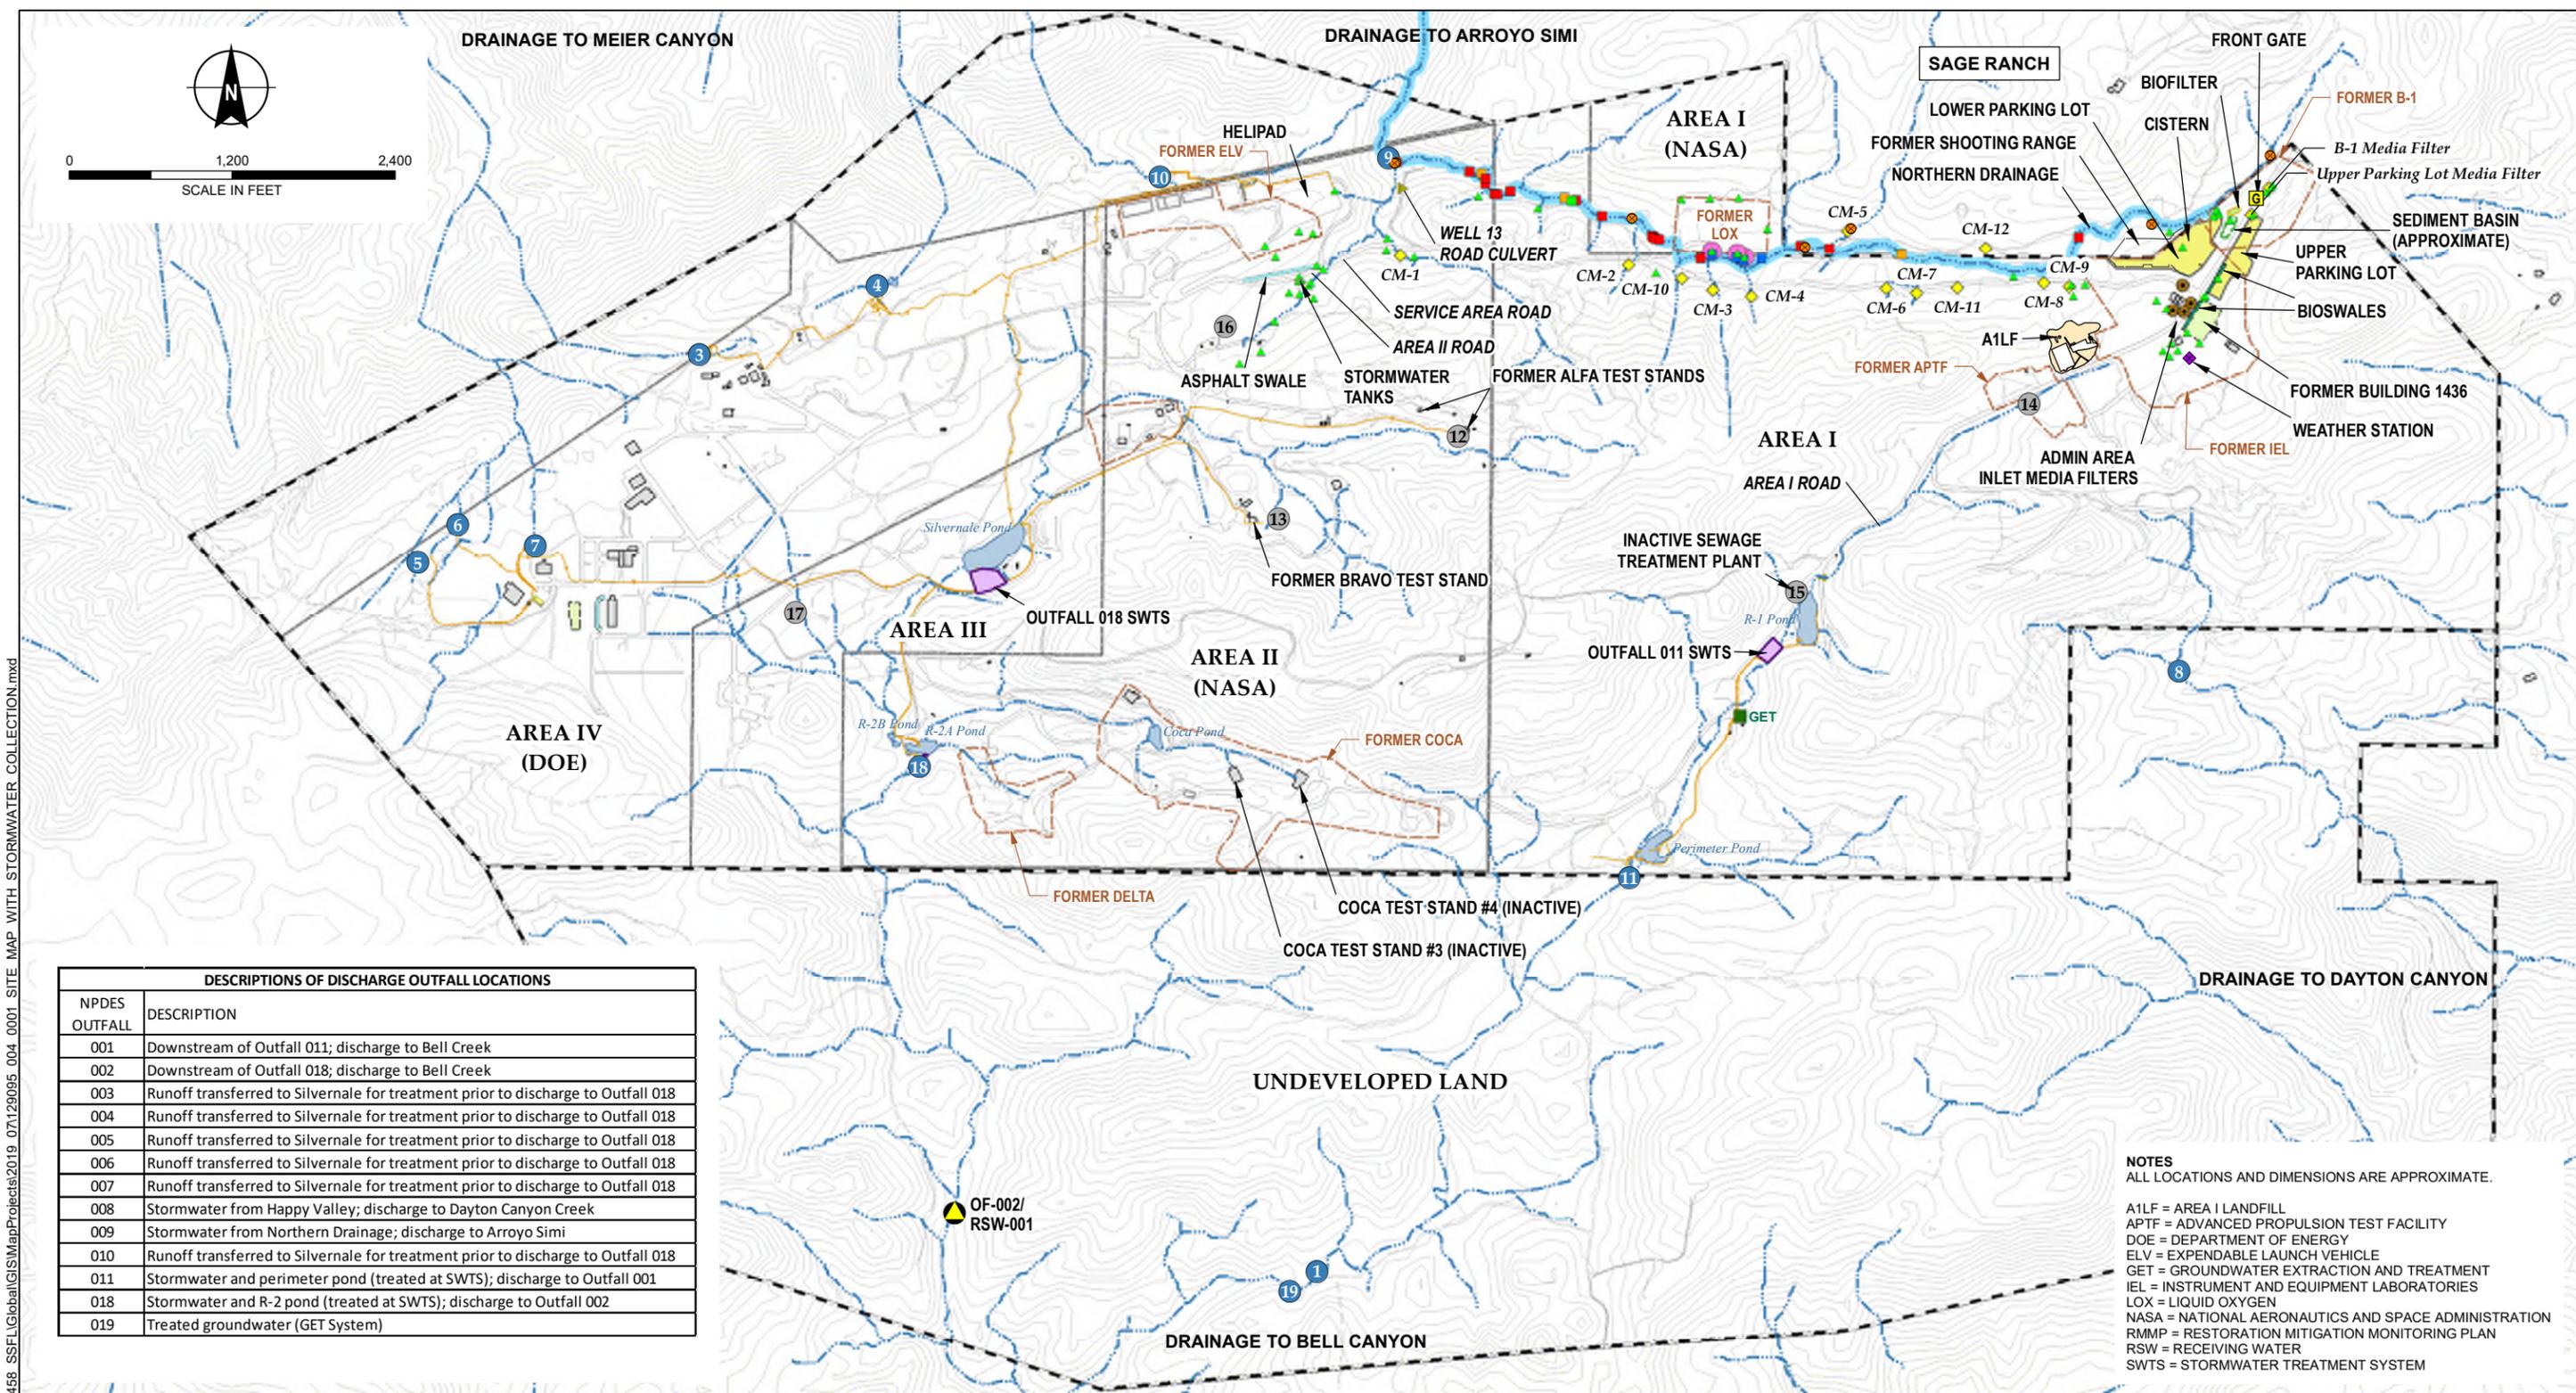
DESCRIPTIONS OF DISCHARGE OUTFALL LOCATIONS	
NPDES OUTFALL	DESCRIPTION
001	Downstream of Outfall 011; discharge to Bell Creek
002	Downstream of Outfall 018; discharge to Bell Creek
003	Runoff transferred to Silvernale for treatment prior to discharge to Outfall 018
004	Runoff transferred to Silvernale for treatment prior to discharge to Outfall 018
005	Runoff transferred to Silvernale for treatment prior to discharge to Outfall 018
006	Runoff transferred to Silvernale for treatment prior to discharge to Outfall 018
007	Runoff transferred to Silvernale for treatment prior to discharge to Outfall 018
008	Stormwater from Happy Valley; discharge to Dayton Canyon Creek
009	Stormwater from Northern Drainage; discharge to Arroyo Simi
010	Runoff transferred to Silvernale for treatment prior to discharge to Outfall 018
011	Stormwater and perimeter pond (treated at SWTS); discharge to Outfall 001
018	Stormwater and R-2 pond (treated at SWTS); discharge to Outfall 002

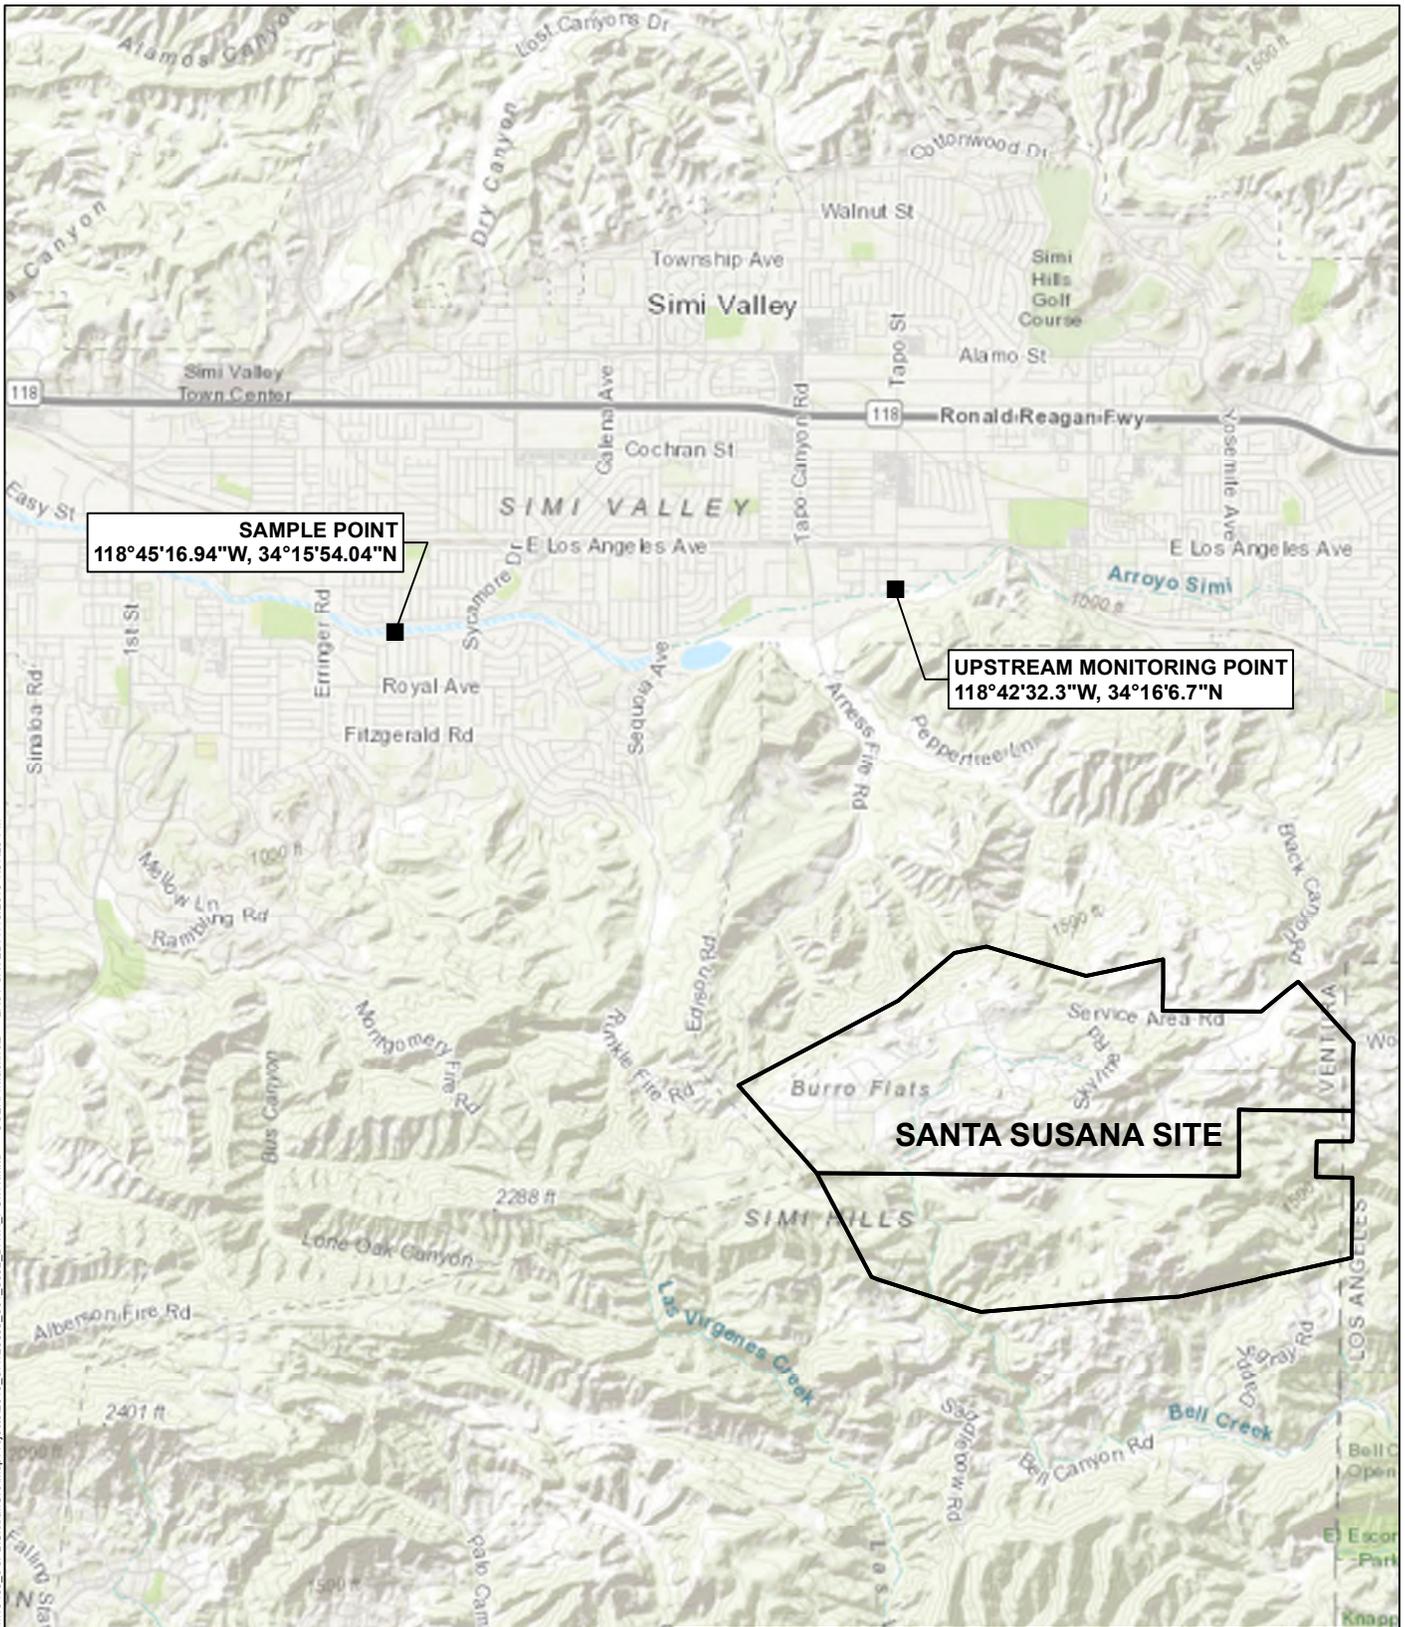
SAMPLE POINT
 118°45'16.94"W, 34°15'54.04"N

UPSTREAM MONITORING POINT
 118°42'32.3"W, 34°16'6.7"N

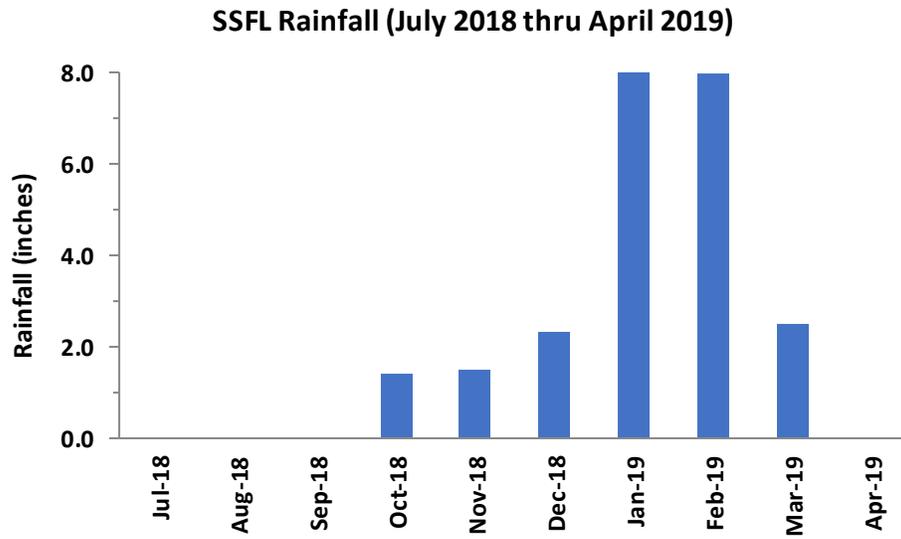
Figure 1. Rainfall (inches) measured July 2018 thru April 2019 at SSFL.

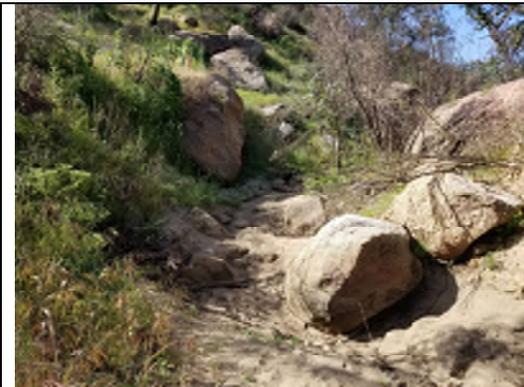
SSFL-001, downstream

Figure 2. Photos taken downstream and upstream of each permitted discharge point from the SSFL property (2019).
