APPENDIX E
BIOASSESSMENT REPORT

RE: BIOASSESSMENT SAMPLING FOR THE BOEING COMPANY AT THE SANTA SUSANA FIELD LABORATORY (2011)

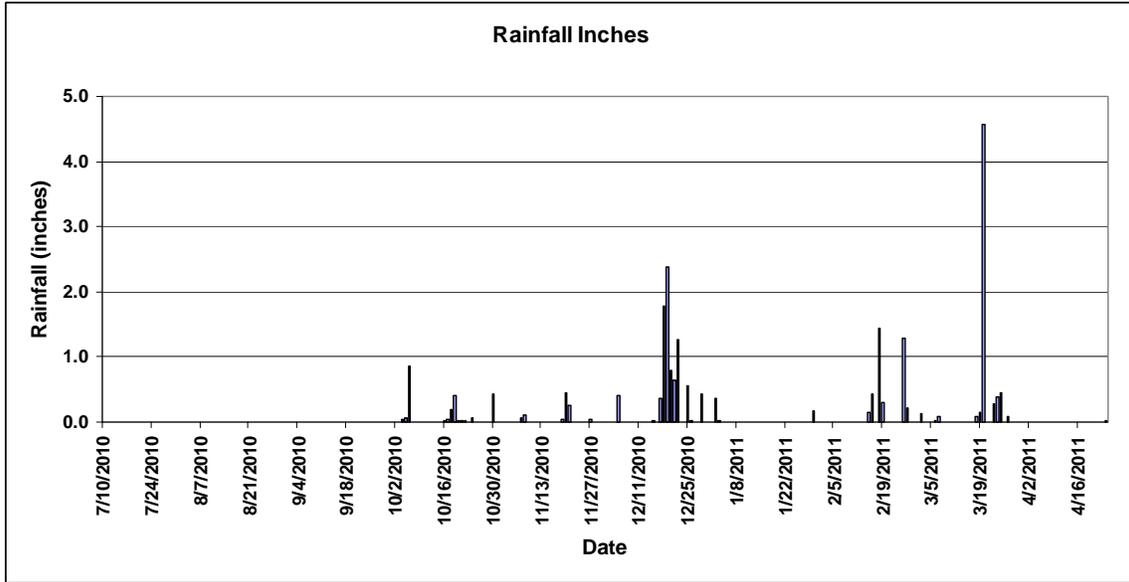
Figure 1. Rainfall (inches) measured thru mid-April on SSFL property during the 2010 to 2011 rain year.

The last storm to generate flow occurred on March 25th, 2011, when 0.45 inches of rain fell on the SSFL property (Figure 1). The final measurable rainfall occurred on April 24th, 2011 when 0.02 inches fell. Discharges from Outfalls 1, 5 and 6 stopped within a week of the March 25th rain event based on site visits by Boeing staff. On May 13th, 2011 Scott Johnson visited each of these outfalls and confirmed that they were dry and that valid BMI samples could not have been collected (see photos).

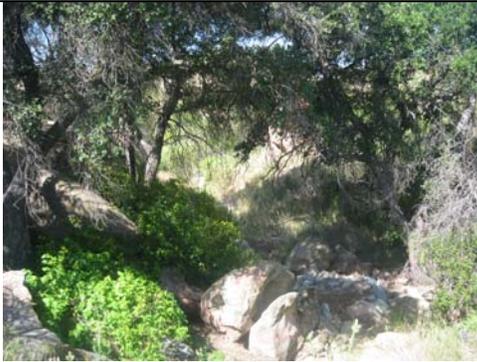
Outfall 1, downstream

Photos taken downstream and upstream of each permitted discharge point from the SSFL property.
