FIGURES

BMP Installations 2010-2012 Outfall 008 Watershed

Outfalls 008 and 009 Potential BMP and Performance Monitoring Locations

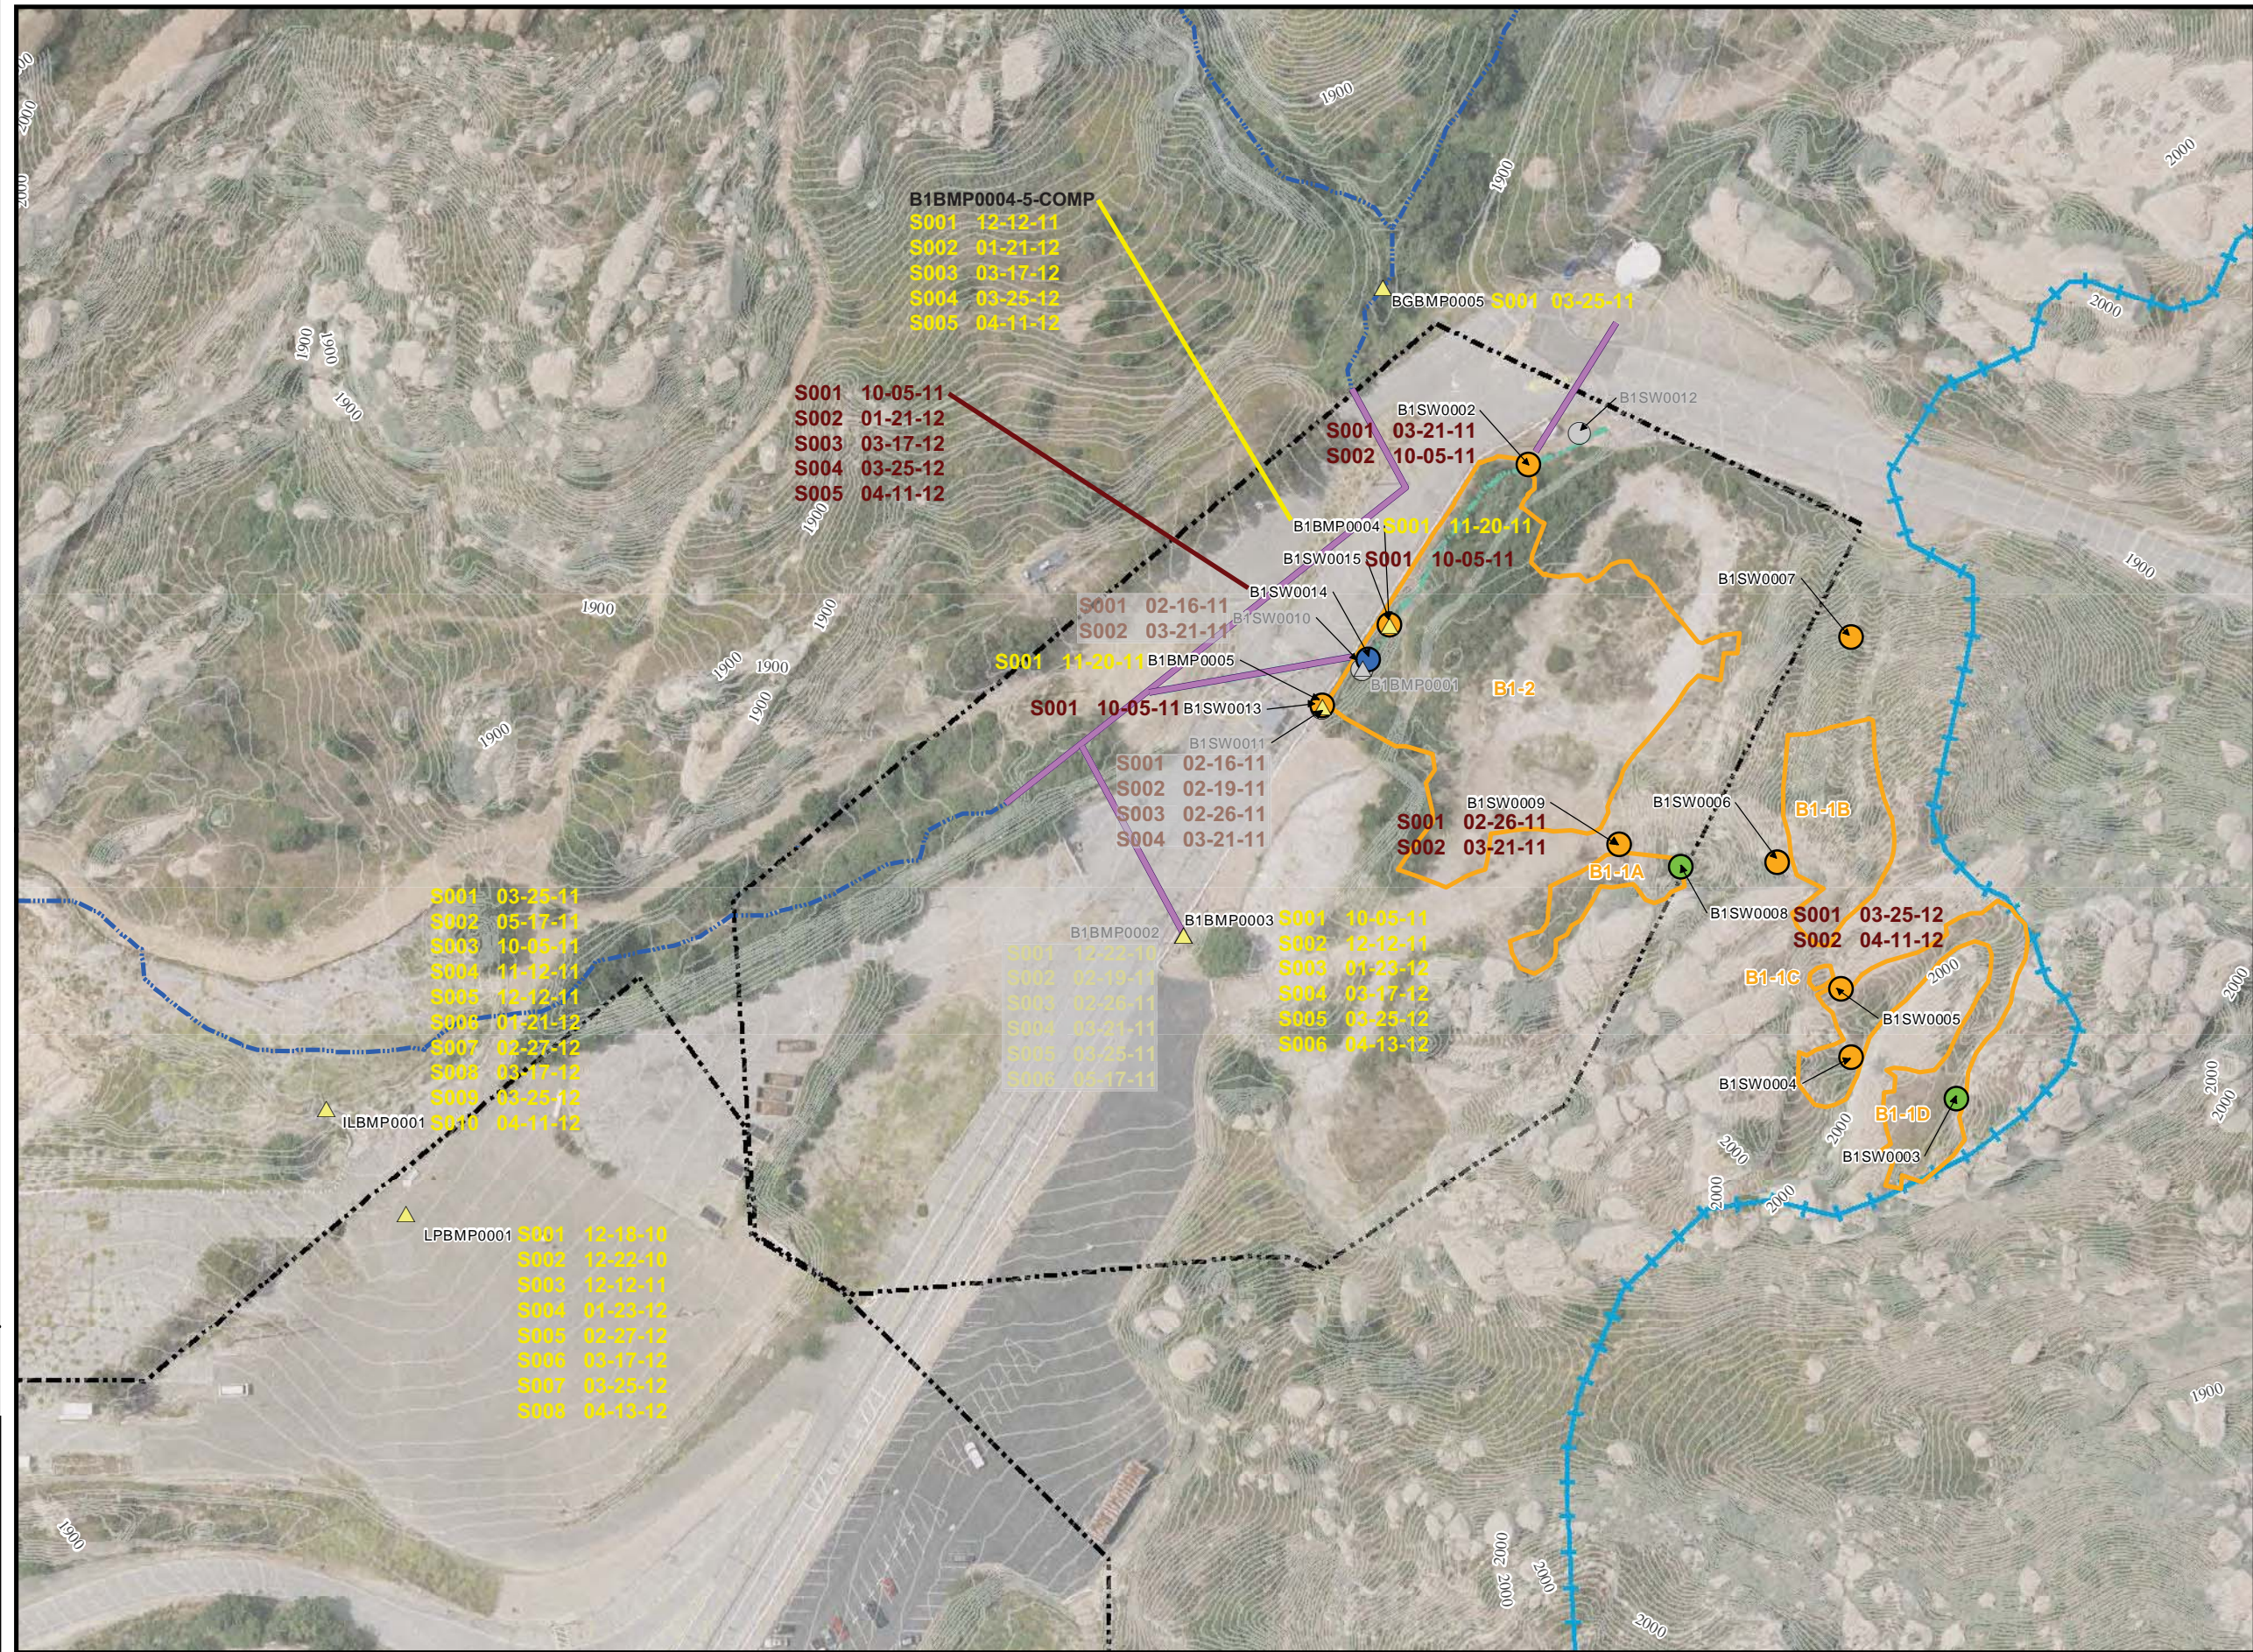
Outfall 009 Potential BMP and Performance Monitoring Locations B-1 Area

Note: Performance monitoring and potential BMP subarea monitoring inspections were performed at locations shown on this figure during daylight hours as soon as possible after the rain event began, and at 24 hour intervals during extended rain events. During inspections, if sufficient storm water runoff was observed at a sample location, a sample was collected. The dates on which samples were collected are shown on the Figure; locations with no dates have never been sampled.
