BMP Installations 2010-2013

**B-1 Area
Outfall 009 Watershed**

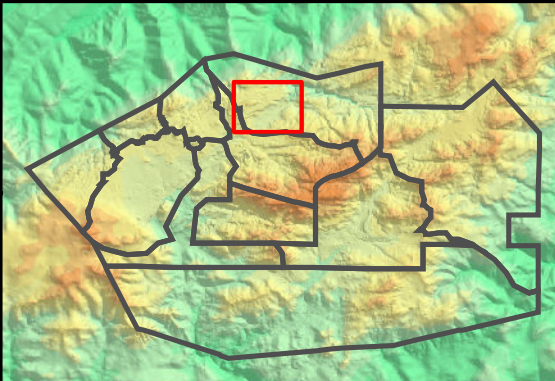
- Topographic contours from 2010 Sage Consultants, Inc
- Covered the weir boards at CM-1, CM-2, CM-3, CM-4, CM-6, CM-8, CM-9, and CM-10 with filter fabric to facilitate ponding behind the boards and increase flow through filter media beds (Fall 2011).
