**EXPERT PANEL'S BMP PERFORMANCE ANALYSIS MEMORANDUM  
2013/2014 RAINY SEASON**

# Memorandum

Subject: BMP Performance Analysis  
Santa Susana Site  
Geosyntec Project: SB0363U

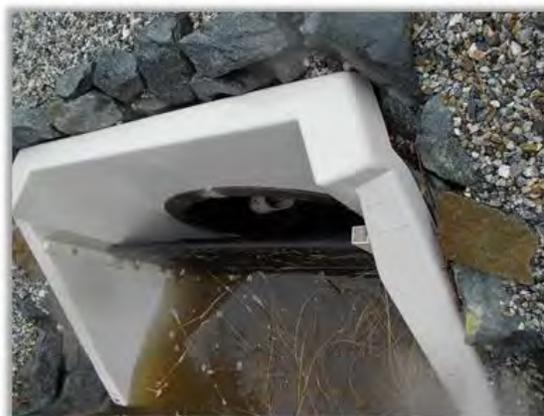
**Figure 36: A photo of the CM-1 weir board taken on 2/28/2014.**

The six monitored CMs (B1, CM-1, CM-3, CM-8, CM-9, and CM-11) are in the Outfall 009 watershed. At the CM monitoring locations, the total number of collected influent and effluent pairs for all of the CM locations combined ranged from 28 (for copper) to 65 (for TSS). Table 3 and Table 4 summarize the paired data statistics for these locations. CM-8, CM-11, and select CM-1 paired statistics are presented separately since the influent flows to these sites come largely from unimpaired/background sites, and therefore significant reduction of the POC concentrations (which are already generally very low) in those flows by CMs is unlikely. No data were collected from these background sites in the 2013-2014 sampling season. Data from the CM-3 background site were excluded since, as described earlier in this memo, this CM cannot be reliably assessed based on the effluent sample results. At the B1 site, media filter bleed-through was observed during initial sampling dates in the 2011-2012 sampling season. Since this was a malfunction that was subsequently corrected, results from these sample dates were removed from the analysis. The CM-1 effluent sample collected on 2/28/2014 represents a blend of underdrain flow and seepage through the upstream weir boards. Figure 36 at right shows the ponding at the CM-1 weir board during that event.

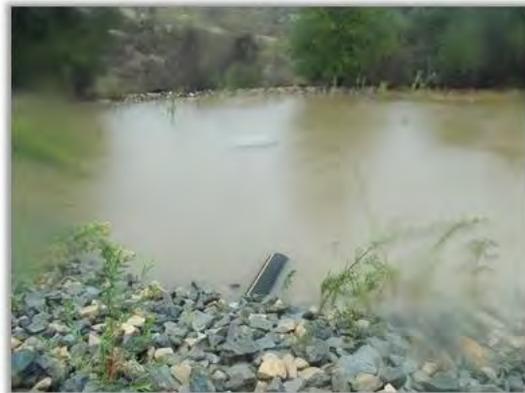
**Figure 37: A photo of the submerged biofilter taken on 2/28/14, facing northeast**

Construction of the lower lot biofilter, located in the Outfall 009 watershed, was completed in 2013. To date, samples were taken at this location only during the two rain events that occurred after the construction was completed, with samples collected at three locations within the biofilter treatment train (influent, post-sedimentation basin, and post-biofilter) the first year, and two locations (influent and post-biofilter) in the most recent sampling year. The post-biofilter samples collected in 2014 represents a blend of filtered underdrain water and overflow A sample was not taken at the biofilter inlet [post-sedimentation basin] during this most recent sampling year due to the sample location being submerged and inaccessible.
