SSFL Surface Water Expert Panel Site Tour

November 17, 2022

**Surface Water Expert Panel
Site Tour Map**

Santa Susana Field Laboratory
Ventura County, CA

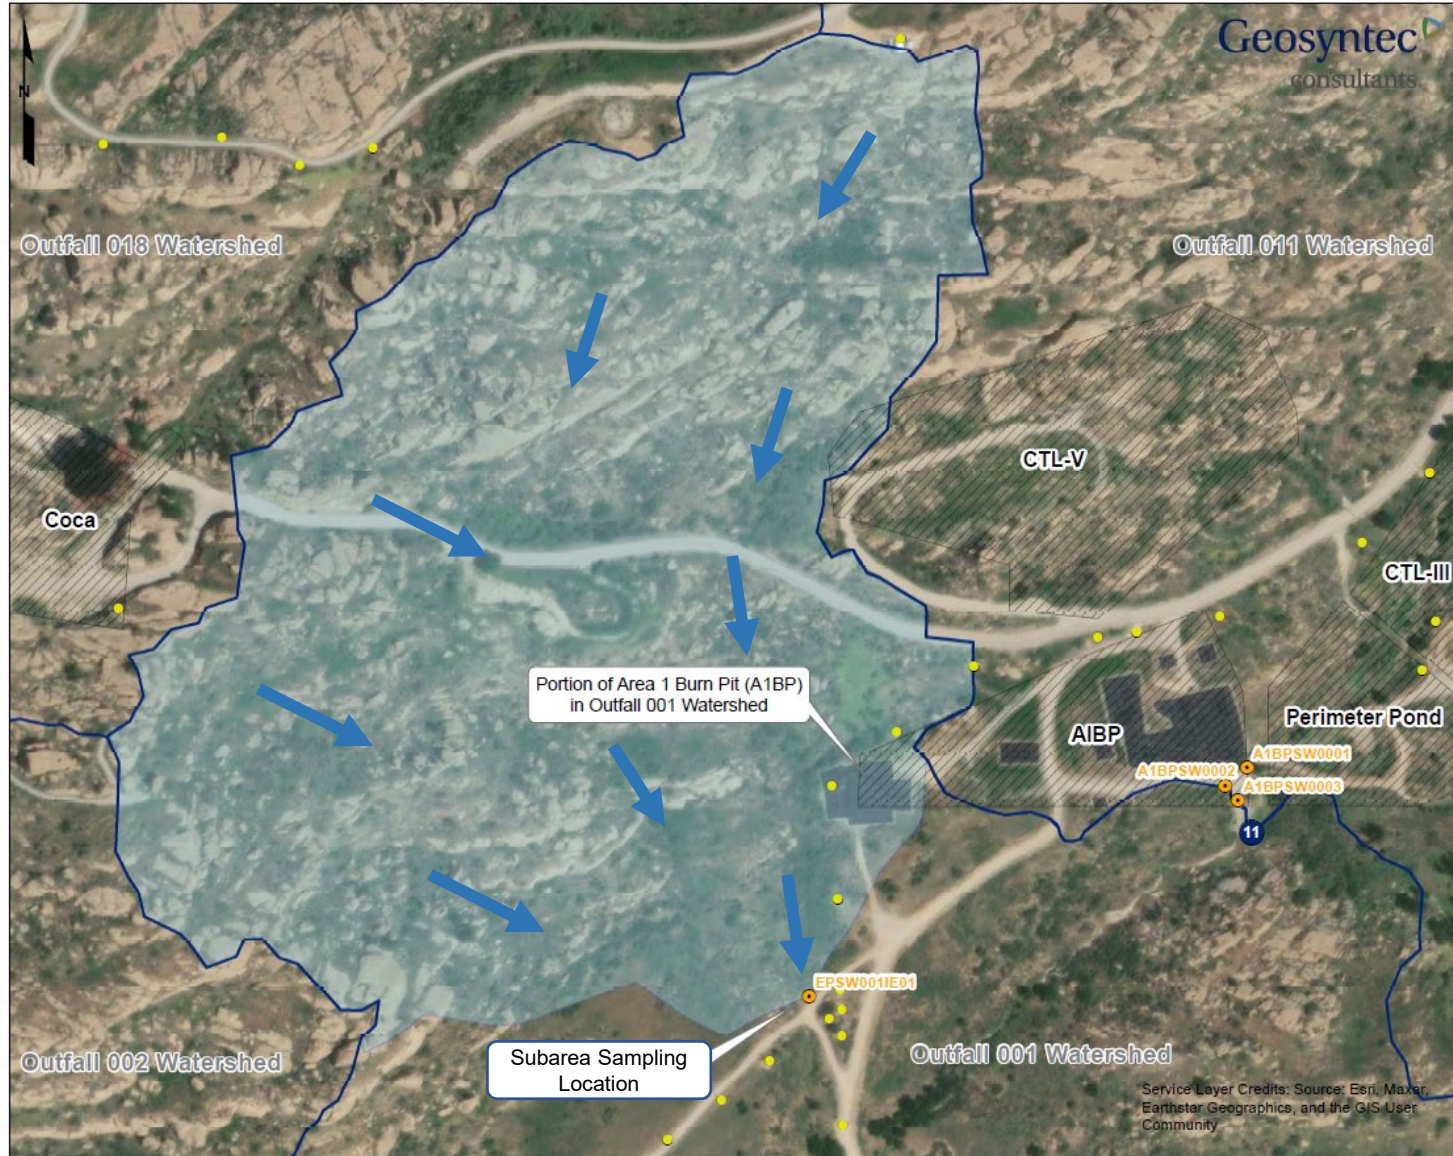
Area 1 Burn Pit Stormwater Monitoring Locations

Area 1 Burn Pit Subarea Stormwater Sampling

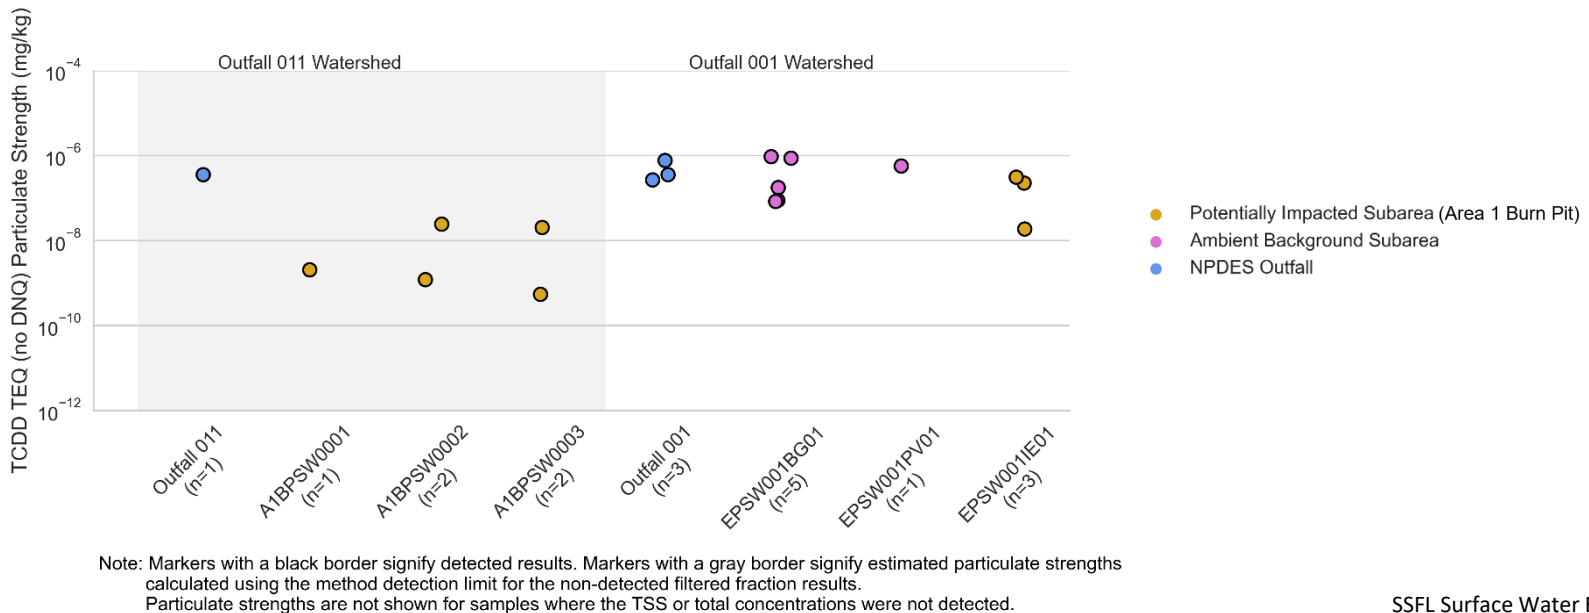
Dioxin Particulate Strengths at SSFL Area 1 Burn Pit and Outfall 001/011 Stormwater Monitoring 2019-2022

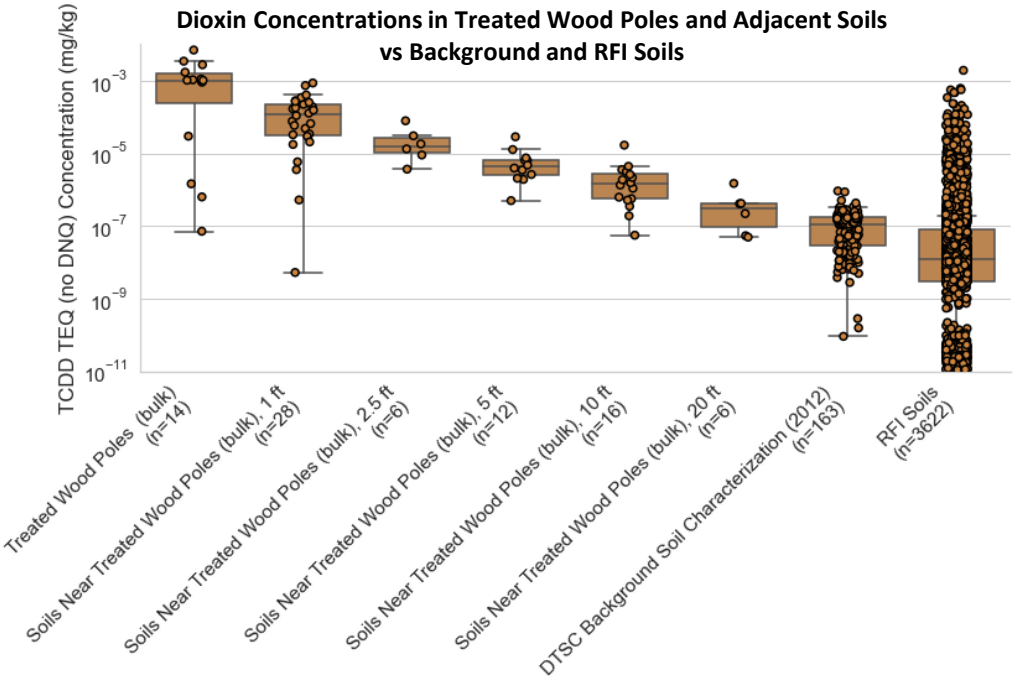
- Key Findings:**
- Distinct relationship between the dioxin concentration in soils and distance from the pole
 - Dioxin concentrations at 1 ft from poles are as high as the highest observed RFI Soil concentrations
 - Between April and June 2022, 42 unused treated wood utility poles were removed from Boeing property, and 12 unused treated wood poles were removed from NASA property. More are being evaluated for removal.
 - Based on these sampling results, BMPs were recommended to be moved 10 ft out from poles to better capture pole-impacted soils
