SANTA SUSANA FIELD LABORATORY

PUBLIC MEETING SITE-WIDE SUMMARY OF ACTIVITIES

July 17, 2019

SSFL Stormwater Expert Panel

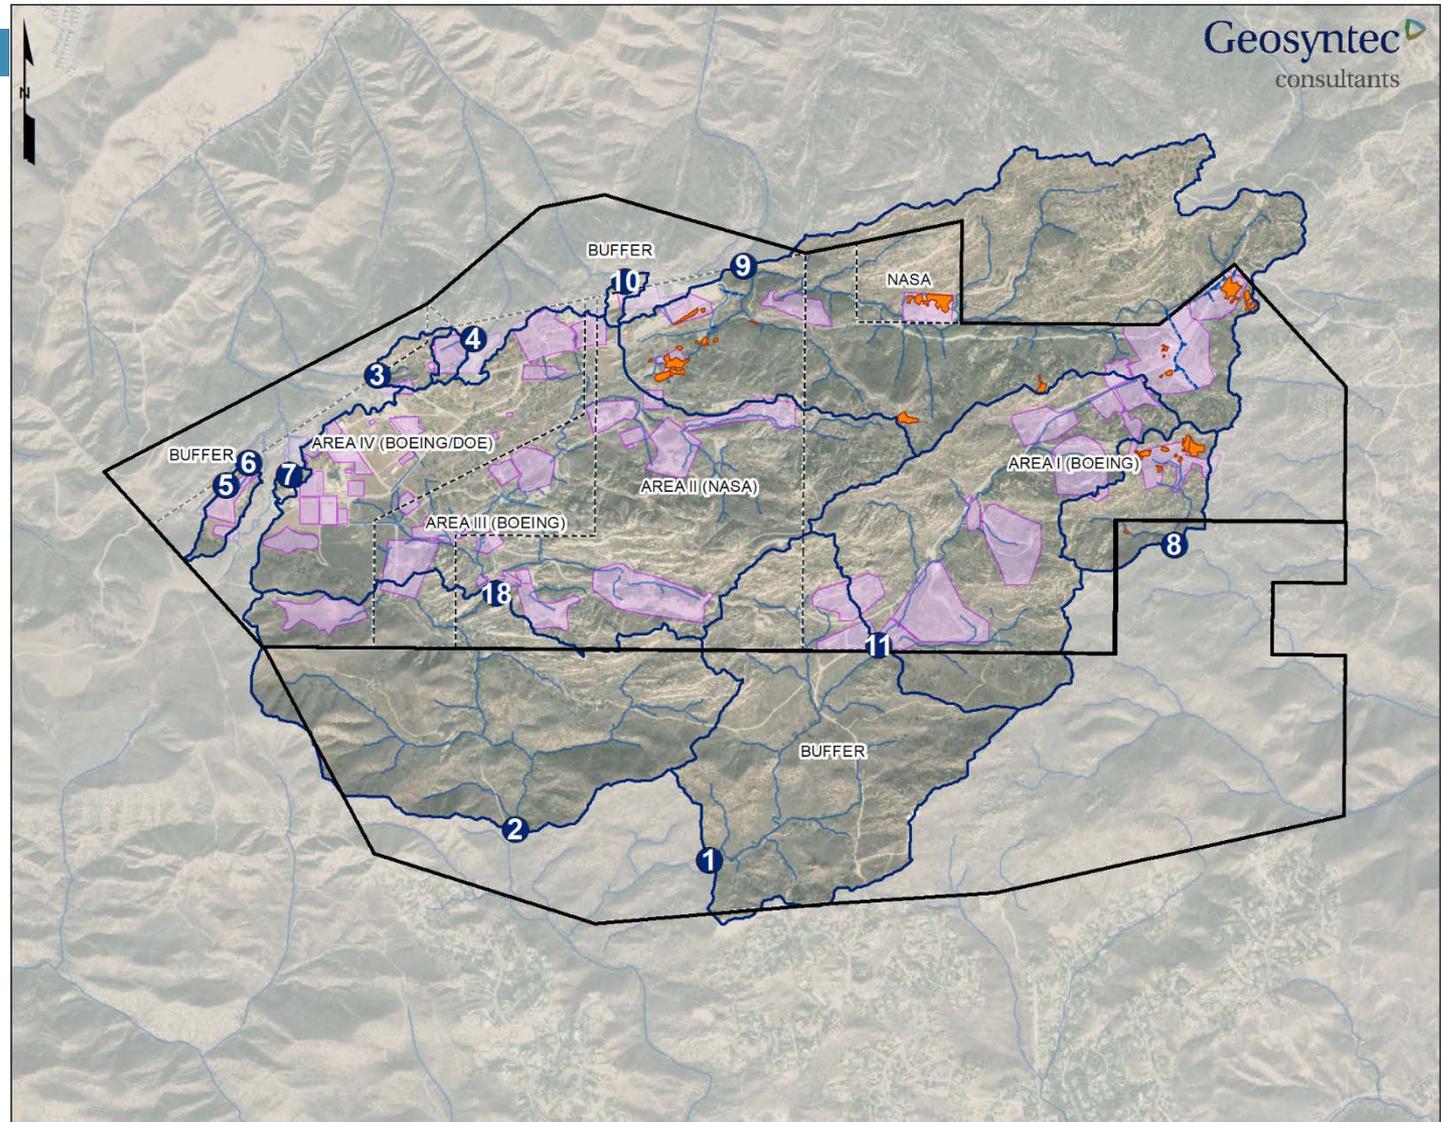
RCRA Facility Investigation (RFI)

Structural treatment controls target RFI Areas

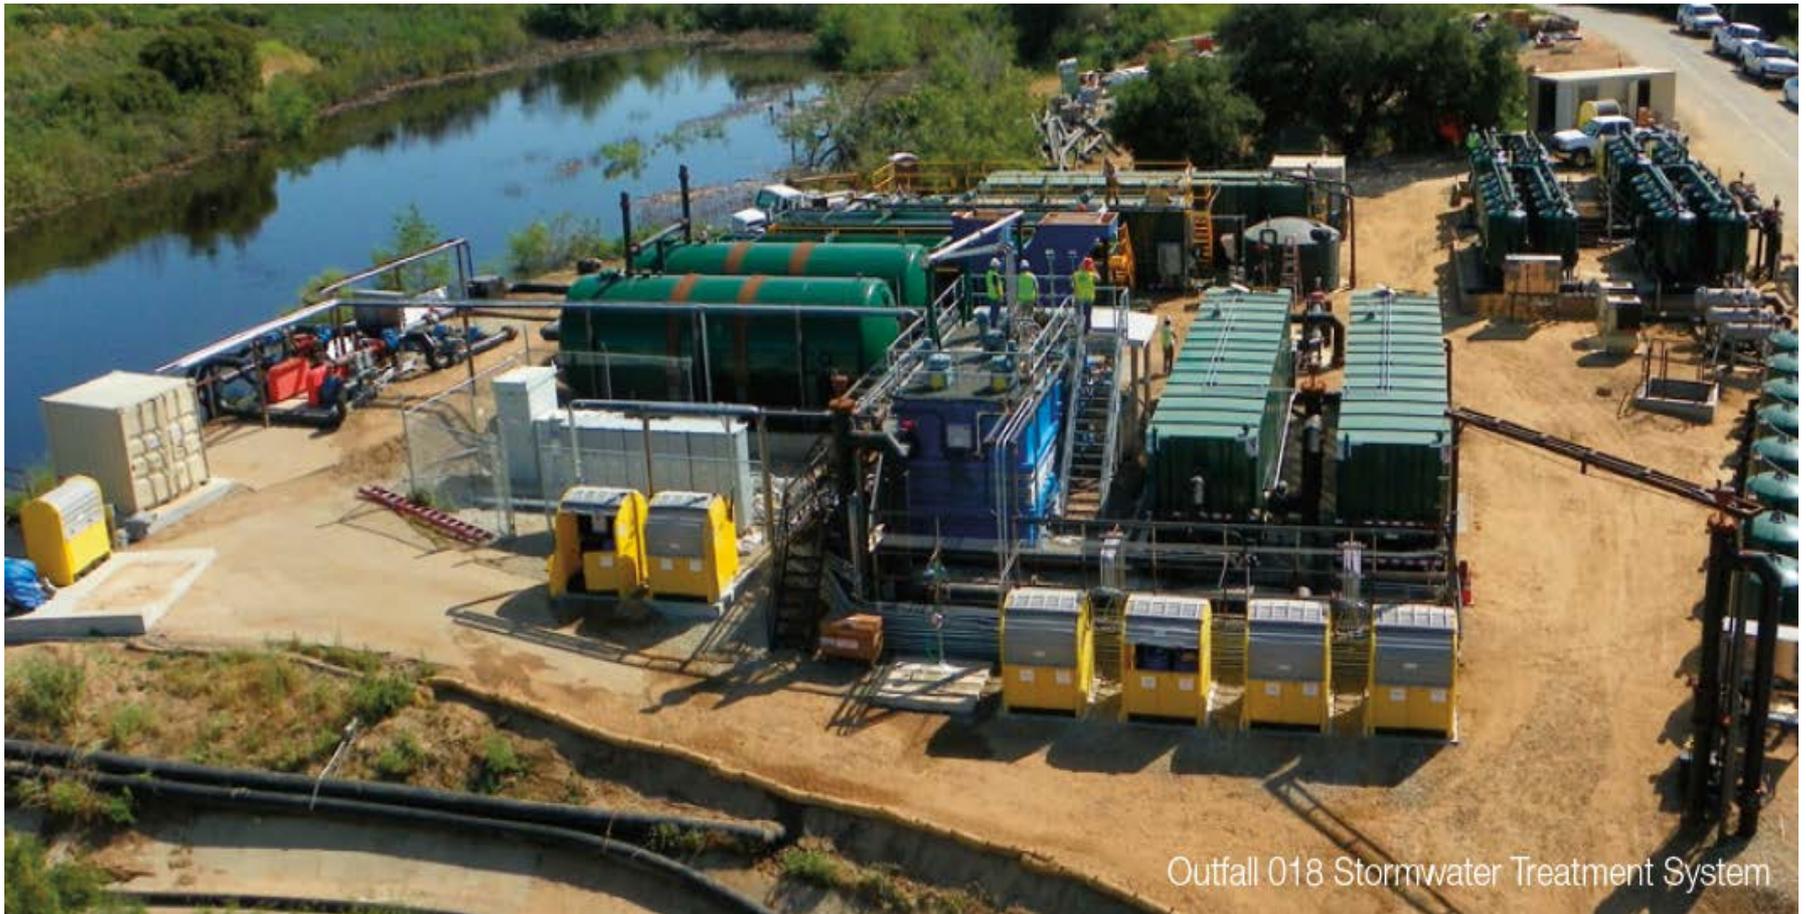
Outfall 018 Stormwater Treatment System

Stormwater not treated by Silvernale treatment system flows through media filters before leaving northern outfalls

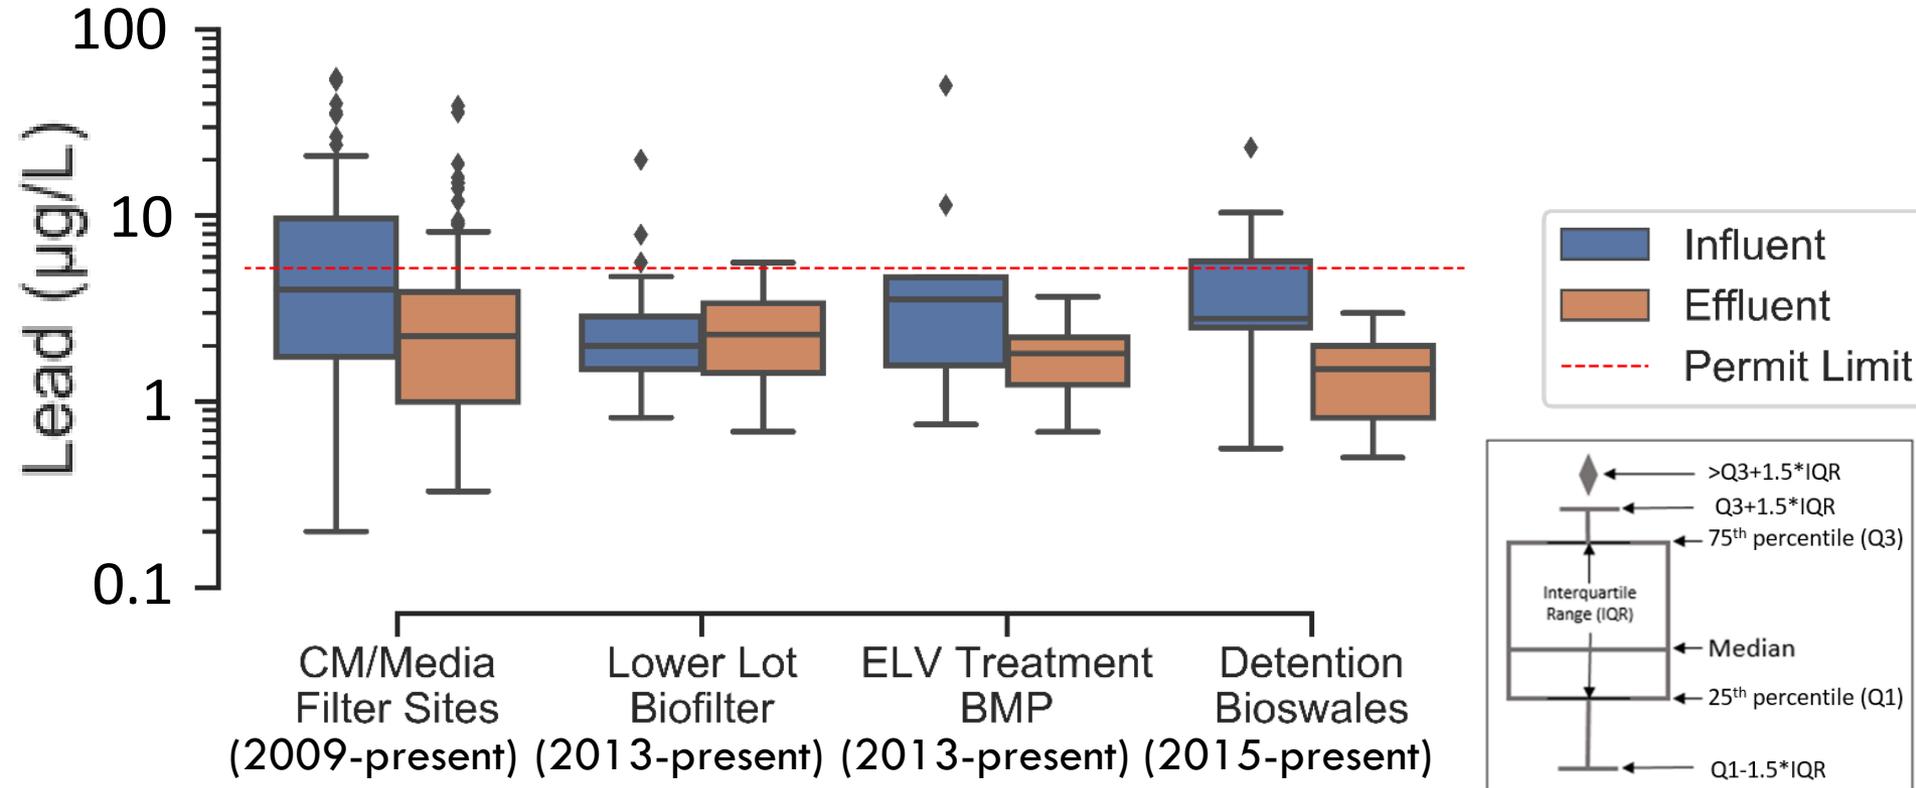
BMP Performance: Lead

Lead concentrations are significantly reduced for most BMP types

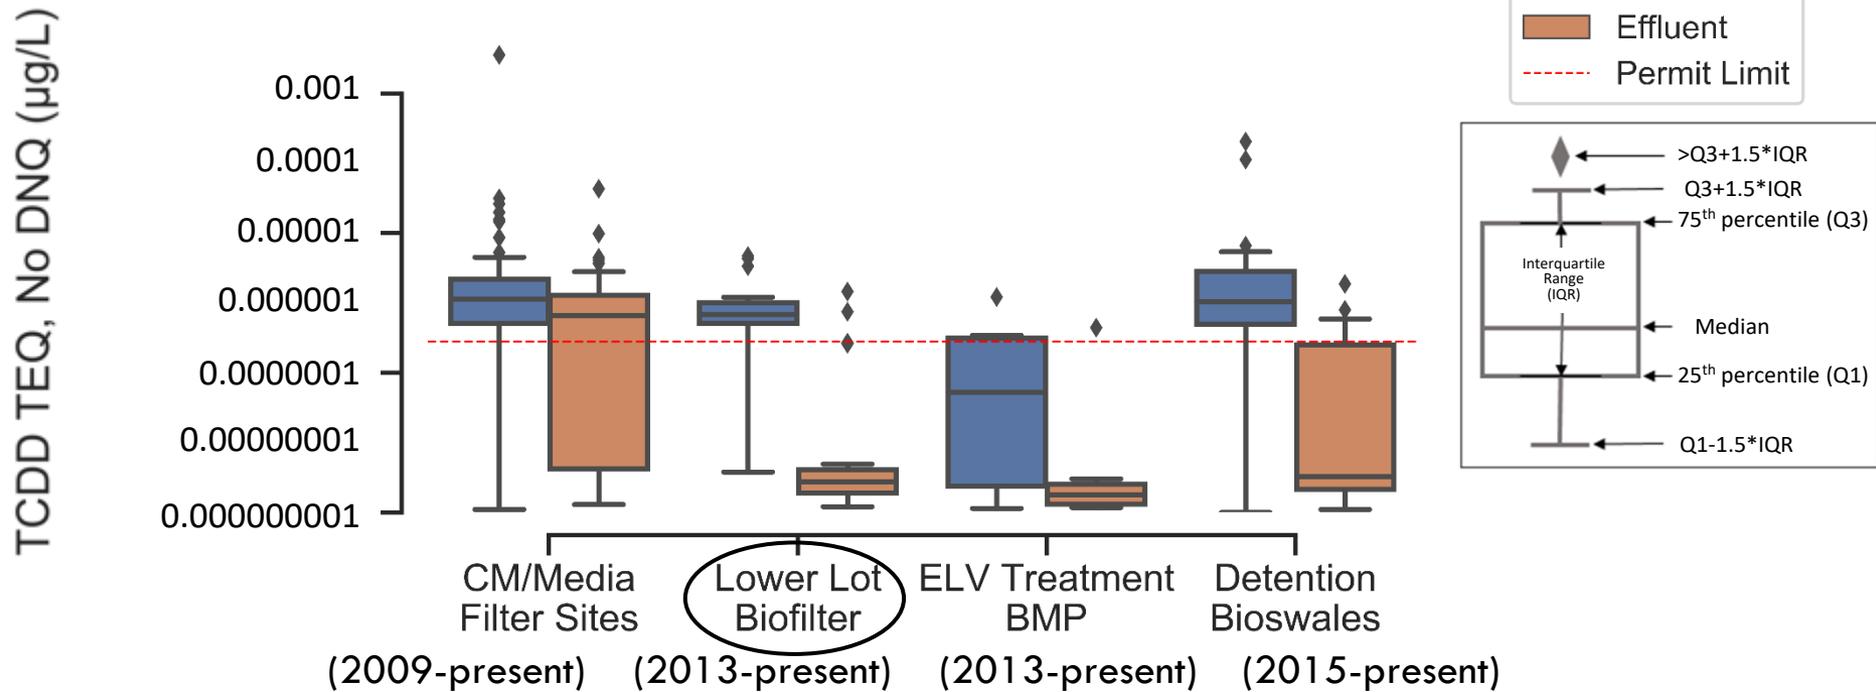
BMP Performance: Dioxin

Dioxin concentrations are significantly reduced for all BMP types

55% of the storms less than 1-inch are contained in the lower lot biofilter and not discharged to the Northern Drainage.

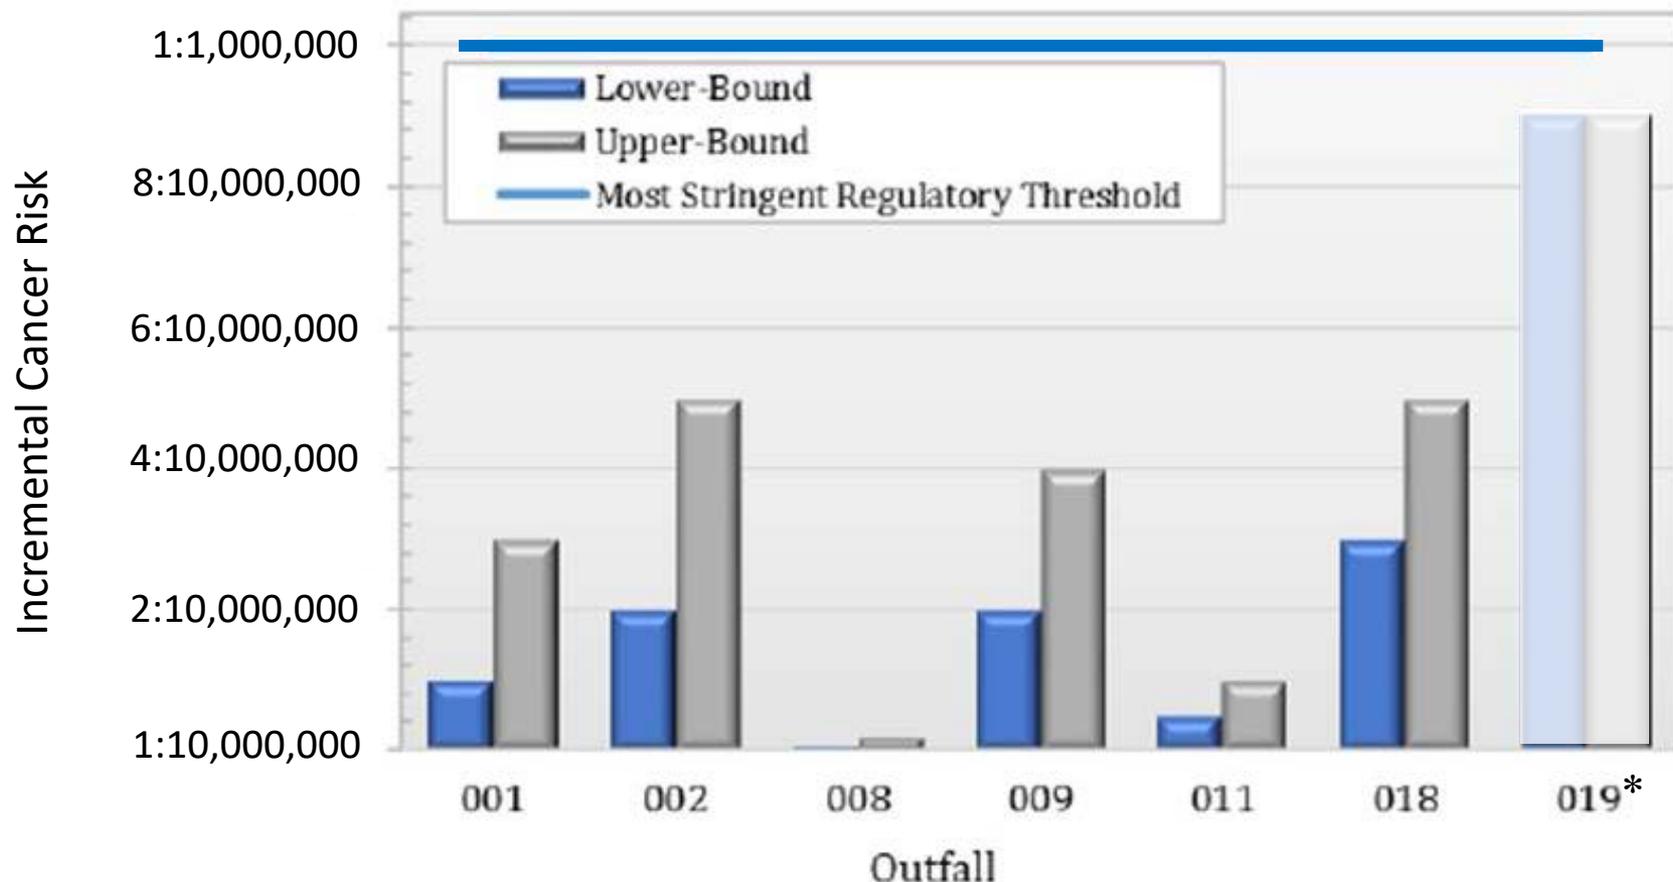
Comparison of Lower and Upperbound Cumulative Incremental Cancer Risk Estimates by Outfall

*Outfall 019 is not planned to be used for surface water discharge

- Potential recreational exposure via incidental ingestion and dermal contact in surface water runoff exiting the SSFL via Outfalls 001, 002, 008, 009, 011, 018, and 019 **are below levels of concern as established by CalEPA and USEPA** (see chart on next slide).
- Volatilization/inhalation risk is insignificant
- Edible aquatic plant risk is insignificant
- Fish consumption does not occur onsite and SSFL flow contributions to nearest downstream fishing locations are insignificant

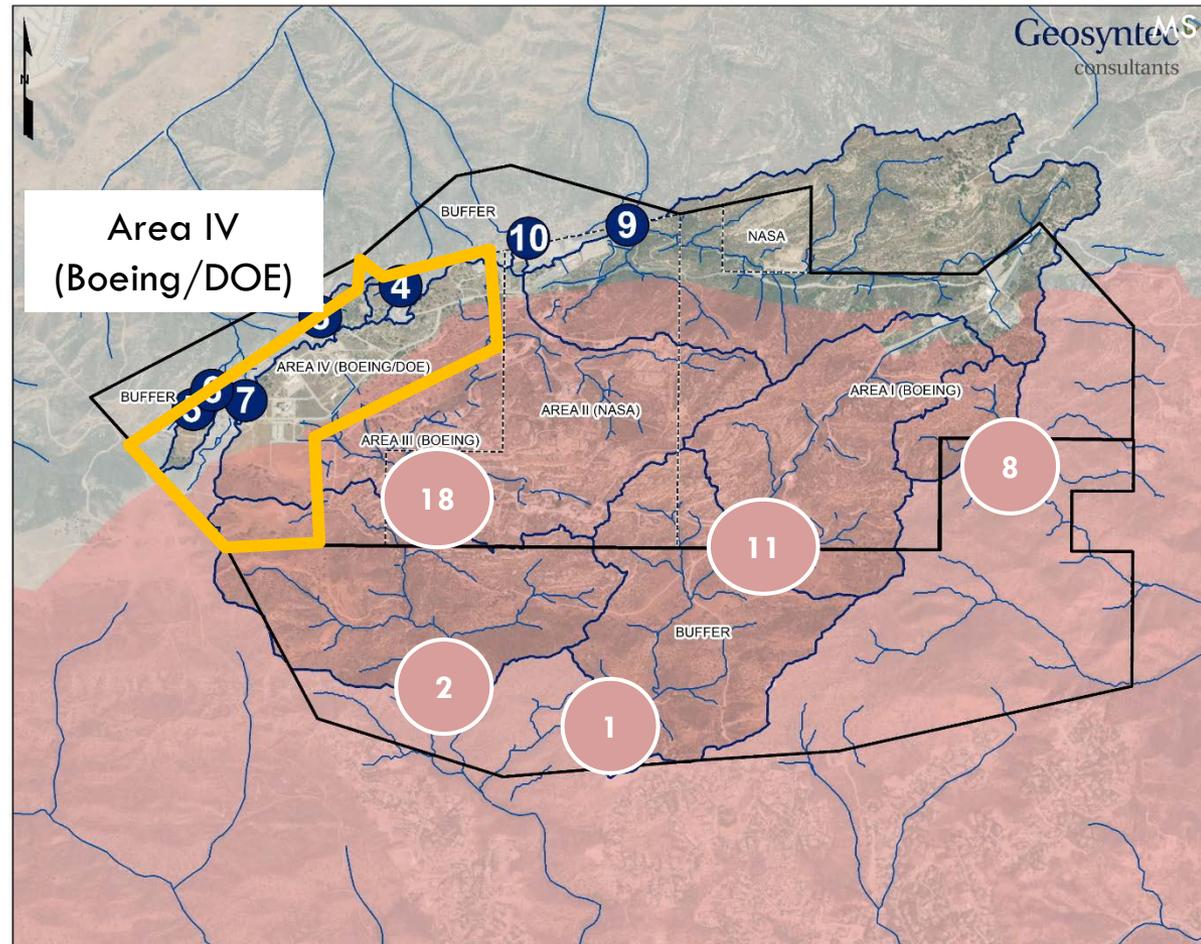
Woolsey Wildfire Extent

- 79% of site burned
- Outfall watersheds most impacted:
 - Outfall 011/001
 - Outfall 018/002
 - Outfall 008
- Last wildfire was in 2005 (Topanga)

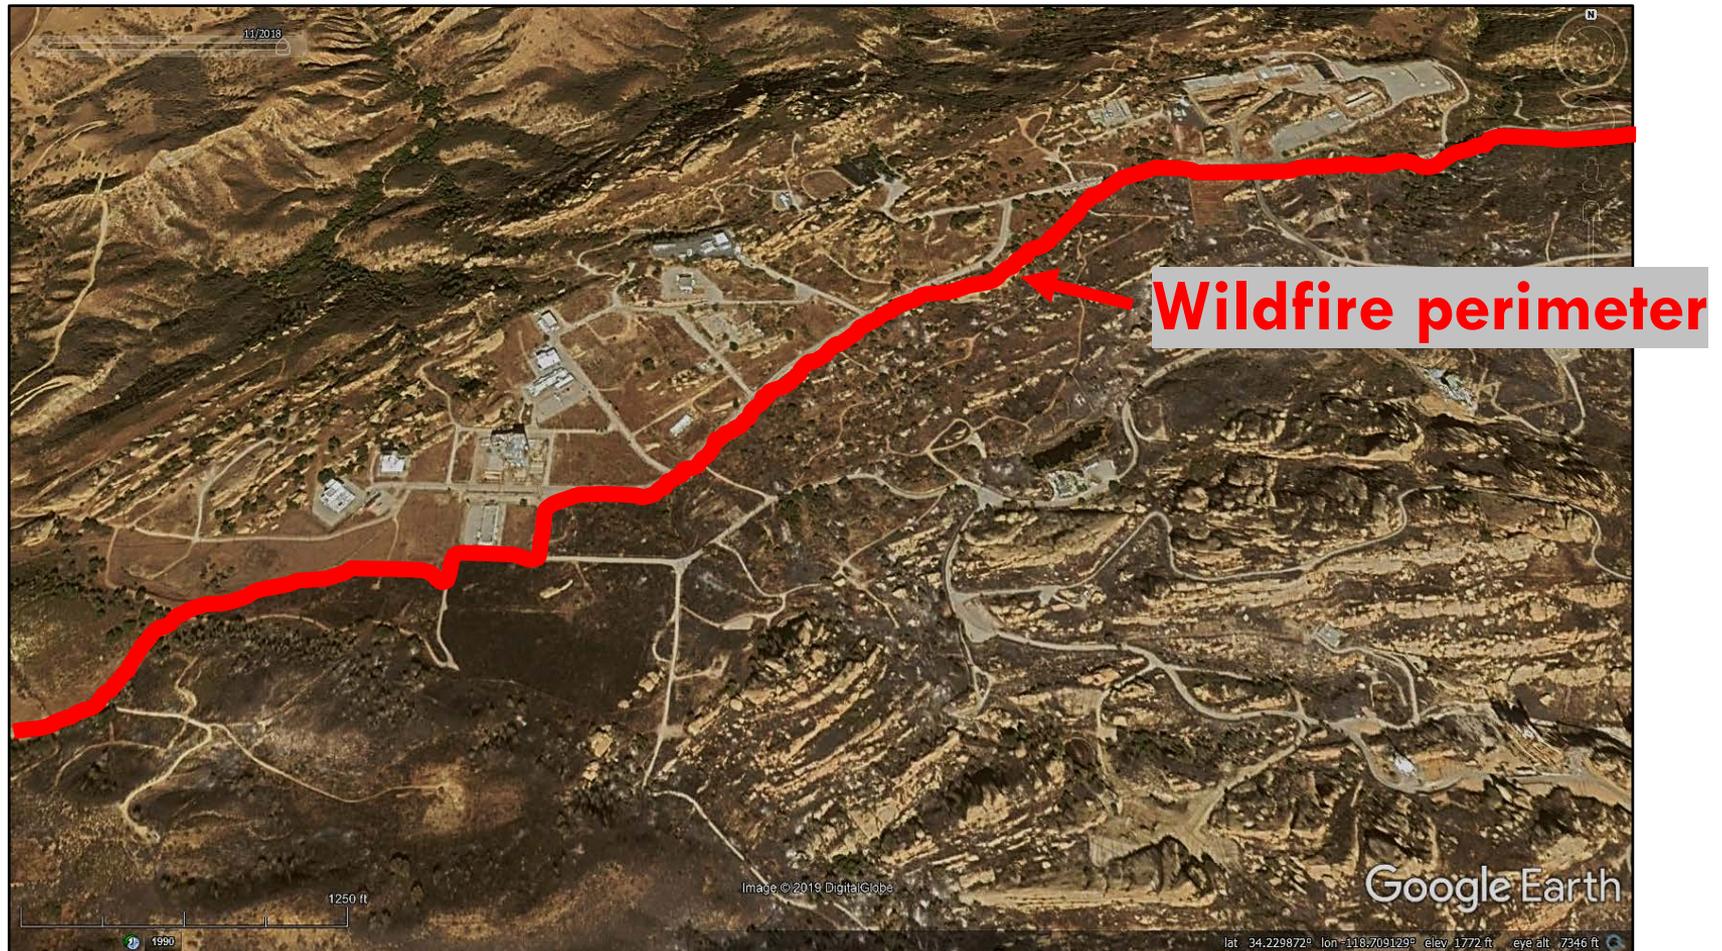
Woolsey Wildfire Extent

Wildfire perimeter

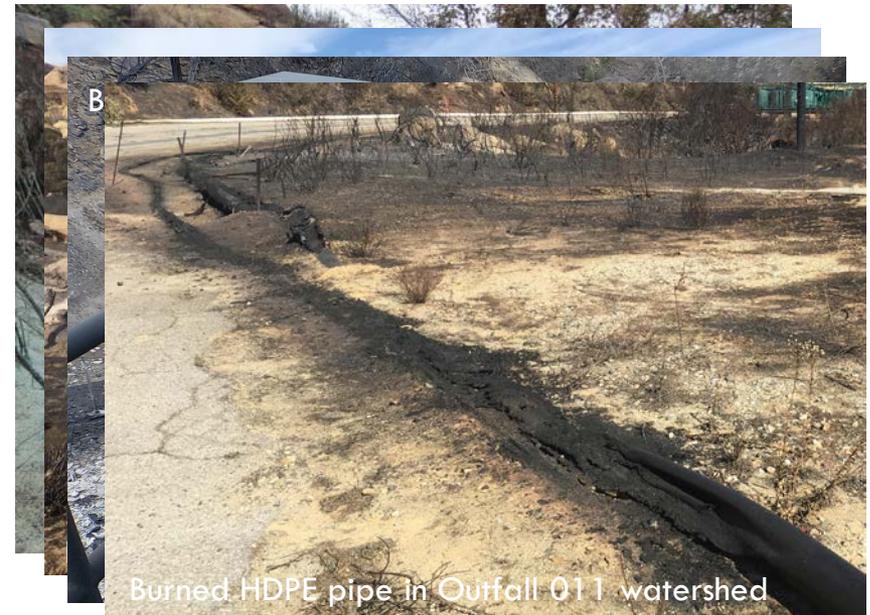
Effects of Wildfire

- Lost vegetative cover
- Lost plant litter
- Increased soil hydrophobicity (water repellent)
- Burned material including plastic sampler housing, metal platforms, batteries, HDPE pipelines, PVC fixtures, utility poles, etc.
- Temporarily damaged stormwater controls (e.g., Storm Water Treatment Systems, conveyance pipes, etc.)

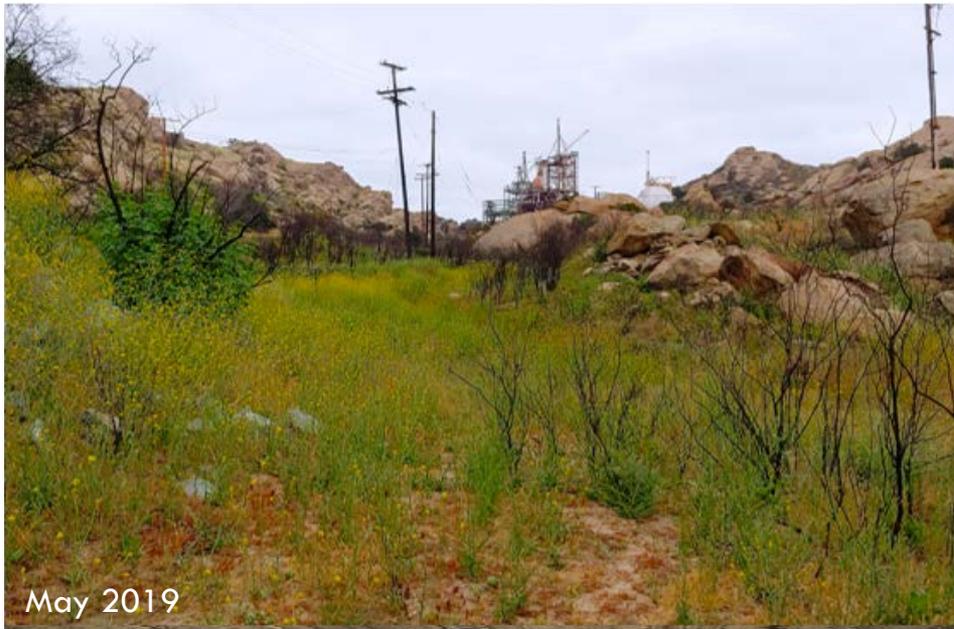
Hydrologic and Water Quality Response

- Increased runoff (frequency and volume)
- New pollutant sources (burned materials)
- Increased soil exposure and associated constituent mobilization

With time these effects are diminished with vegetative regrowth and as soil infiltration characteristics return to pre-wildfire conditions.

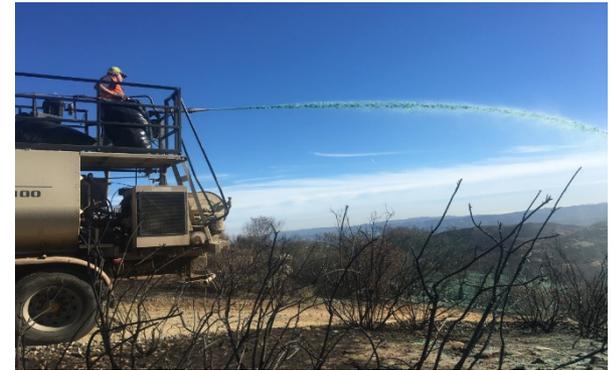
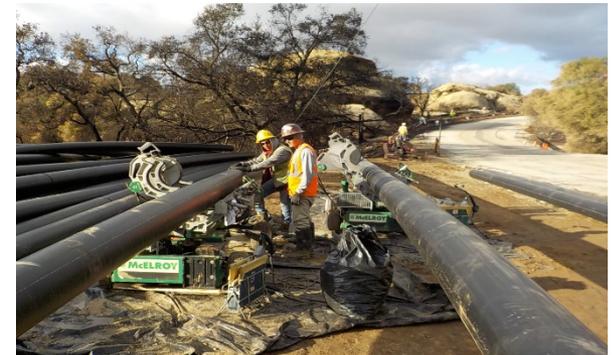
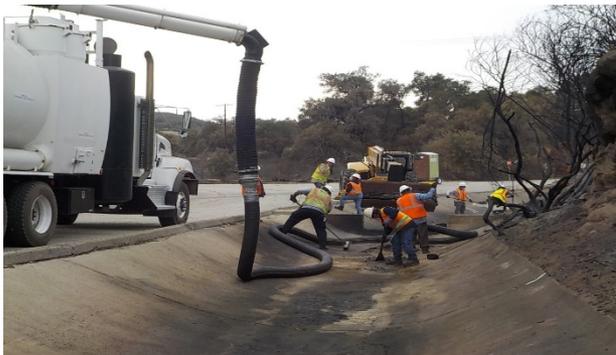
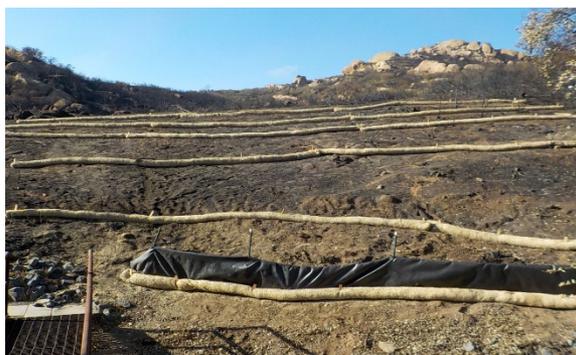
Example SSFL Response, Repairs, and Controls

- Hydromulch applied and fiber rolls installed
- Burned HDPE pipelines replaced to direct runoff to storm water treatment system (SWTS)
- Debris removed and ash vacuumed from burned areas
- Repair and maintenance of stormwater BMPs, including SWTS, and sampling stations
- Majority of repairs completed prior to first runoff producing storm (4 weeks after wildfire)

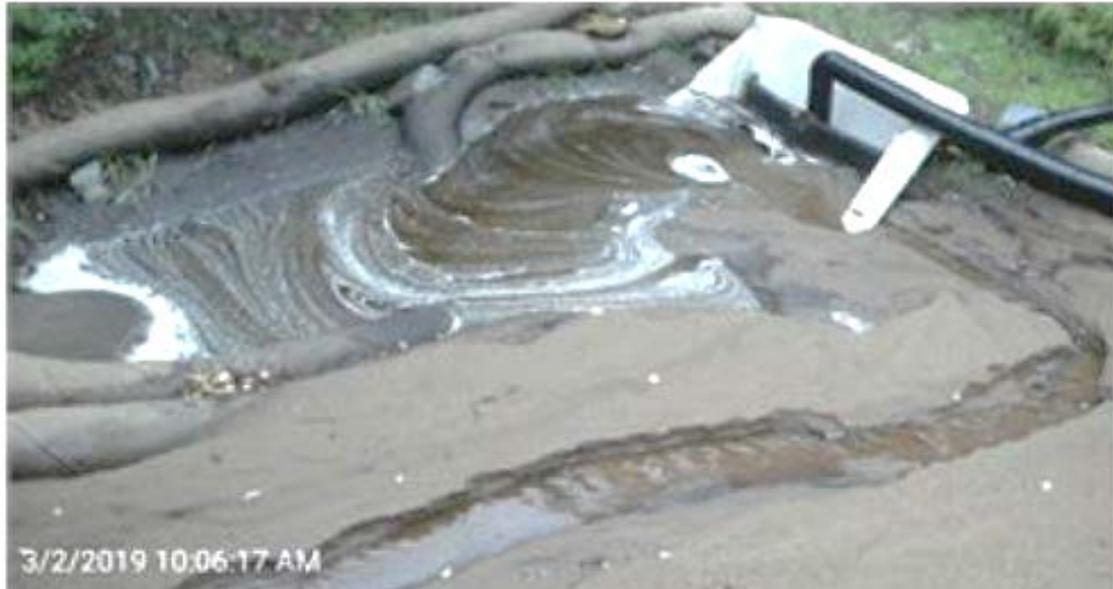
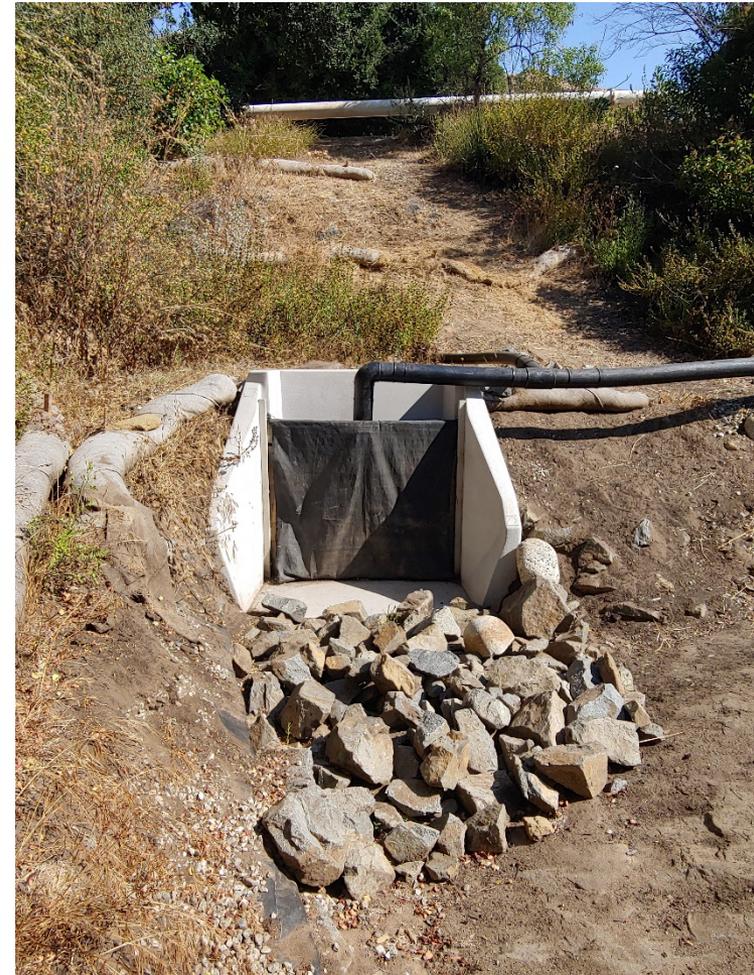
Example Sediment Capture: CM-4

Post-Wildfire sediment accumulation looking downstream toward weir boards.

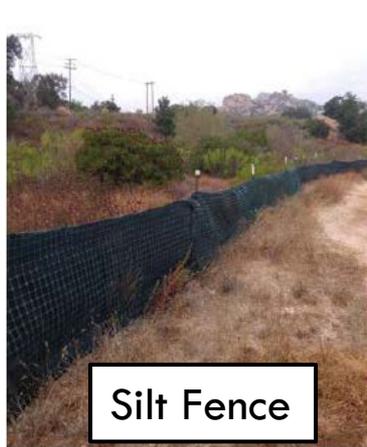
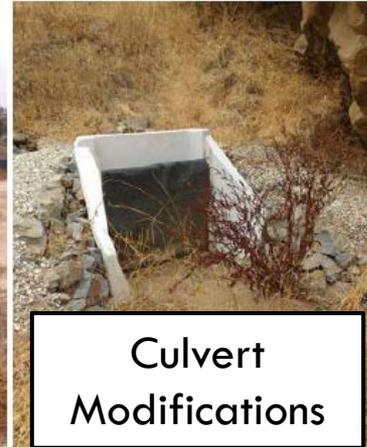
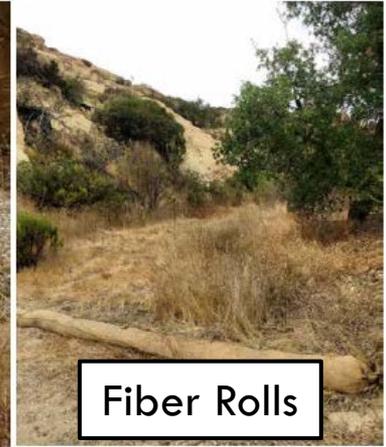
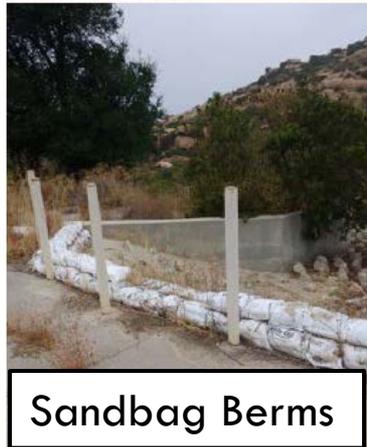
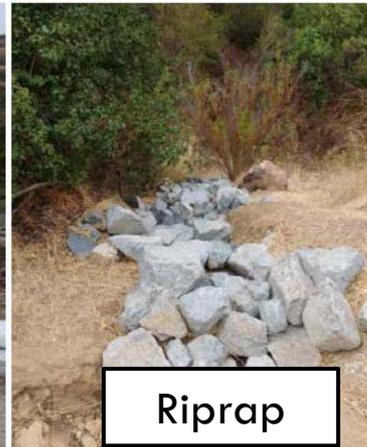
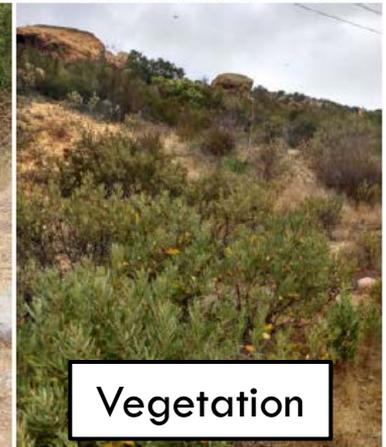
Outfall 009 Shooting Range BMPs

BMPs implemented to capture sediment and particulate-bound lead from the shooting range

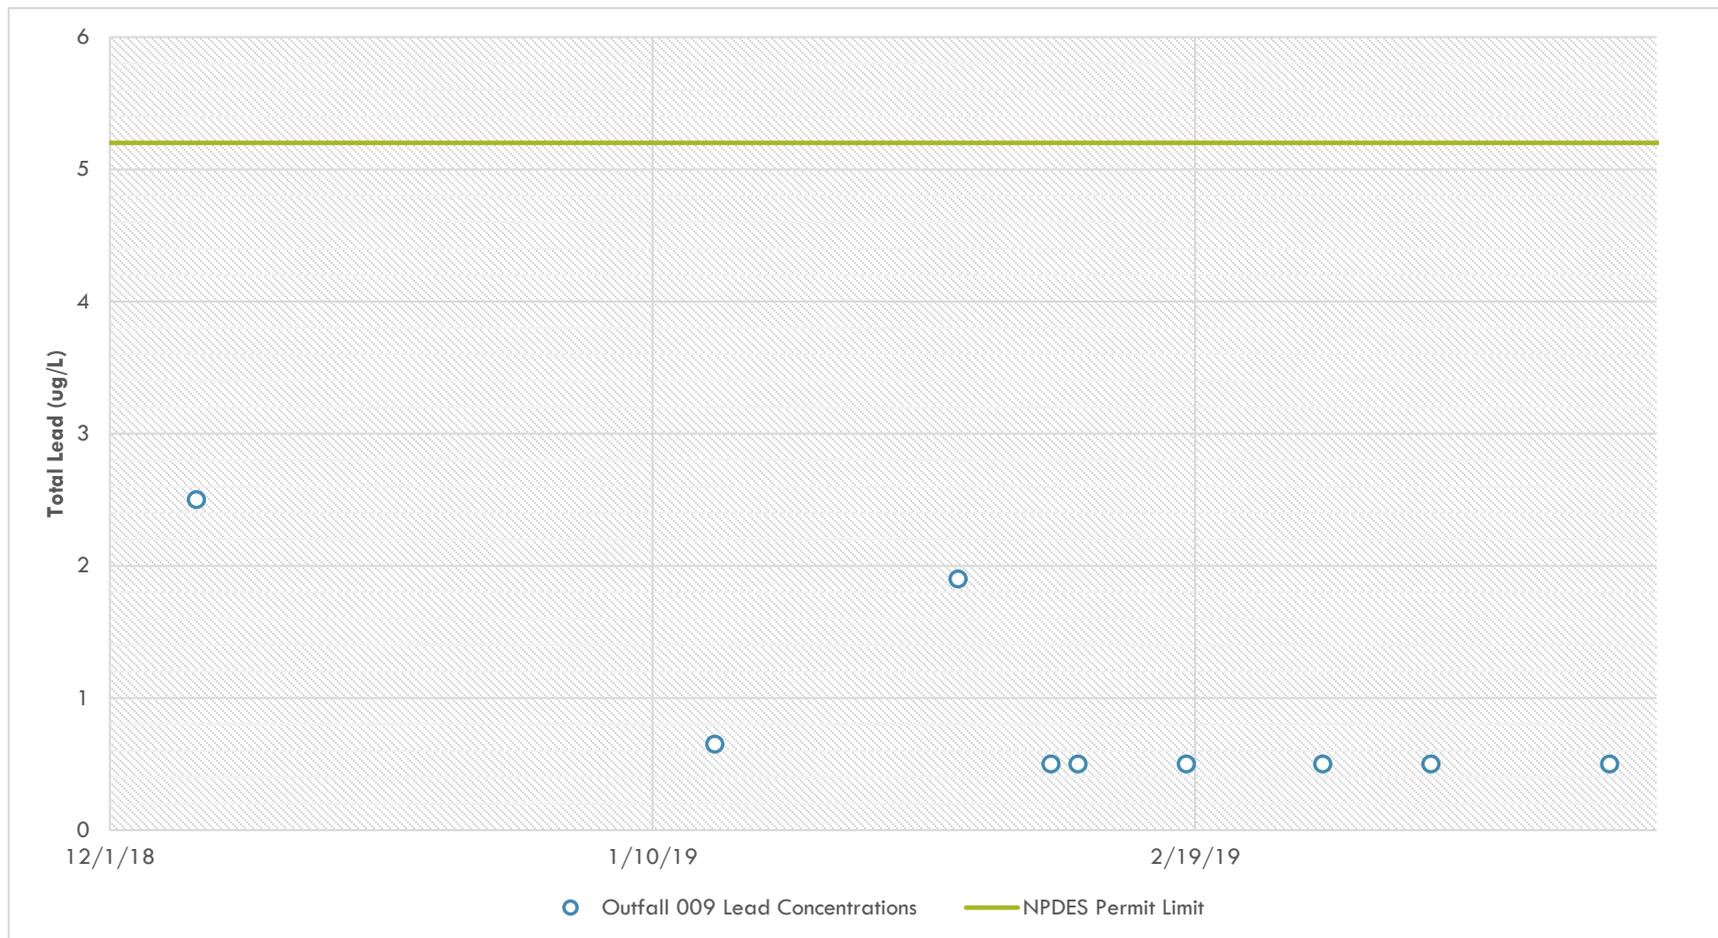
No Lead Exceedances at Outfall 009

This year the lead is being contained on the site

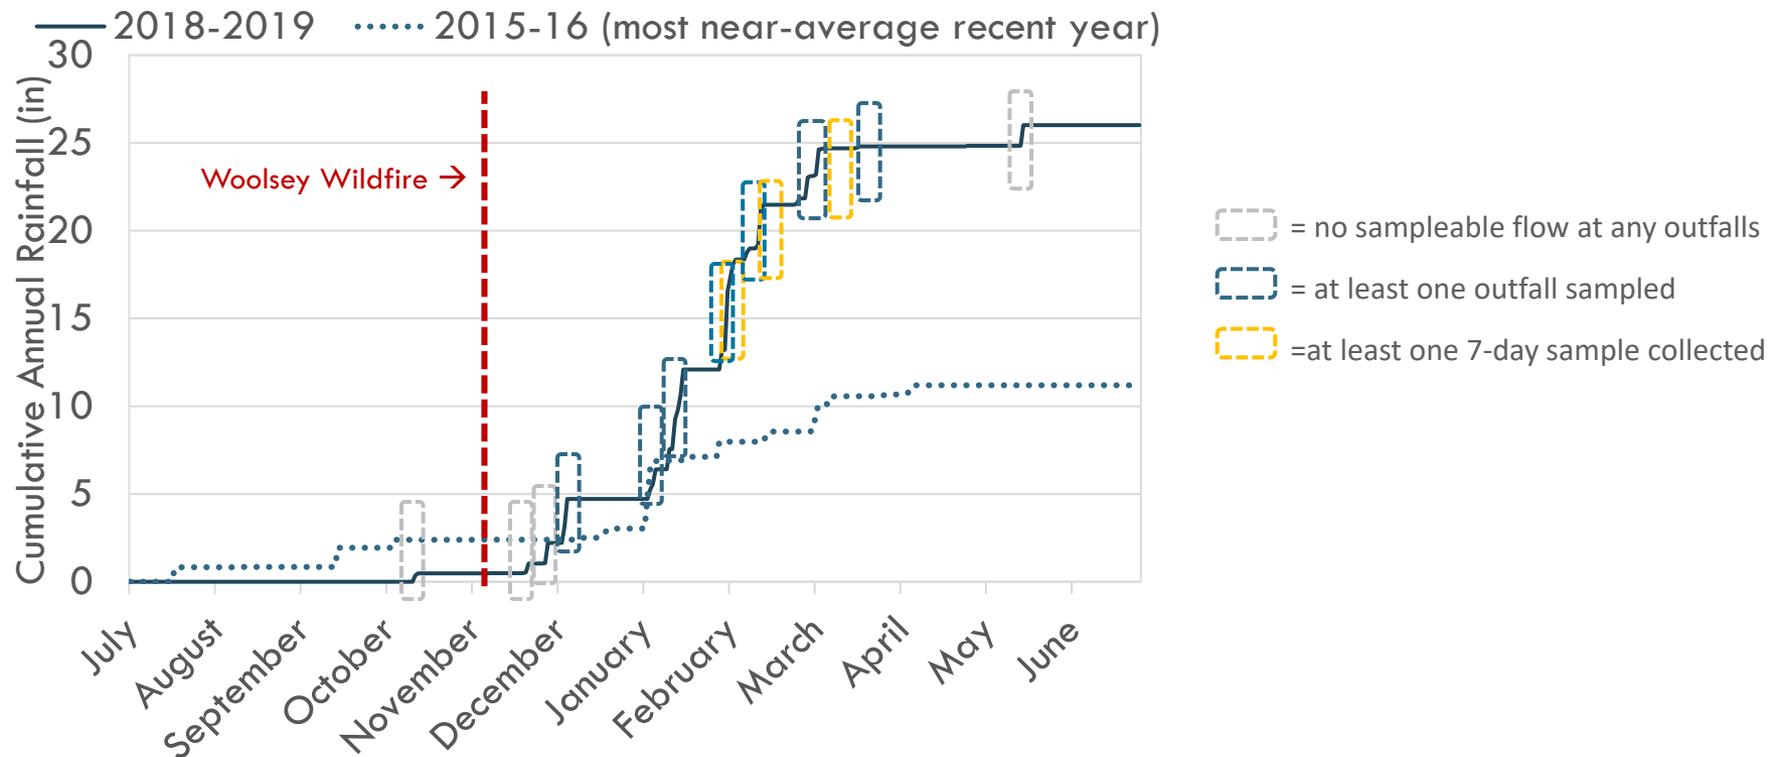
2018-19 was a wetter than average year

- Eleven qualifying rain events (>0.10 inch in 24-hrs)
 - Three 7-day samples
- Total annual rainfall 26.05 inch (vs. 16.8 inch average)

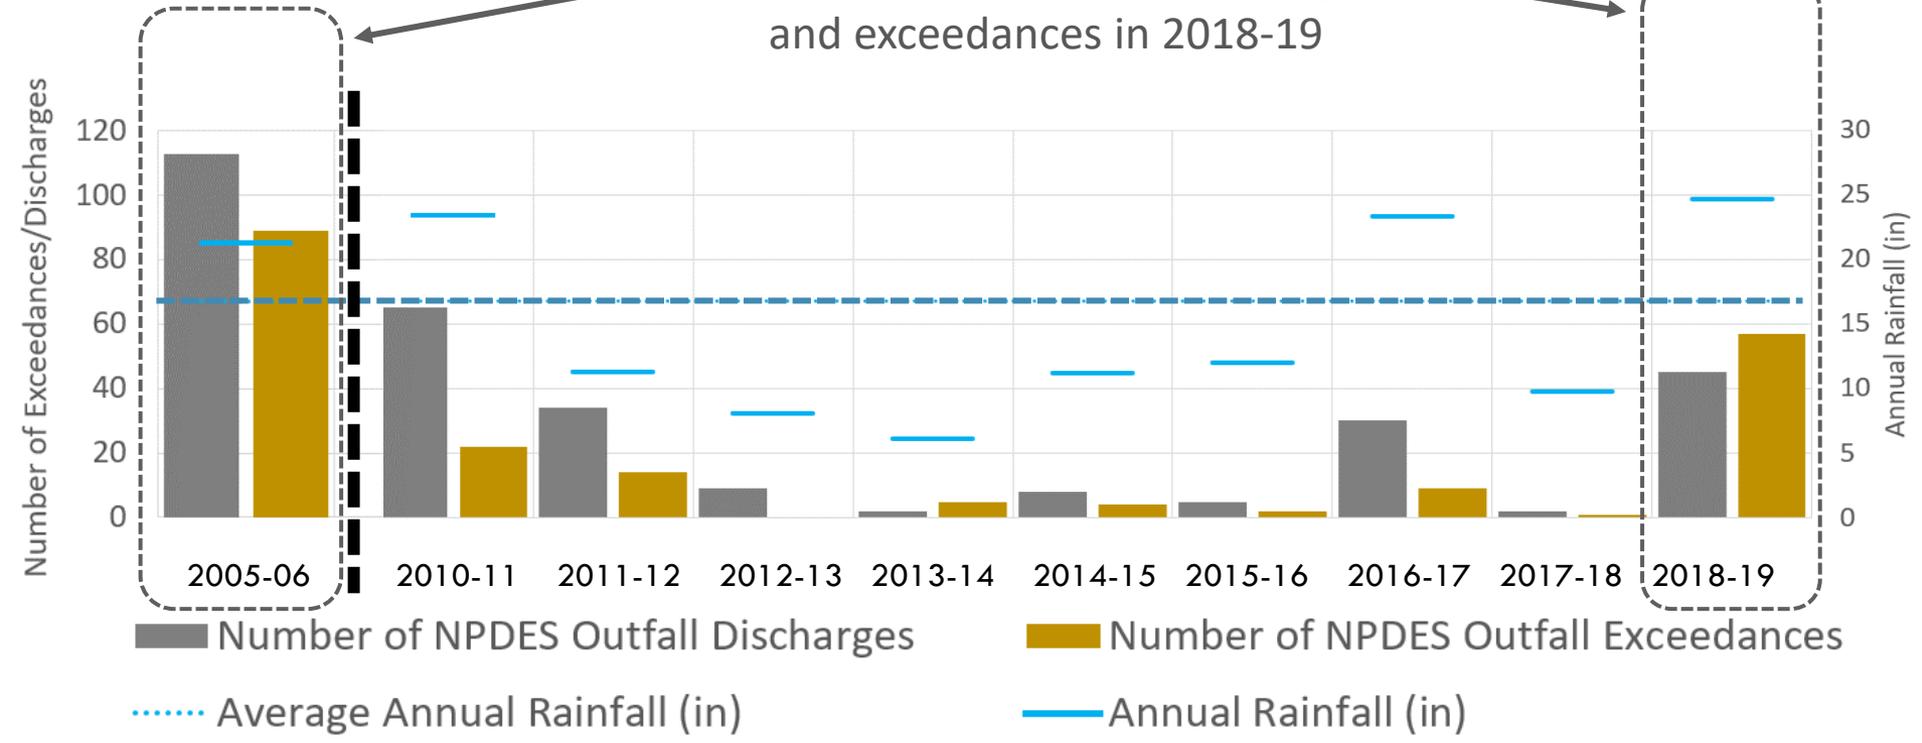
Historical Overview – NPDES Sampling All SSFL Outfalls

Similar post-wildfire rain years,
but substantially fewer discharges
and exceedances in 2018-19
