Santa Susana Field Laboratory (SSFL) Stormwater Public Meeting

November 4, 2025

SSFL Surface Water Expert Panel

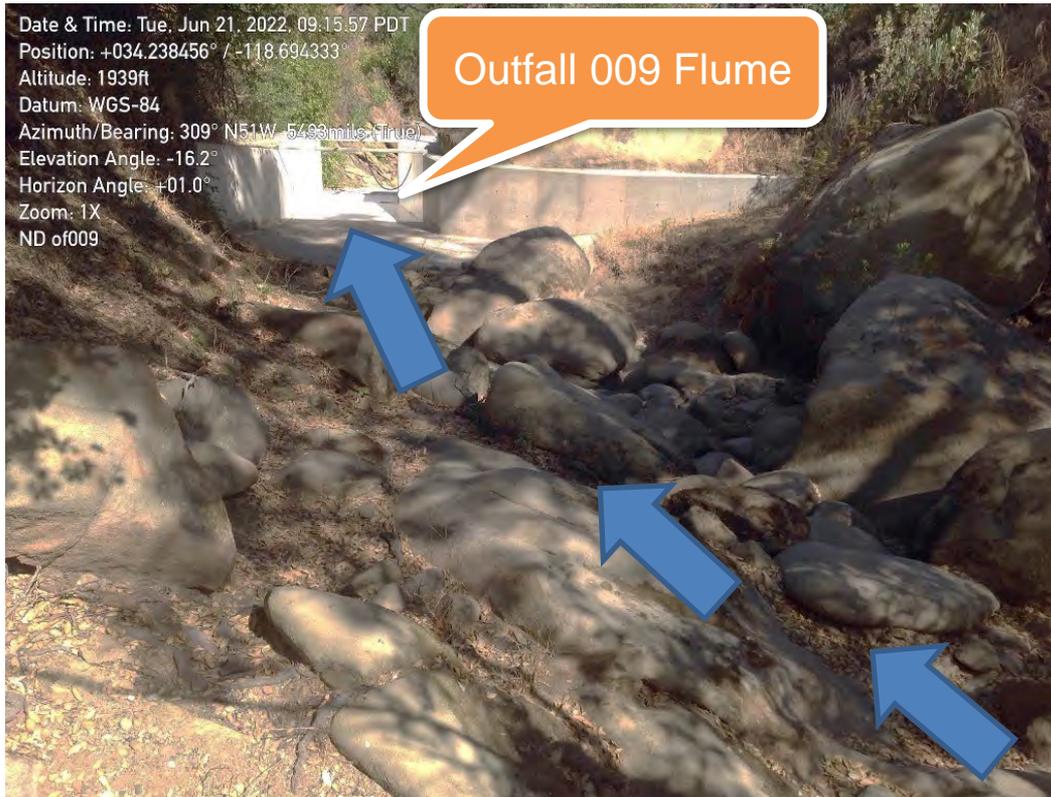
NPDES Outfall Example: Outfall 009

- All creek flow is directed through the flume to enable flow measurement and water sampling
- Outfalls also equipped with autosamplers to enable 24/7 composite sampling

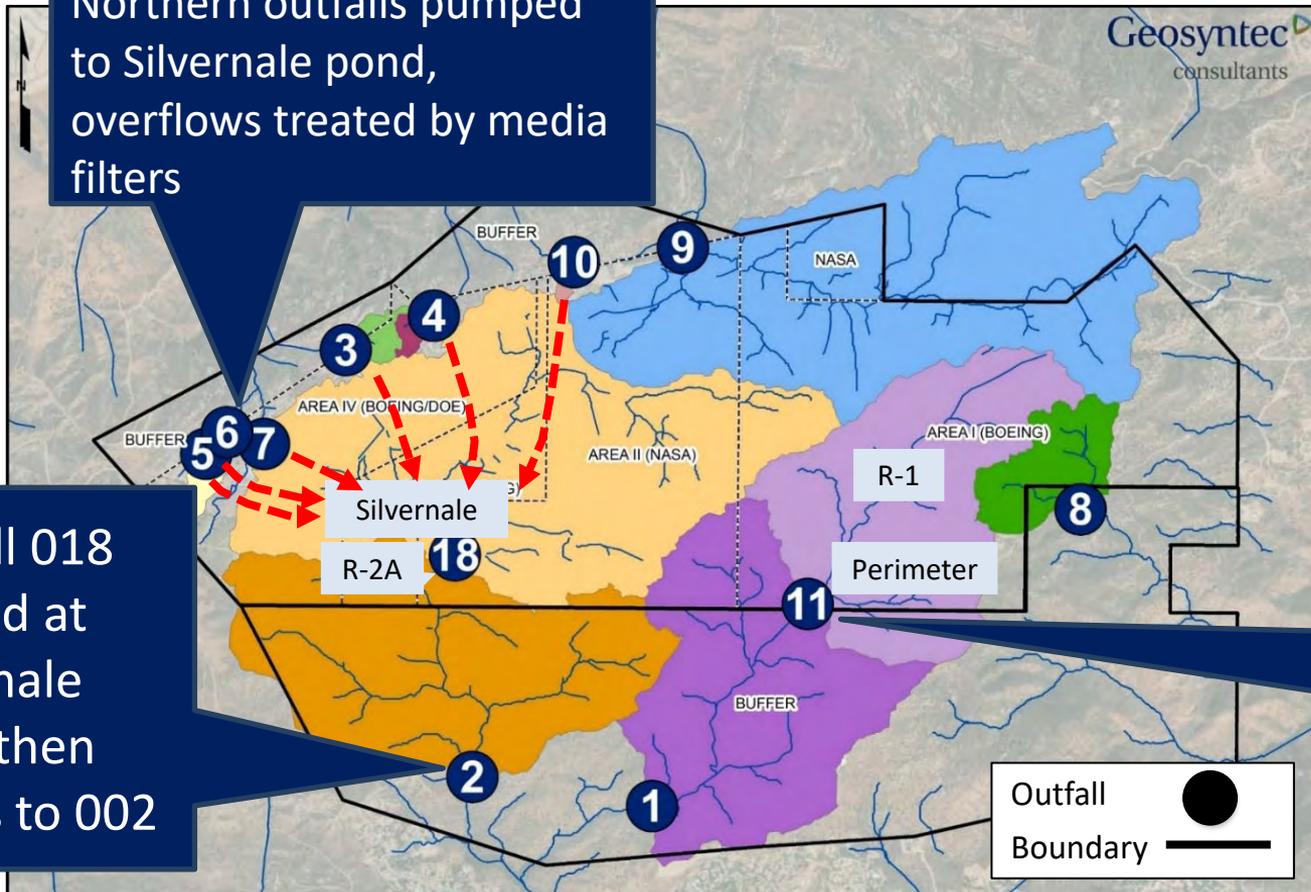
NPDES Outfalls and Watersheds SSFL

Northern outfalls pumped to Silvernale pond, overflows treated by media filters

Outfall 018 treated at Silvernale Pond then drains to 002

Outfall 011 treated at R-1 Pond then drains to 001

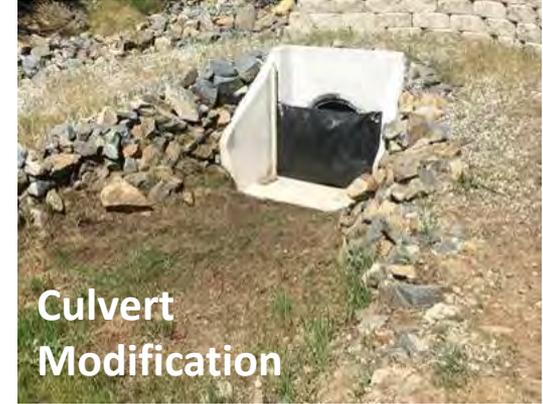
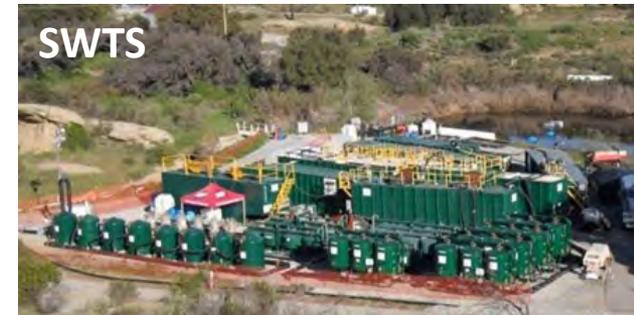
Existing Stormwater Controls

- **Distributed Passive Treatment BMPs**
 - Constructed at prioritized locations in Outfall 009 watershed
 - Include multiple treatment processes and filtration media targeting NPDES exceeding constituents
- **Active stormwater treatment systems (SWTS)**
 - Advanced treatment train (requires power, chemical addition, pressurized vessels)
 - Outfall 011 and 018 watersheds
- **Erosion controls**
 - Implemented site-wide
 - Designed to hold soils in place, especially where surface soils are contaminated

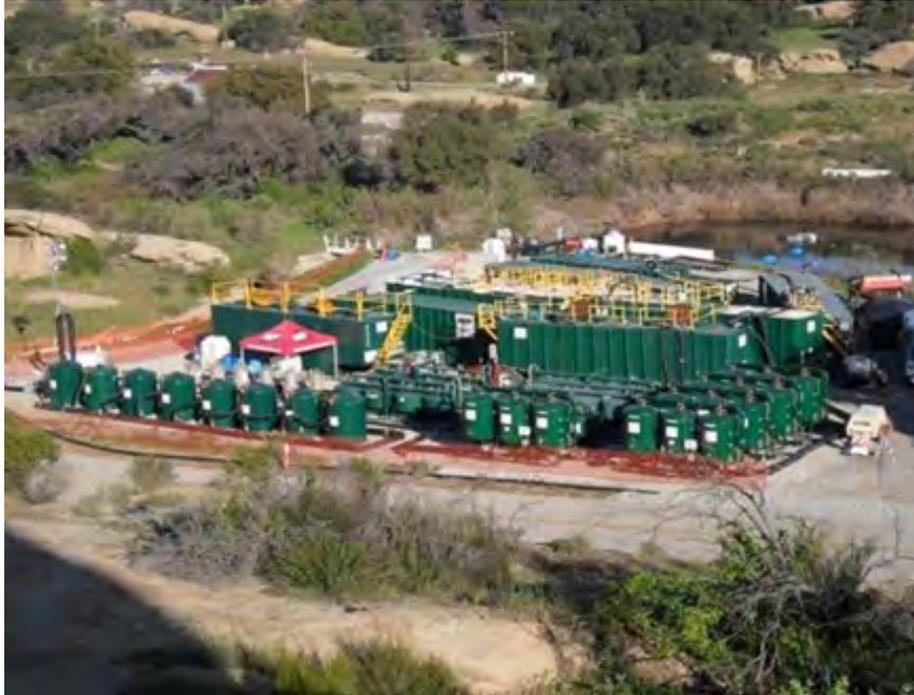
Active Stormwater Treatment Systems (SWTSs)

- Ponds for flow equalization and sedimentation pretreatment
- Screen filters
- pH adjustment (chemical addition)
- ACTIFLO to remove solids, metals, and organics via
 - Coagulation (chemical addition)
 - Flocculation
 - Settled solids removed and transported offsite
- Potassium permanganate-coated sand filter, then bag filters
- Granular Activated Carbon (GAC) filter, for organics removal, if needed
- Treated stormwater discharged at outfalls
- Silvernale SWTS treats >880 acres, at 1200 GPM

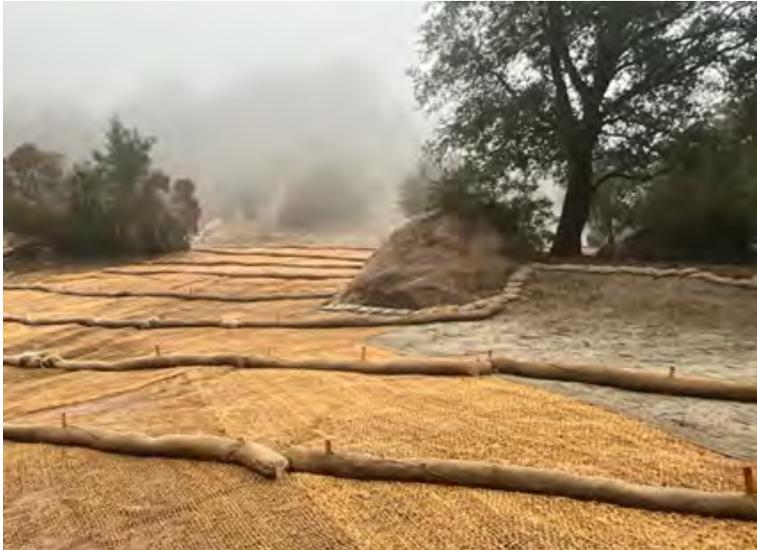
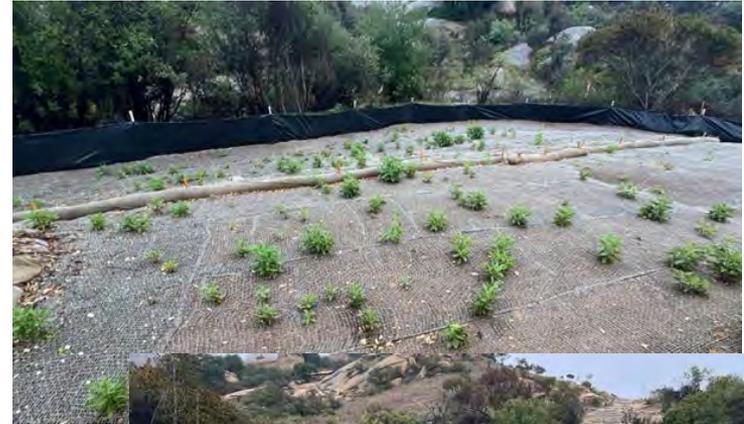
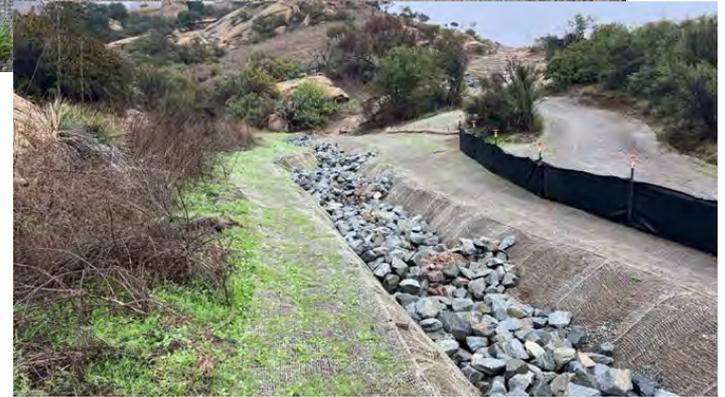
Former Shooting Range

- March 12, 2025 Site Visit

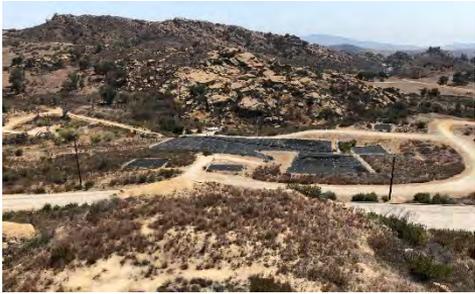
A1BP **before** remediation
September 2021

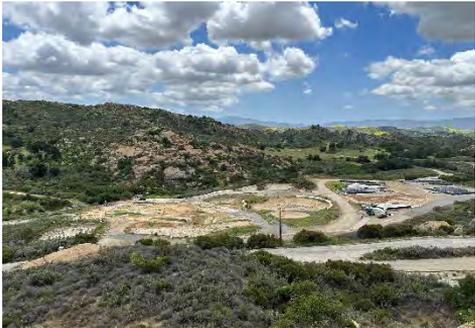
A1BP **during** remediation
May 2025

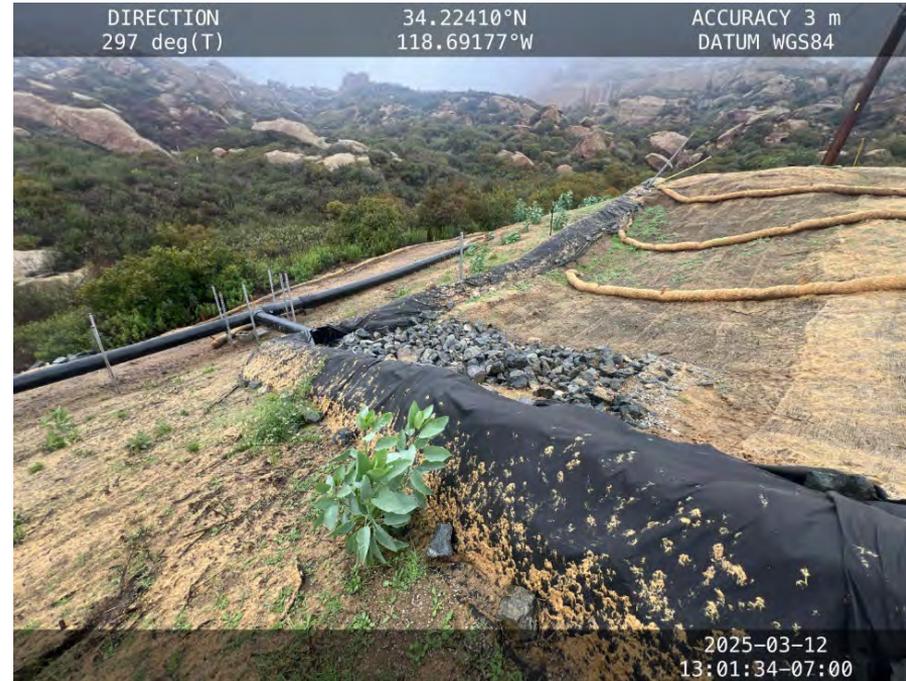
A1BP Updates

- Excavation scheduled during dry season to minimize runoff risk
- Stormwater from western side diverted to SWTS
- Maintain existing BMPs and install final stabilization measures where work is complete

March 12, 2025 Site Visit

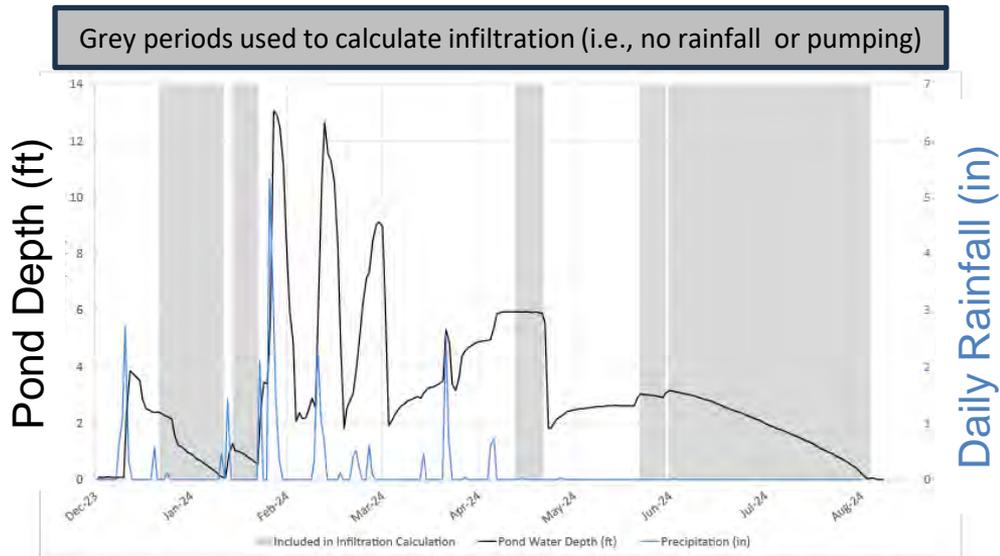
Figure 5. Water Depth and Precipitation at R-1 Pond: December 12, 2023 – August 21, 2024

- Water levels measured over several months with ponded water present
- Infiltration rates calculated after subtracting evaporation when water levels not affected by precipitation

Results confirm that stormwater infiltration in the ponds at SSFL is at or below the least conductive soils identified by the USDA-NCRS (i.e., clay) and therefore **unlikely to contribute significant transport of COPCs to groundwater.**

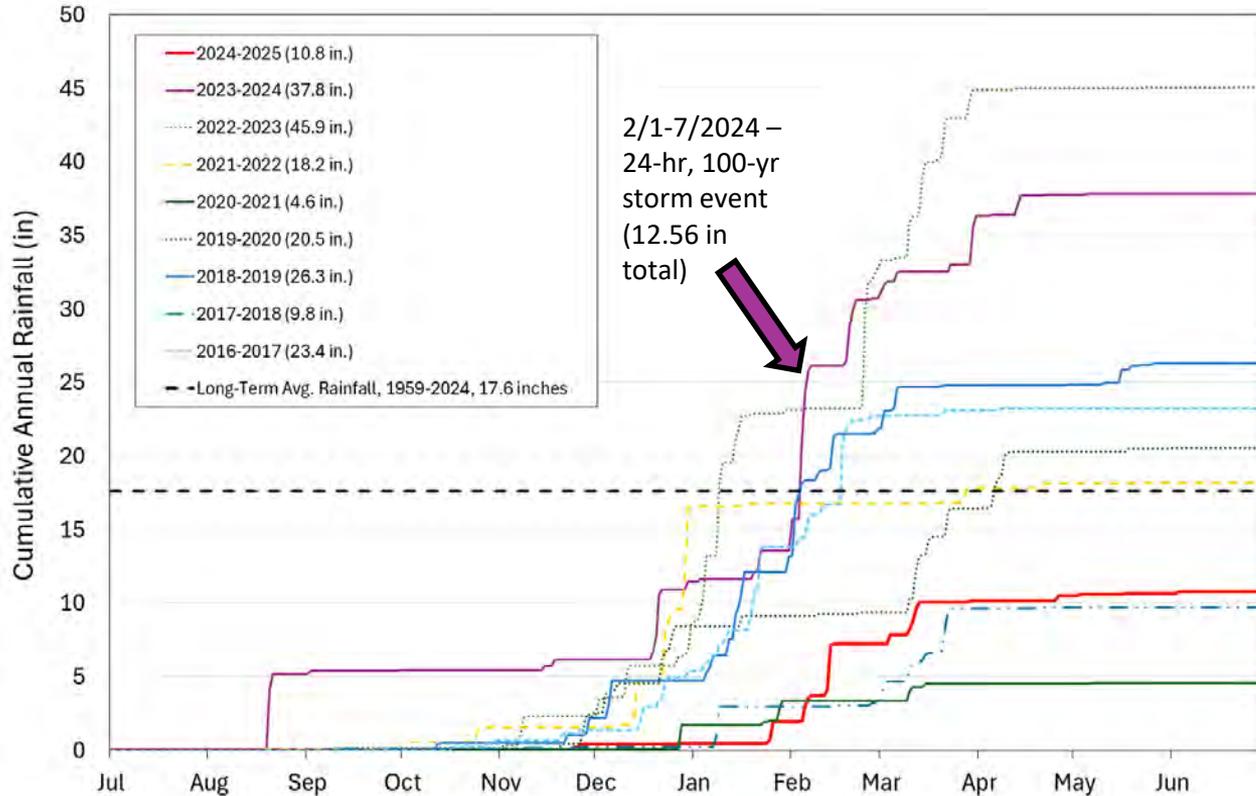
Total Rainfall by Reporting Year

2023/24: 37.8 in

- 2x greater than average annual rainfall
- First 100-year storm event in recorded data at site (66 years)

2024/25: 10.8 in.

- 0.65x of average annual rainfall

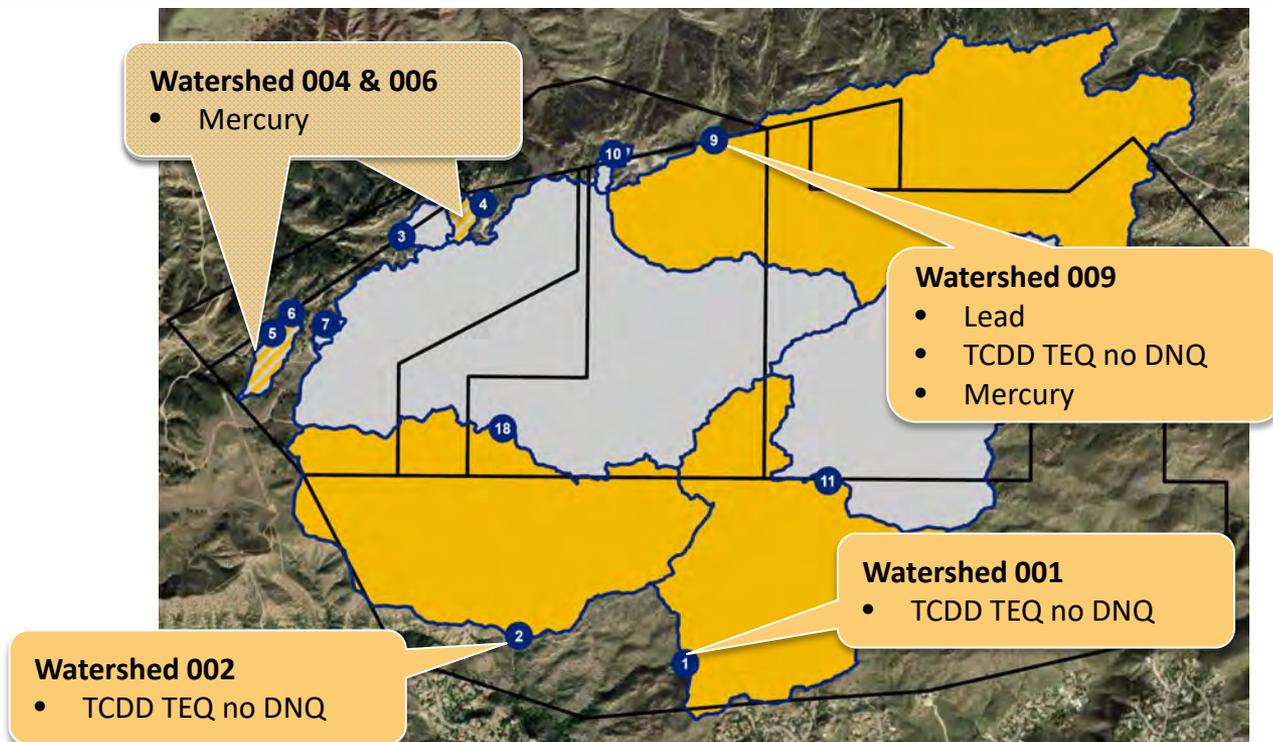
Watersheds with Exceedances potentially attributed* to industrially-impacted Soils (2023/24 and 2024/25)

Non-hashed yellow indicated exceeding watersheds and grey non-exceeding. Note Watersheds 004 and 006 are hashed because the exceedances were associated with extreme storm events that are normally treated.

Exceedances with industrially impacted soils identified as at least one of the sources have been prioritized. Additional non-industrial sources may also have also been identified

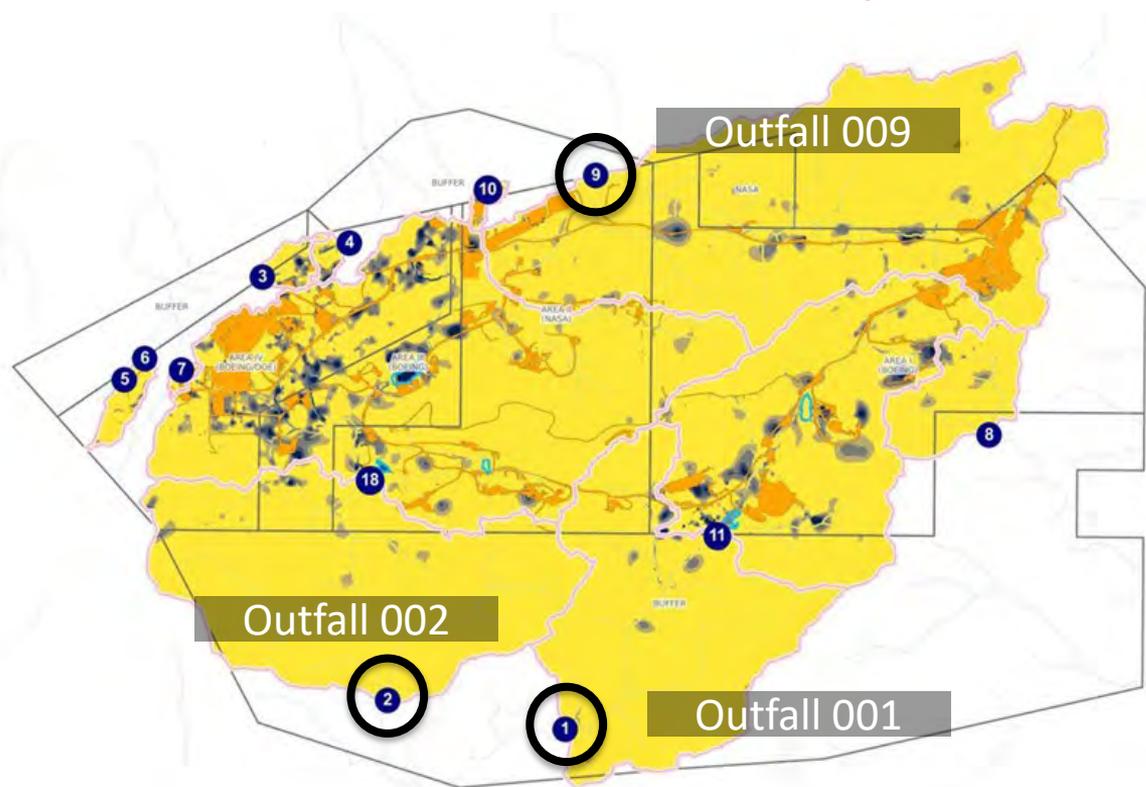
Exceeding Parameters Potentially from Industrially-impacted Surface Soils: Dioxins Example

- Blue areas show surface soils above anticipated clean-up thresholds; orange shows pavement or roof (i.e., no soil exposure)
- **Circled outfalls** had dioxin exceedances in past 2 rainy seasons
- Smaller western watersheds are pumped to and treated at Silvernale, along with watersheds 011 and 018

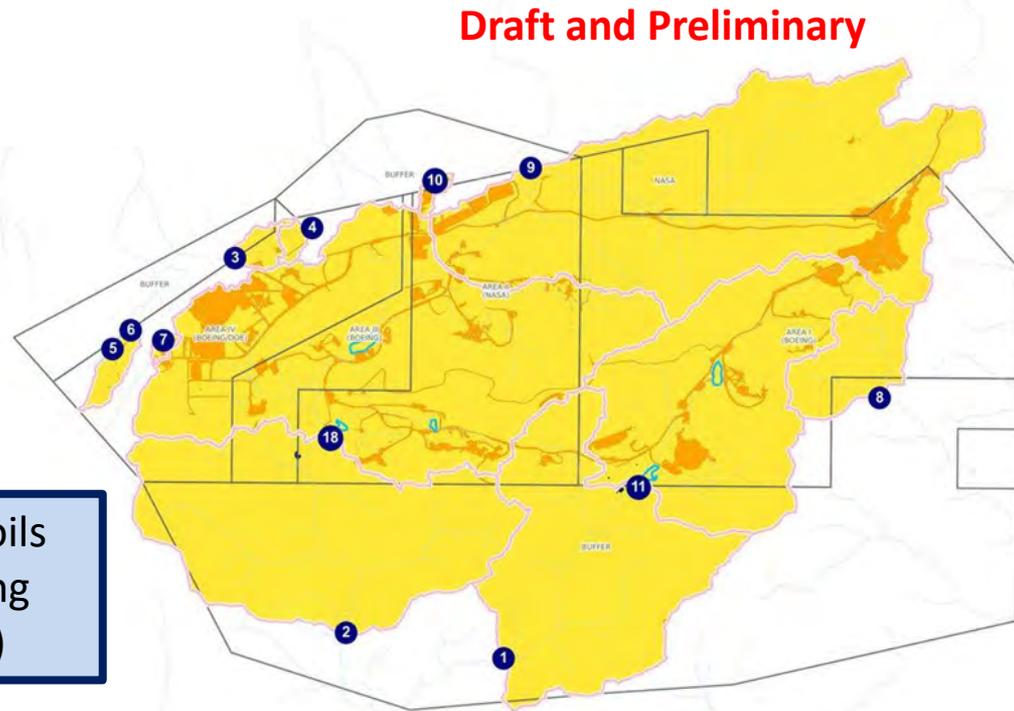
Exceeding Parameters From Natural Background Soils: Aluminum, Iron, and Manganese

- Blue areas (*few and very small*) show surface soils above anticipated clean-up thresholds for manganese; orange shows pavement or roof (i.e., no soil exposure)
- Other forensic lines of evidence also support this conclusion

$\leq 0.02\%$ of area with surface soils above cleanup thresholds (using background threshold for iron)

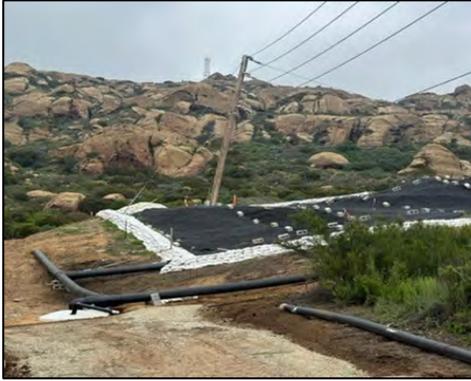
Watersheds 001 & 011: Western A1BP Diversion to Perimeter Pond/SWTS

- Stormwater from western portion of A1BP originally flowed to outfall 001 (no treatment)
- This stormwater is now captured and diverted to Perimeter Pond, treated at SWTS, and discharged and sampled at outfall 011

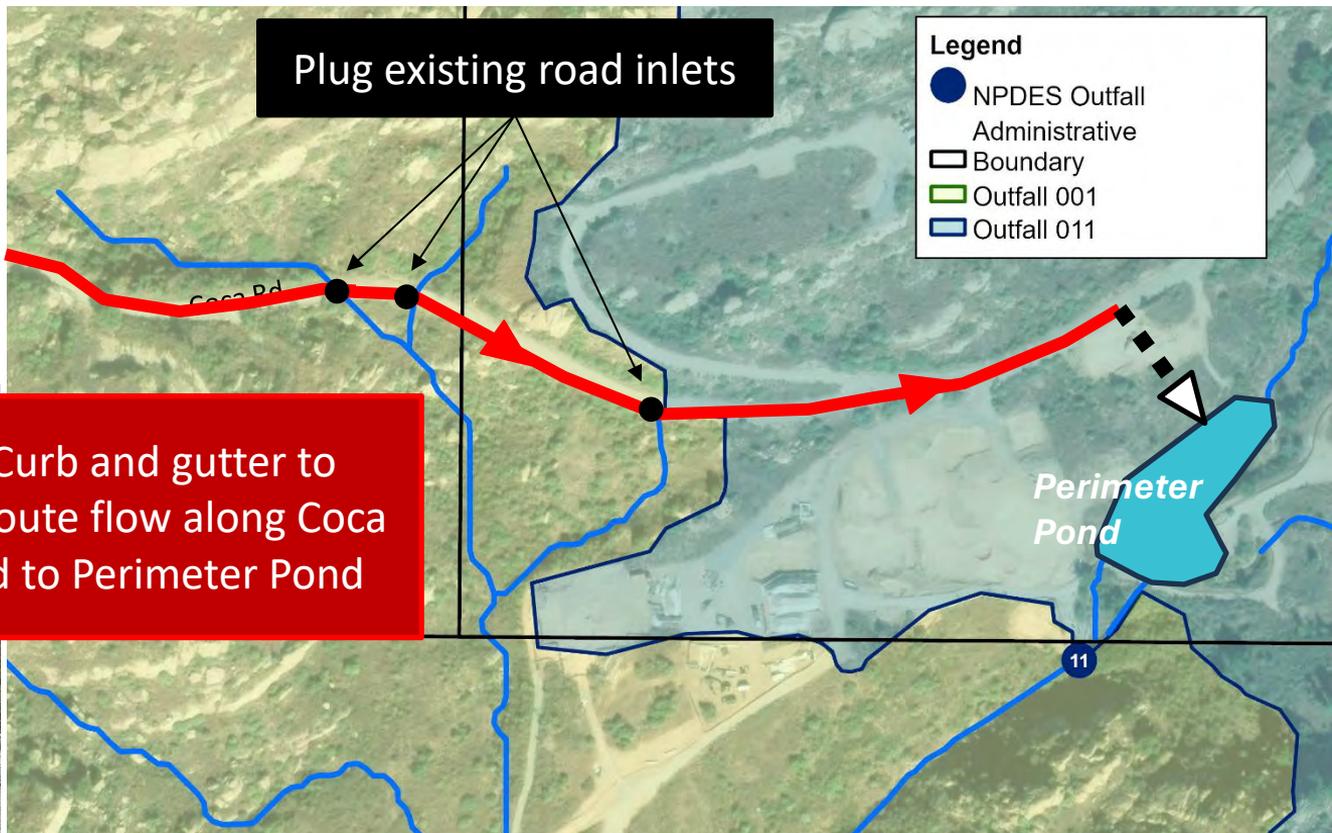
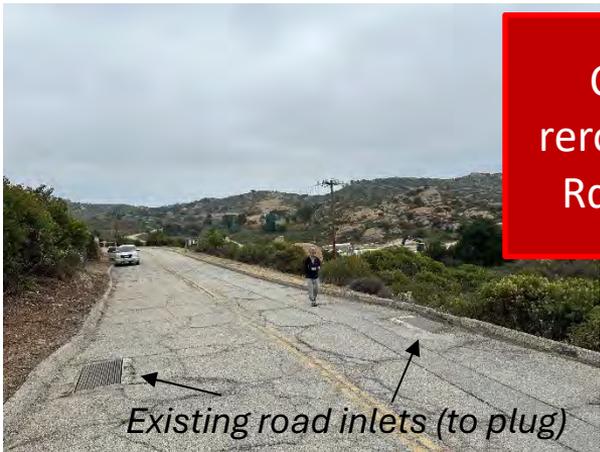
Watersheds 001 & 011: Diversion of Coca Rd Stormwater to Perimeter Pond/SWTS

Coca Road stormwater previously flowed to OF001 (untreated), will later flow to OF011 (treated) via Perimeter Pond

Curb and gutter to reroute flow along Coca Rd to Perimeter Pond

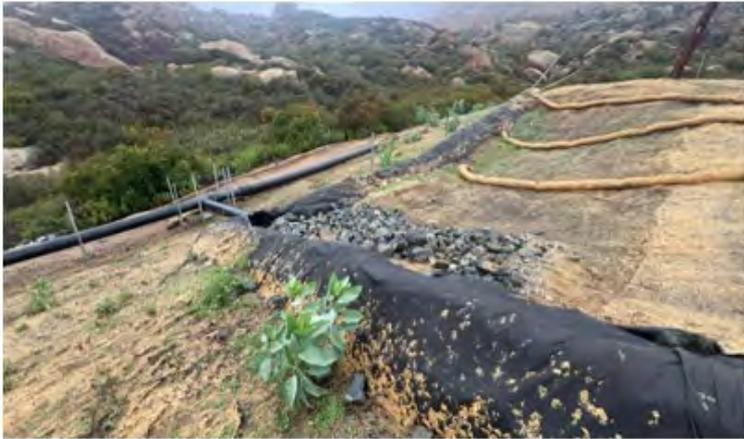
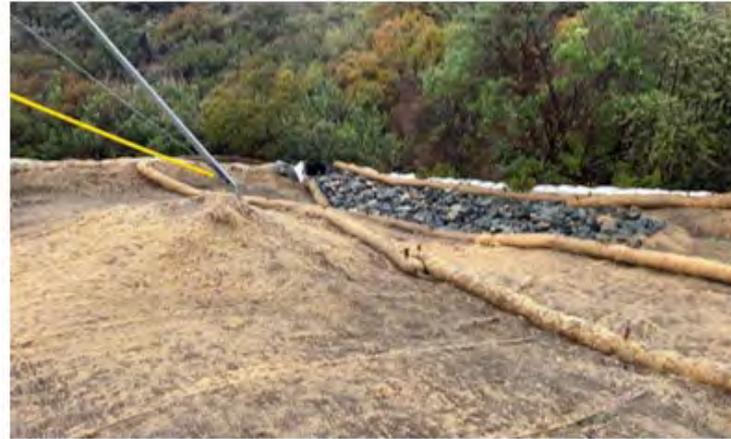
Watersheds 001 & 011 : Erosion Controls at A1BP

- Implemented temporary stabilization BMPs at inactive areas (i.e., hydromulch)
- Final stabilization BMPs at locations where work is complete
- Install stabilized channels along concentrated flow paths

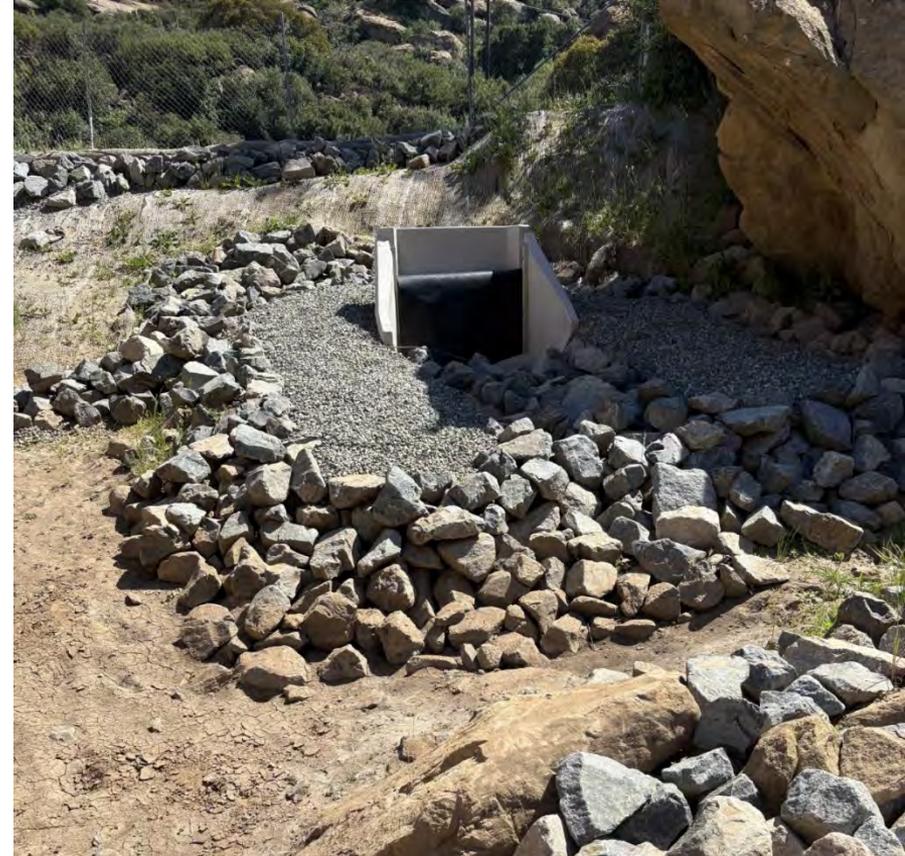
Watershed 009: CM-12 Reconstruction

- CM-12 is located within the Former Shooting Range ISE area
- Impacted by excavation activities
- Important BMP for reducing particulate-bound COPCs entering the Northern Drainage

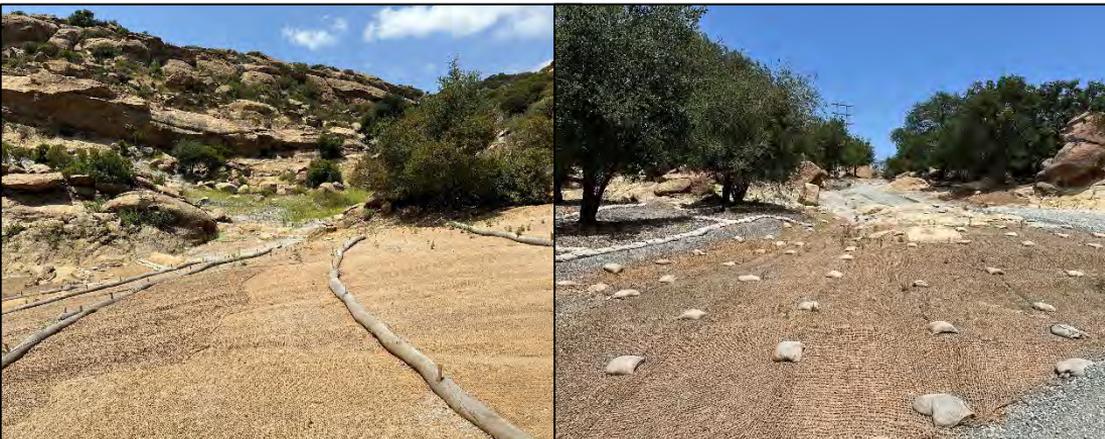
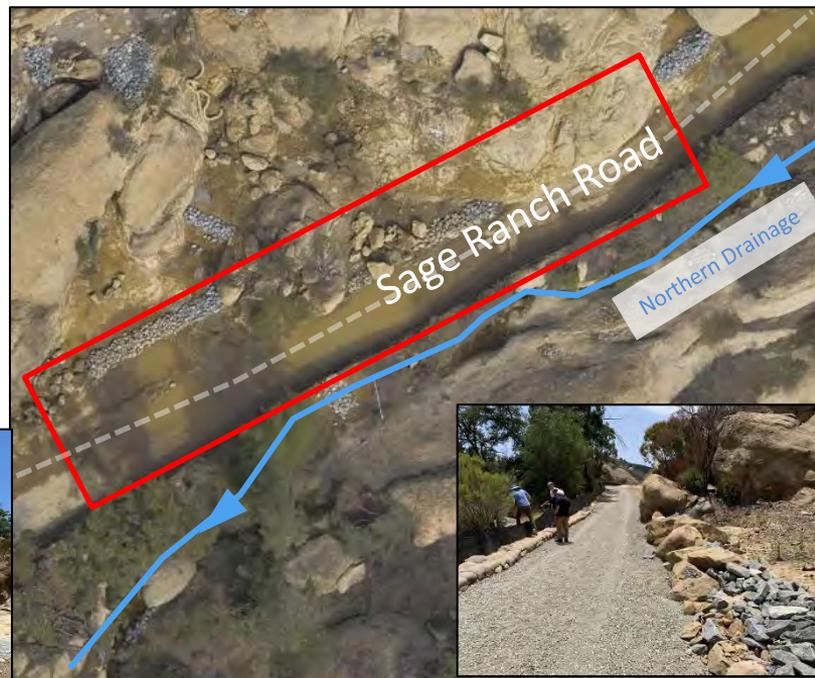
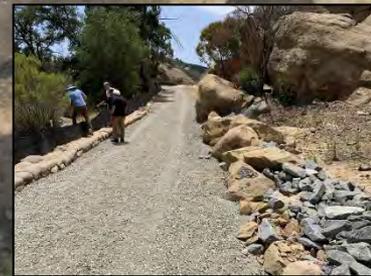
Watershed 009: Shooting Range Stabilization and Sage Ranch Rd.

- Implementation of Shooting range erosion controls
 - (e.g., armored channelized areas, jute netting, staked wattles, and mulch)
- Improvements to Sage Ranch Road near Northern Drainage

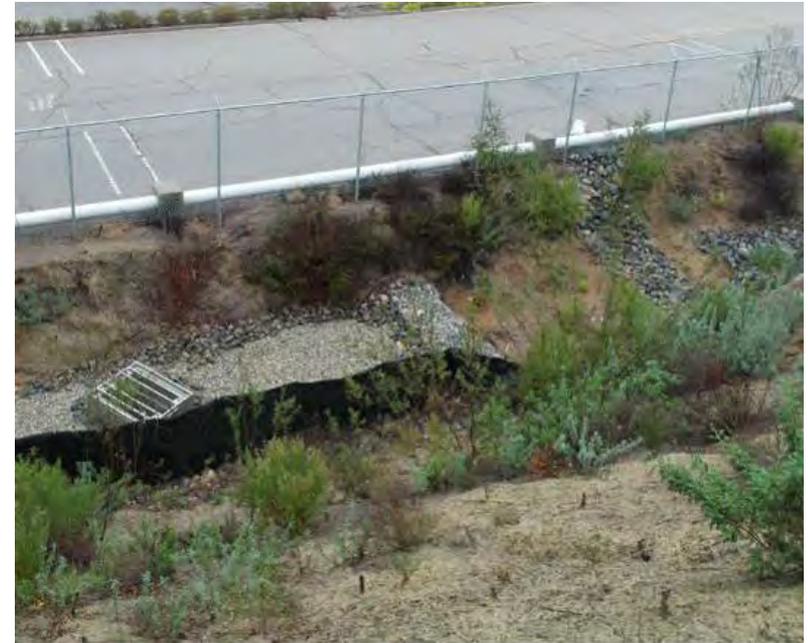
- Stormwater from B1 Media Filter subarea found to have highest mercury concentrations in 009 watershed

- B-1 Media Filter ranked 1 of 33
- Media mix replacement recommended
- Improved GAC within media mix specifically targeting mercury

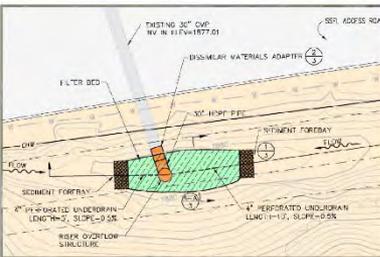
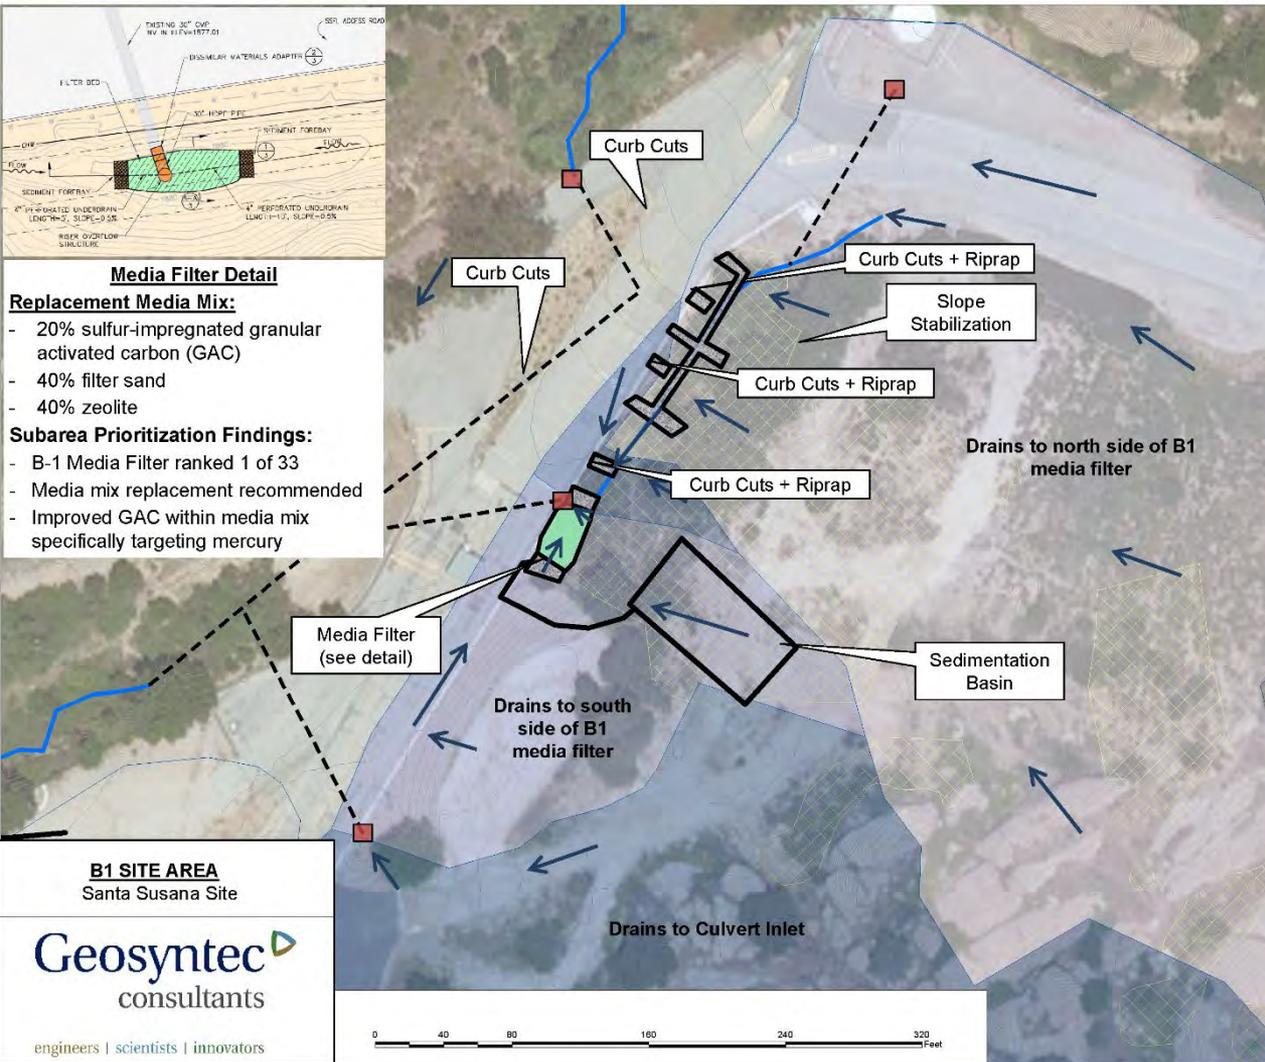
Media Filter Detail

Replacement Media Mix:

- 20% sulfur-impregnated granular activated carbon (GAC)
- 40% filter sand
- 40% zeolite
