# Santa Susana Field Laboratory (SSFL) Site-Wide Stormwater Public Meeting

SSFL Surface Water Expert Panel | November 17, 2022

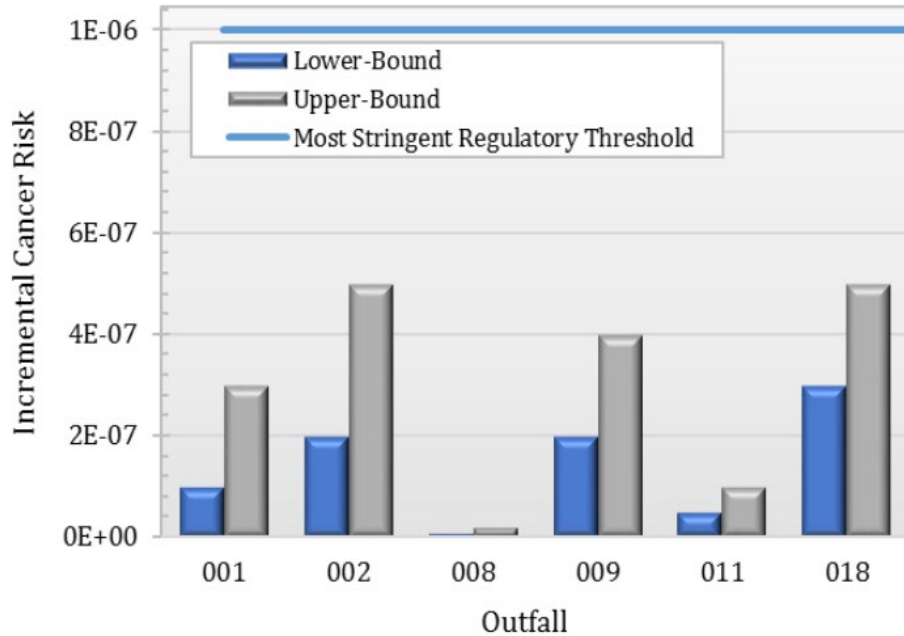
## Cumulative Incremental Cancer Risk Estimates by Outfall

- The stormwater Human Health Risk Assessment (HHRA) found low health risks from exposure to SSFL stormwater based on stormwater conditions present from 2009-2016 (less than the risk level of 1:1,000,000)
- [Stormwater HHRA](#) was reviewed and approved by Office of Environmental Health Hazard Assessment (OEHHA)
- Exposure pathways included:
  - Dermal contact
  - Inhalation
  - Incidental ingestion (e.g., splashing)

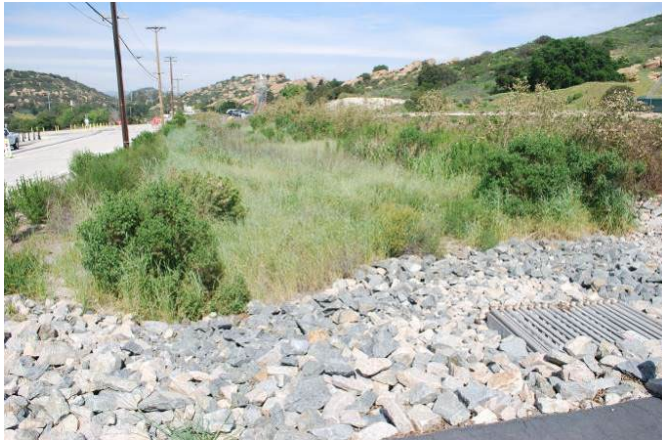
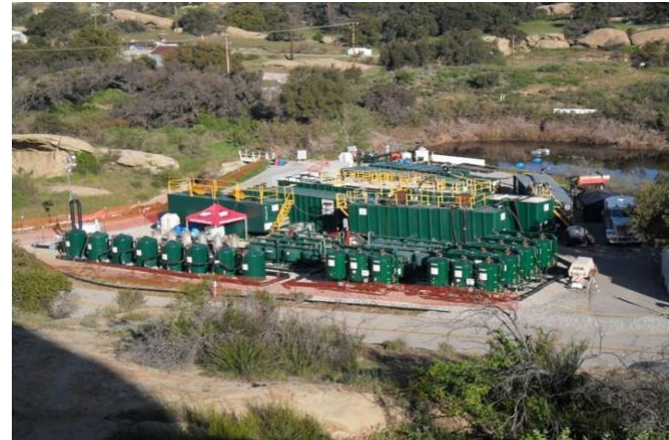
## Existing Structural Controls

- Stormwater control measures
- Active stormwater treatment systems (Outfalls 011 and 018)

- **Distributed Passive Treatment BMPs**
  - Filter media mix developed for SSFL BMPs consisting of sand, zeolite, and granulated activated carbon (GAC)
  - Located throughout Outfall 009 Watershed
  - Variety of formats depending on space available
    - Culvert Modifications (CMs) and Media Filters
    - Lower Lot Biofilter
    - Detention Bioswales
    - ELV Treatment BMP
- **Active stormwater treatment systems (SWTS)**
  - Coagulation, sedimentation, and filtration plants in Outfall 011 and 018 watersheds

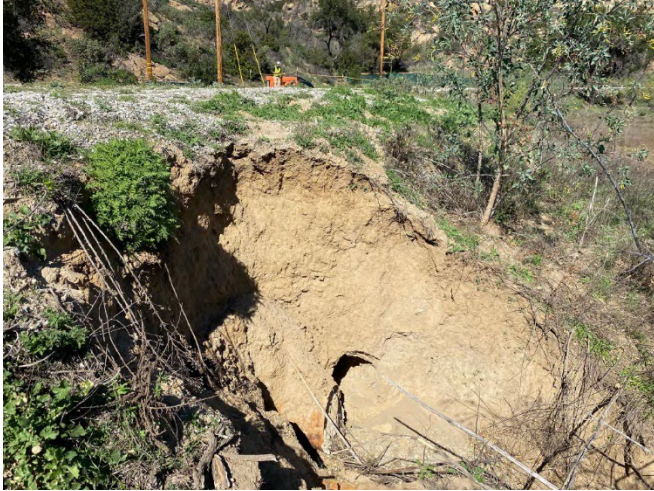
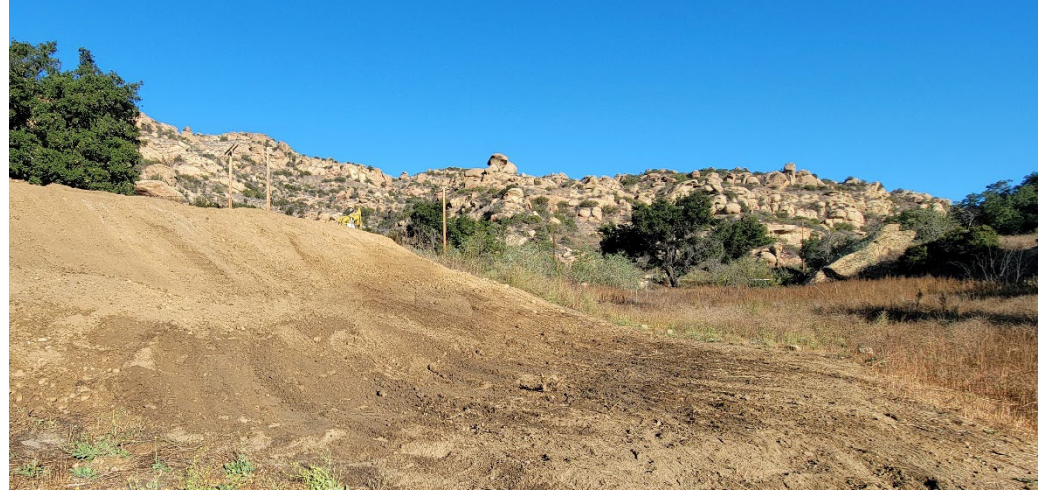
- R1 Pond berm repair completed in November 2022

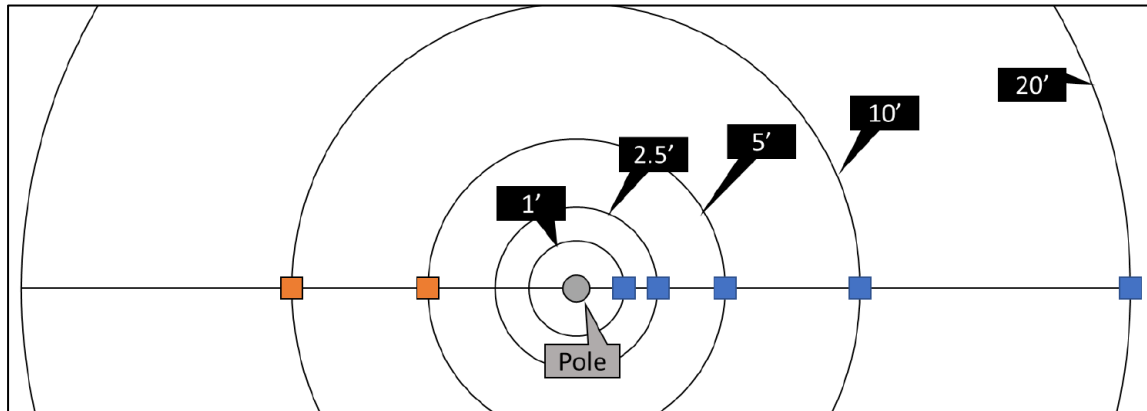
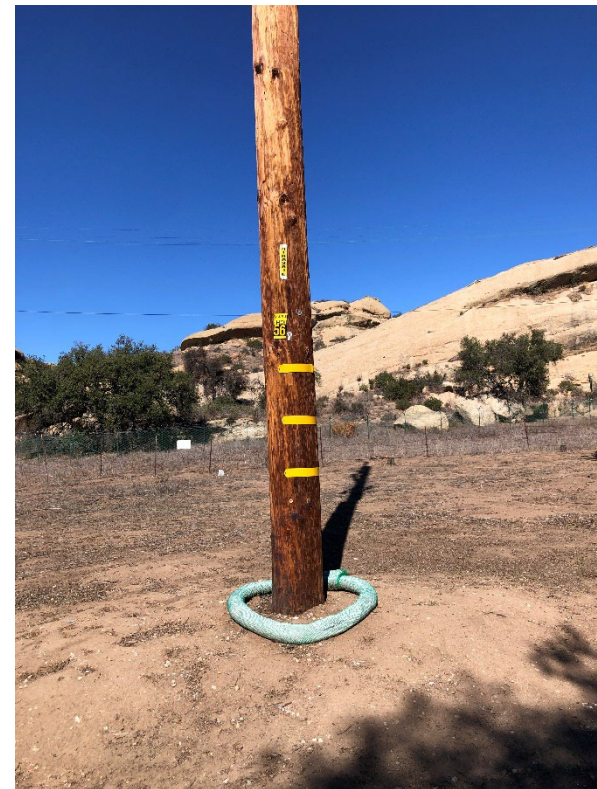
- Sampled soil at various distances from treated wood utility poles
- Distinct relationship between distance from pole and dioxin concentration in soil
- Recommended removing unnecessary poles
- Updated BMP guidance to stabilize soils within a 10 ft radius of poles

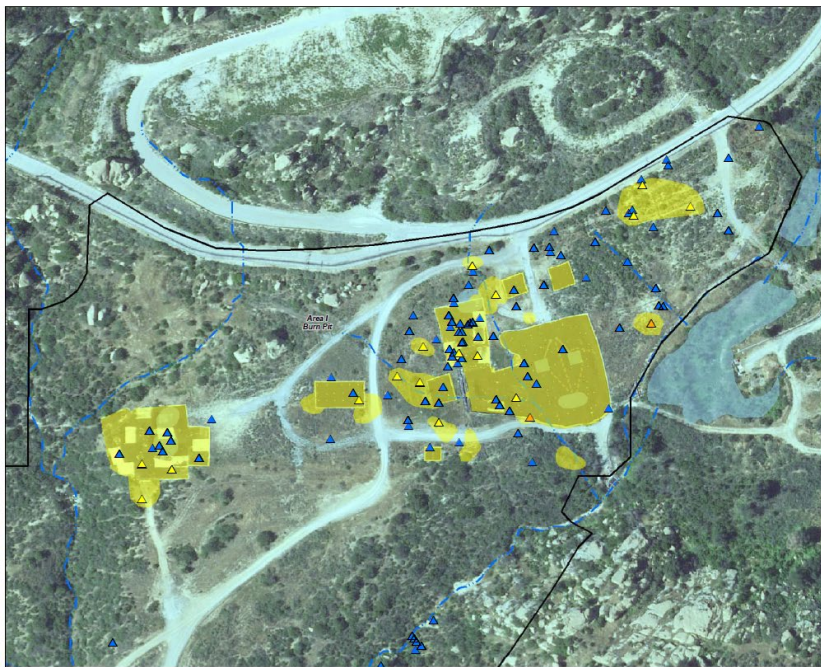
FIGURE 1  
 Corrective Action  
 Imminent and Substantial  
 Determination and Course  
 Area 1 Burn Pit RFI Site  
 Santa Susana Field Lab

Area 1 Burn Pit (Outfall 011 & 001 Watersheds)

Notes:  
 1. Proposed Erosion/Sediment Control BMPs will be determined in the field by the QSP and may include, but are not limited to: silt fencing, gravel bag berms, sand bag berms, and/or fiber rolls.  
 2. When installing silt fence BMPs, also install a cool fiber roll along the base and on the upgradient side of the fence.

- Two early cleanup actions have been ordered by DTSC
- Scheduled to start soil removal in 2023 after the rainy season
- The Panel is reviewing the SWPPPs and recommending stormwater BMPs for during and after cleanup
