Santa Susana Field Laboratory
Site-Wide Stormwater Annual Report
2015/2016 Reporting Year

The Surface Water Expert Panel
and

SB0363W
October 2016

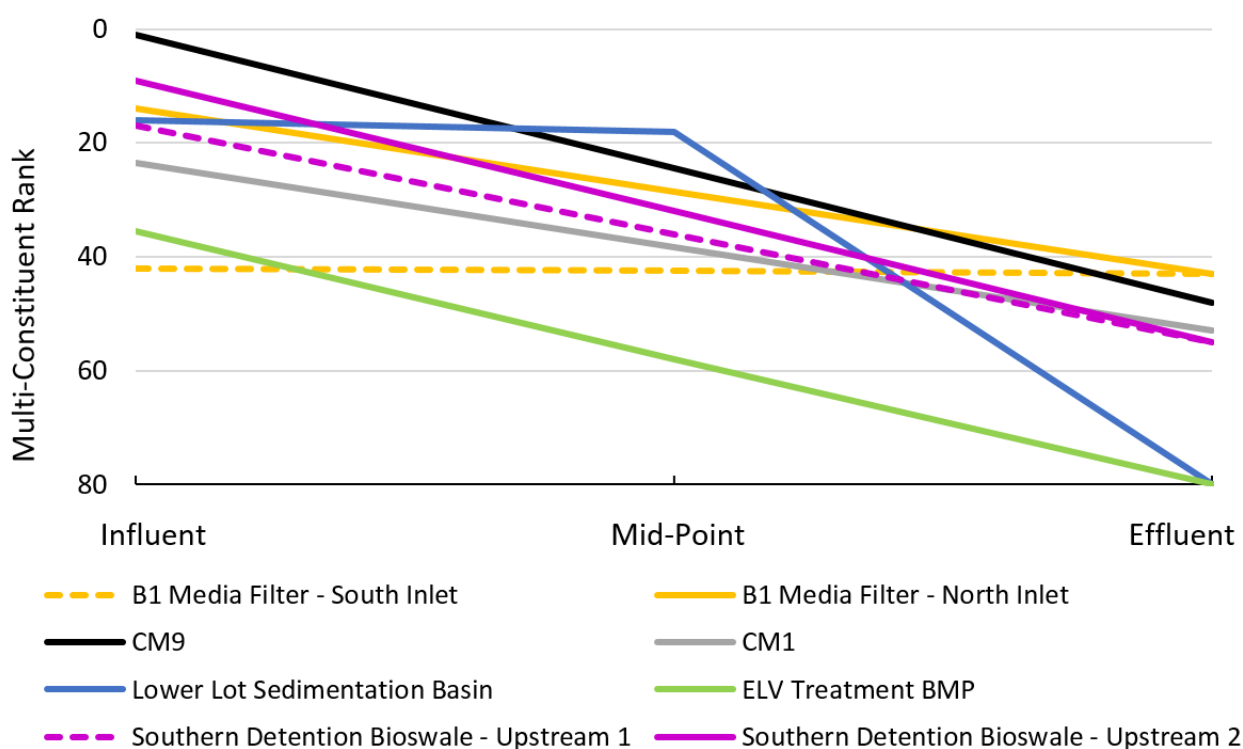
Figure 5. Graphical Comparison of BMP Influent/Effluent Monitoring Location Ranks

on the locations ranked in the top 20 overall in the BMP subarea prioritization analysis. This comparison demonstrates that treatment through the BMPs resulted in improved water quality, as demonstrated by a decrease between the influent and effluent rank. For example, two influent streams within the B-1 area (ranked 14 and 42) are both more highly ranked than the associated B-1 effluent, which is ranked 43. A similar occurrence is observed for the influent/effluent ranks for CM-1, CM-9, the ELV treatment BMP, and the lower lot sedimentation basin and biofilter.

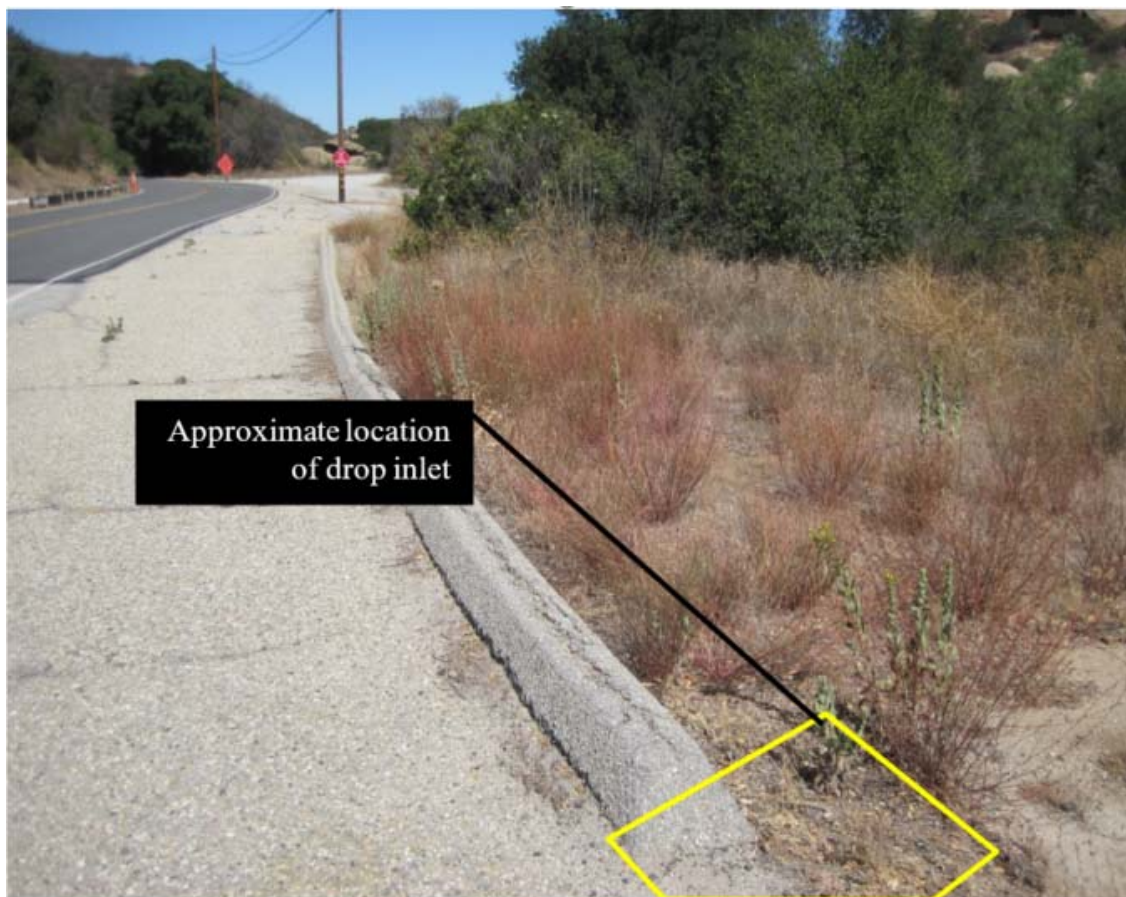
Figure 14. Proposed Location of Drop Inlet along Service Area Road

detailed topographic information, actually drains south across the service area road and is treated by CM-4. The remaining untreated roadway area drains north; it was therefore recommended that runoff from this area be collected at one location near the LOX area, collected by a curb installed along the northern side of the road to prevent the runoff from discharging off the road into the Northern drainage directly. It was further recommended that Boeing install a drop inlet (see Figure 14), that would capture Service Area Runoff upstream and divert it South across the road to CM-10, for treatment through the existing media filter. This design was ultimately selected over a new media filter due to lower construction costs, no additional maintenance requirements, and the available hydraulic capacity at CM-10. To fully treat the Site design storm (1-year, 24-hour storm; 2.3 inches), it is also recommended that the existing weir boards of the CM-10 be extended to a height of two feet. The recommendations above were included in the memorandum *Evaluation of Stormwater BMP Opportunities at SSFL* (Geosyntec Consultants, 2016a).

The expanded CM-10 is expected to capture and treat 100% of the design storm, with effluent pollutant concentrations expected to be consistent with previous CM performance monitoring results. It is anticipated that additional runoff diverted to the CM will result in more frequent maintenance requirements than status quo conditions.

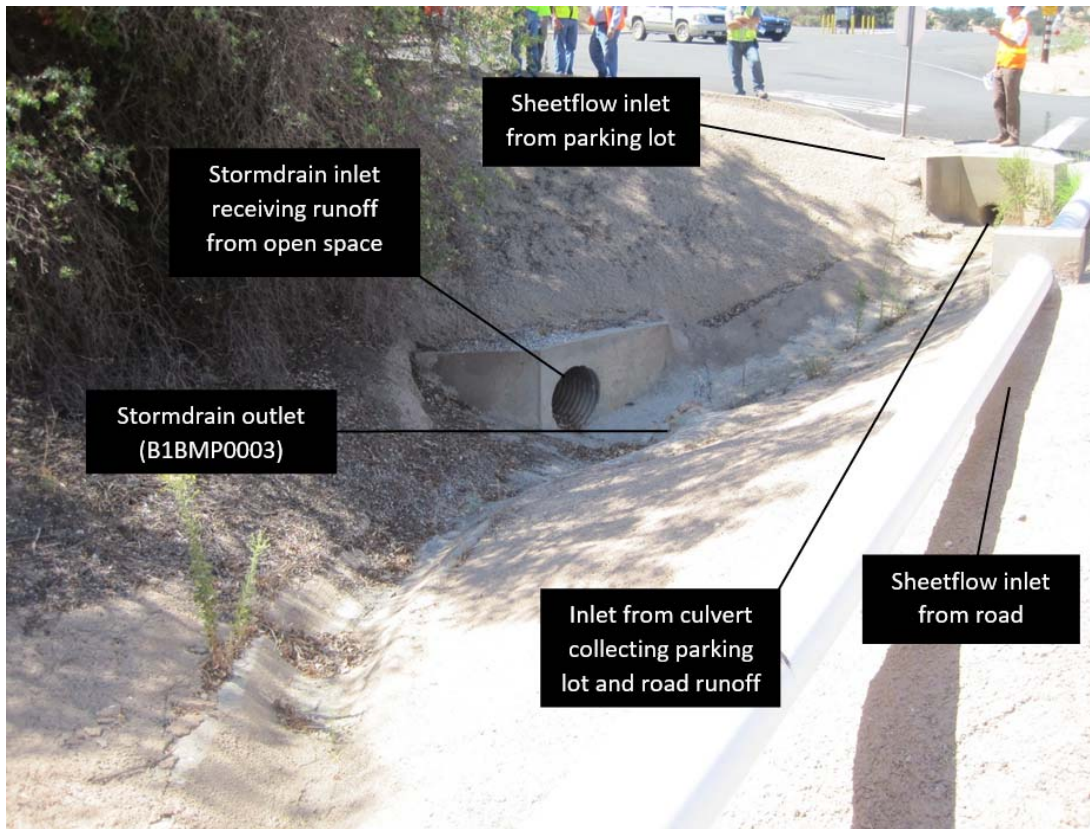
Figure 15. Proposed Location of the B1 Upper Lot BMP

Modeling results indicate that the proposed system is estimated to capture 95% of the Site design storm. Effluent concentrations are expected to be similar to results measured at the nearby B-1 media filter, proven to be effective for removal of dioxins and lead. Maintenance and inspection frequency is anticipated to be identical to what is performed at the B-1 media filter. This would include removal of debris, and long-term maintenance replacement of media as needed.

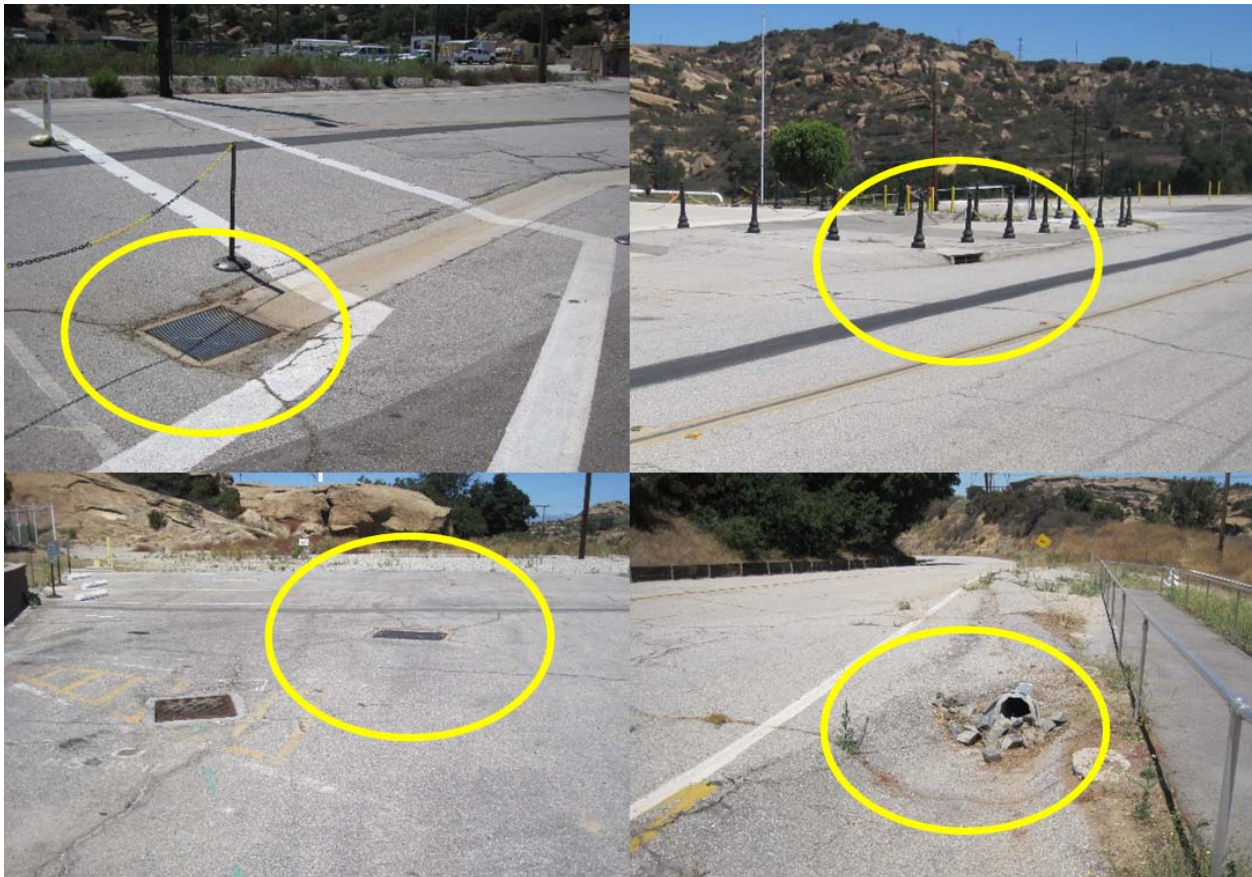
Figure 17. Administration Area Storm Drain Inlets Proposed for Filter Bags

Runoff from the paved Boeing Administrative area drains to the lower parking lot 24-inch storm drain, a portion of which is diverted to the lower lot cistern and media filter. As reported in the BMP Subarea Prioritization Analysis (Appendix F), stormwater monitoring location ILBMP0001 reflects the bypassed flow, and has continued to rank within the top 20 sites based on an overall score of 19 (ranked 11 for dioxins, 70.5 for metals, and 25 for TSS). To address this continued high rank, five storm drain inlets were identified around the Administration area for potential treatment. Since typical surface media filters cannot be installed upstream of these inlets due to space limitations, the Surface Water Expert Panel recommends initial installation of inlet filter bags to provide some filtering of coarse and medium sediments from this paved surface runoff at these locations.. The inlet filters are intended to reduce dioxin and lead concentrations measured at the 24” storm drain outlet, and to provide pretreatment for small storms routed to the biofilter. Boeing is currently evaluating and selecting these inlet filter bags and plans to install these in 2016 if possible. As shown in Figure 17 (bottom right), the inlet shown along the roadway is not conducive to a filter bag installation, therefore this location will include a sand bag berm upstream of the inlet to provide detention and capture of coarse sediments , to the extent feasible without resulting in flooding. Maintenance will require inspection after all large storms, and removal of debris/sediment as needed.

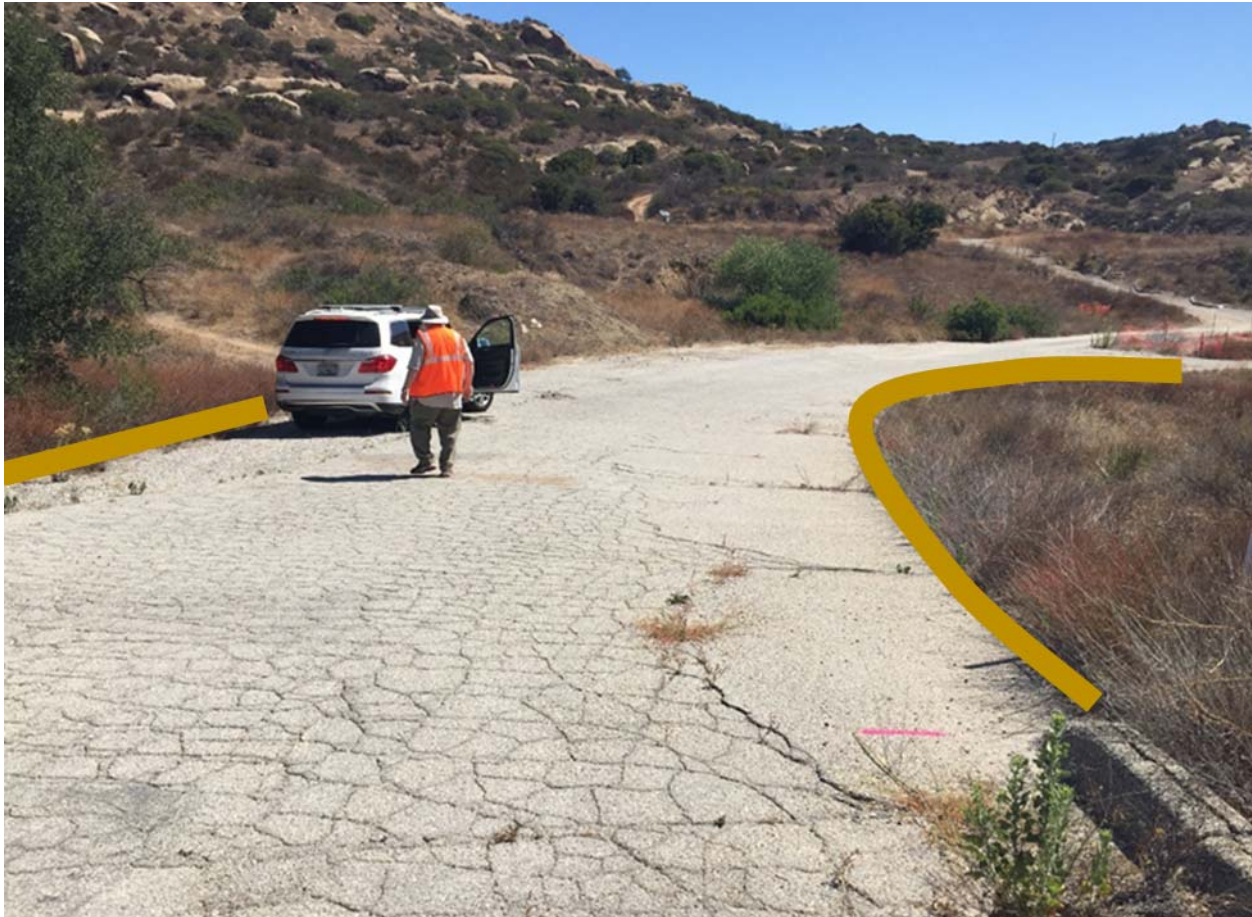
Figure 19. Proposed Location of Sand Bags to Divert Stormwater to Adjacent Vegetated Areas

Resulting from observations made onsite during the July Surface Water Expert Panel meeting, the Surface Water Expert Panel has recommended that the sand bag berms at the entrance to the LOX site be extended southwest. The new sand bag berms are to border both sides of the road (at a typical curb height), where it crosses the Northern Drainage (Figure 19). This improvement is intended to detain runoff and lengthen flow paths prior to entry into the Northern Drainage. NASA completed this improvement in the Fourth Quarter of 2016.

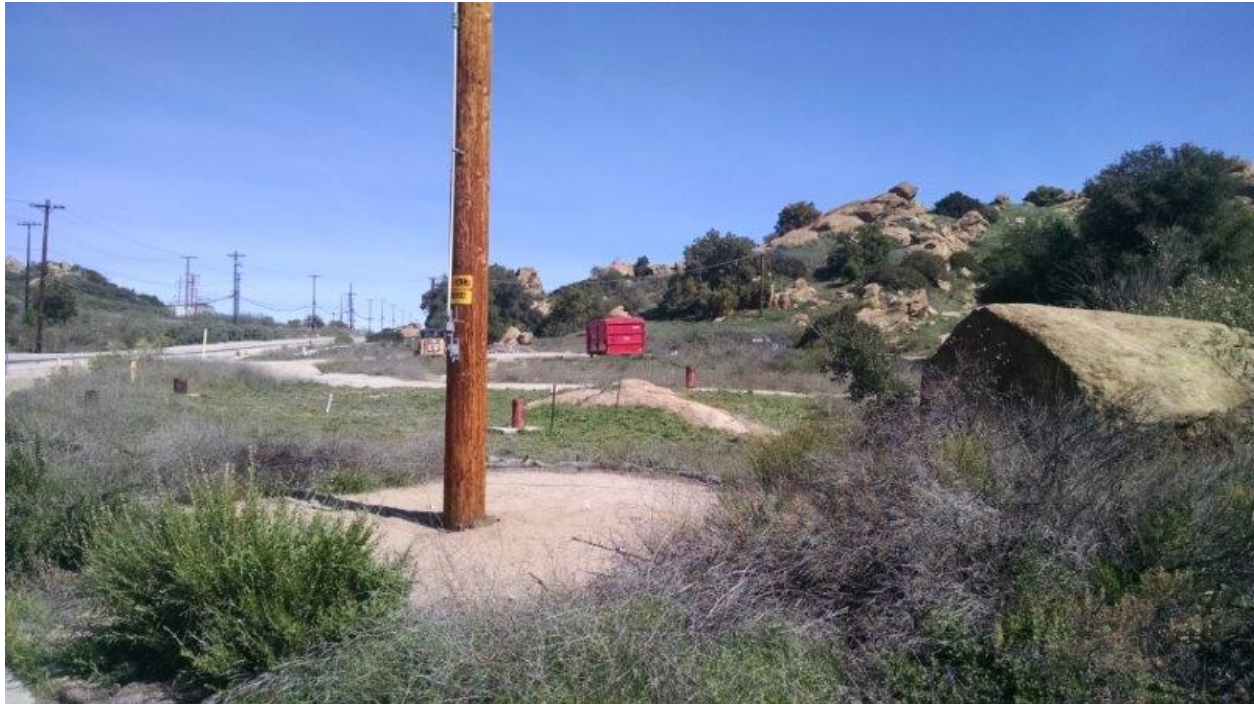
Figure 3. Example of new treated wood pole, EPTWBS03.

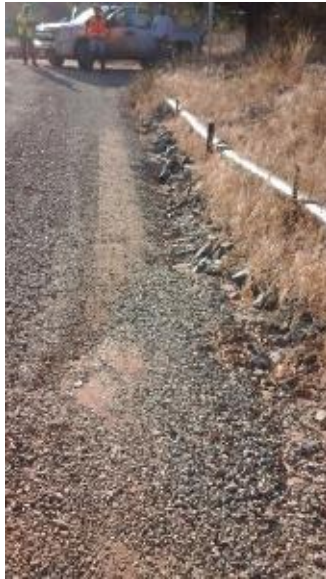
There was evidence of prior erosion due to concentrated flow from a 2014 potable water release from a municipality-owned water main, per discussion with JHA Environmental. Erosion features observed at this location include a rill measuring approximately 8 inches deep by 1-foot wide (see pictures #1 and #2). JHA noted that they add rip-rap periodically to dissipate water velocity within this rill and down the access road to Outfall 001.

Picture #1: Looking southeast at rill near locked gate #575.

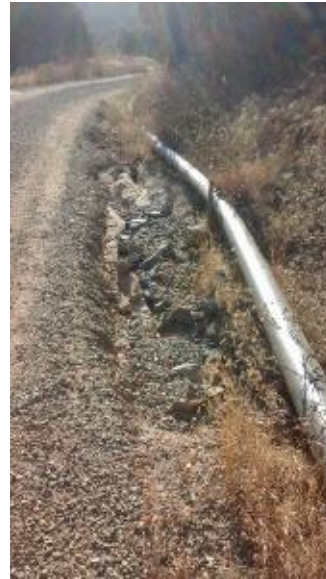
Picture #2: Looking southeast at rill near culvert.

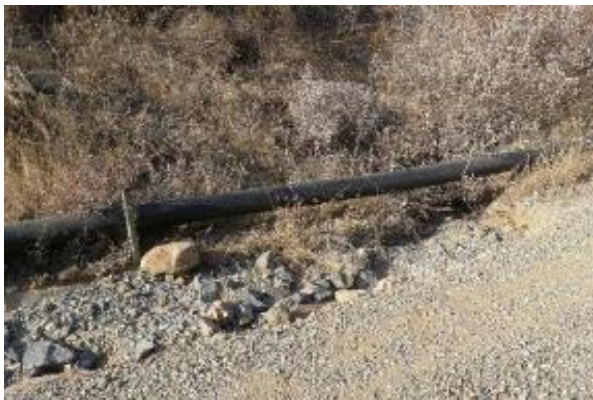
Erosion has occurred underneath portions of the HDPE pipe (from the GETS to Outfall 019) due to the concentrated flow. Another rill measuring approximately 2 feet deep by 4 inches wide was observed about 200 feet further down the spur road at a culvert running beneath the road (see picture #3). Here, concentrated flows have moved gravel from the road into the natural drainage (see picture #4).

Picture #3: Looking southwest at rill underneath HDPE pipe near culvert.

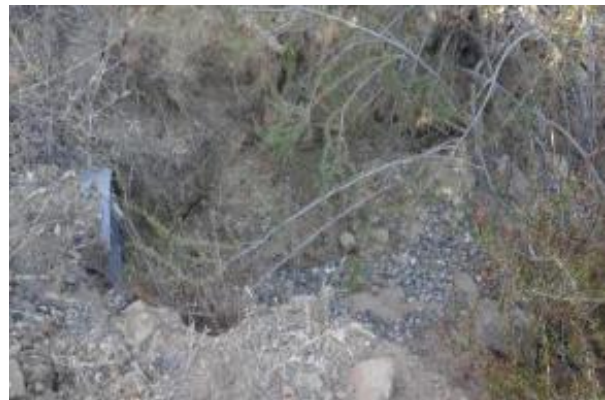
Picture #4: Looking northwest at northern side of culvert where gravel from the road has been deposited in the drainage.

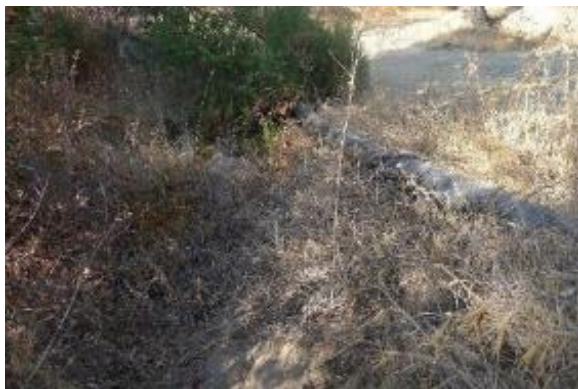
Observed erosion on the south side of the road underneath the HDPE pipe (from the GETS to Outfall 019) and cutting back the banks on the side of the road (see picture #5 and #6).

Picture #5: Looking southwest at erosion underneath HDPE pipe.

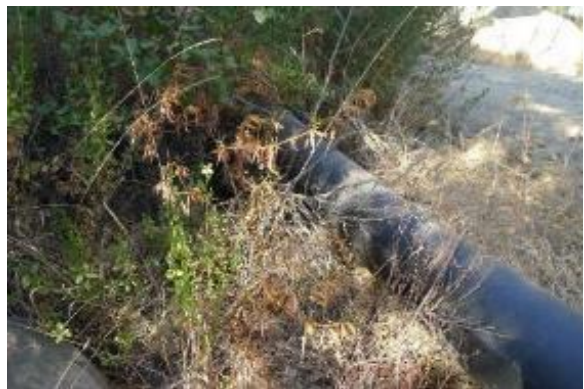
Picture #6: Looking southwest at erosion underneath HDPE pipe

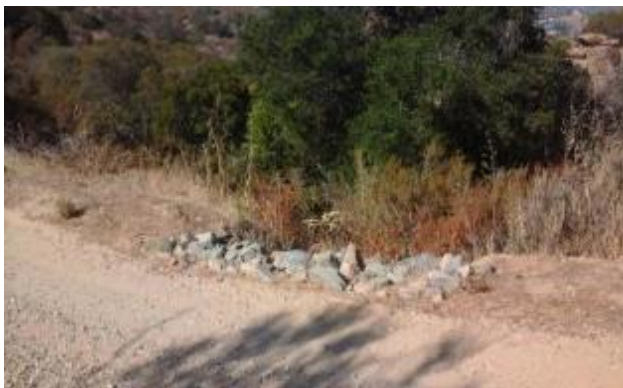
Rip-rap has been placed along the main discharge point (low point), but some active erosion with minor rill development was observed approximately 20 feet to the south along the main road to OF001 (see pictures #7-9).

Picture #7: Looking southwest at rip rap placed at discharge point.

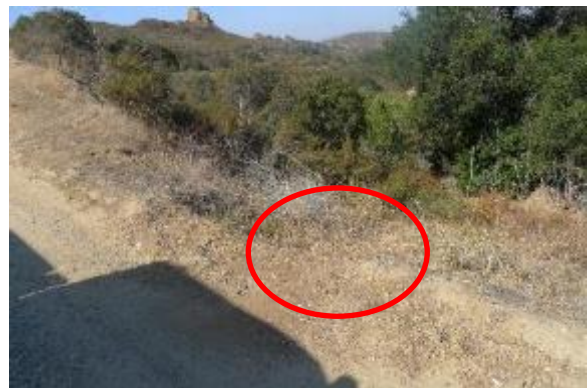
Picture #8: Looking southwest at minor rill development.

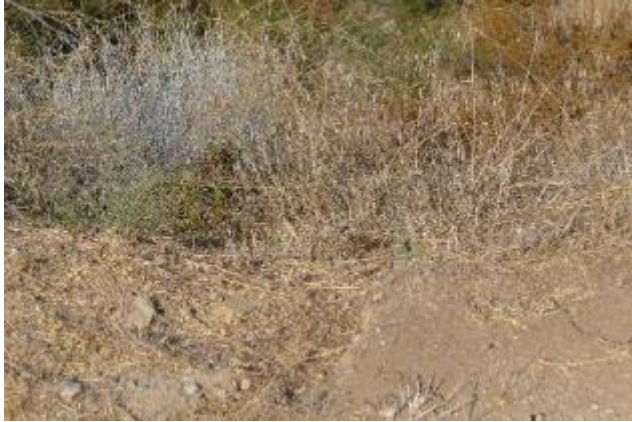
Picture #9: Looking west at minor rill development.

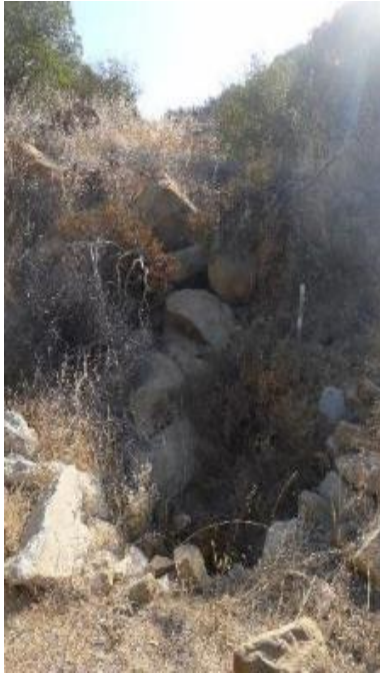
Picture #10: Looking east at rocky hillside upslope of erosion.

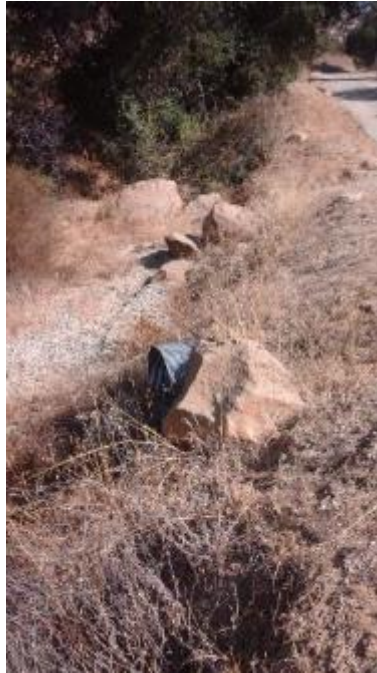
Active erosion was observed along the main road to OF001 immediately north of a 3-foot diameter corrugated metal pipe (CMP) culvert running under the road. Discharges from the road appear to be transporting gravel into the drainage (see picture #11). Erosion features observed at this location include erosion within the channel, which appears to be cutting the bank. Flow to this area comes from the steep rocky hillside on upslope (eastern) side of road which then enters the culvert (see pictures #10 and #12). The culvert was observed to be stable and not conveying gravel with no discernible erosion beneath the HDPE pipe.

Picture #11: Looking north at gravel in drainage and culvert pipe.

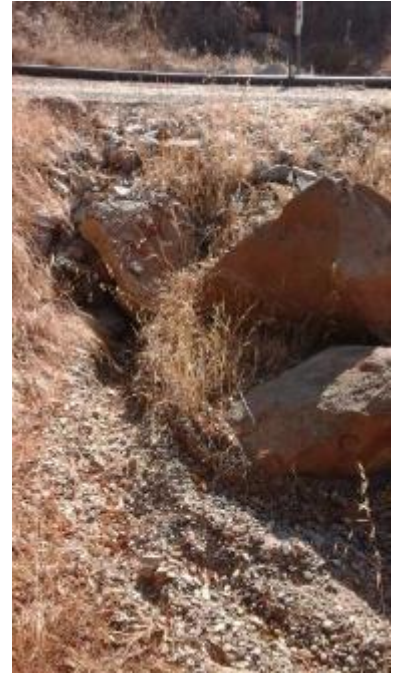
Picture #12: Looking east at erosion upgradient of culvert pipe.

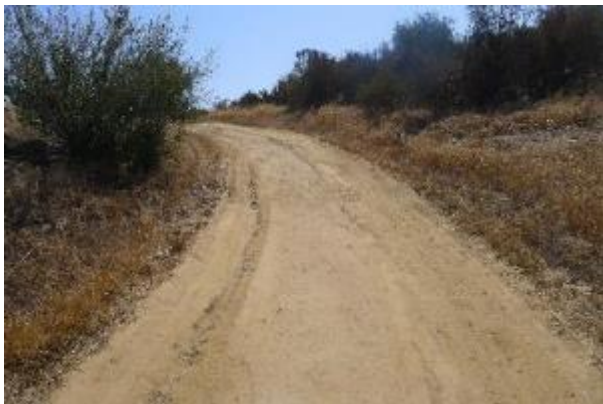
Minor erosion was observed on the road surface at this location (see picture #13).

Picture #13: Looking east at minor erosion on road surface.

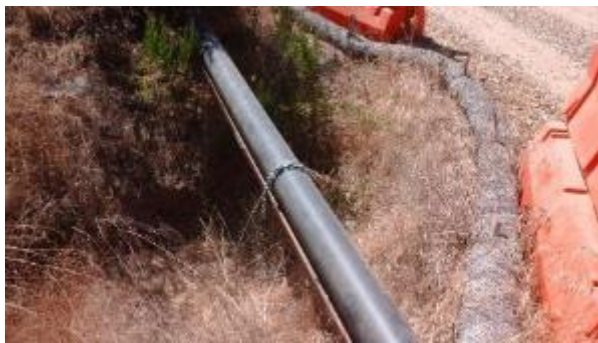
Previous erosion and sediment controls (old fiber roll check dams and rip-rap) were observed at the K-rail that has been placed along the east side of the road where the HDPE pipe crosses the culvert (see pictures #14 and #16). Jute netting was also observed on the slope of the culvert. Loose sandy sediment was observed on the road surface with some minor slope failure along the west bank of road (see picture #15). The bottom of the drainage appeared clear with no notable sediment accumulation (see picture #17).

Picture #14: Looking south at HDPE pipe crossing culvert.

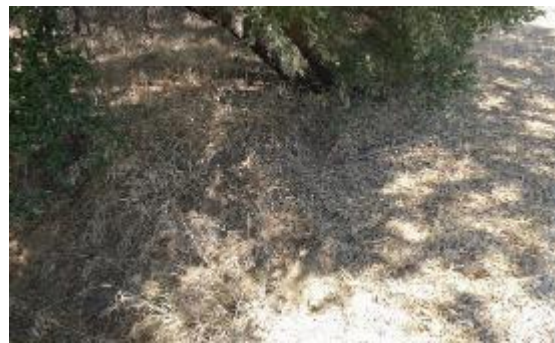
Picture #15: Looking west at minor slope failure along west bank of road

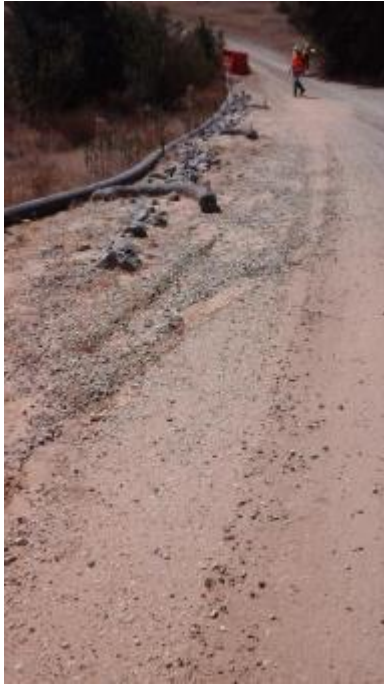
Picture #16: Looking south at old fiber roll check dams and rip rap.

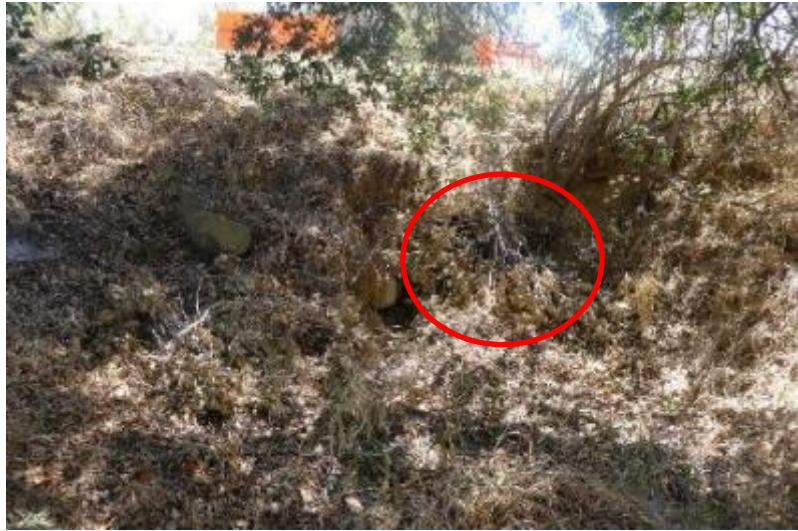
Picture #17: Looking east at culvert discharge location.

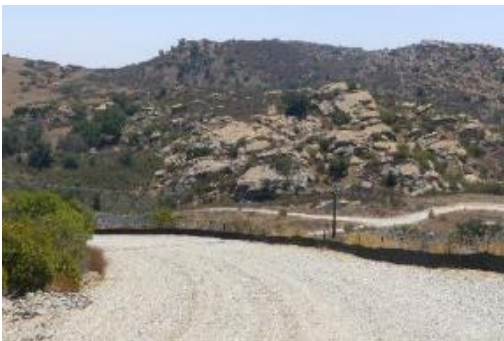
Silt fence and gravel water bars are installed along the road. Observed fine silt accumulating along the south side of the road against the silt fence (see pictures #18 and #19).

Picture #18: Looking south at silt fence and gravel water bar.

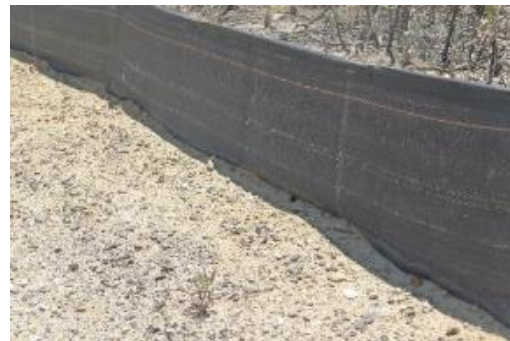
Picture #19: Looking south at loose silt accumulating along silt fence.

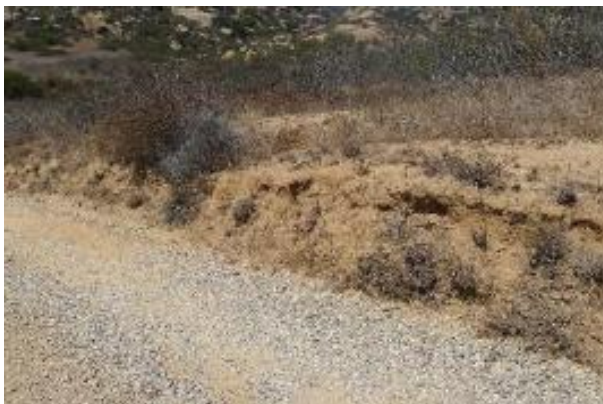
Observed erosion along both sides of the road. Rip-rap has been placed along the south side of road (see picture #22). An escarpment is present along the north side of the road (see picture #20). Slope failure was observed along the south side of the road approximately halfway down the hill (see picture #21).

Picture #20: Looking west at escarpment on north side of road.

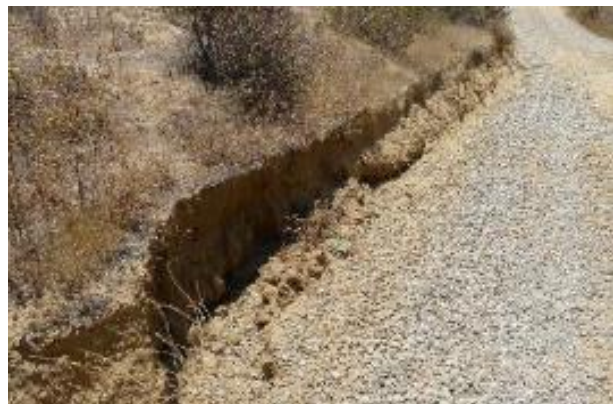
Picture #21: Looking southwest at slope failure along south side of road.

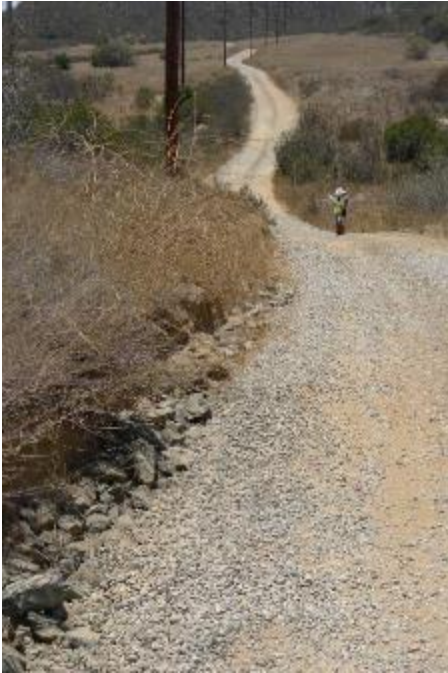
Picture #22: Looking southwest at rip rap and erosion on south side of road.

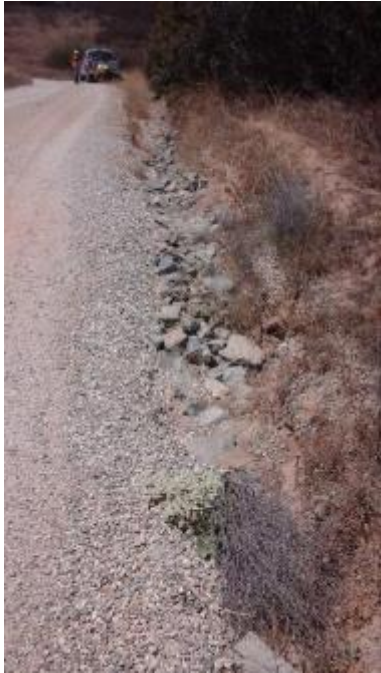
Picture #23: Looking northwest at erosion along north side of road.

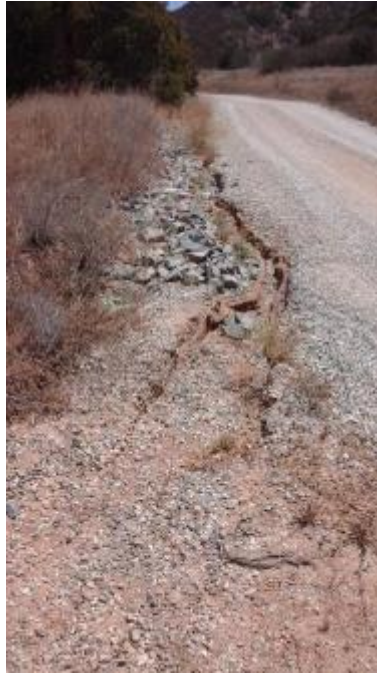
Erosion was observed on the north side of the road. The erosion pattern shows that flow begins to channelize along the north side of the road (see pictures #23 and #24). This channel becomes larger toward the west. Rip-rap has been placed in this area and some gravel from the road was observed in vegetation along the drainage (see picture #25).

Picture #24: Looking southeast at erosion along north side of road.

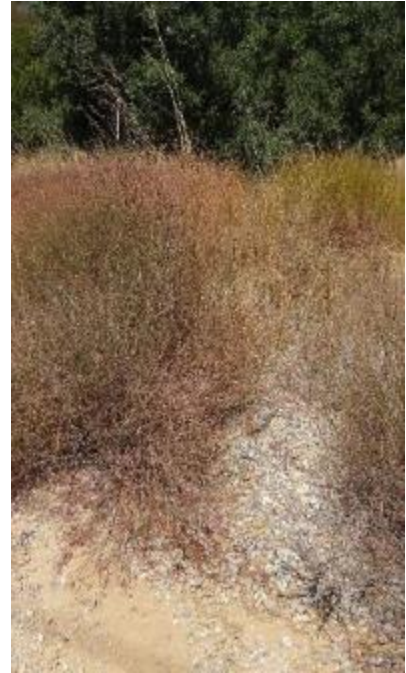
Picture #25: Looking north at gravel in vegetation within drainage.

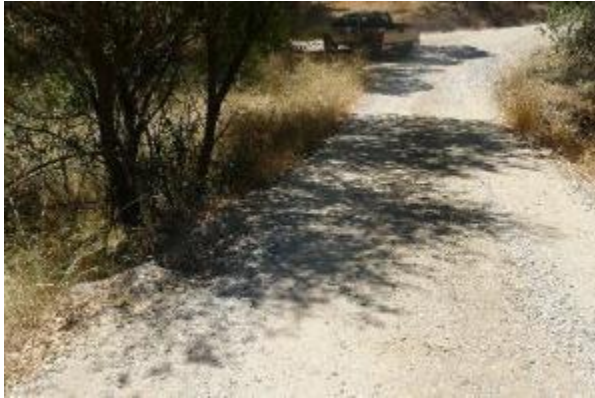
There is a double culvert CMP crossing under the road in this area. Active erosion is occurring on the southeastern corner of the culvert crossing with a rill forming (see picture #26). The smaller of the two culverts is partially blocked (see picture #27). This is also erosion occurring along the road on the other side of the "T" intersection (see picture #28) which leads to the drainage with minor erosion at the northwest end of the culvert crossing (see picture #29).

Picture #26: Looking west at erosion on southeast corner of culvert crossing.

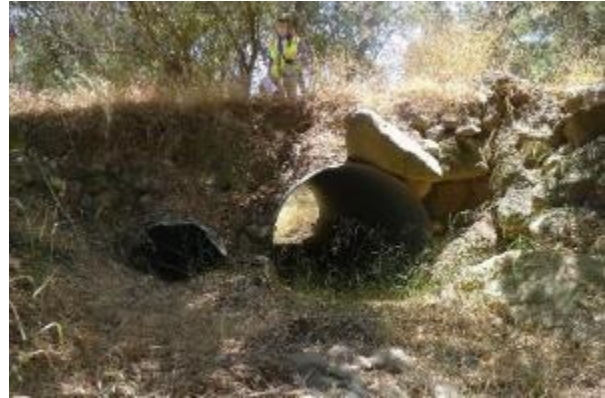
Picture #27: Looking south at culverts under road. Culvert on the left is partially blocked.

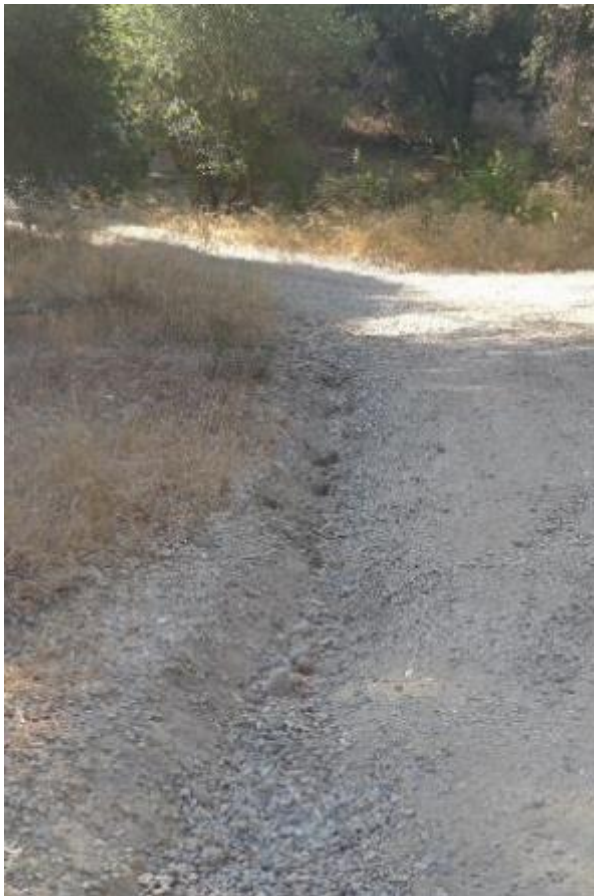
Picture #28: Looking southeast at erosion along northeast side of road.

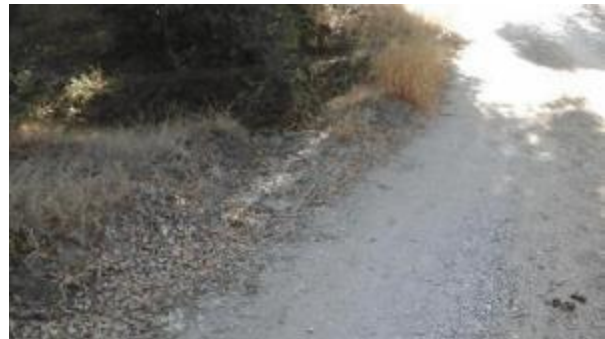
Picture #29: Looking east at erosion at northwest corner of culvert crossing.

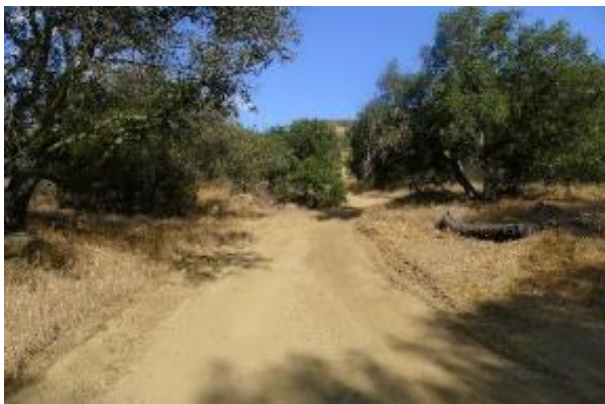
There is a substantial amount of very fine, loose sediment on the road surface and on both sides of the road due to recent blading by the County of Ventura (see picture #30 and #31). This sediment could be mobilized directly into the OF002 drainage by wind erosion or stormwater runoff.

Picture #30: Looking west at fine sediment on road surface.

Install two water bars across the steep portion of the western spur road at the “T” intersection with the main road to OF002 (see photo below). Also, consider spraying a calcium magnesium chloride-based soil stabilization product along the flat part and sides of the steep portion of the road. If a calcium magnesium chloride-based soil stabilization product will be used at this location, the product will need to be reviewed and approved for use at SSFL.

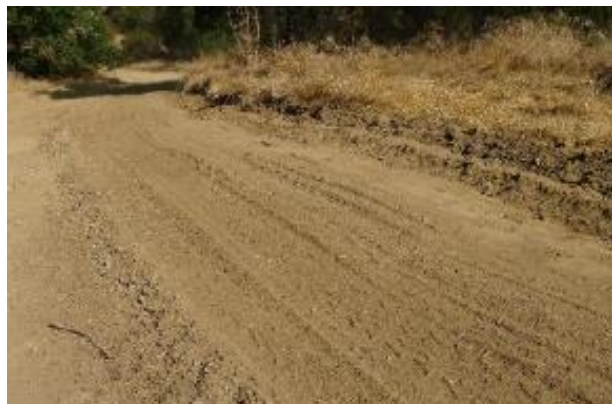
Picture #31: Looking east at fine sediment on road surface.

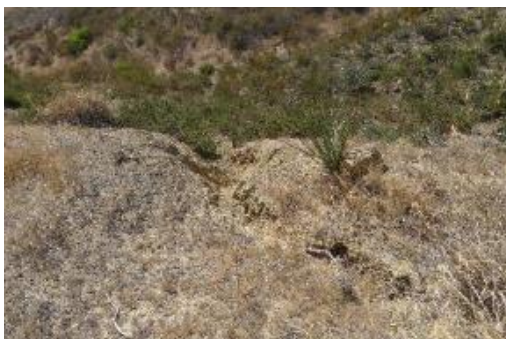
The surface of this steep road is rutted out and has rill development of several inches deep along the east/southeast side of road (see pictures #33 and 34). The rill crosses the road along the lower slope (see picture #32). This is a potential source of sediment in the watershed as the rill leads into the drainage.

Picture #32: Looking east at rill on south/southeast side of road.

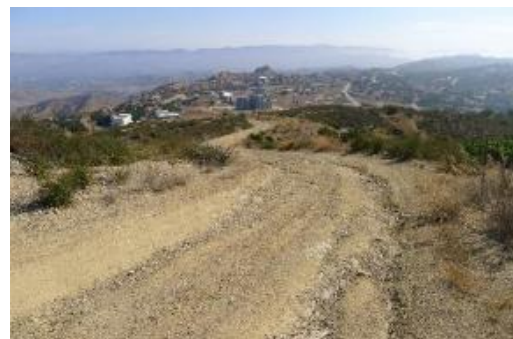
Picture #33: Looking northeast at rutting across road.

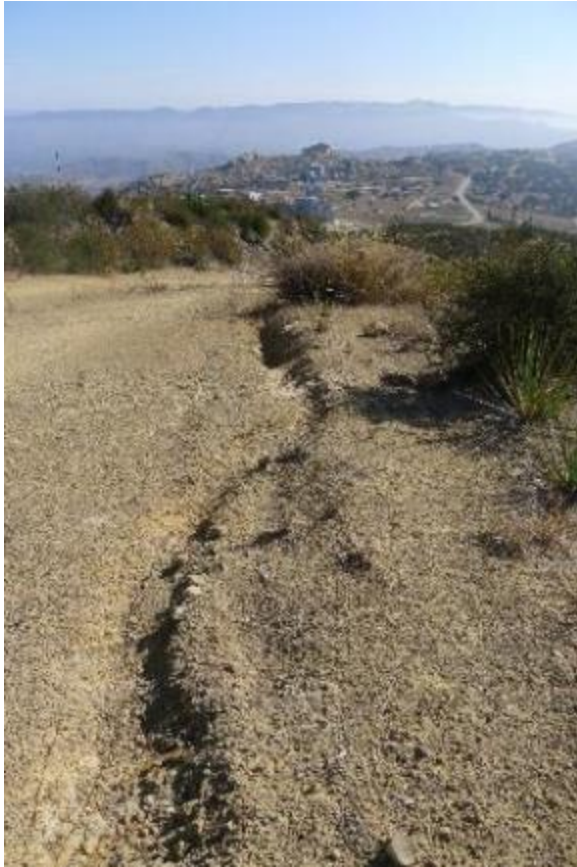
Picture #34: Looking northeast at rutting along southwestern side of road

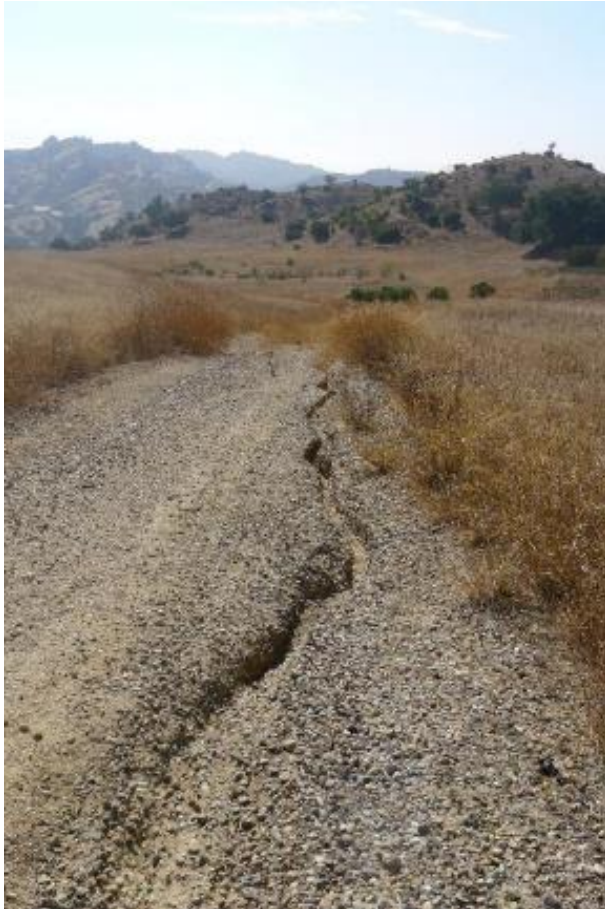
Picture #35: Looking southeast at rill development along south side of road.

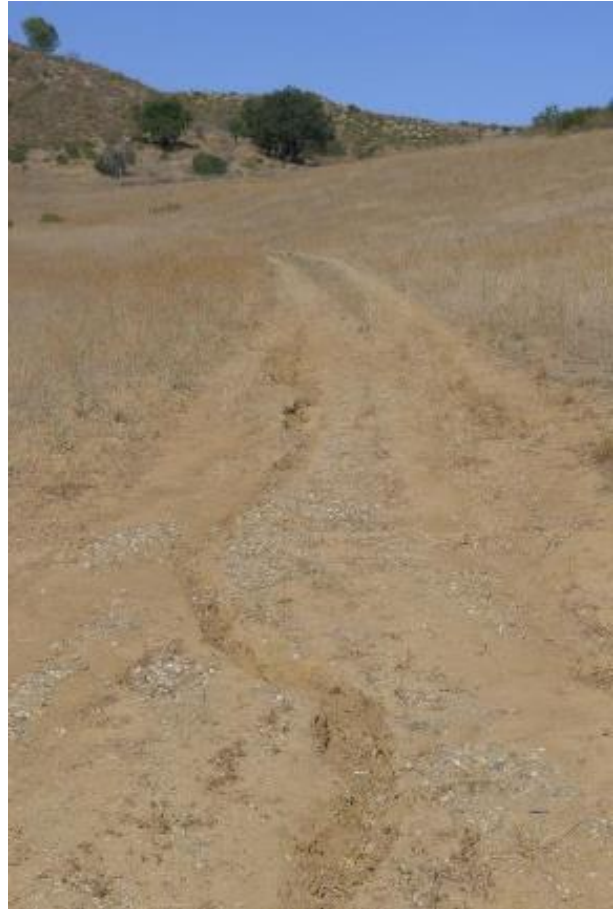
Picture #36: Looking east at rill development across road.

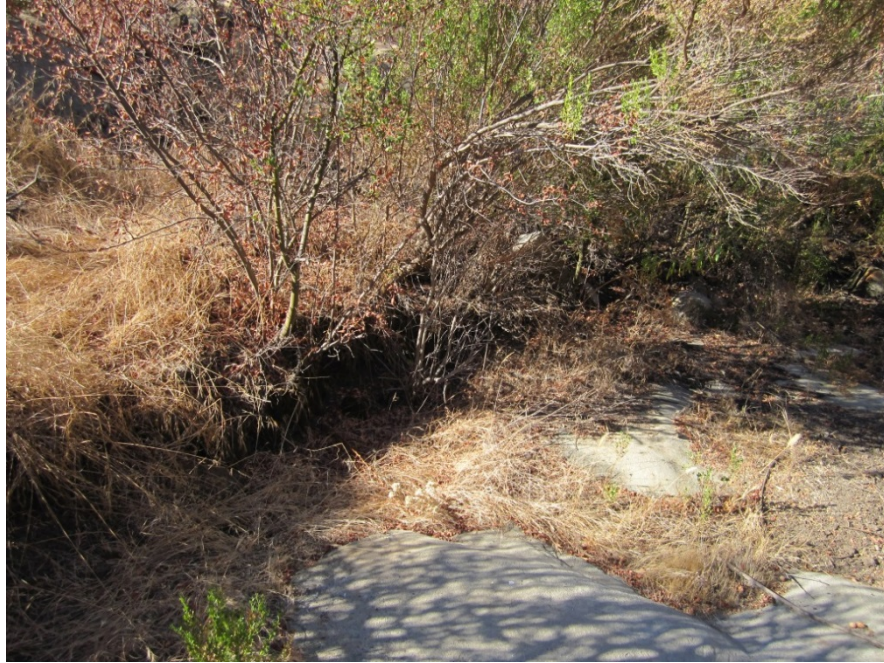
OF001Insp_08192016_18

Comments:
Vertical soft bank, 1 ft vertical height. Immediately downstream of OF011. This is a fairly common feature between OF011 and the road crossing of Sta 38+00.

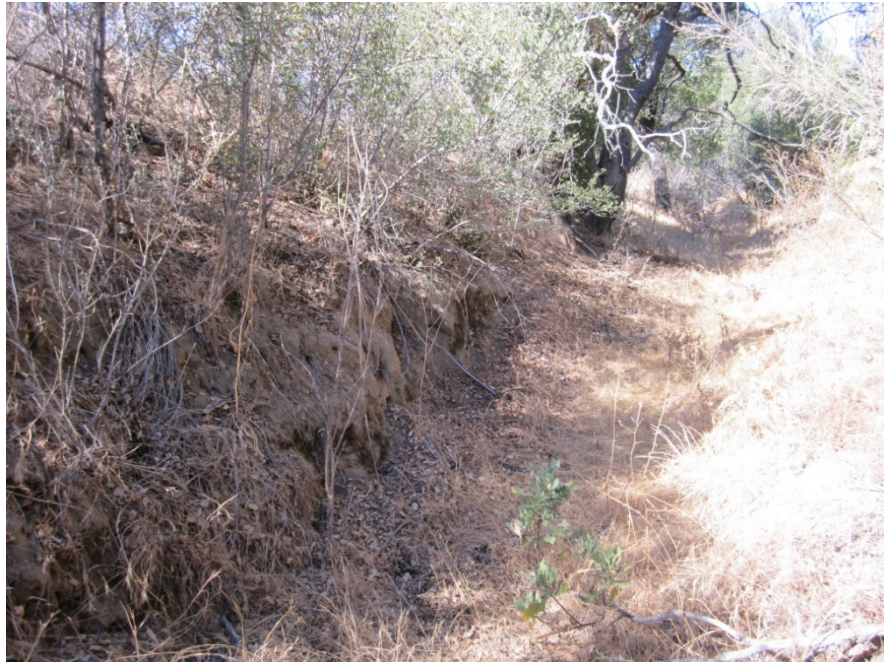
Comments: Vertical soft bank, 1 – 1.5 ft vertical height. This is a fairly common feature between OF011 and the road crossing (Sta 38+00).

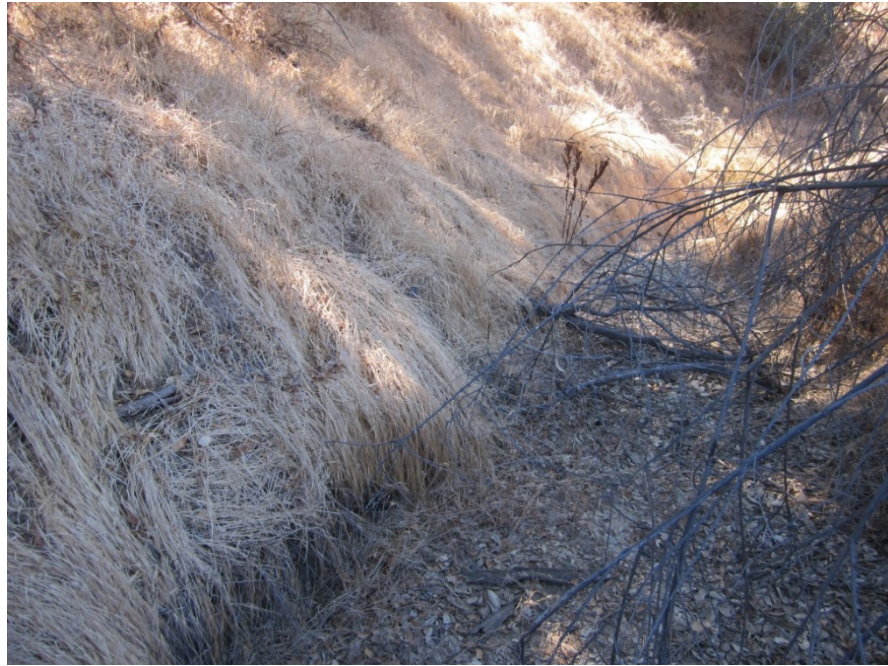
OF001Insp_08192016_33

Typical channel bank and bed between Sta 28+00 and the road crossing (Sta 38+00). Grass covering a majority of the slopes, with minor undercutting of the top of the bank. Channel bottom is soft.

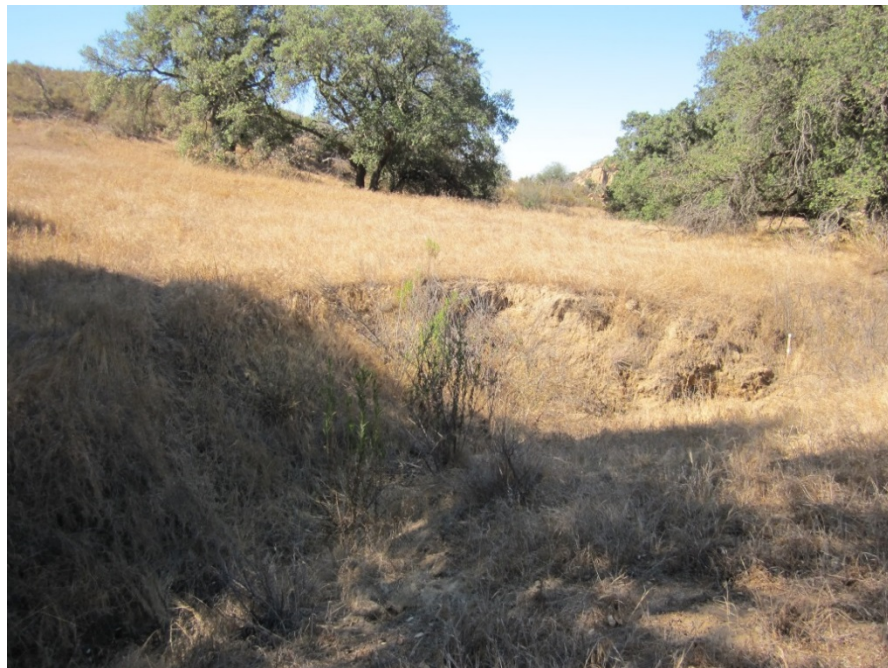
Major bank scarring along the left bank at this bend. Vertical height approximately 4 – 5 ft. Appears to be naturally occurring.

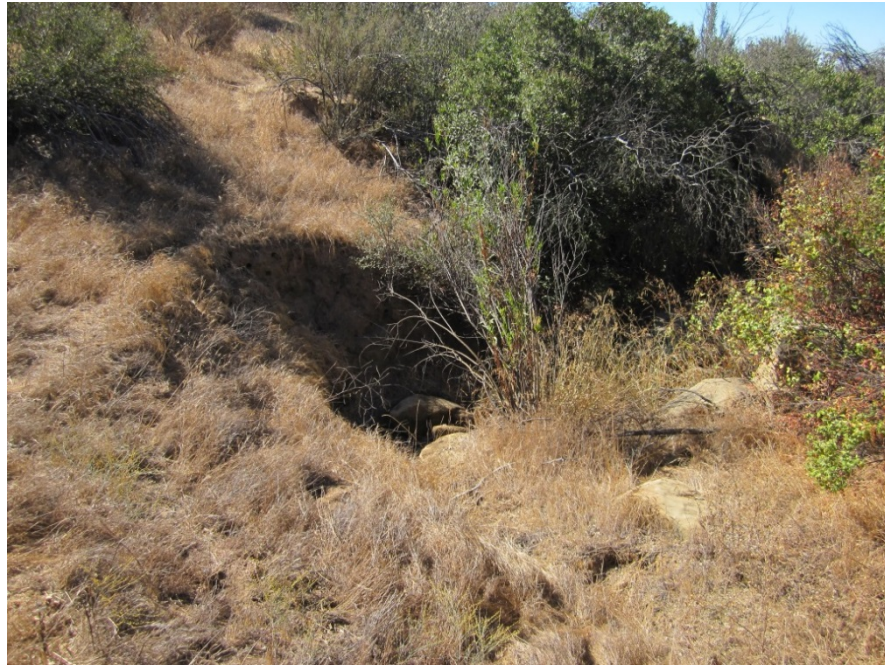
OF001Insp_08192016_42

Comments:
Major bank scarring along left bank at this sharp turn. Vertical height approx. 4 ft.

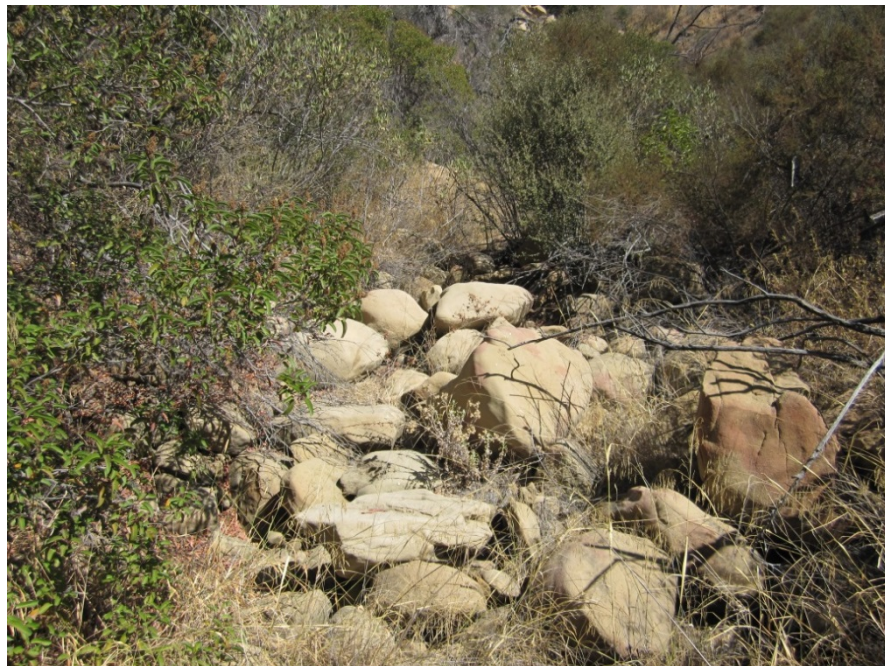
Comments:
Near the bottom of the steep portion of the drainage, at approximately Sta 22+00. Channel filled with boulders and large cobbles.
