Santa Susana Field Laboratory
Site-Wide Stormwater Annual Report
2015/2016 Reporting Year

The Surface Water Expert Panel
and

SB0363W
October 2016

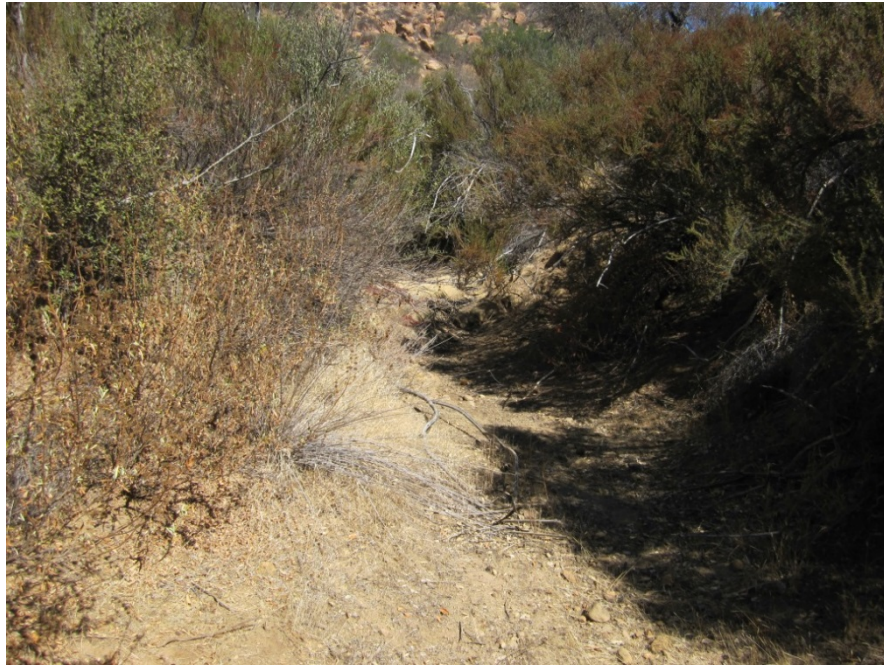
OF001Insp_08192016_63

Comments:
Typical stream section between OF001 and Sta 22+00. Soft bottom with shrubs on the banks.

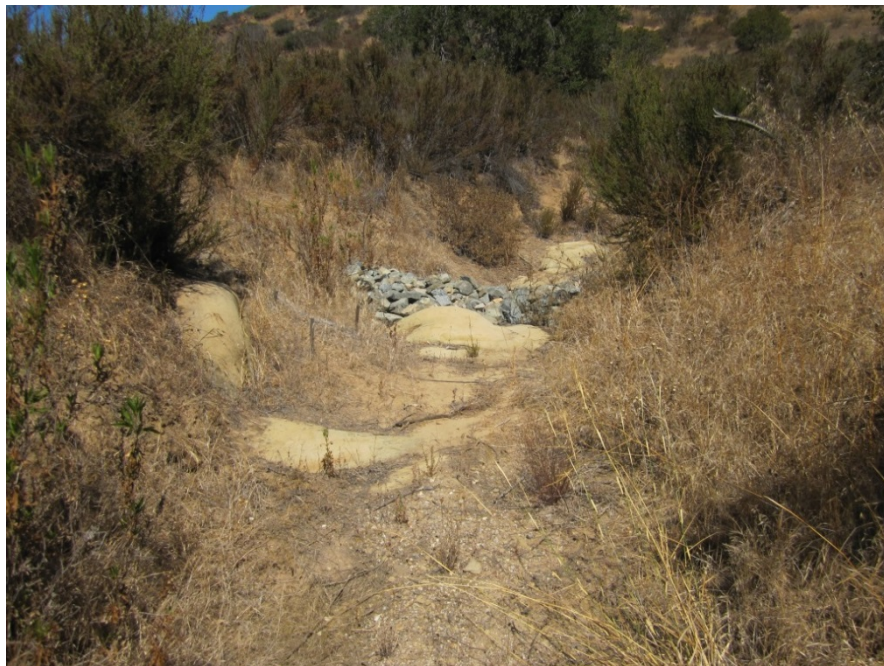
Comments:
Installed check-structure, facing downstream. No sediment buildup present on upstream side of the structure. Found to be in good shape.

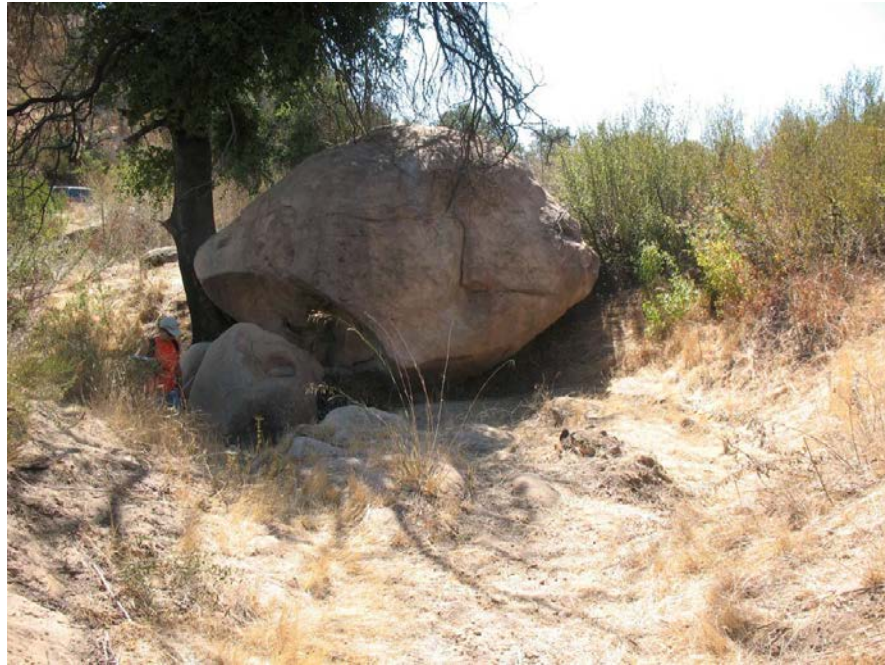
OF001Insp_08192016_64

Comments:
Comparison photographs.

Boulder Pinch-Point in 2009.

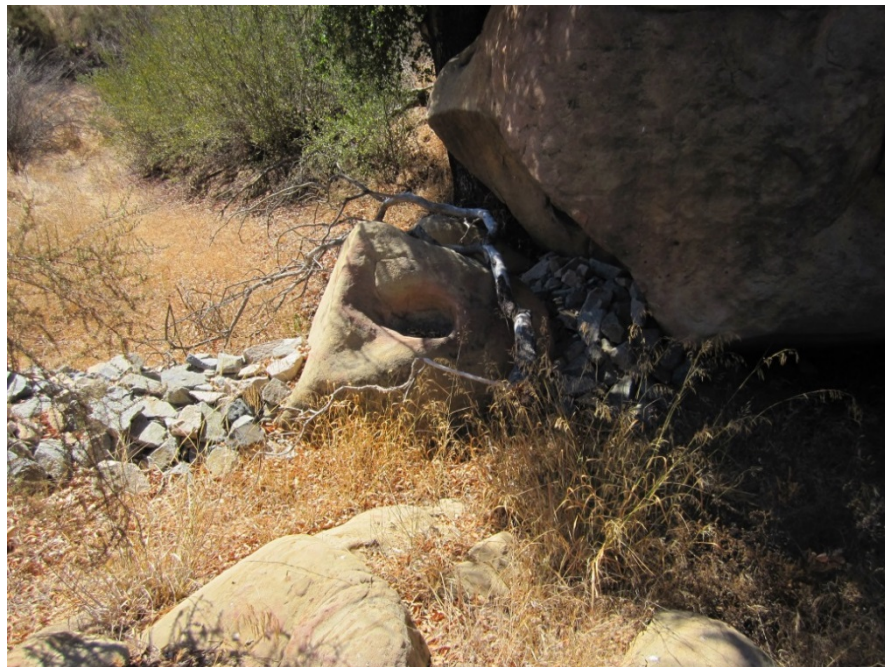
Comments:
Comparison photographs.

Boulder Pinch-Point in 2016, with rock check structure. View downstream.

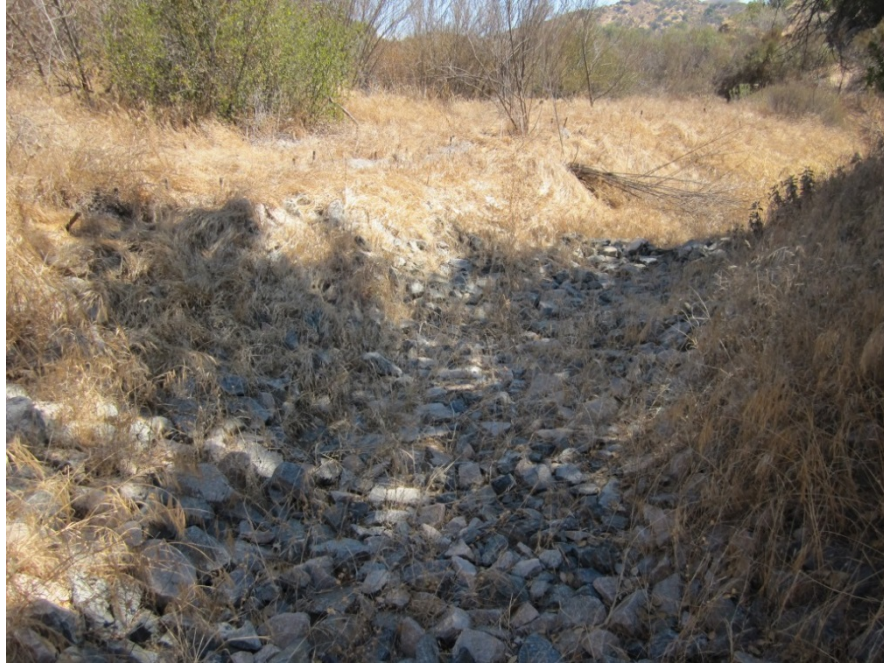
**Station ID:
OF001 00+25**

Comments:
View facing upstream
from OF001.

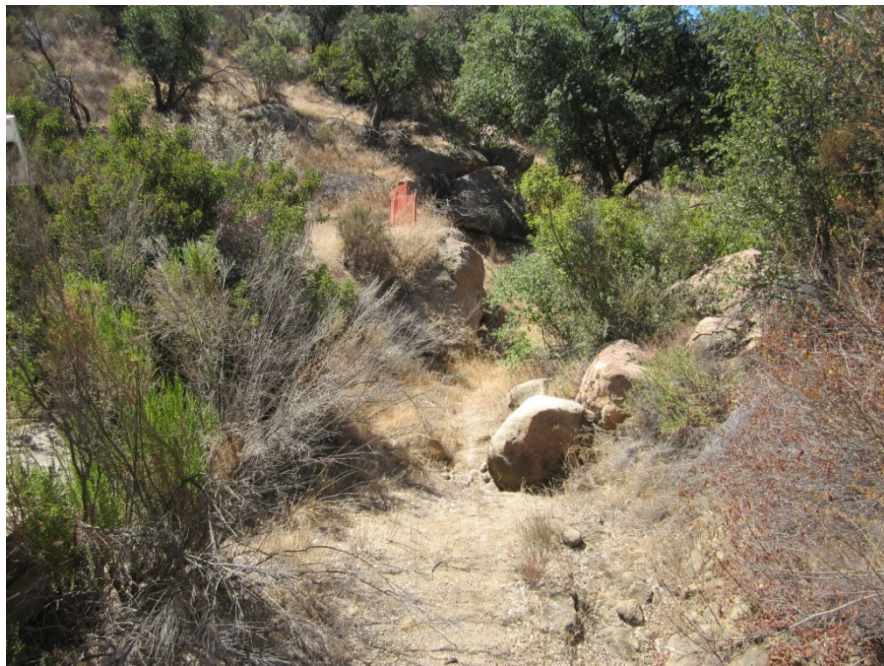
**Station ID:
OF001 100**

Comments:
View facing
downstream from
OF001.

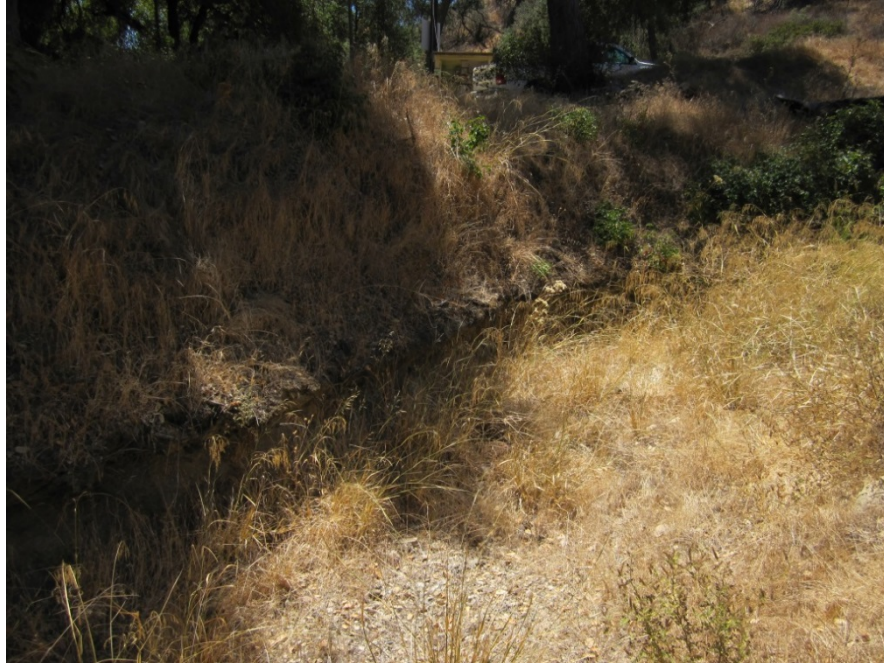
**Station ID:
OF002 39+00**

Comments:
Steep right bank approx. 30 ft from road, approx. 6 ft vertical height. Toe erosion is approximately 1-1.5 ft in height.

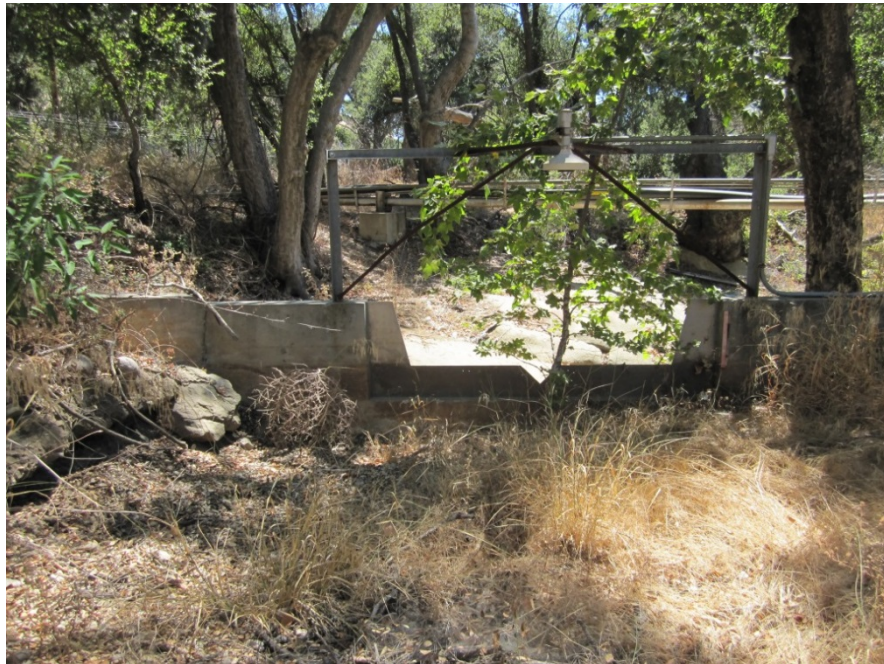
**Station ID:
OF002 38+00**

Comments:
In-channel weir structure.

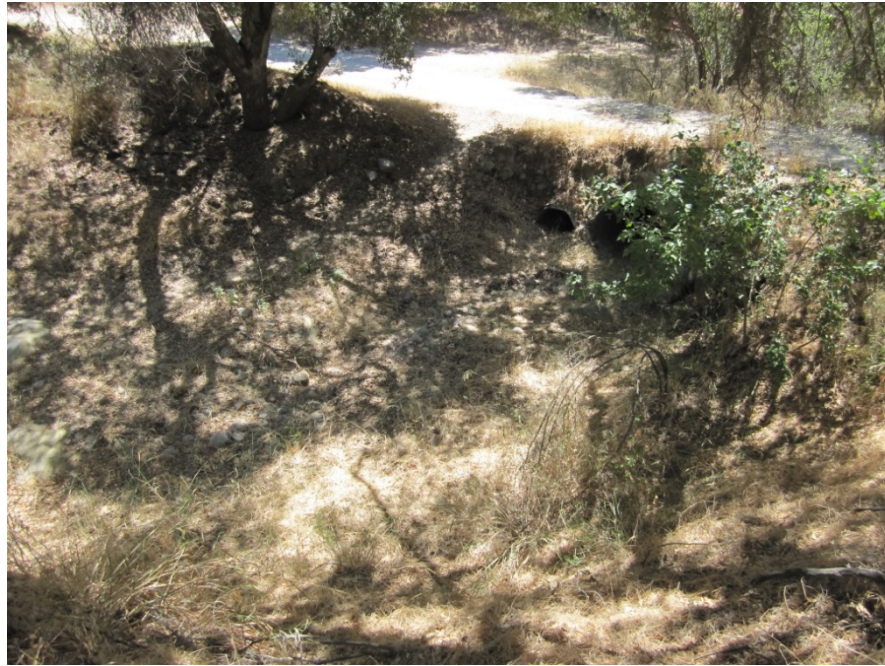
**Station ID:
OF002 34+50**

Comments:
CMP culvert at Roca Ave, facing downstream.

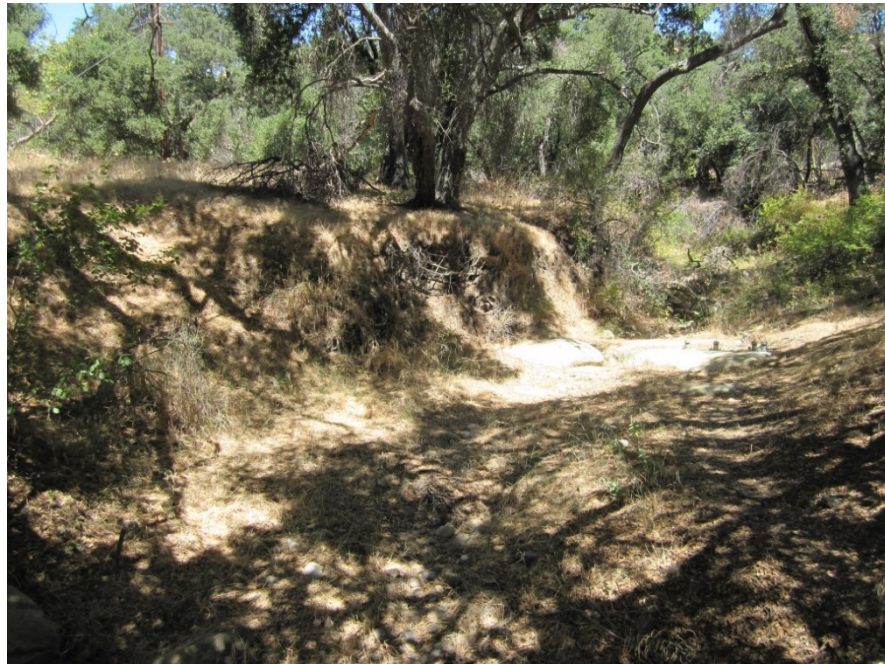
**Station ID:
OF002 34+00**

Comments:
From Roca Ave crossing, facing upstream, above the CMP culvert. Steep vertical right bank, with a more gently sloped left bank.

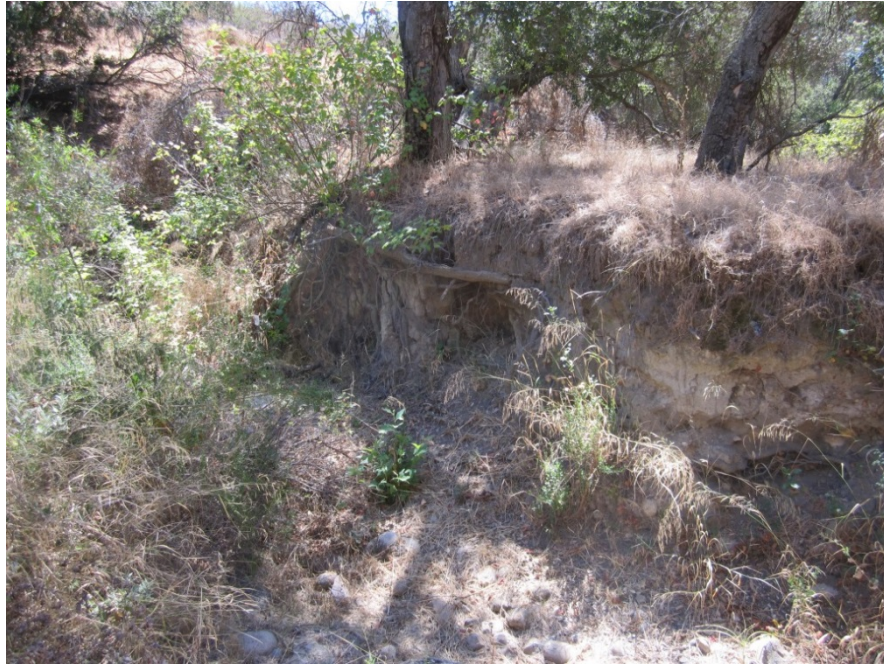
**Station ID:
OF002 30+00**

Comments:
 Bank held by oaks.
 Approx. 4 - 5 ft
 vertical height. This
 is a fairly common
 occurrence in this
 portion of the reach –
 steep banks, heavy
 vegetation, and
 cobbles throughout
 the bottom of the
 channel.

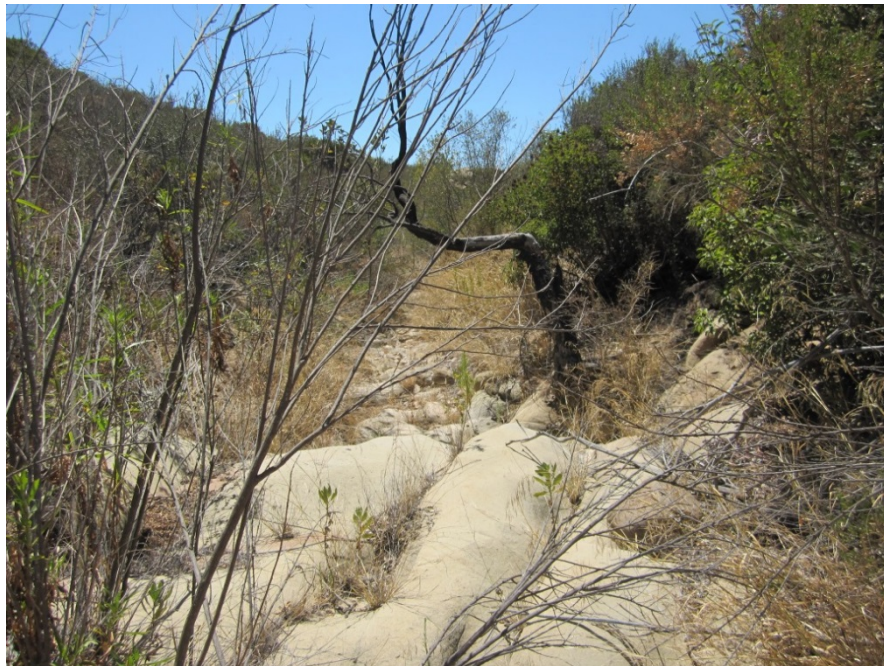
**Station ID:
OF002 12+00**

Comments: Facing
 downstream at the
 point where the reach
 transitions from dense
 tree canopy to shrubs.
 Bedrock is exposed
 here for a significant
 portion of the stretch
 from OF002 to Sta
 12+00.

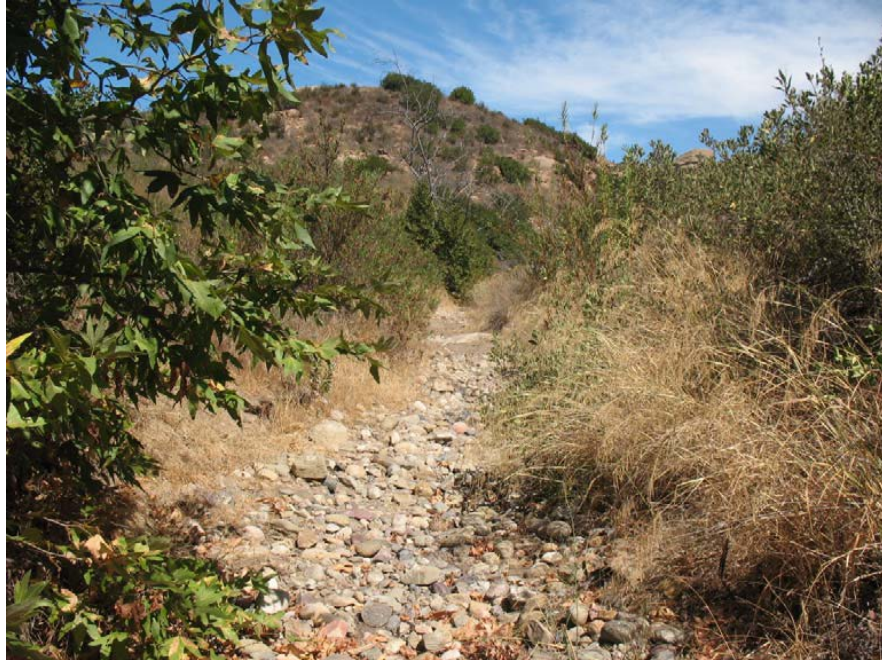
Comparison photographs.

Channel bottom with significant cobble. View facing upstream.

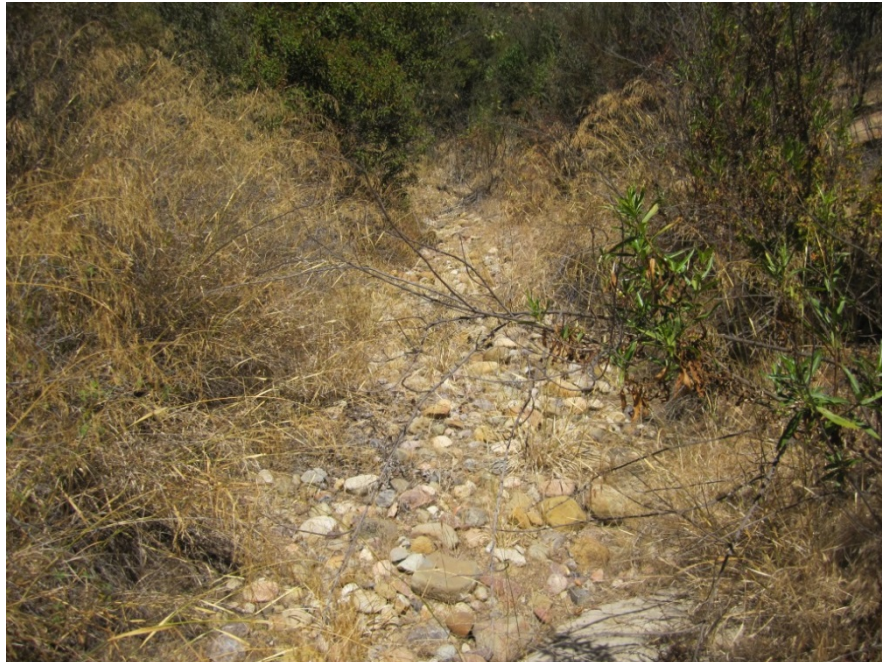
Comparison photographs.

Channel bottom with significant cobble upstream of OF002. View facing upstream.

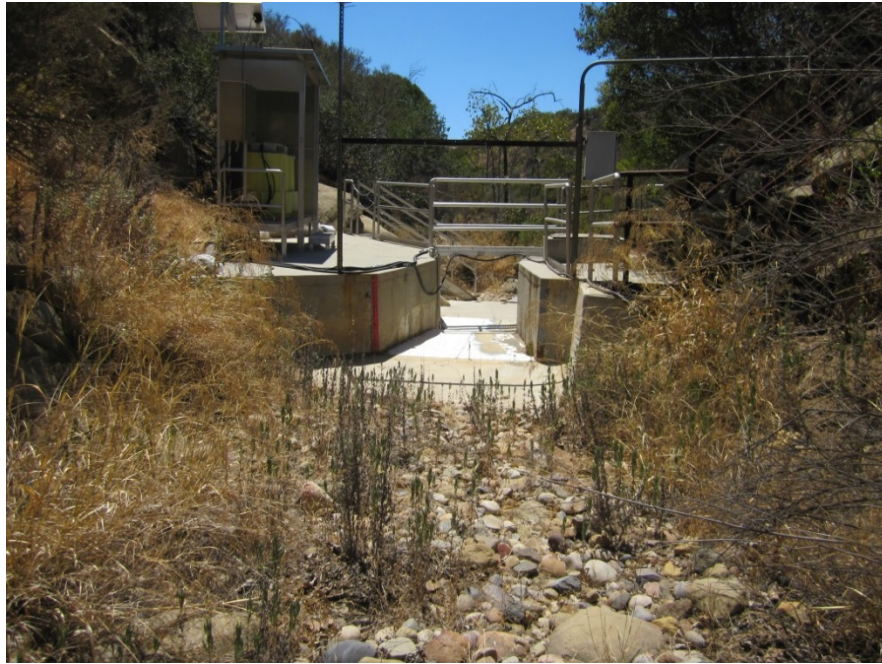
**Station ID:
OF002 00+20**

Comments: View of OF002, from upstream.

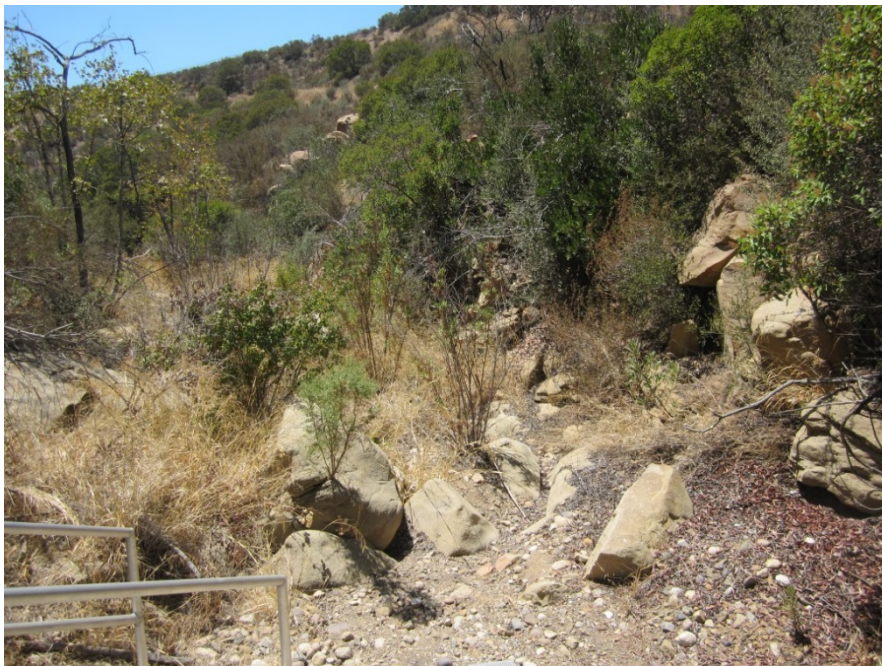
**Station ID:
OF002 00+25**

Comments: View from OF002, facing downstream.

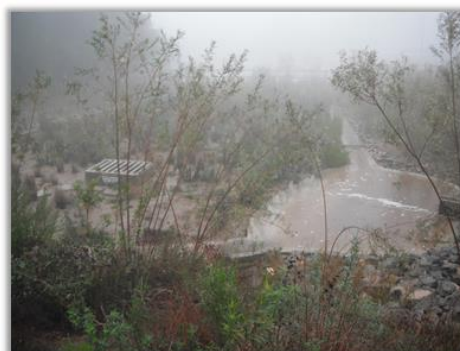
Figure 48. A photo of the biofilter taken on 12/2/2014

Construction of the lower lot biofilter, located in the Outfall 009 watershed, was completed in 2013. To date, samples were taken at this location during 15 rain events that occurred after the construction was completed, with samples collected at three locations within the biofilter treatment train (influent, post-sedimentation basin, and post-biofilter) for one rain event during 2012/2013, two locations (influent and post-biofilter) for a single rain event in the 2013/2014 sampling year, and three locations within the treatment train (influent, post-sedimentation basin, and post-biofilter) for five rain events during the 2014/2015 sampling year and eight events during the most recent sampling year. The post-biofilter samples collected in early 2014 represents a blend of filtered underdrain water and overflow. A sample was not taken at the biofilter inlet (post-sedimentation basin) during the 2013/2014 sampling year due to the sample location being submerged and inaccessible. During one event in the 2014/2015 reporting year, unusually turbid water was observed in the biofilter; this may have been due to sediment-laden run-on from the Building 1436 detention bioswale construction area (Figure 38).

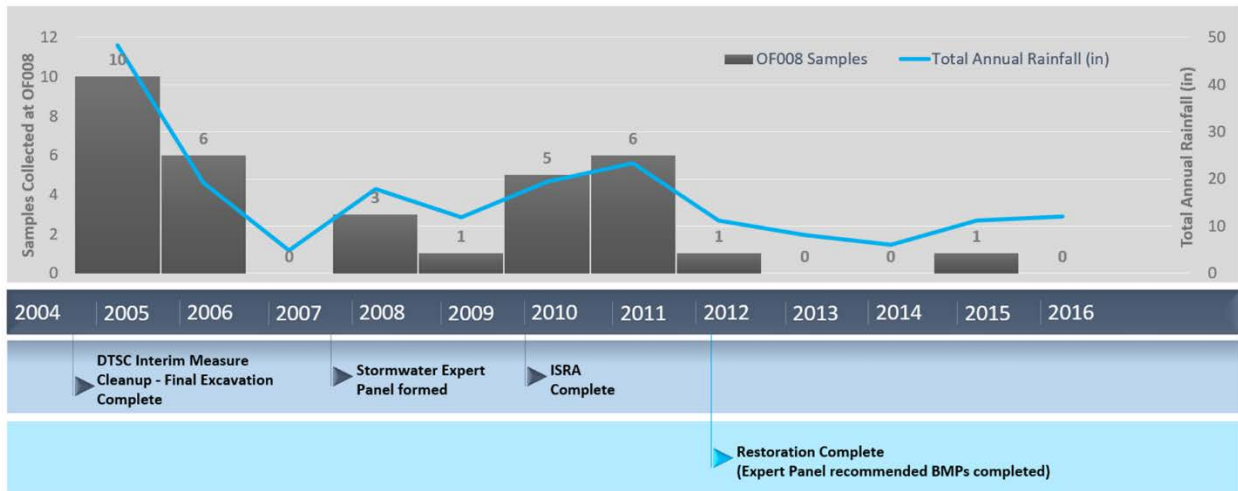
Figure 2. Timeline of Outfall 008 Restoration Activities and Outfall Sampling

Note: Bars represent reporting years (June 1 – May 31)
