Effects of Alkali Metal Runway Deicers on Carbon Brakes

By Michael Arriaga, Service Engineer

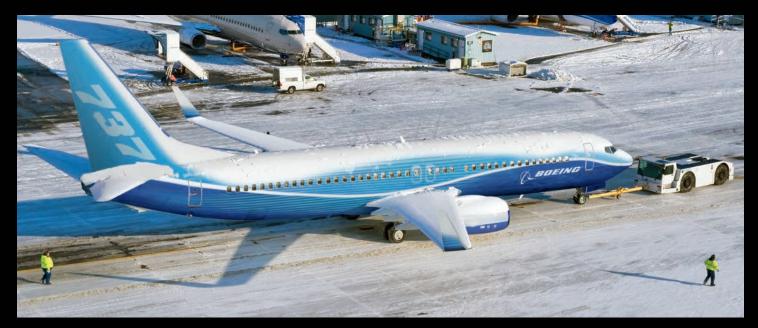
Figure 2: Carbon brake contamination by runway deicers

When deicers are present on taxiways and runways, alkali metal runway deicers splash onto the carbon brakes.

Carbon brakes become contaminated by runway deicers during taxi, takeoff, and landing when runway deicers splash onto the carbon brakes (see fig. 2).

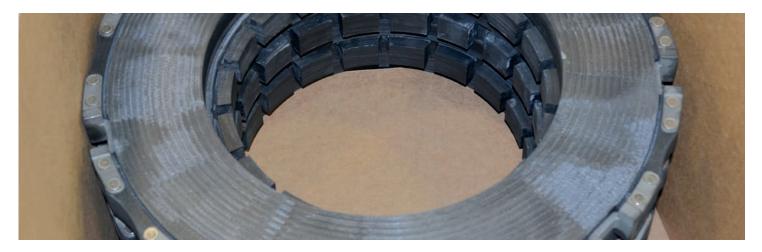
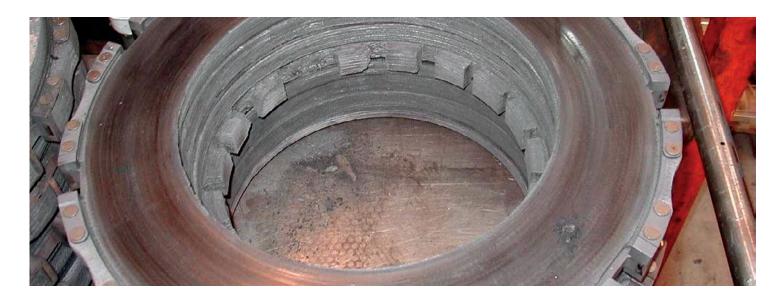
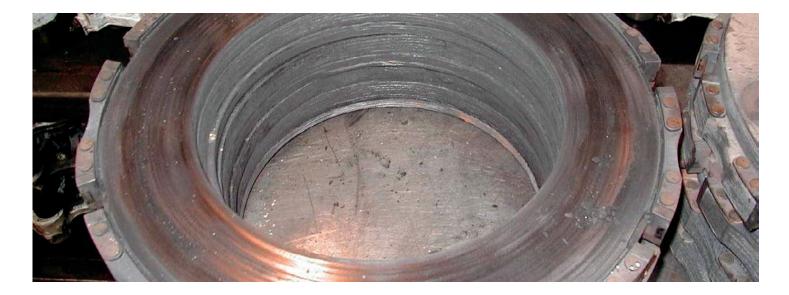
Figure 3: Carbon stator-disk-drive lug damage

The damaged stator-disk-drive lugs on this carbon heat-sink are an example of the type of damage alkali metal runway deicers can cause to carbon brakes. The top photo shows a new carbon heat-sink. The middle photo reveals significant damage with most of the stator-disk-drive lugs missing. The bottom image shows a complete loss of all stator-disk-drive lugs.

Catalytic oxidation of the carbon does result in decreased service life (premature removal) of a carbon brake (see fig. 3). In rare instances, severely catalytically oxidized carbon brakes have caused a brake fire when a piston (or pistons) penetrates a severely catalytically oxidized carbon pressure plate (first rotor disk) and contacts the adjacent rotor disk, which is rotating at the same speed as the wheel. The rotational force of the rotor disc fractures the piston assembly, allowing hydraulic fluid to contact the carbon heat-sink, which is at an elevated temperature as a result of the kinetic energy absorbed by the brake during the landing stop (see fig. 4).

- Both FAA and EASA bulletins recommend that when an airline removes a wheel and tire assembly from the landing gear axle, a detailed inspection of the periphery of the carbon heat-sink be performed per the aircraft maintenance manual (AMM) for indications of catalytic oxidation of the carbon disks.
