Matters of Precision

A focus on near-microscopic levels of detail was the catalyst in resuming 787 Dreamliner deliveries

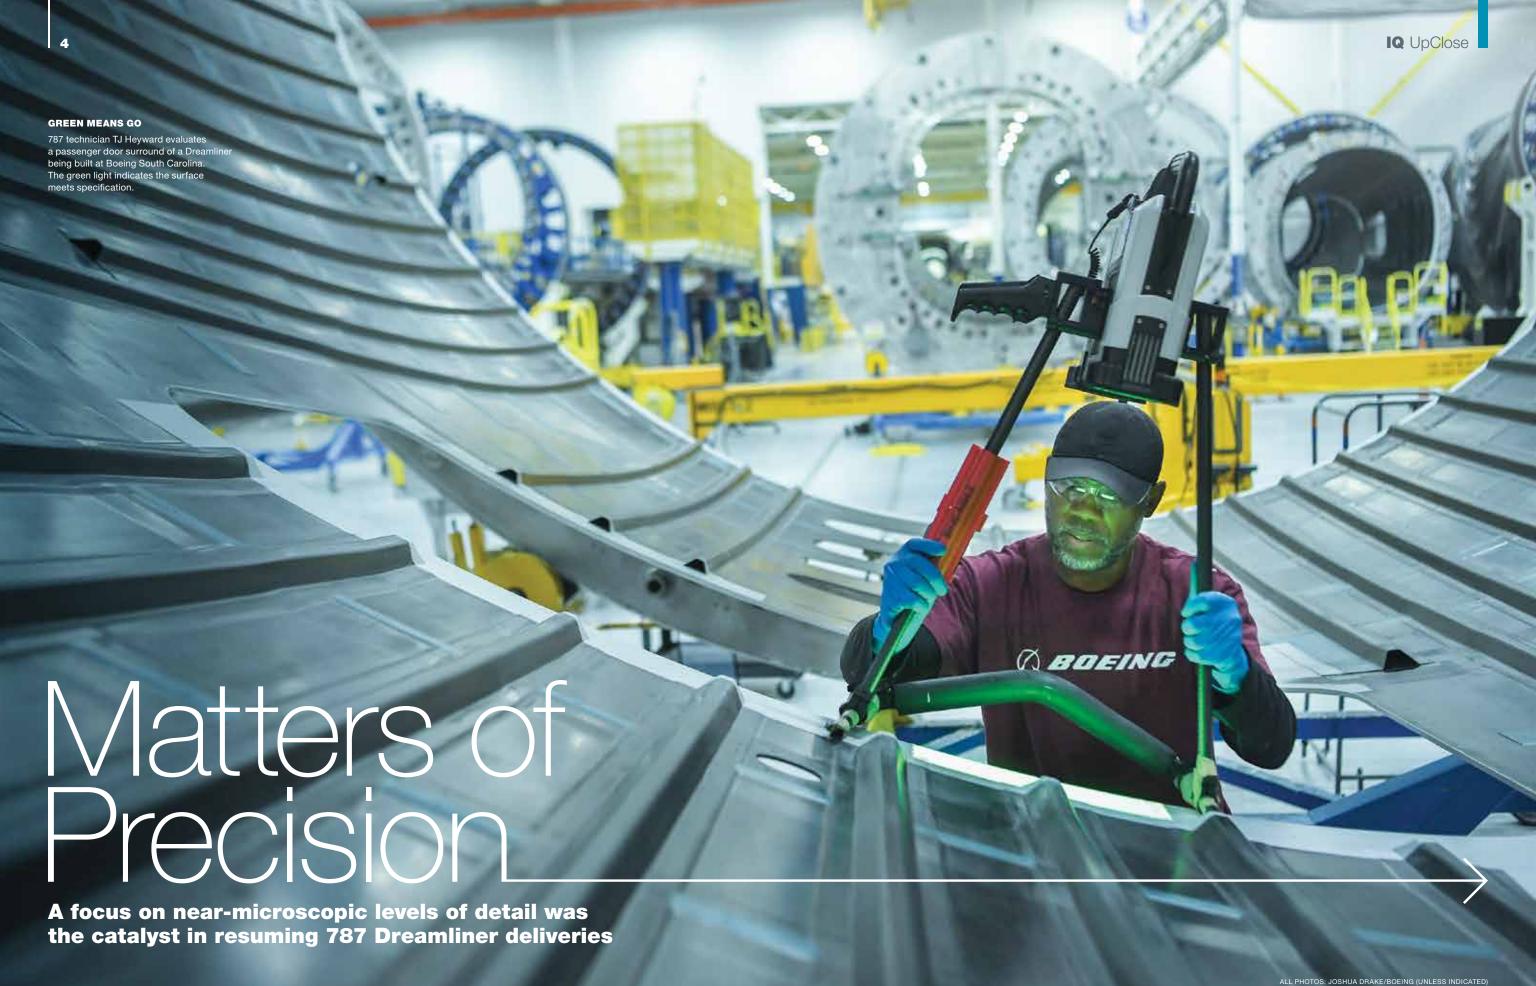
POINT OF LIGHT

787 chief mechanic Kevin Landy inspects a forward pressure bulkhead join surface.

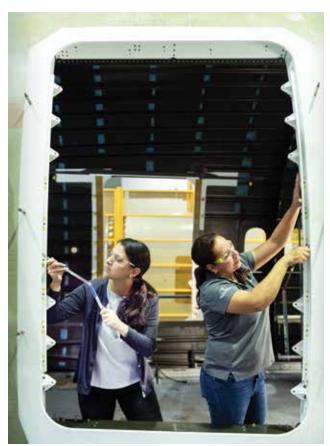
TIGHT-SPOT TOOL

A feeler gauge is used to check for near-microscopic gaps between surfaces to be joined.

There can be a variance of no more than 0.005 inch (0.13 millimeter) — roughly the width of a human hair — over a given 5-inch (13-centimeter) span along the join surface.

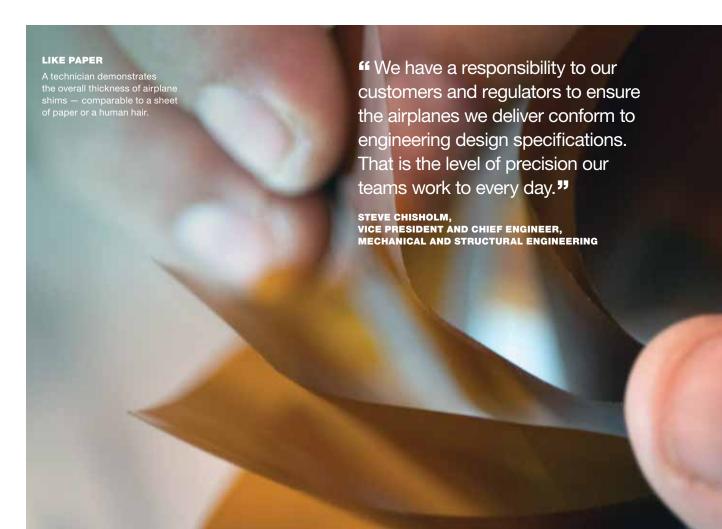
MINDING THE GAPS 787 chief mechanic Matthew Bucalo checks for gap tolerance between join surfaces. "We asked our suppliers to inspect the join surfaces on the fuselage sections they produce, and what we found was a skin flatness variance that was present in multiple locations. This variance could result in minute gaps in the join which, while no thicker than a human hair or a sheet of paper, were outside of our design requirements." MARK STOCKTON, SENIOR DIRECTOR, INNOVATION QUARTERLY | 2022 Q4 | Volume 6 | Issue 22

"We asked our suppliers to inspect the join surfaces on the fuselage sections they produce, and what we found was a skin flatness variance that was present in multiple locations," said Mark Stockton, senior director for 787 Engineering. "This variance could result in minute gaps in the join which, while no thicker than a human hair or a sheet of paper, were outside of our design requirements."

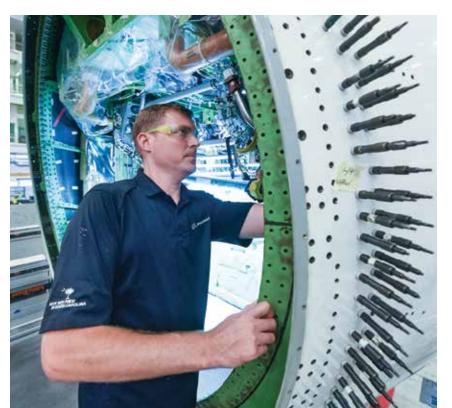
UP TO SPEC

787 chief mechanic Kevin Landy checks measurements during the installation of a 787 forward pressure bulkhead.

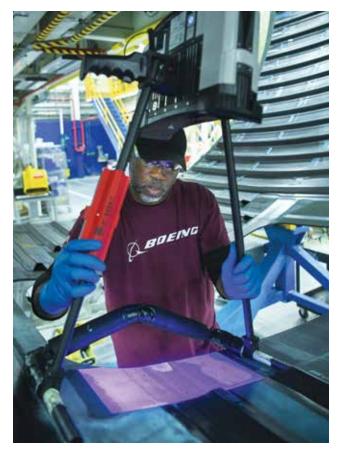
PURPLE POWER

The scanning tool Heyward is using was adapted from the automotive industry. The purple light indicates the machine is calibrating.

New capabilities were tested and incorporated into the production process to verify skin flatness conformance following the fabrication of the fuselage section. The team adapted a tool, originally developed in the automotive industry, as a shop aid to identify areas where the join surface potentially didn't meet flatness requirements. Following the final preparation of the fuselage join surface, a laser scanner is now used to confirm conformance to design specifications.

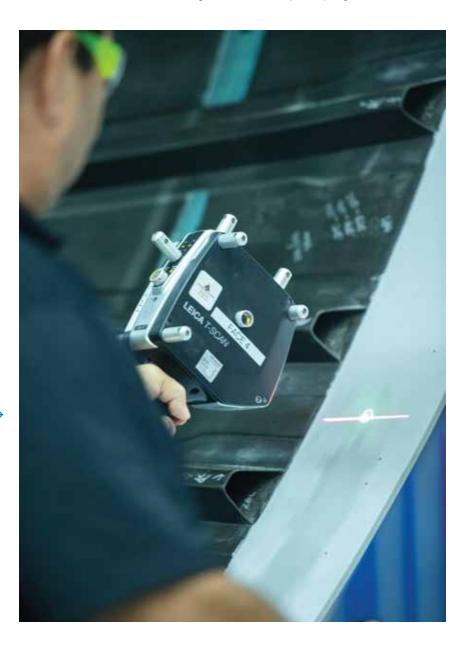
GUIDING LIGHT

A technician uses a laser scanner to perform a final confirmation on the aftbody fuselage join surface.
