APPENDIX H

**BUILDING FEATURE DESCRIPTION LOGS AND
BUILDING FEATURE REMOVAL LOGS**

Appendix H – Building Feature Description (BFD) Logs and Building Feature Removal (Feature Removal) Logs

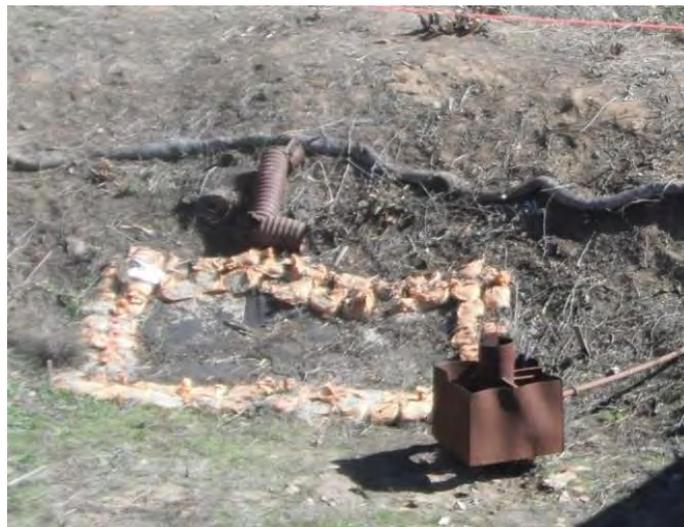
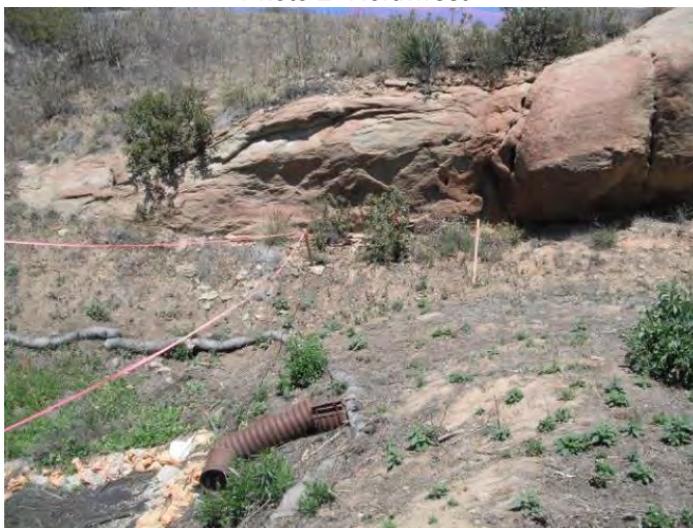
Building Feature Documentation Log
Feature Number: ELV-1D-02
Santa Susana Field Laboratory, Ventura County, California

General Condition: **Intact some corrosion**
Debris: **No**
Staining: **No**
Odor: **No**
PID Reading: **0.0 ppm**
Likelihood of Impact from Feature: **Potential**

Sampling Warranted?: **Yes, inspect and sample, if warranted**
Sampling Description/Notes: **N/A**
Sampling Type: **N/A**
Sample ID Number(s): **None**
Analyses: **N/A**

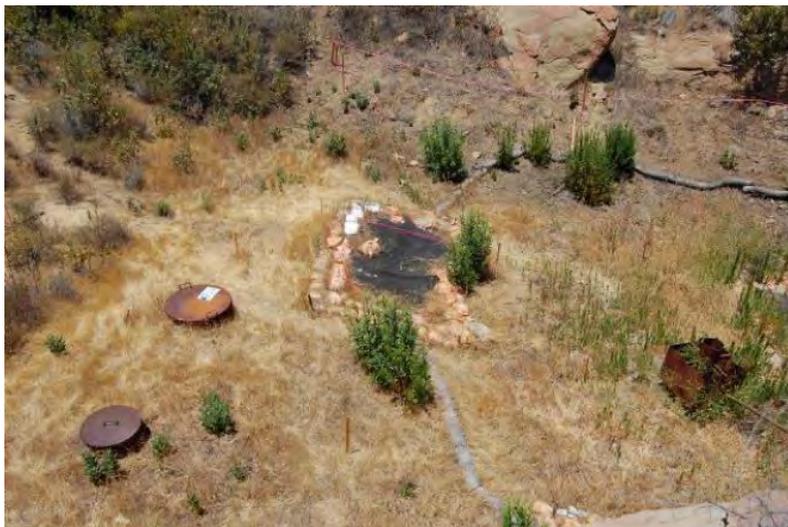
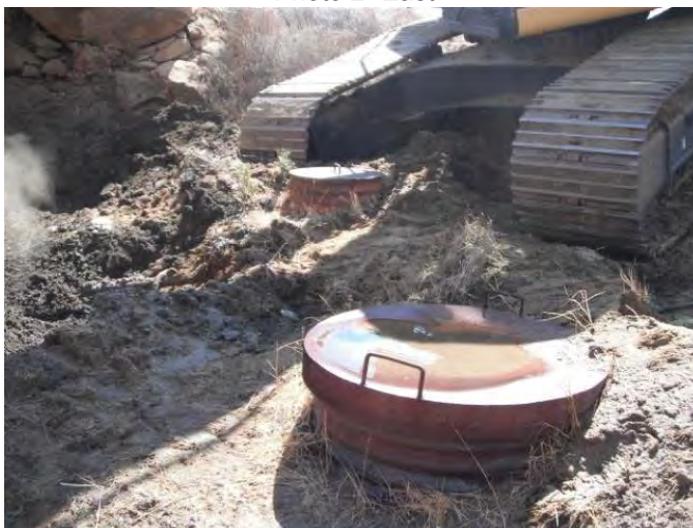
Building Feature Documentation Log
Feature Number: ELV-1D-03
Santa Susana Field Laboratory, Ventura County, California

General Condition: **Intact some corrosion**
Debris: **No**
Staining: **No**
Odor: **No**
PID Reading: **0.0 ppm**
Likelihood of Impact from Feature: **Potential**

Sampling Warranted?: **Yes, inspect and sample, if warranted**
Sampling Description/Notes: **N/A**
Sampling Type: **N/A**
Sample ID Number(s): **None**
Analyses: **N/A**

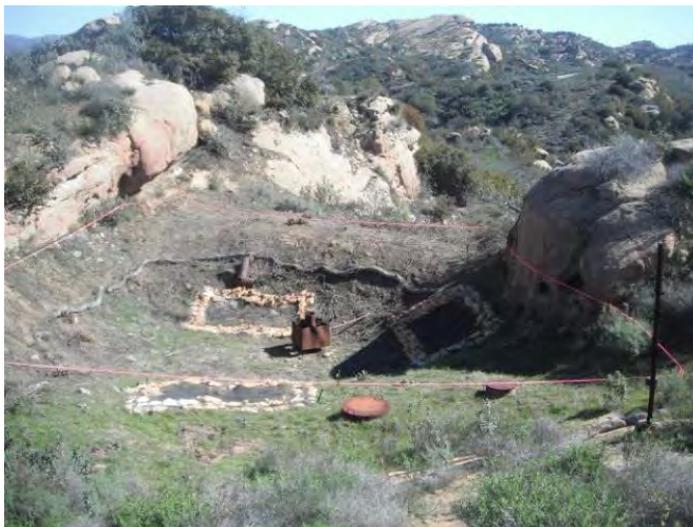
Building Feature Documentation Log
Feature Number: ELV-1D-04
Santa Susana Field Laboratory, Ventura County, California

General Condition: Intact some corrosion
Debris: No
Staining: No
Odor: No
PID Reading: 0.0 ppm
Likelihood of Impact from Feature: Potential

Sampling Warranted?: Yes, inspect and sample, if warranted
Sampling Description/Notes: N/A
Sampling Type: N/A
Sample ID Number(s): None
Analyses: N/A

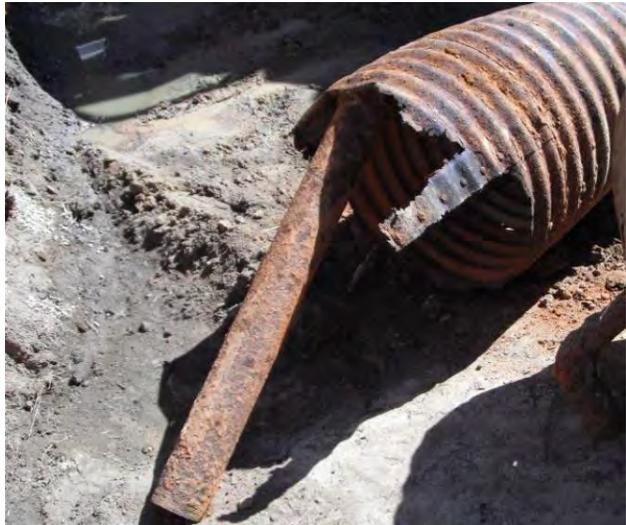
Building Feature Removal Log
Feature Number: ELV-1D-04
Santa Susana Field Laboratory, Ventura County, California

- Condition of Soil: **Not impacted**
- PID Headspace Reading: **0.0 ppm**
- Sample Collected: **No**
- Sample ID: **N/A**
- Analyses: **N/A**
- Comments: **Feature ELV-1D-04 was a subsurface 24-inch corrugated vertical pipe with lid in the western portion of the ELV pond. Pipe was removed during ISRA implementation activities at ISRA area ELV-1D in September 2013. No staining or odors observed in soils during removal (soils were excavated to bedrock within this ISRA area); soil appears to be fill material. GPS Coordinates 268945.330 Northing - 1789628.673 Easting**

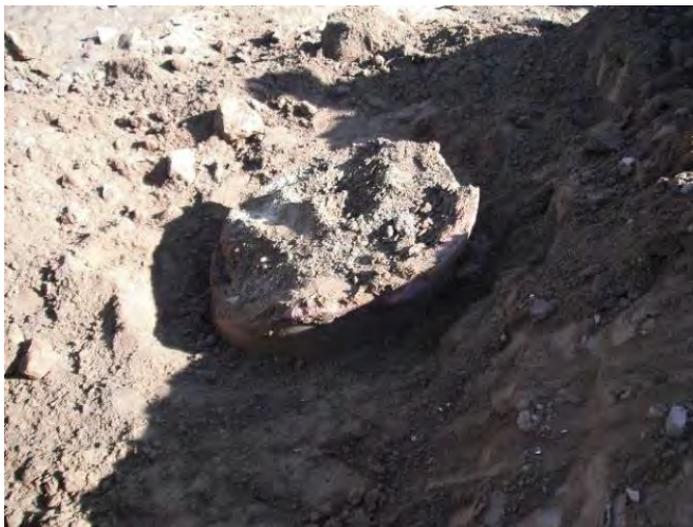
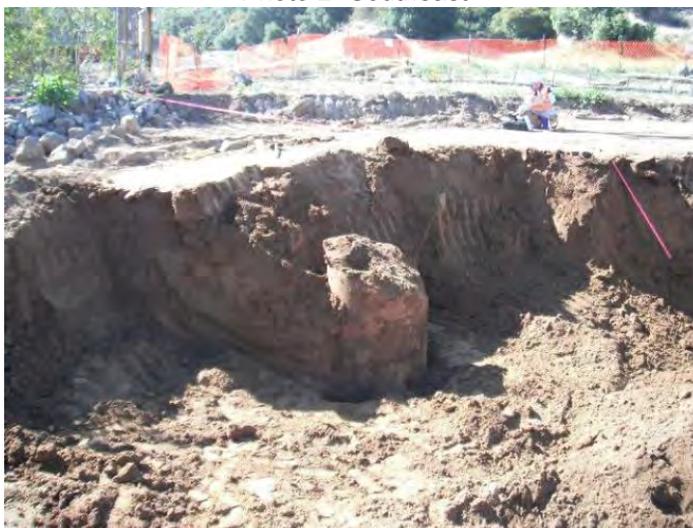
Building Feature Documentation Log
Feature Number: 1301-31
Santa Susana Field Laboratory, Ventura County, California

General Condition: **Broken**
Debris: **No**
Staining: **No**
Odor: **No**
PID Reading: **None**
Likelihood of Impact from Feature: **Unlikely**

Sampling Warranted?: **Yes, sample post-demolition**
Sampling Description/Notes: **A floor soil sample collected on 5/24/11 below feature following removal of feature.**
Sampling Type: **Soil**
Sample ID Number(s): **ILET0114**
Analyses: **VOCs, SVOCs, PCBs, Perchlorate, Metals, Anions, pH, TPH**

- Condition of Soil: **Not Impacted**
- PID Headspace Reading: **0.0 ppm**
- Sample Collected: **Yes**
- Sample ID: **ILET0114**
- Analyses: **VOCs, SVOCs, PCBs, metals, TPH, perchlorate, pH**
- Comments: **Feature 1301-031 was a subsurface concrete cylindrical pipe standing upright and filled with pea gravel near the former location of Building 1301. No staining or odors were observed however a sample was collected from underneath the previous location of the pipe following its removal as part of confirmation sampling at ISRA area IEL-2.**

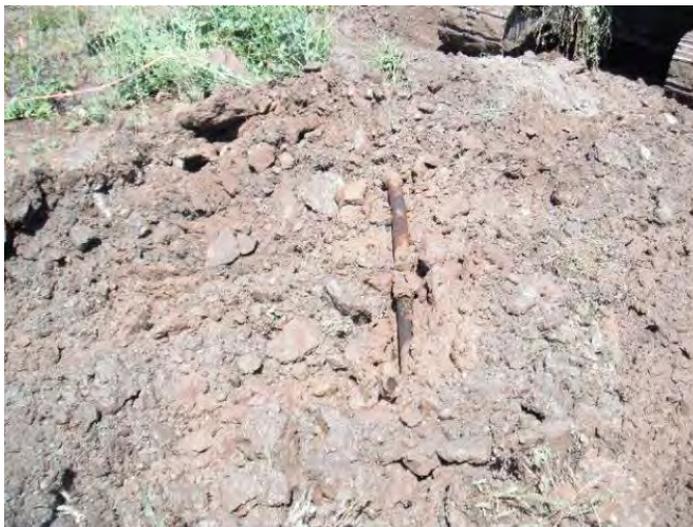
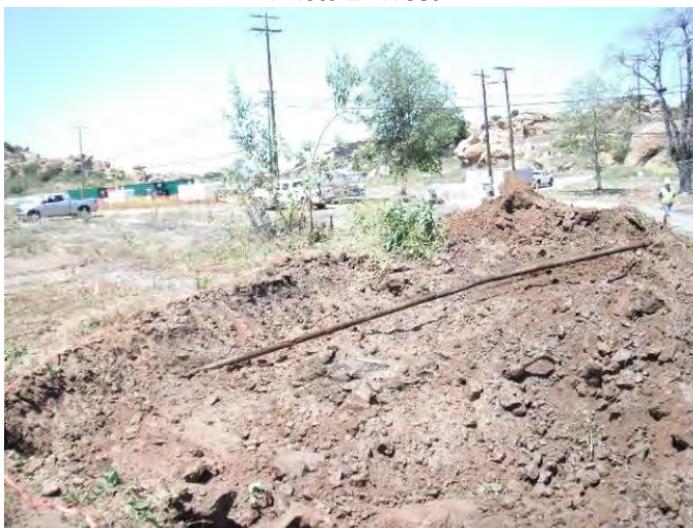
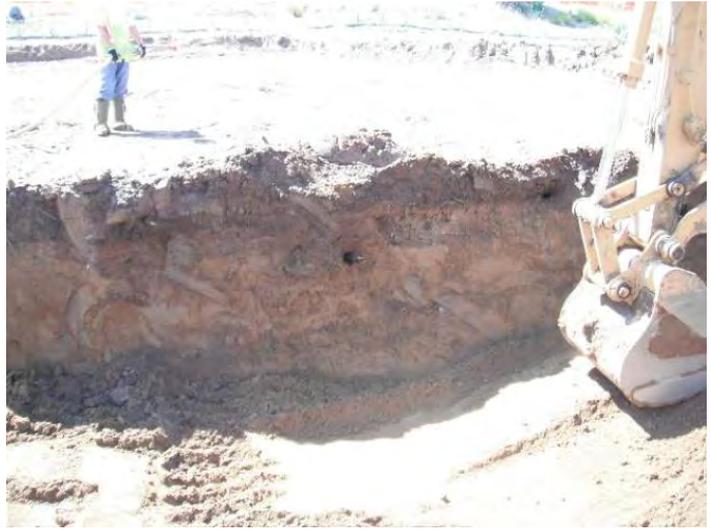
Building Feature Documentation Log
Feature Number: 1301-32
Santa Susana Field Laboratory, Ventura County, California

General Condition: Intact/corrosion
Debris: No
Staining: No
Odor: No
PID Reading: 0.0 ppm
Likelihood of Impact from Feature: Unlikely

- Condition of Soil: **Not Impacted**
- PID Headspace Reading: **0.0 ppm**
- Sample Collected: **No**
- Sample ID: **N/A**
- Analyses: **N/A**
- Comments: **Feature 1301-032 was a subsurface 2-inch metal pipe with couplers trending N 60 E and then N 15 W. Approximately 16 feet of pipeline was removed during ISRA Implementation activities. No staining or odors were observed.**

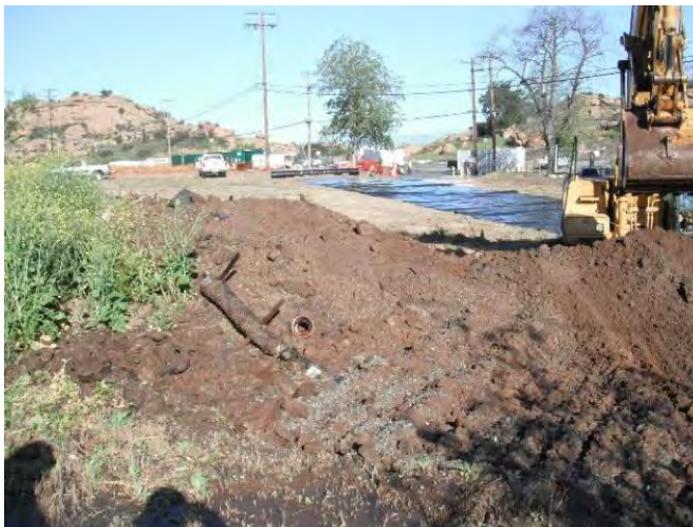
General Condition: Broken
Debris: No
Staining: No
Odor: No
PID Reading: 0.0 ppm
Likelihood of Impact from Feature: Unlikely

- Condition of Soil: **Not Impacted**
- PID Headspace Reading: **N/A**
- Sample Collected: **No**
- Sample ID: **N/A**
- Analyses: **N/A**
- Comments: **Feature 1301-033 was a subsurface 3-inch clay sewer drain line. Approximately 1.5 feet was removed during ISRA implementation activities. No staining or odors were observed.**

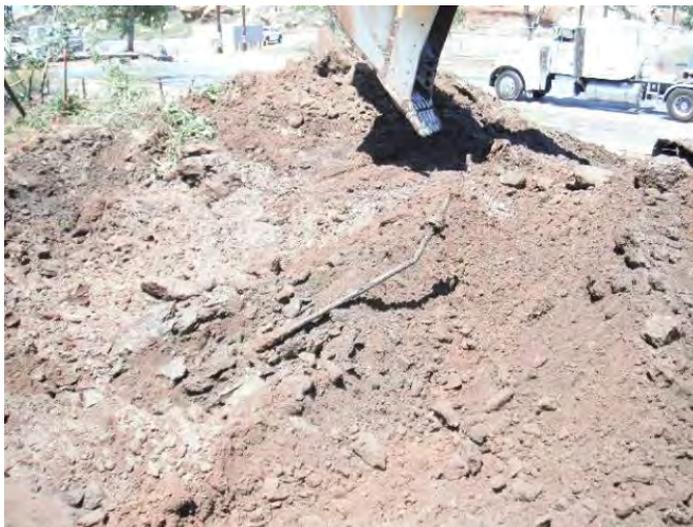
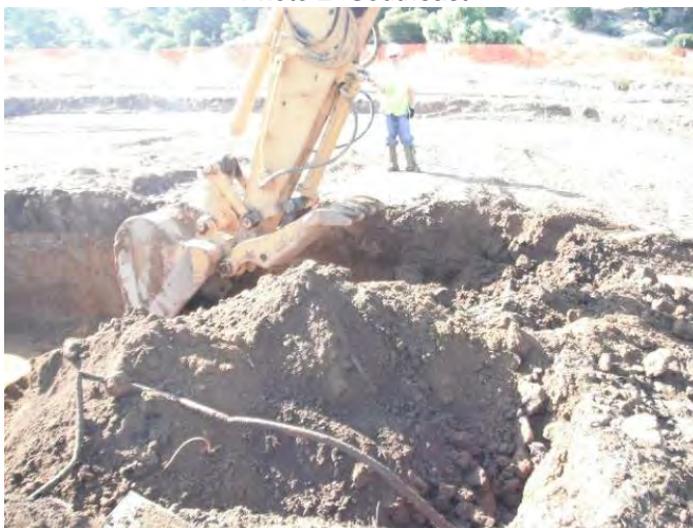
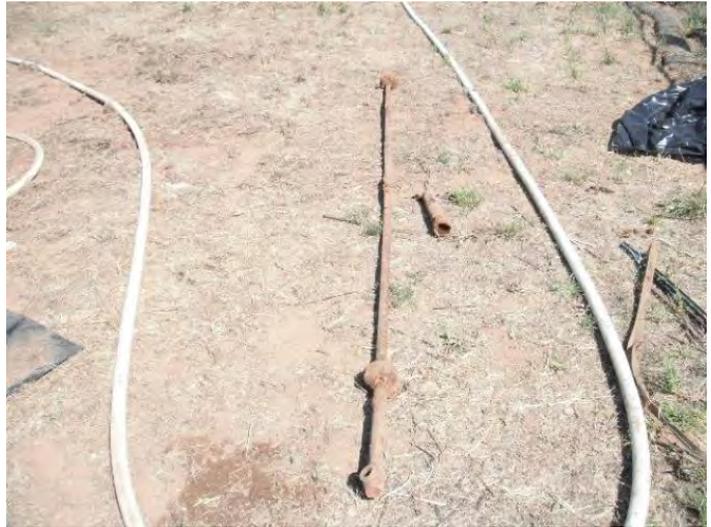
Building Feature Documentation Log
Feature Number: 1301-34
Santa Susana Field Laboratory, Ventura County, California

General Condition: Intact/corrosion
Debris: No
Staining: No
Odor: No
PID Reading: 0.0 ppm
Likelihood of Impact from Feature: Unlikely

- Condition of Soil: **Not Impacted**
- PID Headspace Reading: **0.0 ppm**
- Sample Collected: **No**
- Sample ID: **N/A**
- Analyses: **N/A**
- Comments: **Feature 1301-034 was a subsurface 1-inch metal pipe with couplers trending N 60 E then N 15 W. Approximately 26 feet of pipeline was removed during ISRA Implementation activities. No staining or odors were observed.**

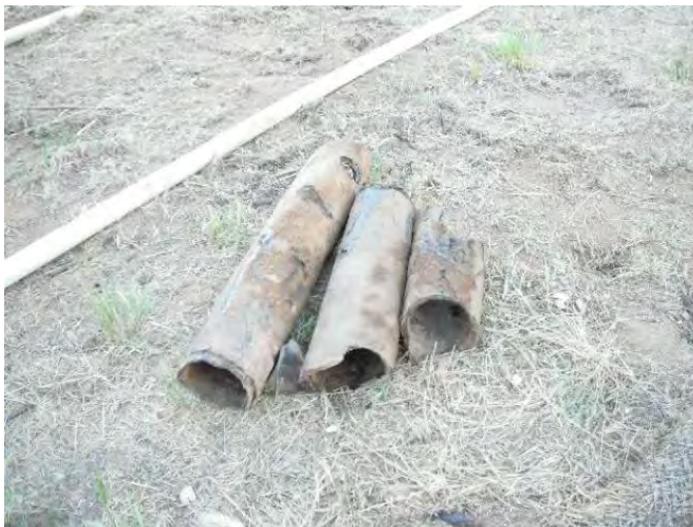
General Condition: Broken
Debris: No
Staining: No
Odor: No
PID Reading: 0.0 ppm
Likelihood of Impact from Feature: Unlikely

Sampling Warranted?: Yes
Sampling Description/Notes: Piping sampled by Boeing for ACMs
Sampling Type: Solids
Sample ID Number(s): ISRA-051011-1, ISRA-051011-2, ISRA-051011-3
Analyses: Asbestos

- Condition of Soil: **Not Impacted**
- PID Headspace Reading: **0.0 ppm**
- Sample Collected: **No**
- Sample ID: **N/A**
- Analyses: **N/A**
- Comments: **Feature 1301-035 was a subsurface 3-inch section of pipe that did not appear to be in place when it was removed. Approximately 3 feet of pipe was removed during ISRA Implementation activities. No staining or odors were observed.**

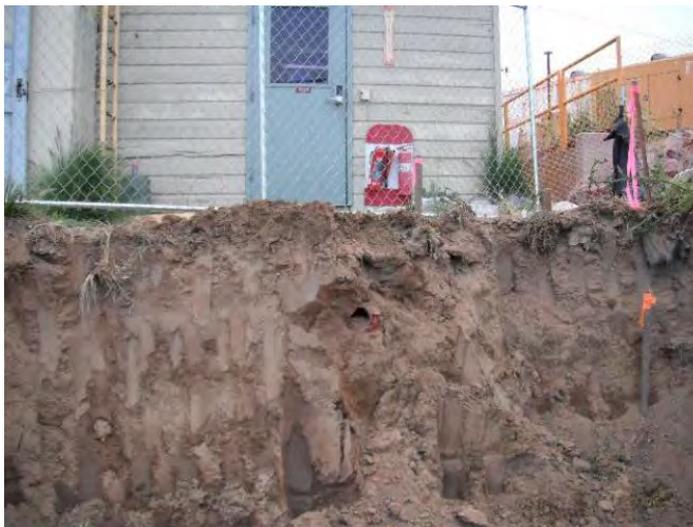
General Condition: Broken pieces
Debris: No
Staining: No
Odor: No
PID Reading: 0.0 ppm
Likelihood of Impact from Feature: Unlikely

- Condition of Soil: **Not Impacted**
- PID Headspace Reading: **0.0 ppm**
- Sample Collected: **No**
- Sample ID: **N/A**
- Analyses: **N/A**
- Comments: **Feature 1301-036 was a subsurface 3-inch clay sewer drain pipeline, which trends N 45 E and continues beneath Building 1302 (Fire Station) where it is in place. Approximately 3 feet of pipe was removed during ISRA Implementation activities. No staining or odors were observed.**

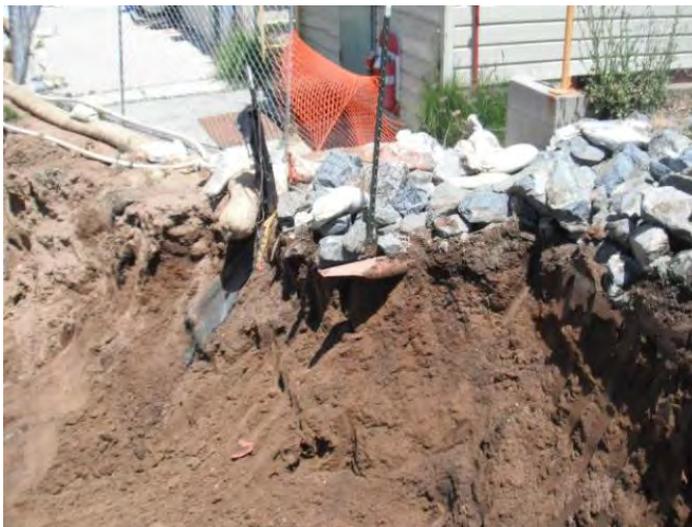
General Condition: Broken pieces
Debris: No
Staining: No
Odor: No
PID Reading: 0.0 ppm
Likelihood of Impact from Feature: Unlikely

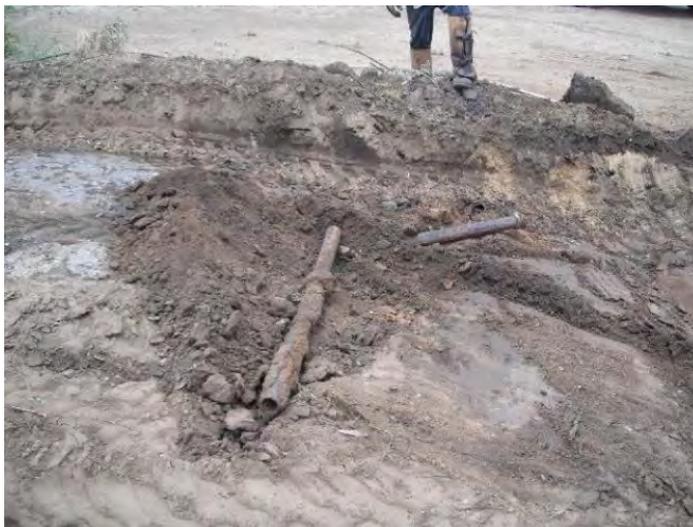
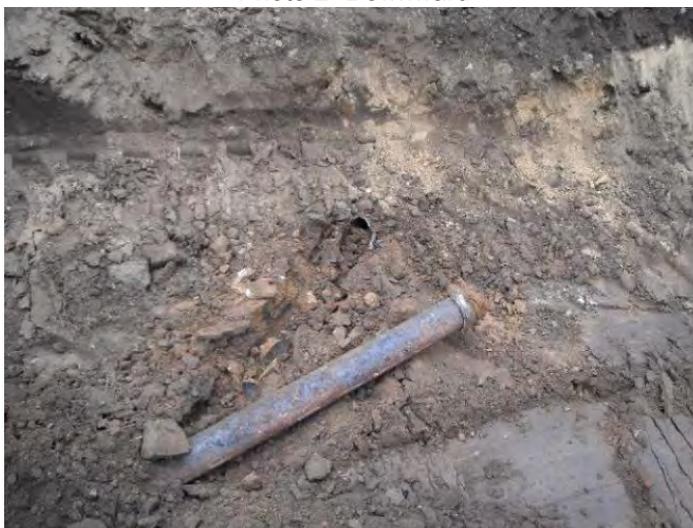
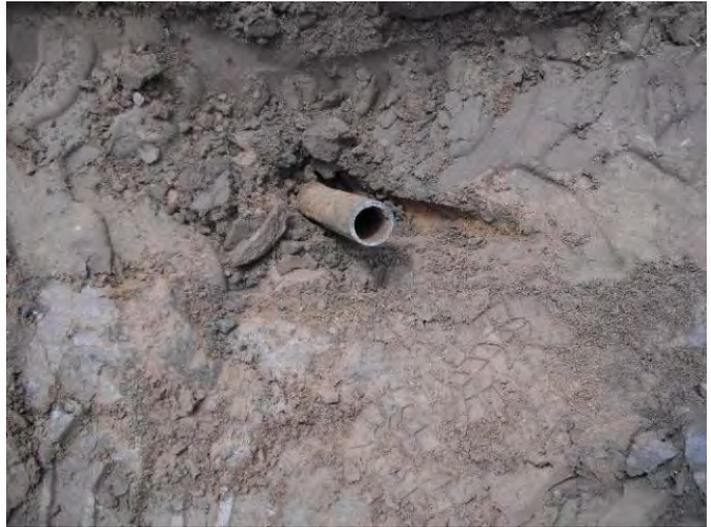
Building Feature Documentation Log
Feature Number: 1301-38
Santa Susana Field Laboratory, Ventura County, California

General Condition: Intact
Debris: No
Staining: No
Odor: No
PID Reading: 0.0 ppm
Likelihood of Impact from Feature: Unlikely

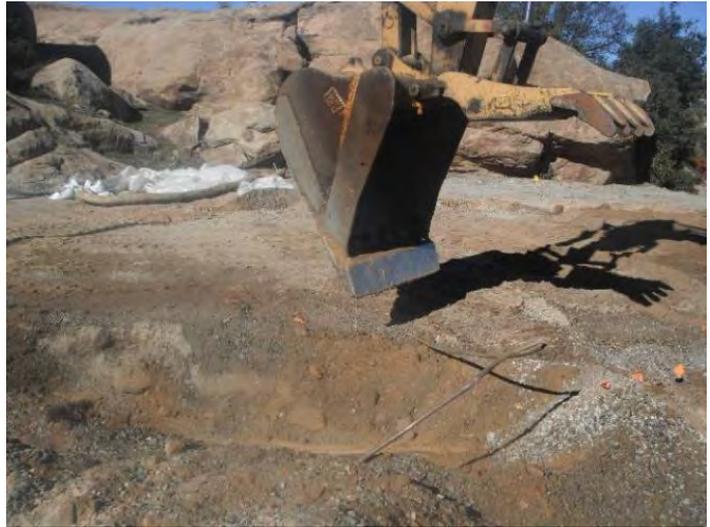
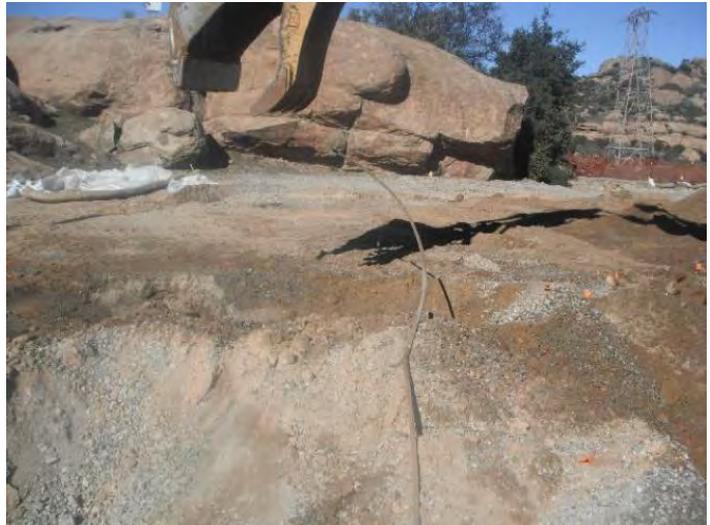
Building Feature Removal Log
Feature Number: 1300-43
Santa Susana Field Laboratory, Ventura County, California

- Condition of Soil: **Not impacted.**
- PID Headspace Reading: **0.0 ppm**
- Sample Collected: **No**
- Sample ID: **N/A**
- Analyses: **N/A**
- Comments: **Feature 1300-043 was a subsurface 1.5-inch pipe with couplers, trending approximately N 30 E in the western portion of former Building 1300. Approximately 15 feet of pipe was removed during ISRA Implementation activities at ISRA area IEL-3 in January 2013. No staining or odors observed in soils during removal; soil appears to be fill material. GPS Coordinates: 268443.744 Northing - 1795960.637 Easting.**

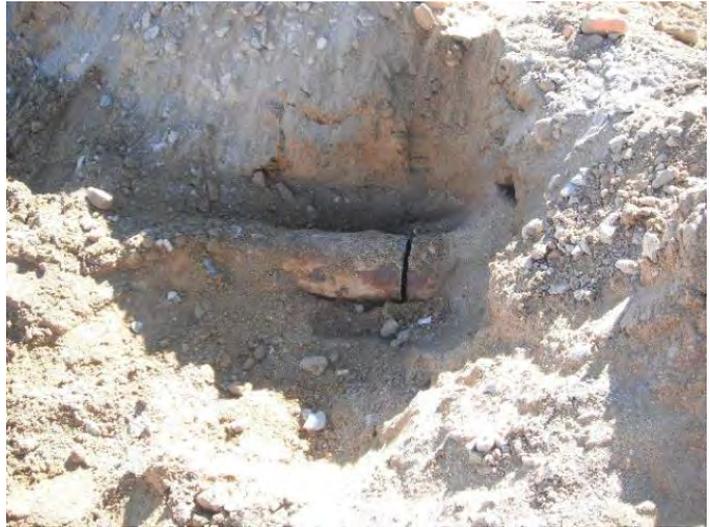
Building Feature Removal Log
Feature Number: 1300-44
Santa Susana Field Laboratory, Ventura County, California

- Condition of Soil: **Not impacted**
- PID Headspace Reading: **0.0 ppm**
- Sample Collected: **No**
- Sample ID: **N/A**
- Analyses: **N/A**
- Comments: **Feature 1300-044 was a subsurface 4-inch electrical conduit, trending approximately N 30 E in the western portion of former Building 1300. Approximately 70 feet of pipe was removed during ISRA Implementation activities at ISRA area IEL-3 in January 2013. No staining or odors observed in soils during removal; soil appears to be fill material. GPS Coordinates: 268416.319 Northing - 1795968.853 Easting.**

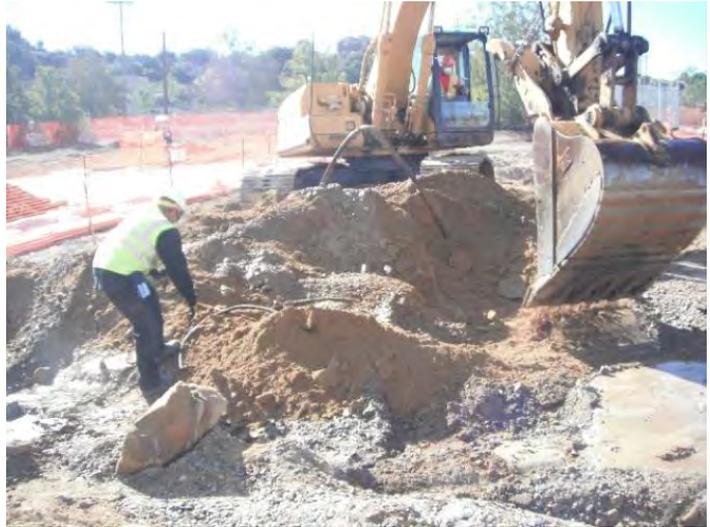
Photo 1- South

- Condition of Soil: **Not impacted**
- PID Headspace Reading: **0.0 ppm**
- Sample Collected: **No**
- Sample ID: **N/A**
- Analyses: **N/A**
- Comments: **Feature 1300-046 was a subsurface 1-inch piping with couplers trending approximately N 60 W in the western portion of former Building 1300. Approximately 15 feet of piping was removed during ISRA Implementation activities at ISRA area IEL-3 in January 2013. No staining or odors observed during removal; soil appears to be fill material. GPS Coordinates: 268421.964 Northing 1795960.637 Easting.**

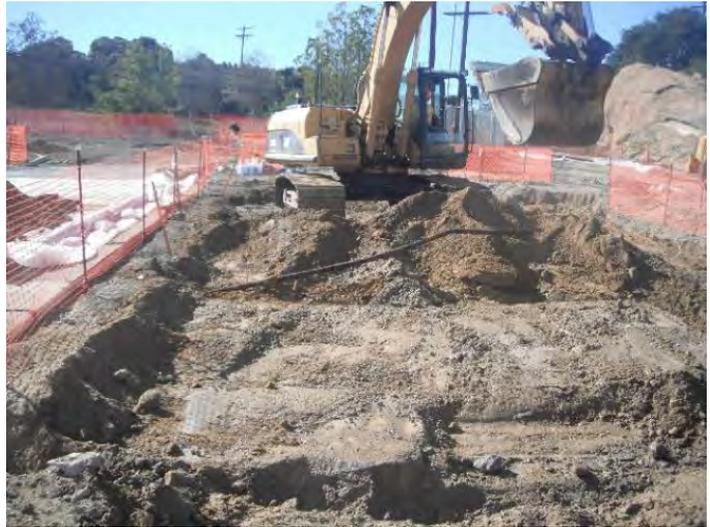
Photo 1- Southwest

- Condition of Soil: **Not impacted.**
- PID Headspace Reading: **0.0 ppm**
- Sample Collected: **No**
- Sample ID: **N/A**
- Analyses: **N/A**
- Comments: **Feature 1300-048 was a subsurface 2-inch piping with couplers trending N 60 W in the western portion of former Building 1300. Approximately 10 feet of piping was removed during ISRA Implementation activities at ISRA area IEL-3 in January 2013. No staining or odors observed during removal; soil appears to be fill material. GPS coordinates 268421.134 Northing 1795980.54 Easting.**
